# Stormwater Inspection

07/11/2016

Operator: Western Operating

Location ID: 435387

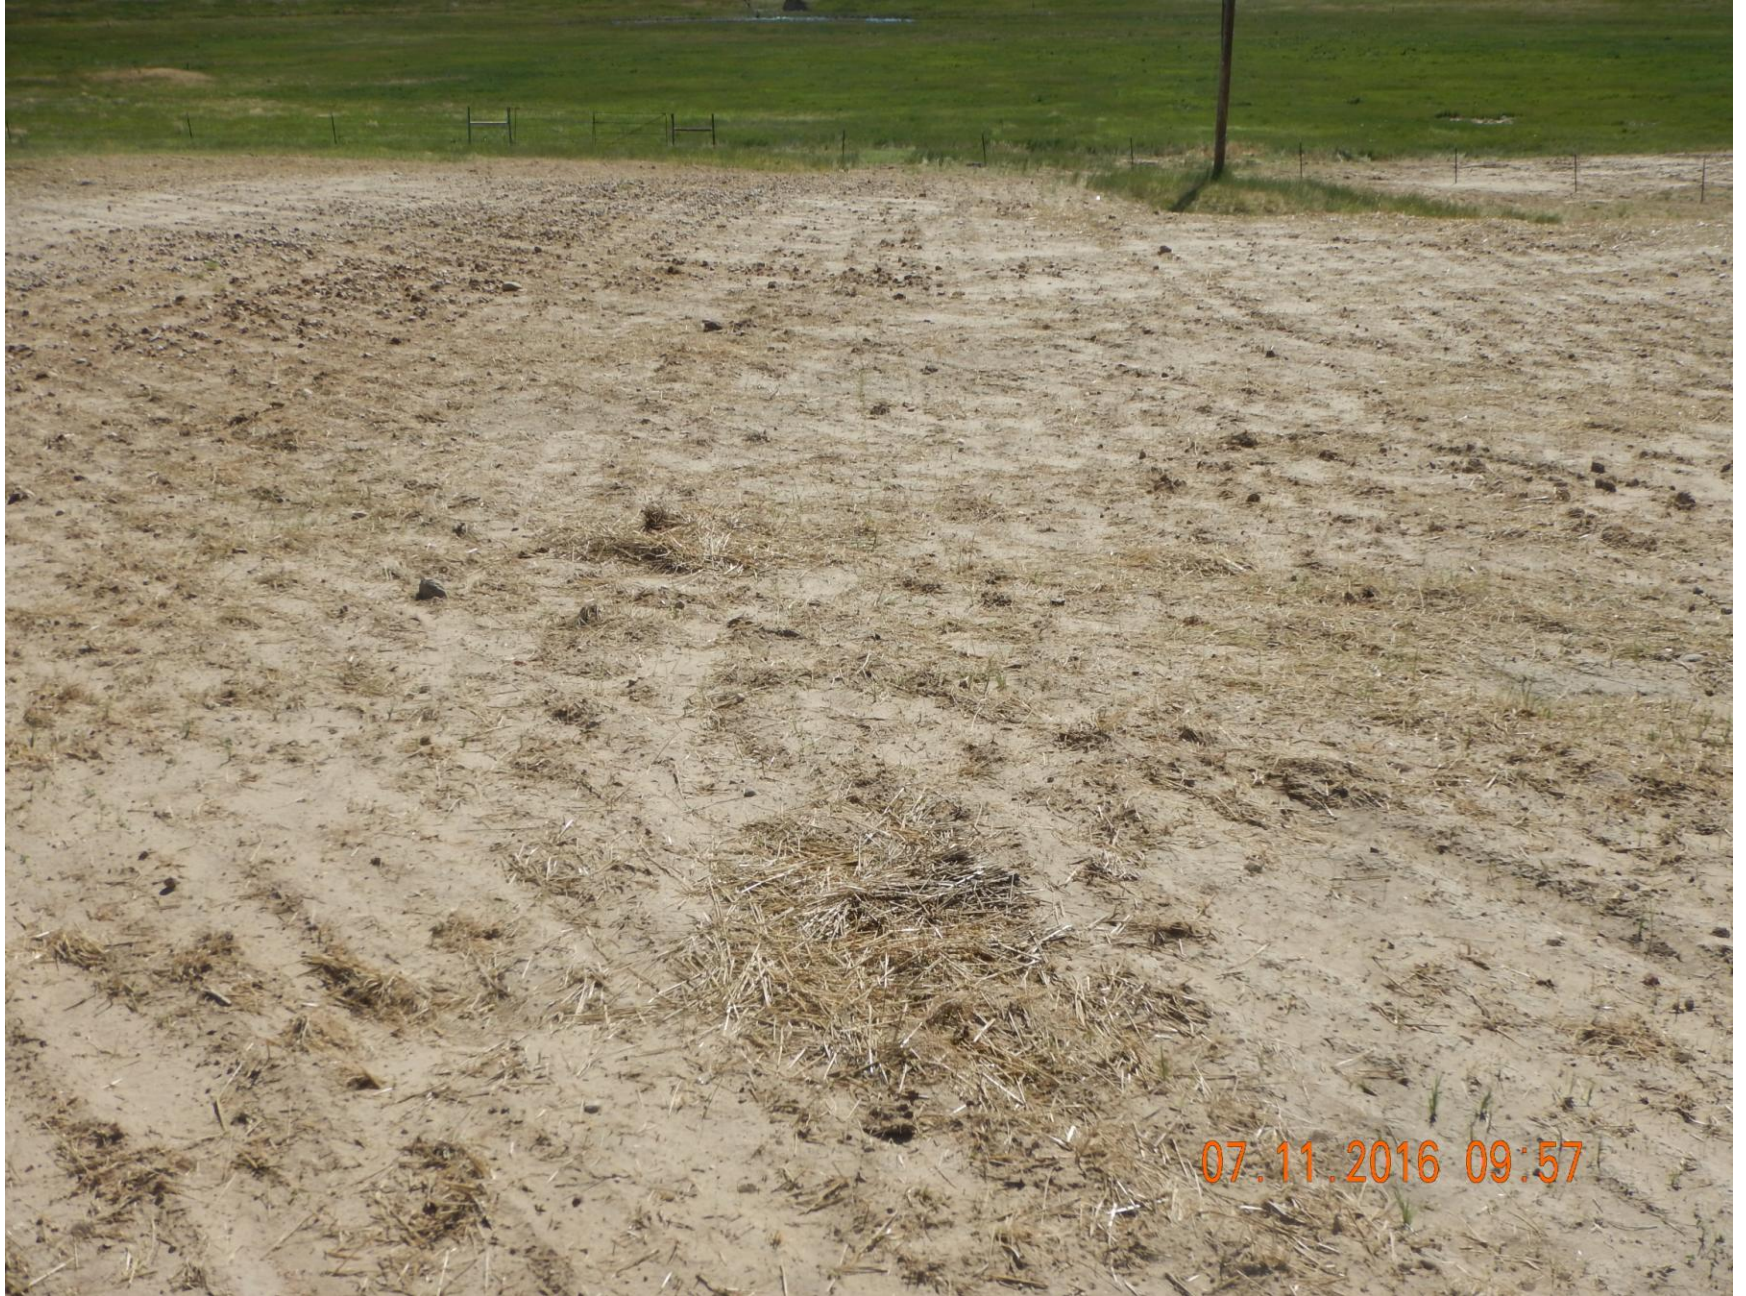
**Figure 2:** Photo taken from the south end of the location, facing east. Photo shows area where gully erosion had occurred had been repaired and seeded.

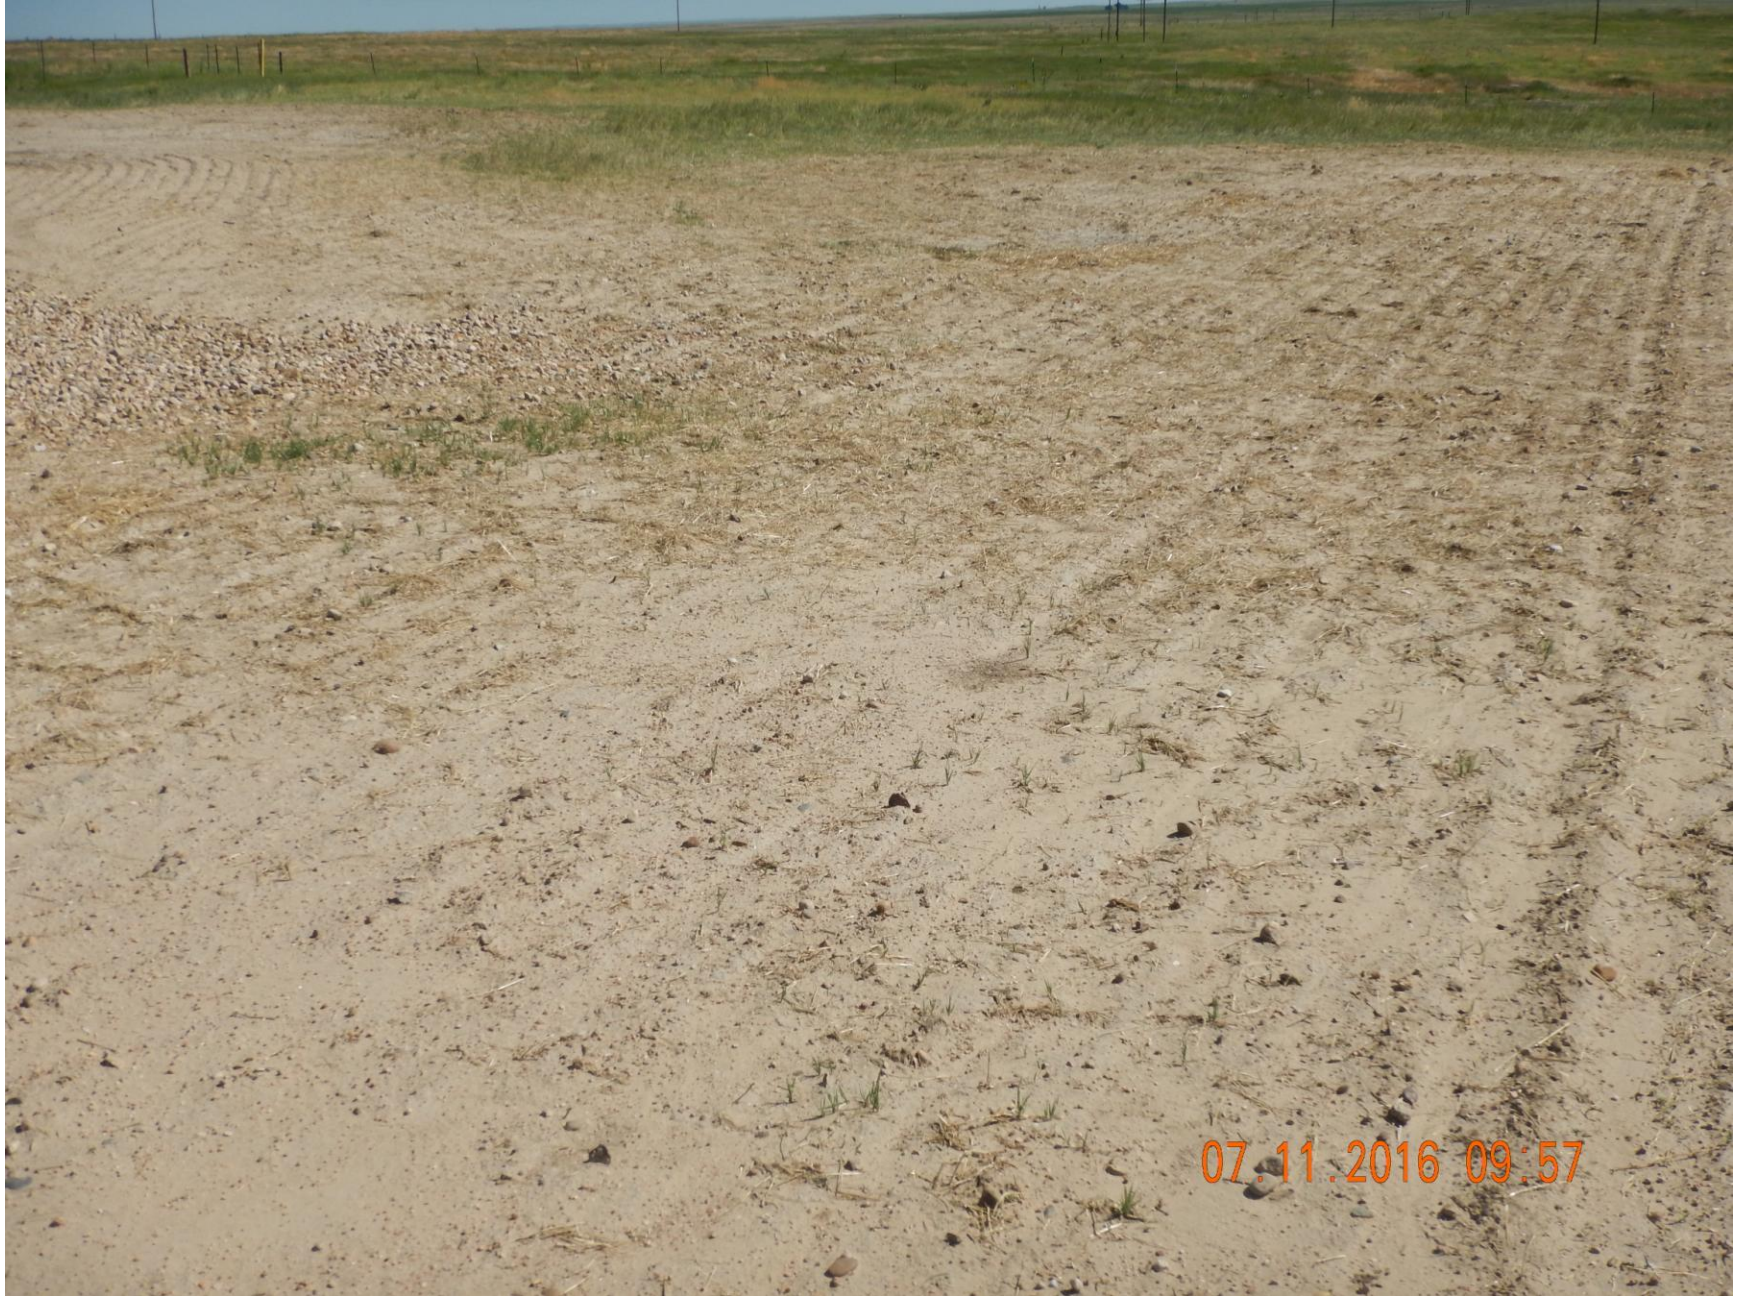
**Figure 3:** Photo taken from the south end of the location, facing northeast. Photo shows area where gully erosion had occurred had been repaired and seeded.

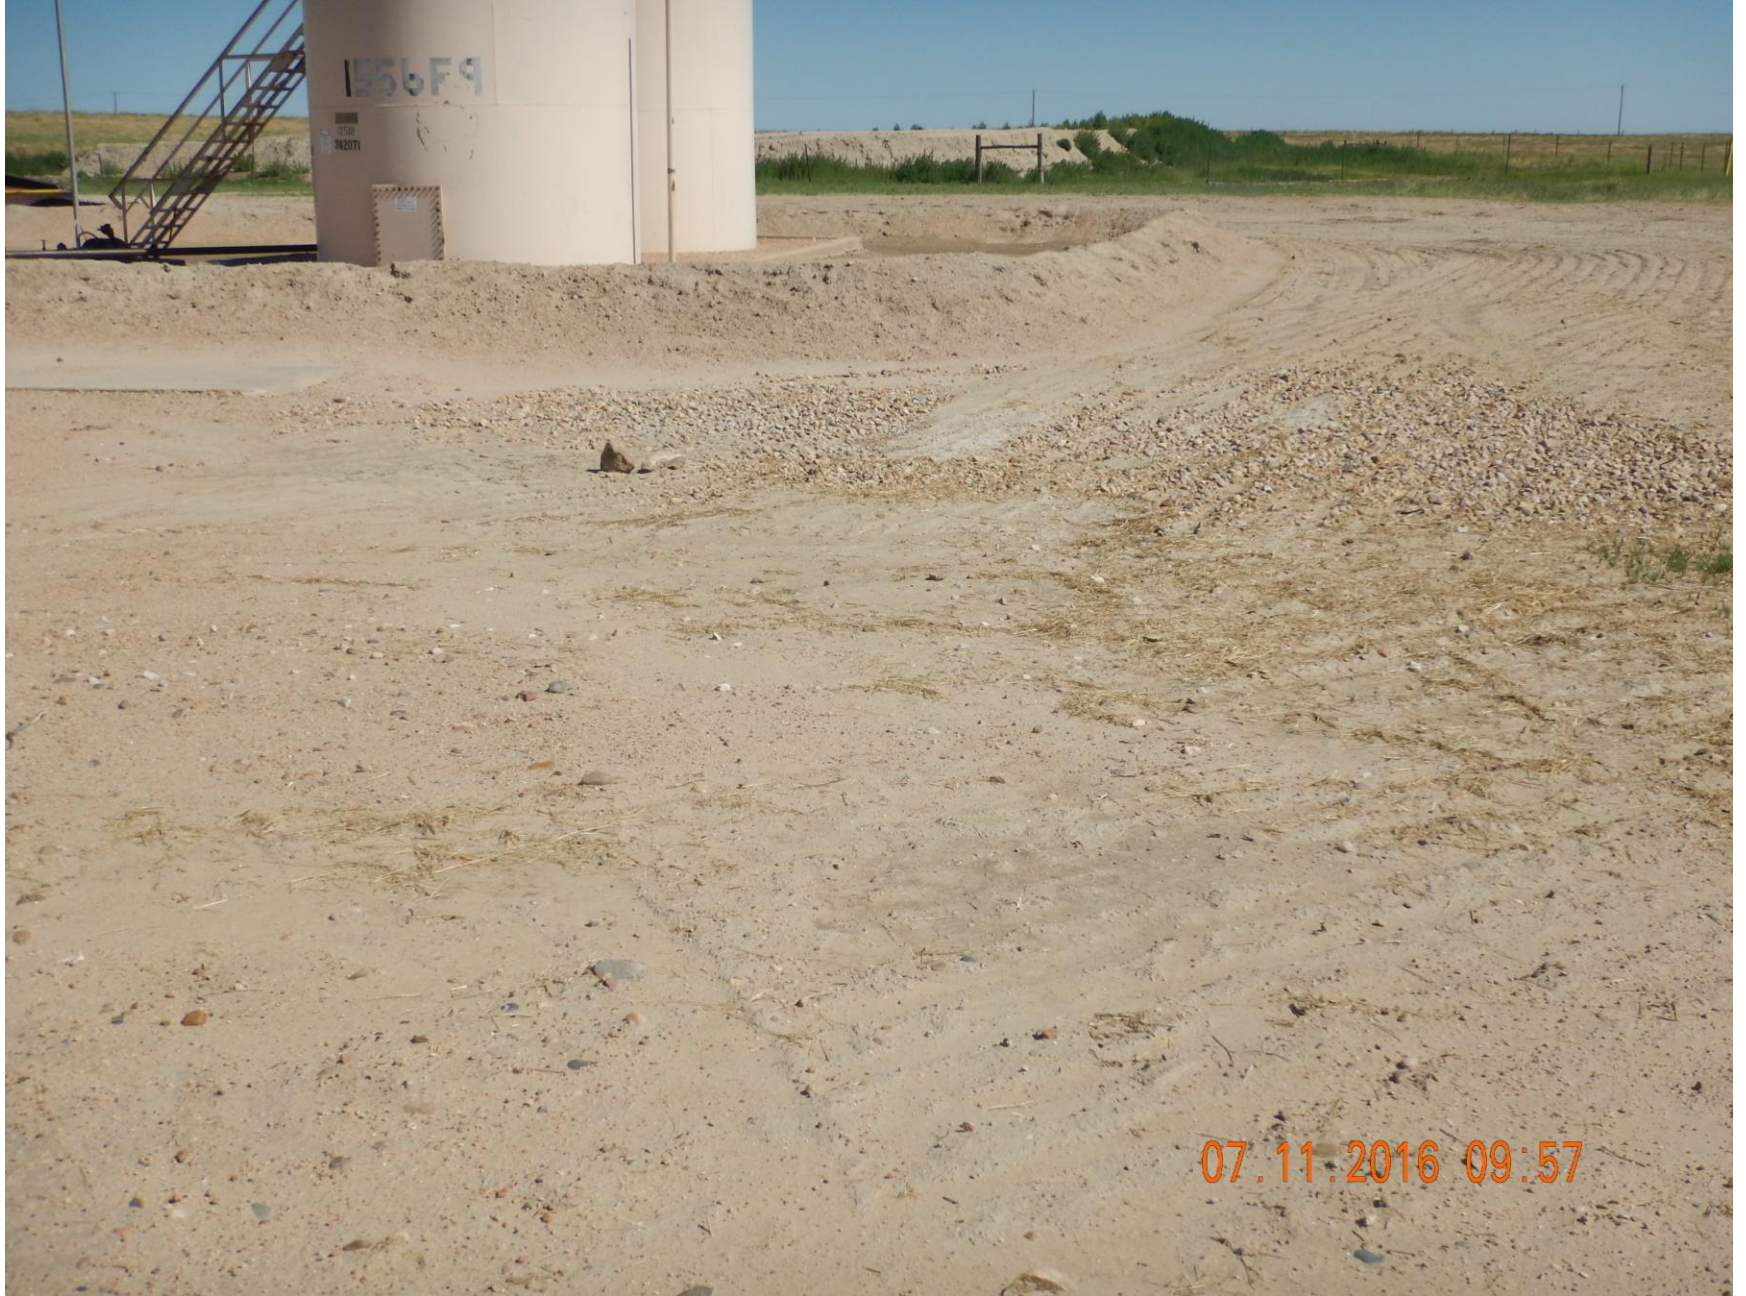
**Figure 4:** Photo taken from the south end of the location, facing north. Photo shows area where gully erosion had occurred had been repaired and seeded.

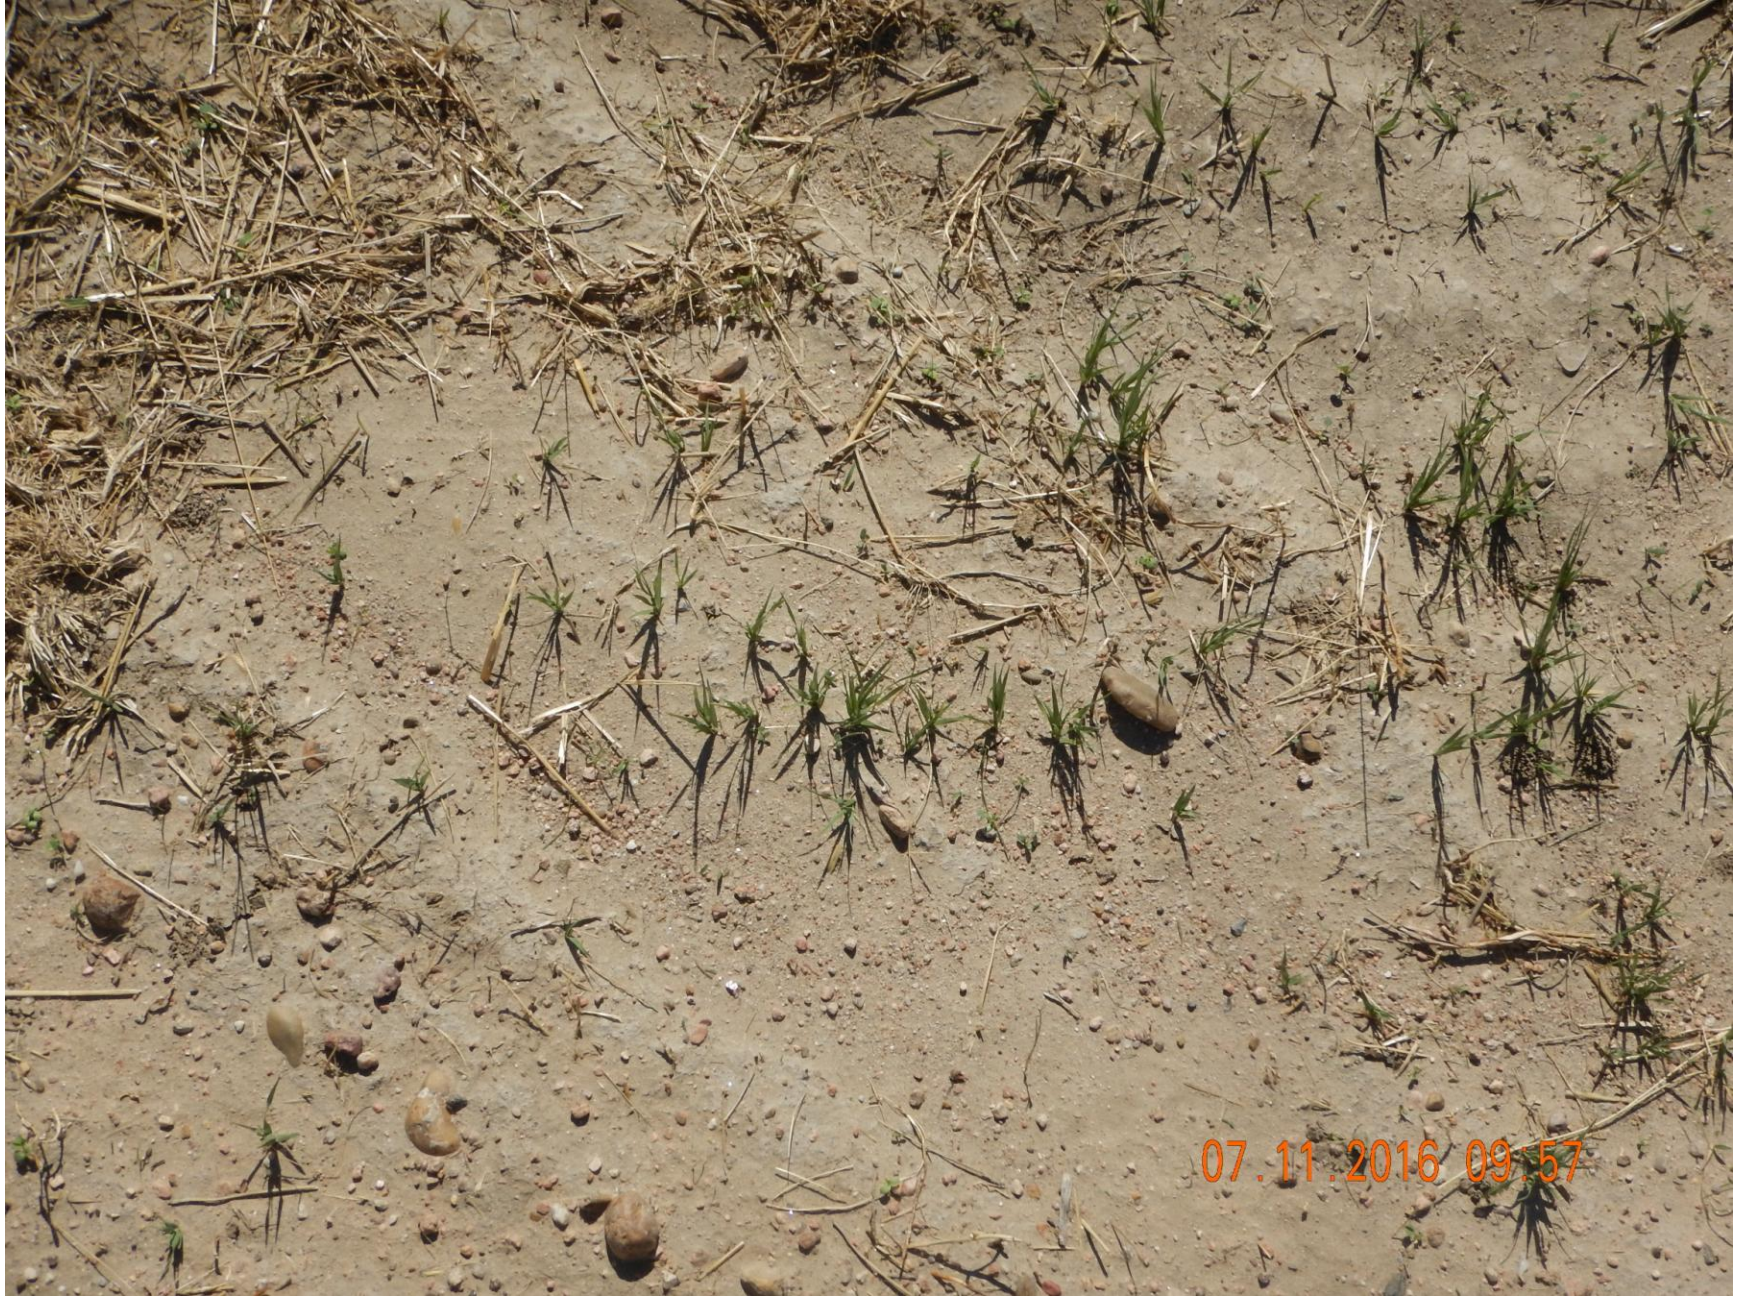
**Figure 5:** Photo taken from the east end of the location. Photo shows germination over the seeded area.

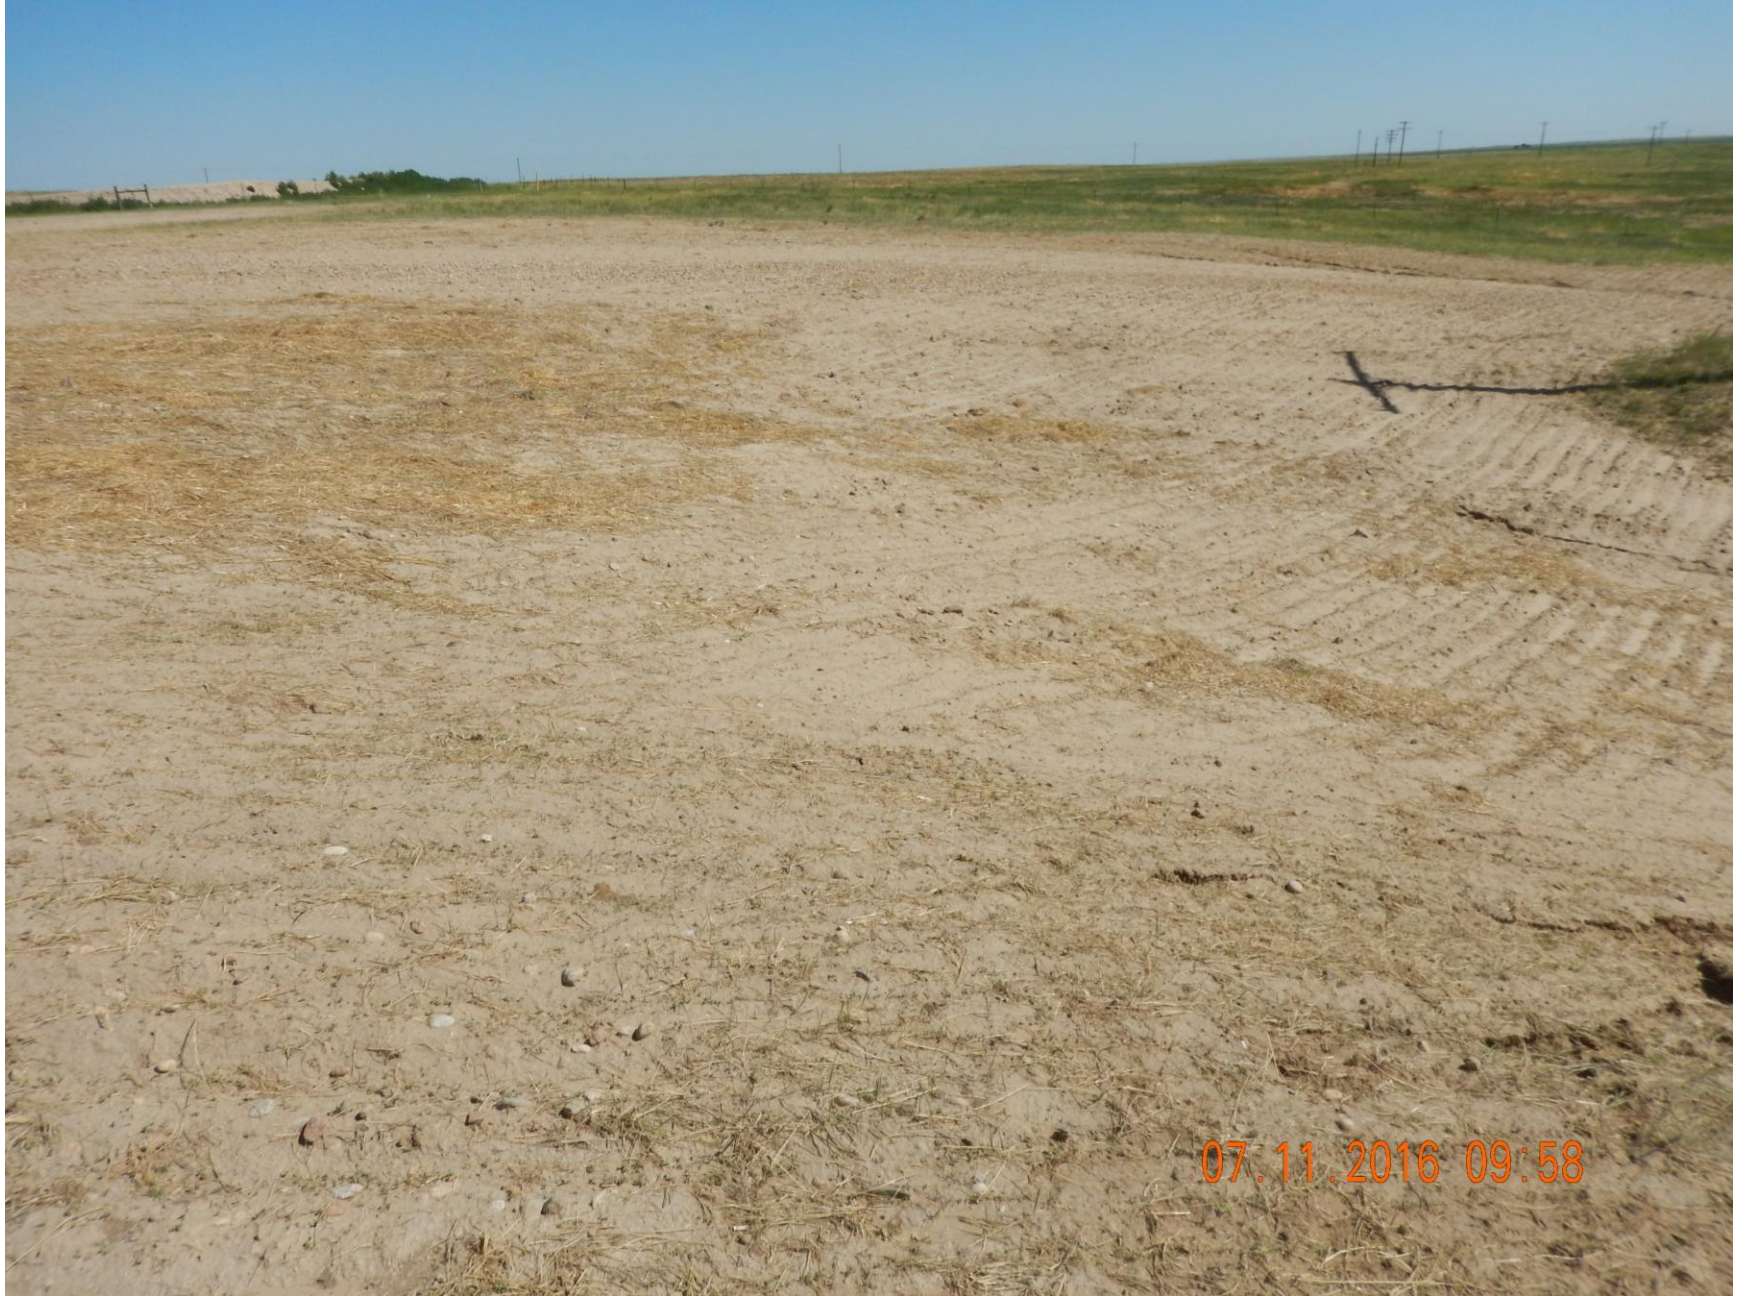
**Figure 6:** Photo taken from the east end of the location, facing north. Photo shows gully erosion beginning to reform on the right of the photo.

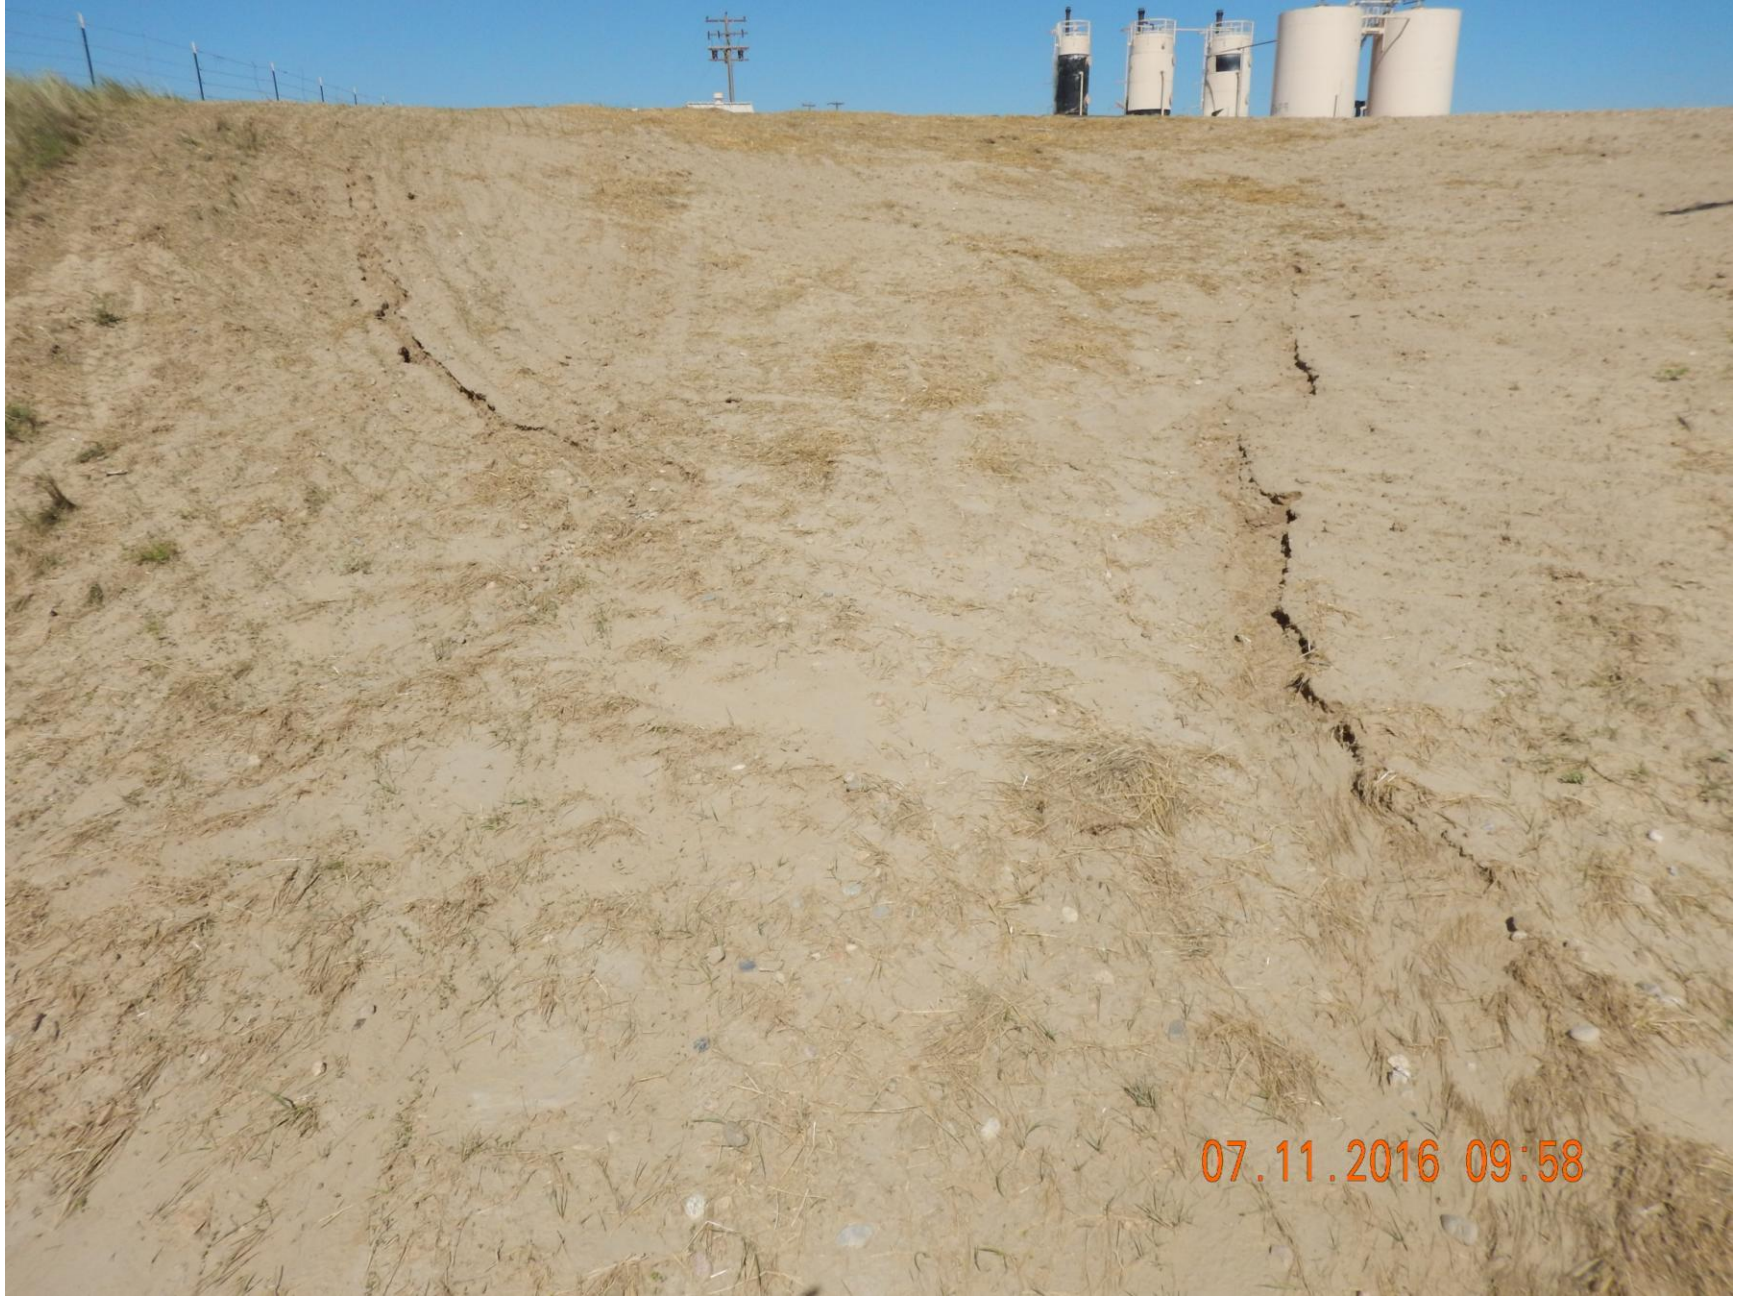
**Figure 7:** Photo taken from the east end of the location, facing west. Photo shows erosion occurring over the reclamation area.

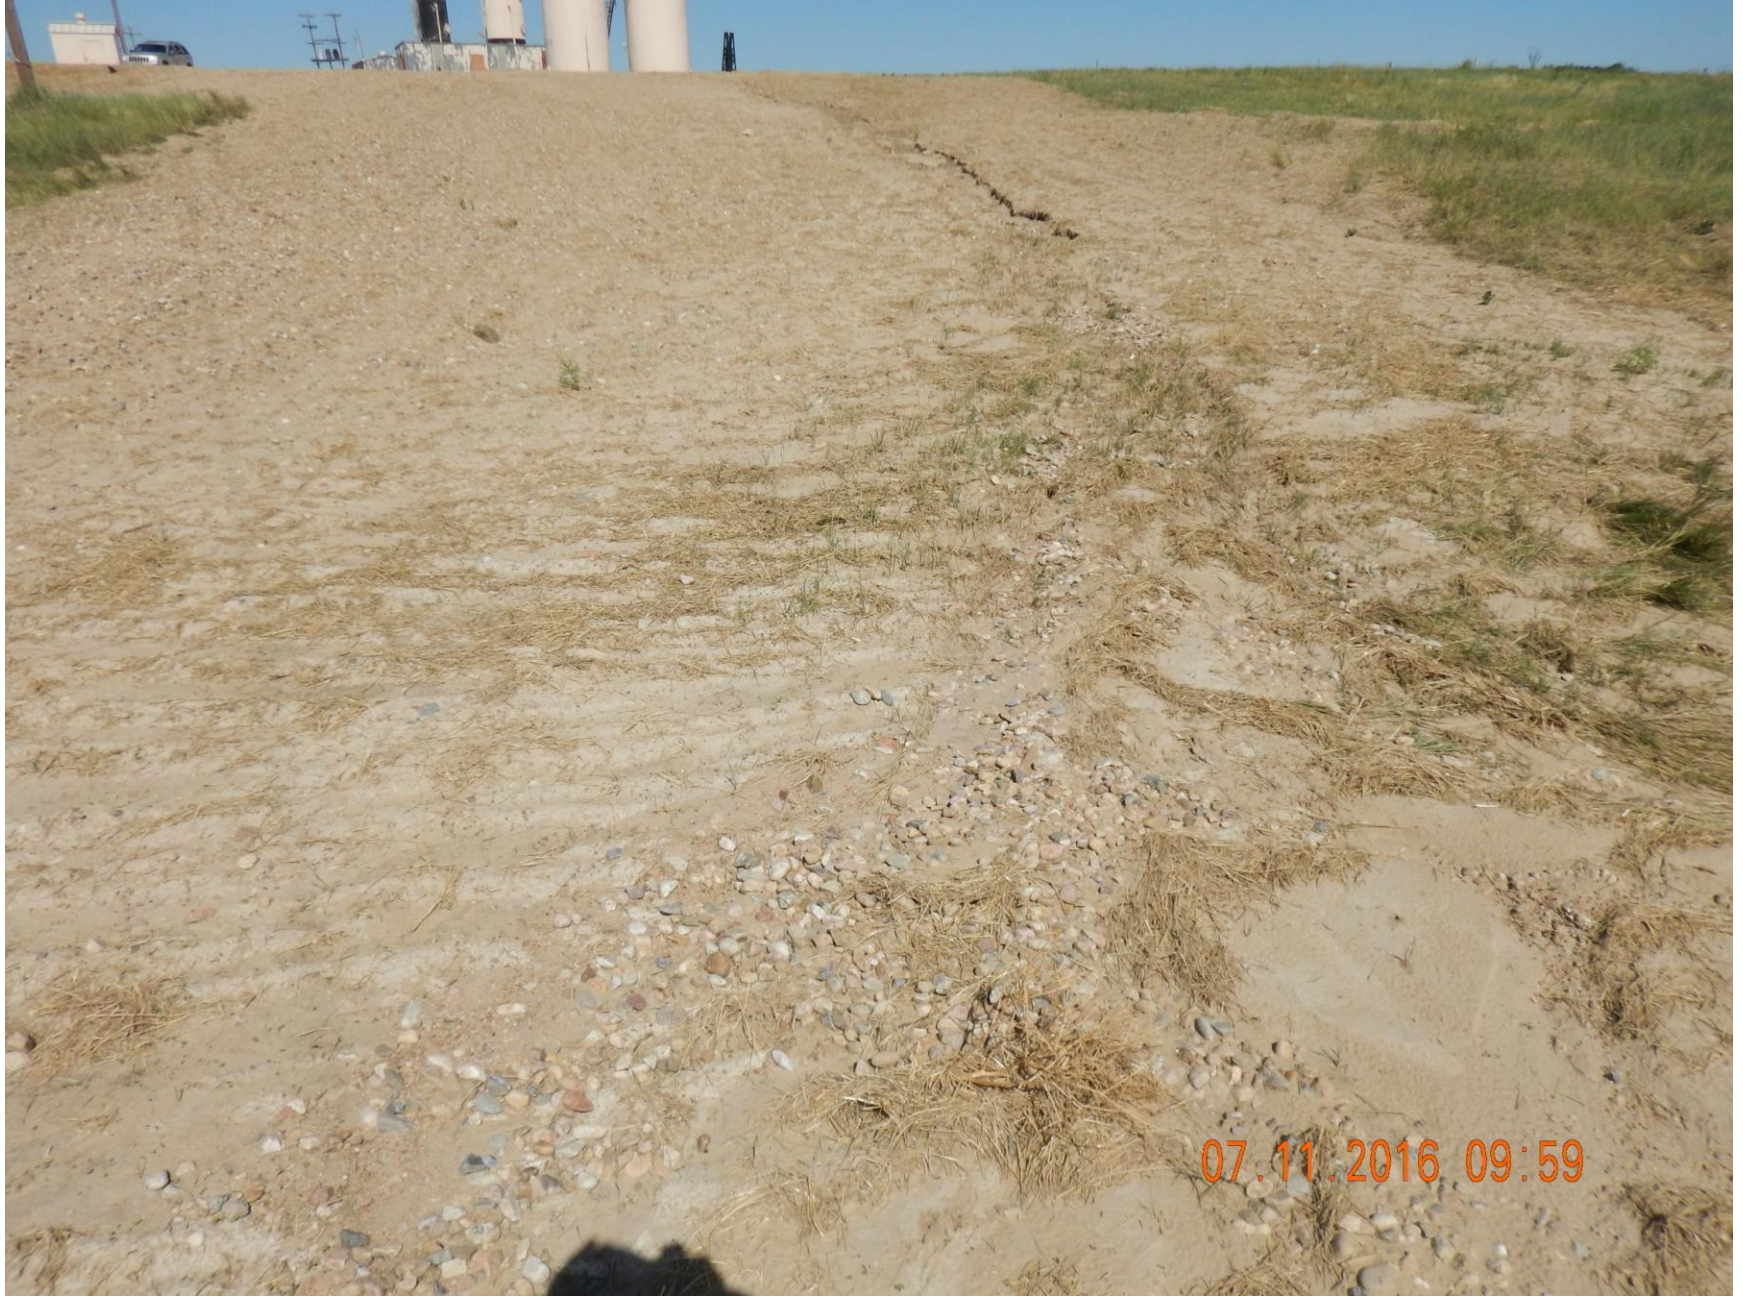
**Figure 8:** Photo taken from the east end of the location, facing west. Photo shows erosion occurring over the reclamation area. Note rock/gravel bottom of photo was transported via stormwater from battery location

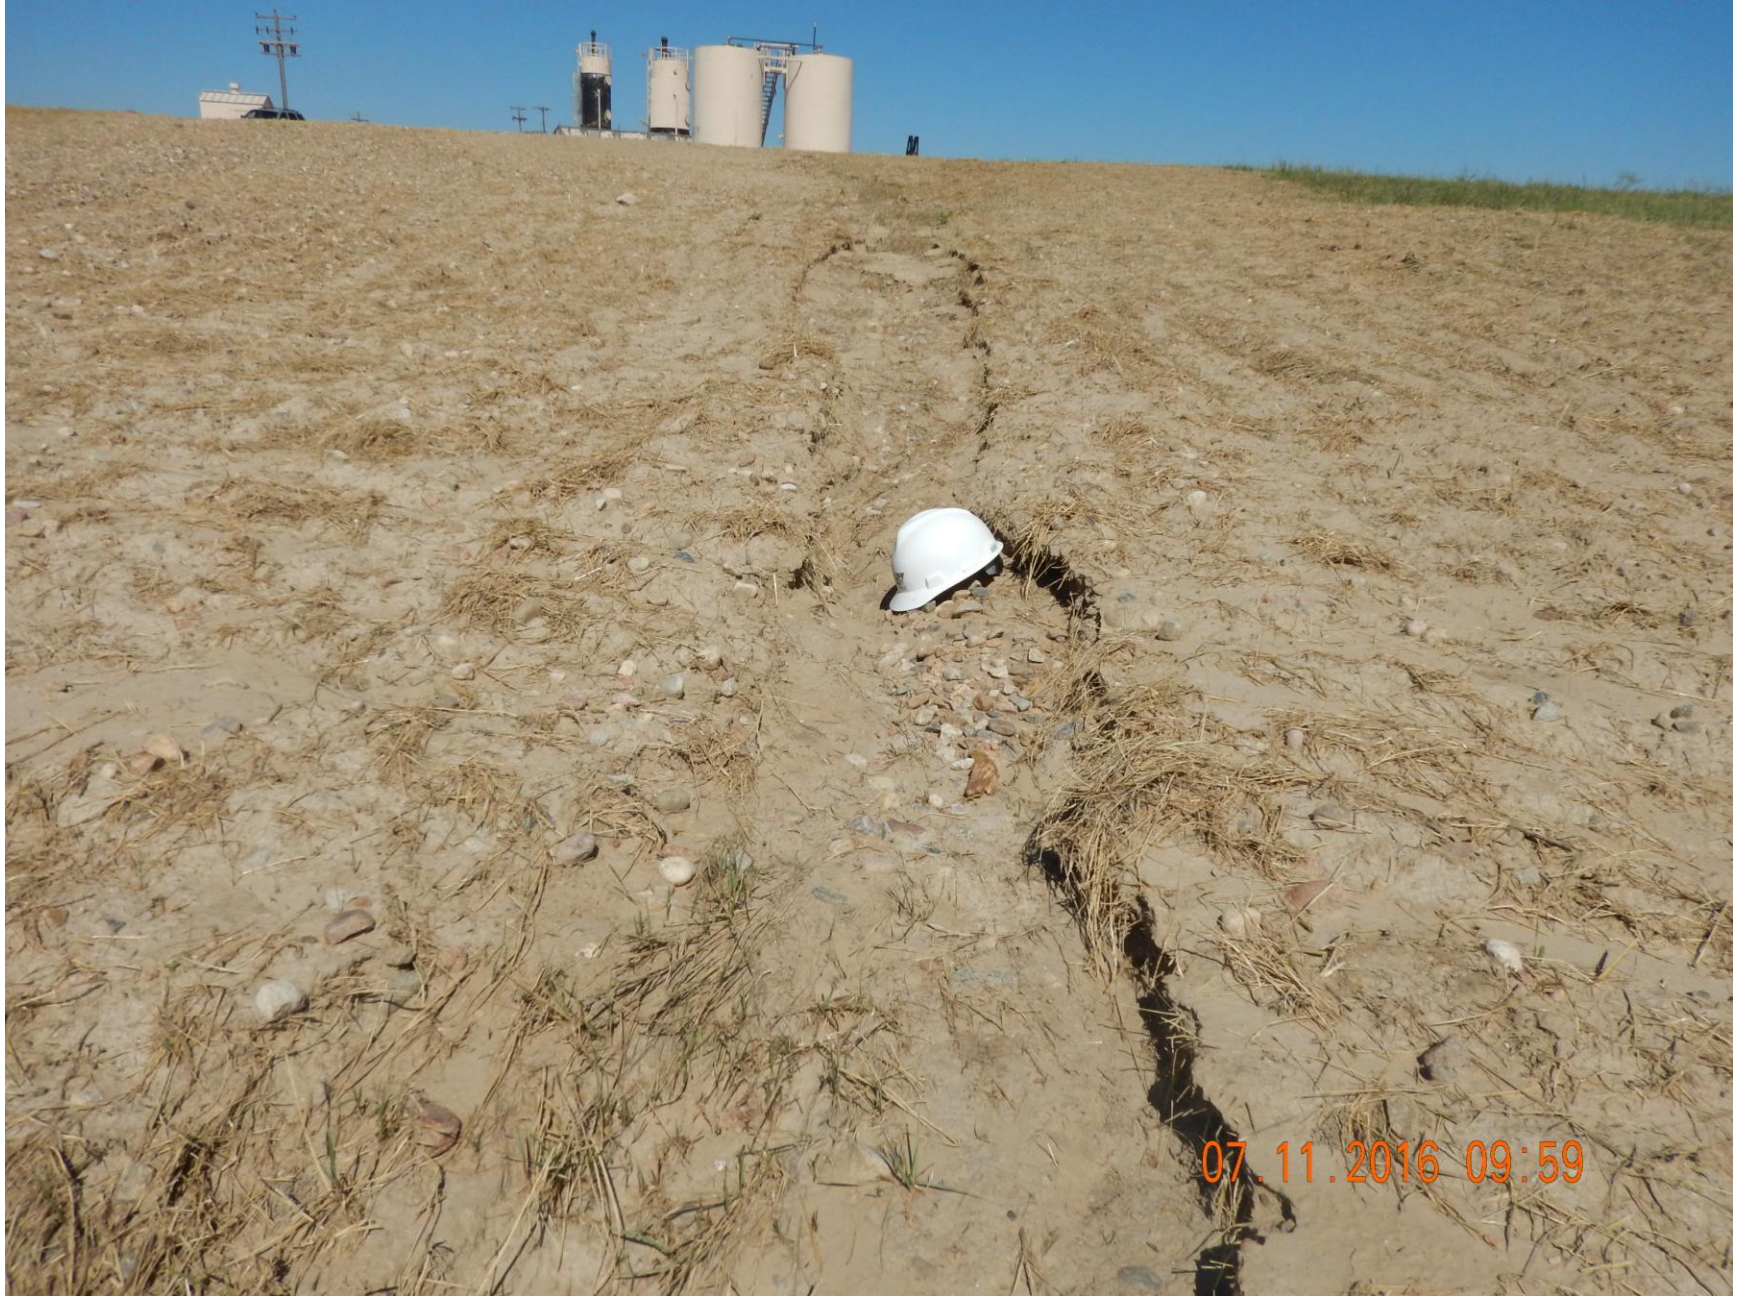
**Figure 9:** Photo taken from the east end of the location, facing west. Photo shows erosion occurring over the reclamation area. White hard hat used for reference.

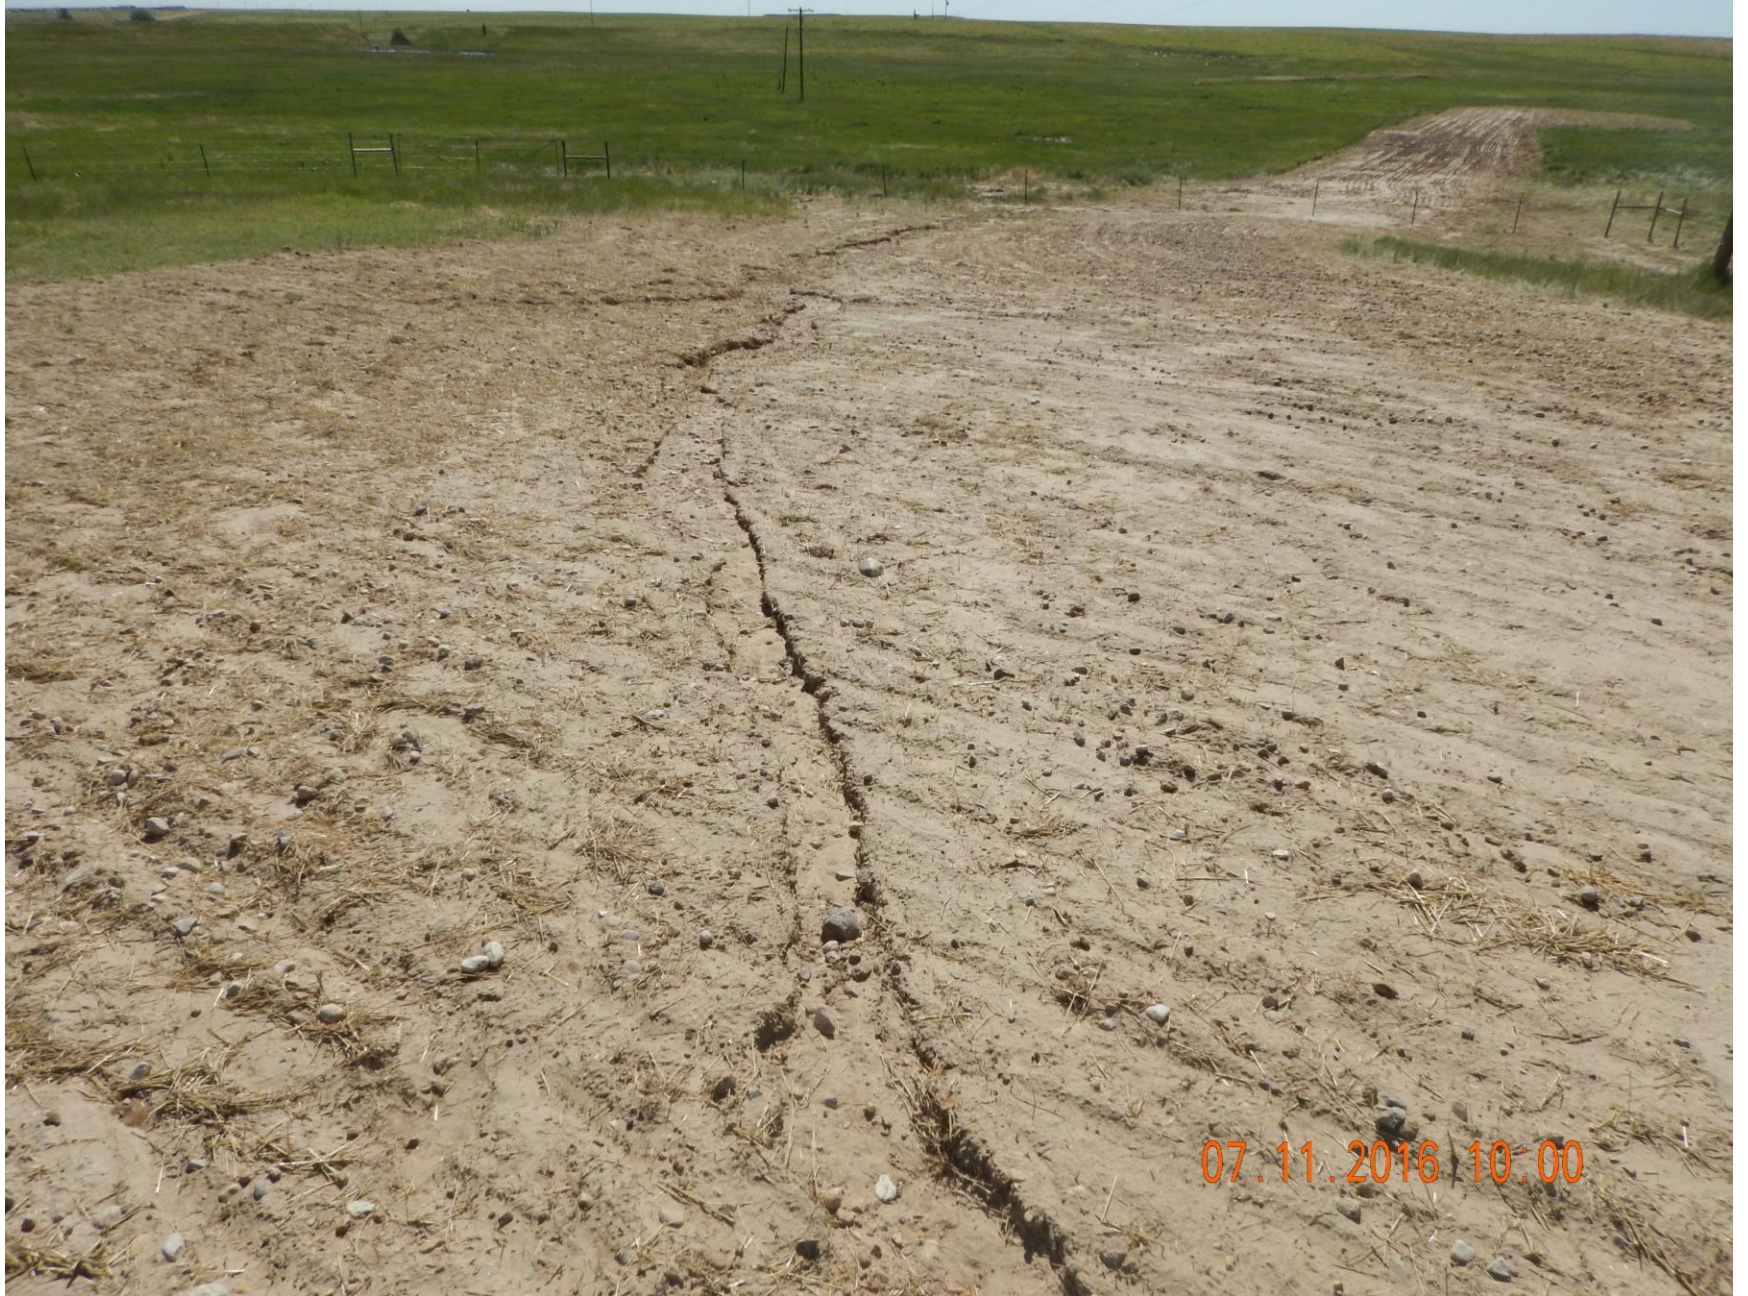
**Figure 10:** Photo taken from the east end of the location, facing east. Photo shows erosion occurring over the reclamation area.

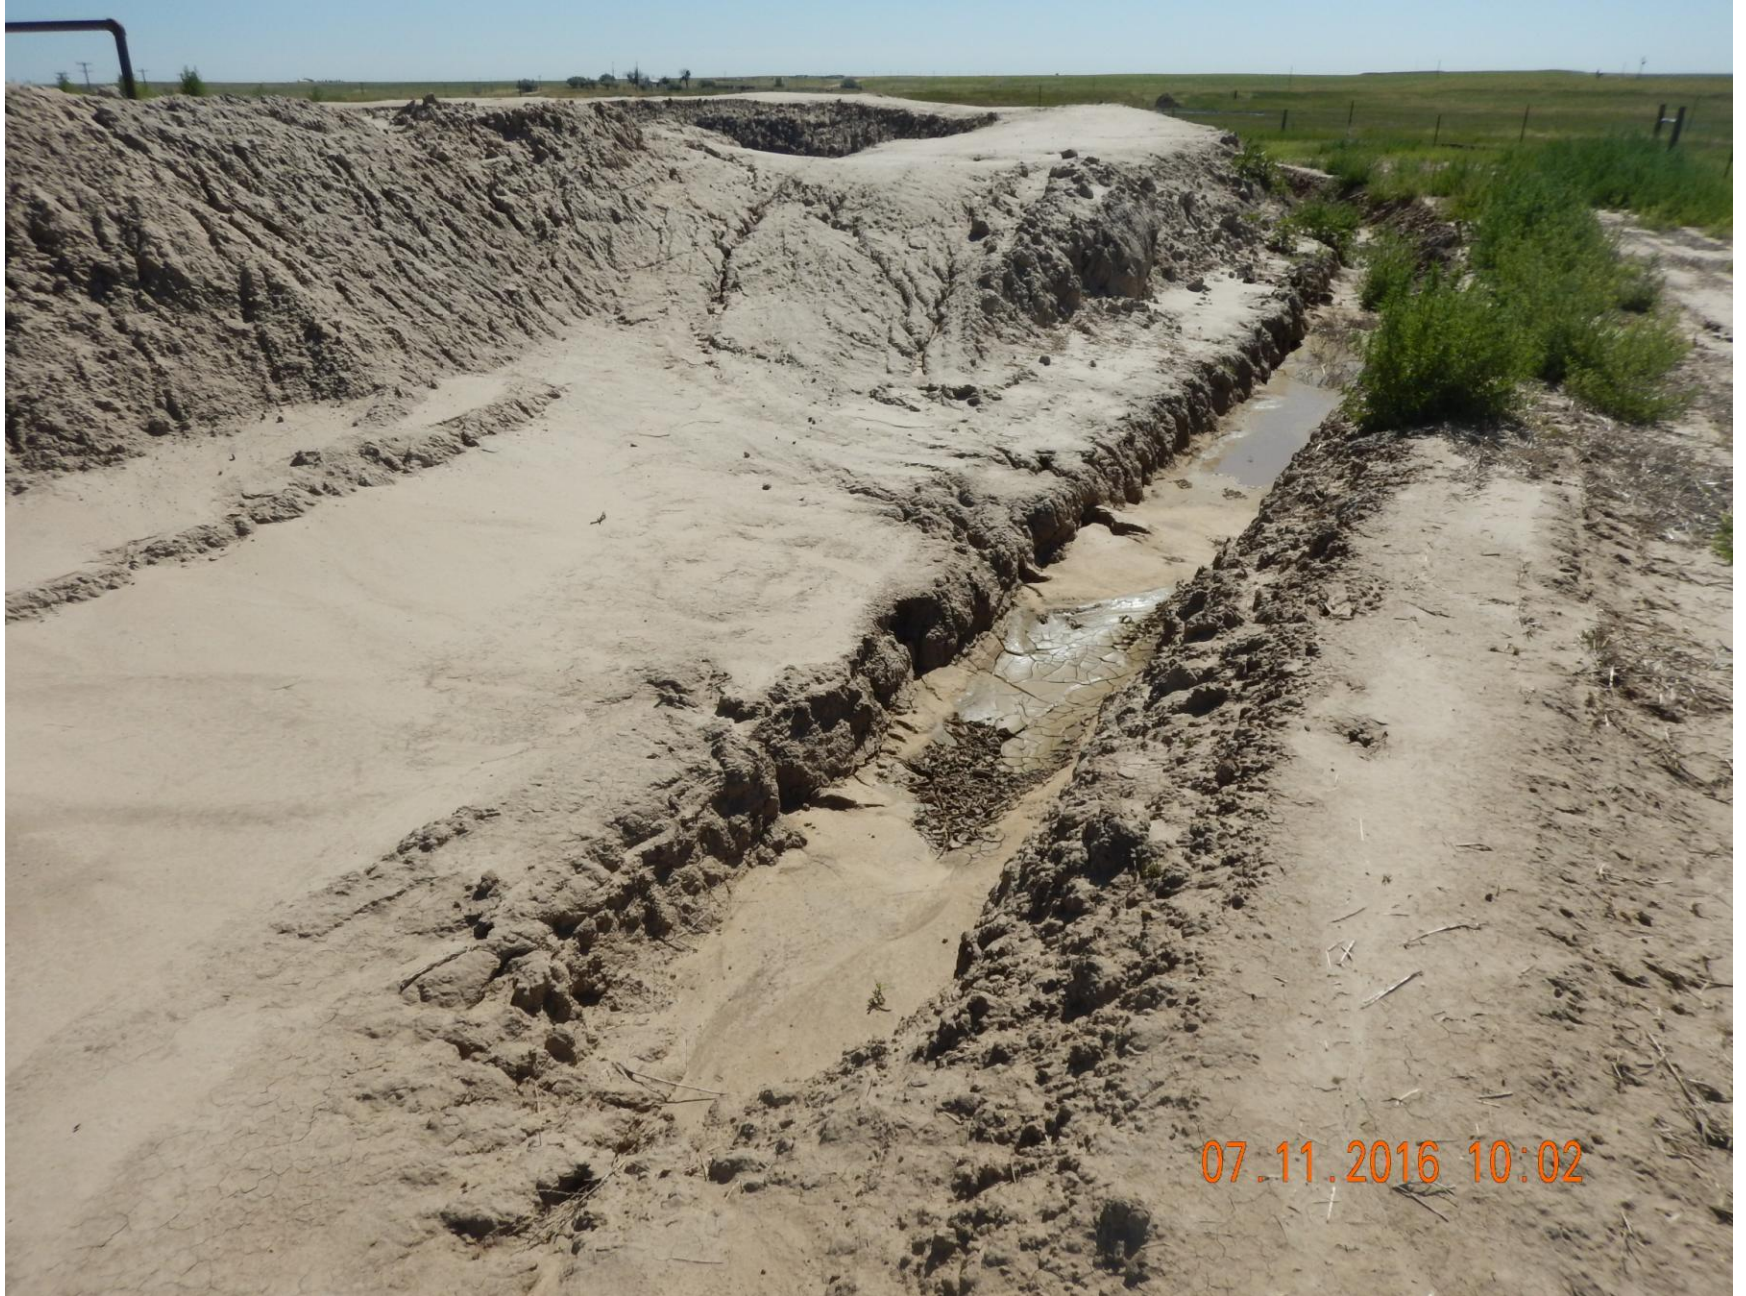
**Figure 11:** Photo taken from the south end of the pit location, facing east. Photo shows berm has been reworked, stormwater and sediment ditch constructed.
