# Stormwater Inspection

07/11/2016

Operator: Western Operating

Location ID: 435387

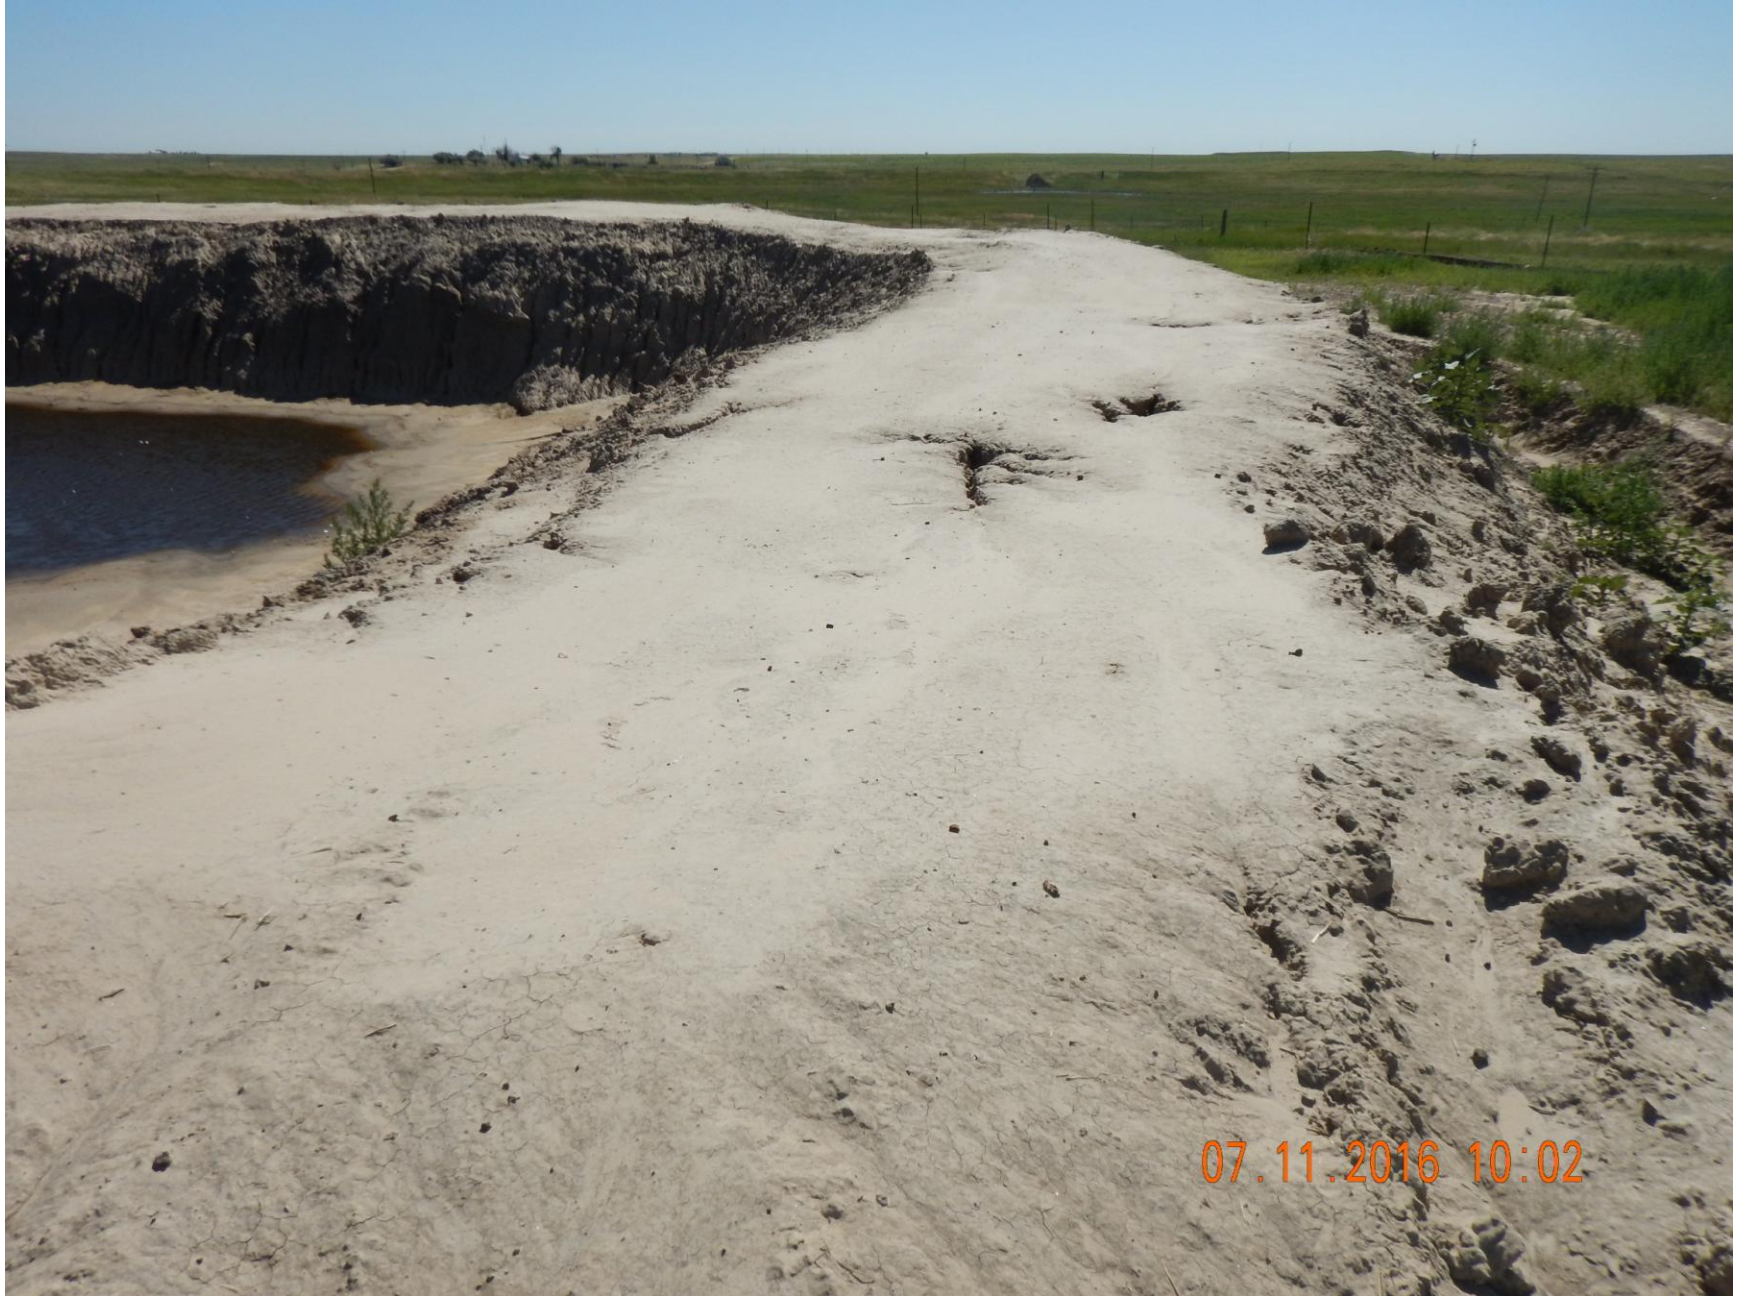
**Figure 12:** Photo taken from the south end of the pit location, facing east. Photo shows berm has been reworked.

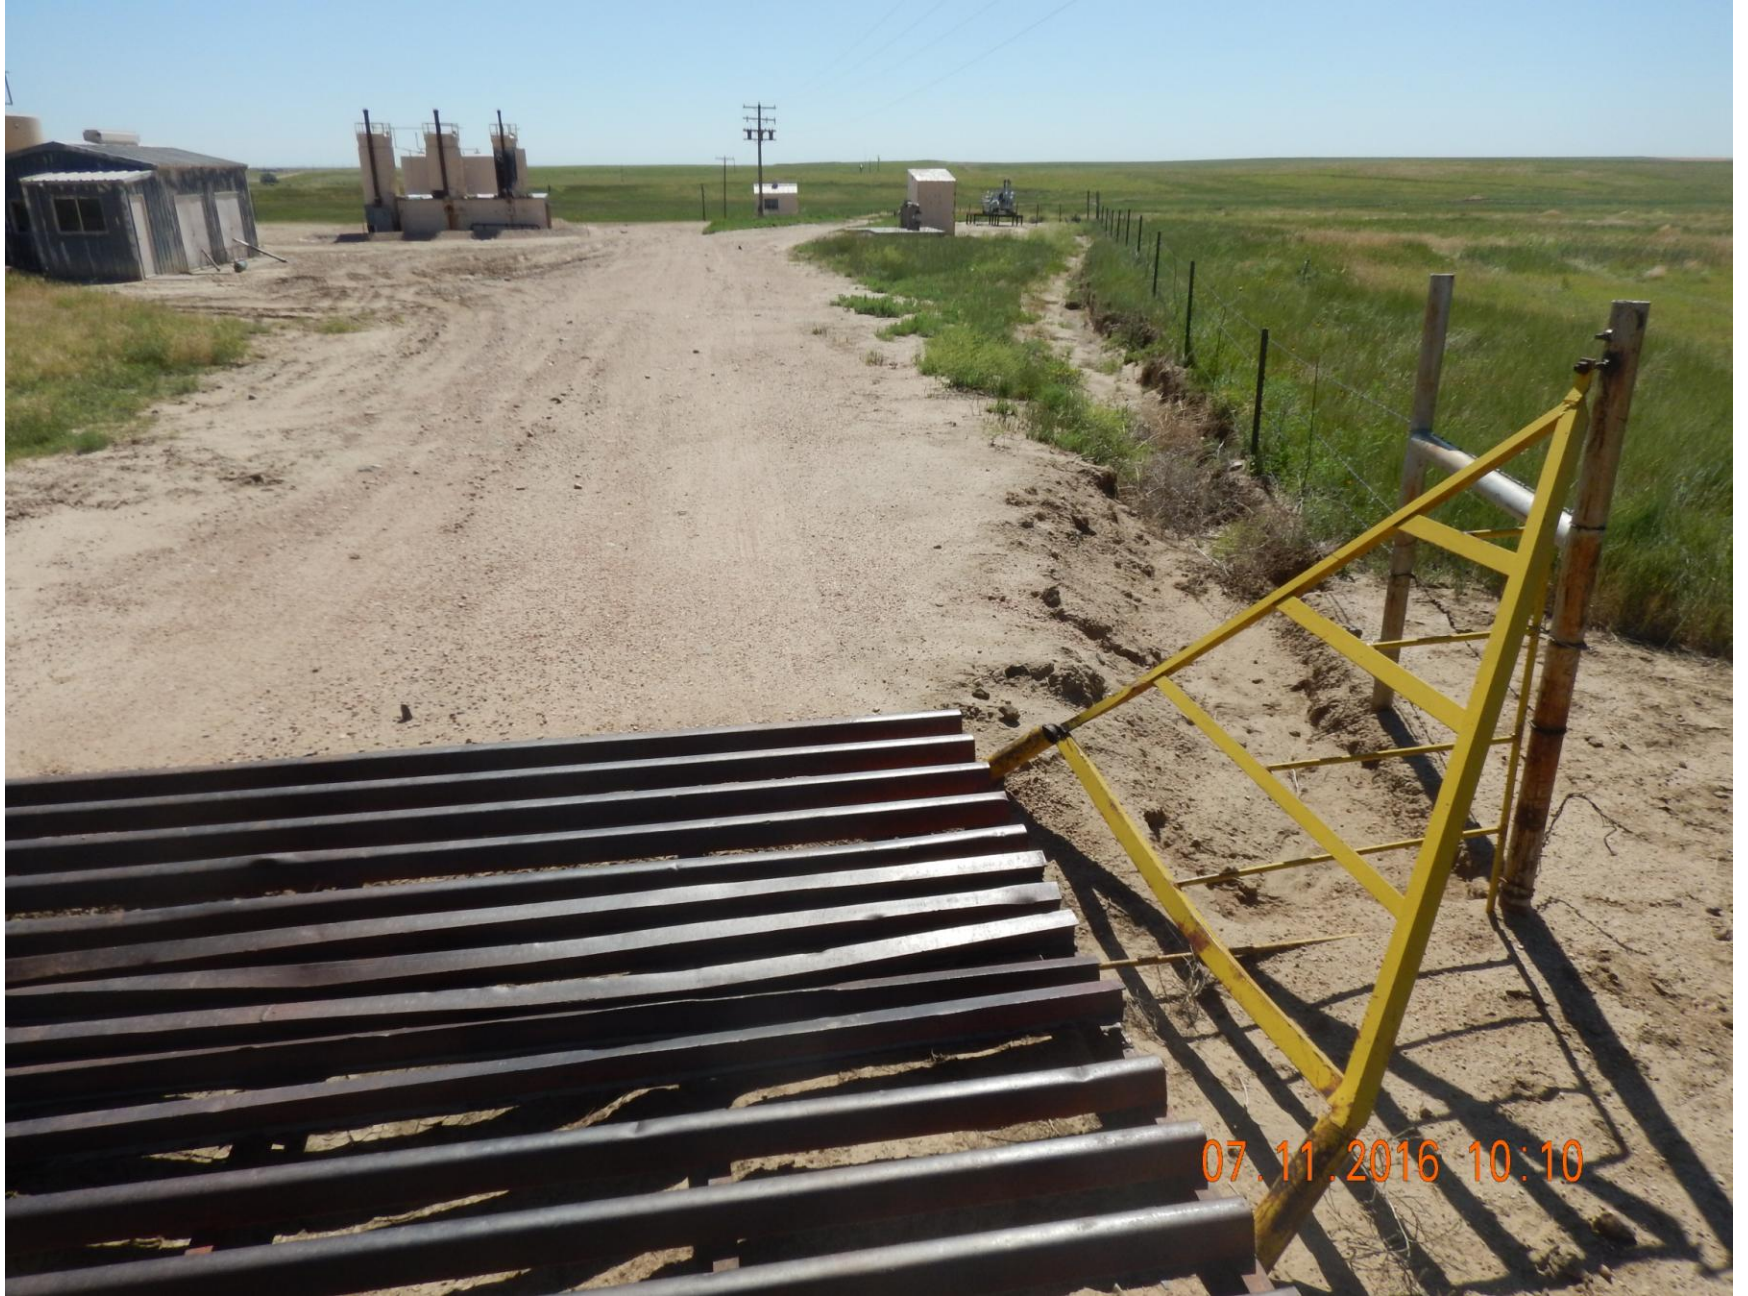
**Figure 13:** Photo taken from access road on the west end of the location. Photo shows stormwater diversion ditch constructed on the south end of the location.
