Construction Inspection

07/12/2016

Operator: Grand Mesa Operating

Location ID: 446515

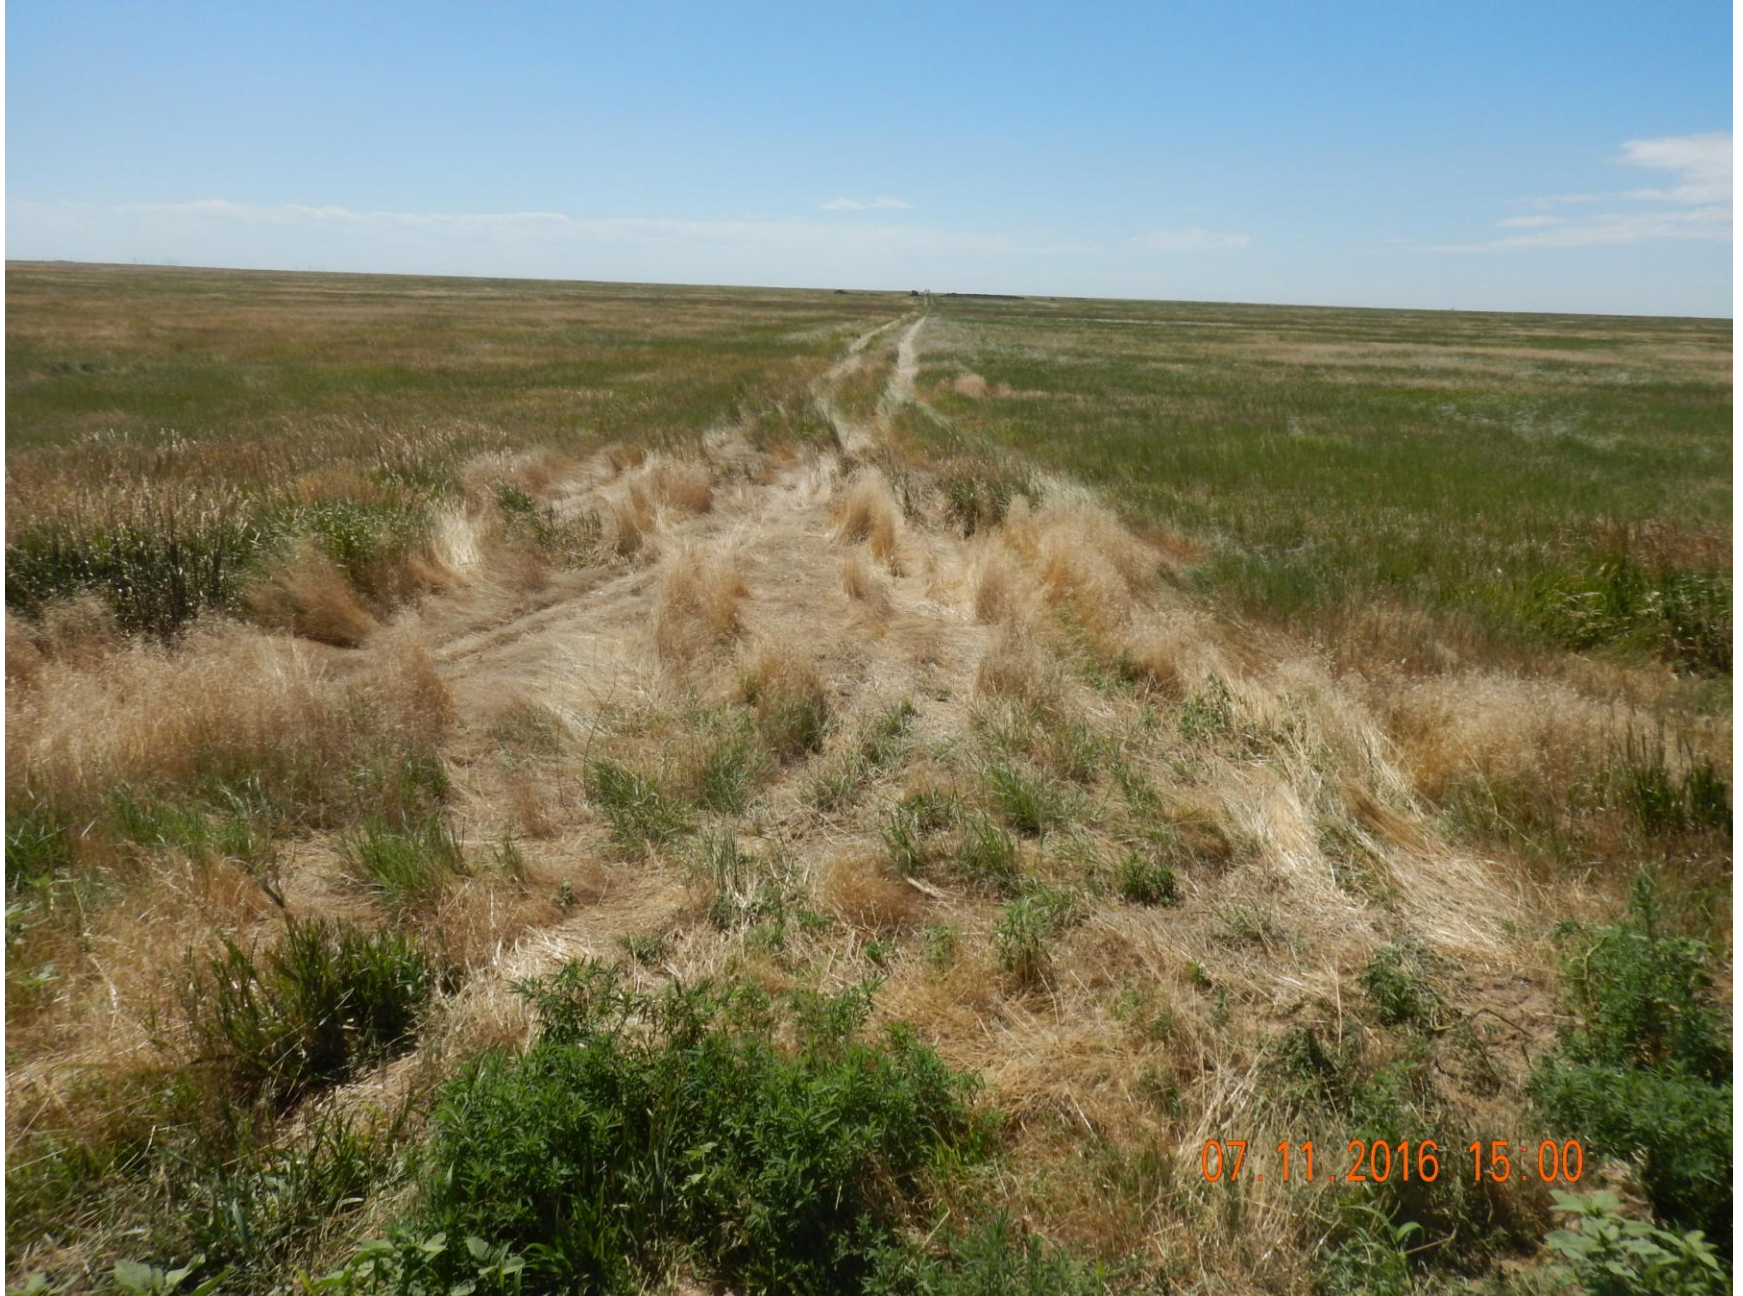
Figure 1: Photo taken from CR U, facing west towards location. Access road has not been constructed.

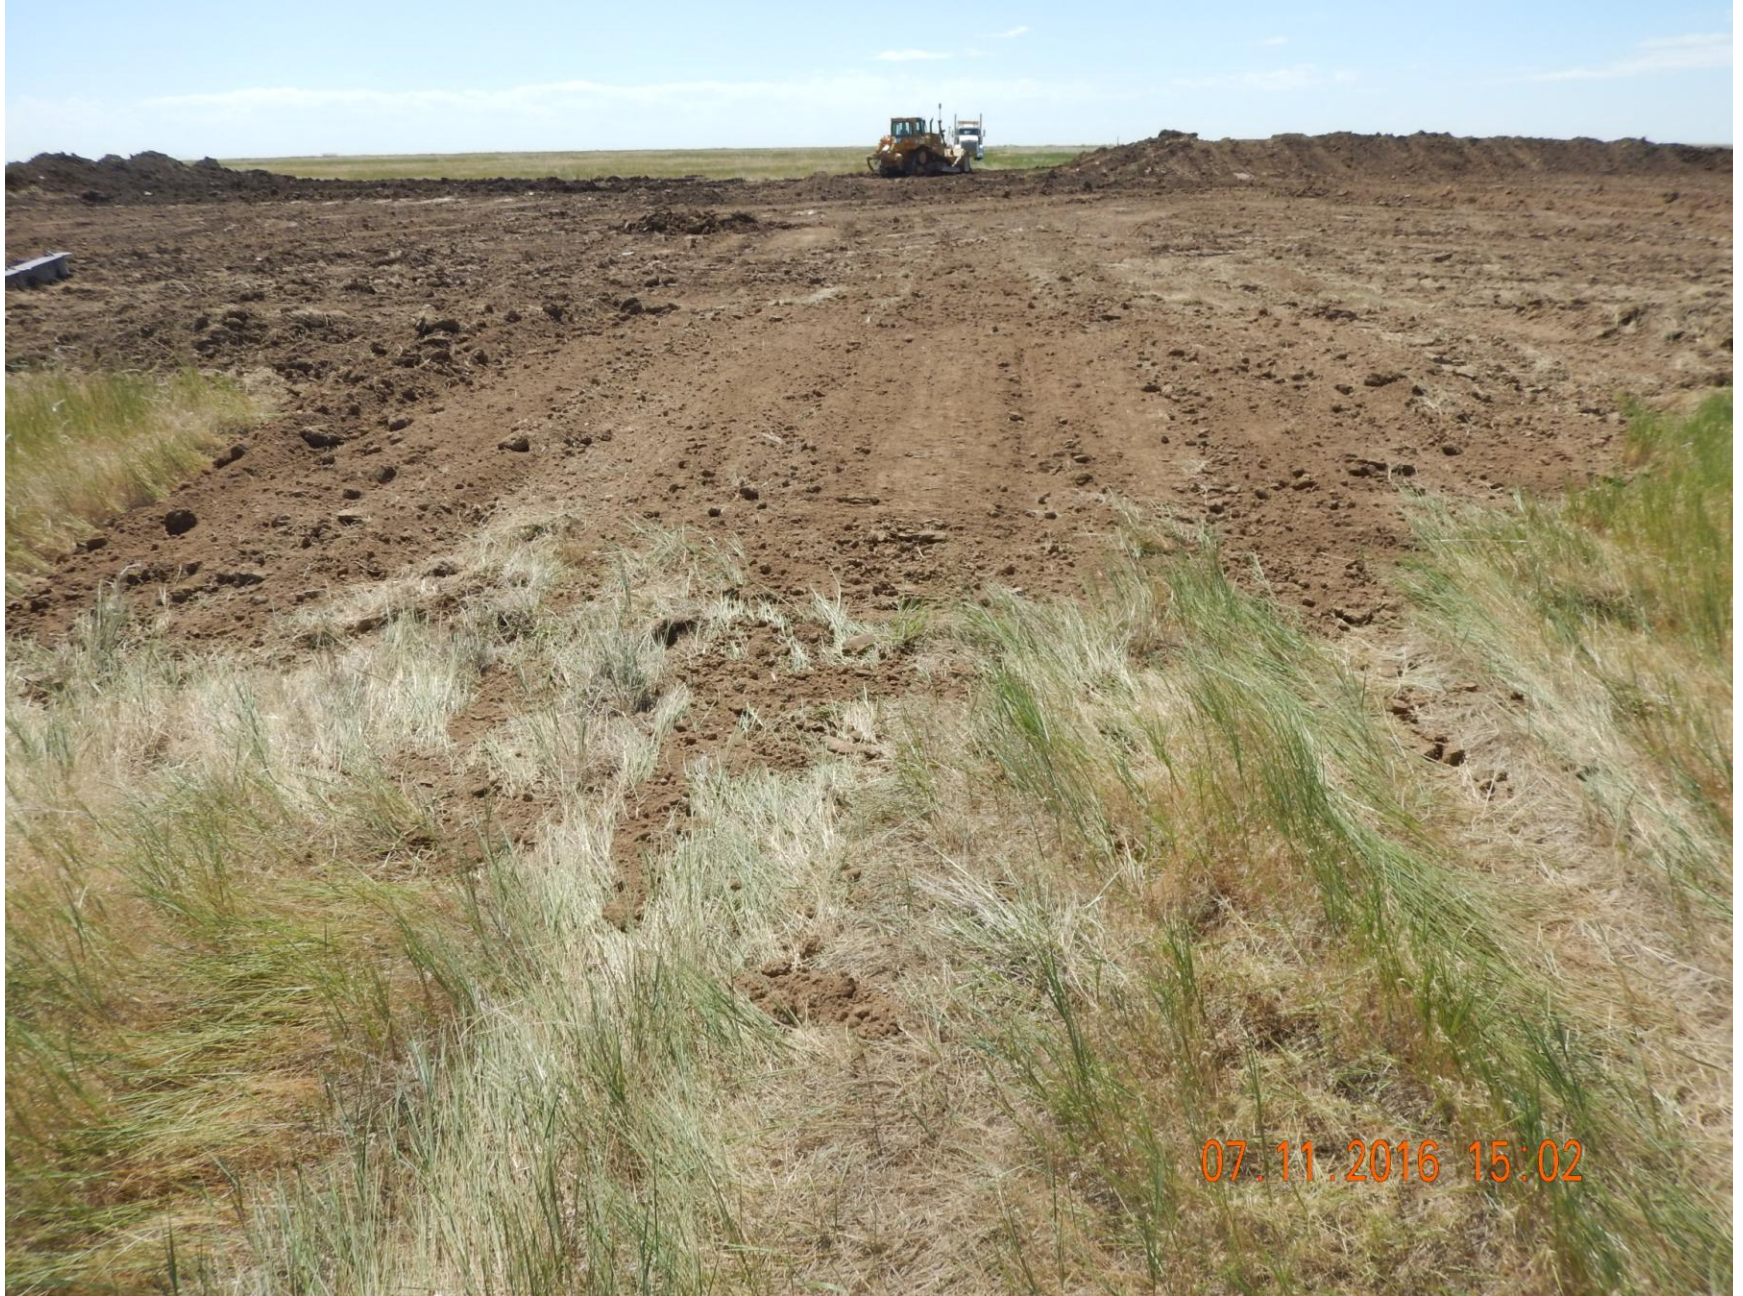
Figure 2: Photo taken from the east end of the location, facing west. Photo shows entrance to location. Note vehicle tracking BMPs absent.

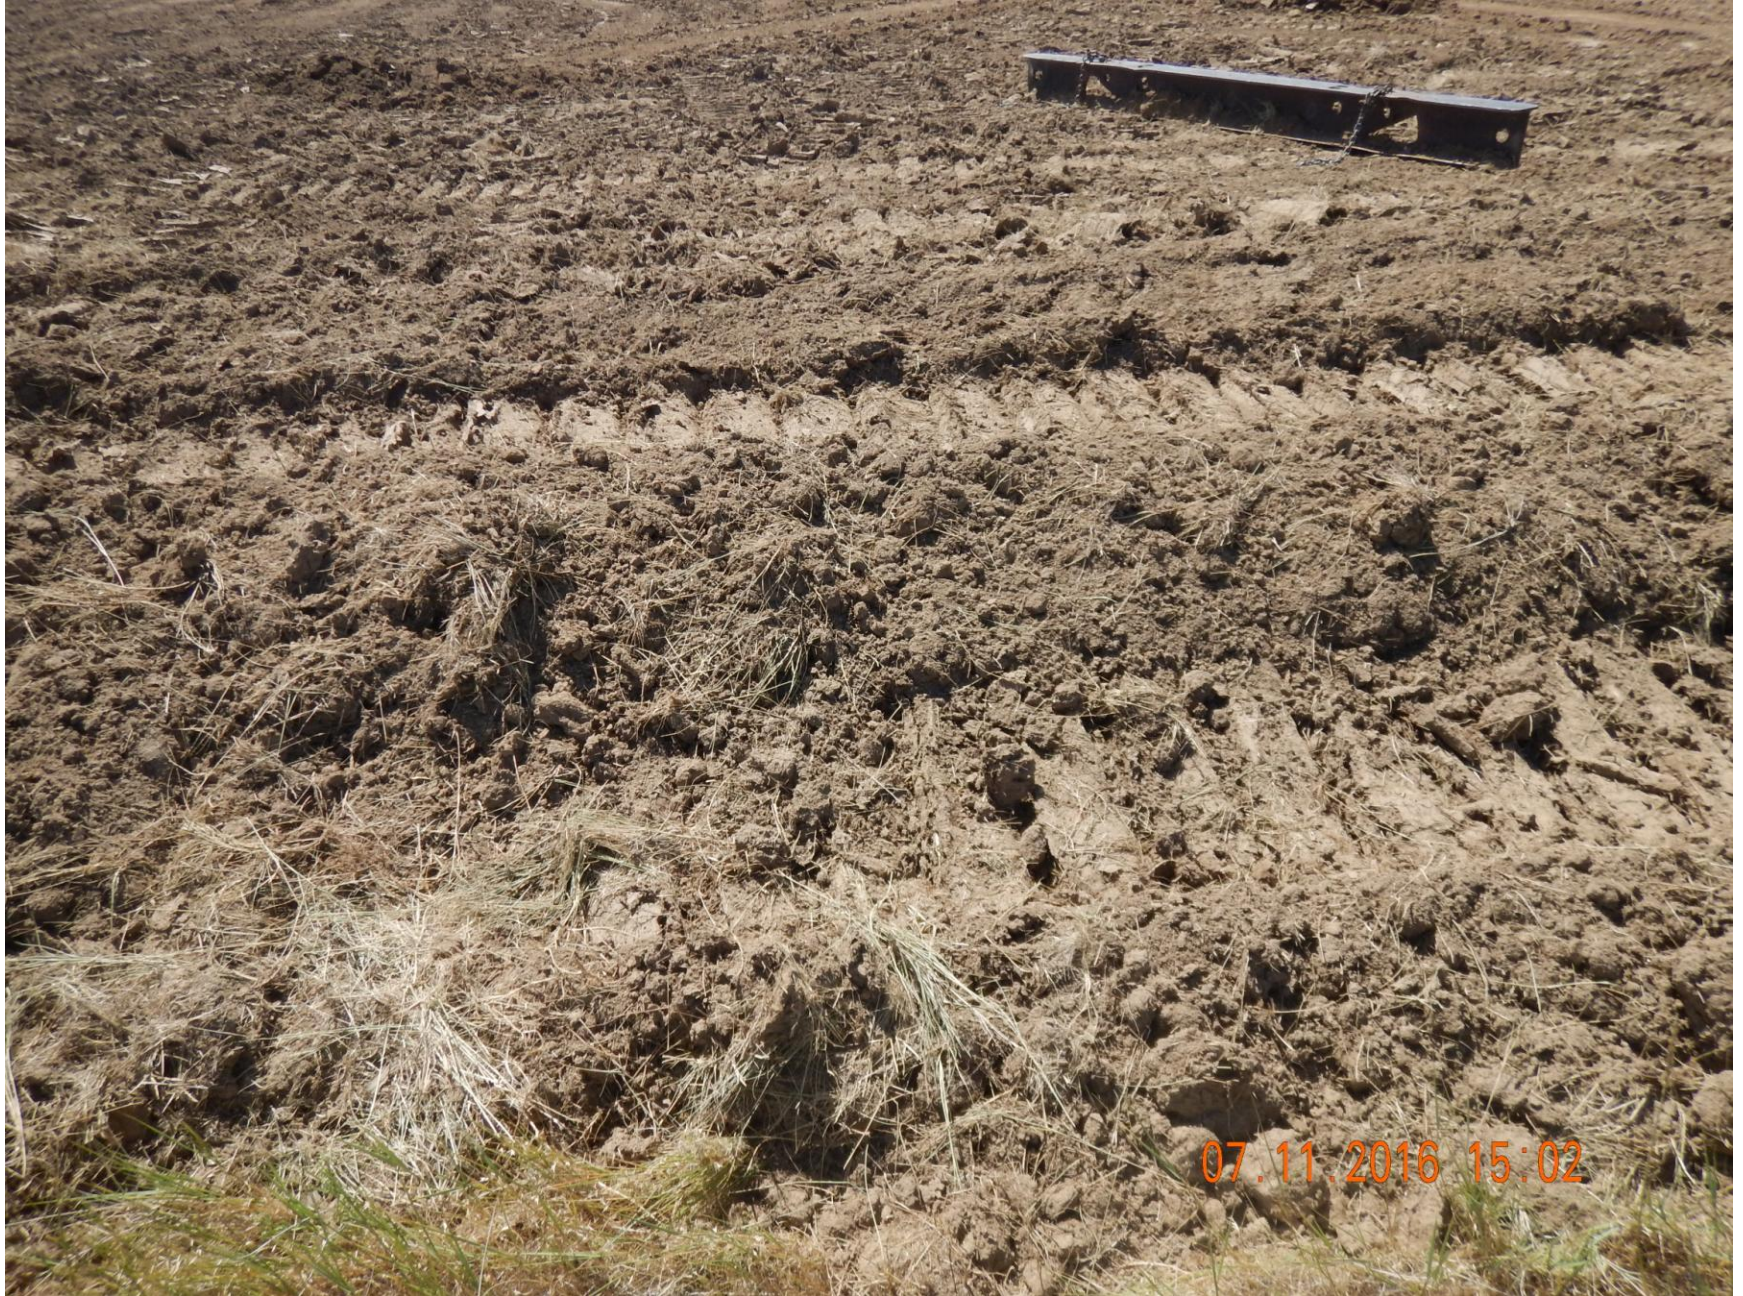
Figure 3: Photo taken from the east end of the location. Photo shows perimeter berms have been constructed improperly; berms along perimeter are not compacted and have either been incorrectly tracked, or not tracked at all.

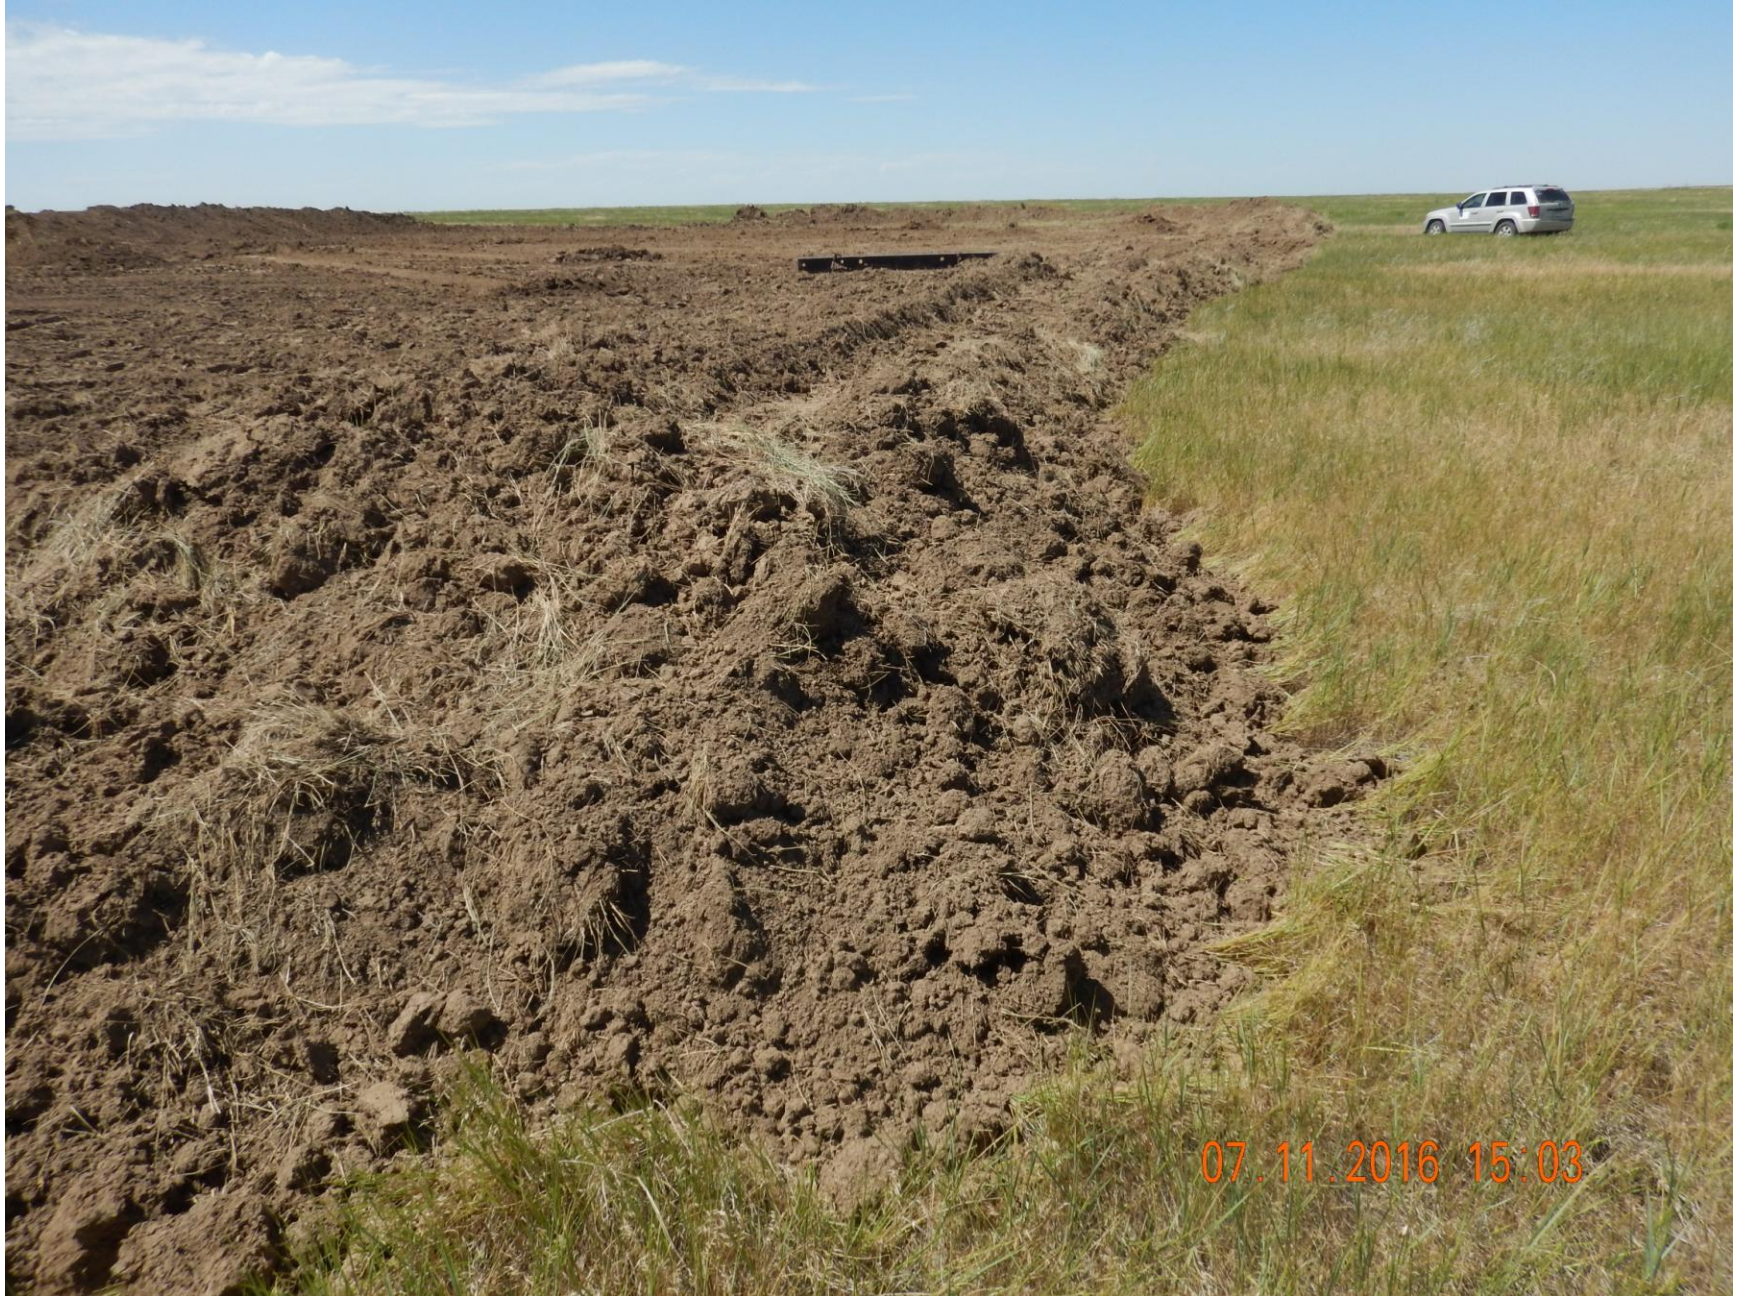
Figure 4: Photo taken from the southeast corner of the location, facing north. Photo shows berms have not been constructed properly; berms along perimeter are not compacted and have either been incorrectly tracked, or not tracked at all.

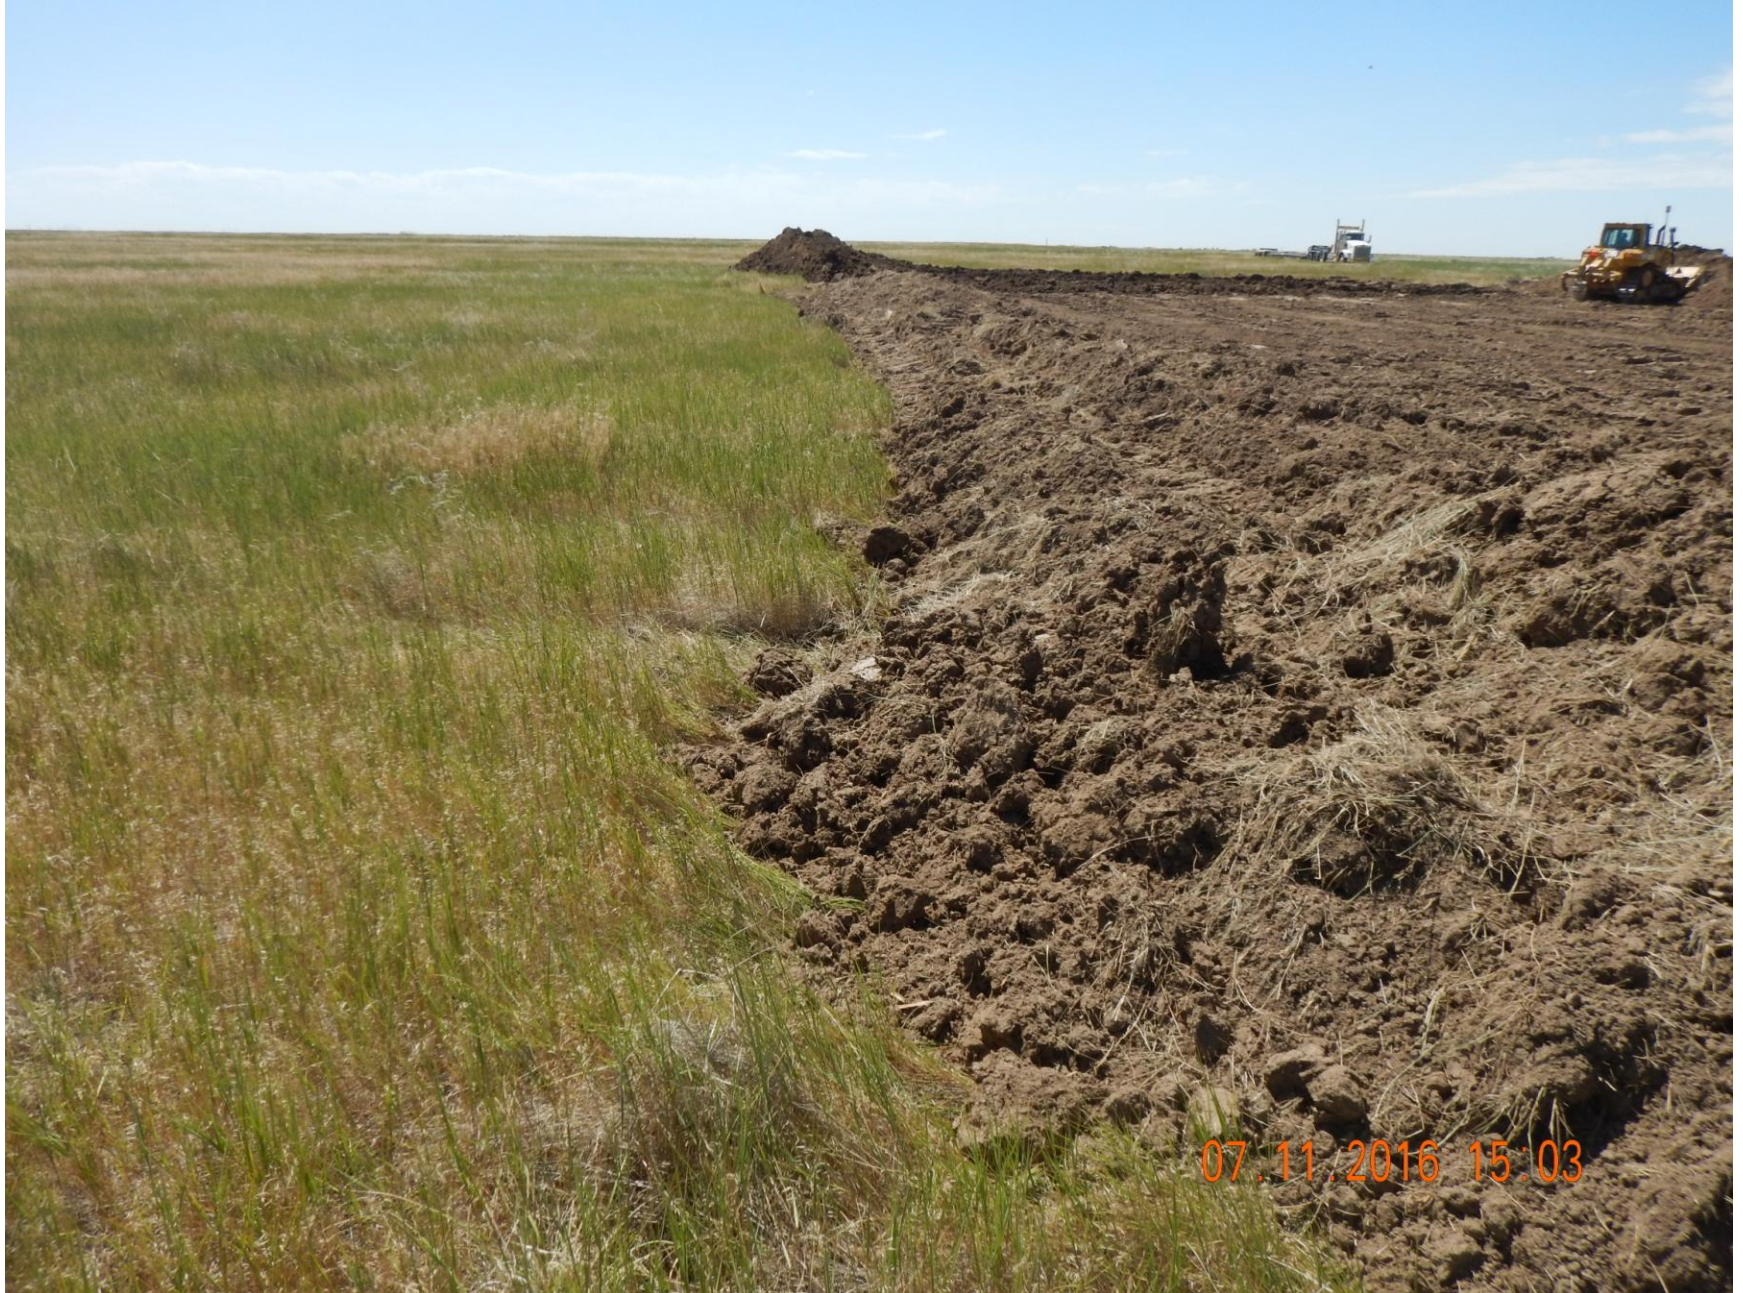
Figure 5: Photo taken from the southeast corner of the location, facing west. Photo shows berms have not been constructed properly; berms along perimeter are not compacted and have either been incorrectly tracked, or not tracked at all.

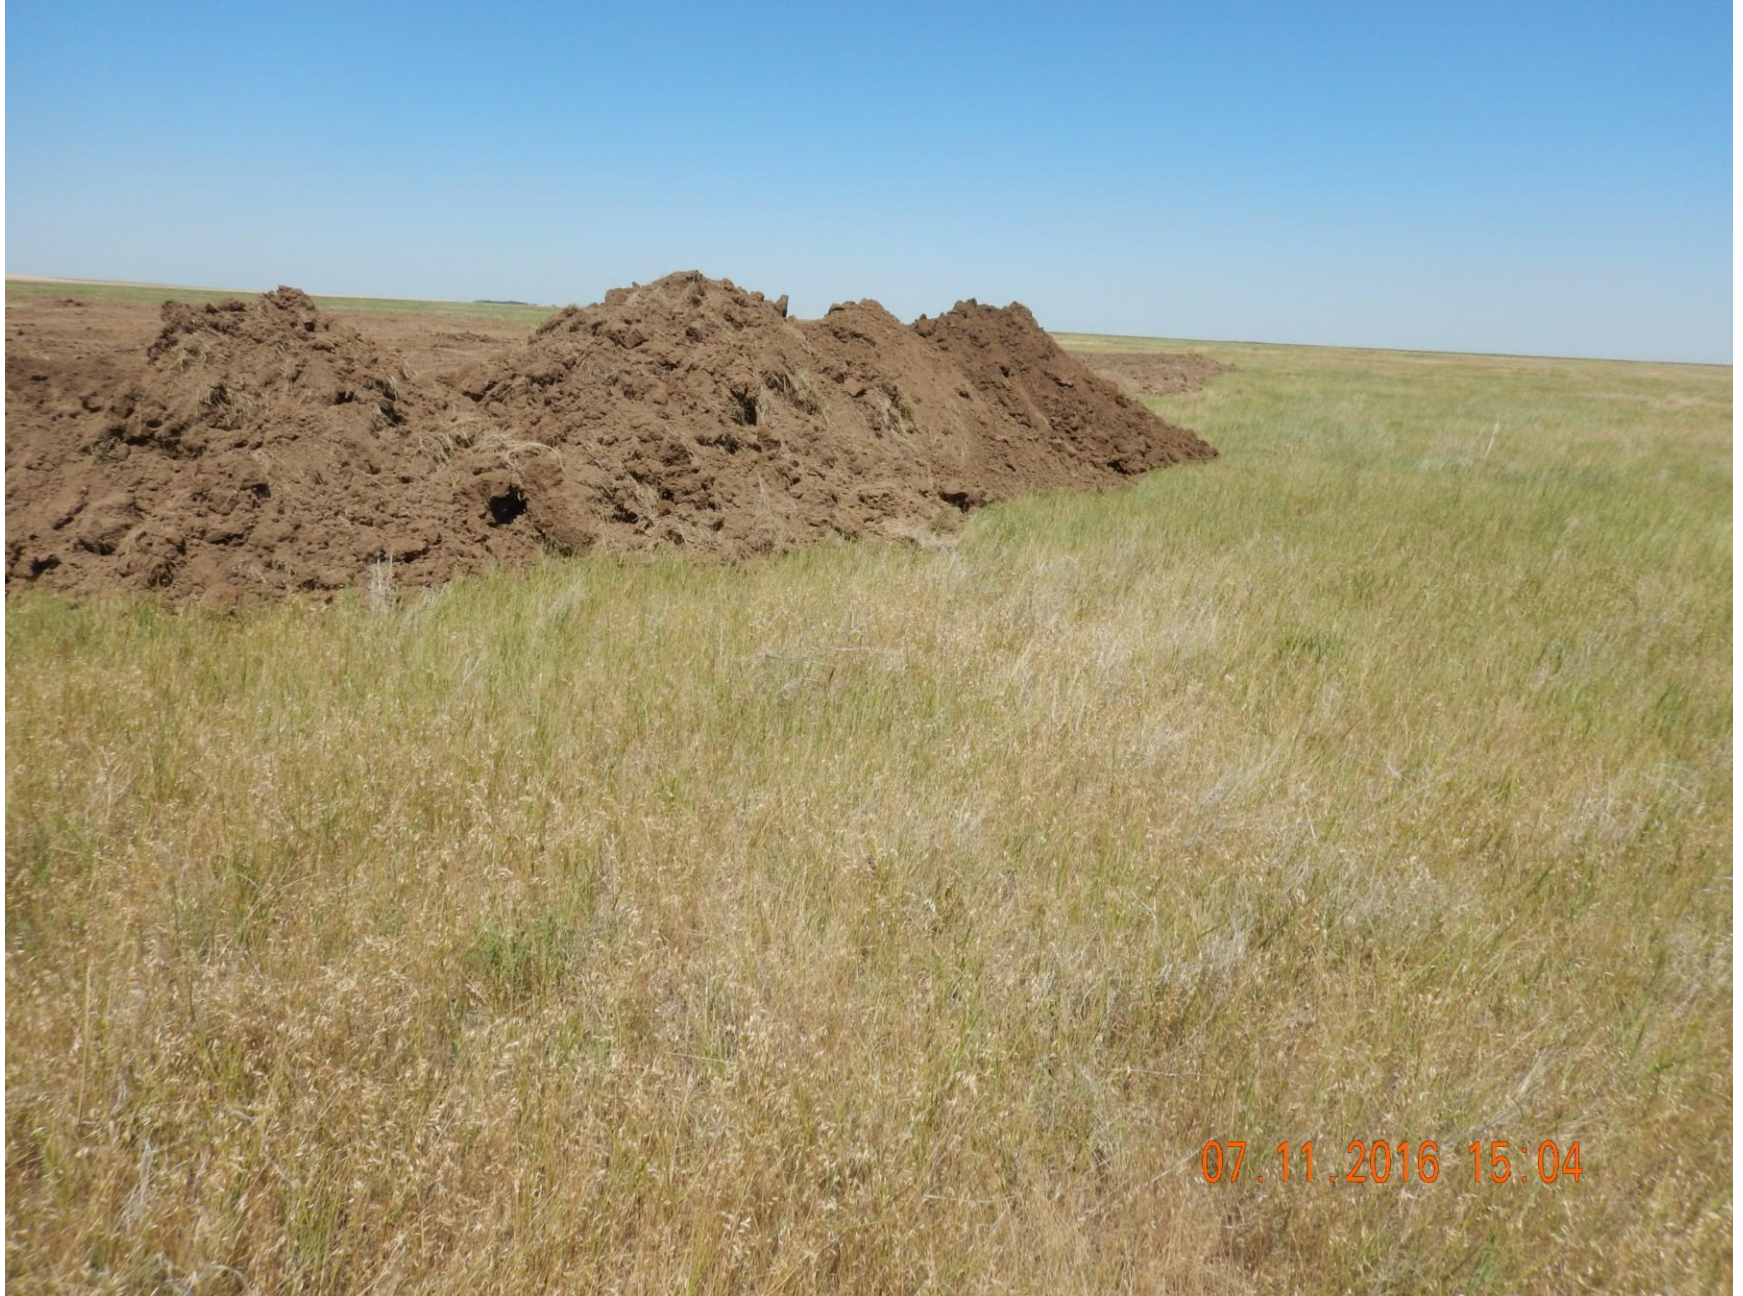
Figure 6: Photo taken from the southwest corner of the location, facing east. Photo shows portion of the topsoil pile. No stormwater or sediment control BMPs in place.

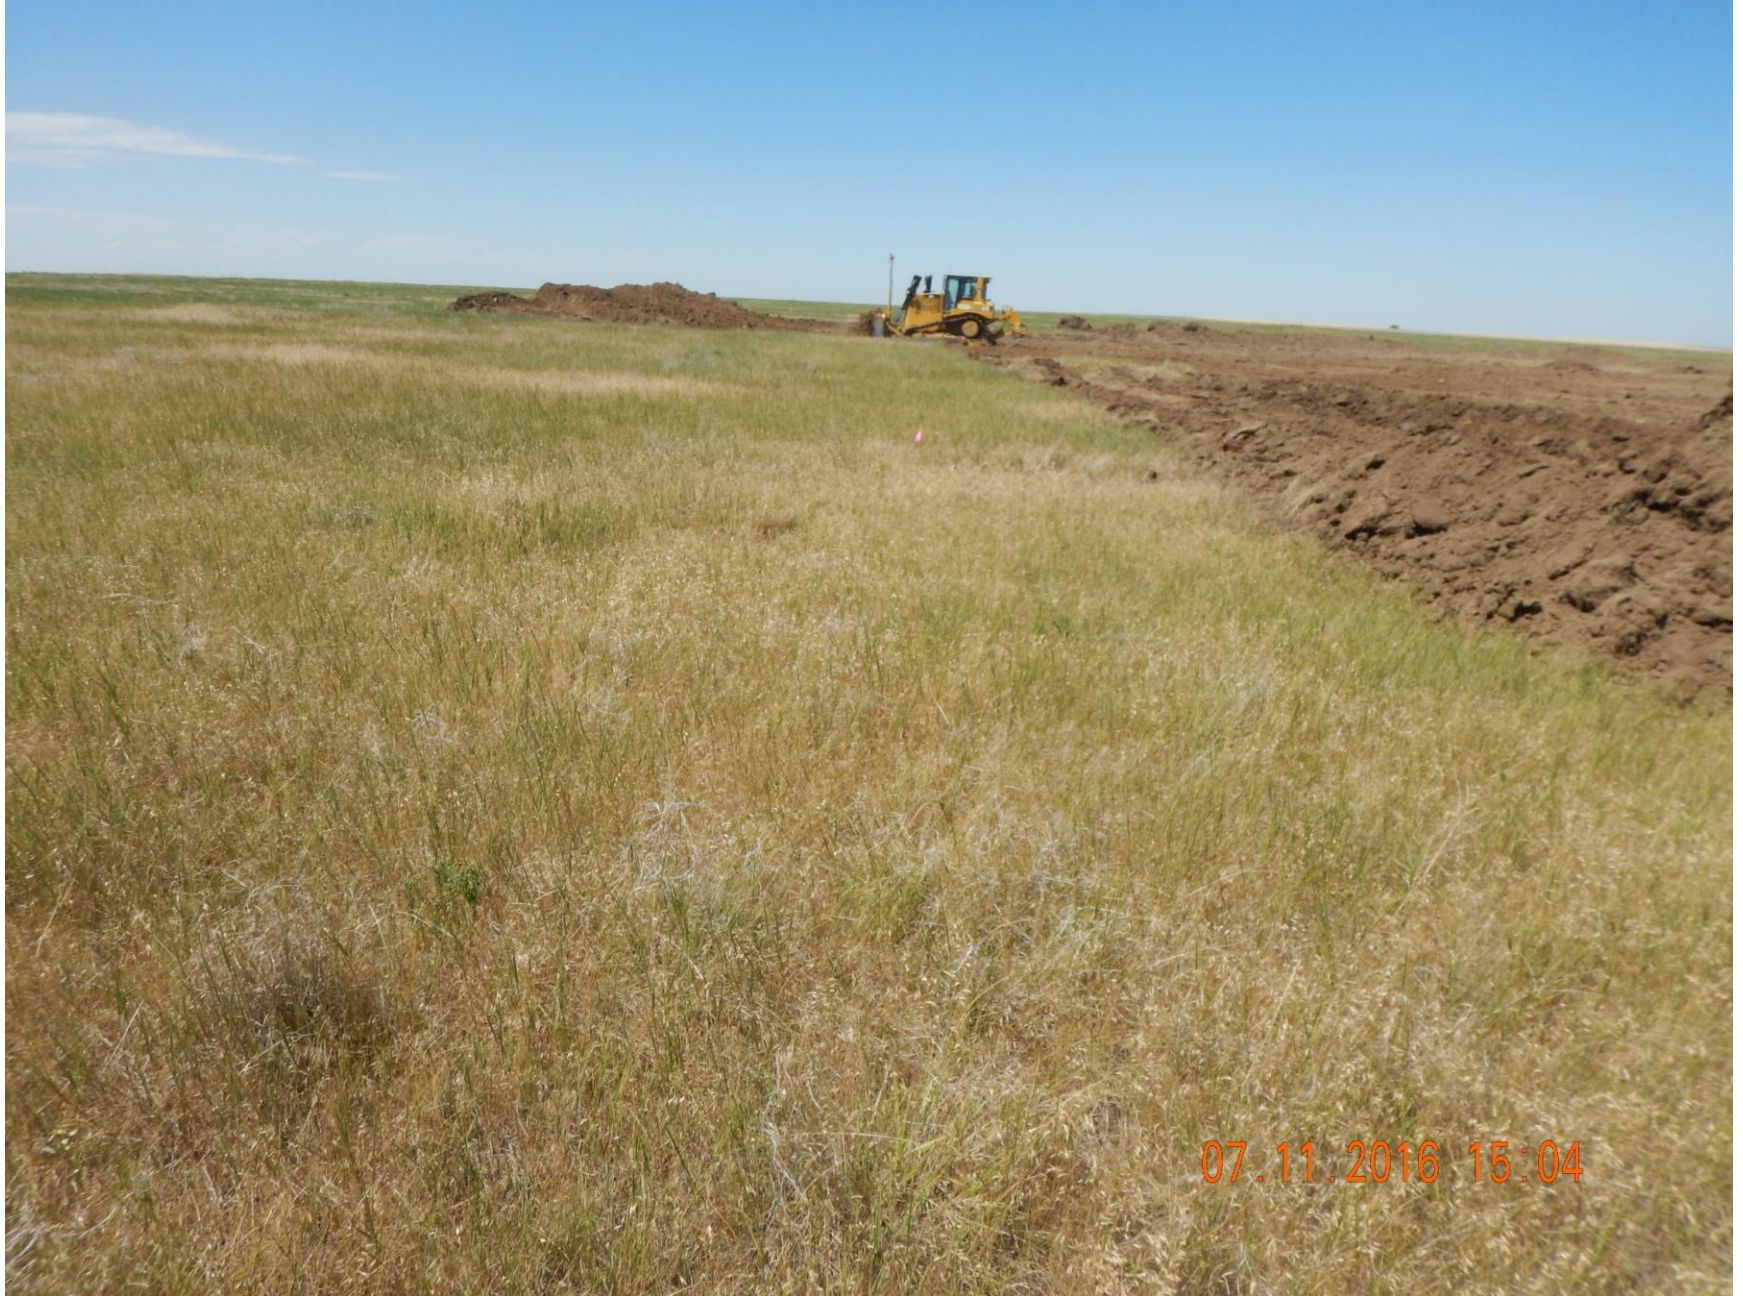
Figure 7: Photo taken from the southwest corner of the location, facing north. Photo shows portion of the topsoil pile. No stormwater or sediment control BMPs in place.

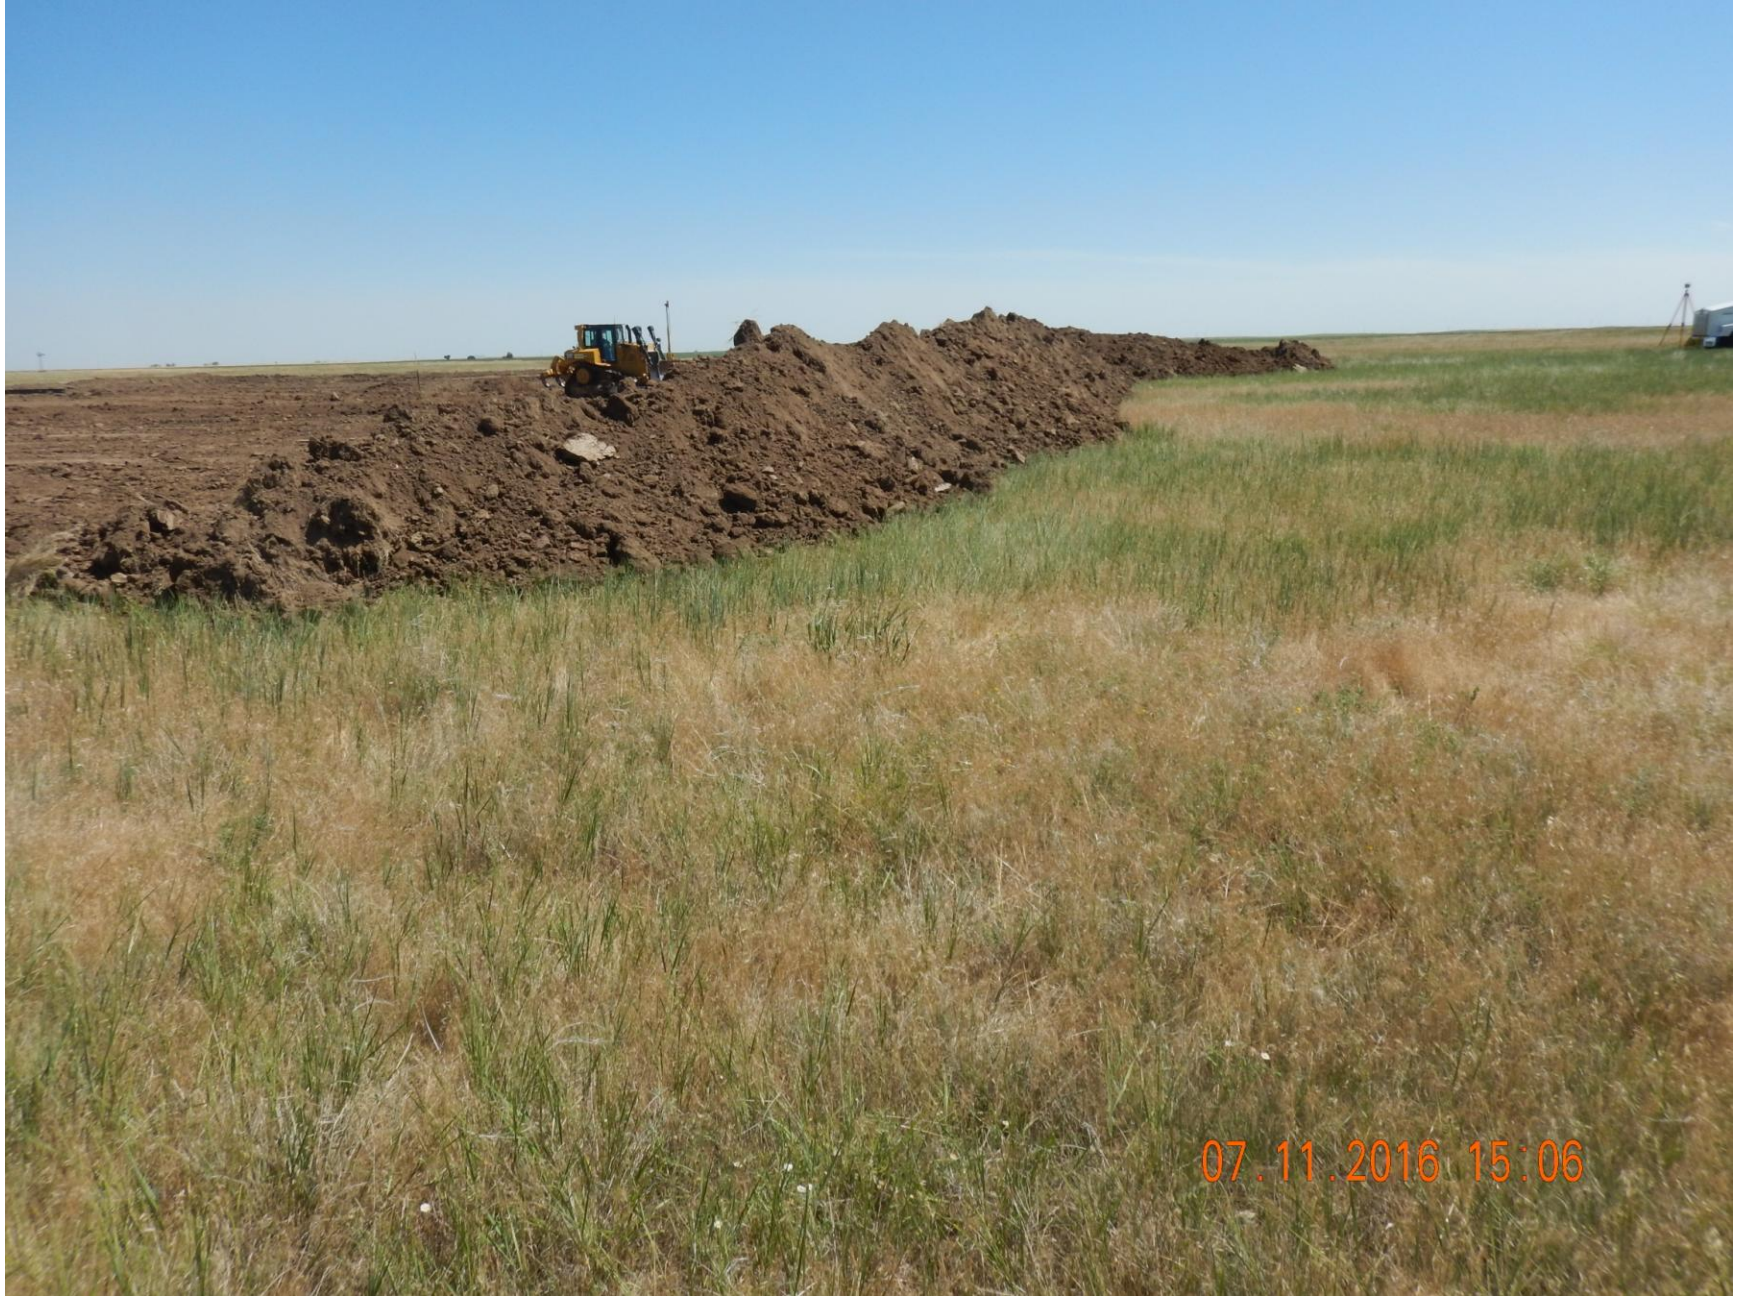
Figure 8: Photo taken from the northwest corner of the location, facing south. Photo shows portion of the topsoil pile. No stormwater or sediment control BMPs in place.

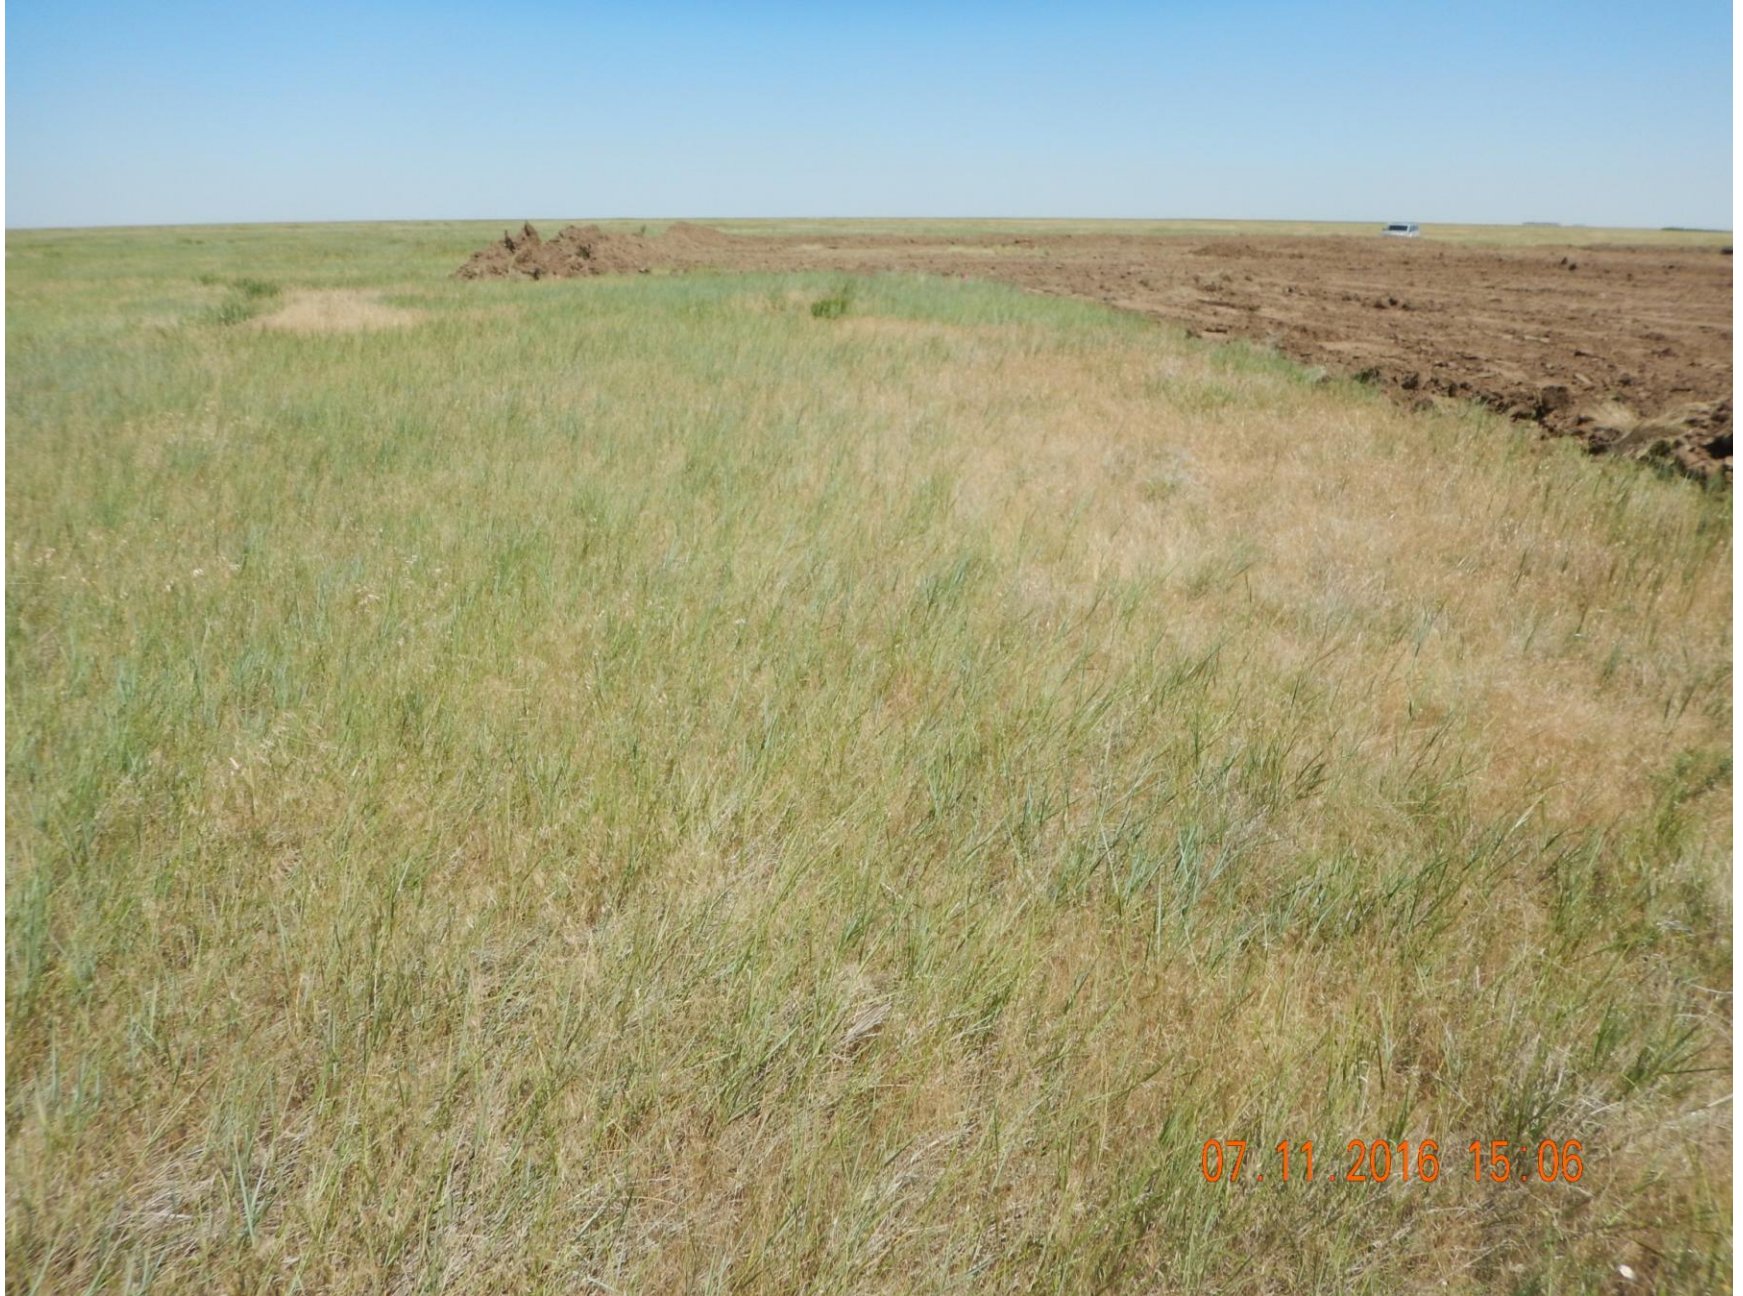
Figure 9: Photo taken from the northwest corner of the location, facing east. Photo shows no stormwater or sediment control BMPs in place.

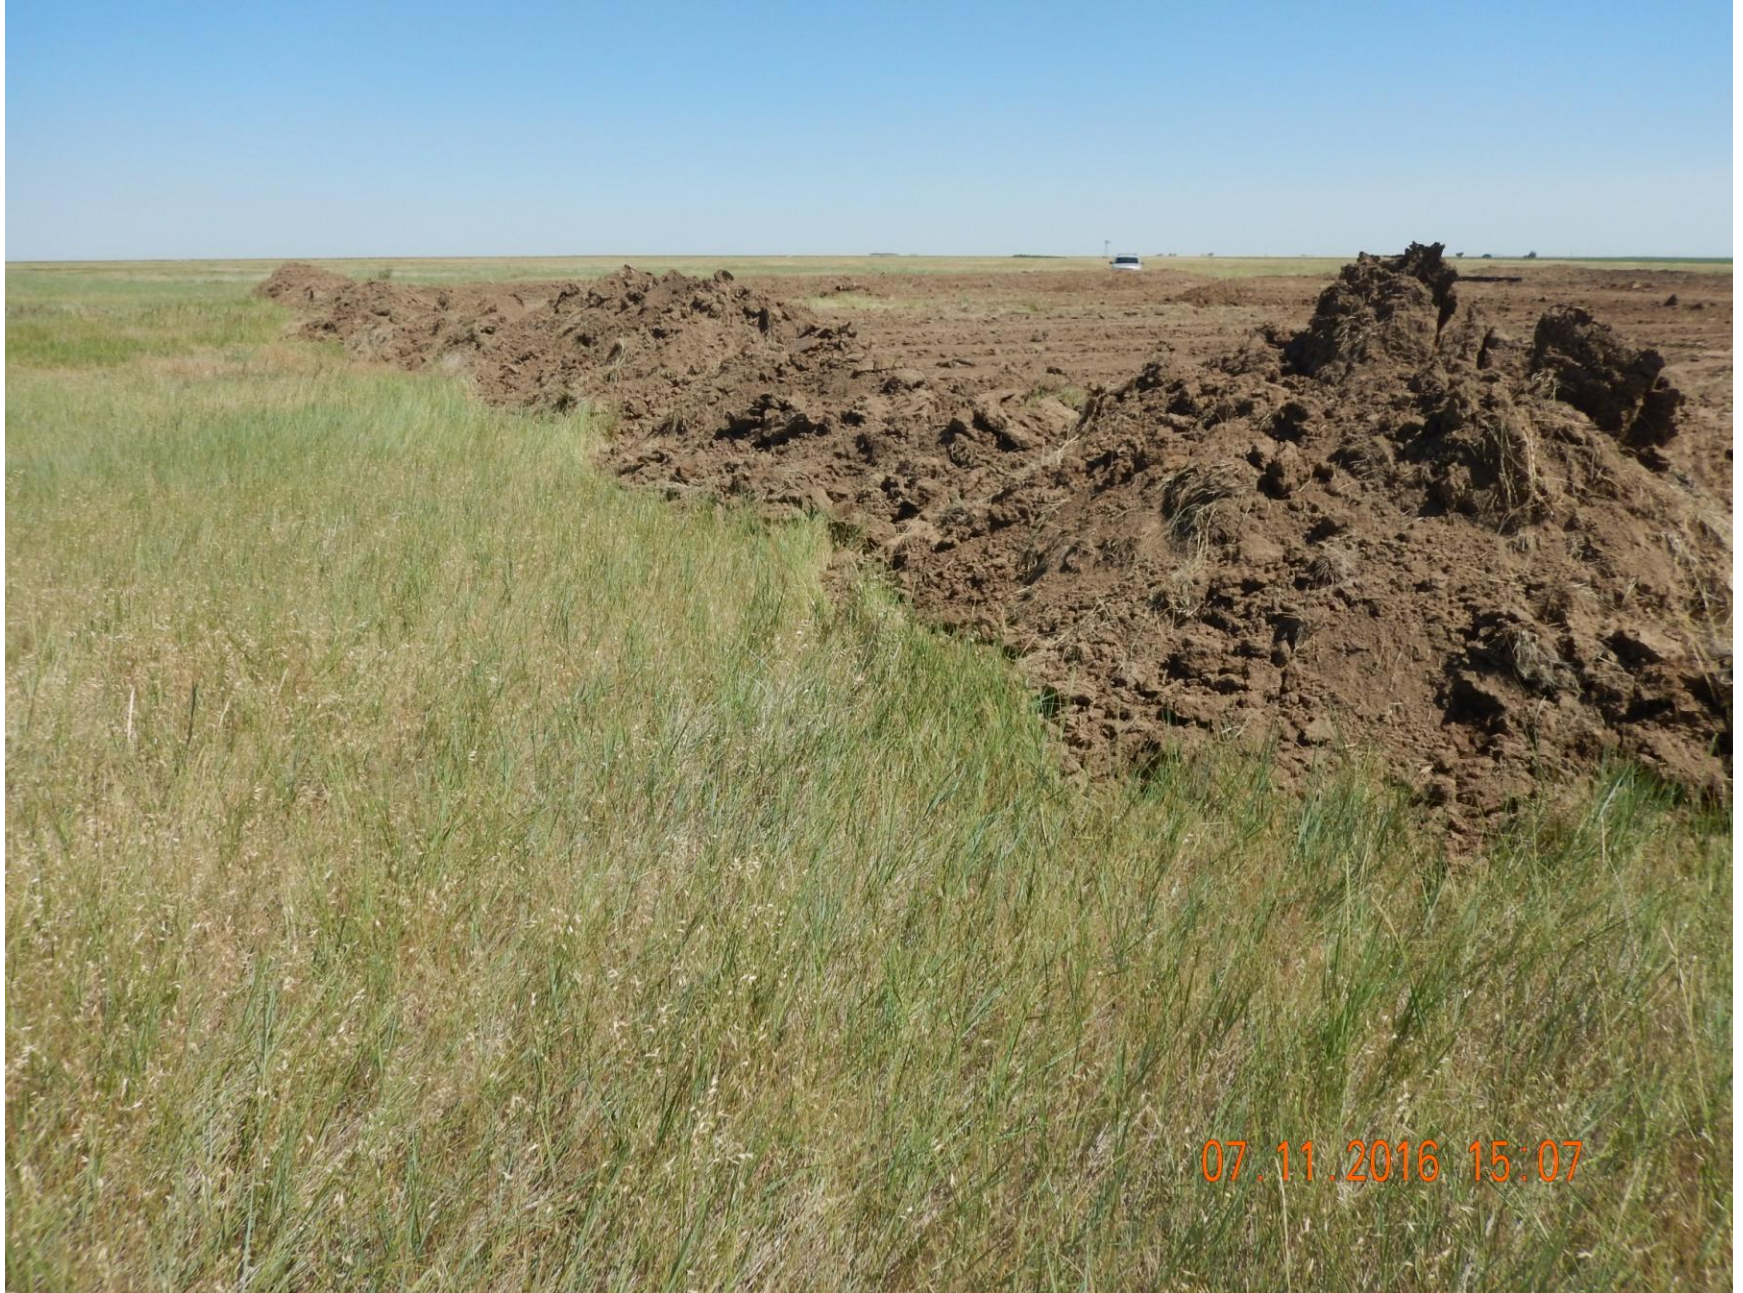
Figure 10: Photo taken from the north end of the location, facing east. Photo shows berms have not been constructed properly; berms along perimeter are not compacted and have either been incorrectly tracked, or not tracked at all.
