Construction Inspection

07/12/2016

Operator: Grand Mesa Operating

Location ID: 446515

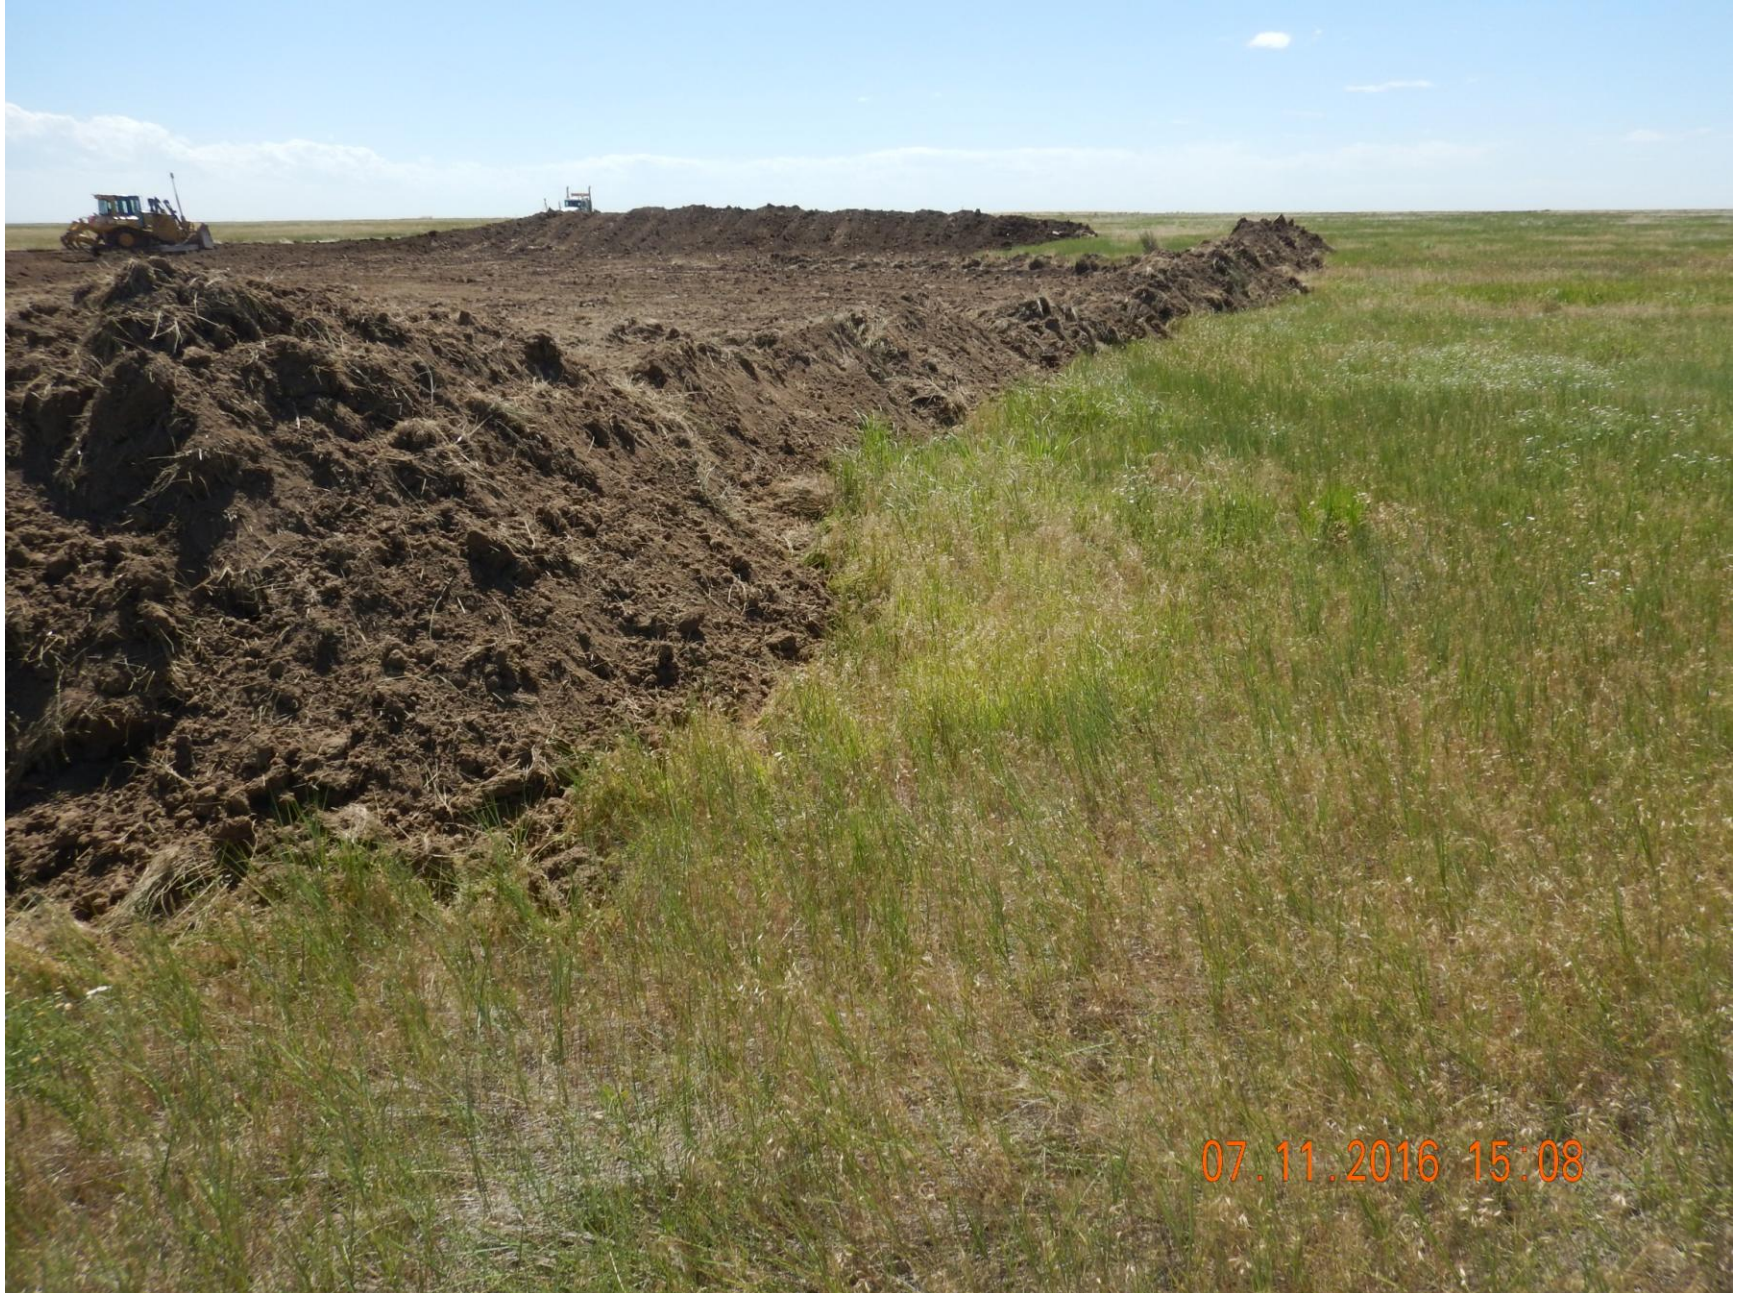
Figure 11: Photo taken from the northeast end of the location, facing west. Photo shows berms have not been constructed properly; berms along perimeter are not compacted and have either been incorrectly tracked, or not tracked at all.

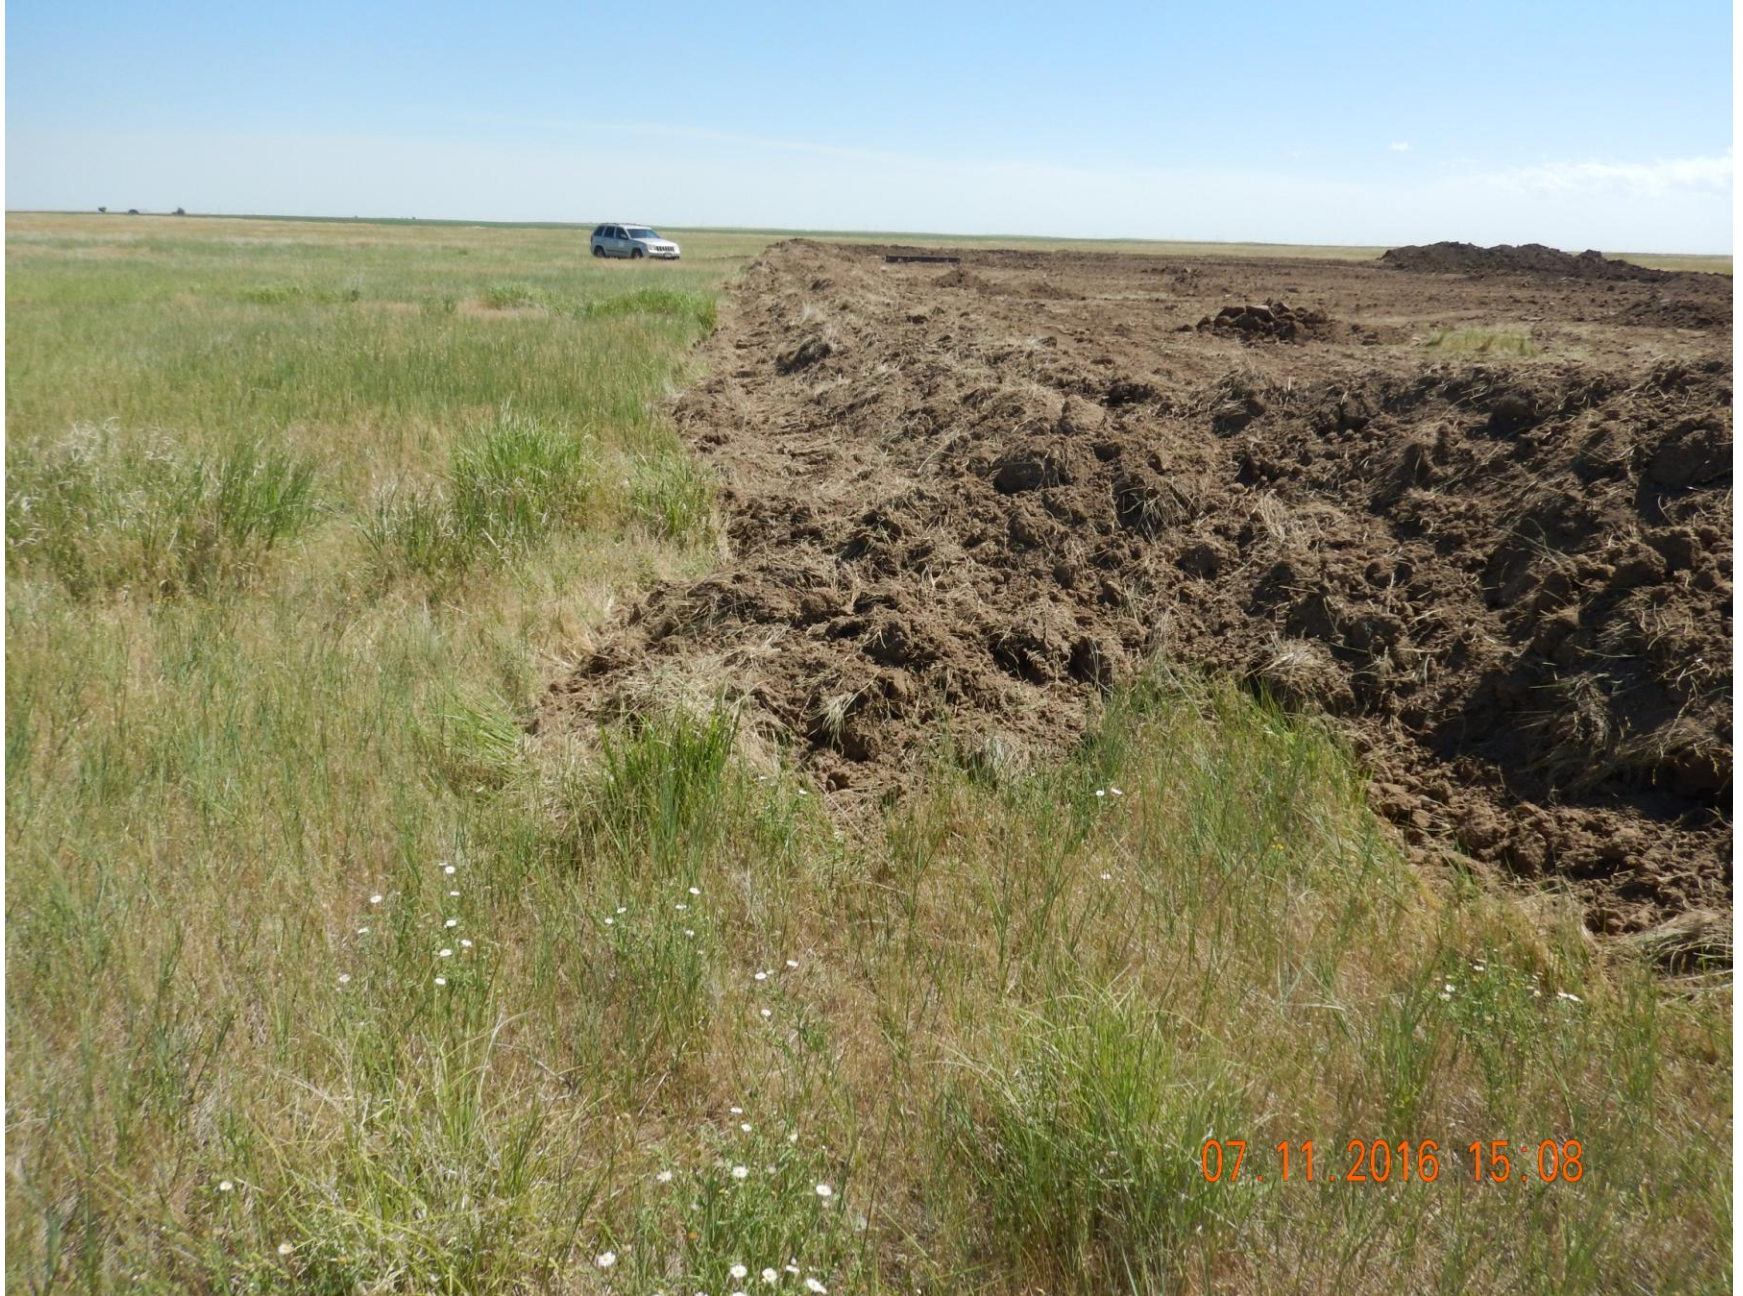
Figure 12: Photo taken from the northeast end of the location, facing south. Photo shows berms have not been constructed properly; berms along perimeter are not compacted and have either been incorrectly tracked, or not tracked at all.

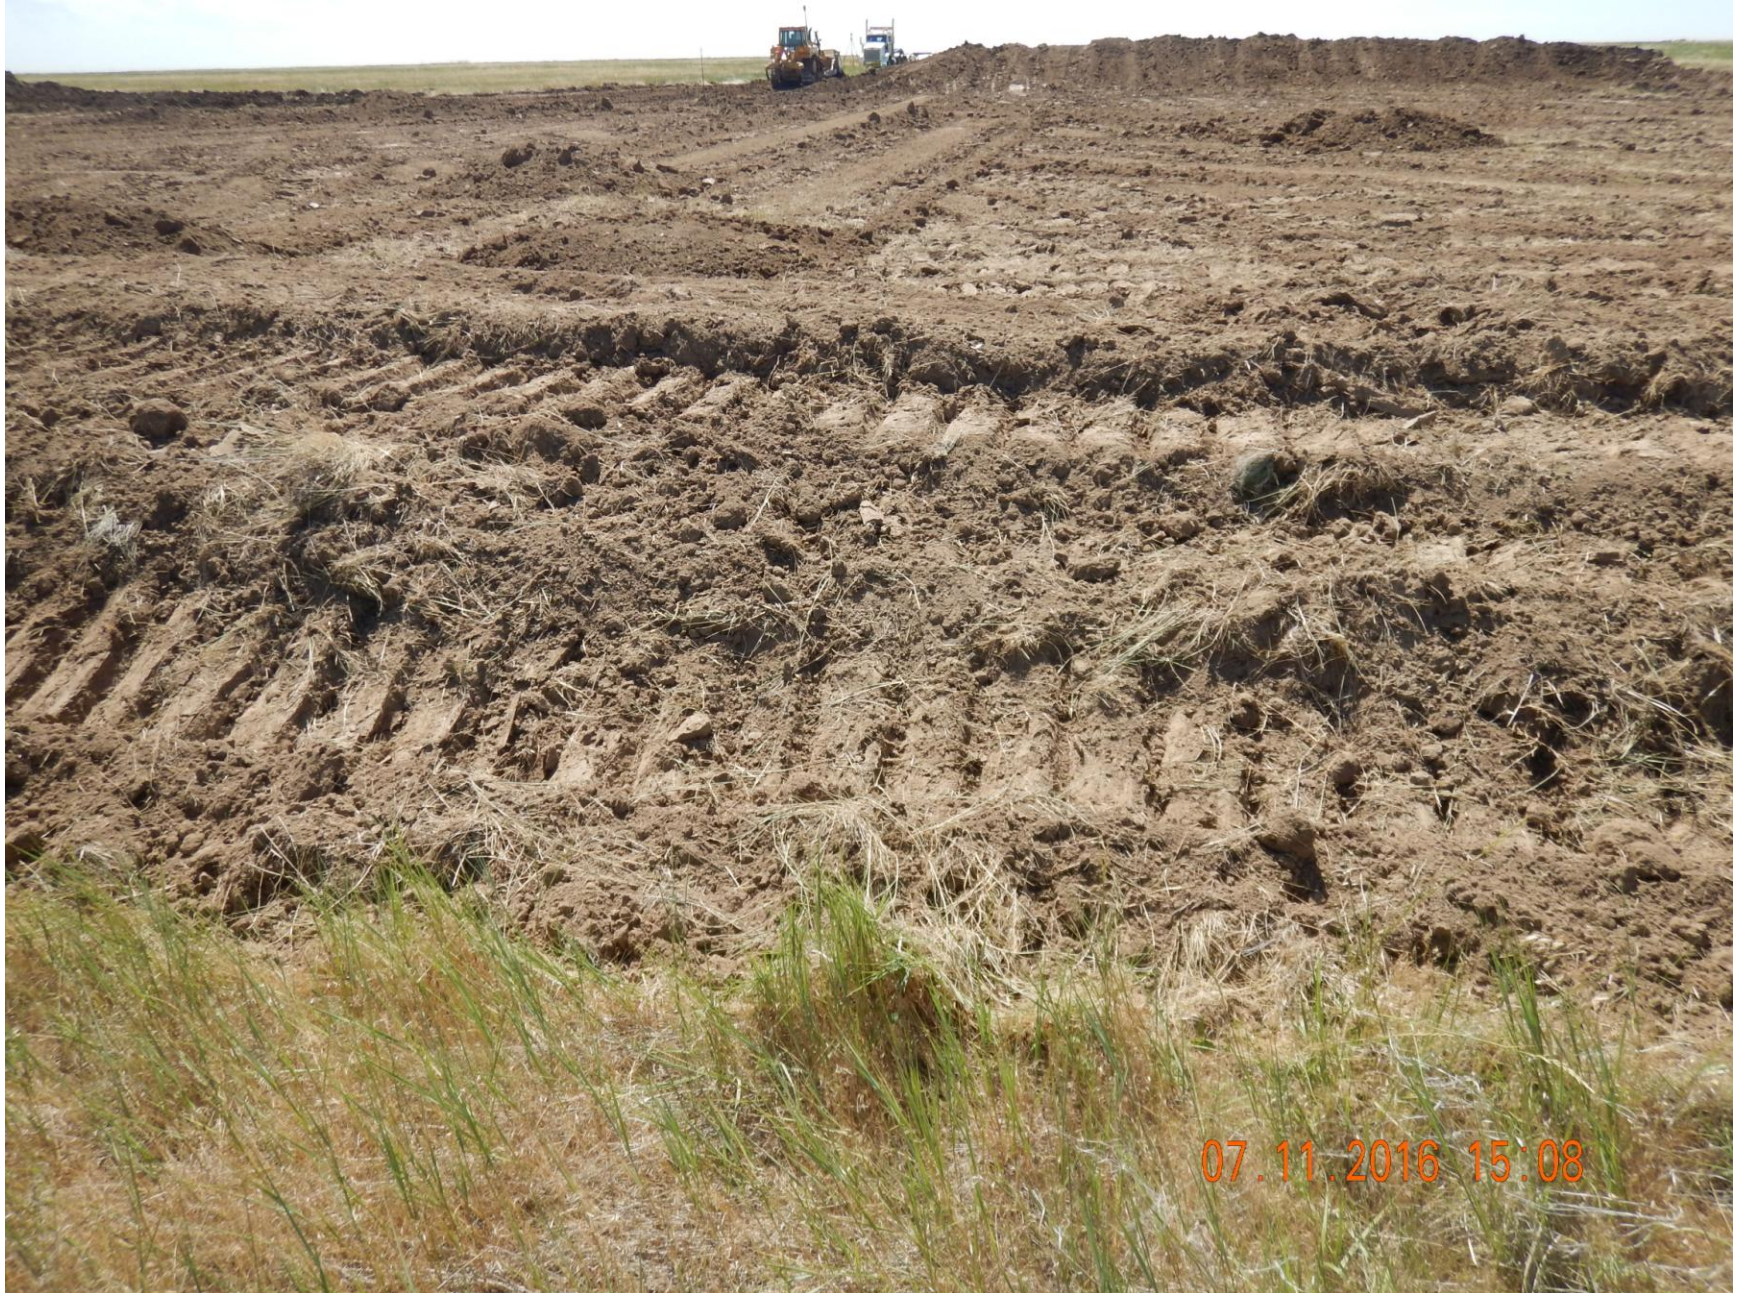
Figure 13: Photo shows perimeter berms have been constructed improperly; berm has been improperly tracked.
