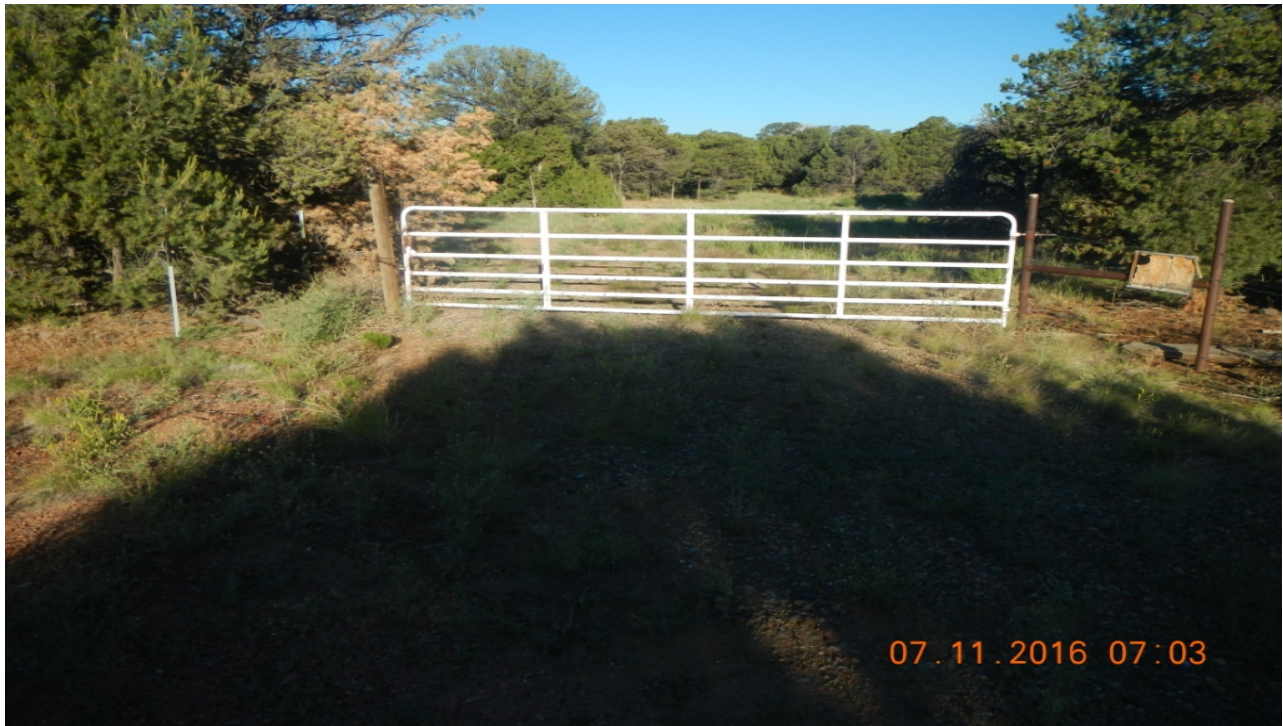
**photo 1:** Facing toward the beginning of the access road.

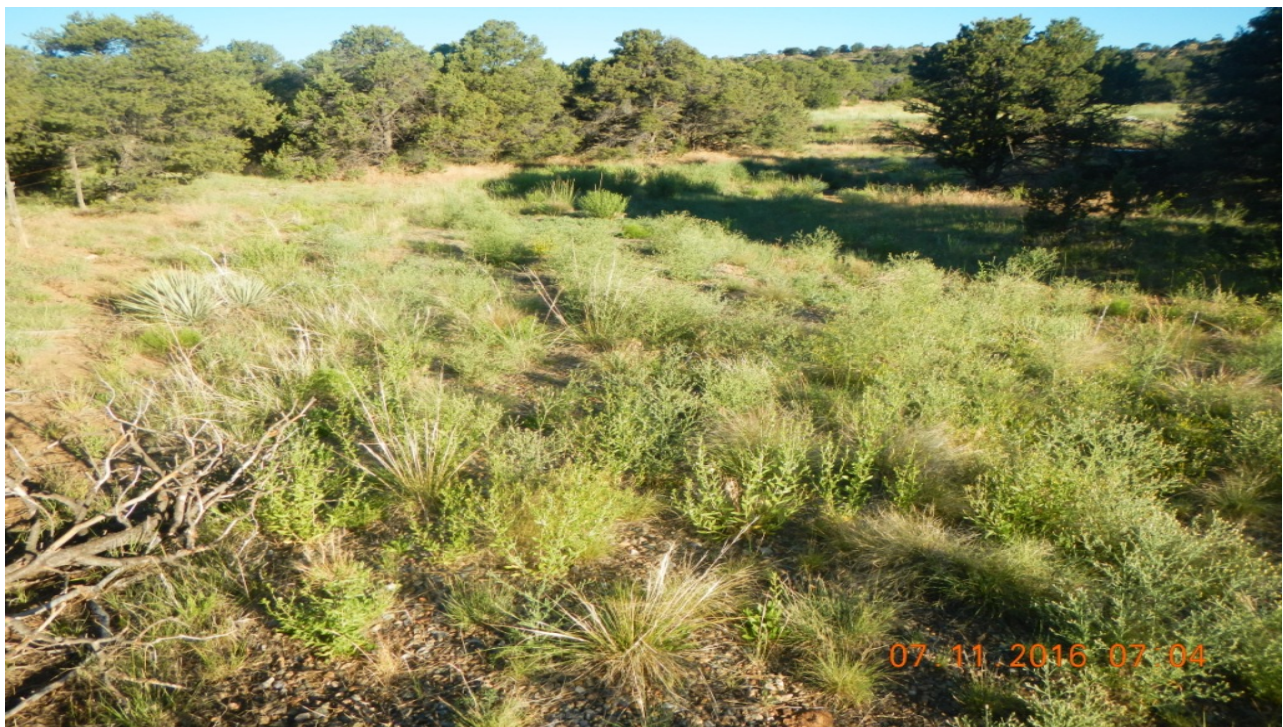
**photo 2:** Facing northwest along the access road. The access road has not been reclaimed and there is noxious weed infestation along the road.

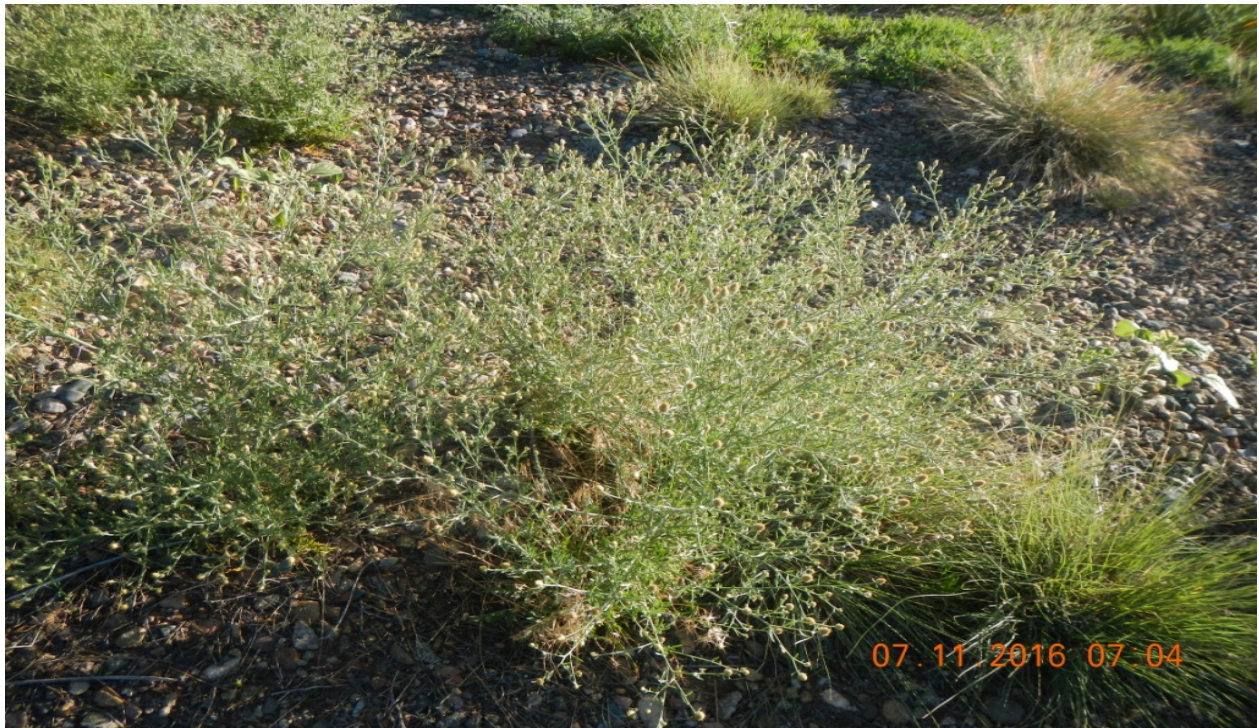
**photo 3:** There is Diffuse and Spotted knapweed (List B noxious weeds) growing along the access road and at the location.

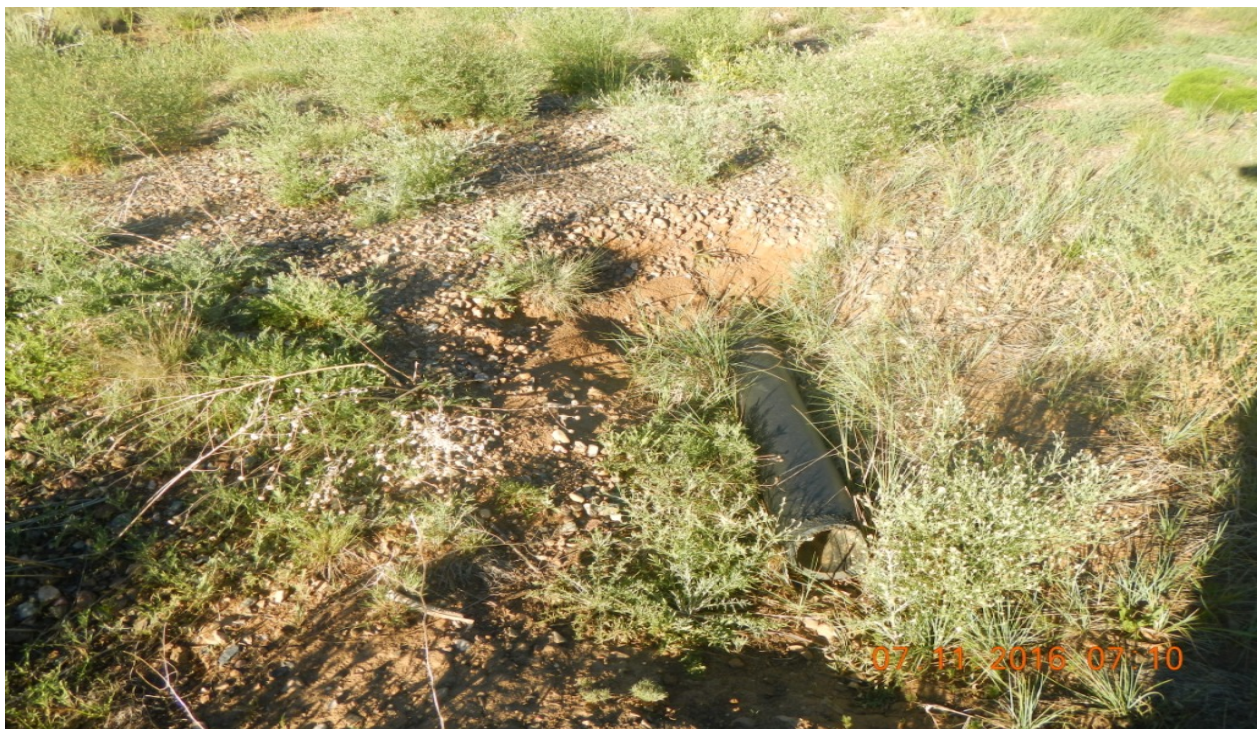
**photo 4:** A plastic culvert and gravel remains along the access road.

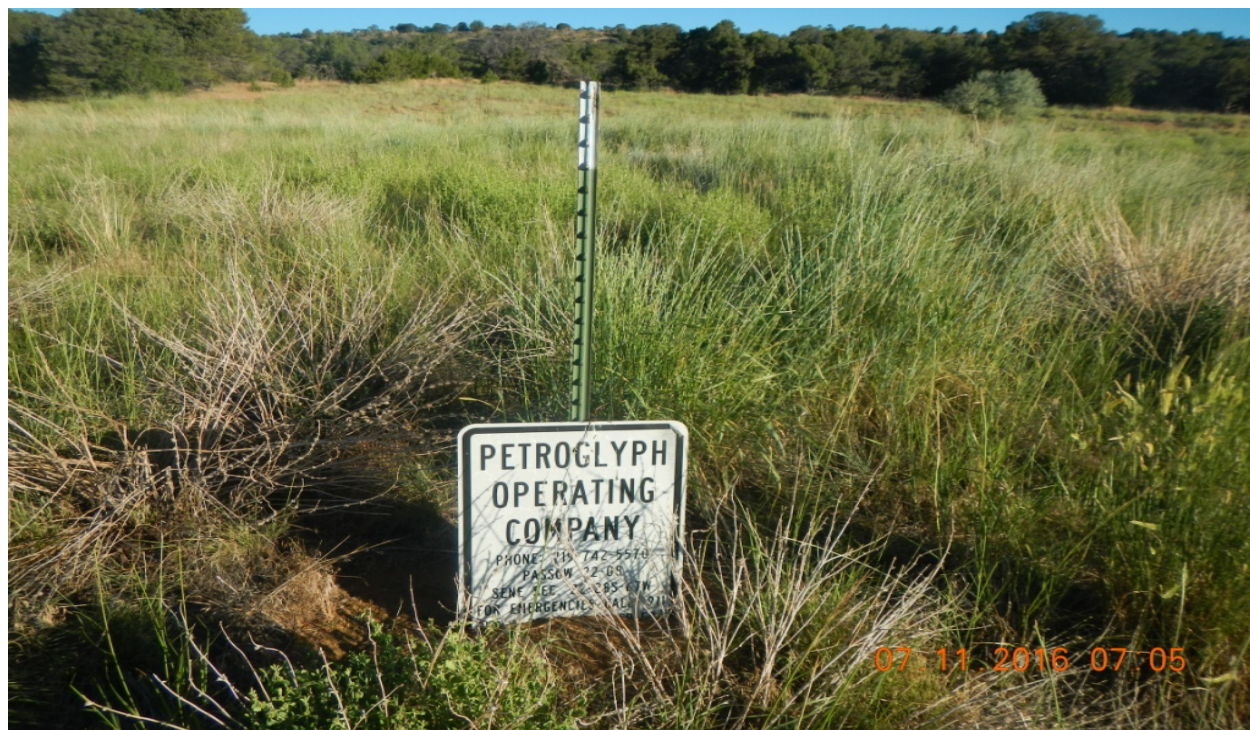
**photo 5:** Facing northwest toward the location.

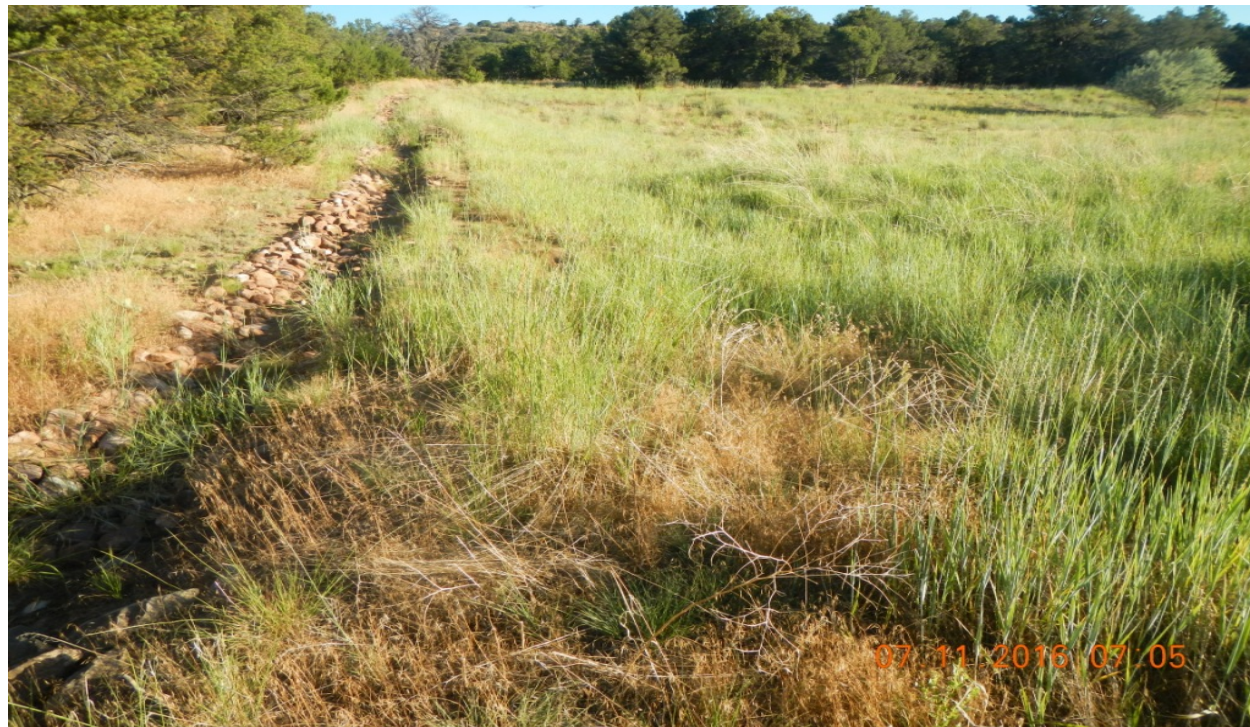
**photo 6:** Northwest side of the location facing northeast.

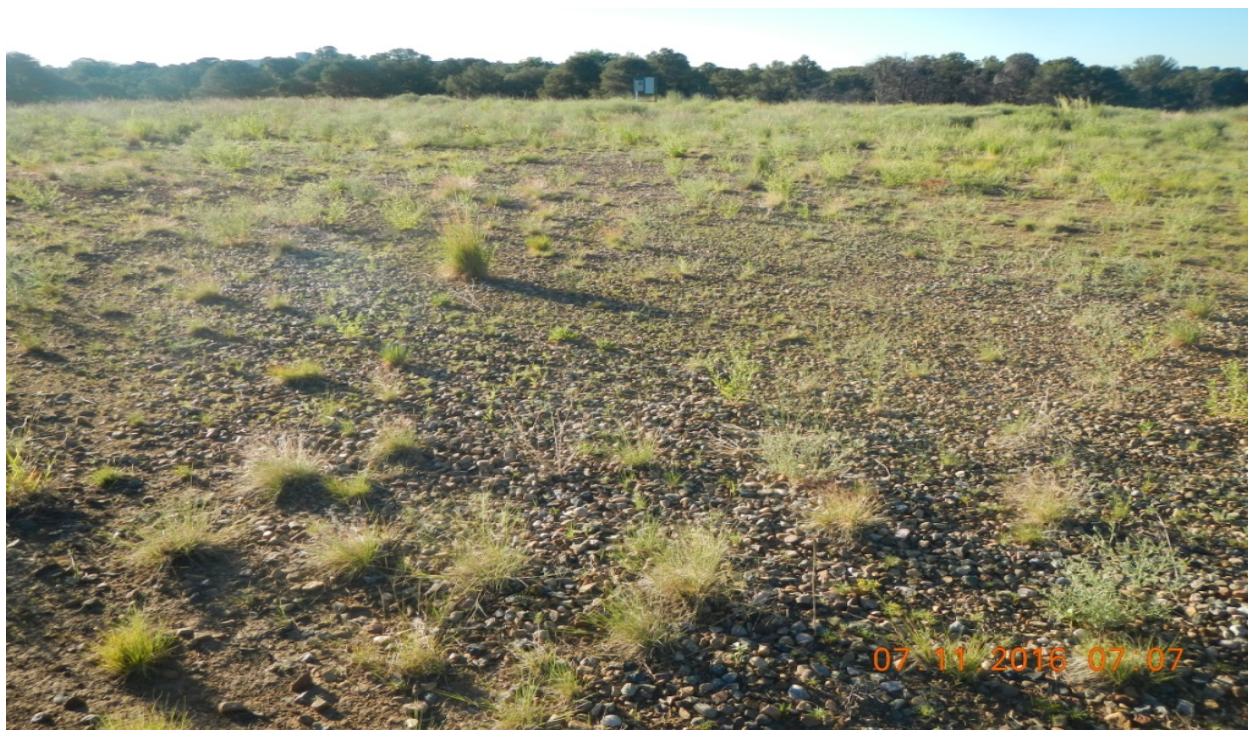
**photo 7:** North side of the location facing south. Gravel remains in this area where there is less vegetation establishment.

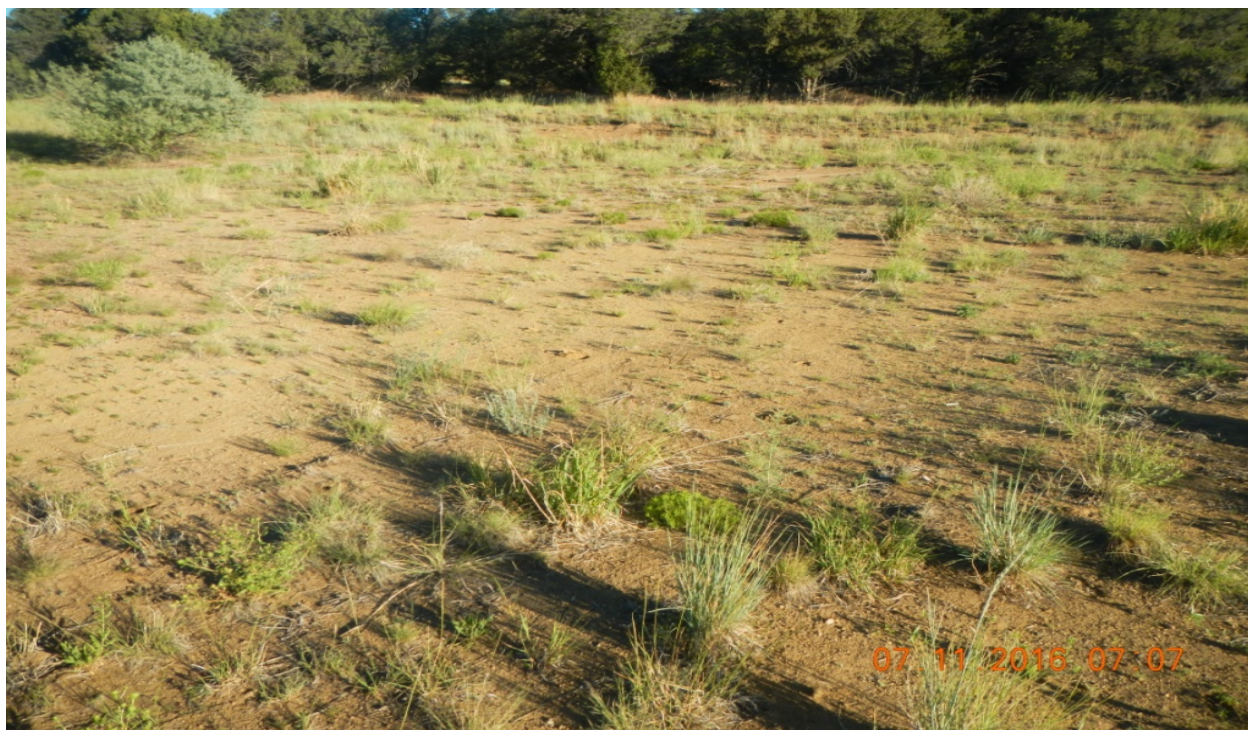
**photo 8:** Facing along the northwest side of the location.

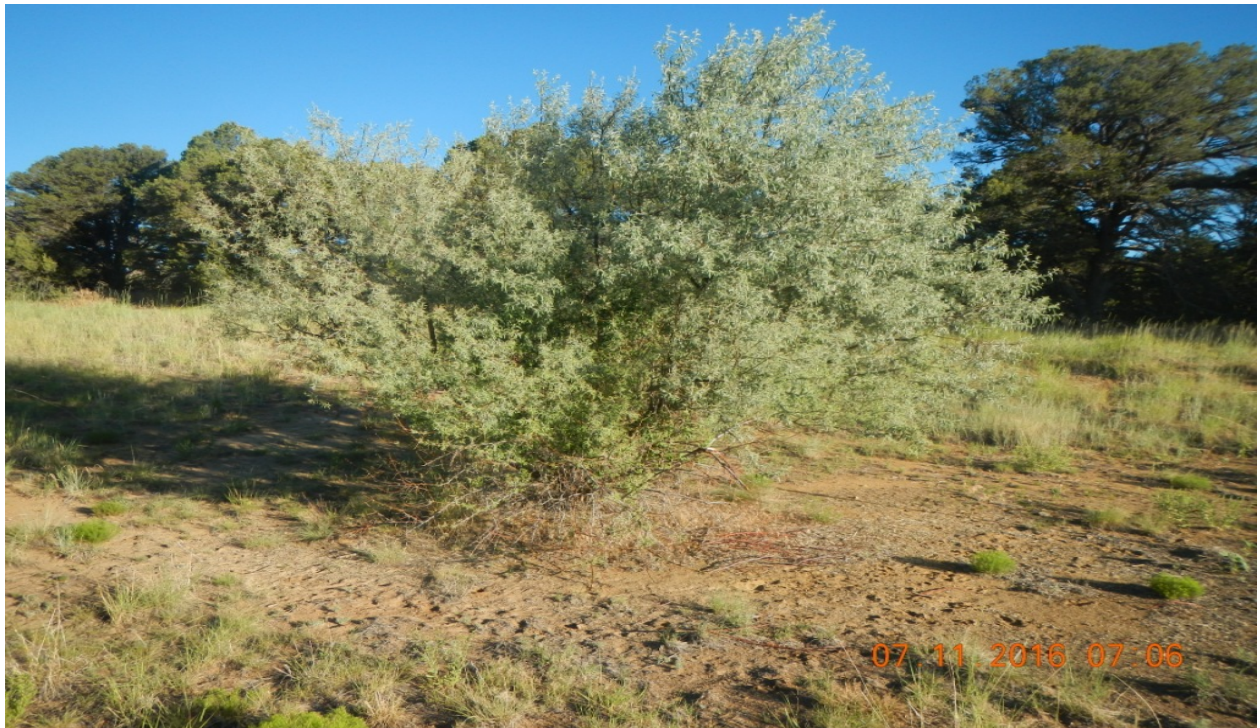
**photo 9:** There is a Russian olive tree which is a List B noxious weed growing at the northwest side of the location.

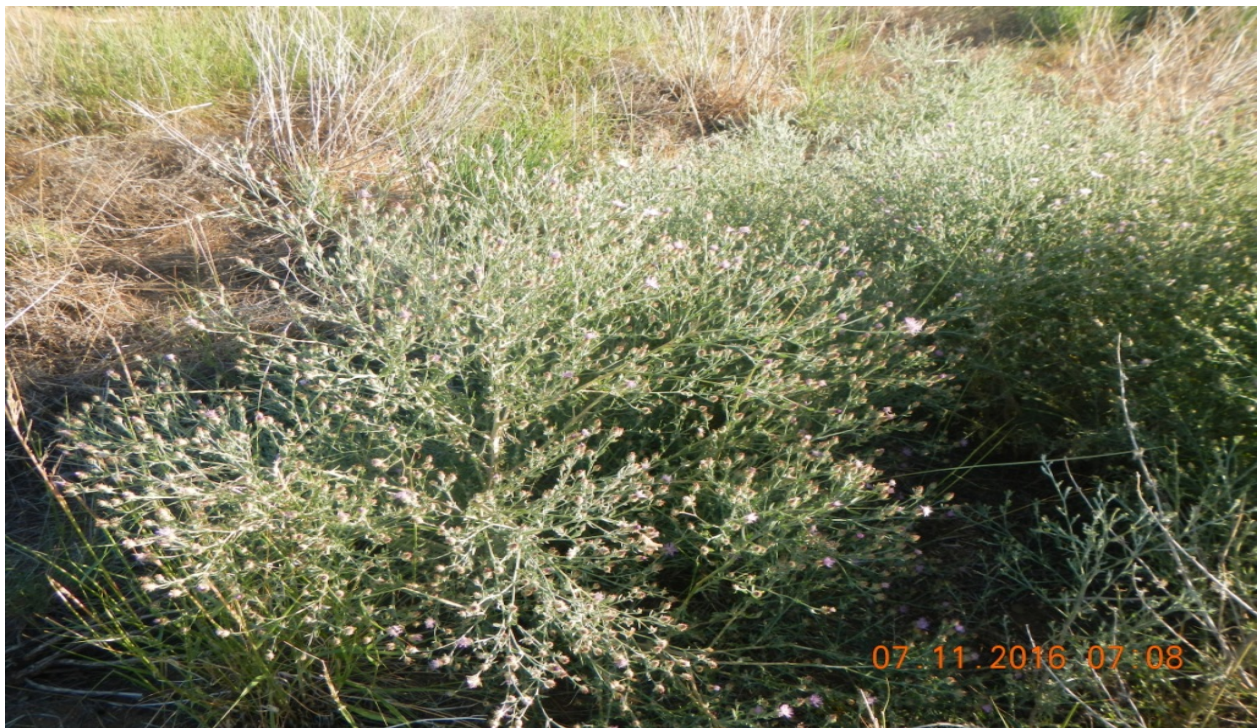
**photo 10:** There is Diffuse and Spotted knapweed growing at the location which is beginning to produce seed.

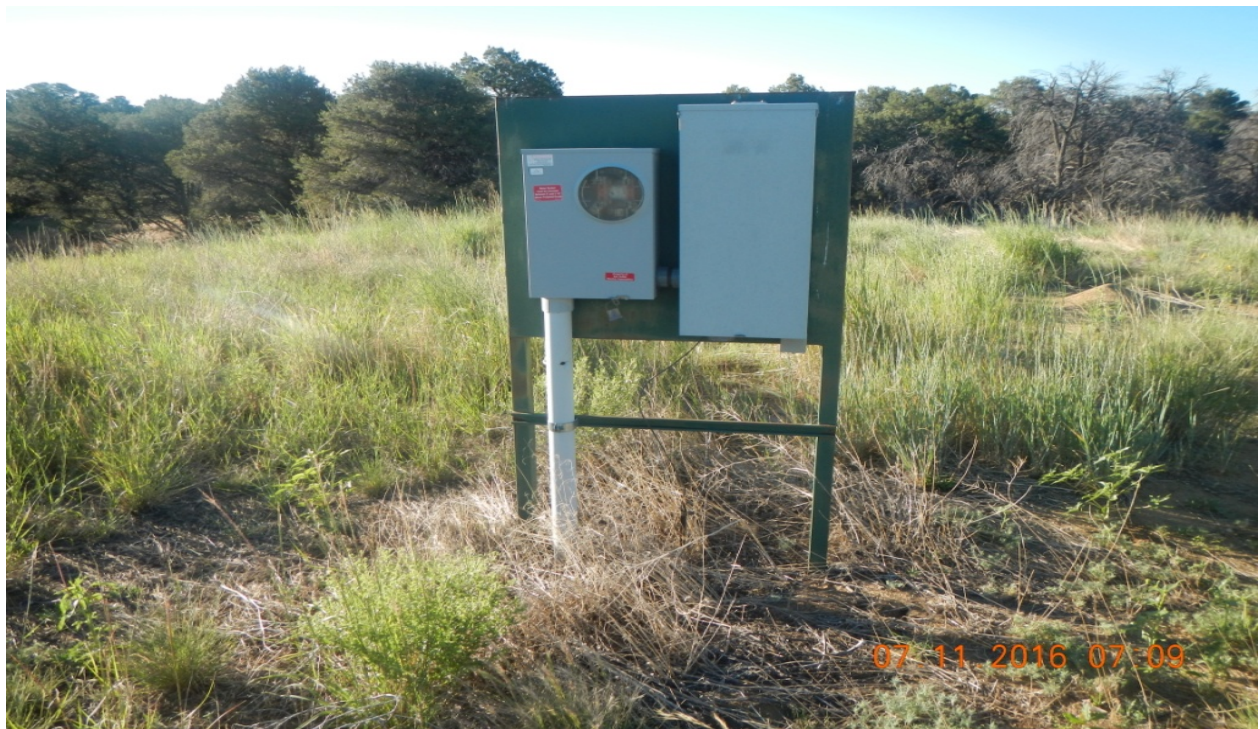
**photo 11:** An electrical utility remains at the southeast side of the location.

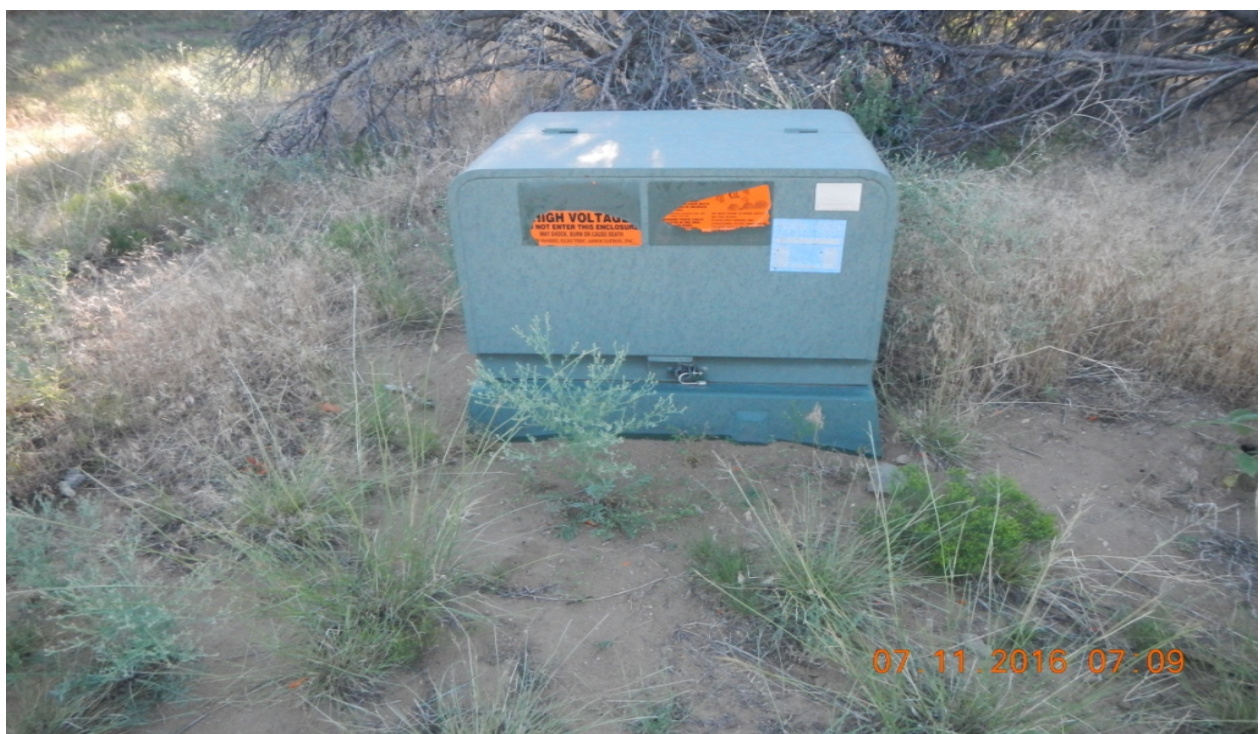
**photo 12:** An electrical utility remains along the access road.
