Final Reclamation Inspection- Pit

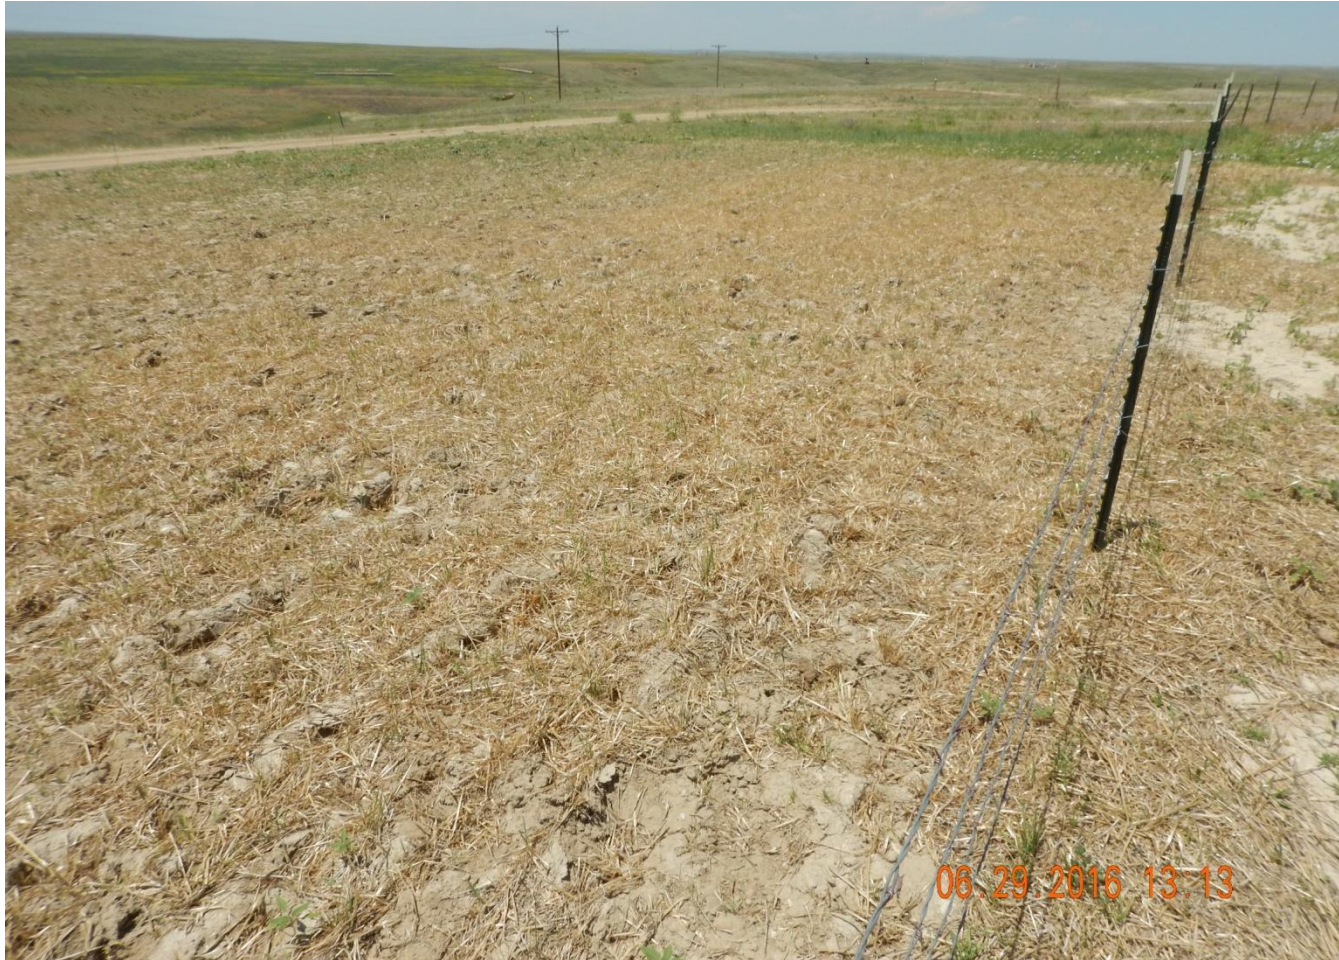
Photo 1. Photo taken from the eastern skim and produced water pit location, facing Northwest. Reclamation is IN PROCESS and will be evaluated on a future date to ensure compliance with Rule 1004.

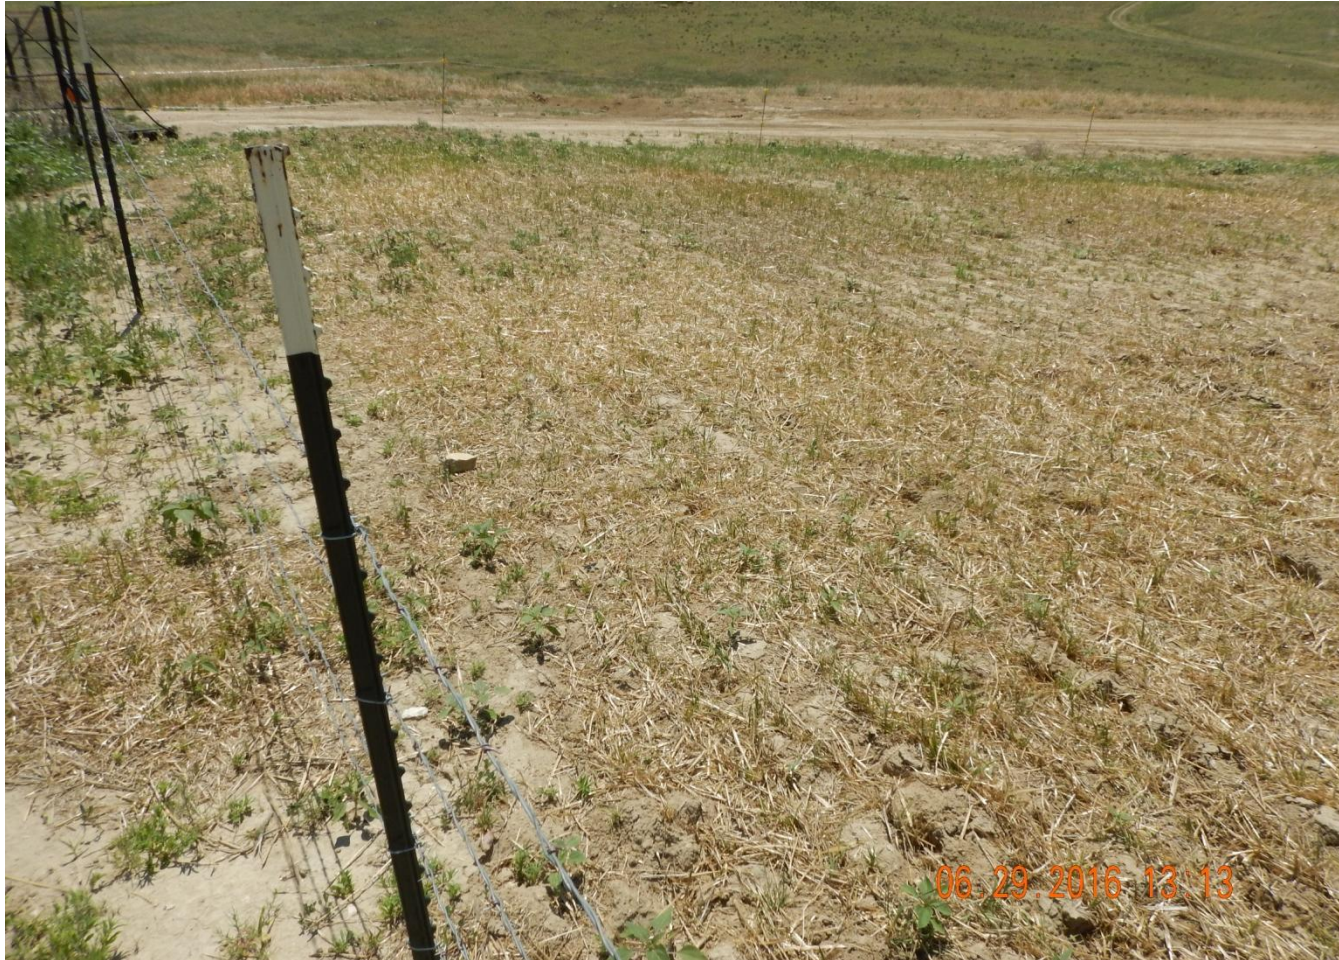
Photo 2. Photo taken from the eastern skim and produced water pit location, facing Southwest. Reclamation is IN PROCESS and will be evaluated on a future date to ensure compliance with Rule 1004.

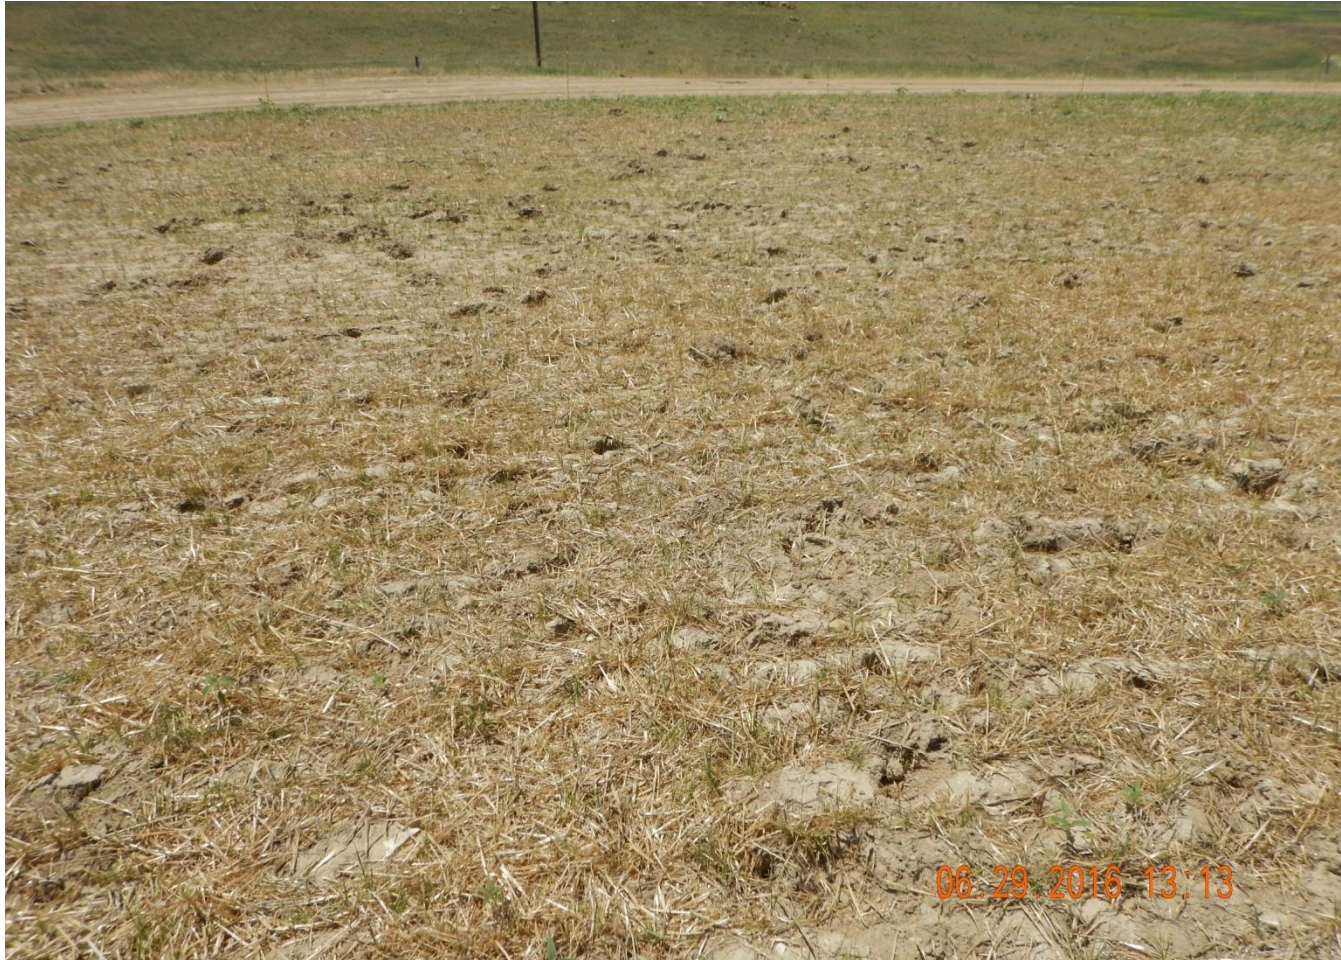
Photo 3. Photo taken from the eastern skim and produced water pit location, facing West. Reclamation is IN PROCESS and will be evaluated on a future date to ensure compliance with Rule 1004.
