Final Reclamation Inspection- Flowline Release Area

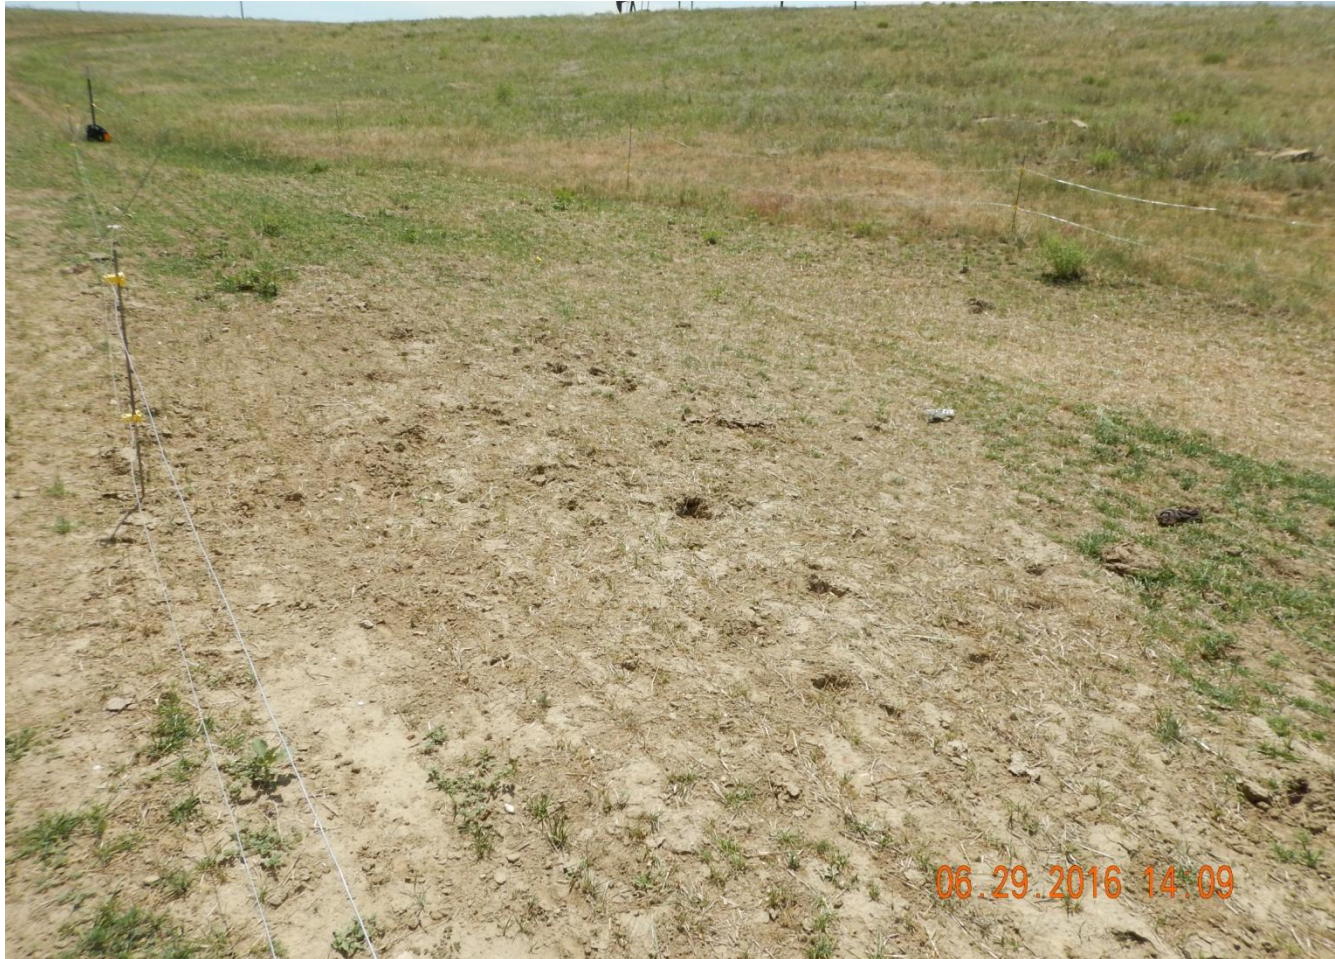
Photo 1. Photo taken from east of release area, facing South. Reclamation is IN PROCESS. Location has been seeded and vegetation appears to be establishing.

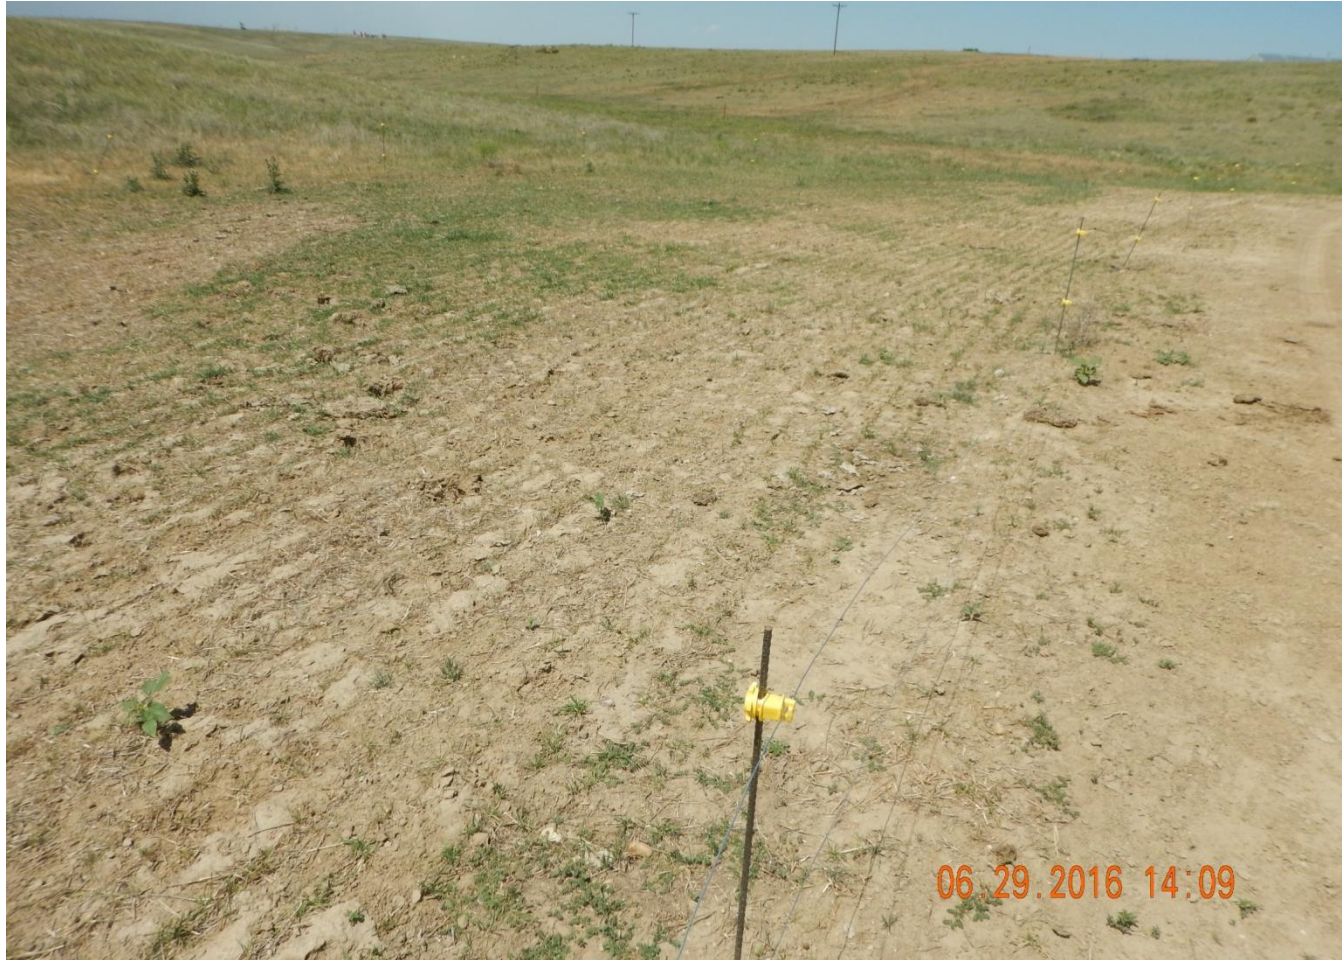
Photo 2. Photo taken from east of release area, facing North. Reclamation is IN PROCESS. Location has been seeded and vegetation appears to be establishing.
