Inspection Photos: Exxon Mobil PA API#045-14231

July 7, 2016

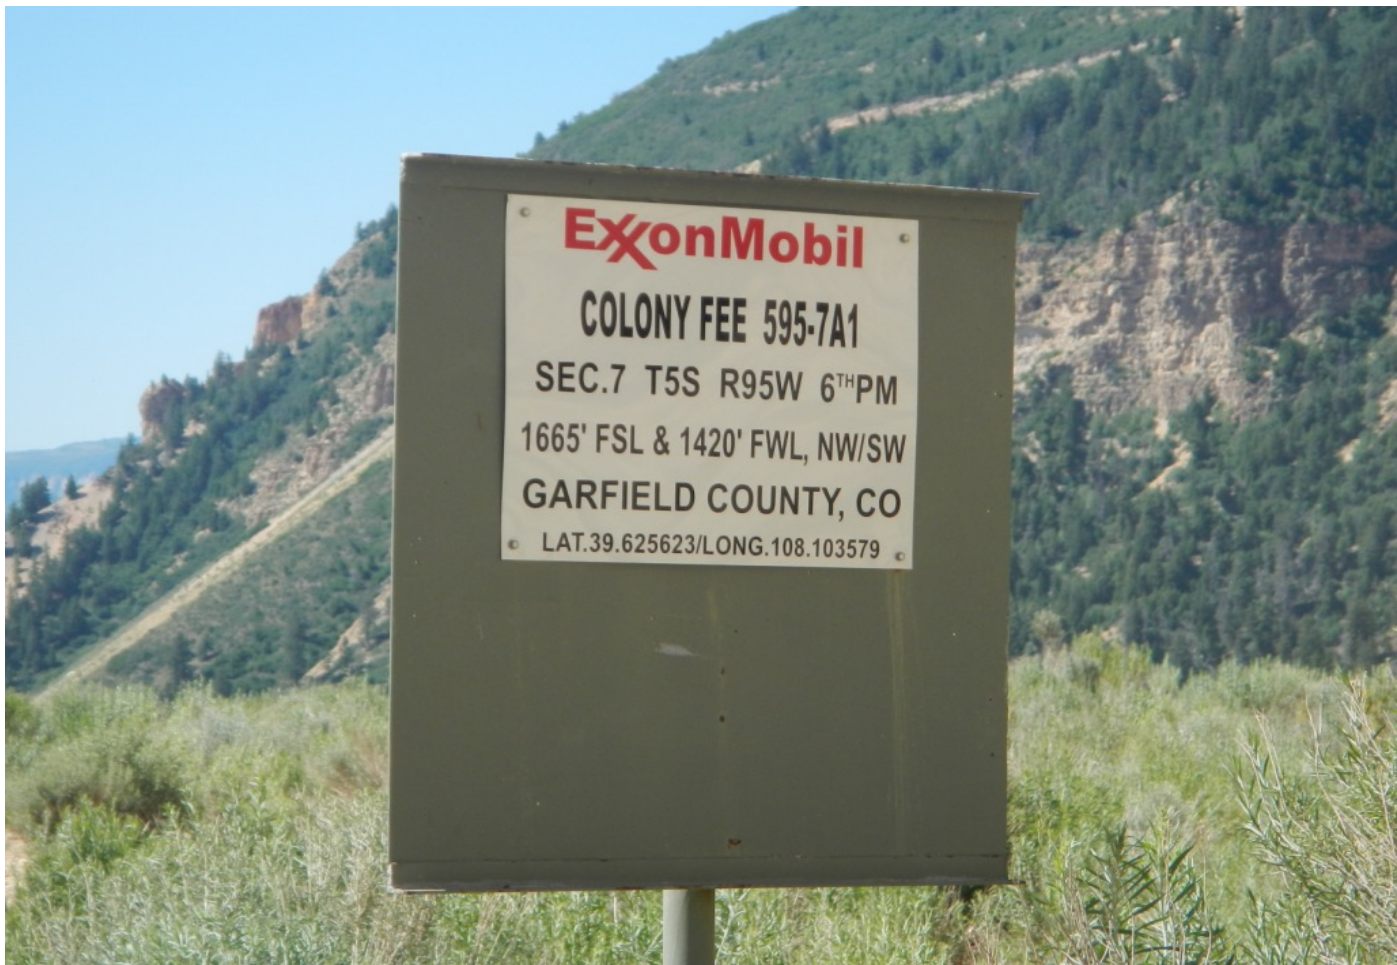
Photo#1: Location Sign at Entry.

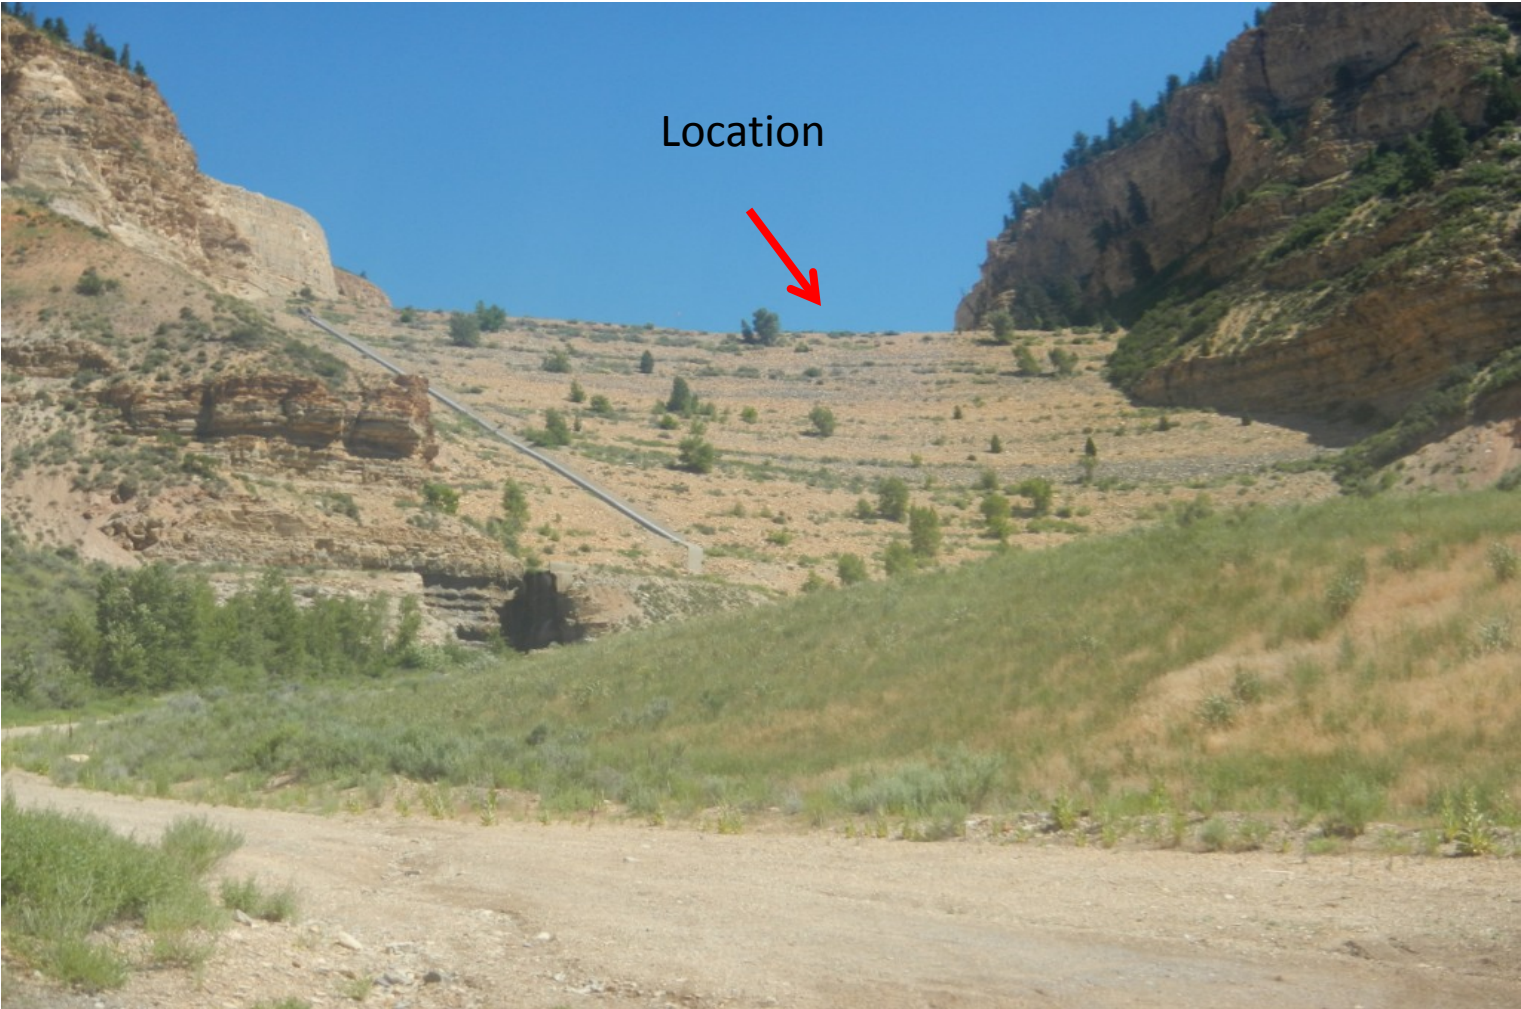
Photo#2: Location site is at top of 300Ft of Fill from Road Construction.

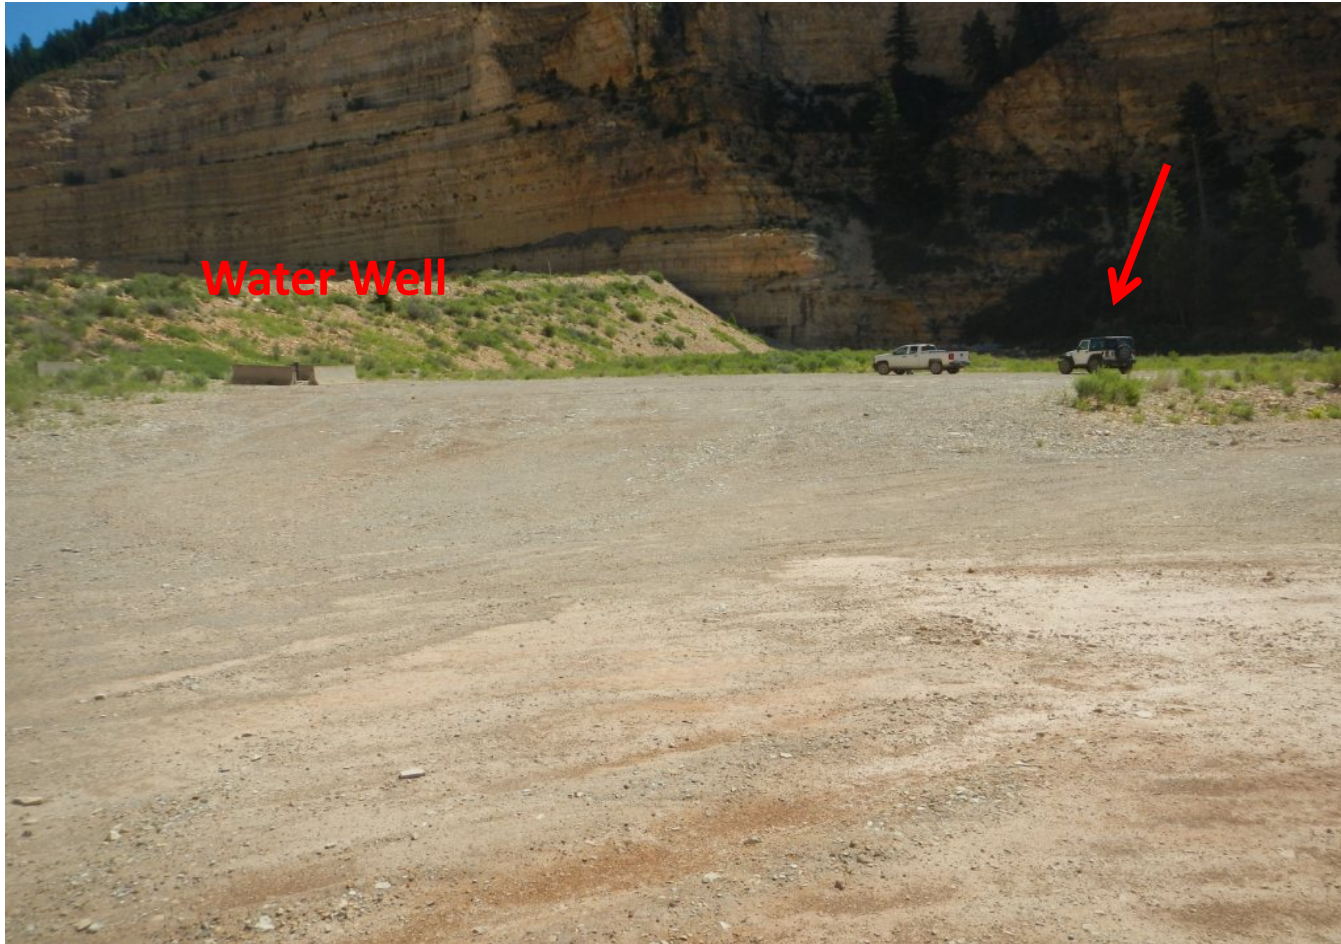
Photo#3: Entry into Helipad/ Muster area. Location center to East of vehicles , noted by Arrow.

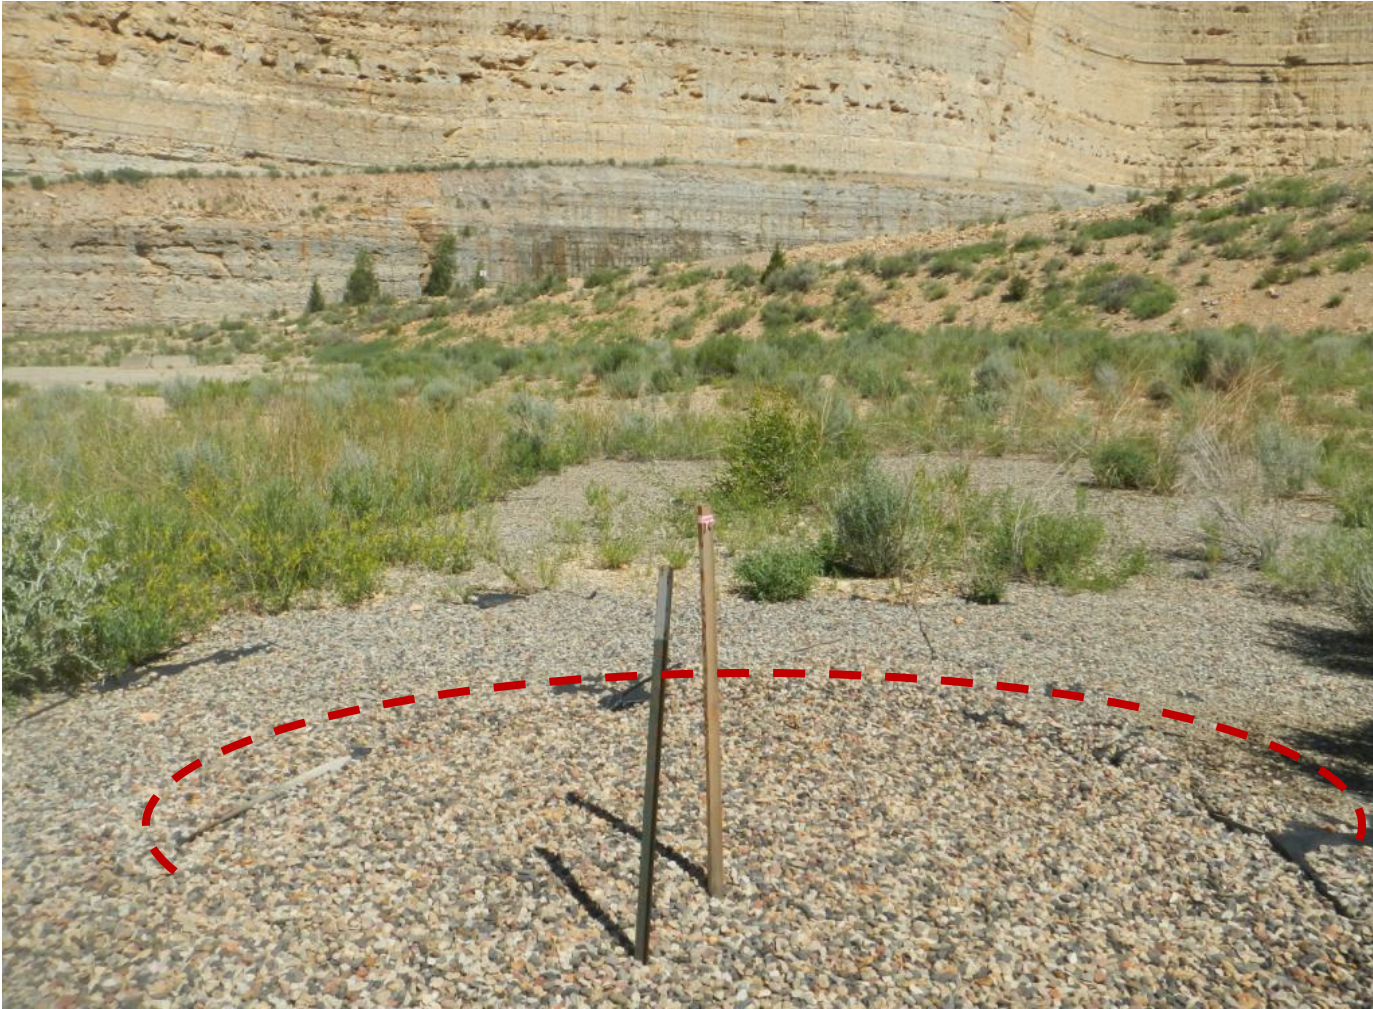
Photo#4: : View over Location Center to North. Cellar and Liner Visible , indicated by Dash line.

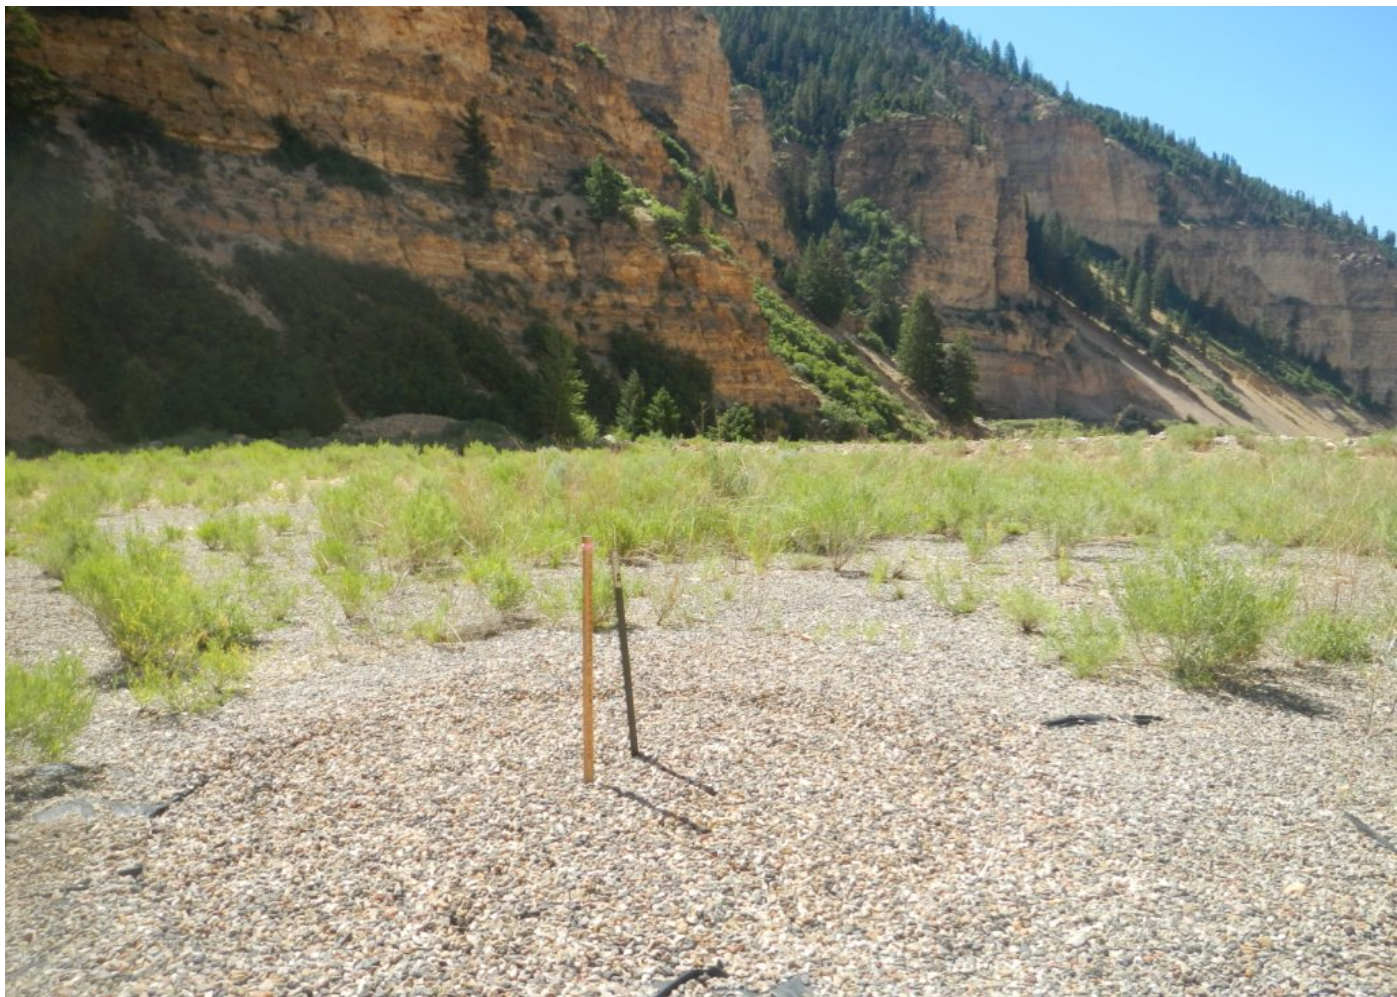
Photo#5: : View over Location Center to South.

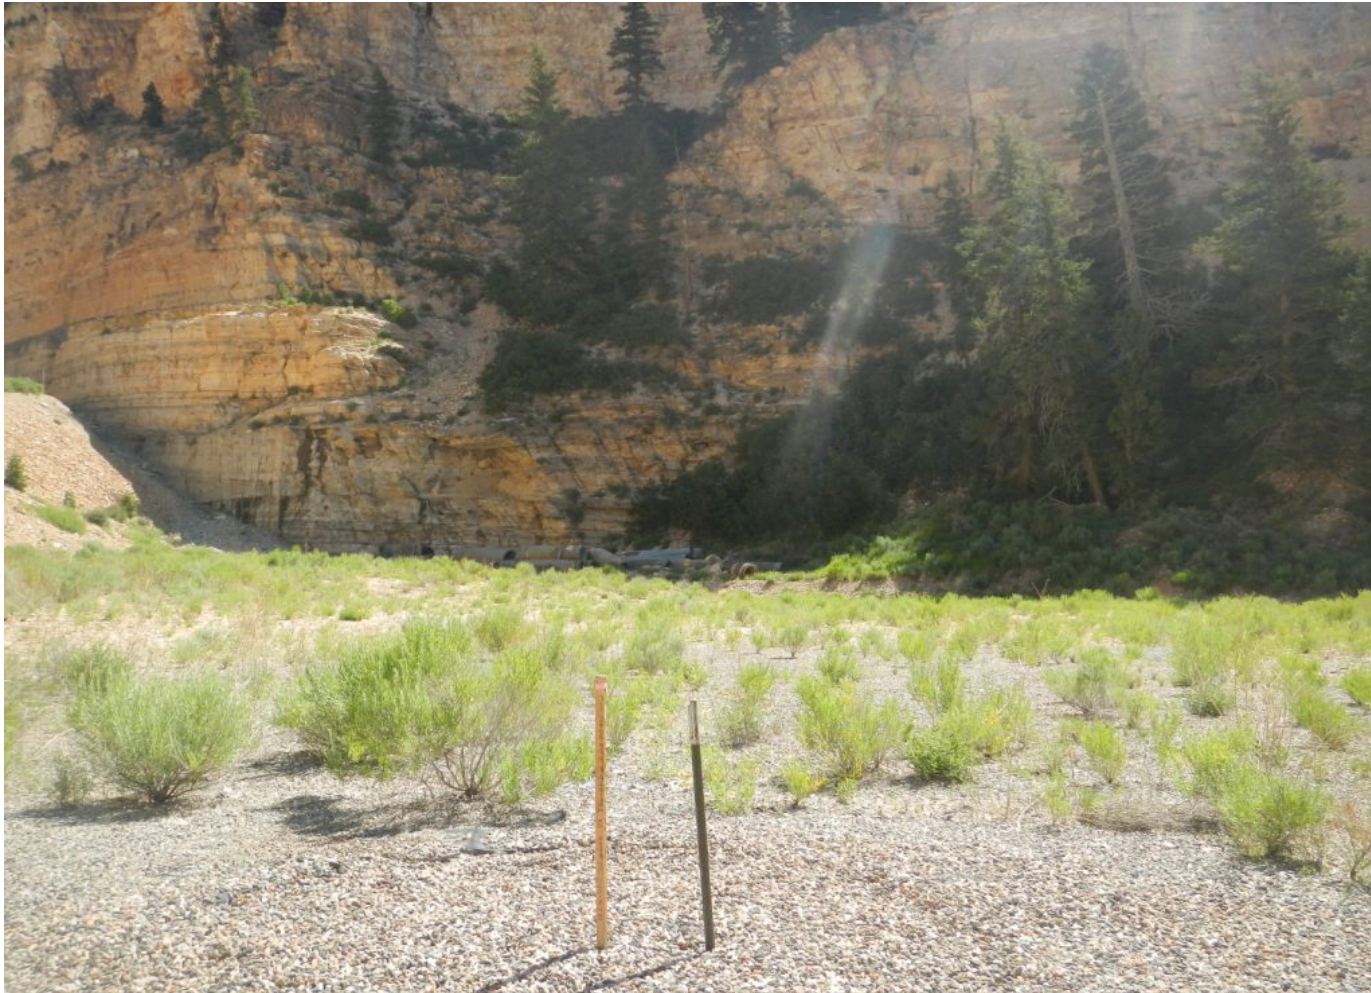
Photo#6: View over Location Center to East.

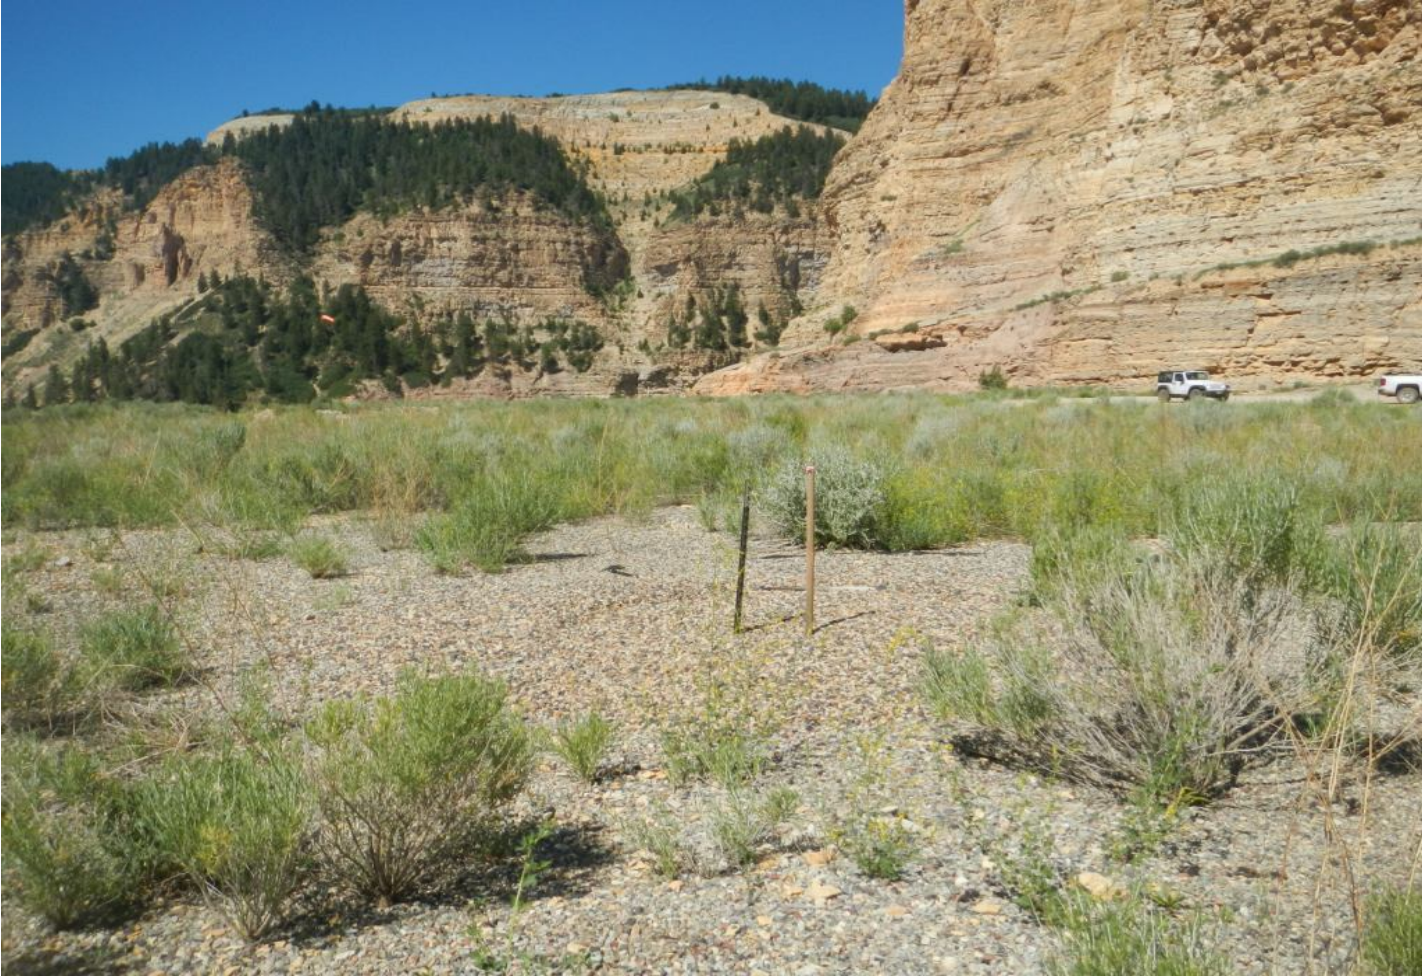
Photo#7: View over Location Center to West.

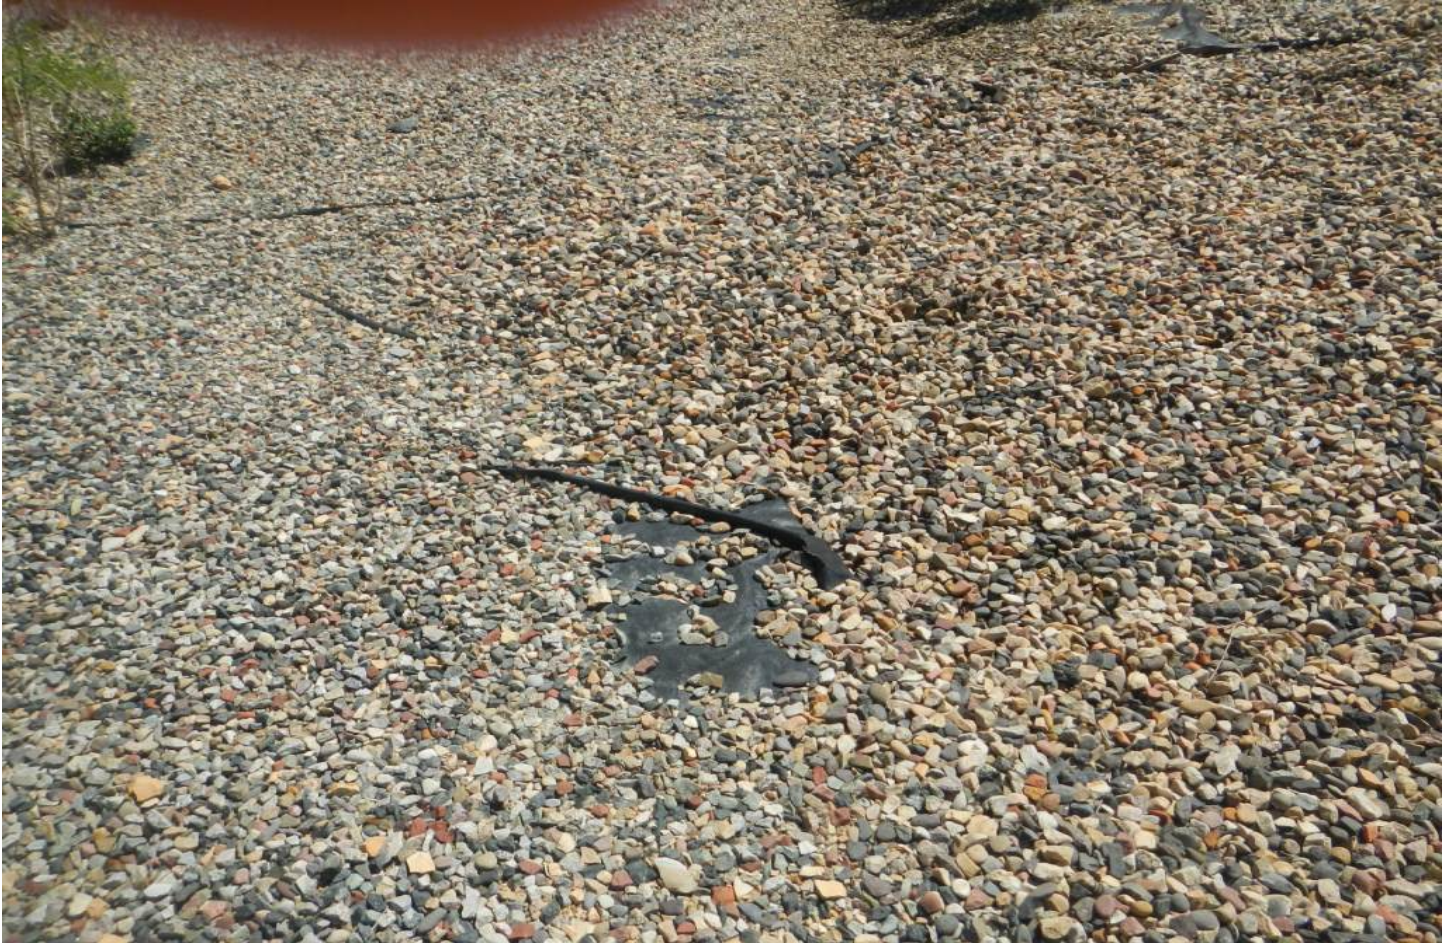
Photo#8: Gravel & remnants of Liner on Location.

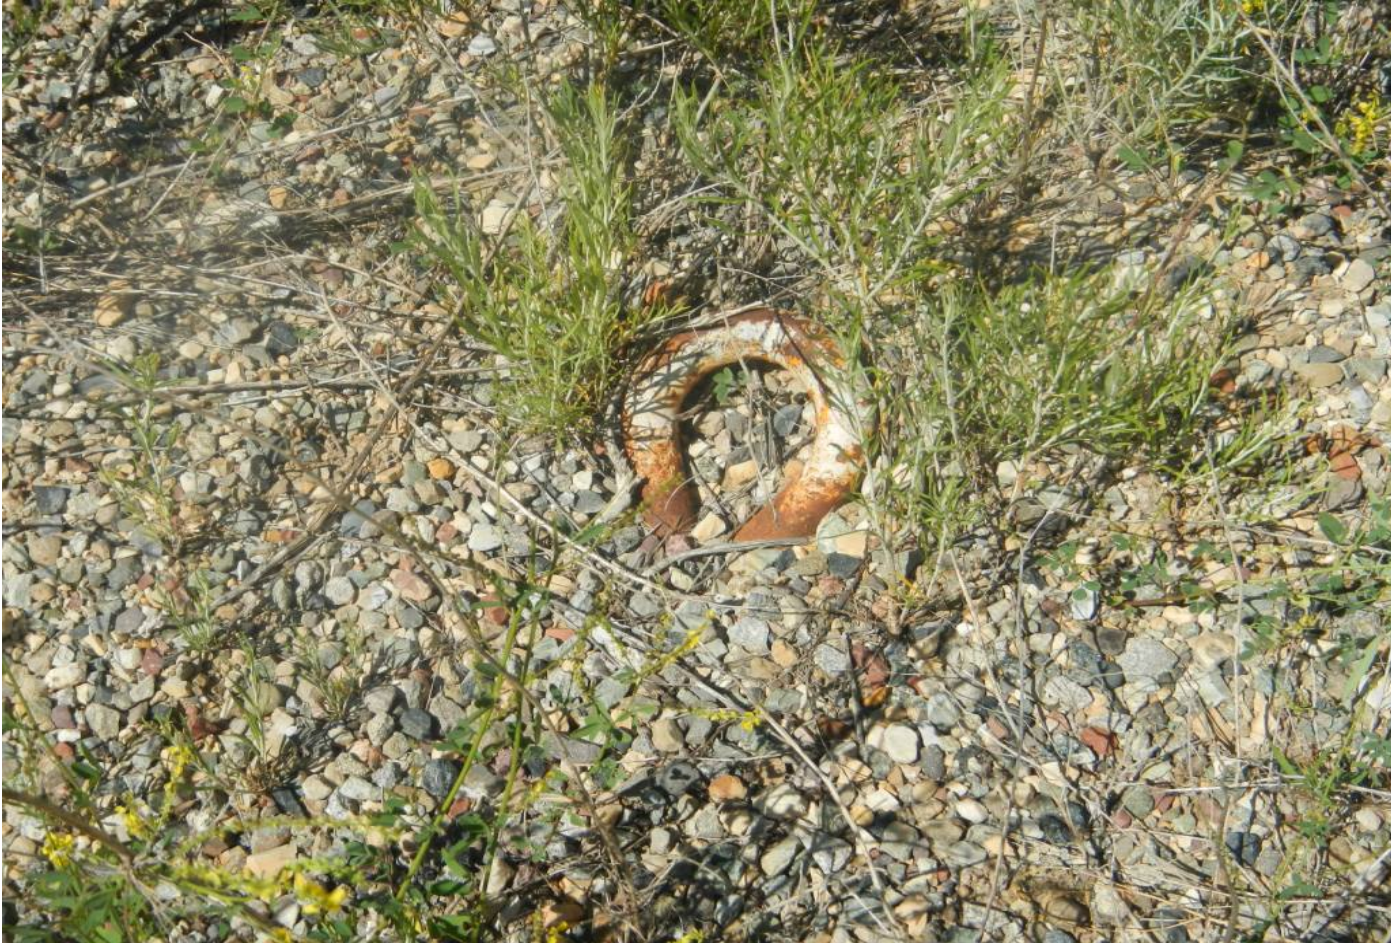
Photo#9: Guy Anchor not removed.

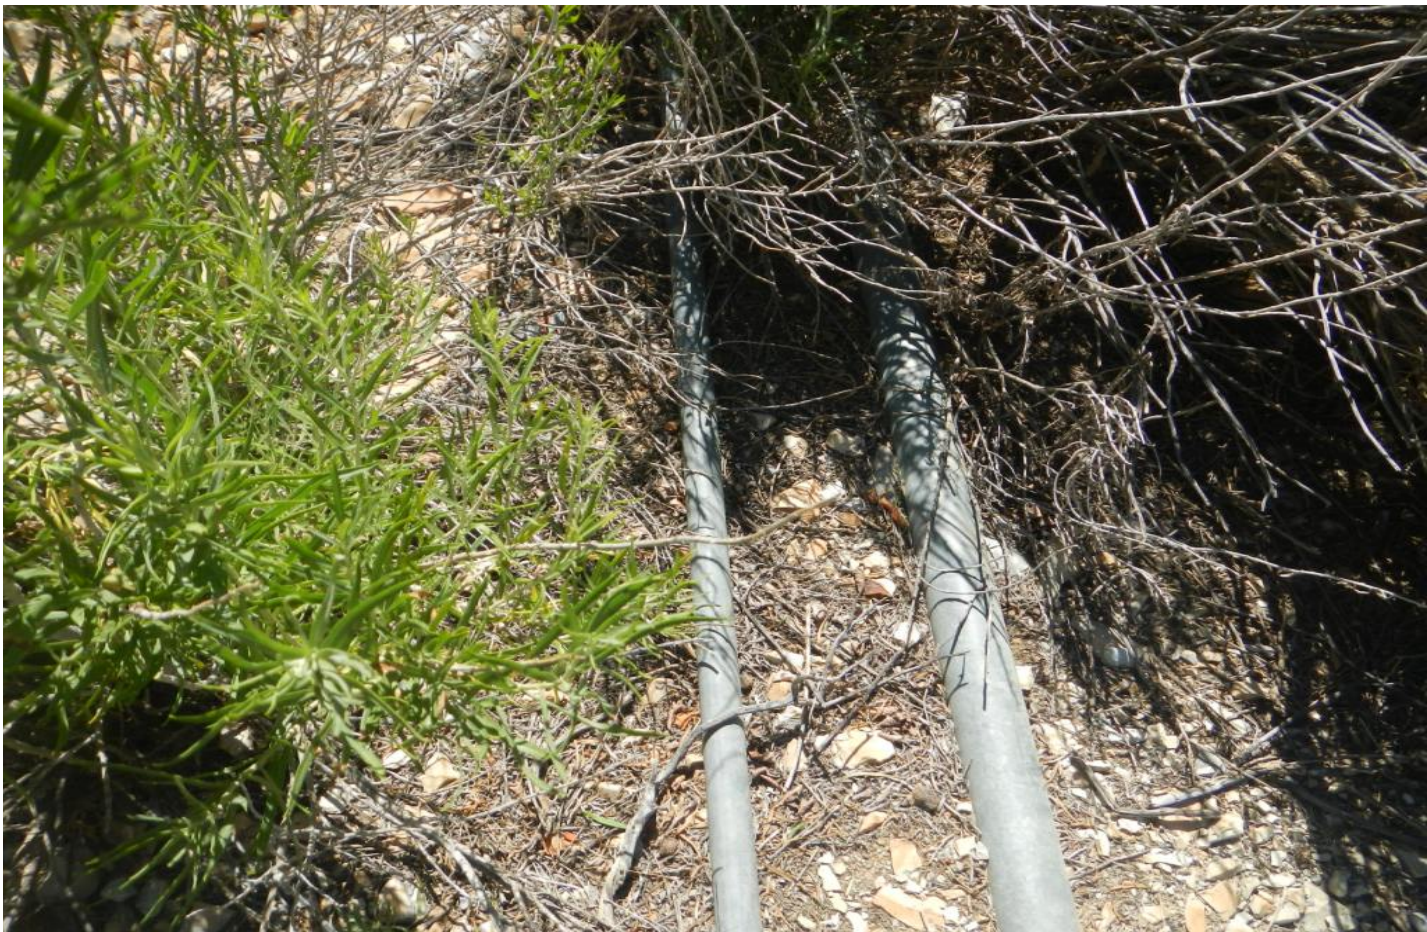
Photo#10: Flow lines or other Facility ? to be identified as related to Location or to other uses of Area.

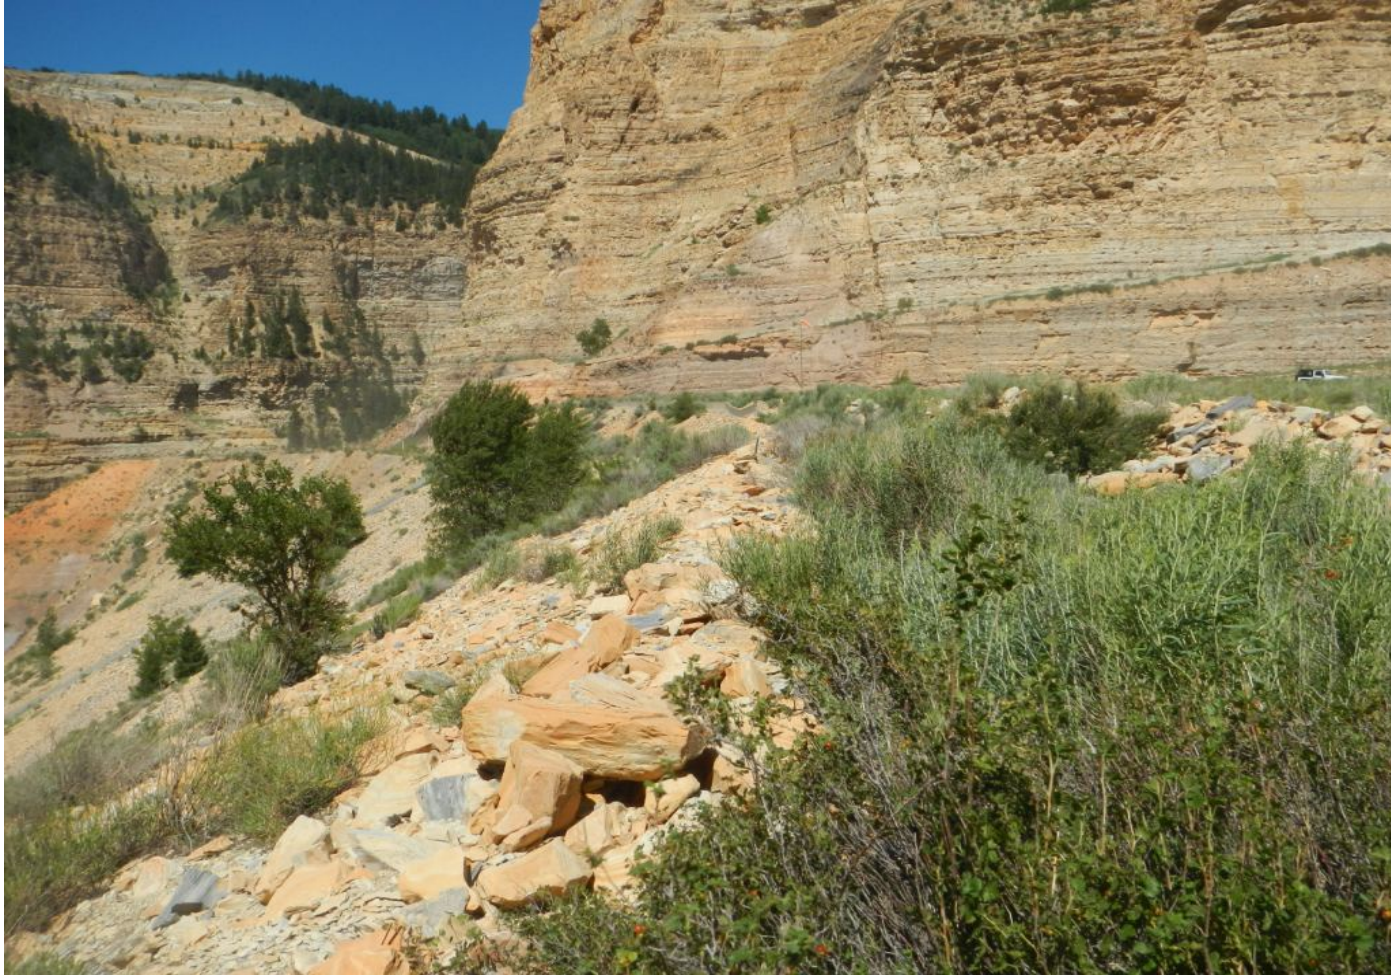
Photo#11: View to West along Fill Slope ditch and Berm at South edge of Location

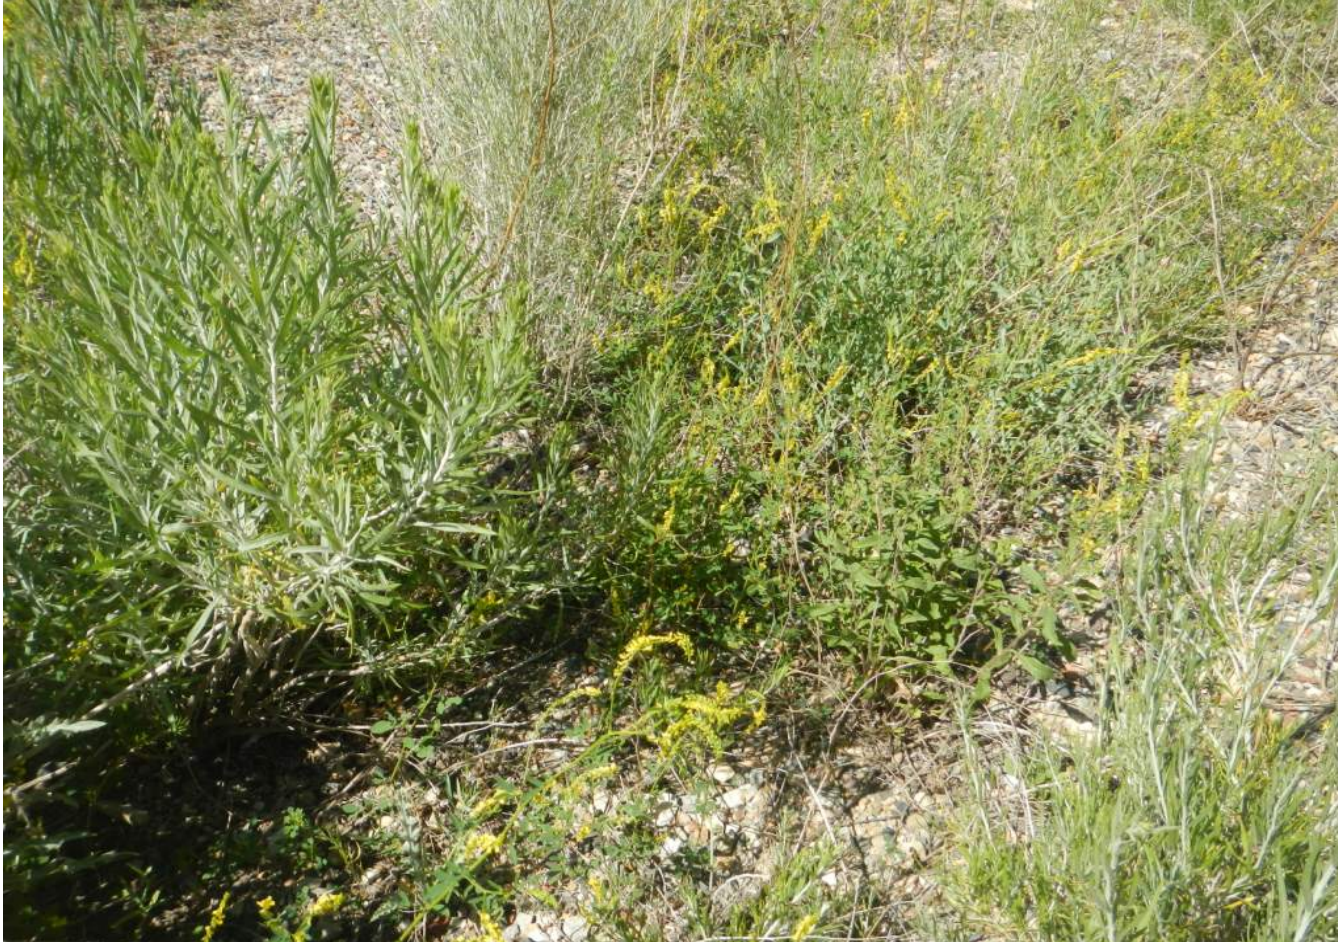
Photo#12: Vegetation establishing in heavily graveled portions of Location predominately Rabbit Brush and Clover.

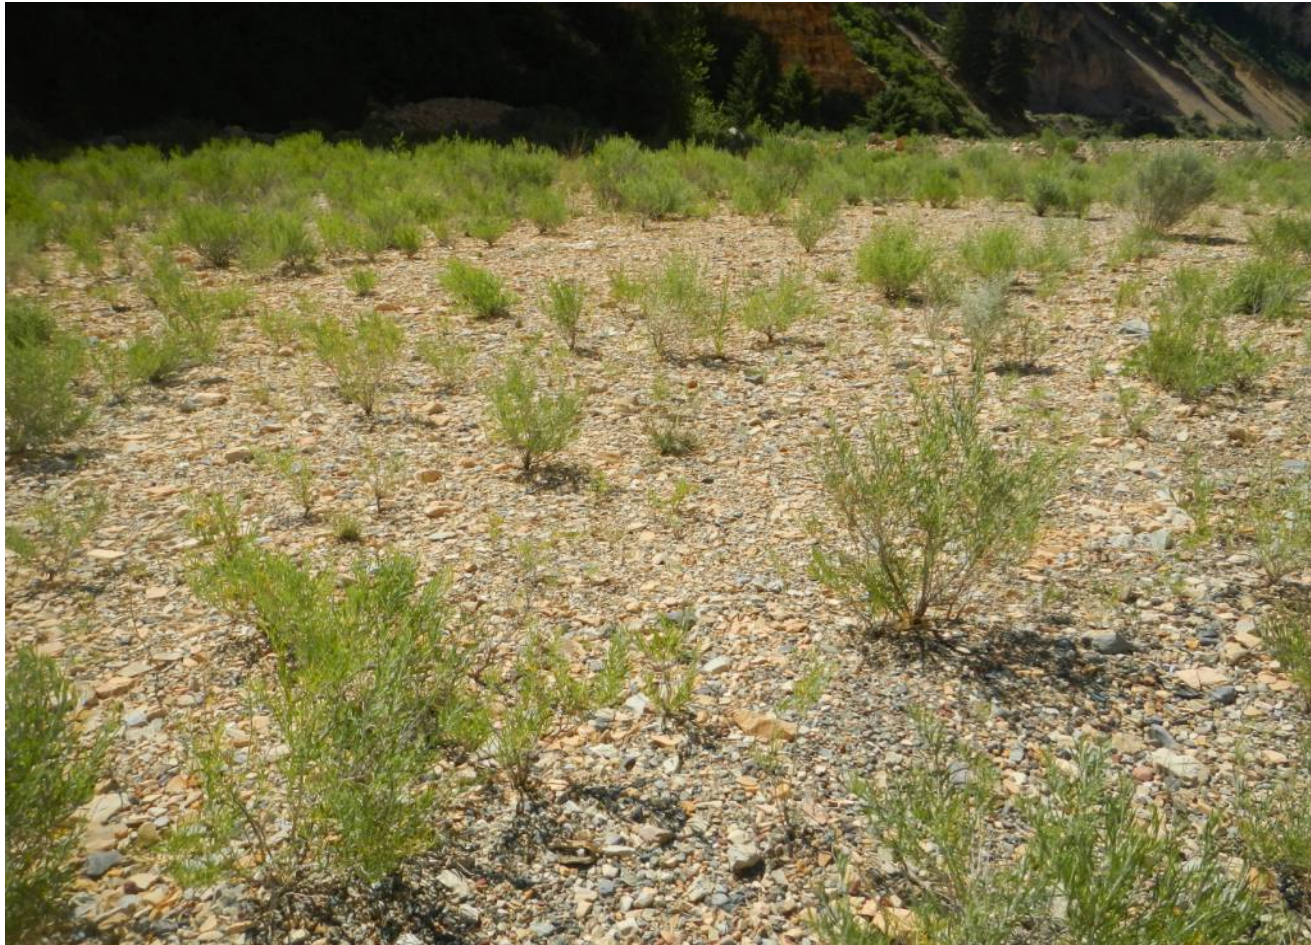
Photo#13: Rabbit Brush establishing in Rocky Fill Material.
