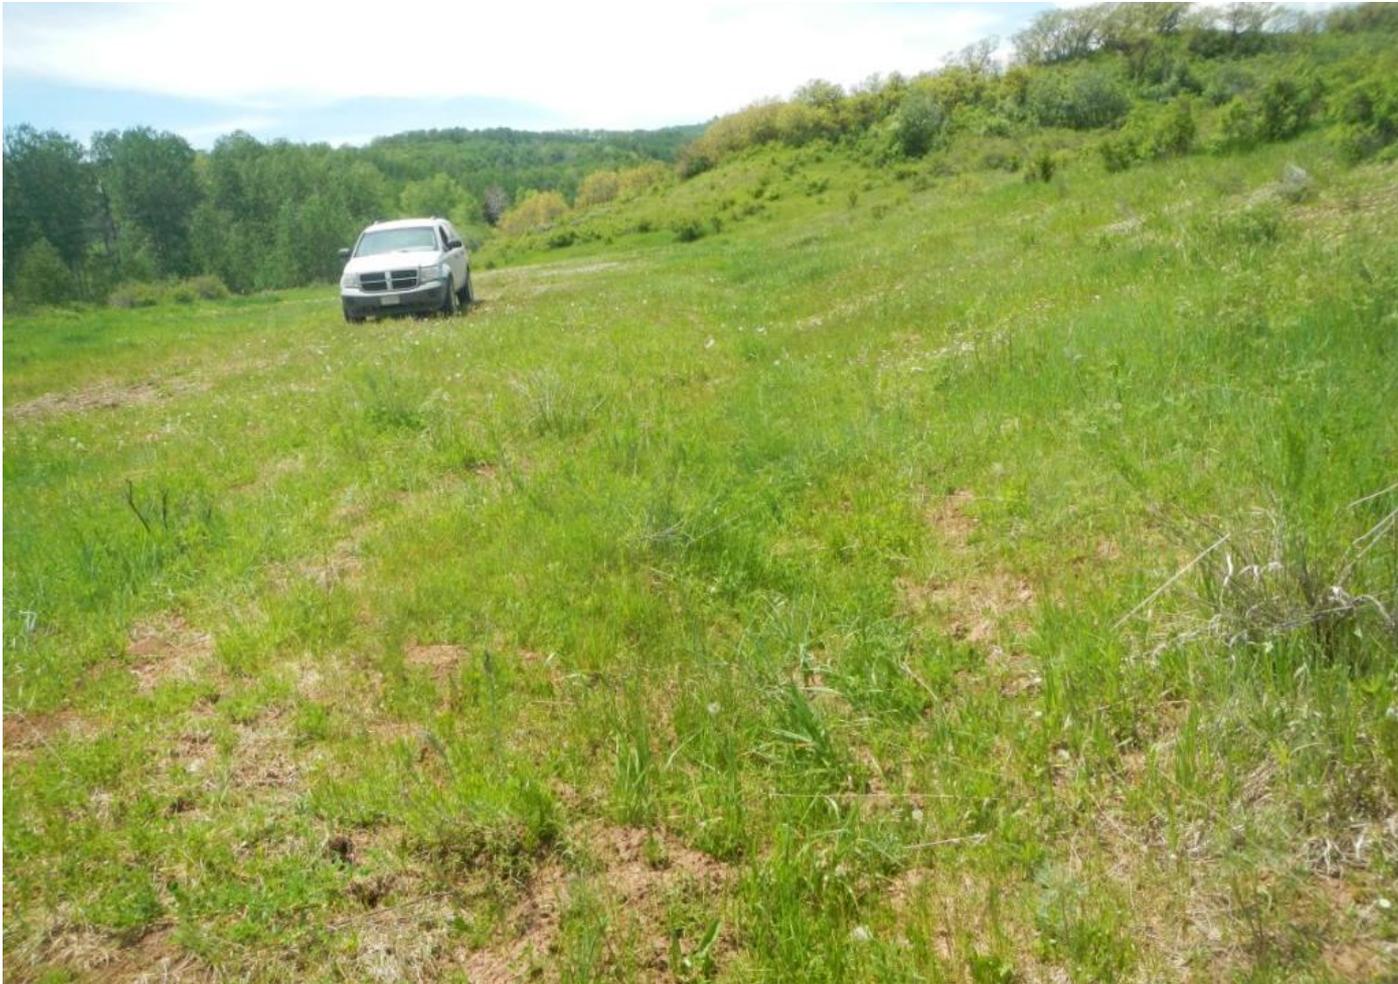
Photo 1. View of the northern portion of the project area from the northeastern corner facing westward.

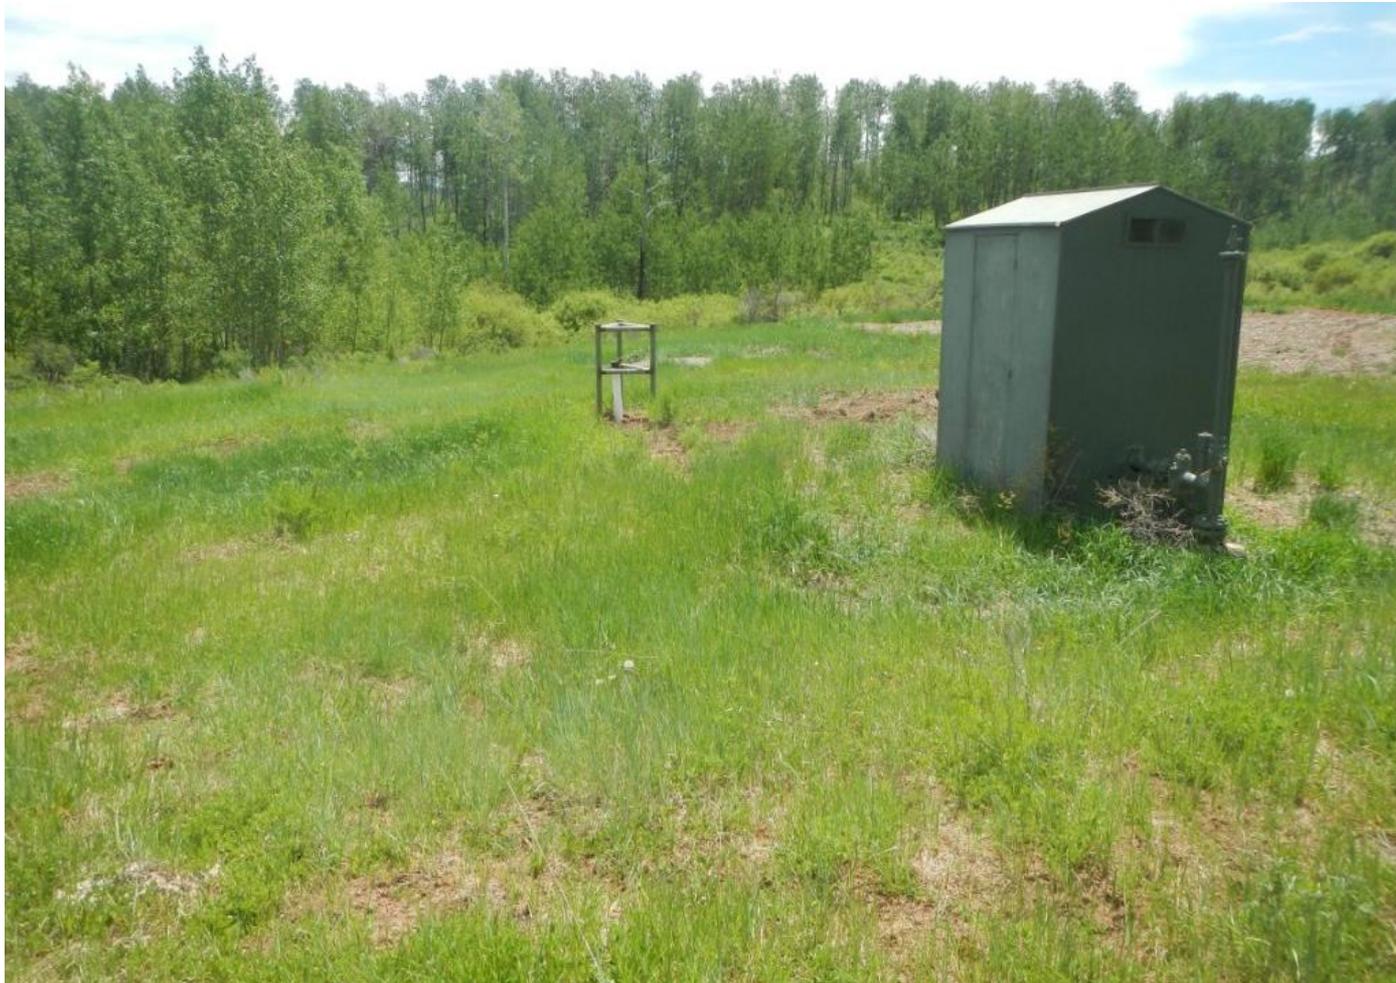
Photo 2. View of the eastern portion of the project area from the northeastern corner facing southward. Possible pit subsidence where dark vegetation is growing in left hand side of photo.

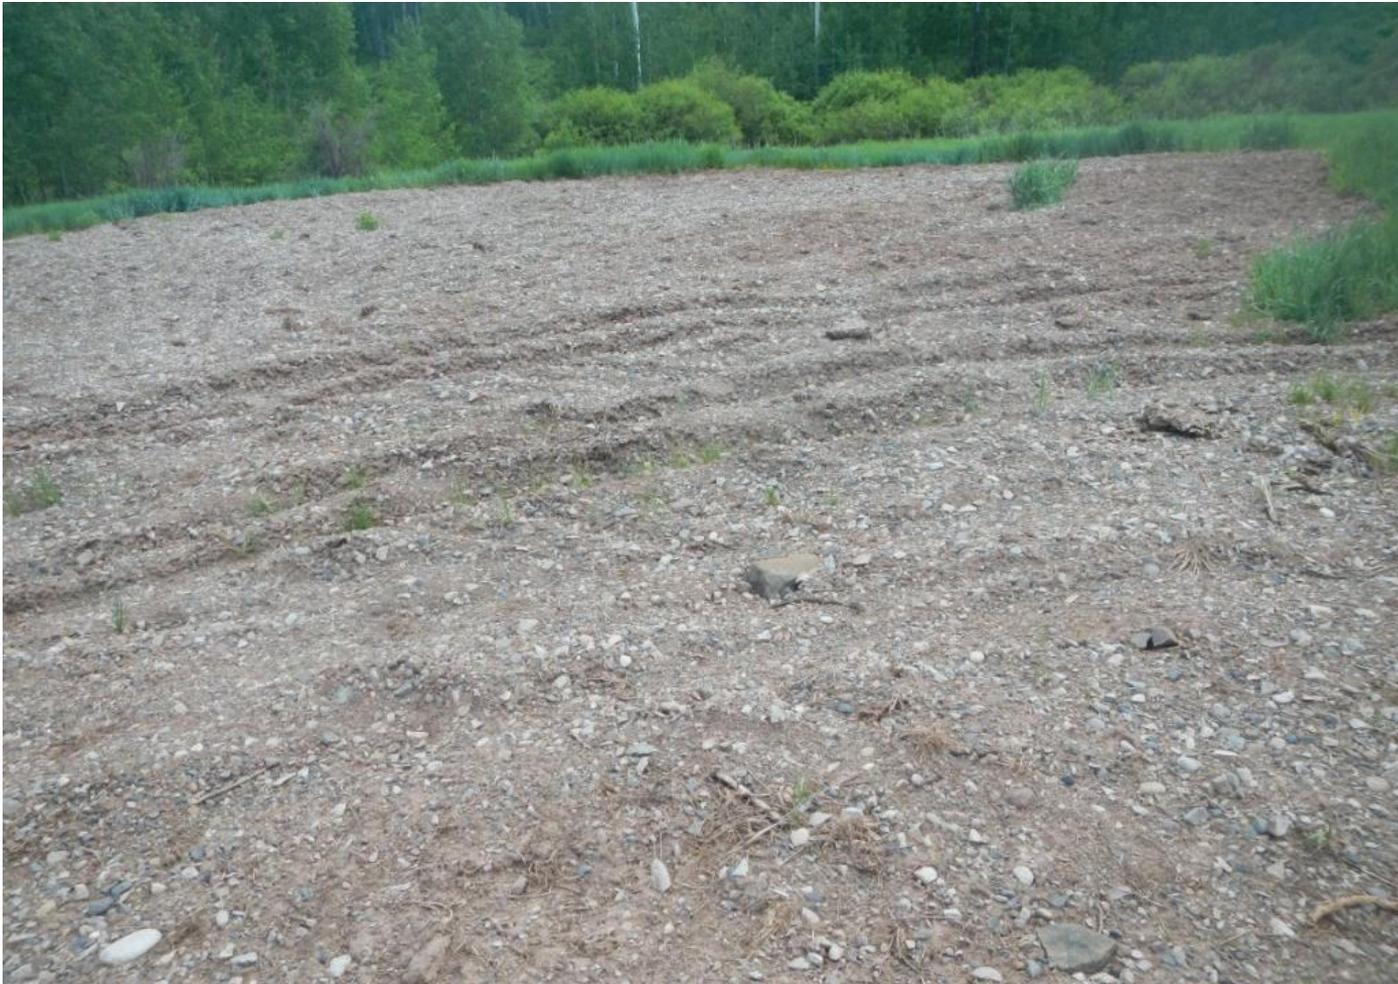
Photo 3. View of bare area on well pad where it appears tanks have been removed.

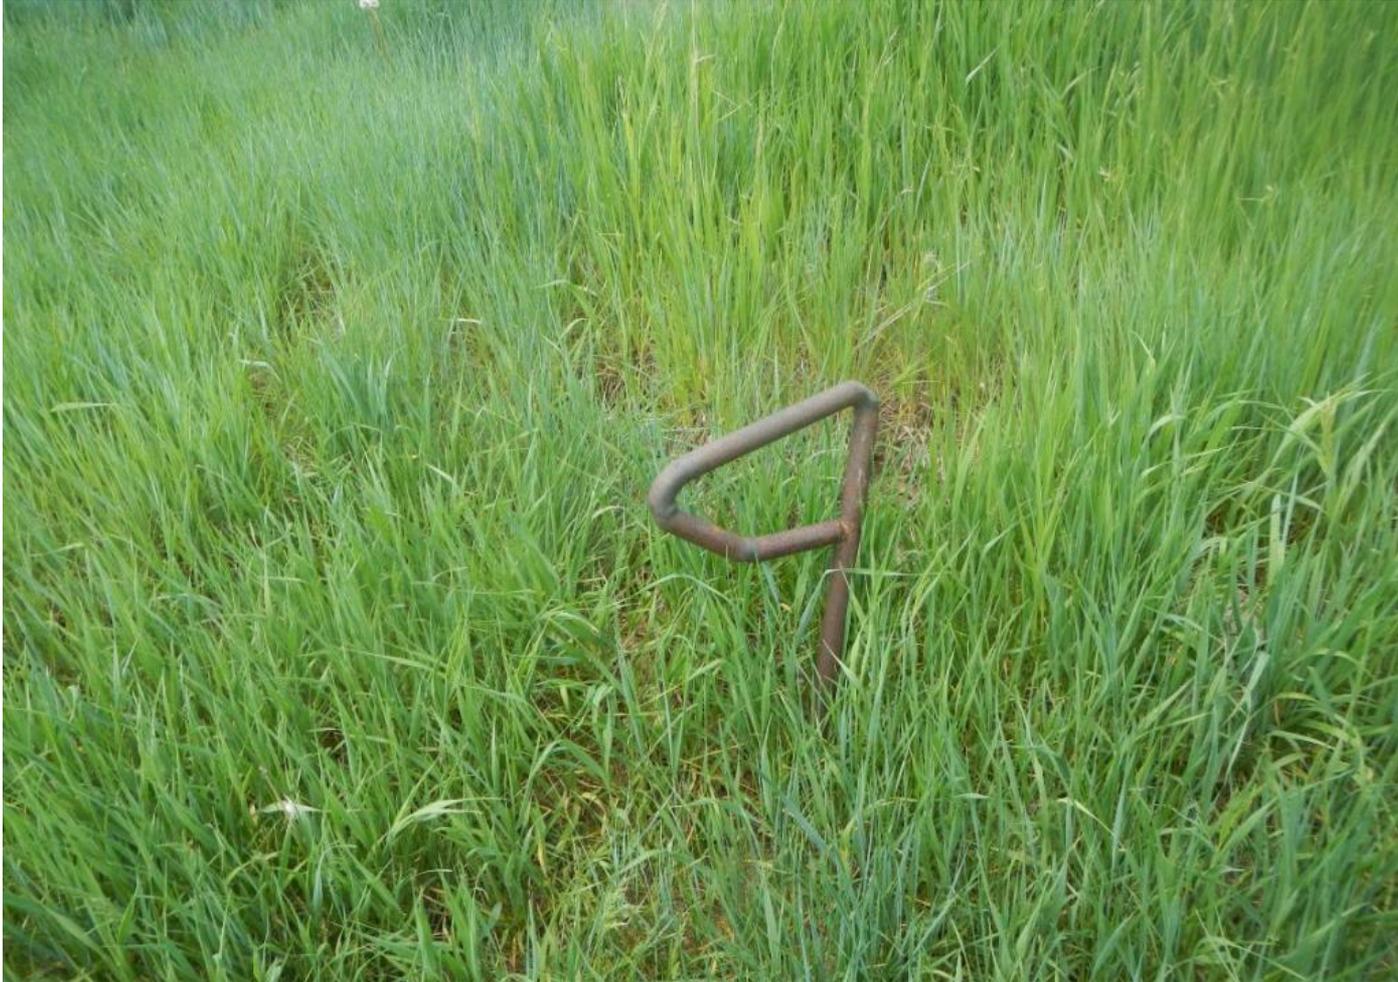
Photo 4. View of debris that needs to be removed.

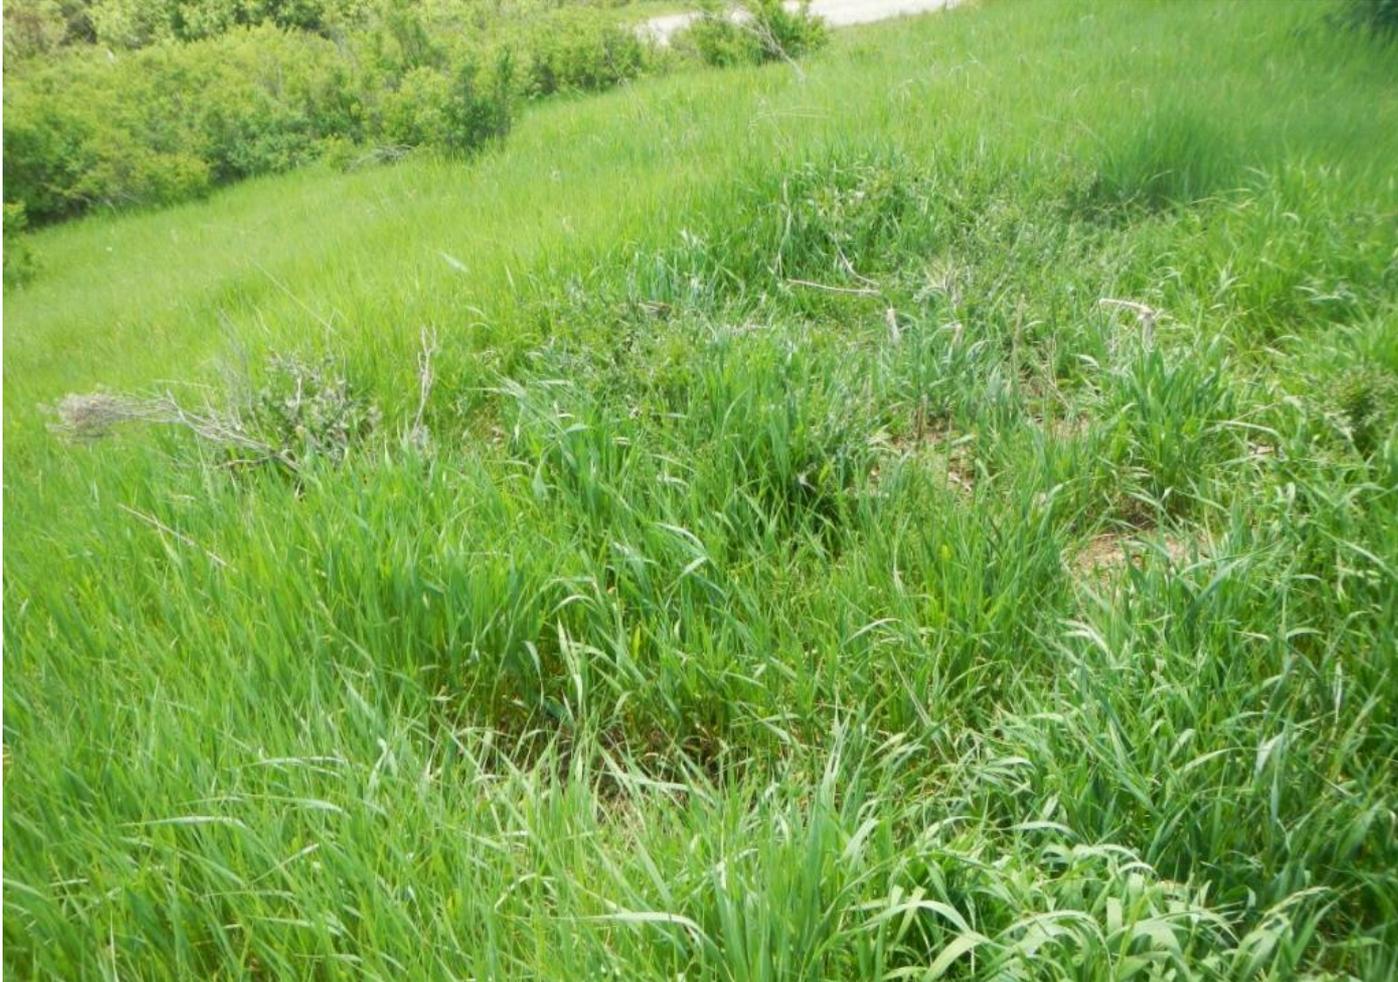
Photo 5. View of musk thistles in southern portion of the project area.

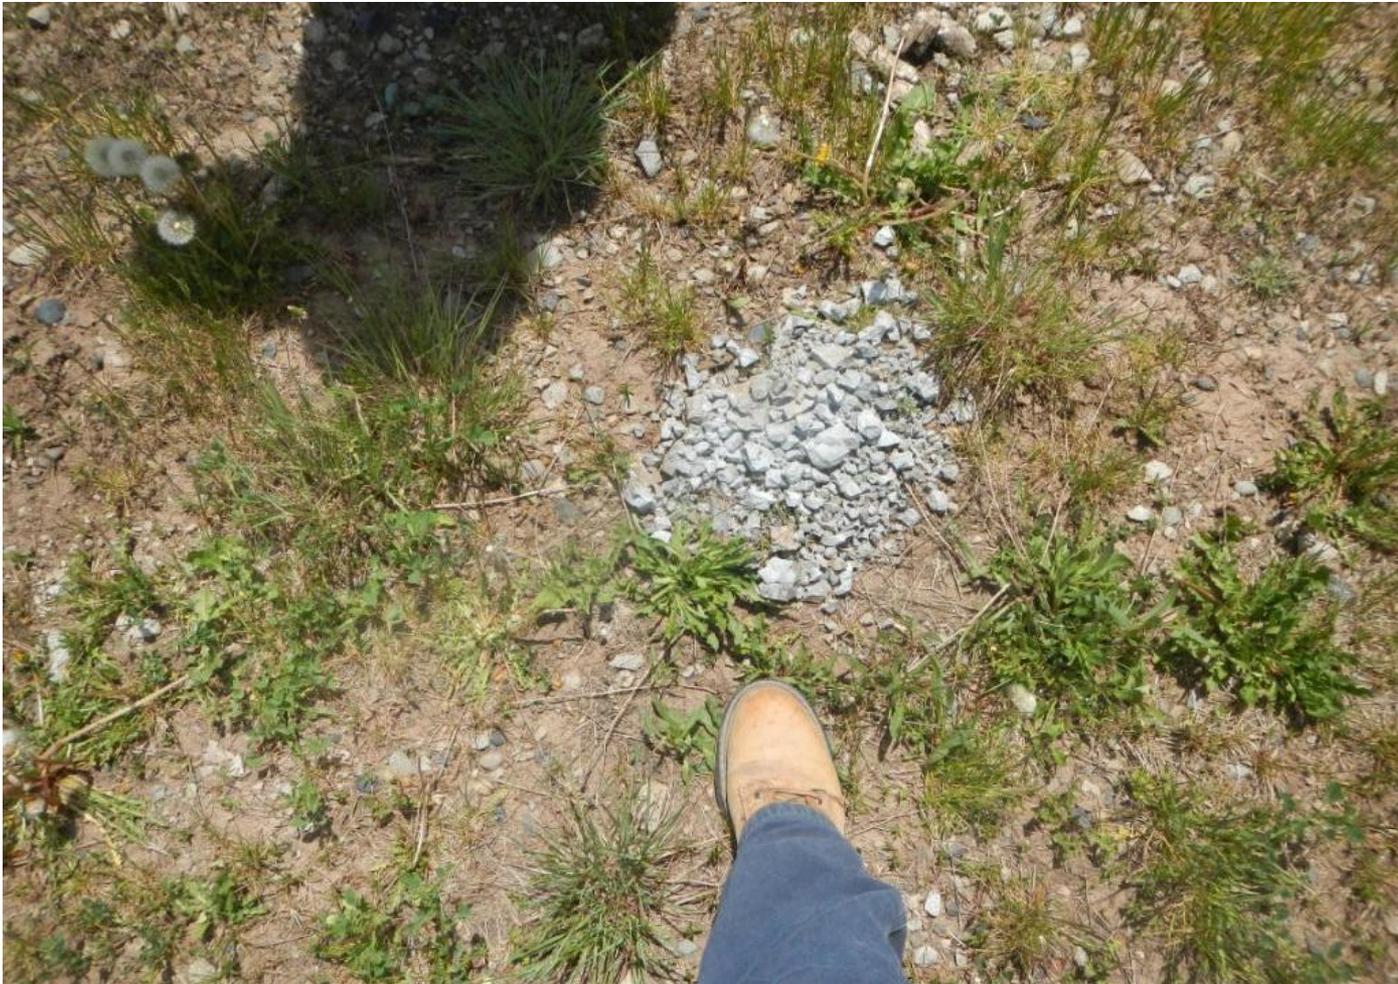
Photo 6. View of cement debris on well pad area.

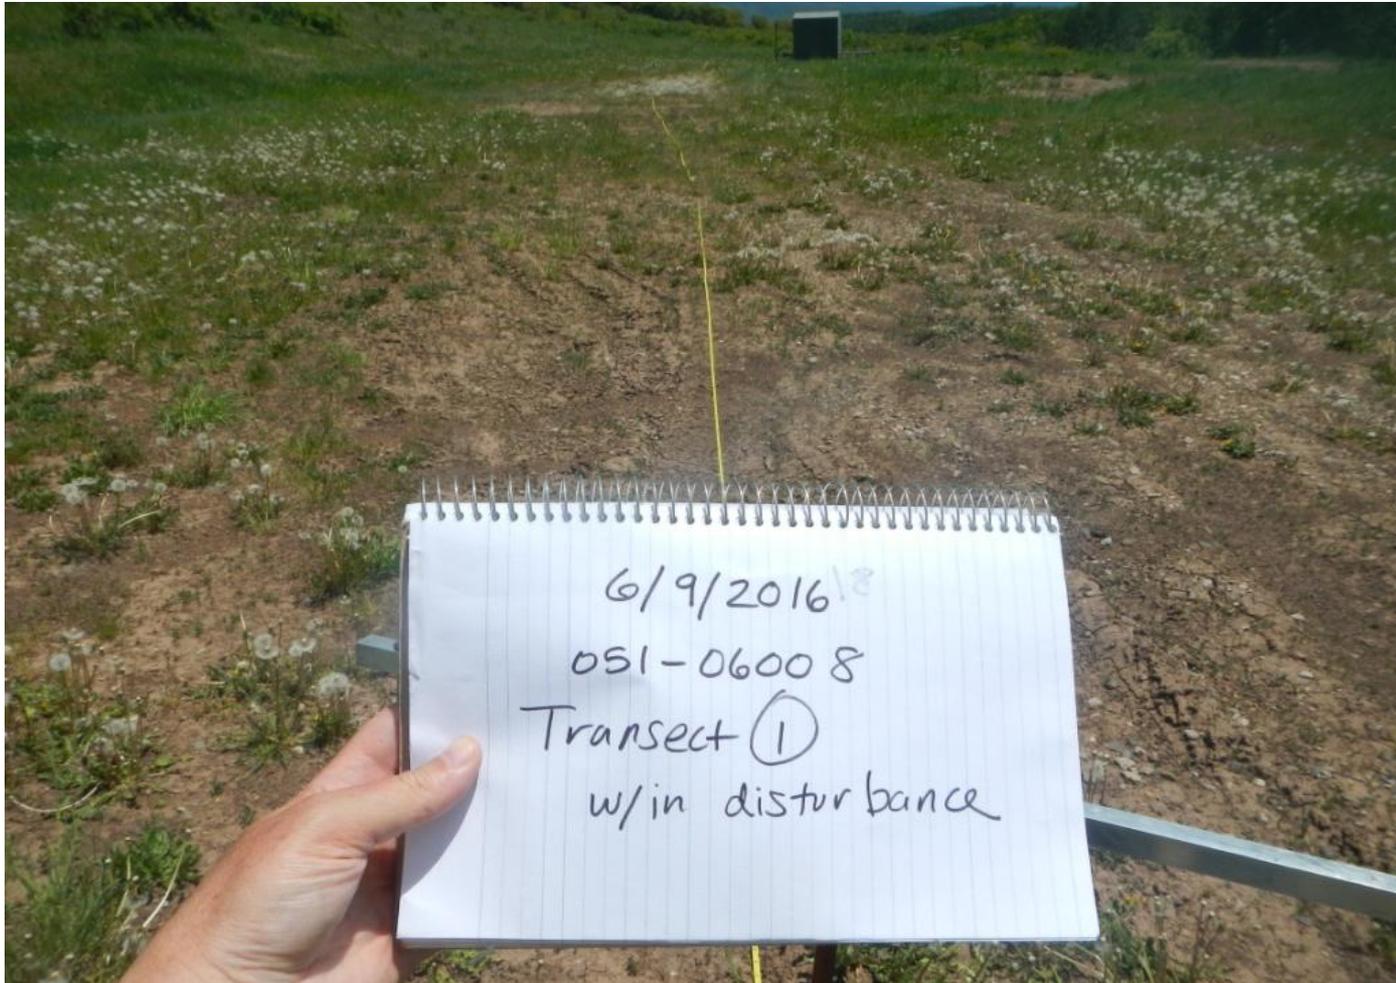
Photo 7. View of the beginning of Transect 1, on well pad, facing eastward.

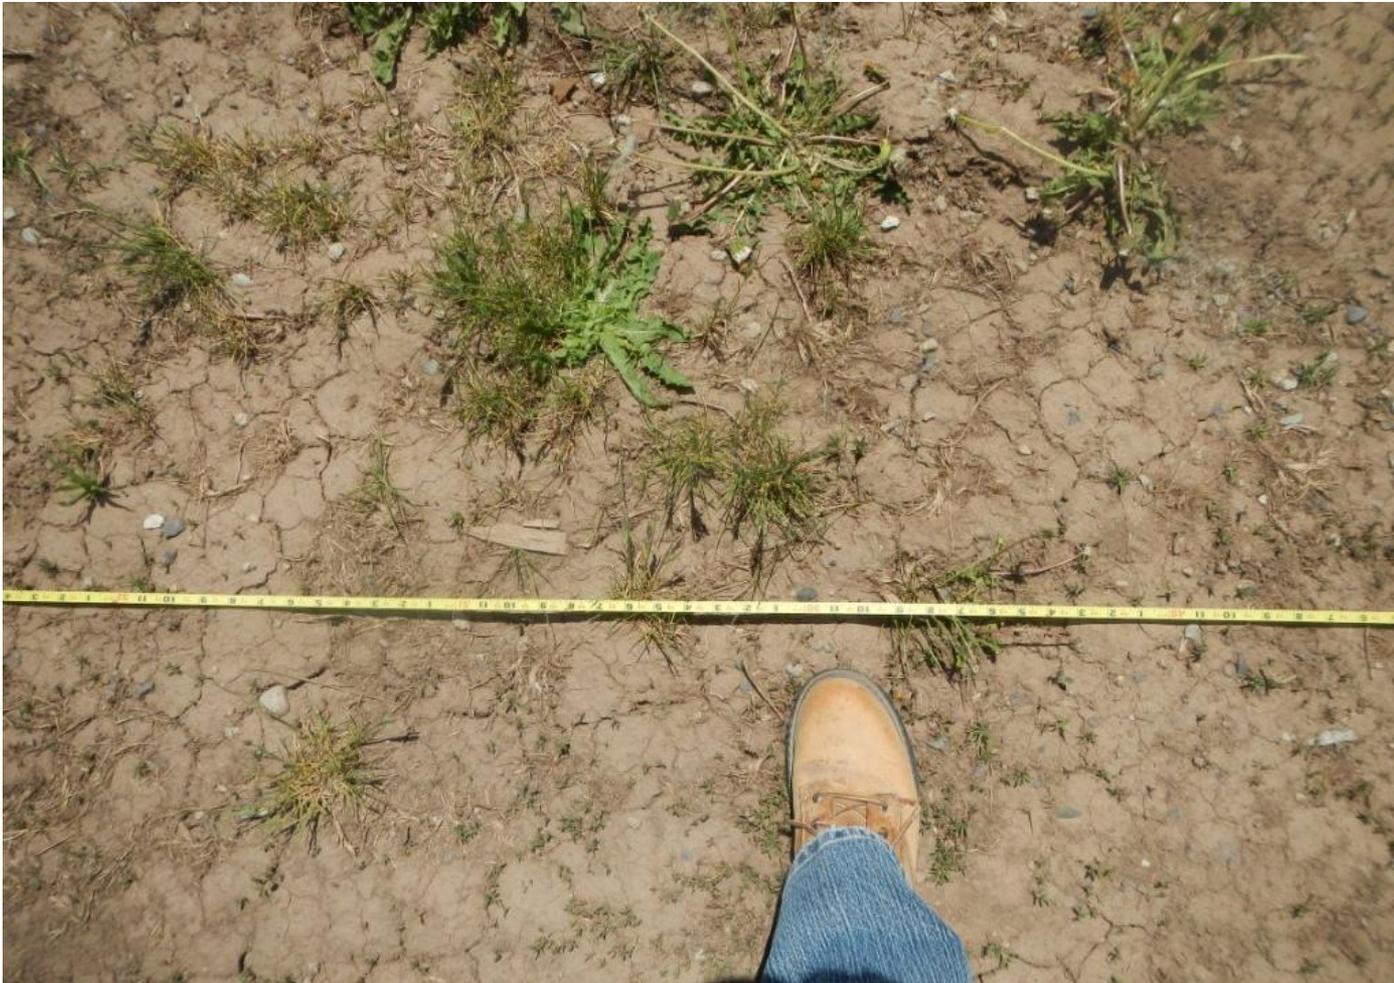
Photo 8. Birdseye vies of vegetation present at mid-point along Transect 1, within the project area.

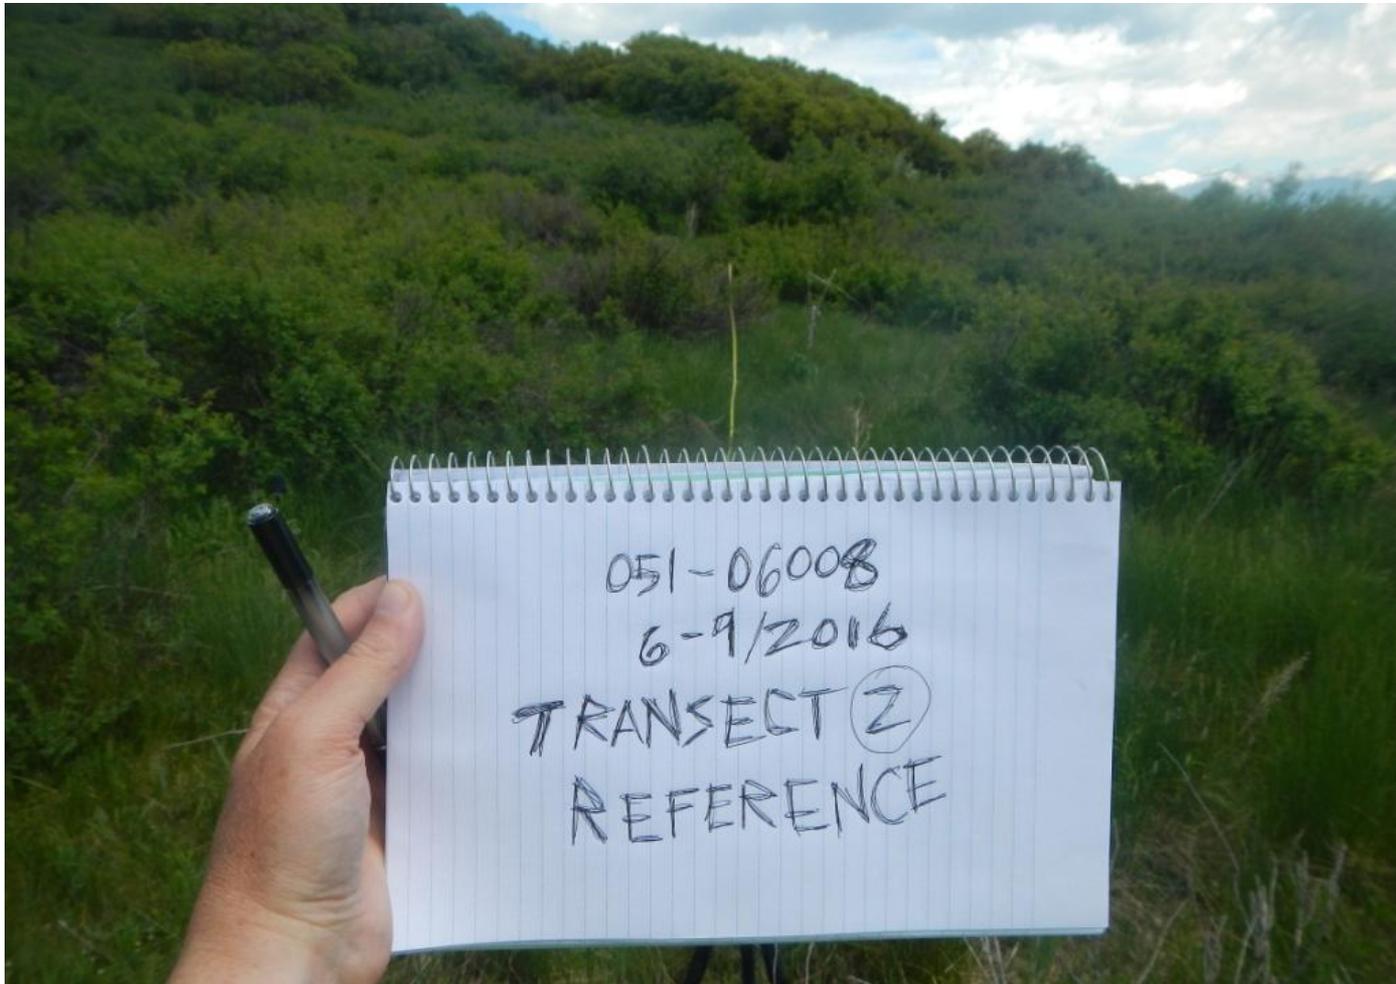
Photo 9. View of the beginning of Transect 2, reference area transect, located north of the project area, facing eastward.

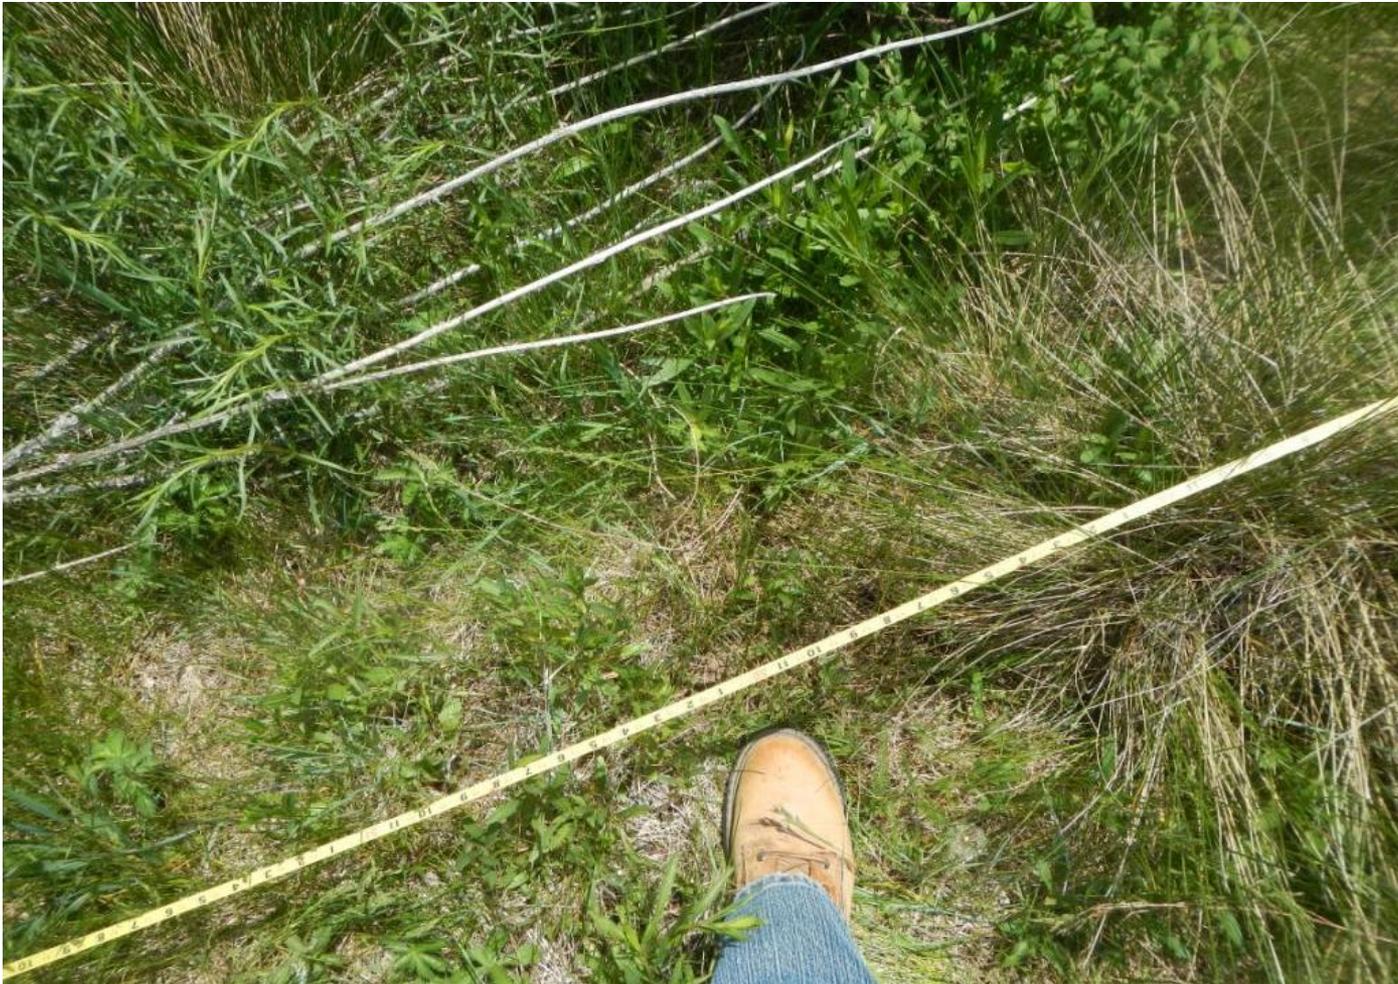
Photo 10. Birdseye view of vegetation at midpoint along reference area transect.

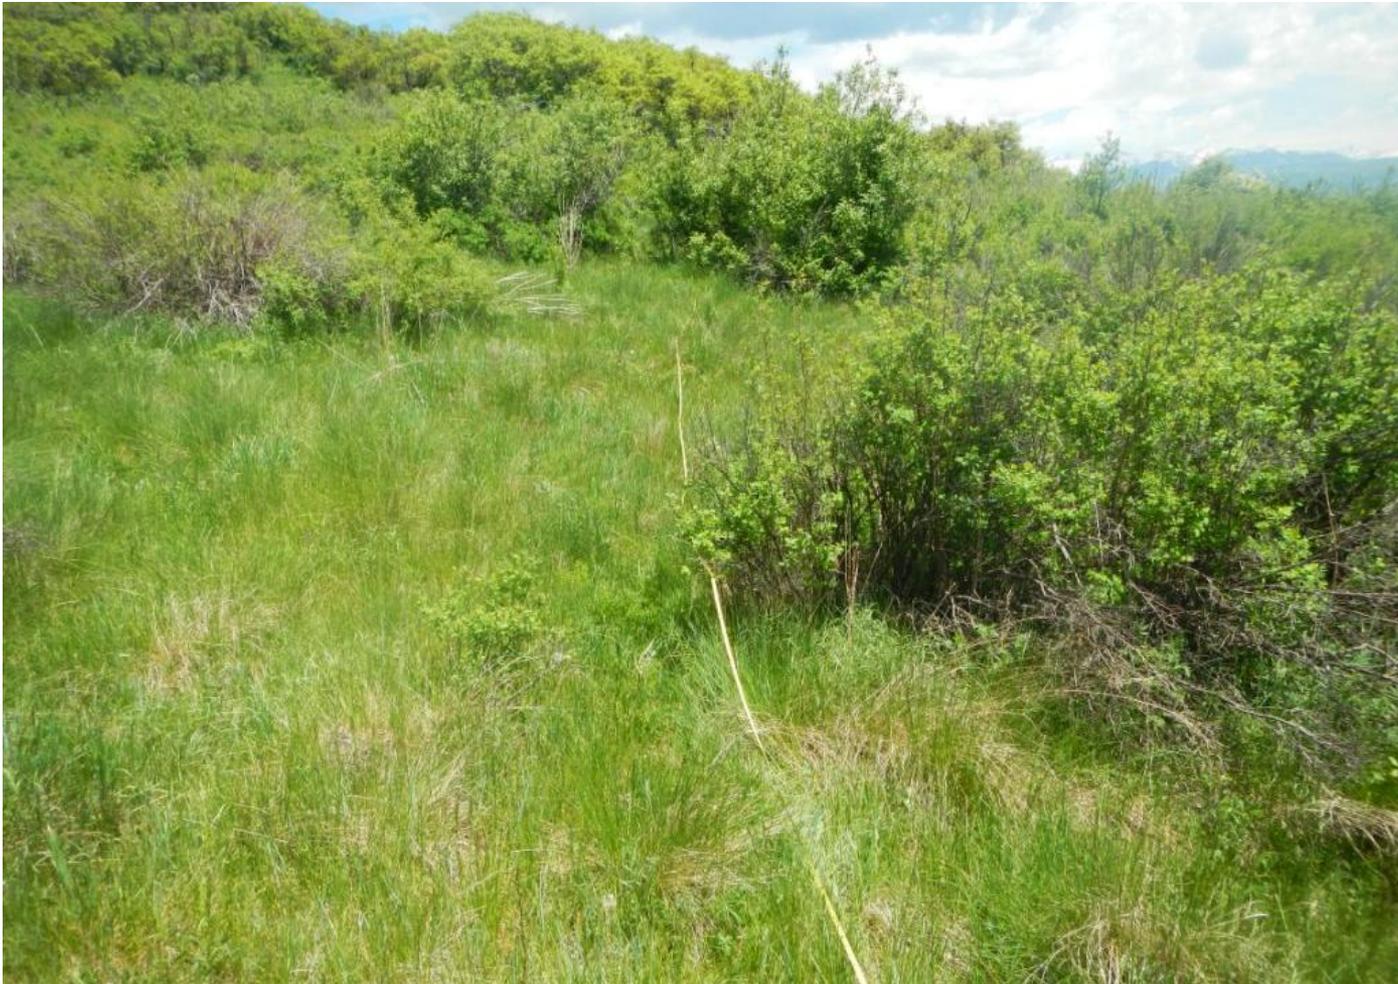
Photo 11. Another view of vegetation along reference area transect, from midpoint to end, facing eastward.
