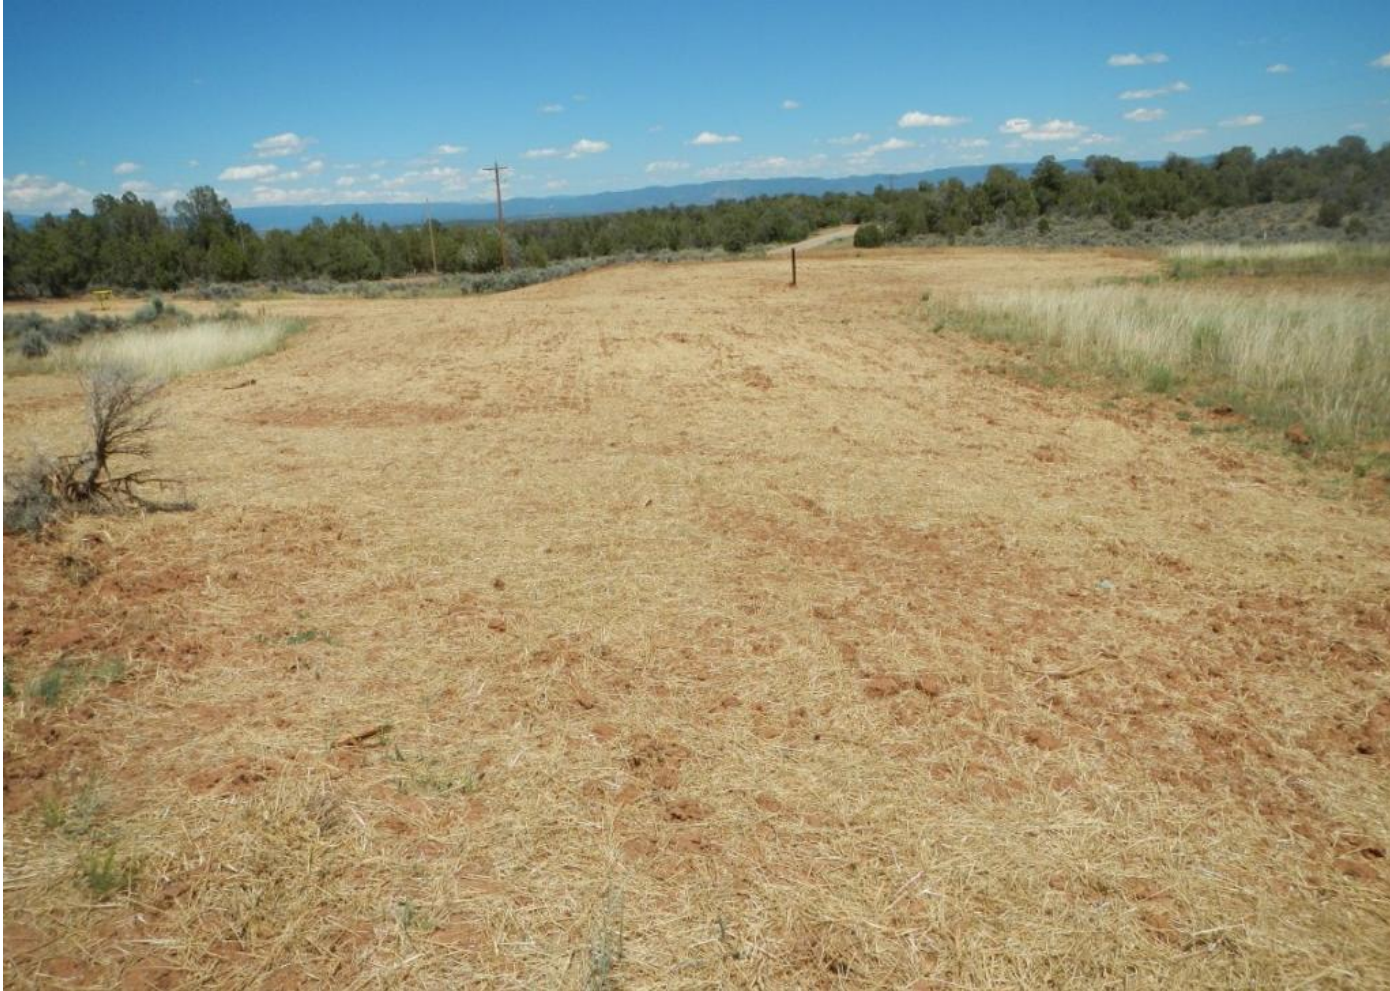
Photo 1. View of the project area from the beginning of the access road foacing southward. Well pad has been reclaimed and straw mulch has been crimped.

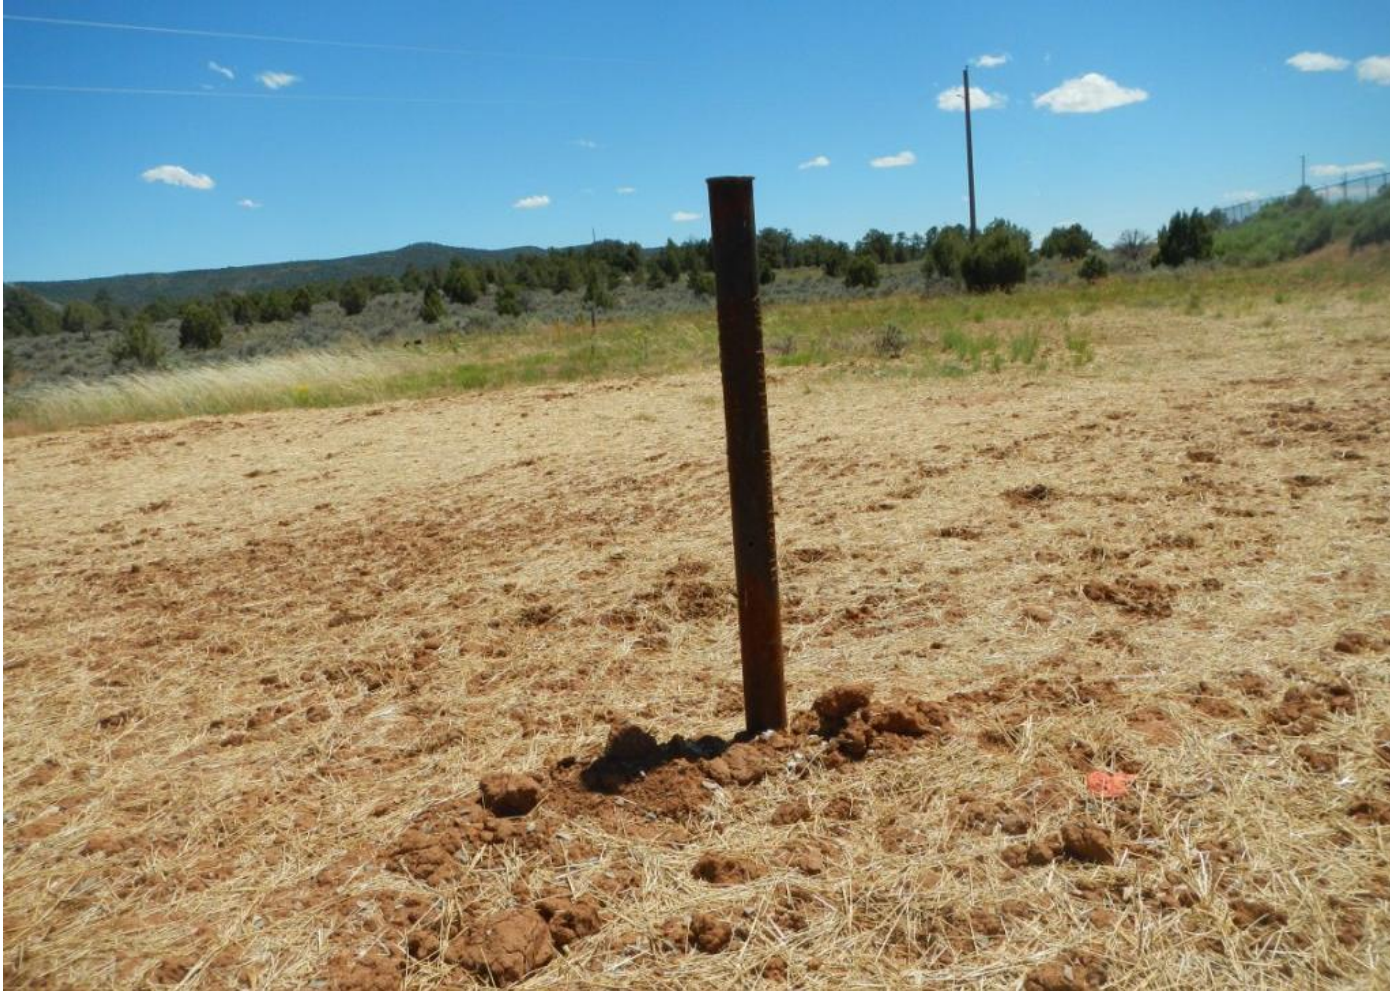
Photo 2. View from the wellhead facing southward.

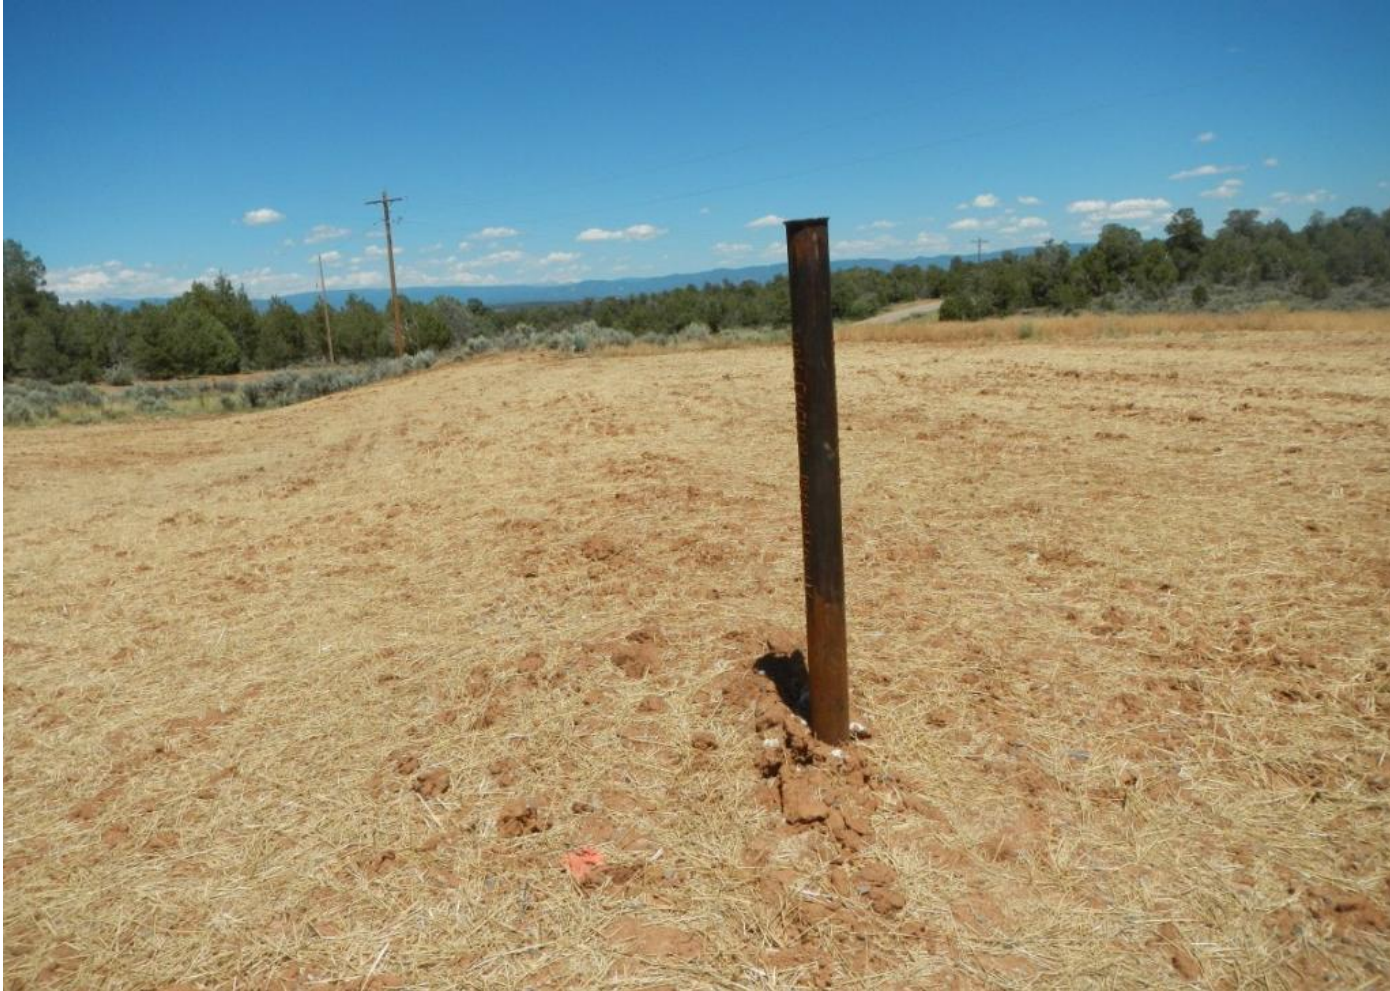
Photo 3. View from the wellhead facing eastward.

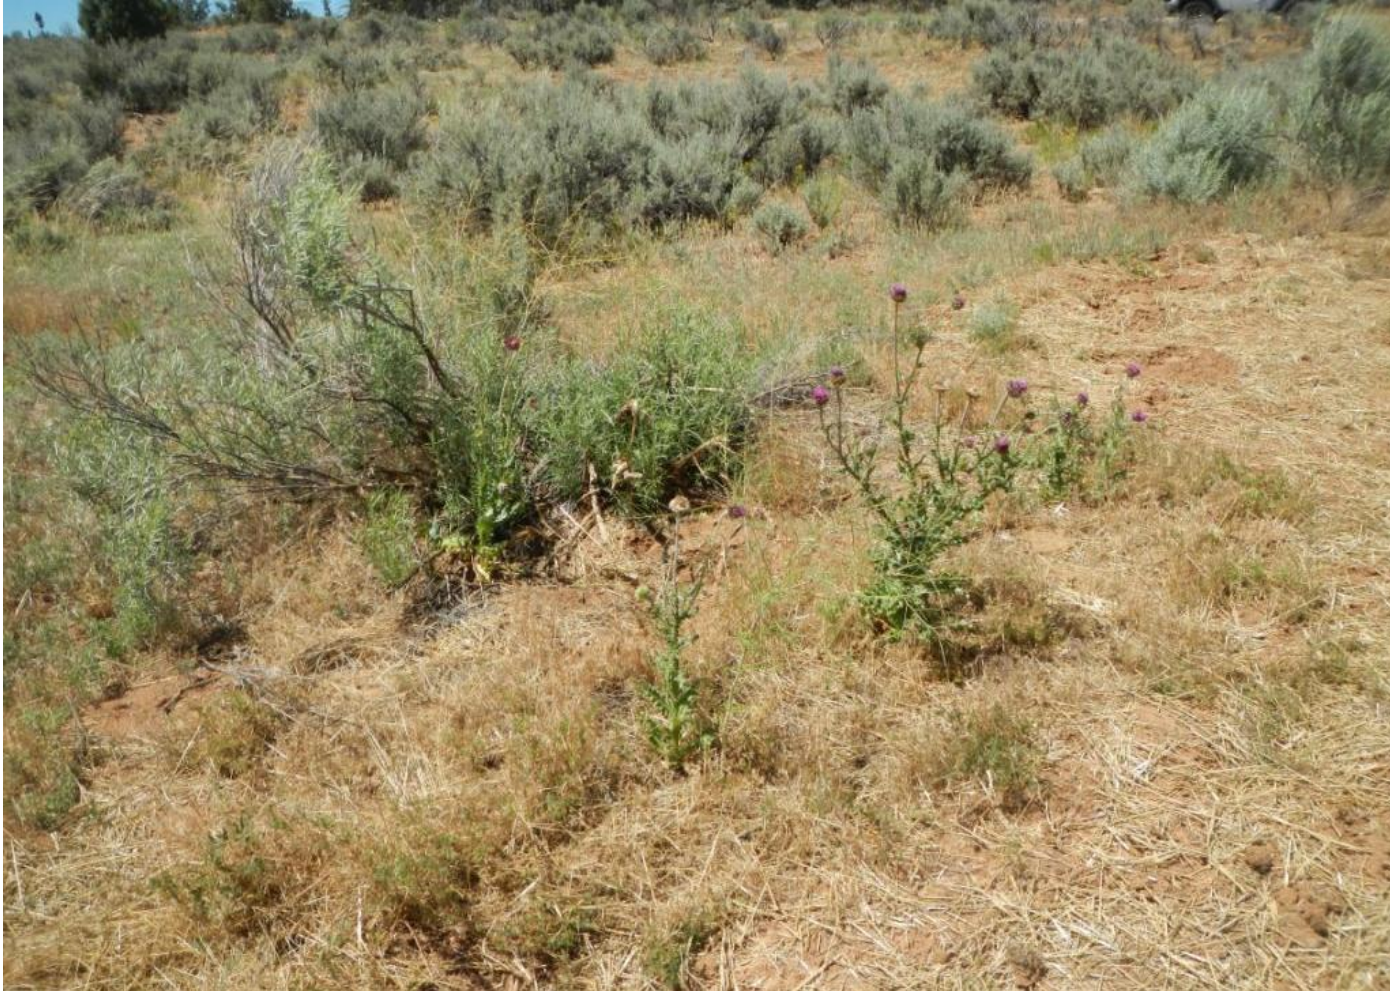
Photo 4. View of musk thistles around the edge of the project area.

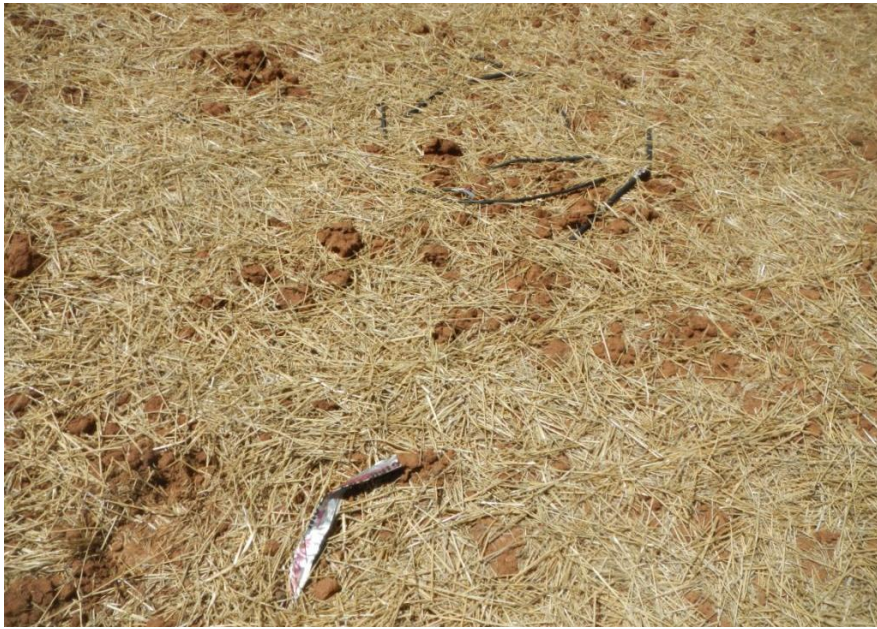
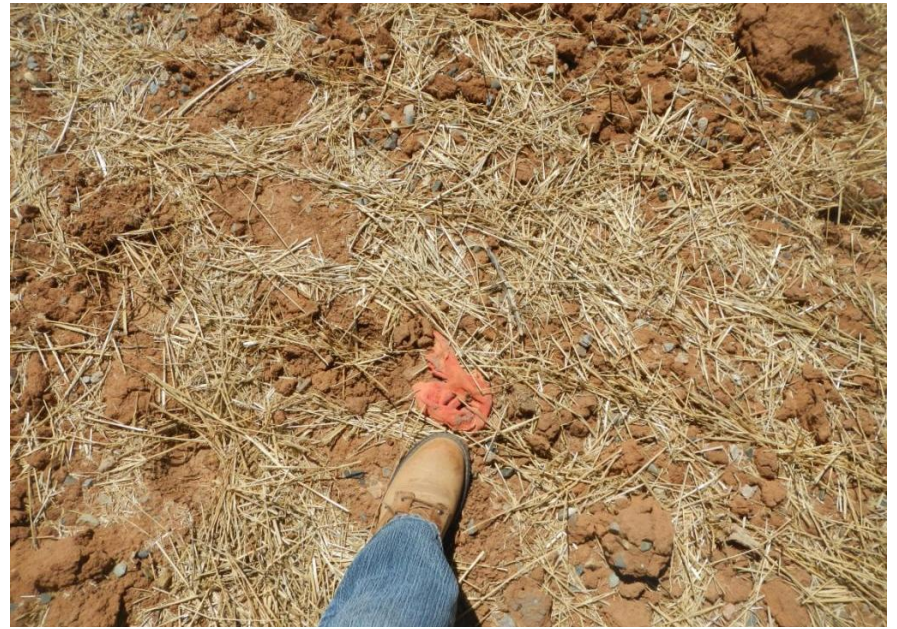
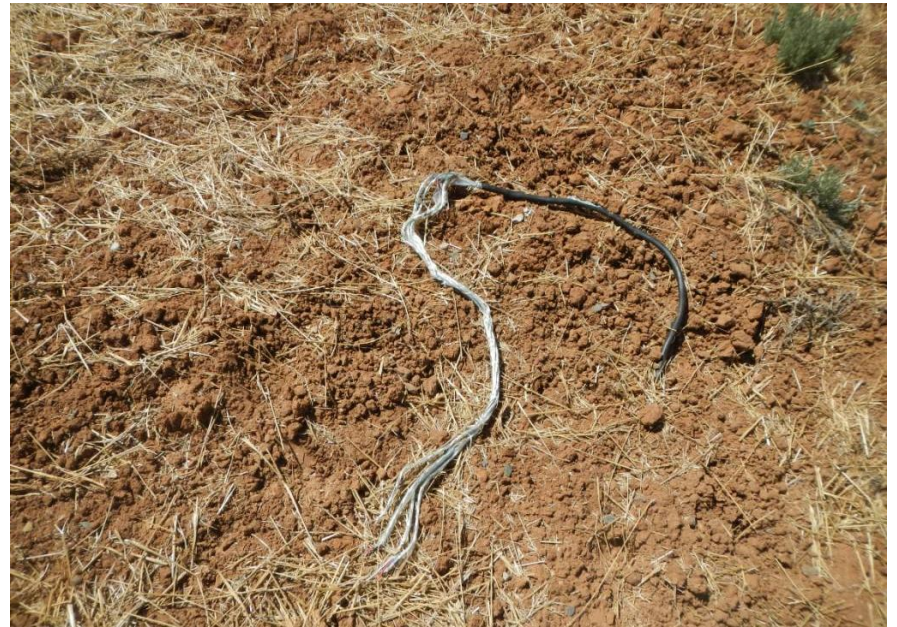
Photo 5-7. View of small pieces of debris scattered around the well pad.
