July 7, 2016

Inspection Photos: LINN Loc#335673

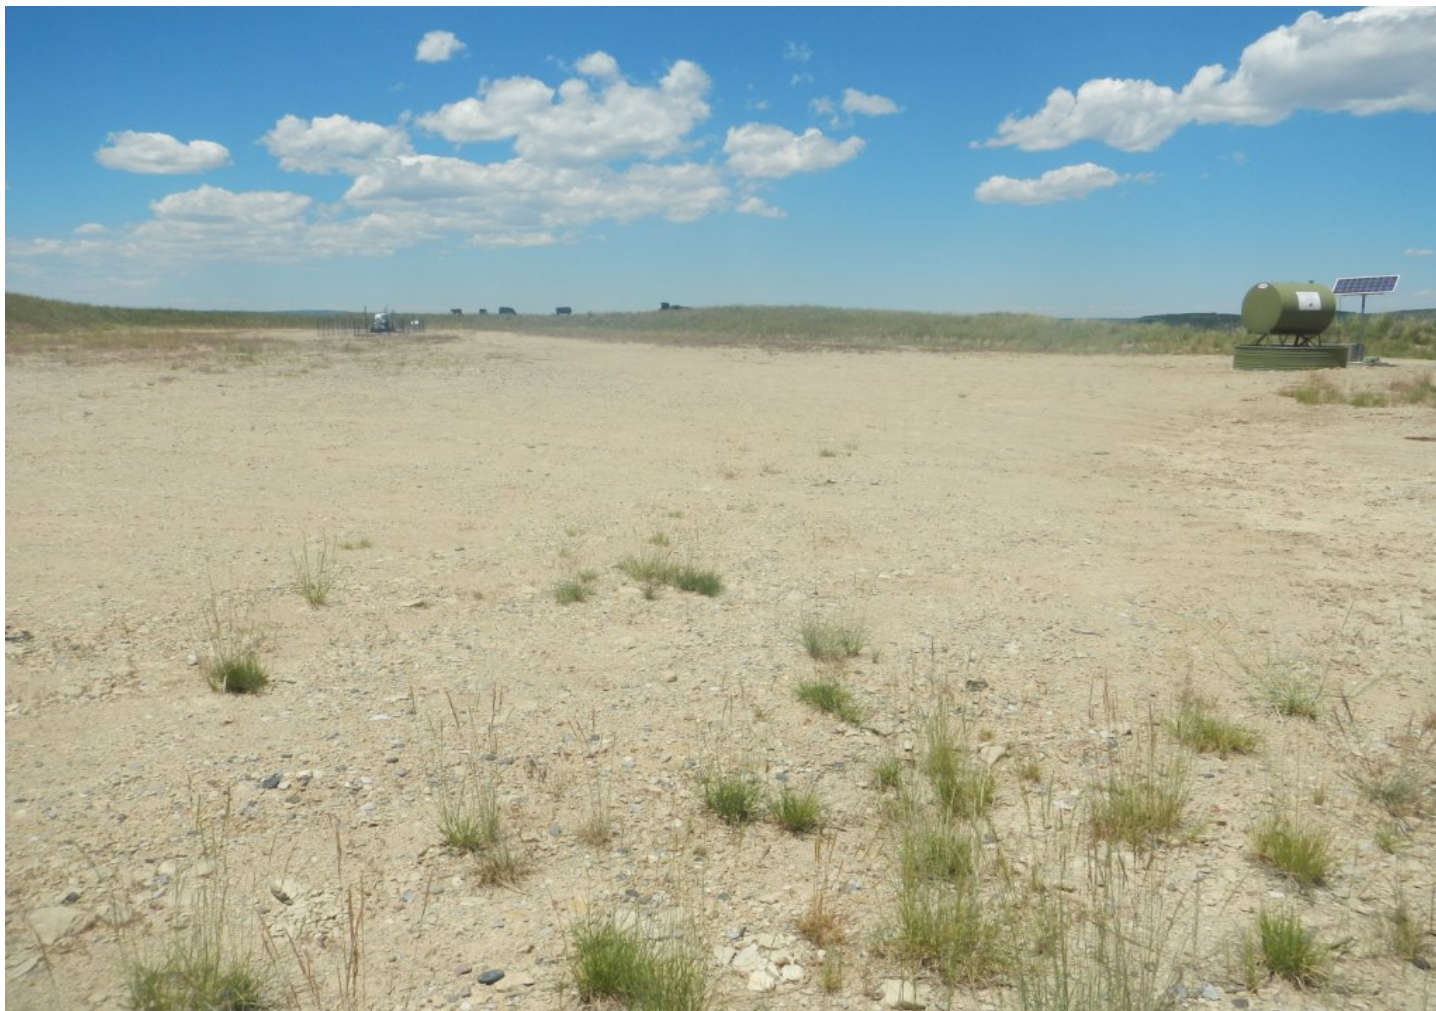
Photo#1: Overview of Location from Entry to NW.

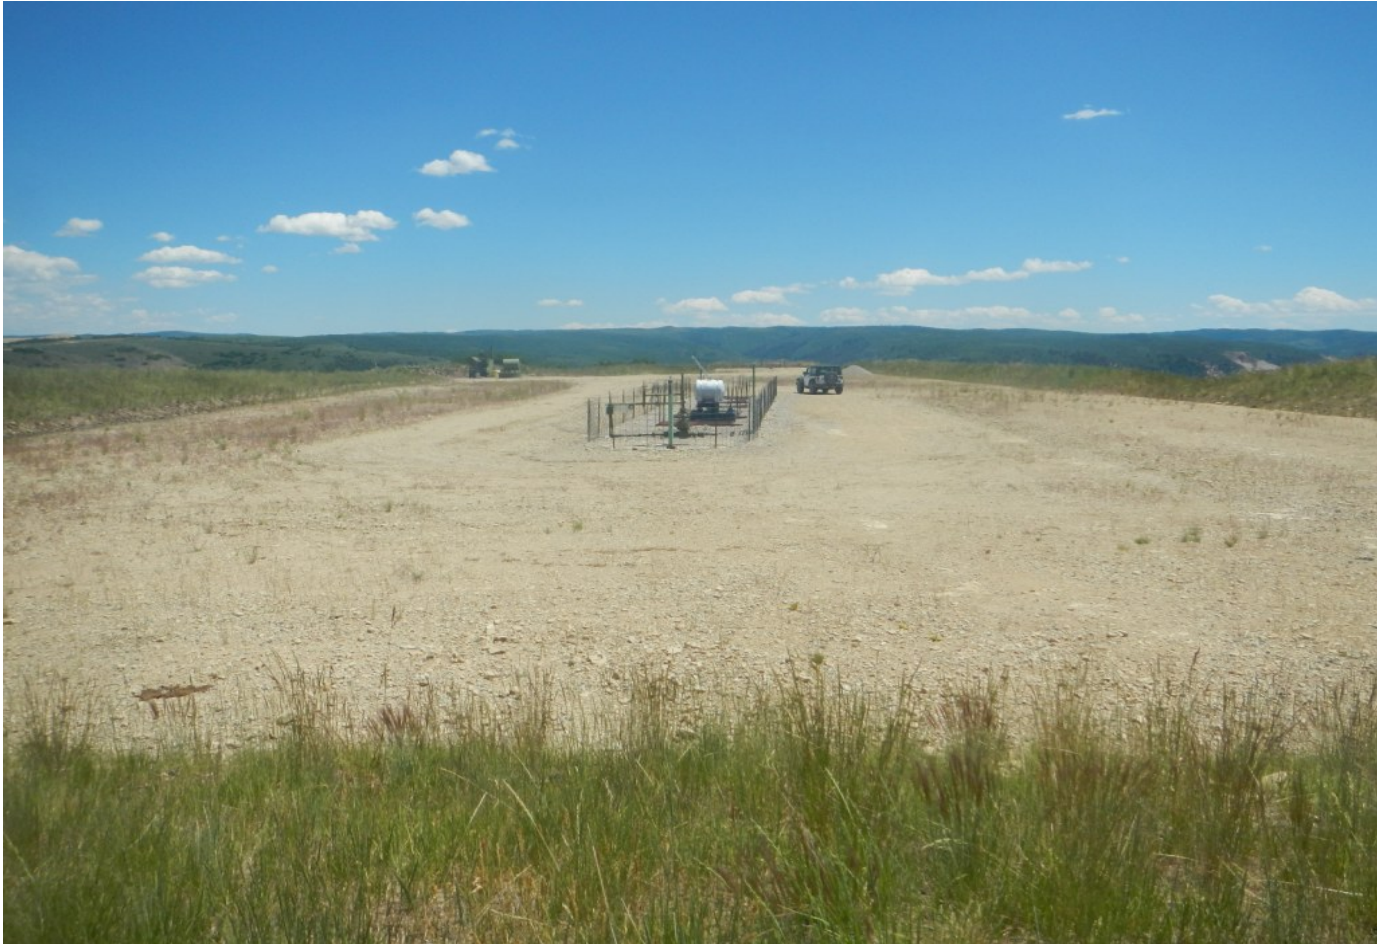
Photo#2: Overview of Location from West end to SE.

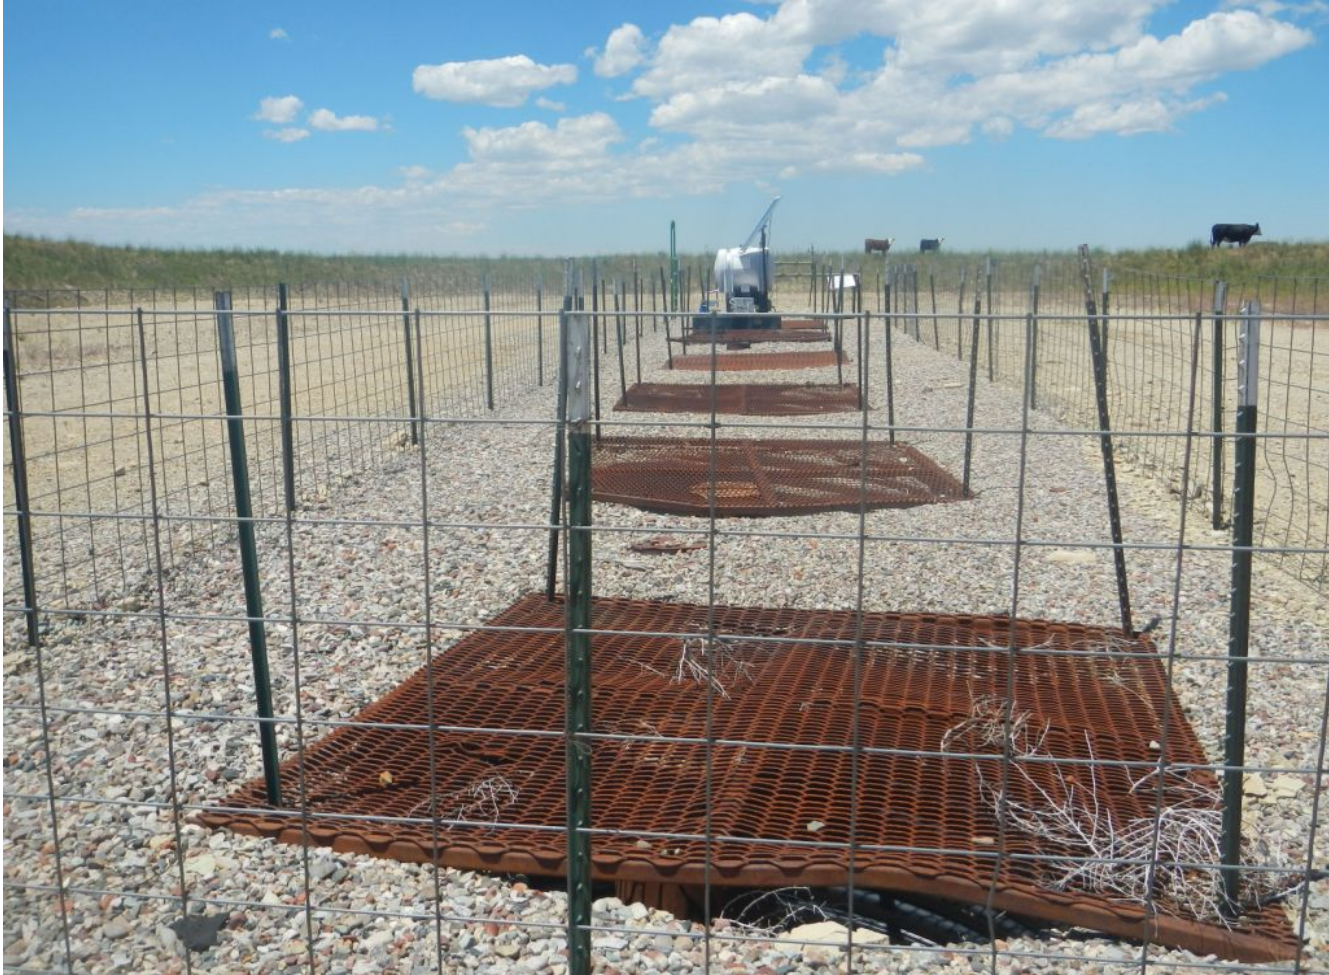
Photo#3: View of Well Corral with Six Cellars, Conductors Set.

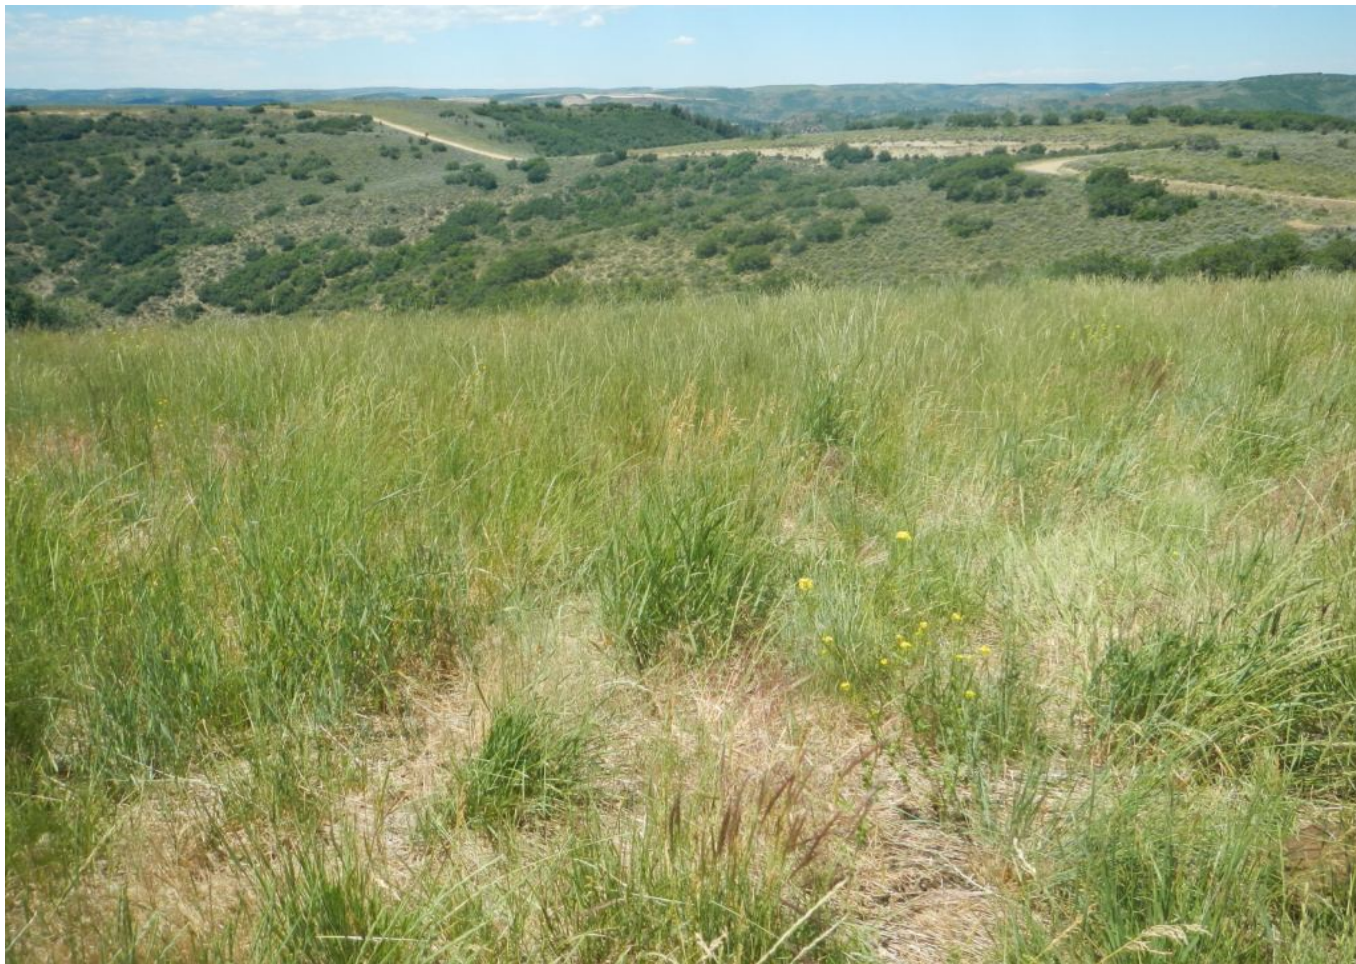
Photo#4: Interim Reclamation Fill Slope , view to West.

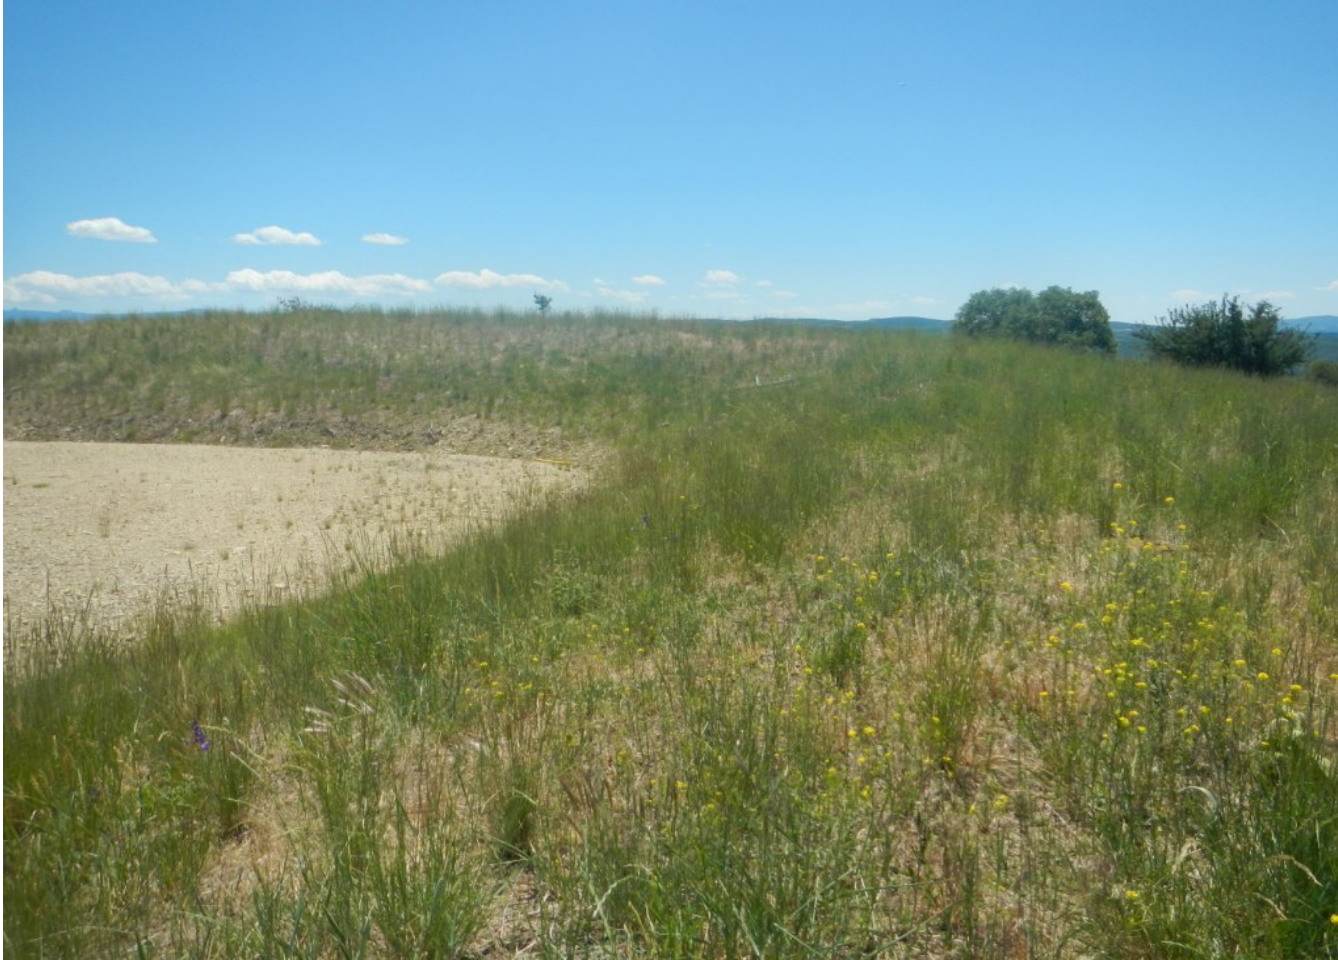
Photo#5: Interim Reclamation Area Fill Slope ,Vegetation well established..

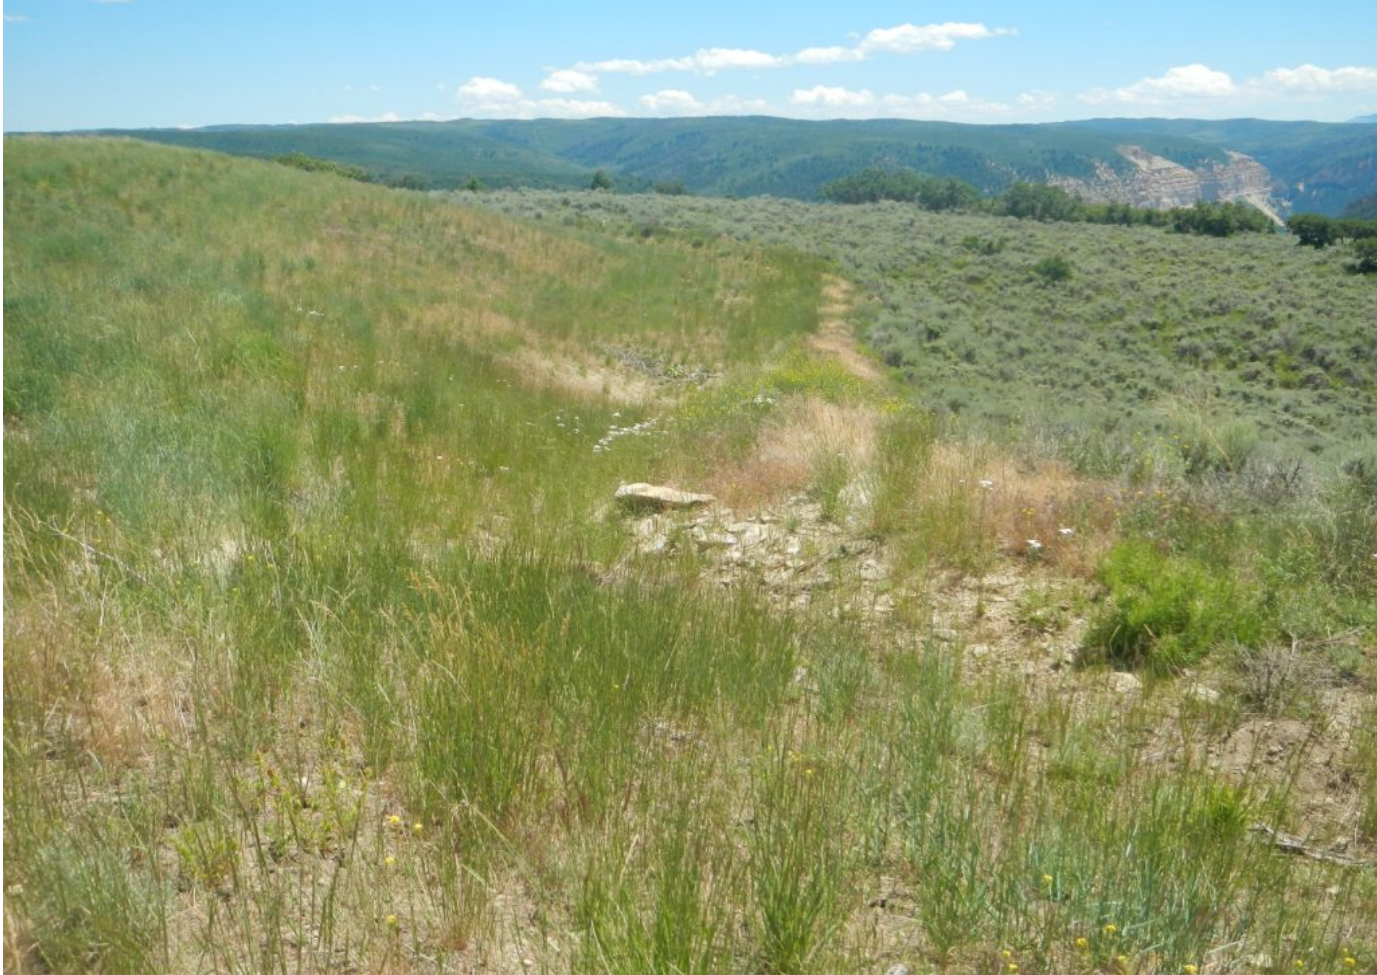
Photo#6: View to West of Interim Reclamation, Ditch and small Berm running along base of Fill Slopes.
