Final Reclamation Inspection

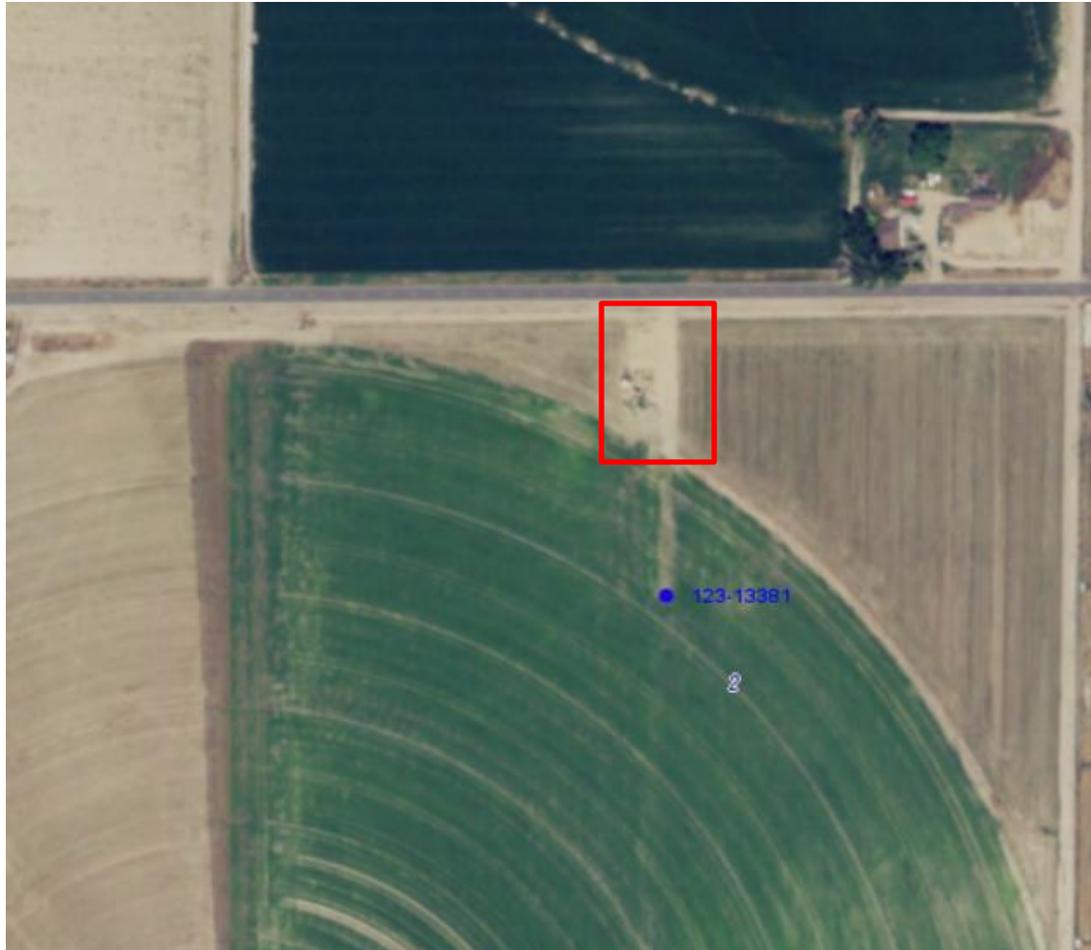
Photo 1. 2015 aerial imagery using COGCC GISOnline database, illustrating the area that has not been reclaim and equipment remains (highlighted in the red box).

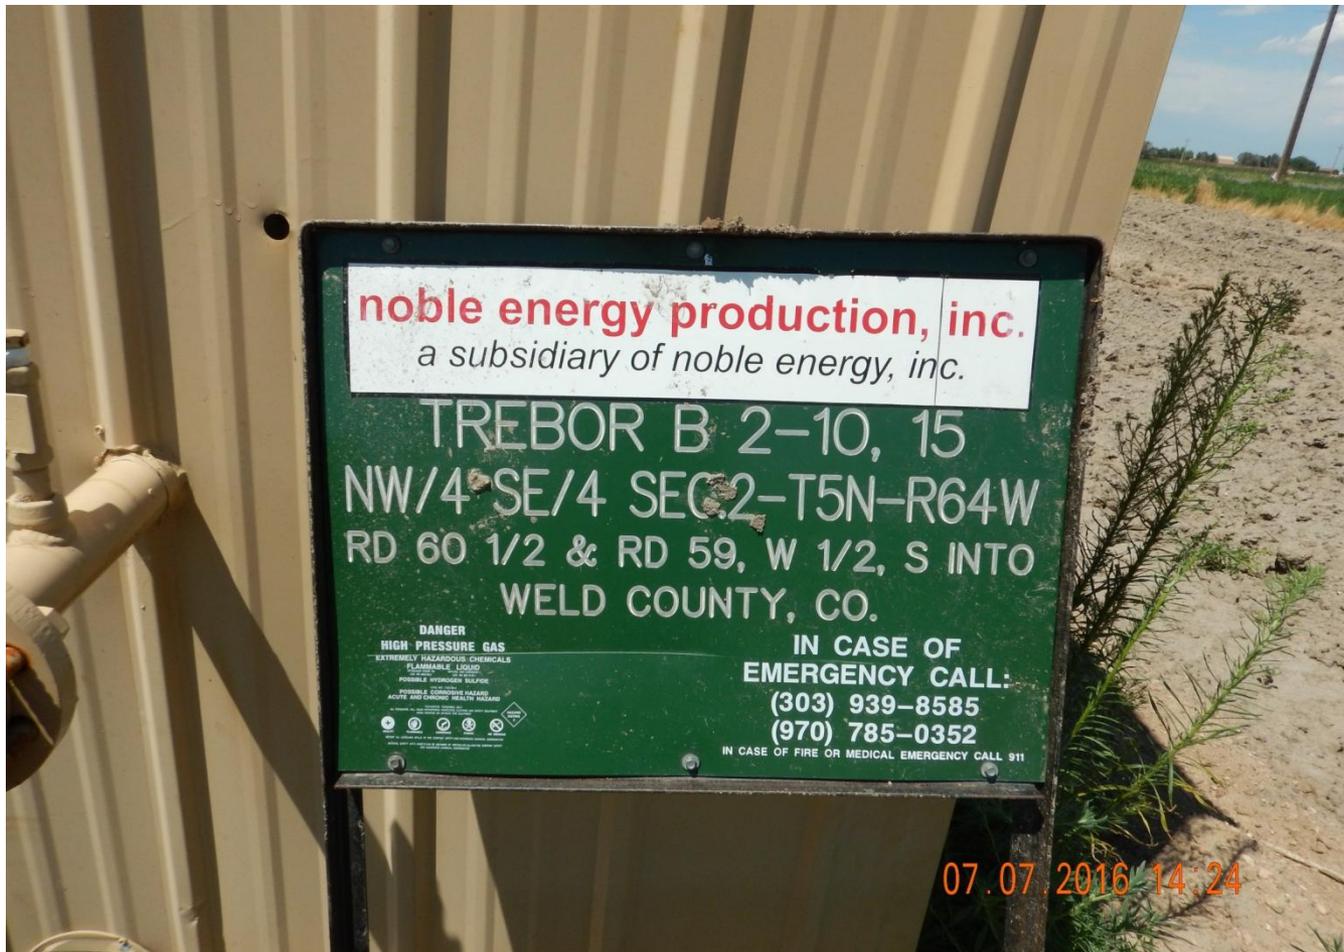
Photo 2. Photo taken of well location sign which needs to be removed along with other remaining surface equipment.

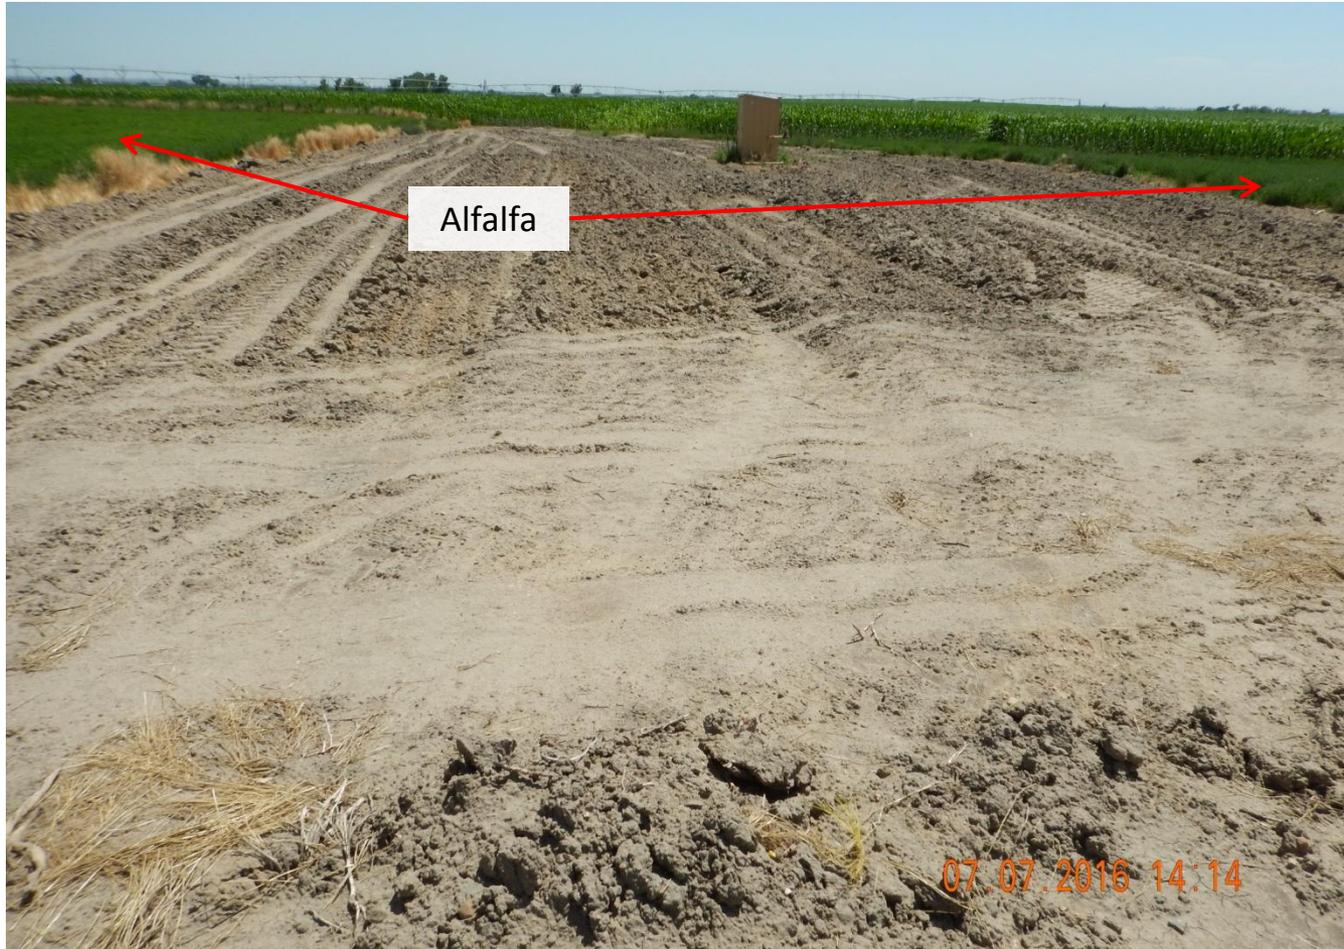
Photo 3. Photo taken of unused equipment that needs to be removed per Rule 1004. Location will not be released until all equipment is removed, regardless of ownership. Alfalfa (*Medicago sativa*) is planted outside of the pivot irrigation and appears the unused equipment is preventing the landowner from farming this disturbed location. Also, corn crop growth is stunted along the perimeter of the pivot where the southern location once existed. Well location has proper growth and passes Rule 1004.

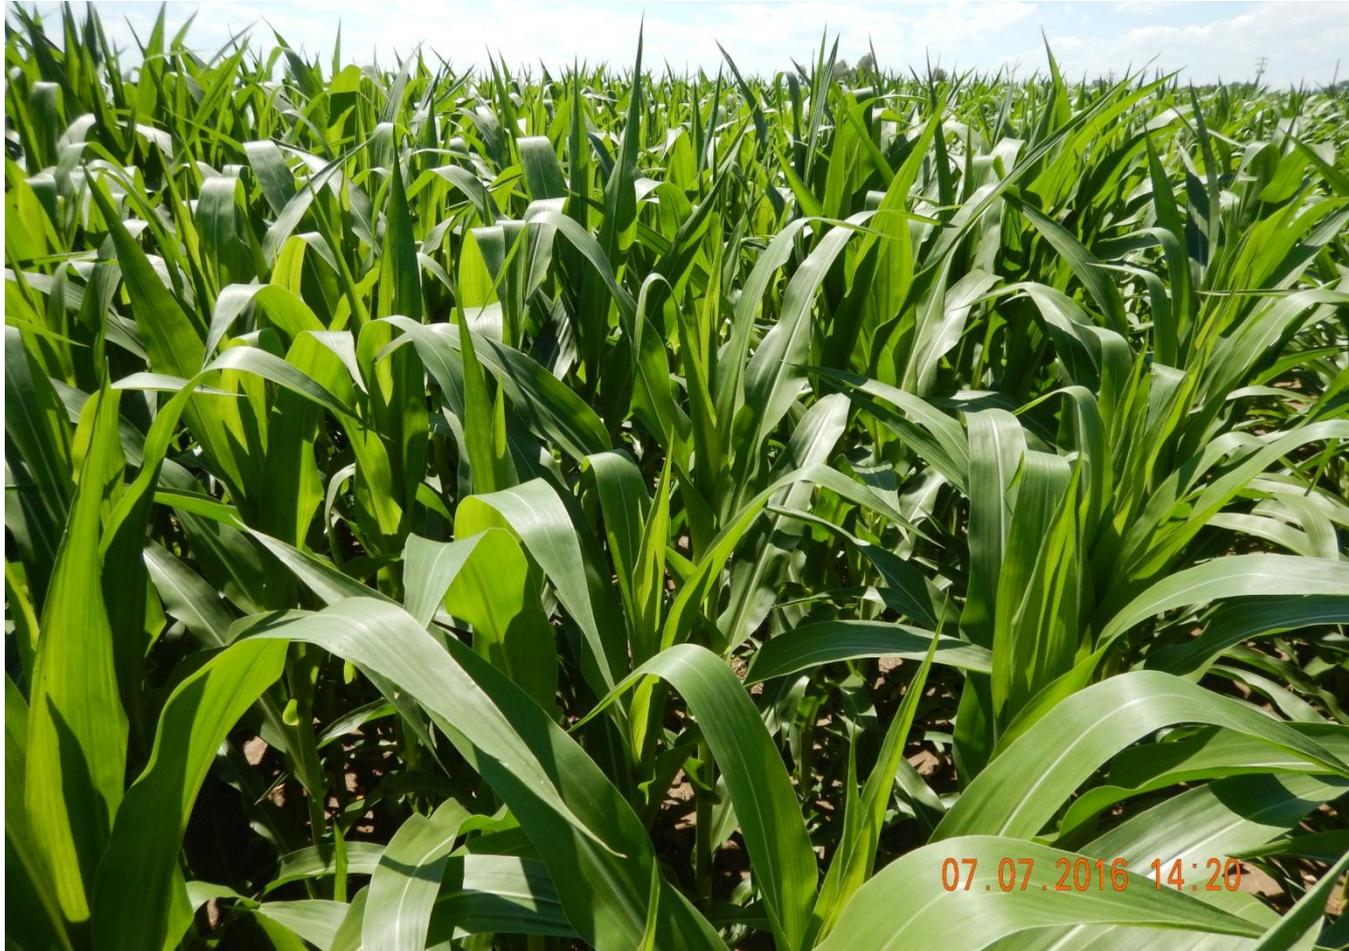
Photo 4. Photo taken from center of location, facing West. Uniform, vegetative plant cover appears to be representative in both the disturbed and reference areas.

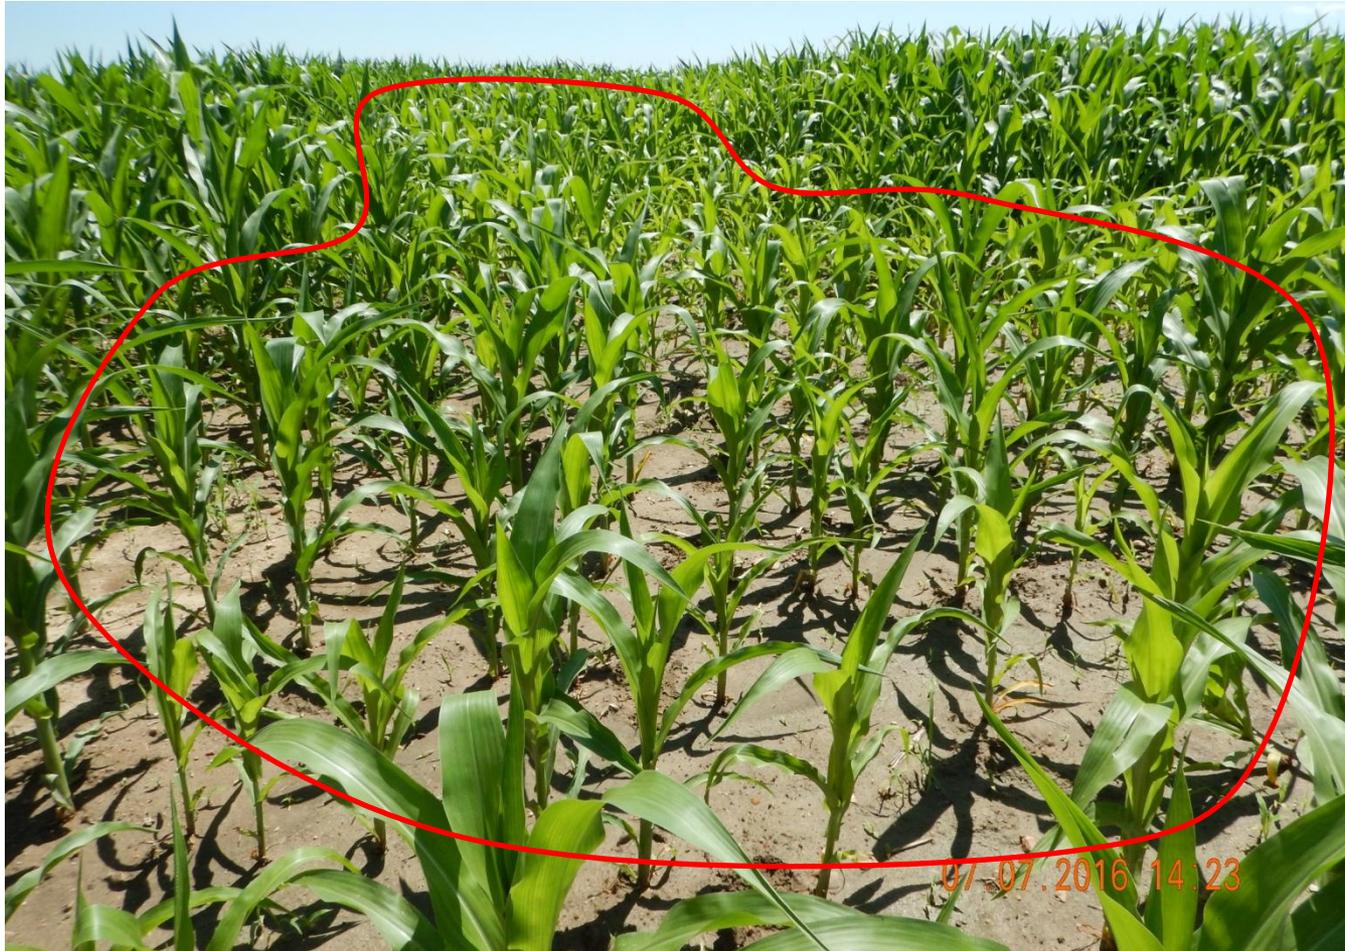
Photo 5. Photo taken from the pivot perimeter, facing South towards the historic access road. Notice the stunted corn crop growth in the disturbance area versus the immediate reference area surrounding the well location. The likely cause of stunted growth occurs when root barriers form from compacted soils which diminish growth potential, as shown here.
