Stormwater Inspection

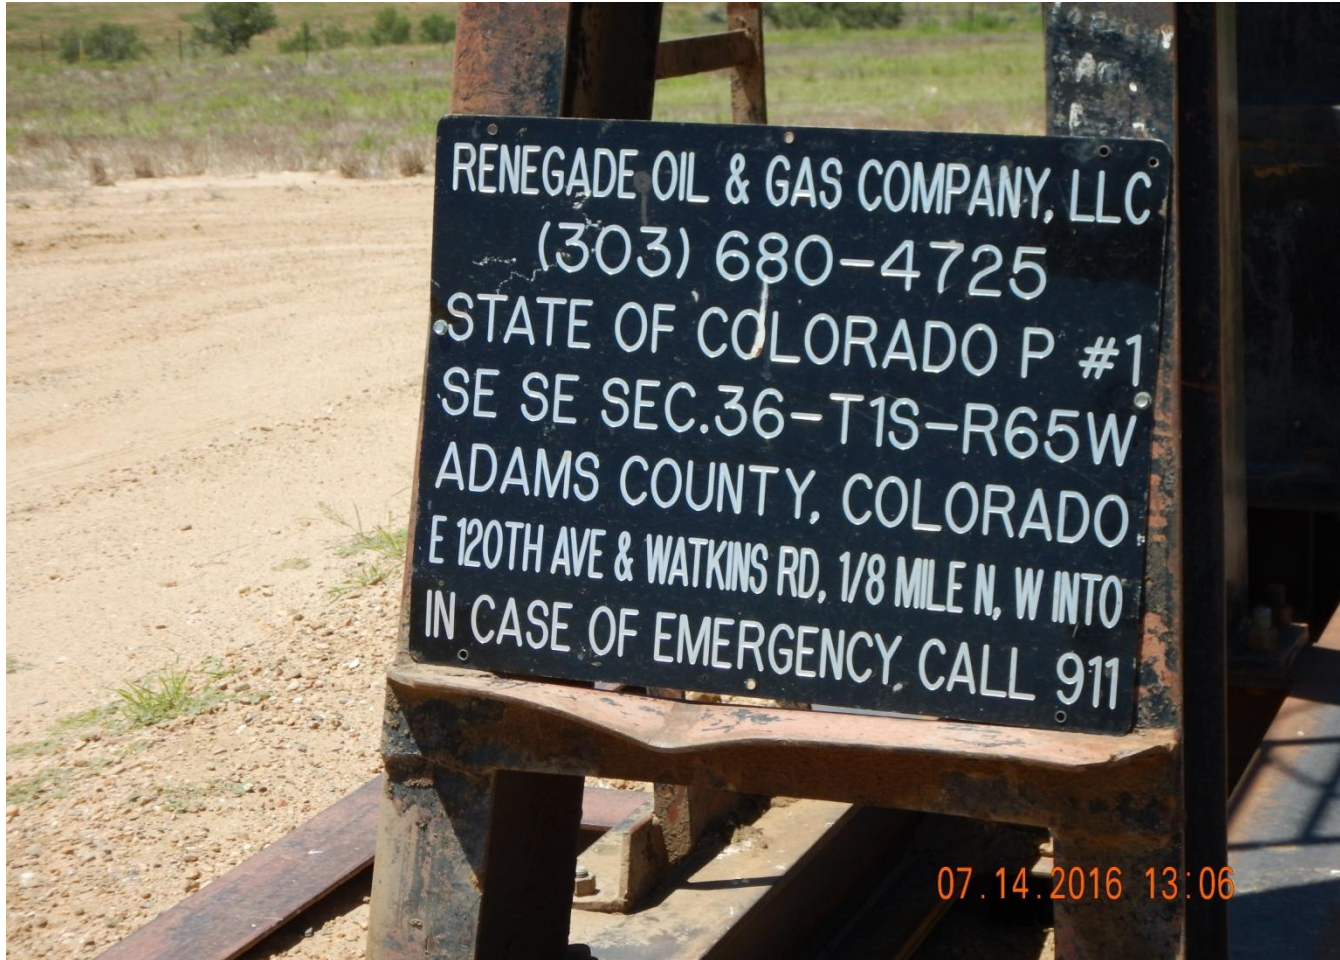
Photo 1. Photo taken of PR well sign for API #001-06321.

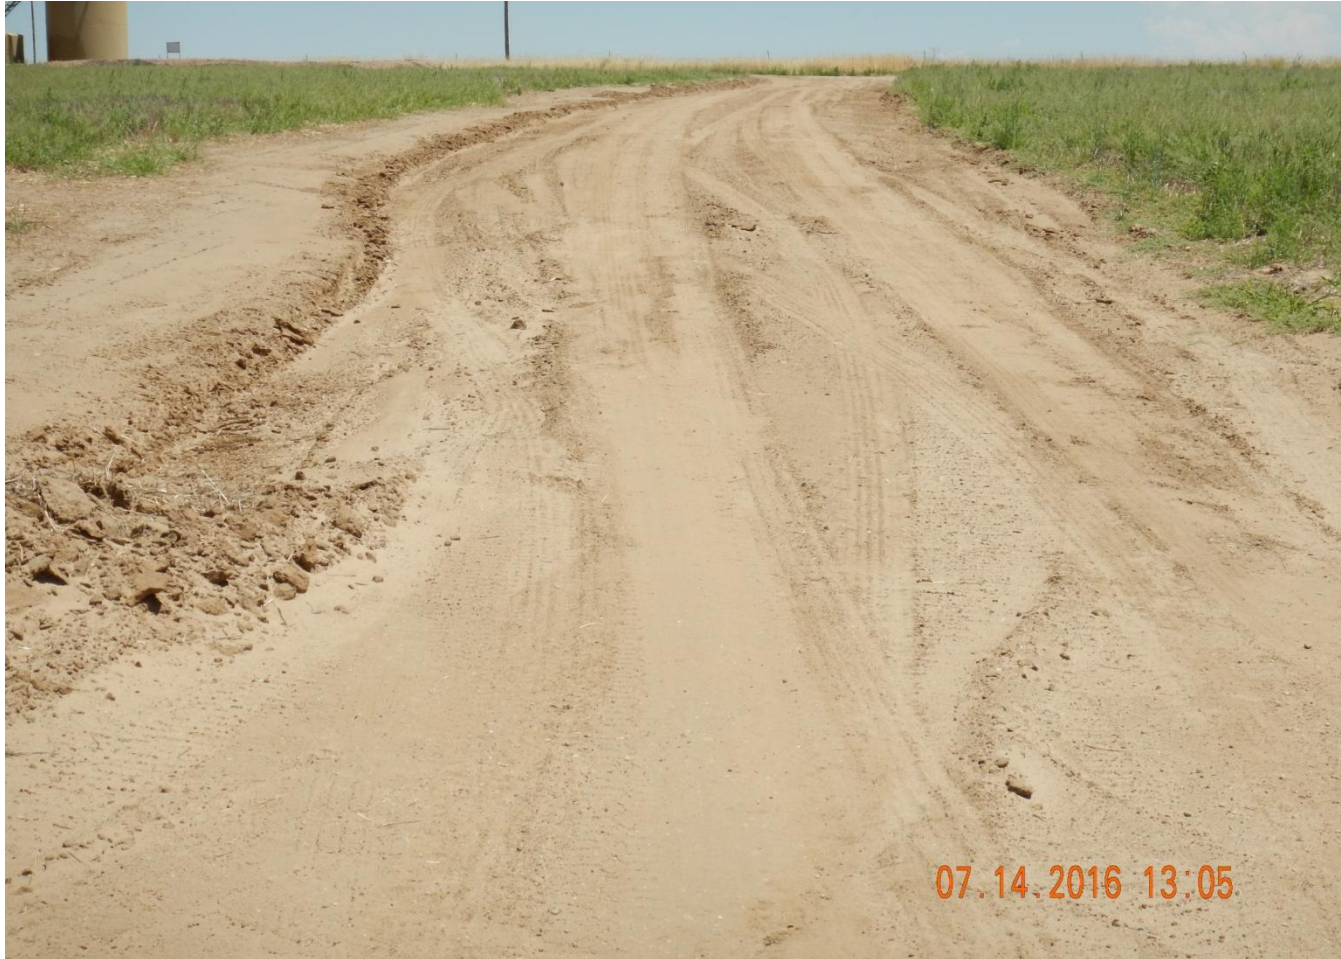
Photo 2. Photo taken from well location, facing East, along the access road. Rills from erosion along the access road have been fixed.

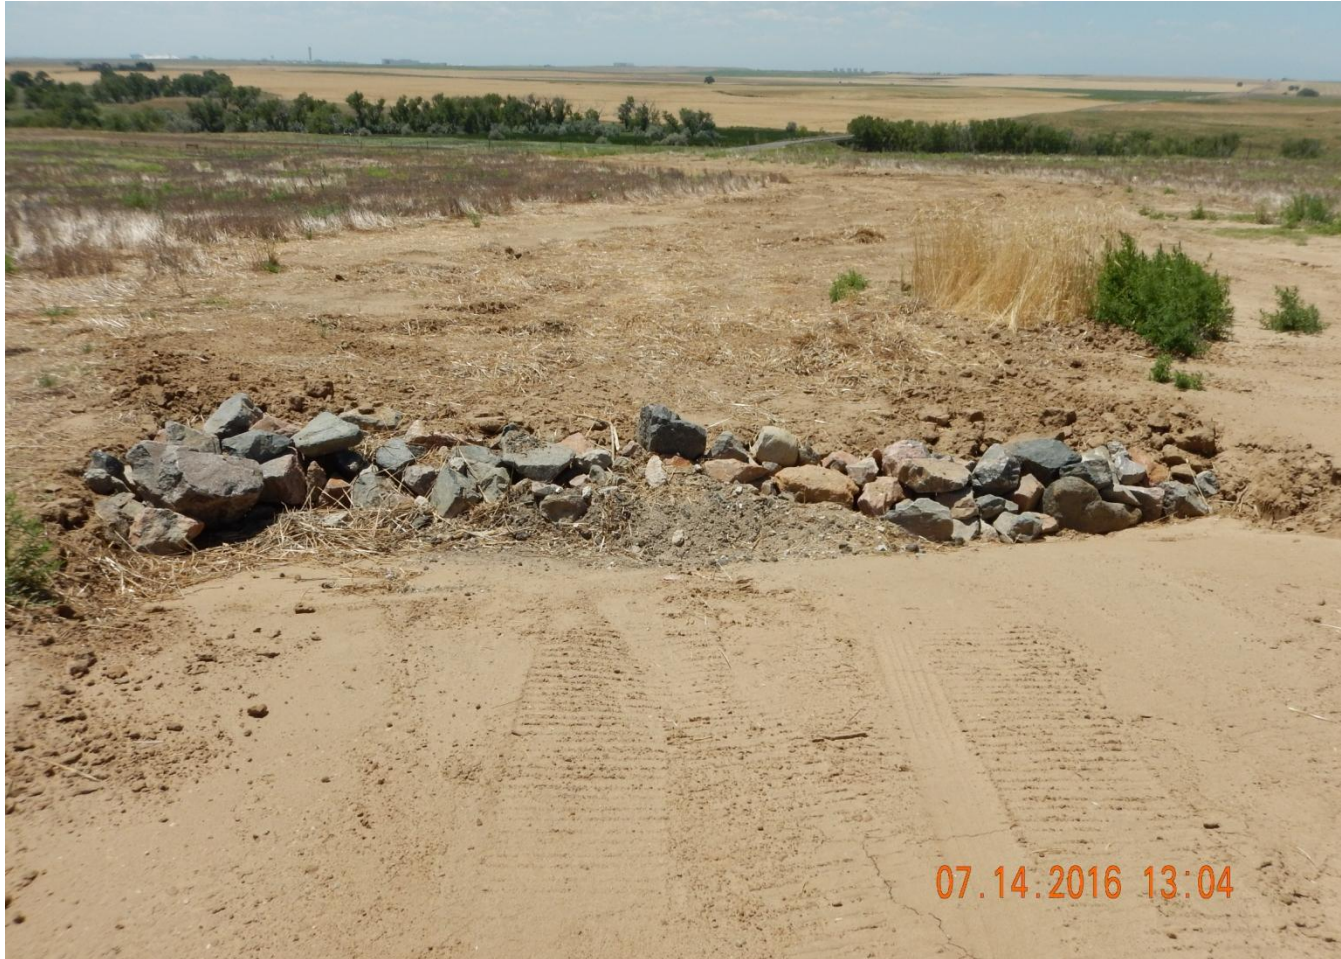
Photo 3. Photo taken from the southern well location, facing West, toward the first BMP. Two stormwater BMPs installed along the southern location to control stormwater and transport of sediment.

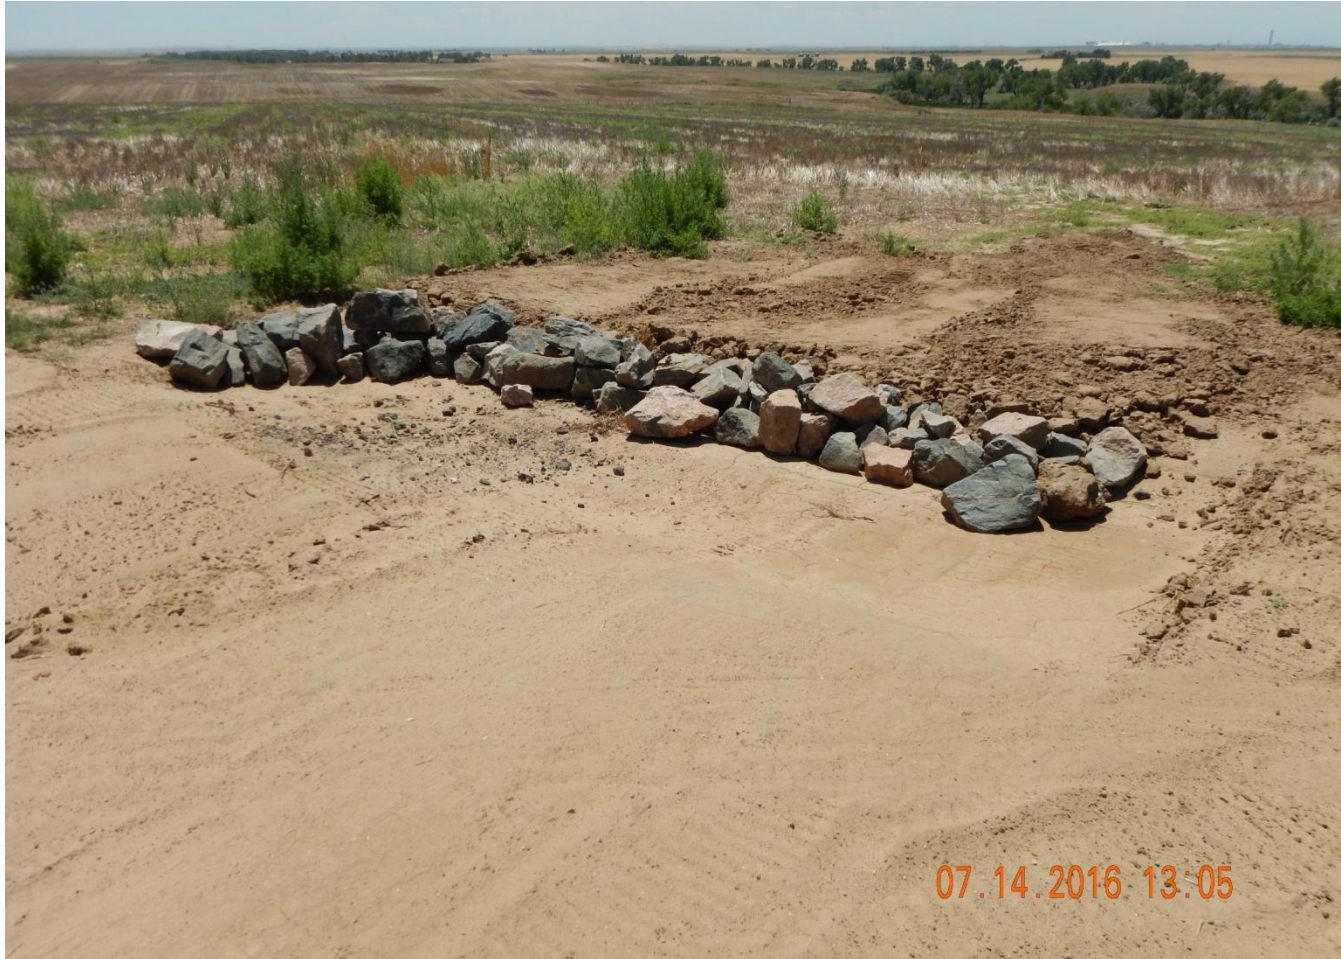
Photo 4. Photo taken from the southern well location, facing West, toward the second BMP. Two stormwater BMPs installed along the southern location to control stormwater and transport of sediment.

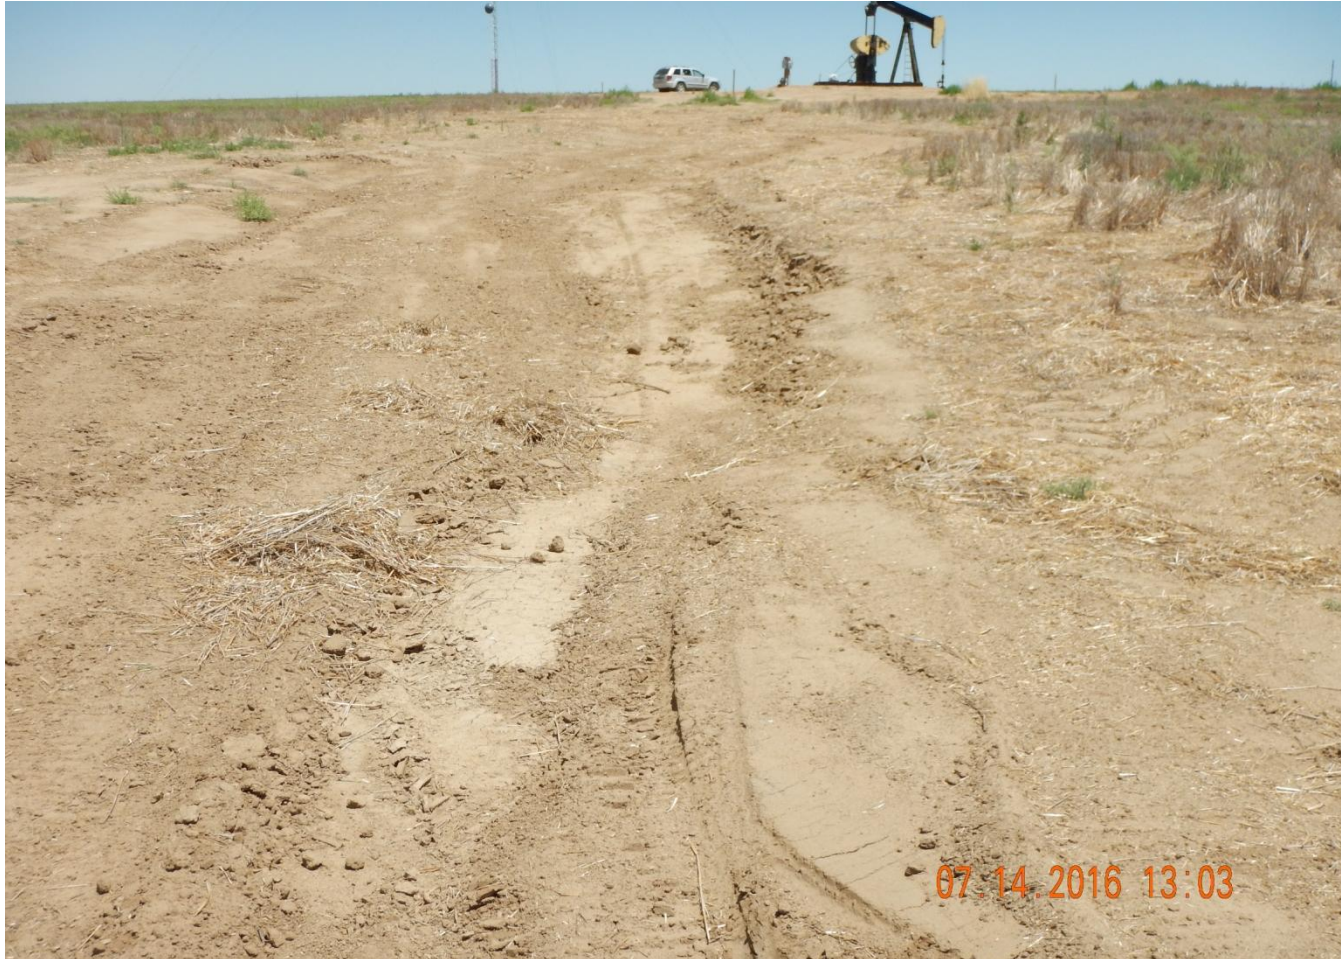
Photo 5. Photo taken from southwest of well location, facing North. Gully from erosion has been filled in.

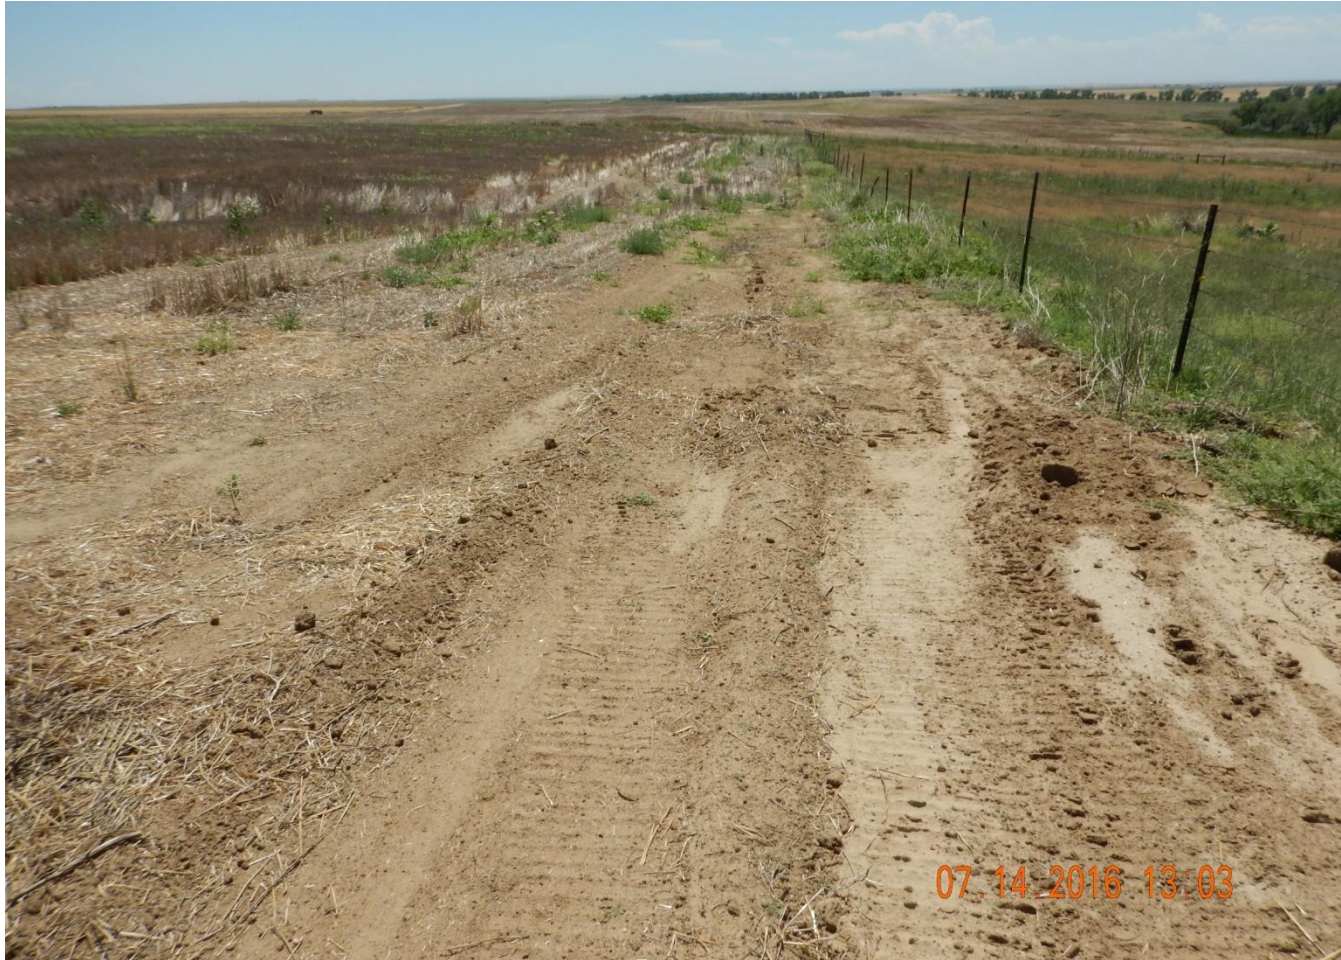
Photo 6. Photo taken from southwest of well location, facing South. Gully from erosion has been filled in.
