# Final Reclamation Inspection

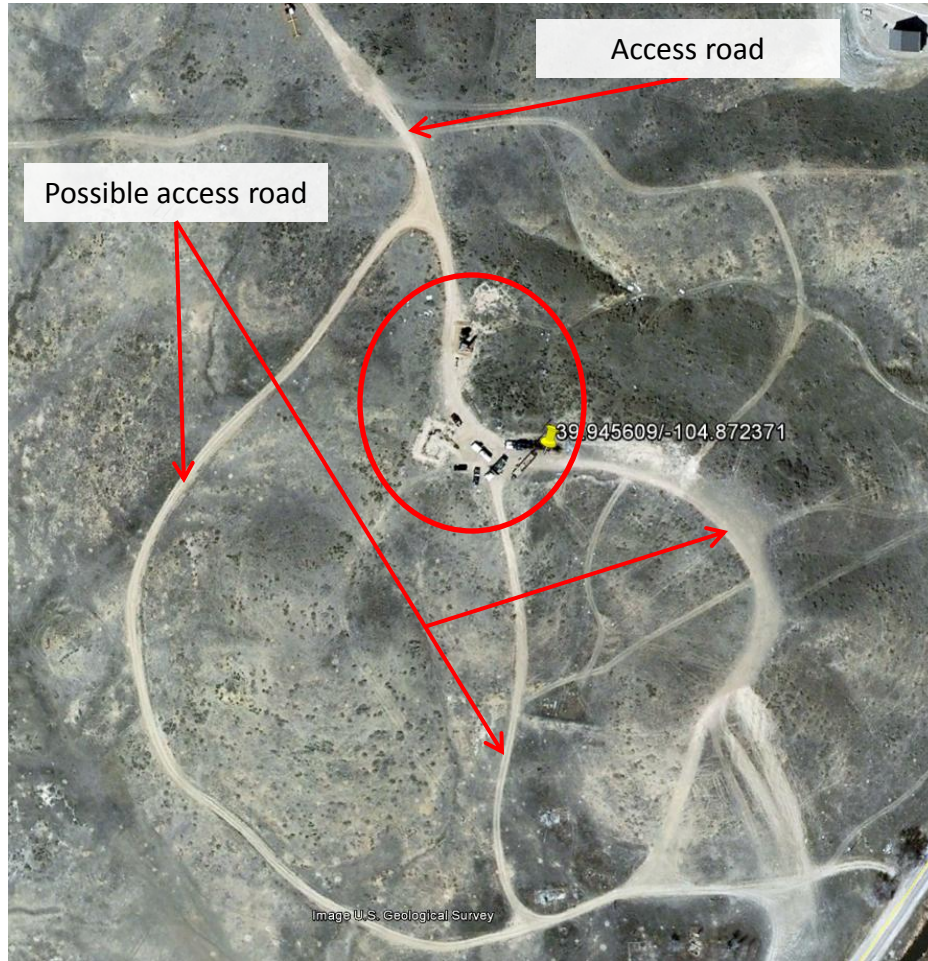
**Photo 1.** Google Earth aerial photo taken 3/31/2006 illustrating total disturbance of location and other existing roads. It appears multiple roads could have been used that have not been reclaimed.

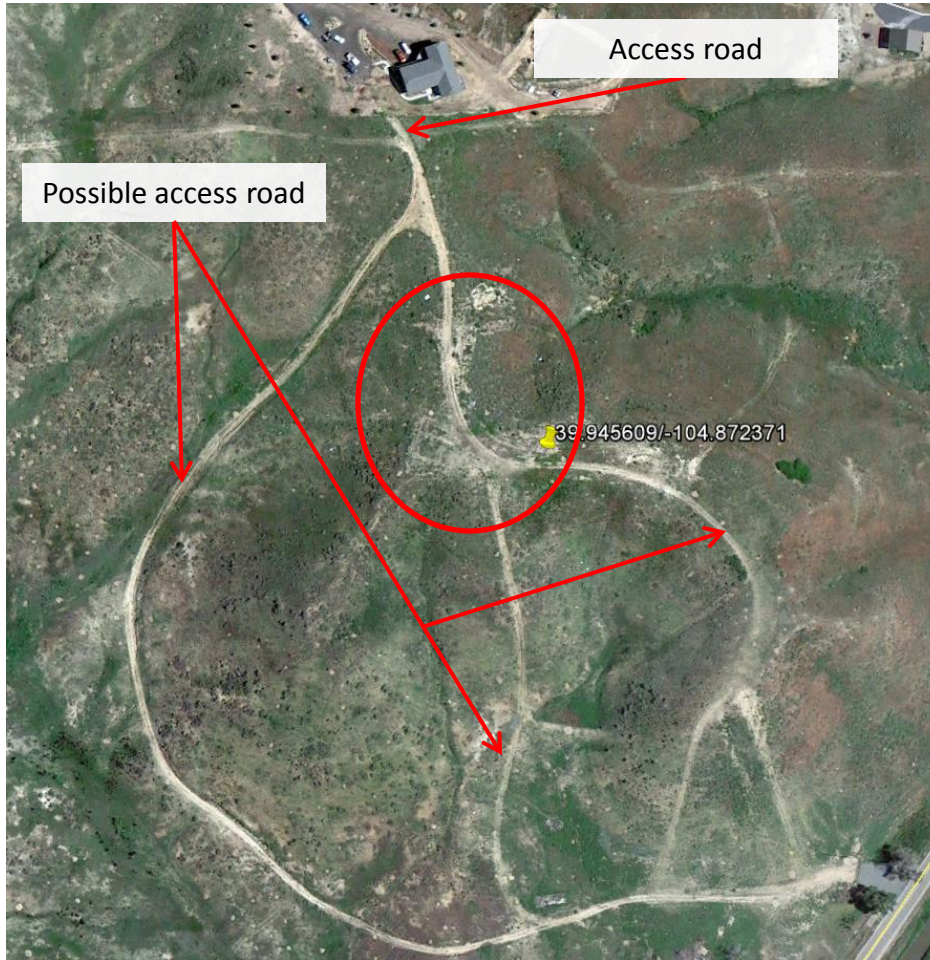
**Photo 2.** Google Earth aerial photo taken 6/15/2010. It appears multiple roads could have been used that have not been reclaimed. Residential housing development has occurred north of location.

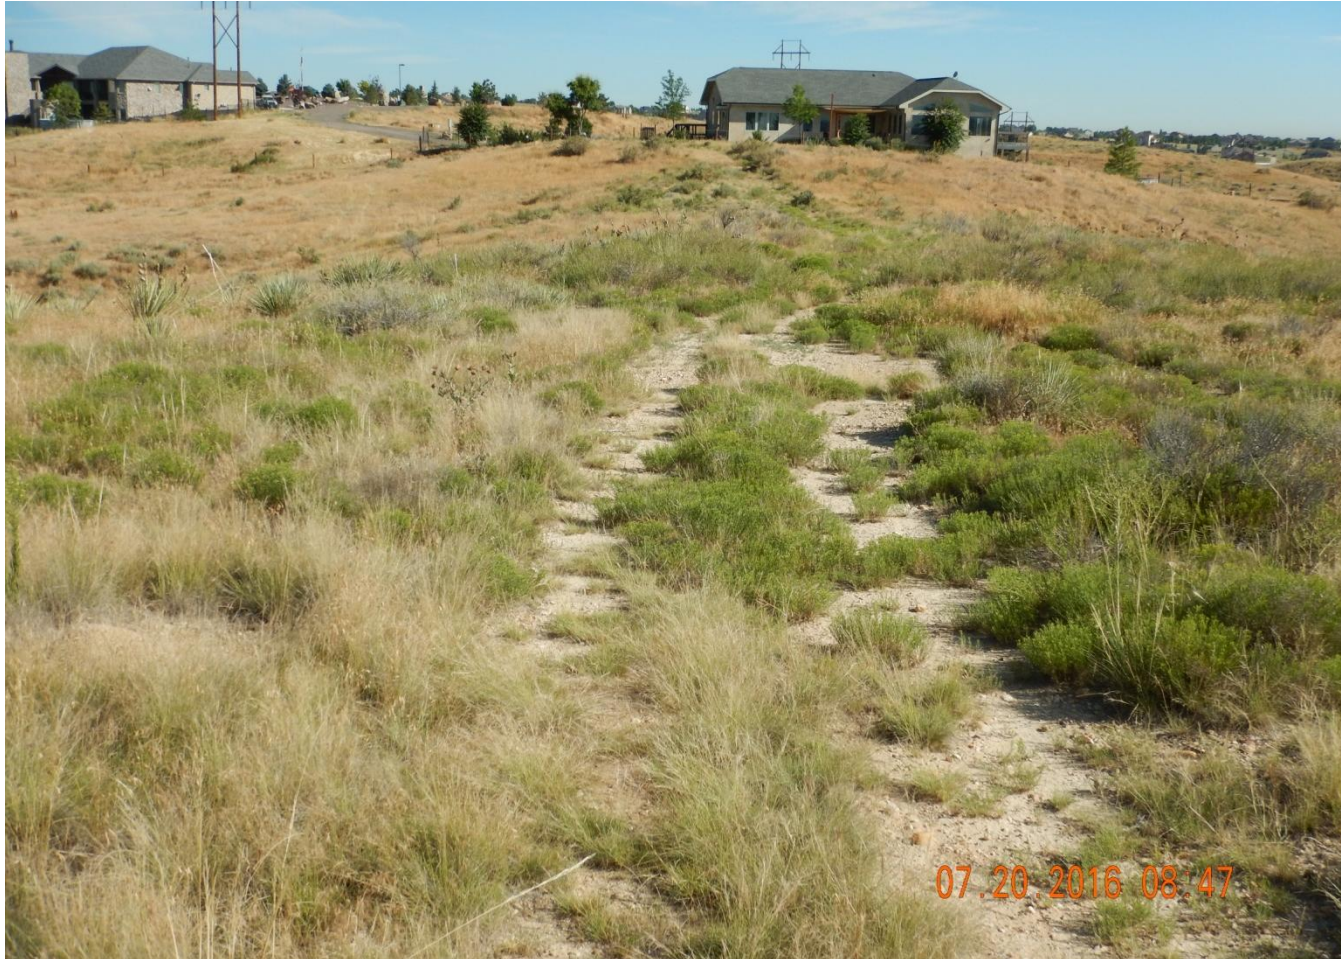
**Photo 3.** Photo taken from well location, facing North. Main access not reclaimed and gravel not removed.

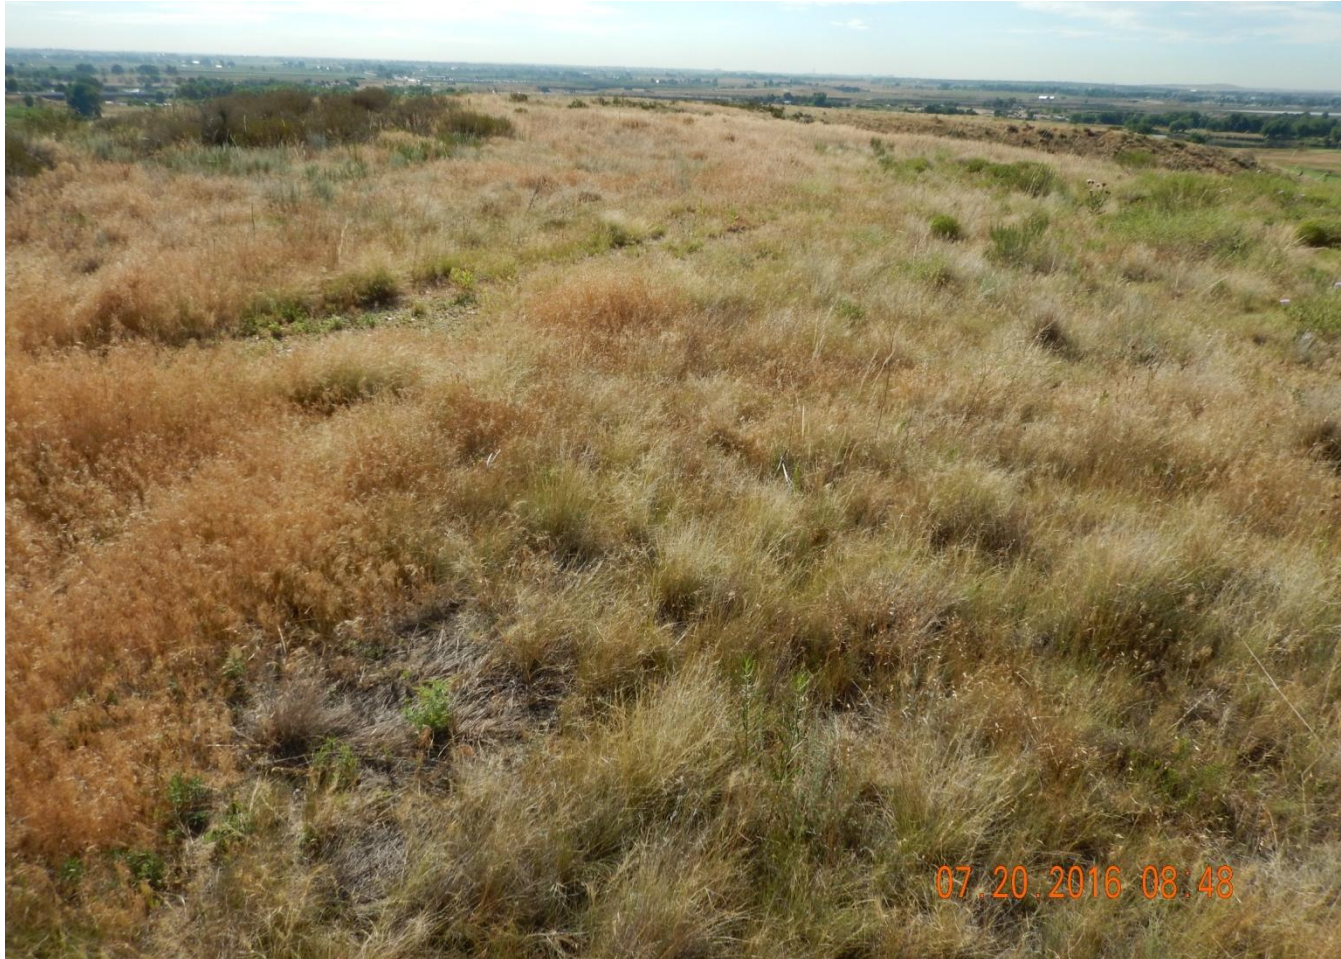
**Photo 4.** Photo taken from northern well location, facing East. Location has native grasses and shrubs, but also has a high density of cheatgrass. Cheatgrass also exists throughout this entire local region, not just this well location.

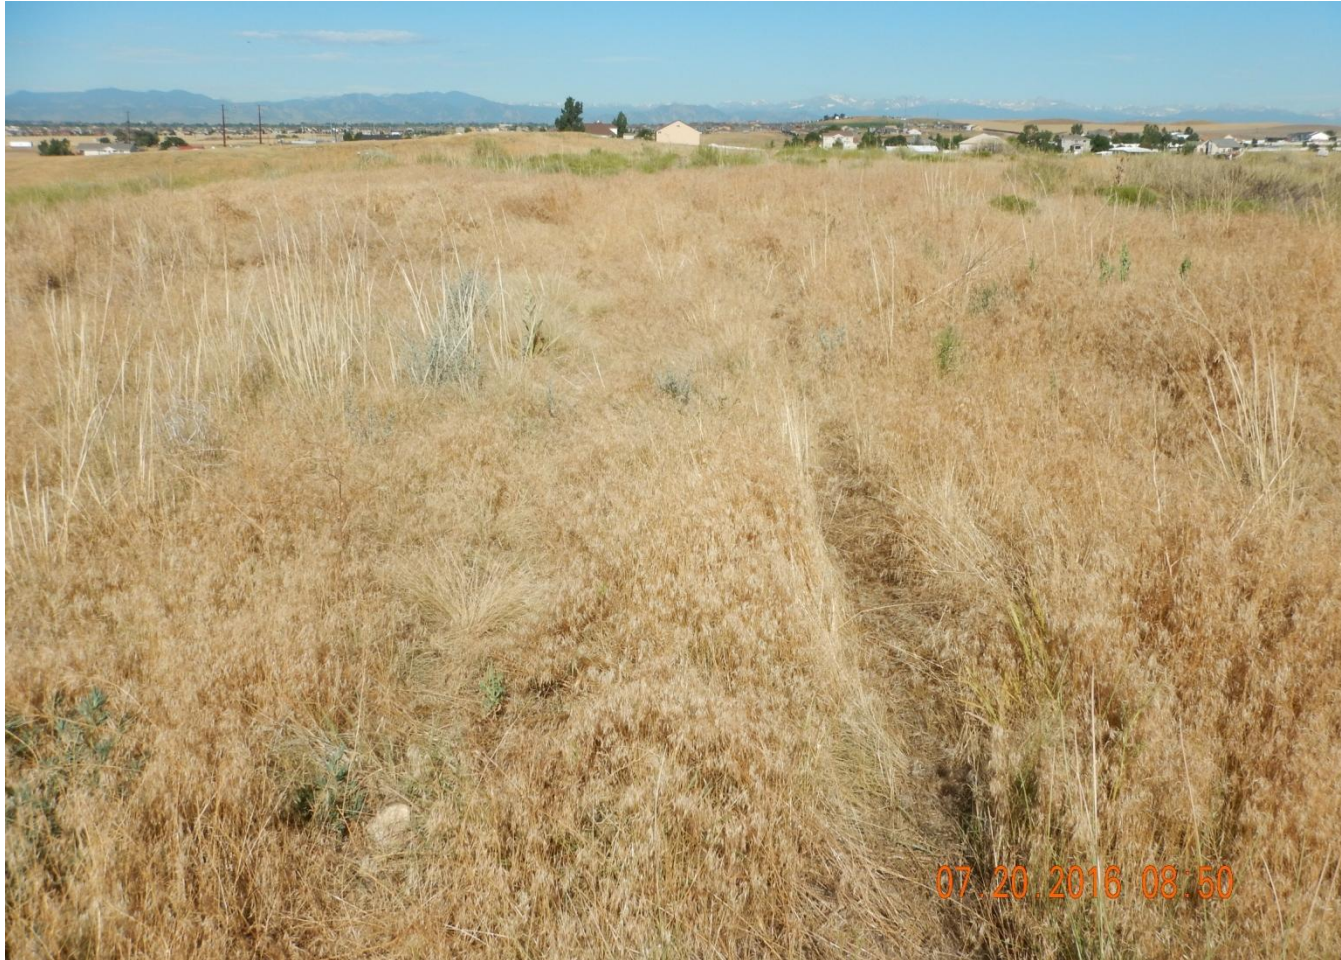
**Photo 5.** Photo taken from the eastern location, facing West. Cheatgrass observed in high densities.

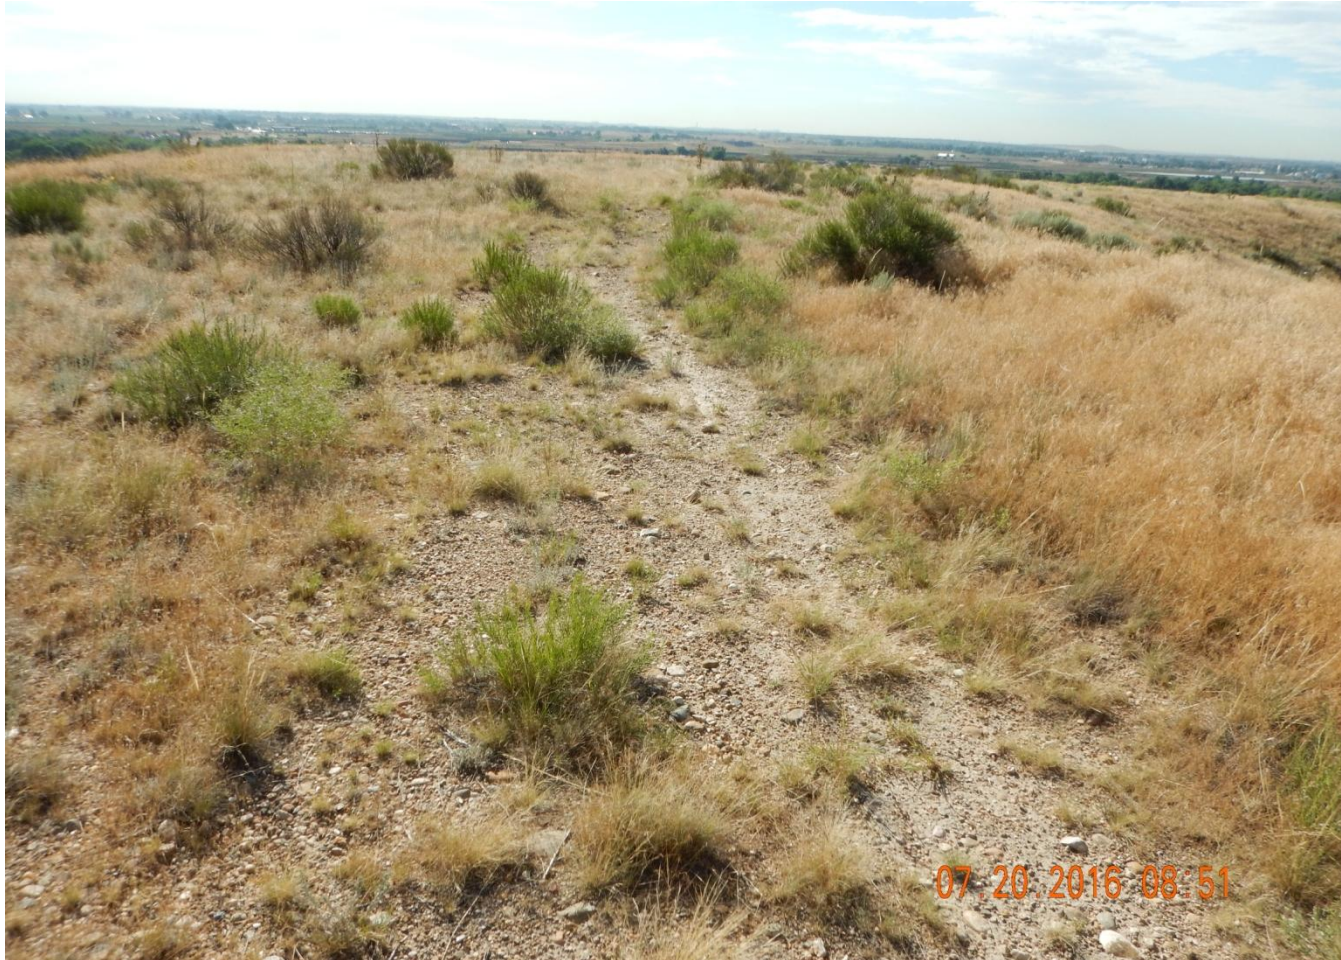
**Photo 6.** Photo taken from previous photo location, facing Southeast. Gravel not removed but several native species exist throughout location.

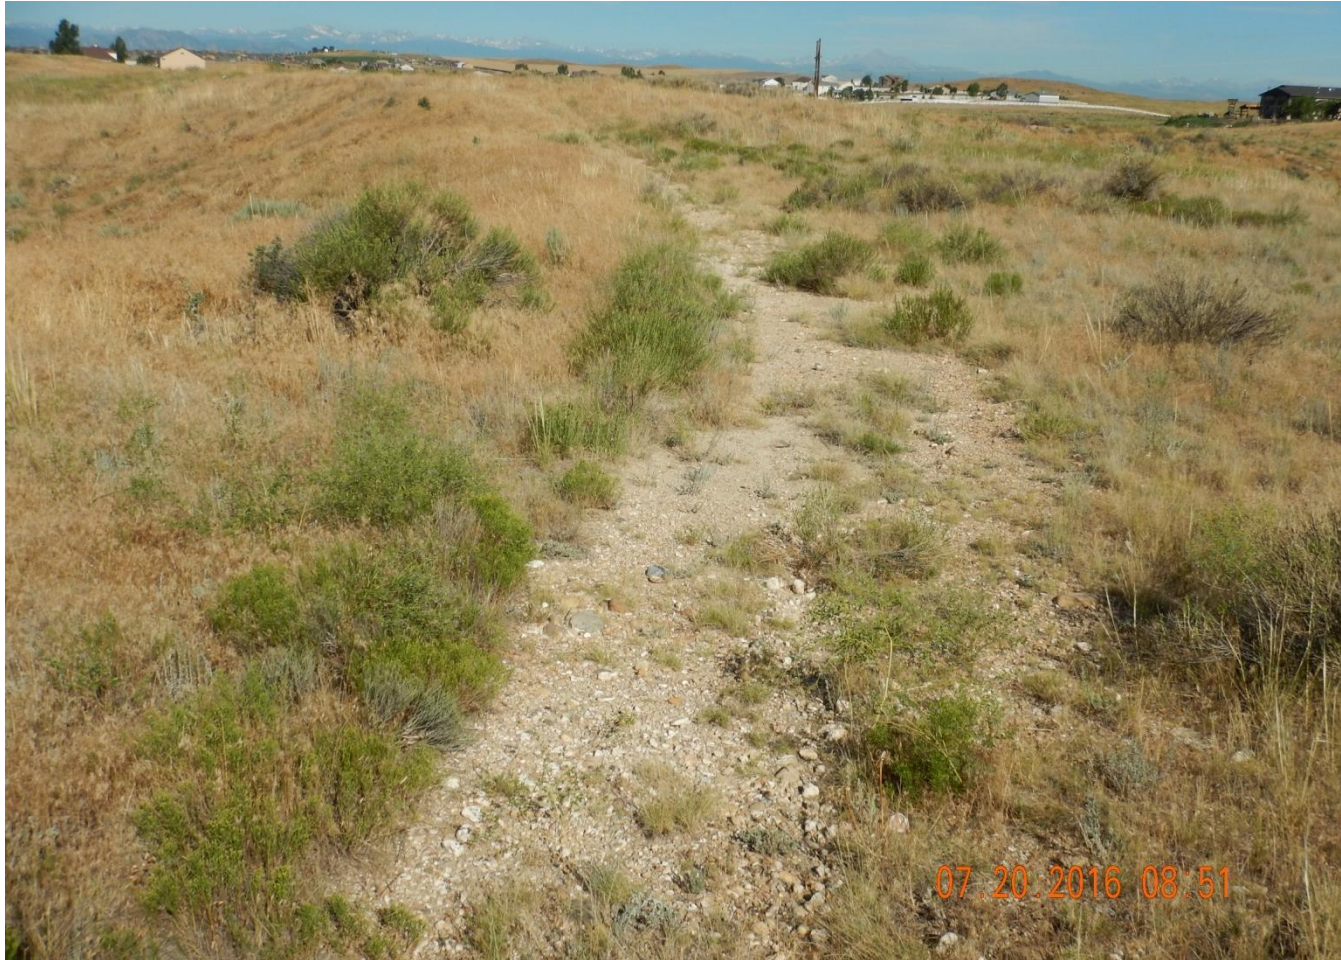
**Photo 7.** Photo taken from the eastern portion of what may have been used as an access road. Access road not reclaimed and gravel was not removed.
