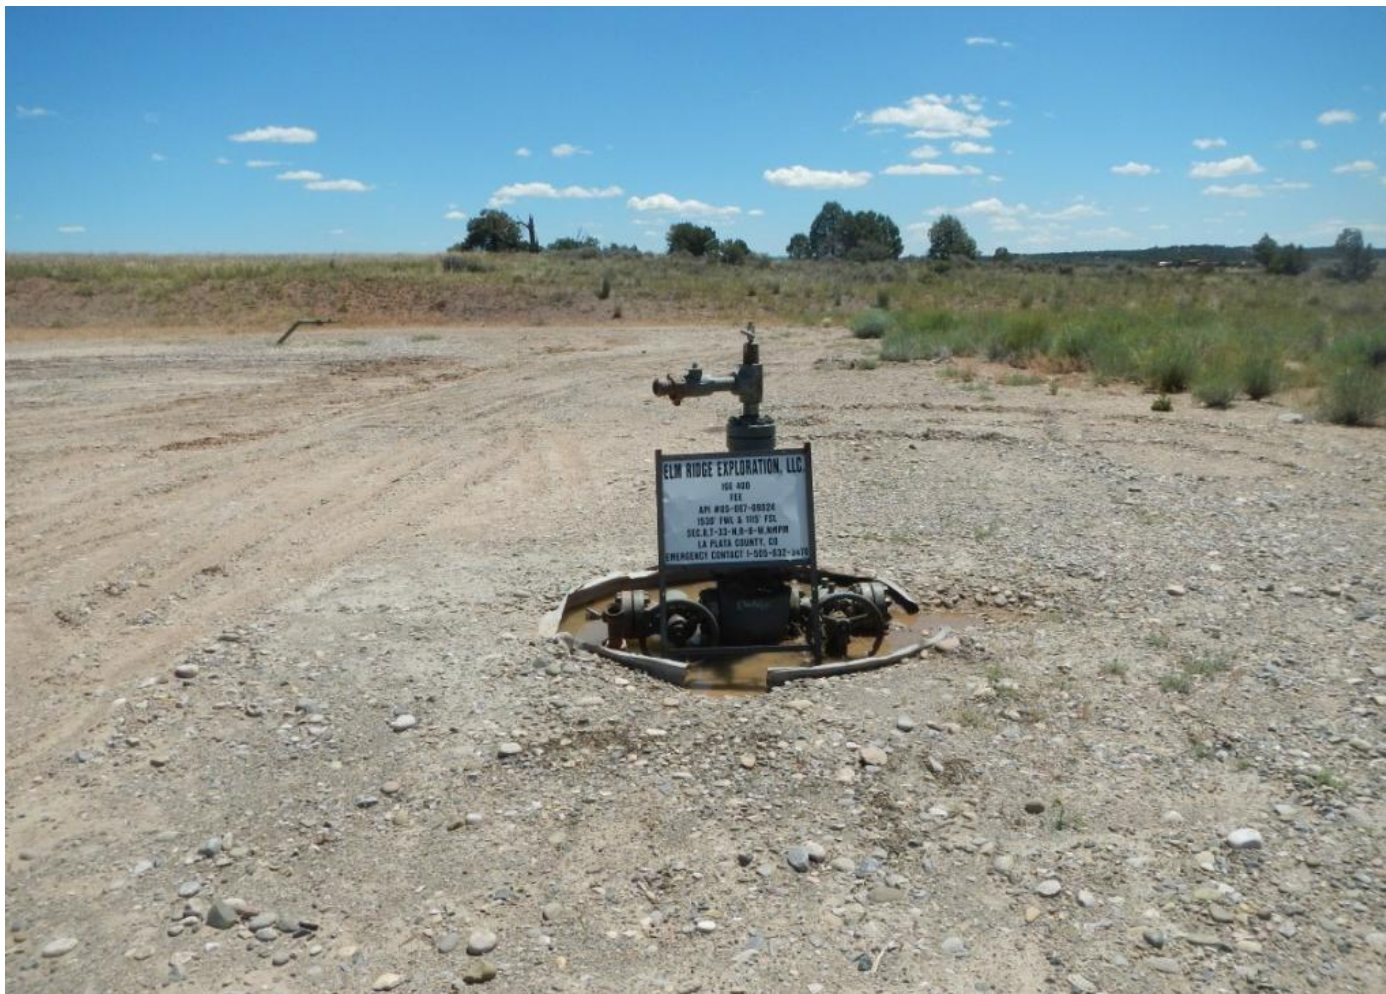
Photo 1. View of wellhead in the southern portion of the working area facing eastward.

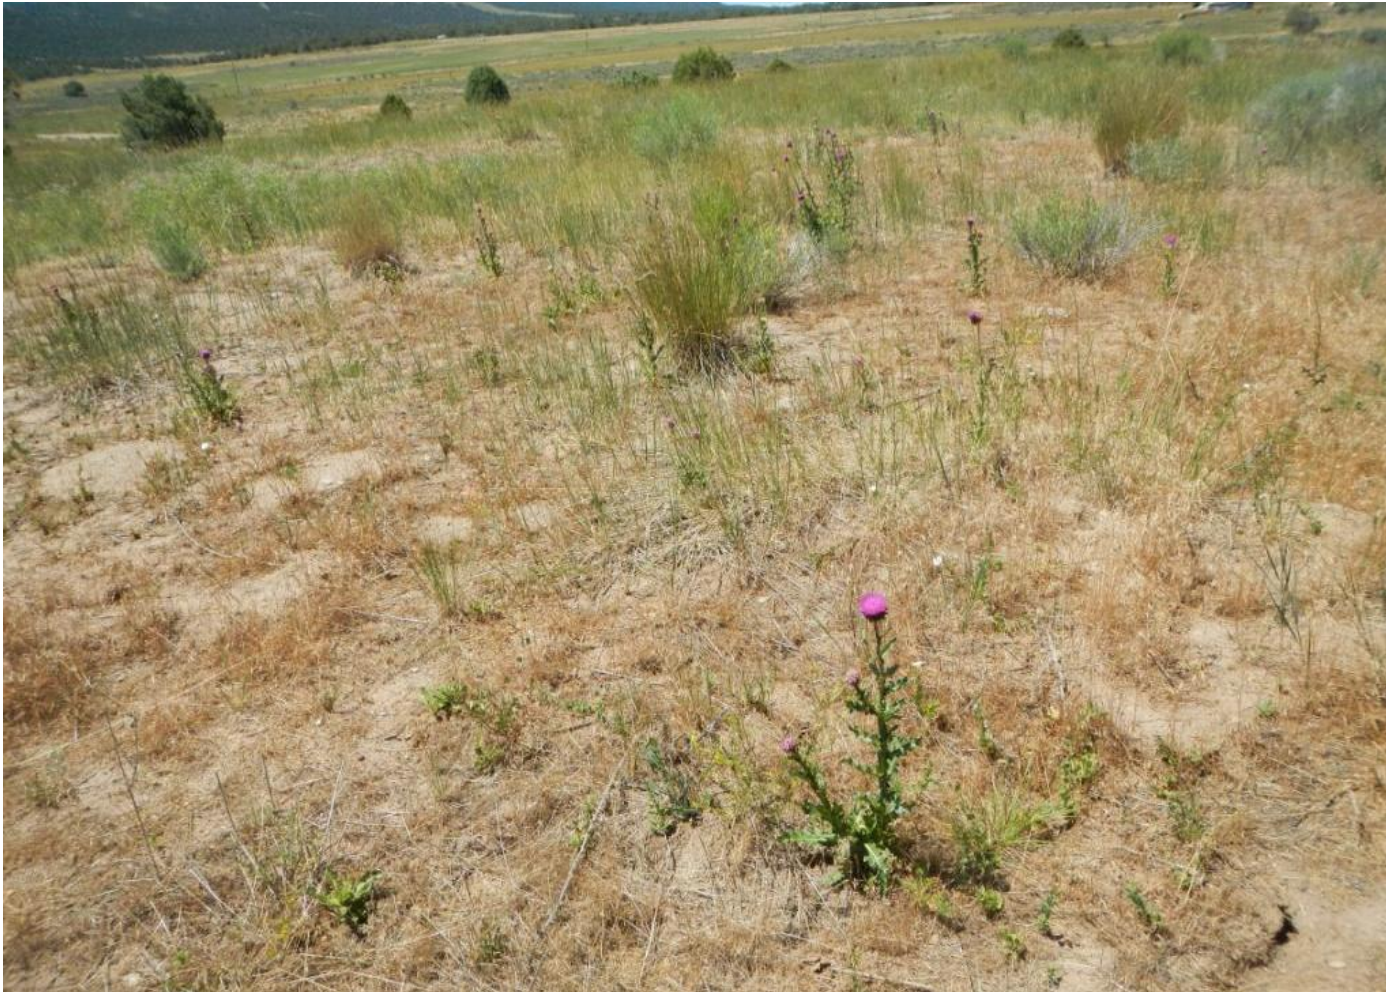
Photo 2. View of blooming musk thistles (*Carduus nutans*) in the southern portion of the project area.

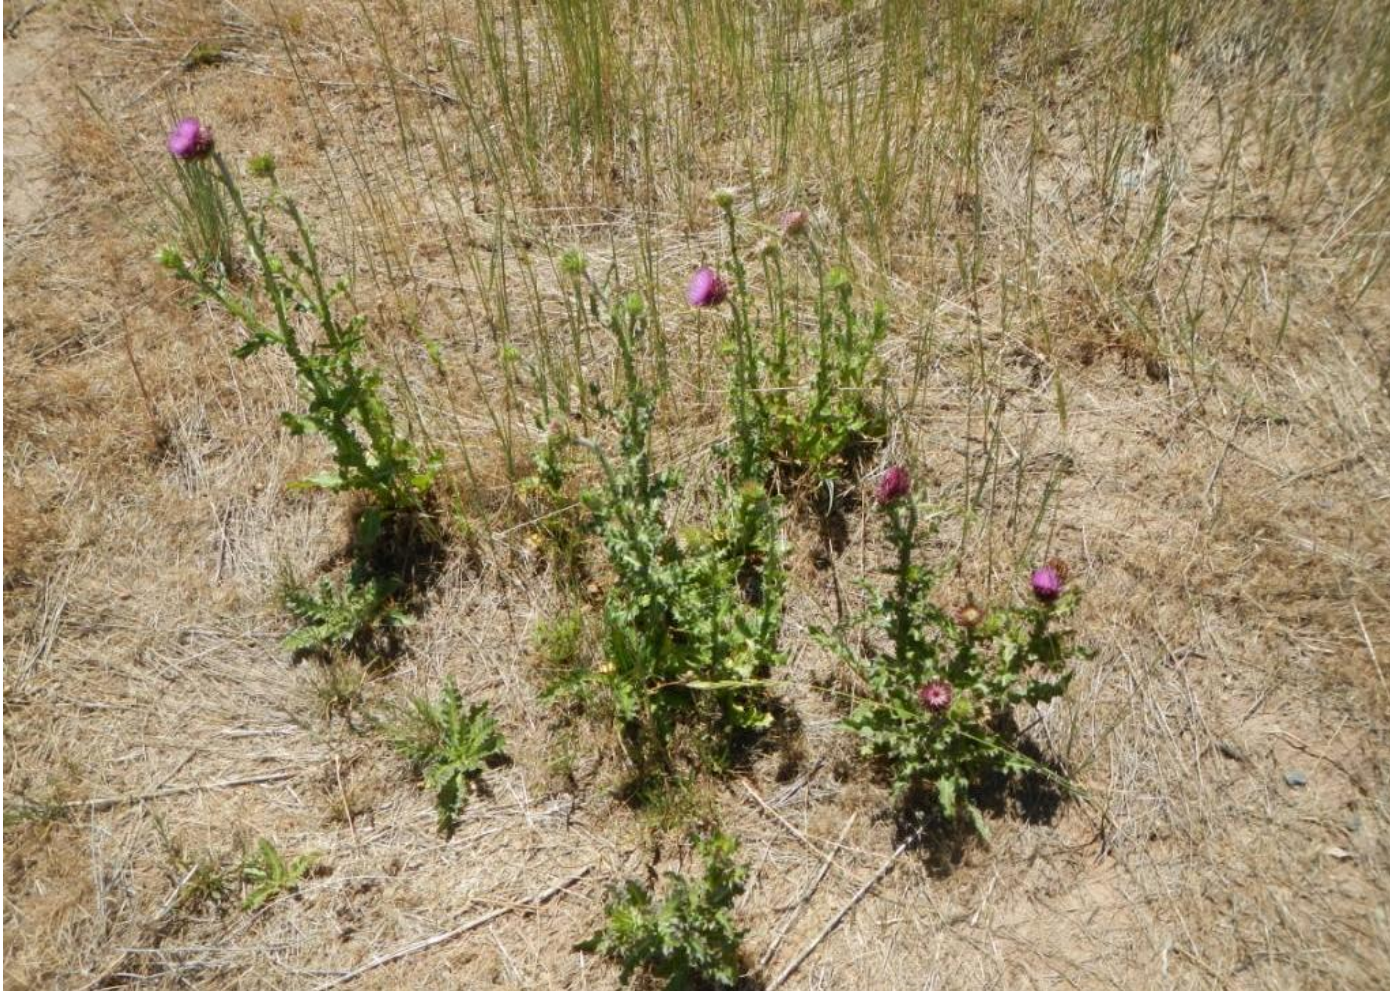
Photo 3. Another view of blooming musk thistles within the interim reclamation area.

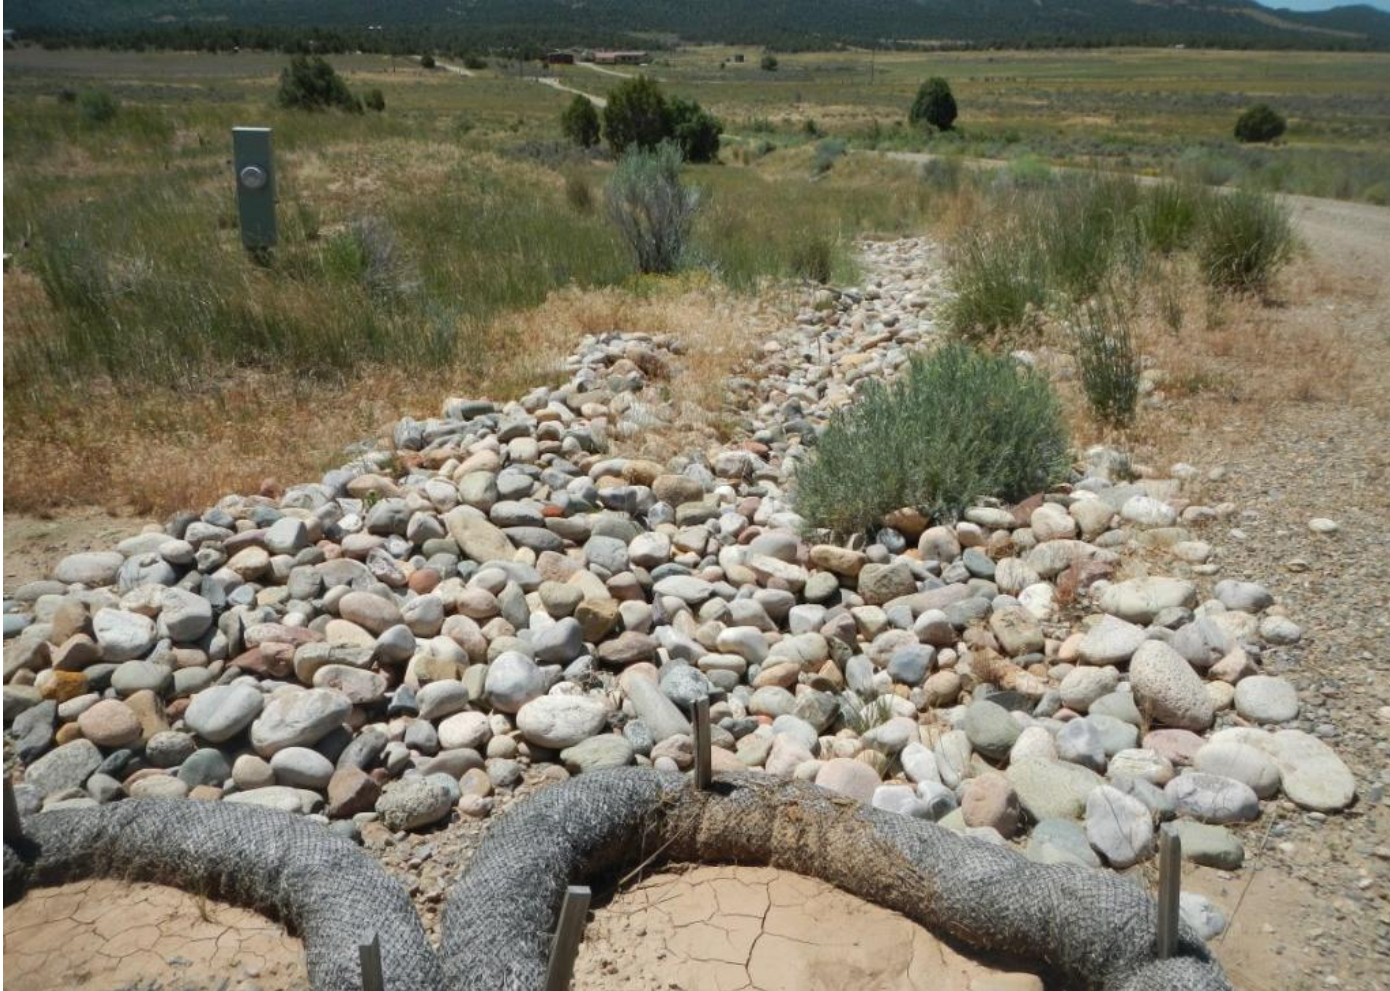
Photo 4. View of stormwater controls near the well pad entrance.
