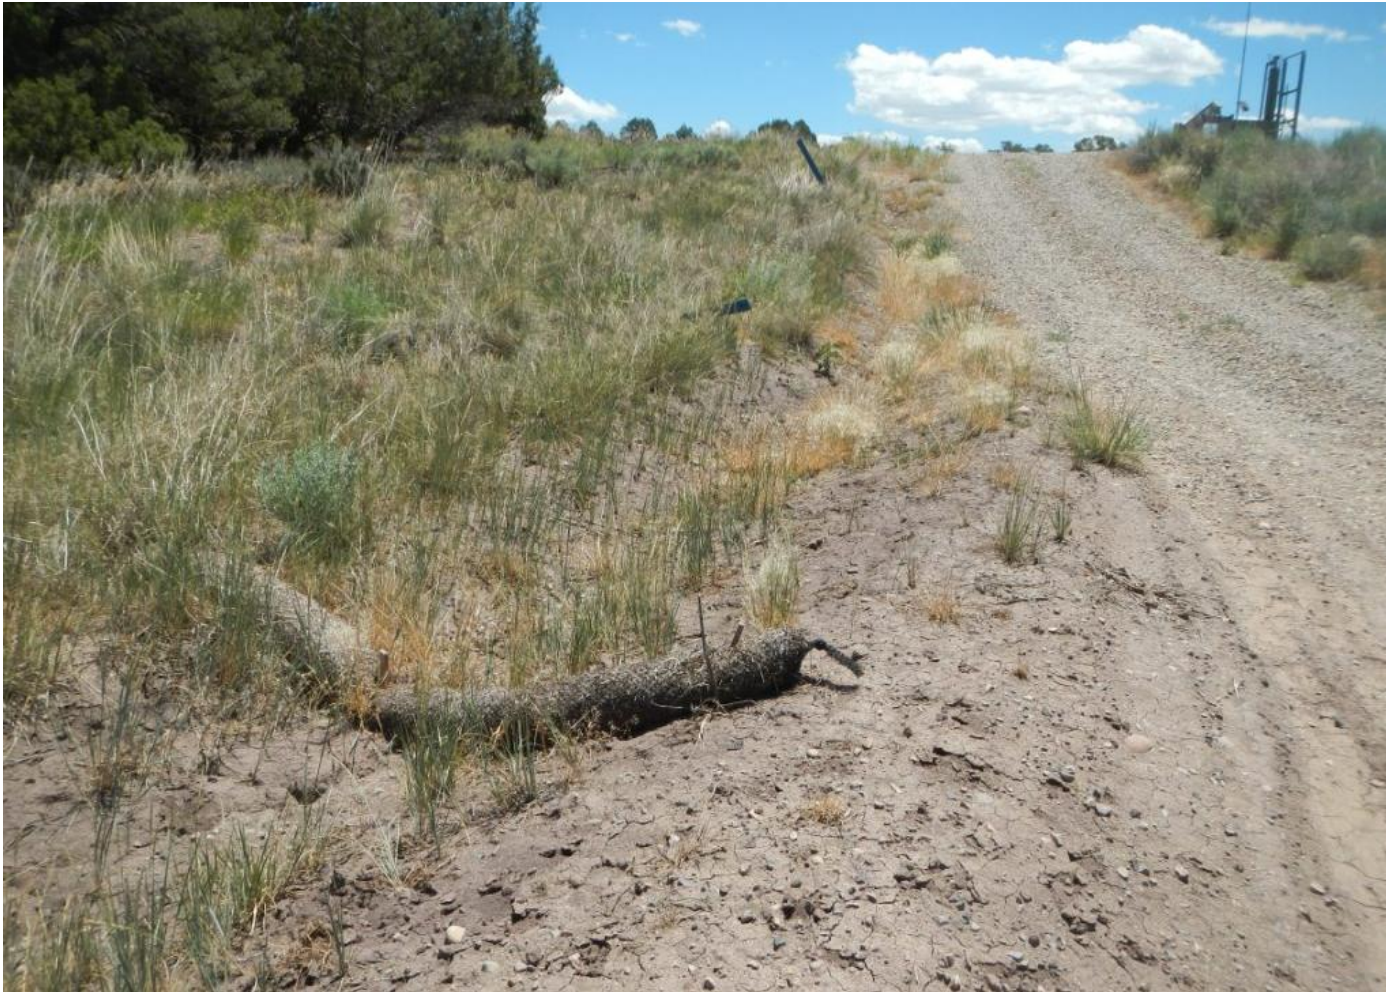
Photo 1. View of the access road to the well pad facing upslope from the well pad entrance. Revegetation appears to be helping to stabilize slope. Wattles here are in acceptable condition.

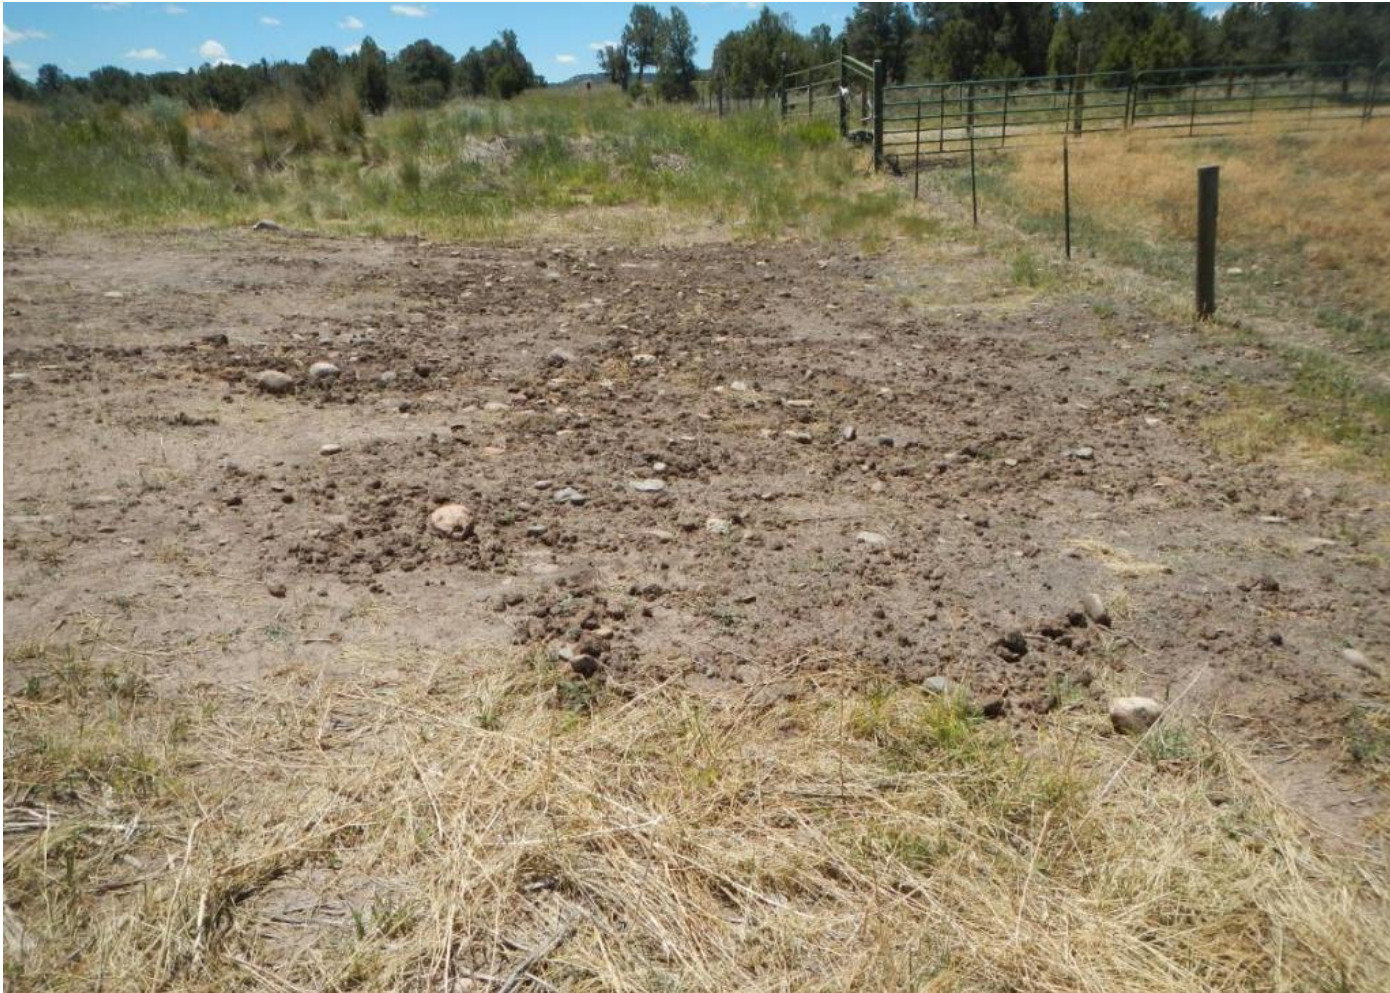
Photo 2. View of area of recent flowline disturbance. This needs to be seeded mulched.

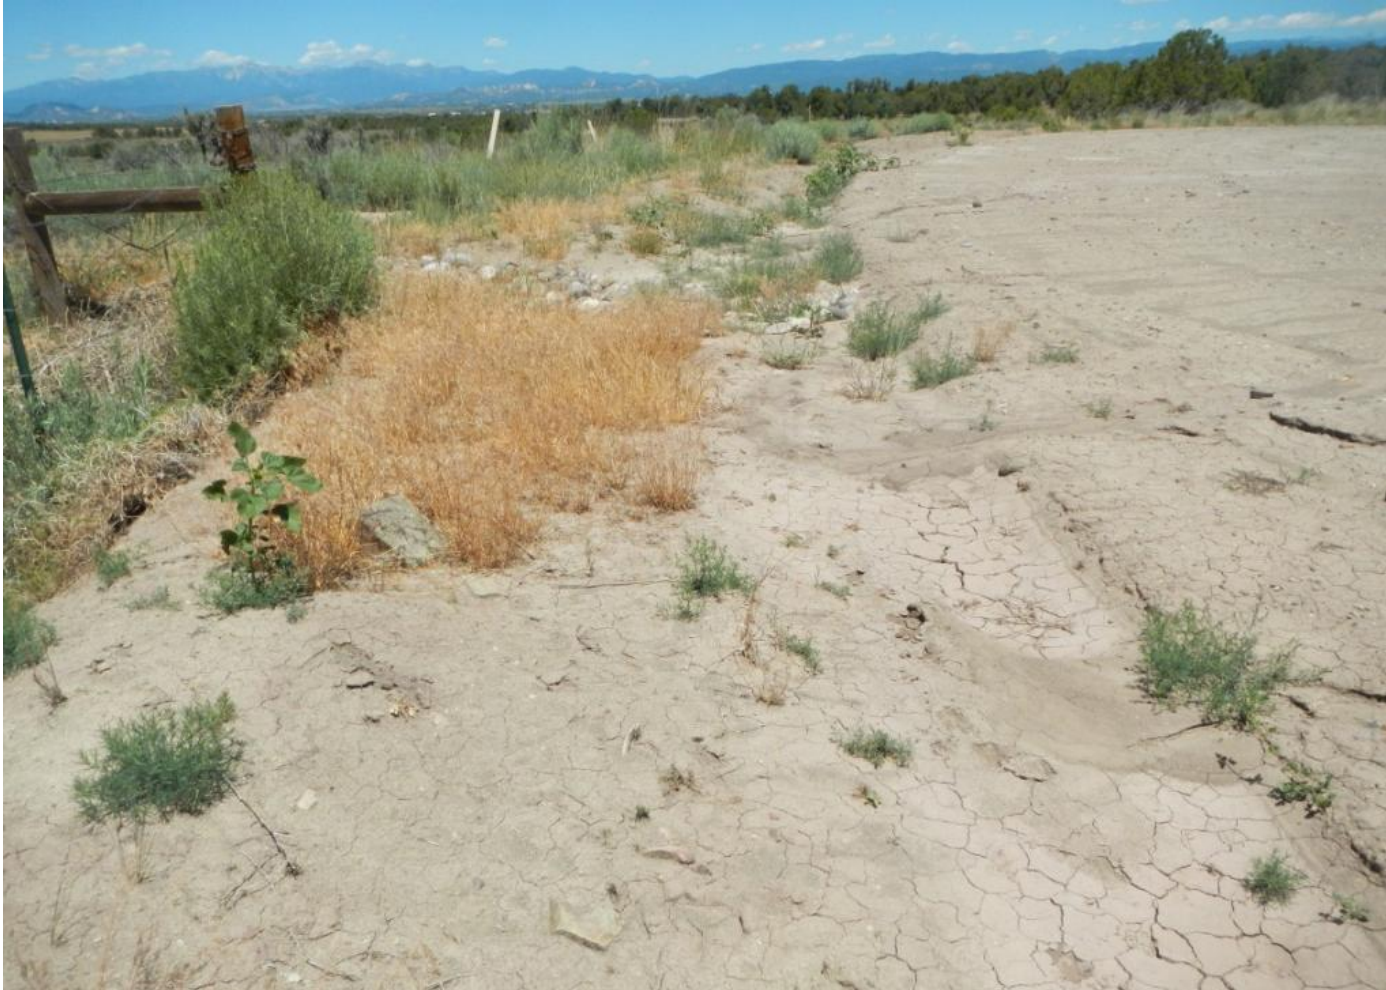
Photo 3. View of the western edge of the project area. Diversion ditch is full of sediment and needs to be cleaned. Erosion from well pad surface is depositing sediment in diversion, as evidenced by erosional channels on the well pad surface and sediment plumes where it settles in diversion channel. Well pad surface needs erosion controls such as gravelling.

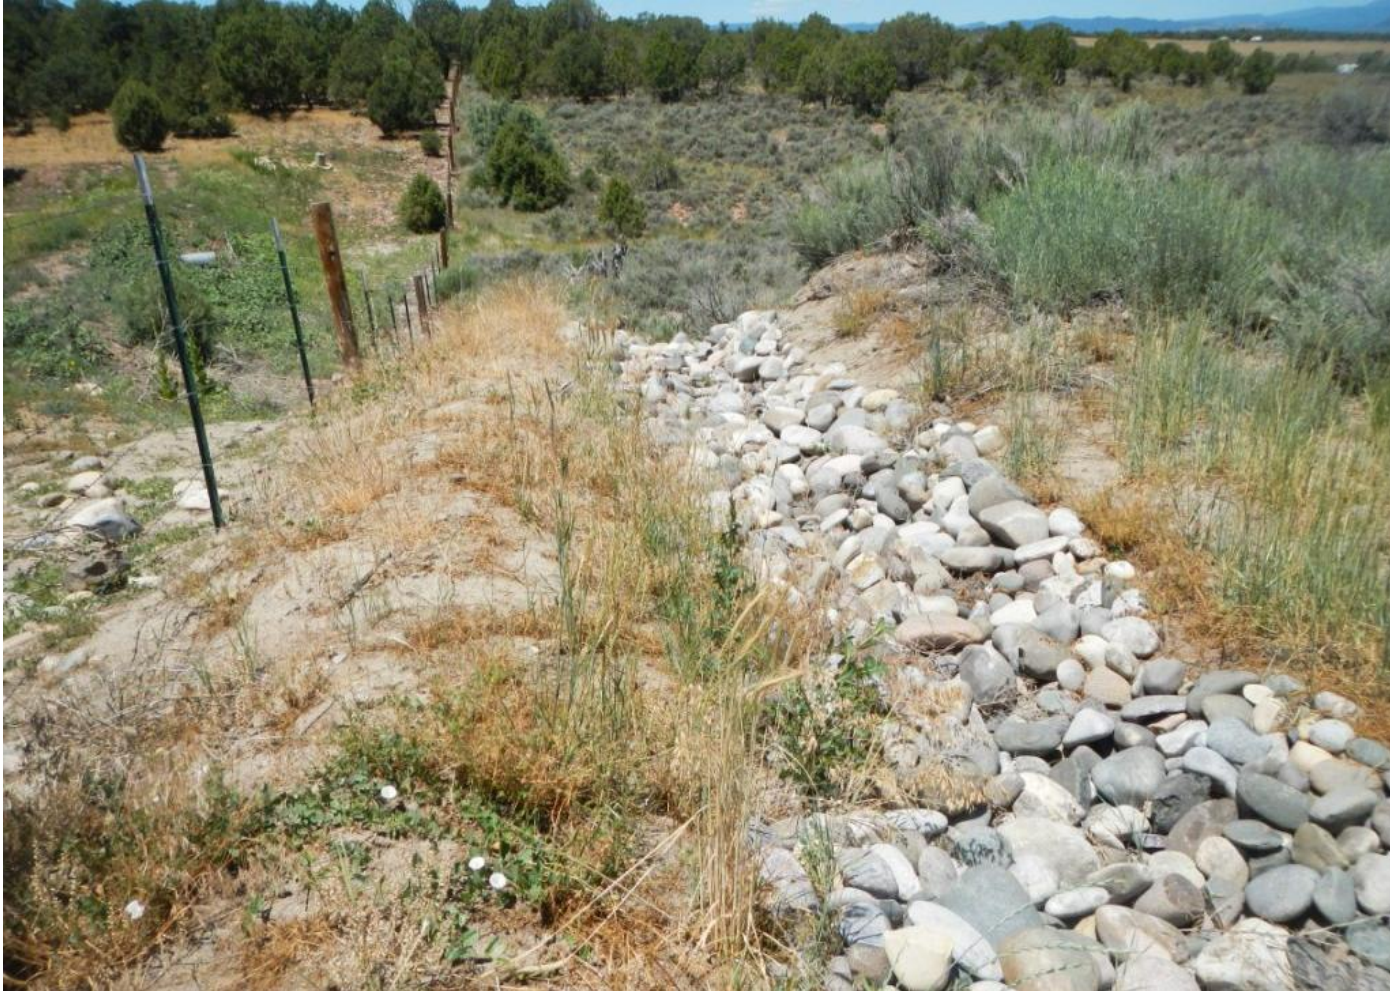
Photo 4. View of cobble run-down in the western portion of the project area appears to be functioning.

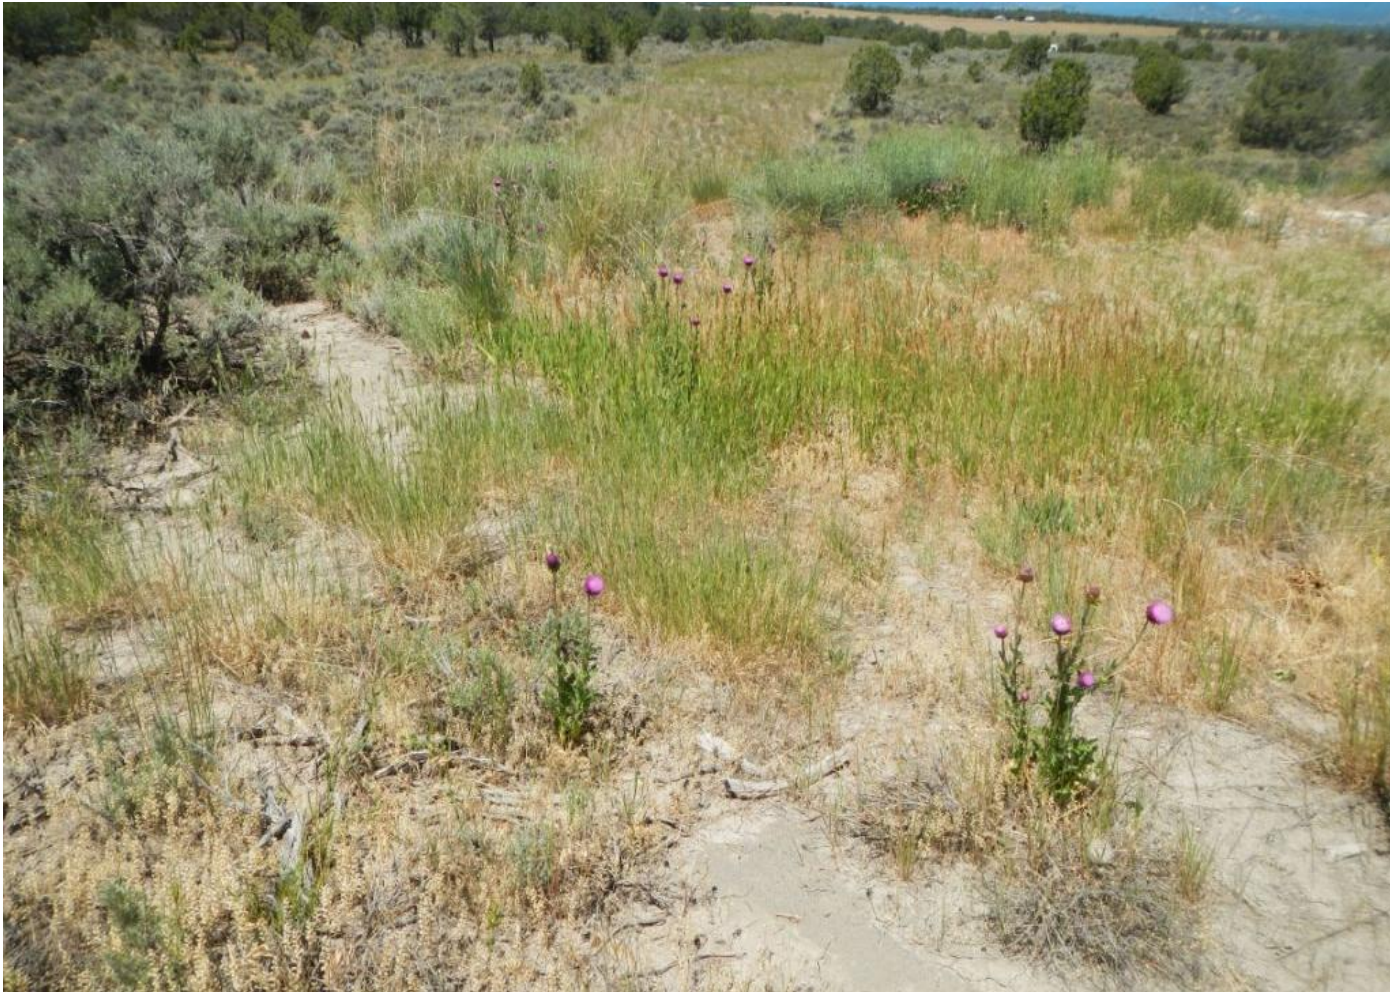
Photo 5. View of blooming musk thistles (*Carduus nutans*) in the northern portion of the project area.

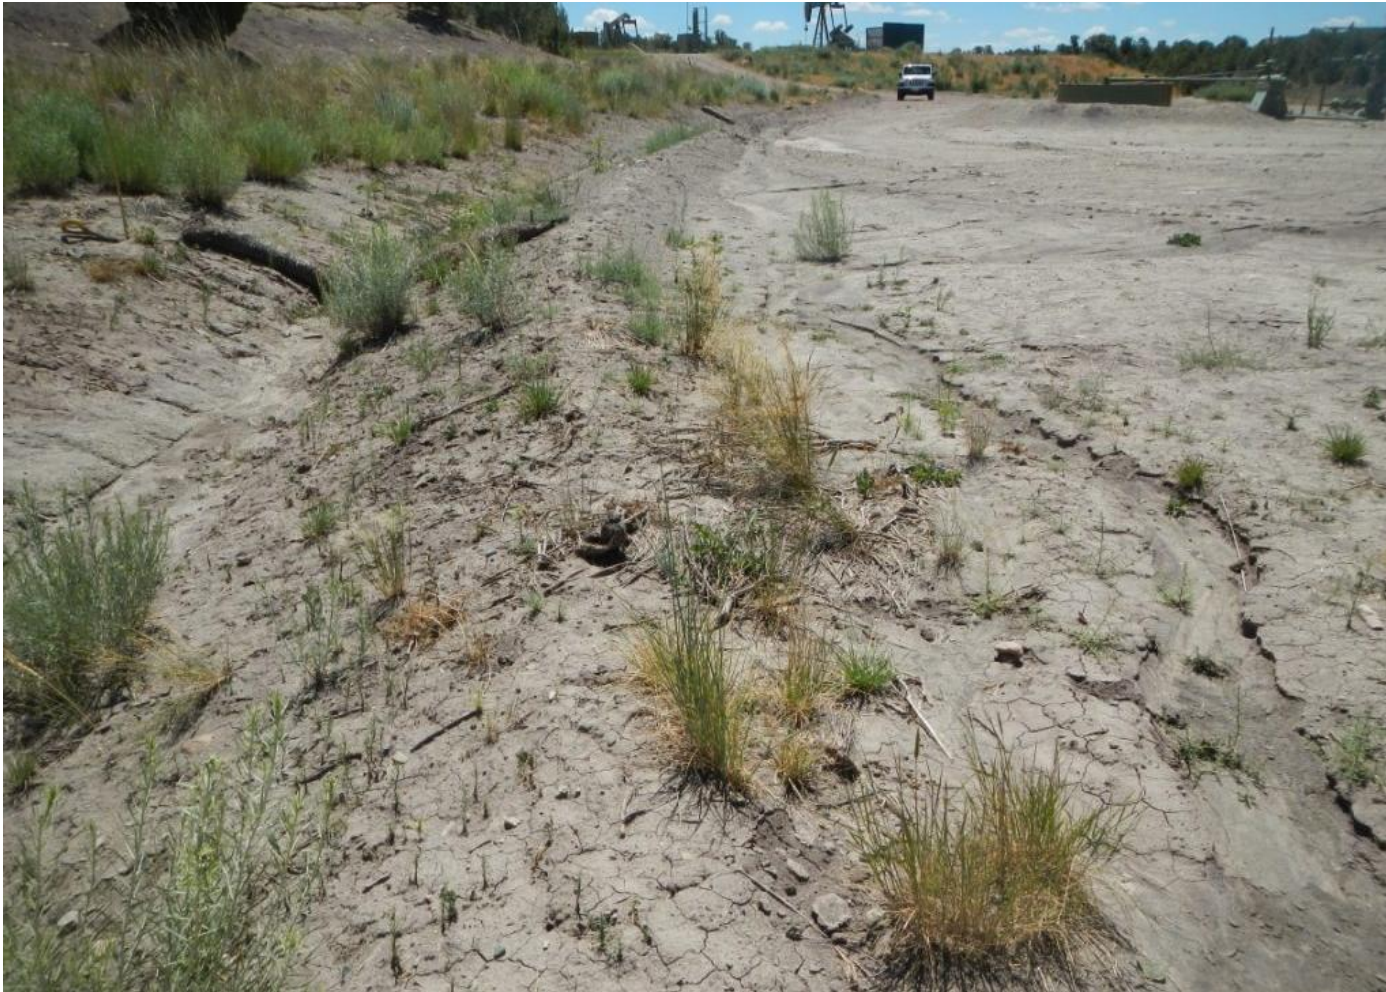
Photo 6. View of eastern edge of the well pad working area from the northeastern corner facing southward. Stormwater flows on the well pad surface is resulting in channeling on the well pad (right hand side of photo).
