July 7, 2016

Inspection Photos: LINN Loc#335568

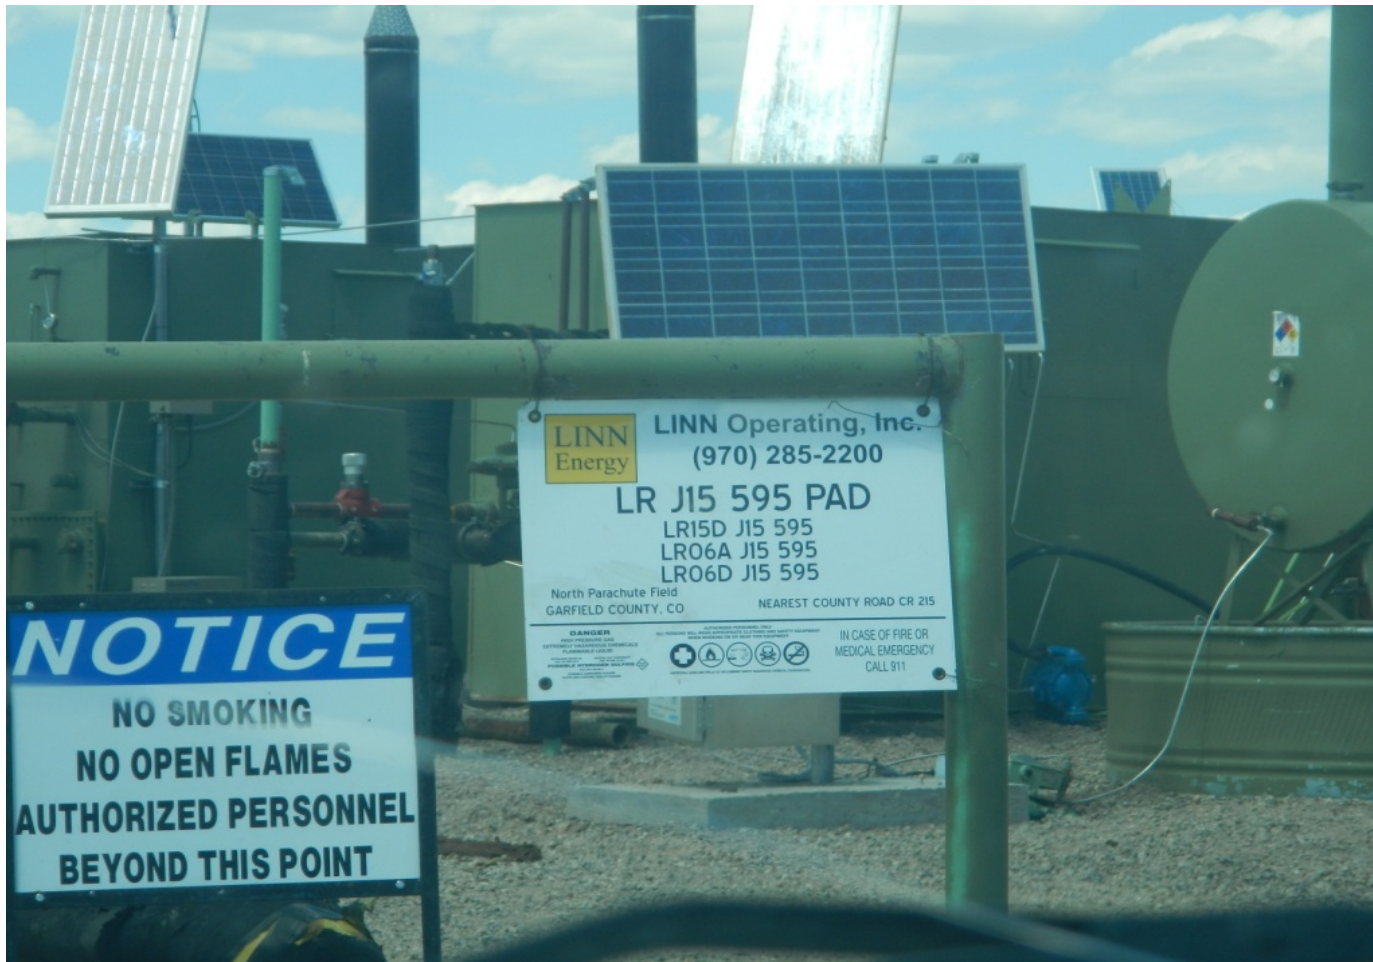
**Photo#1: Location Signs**

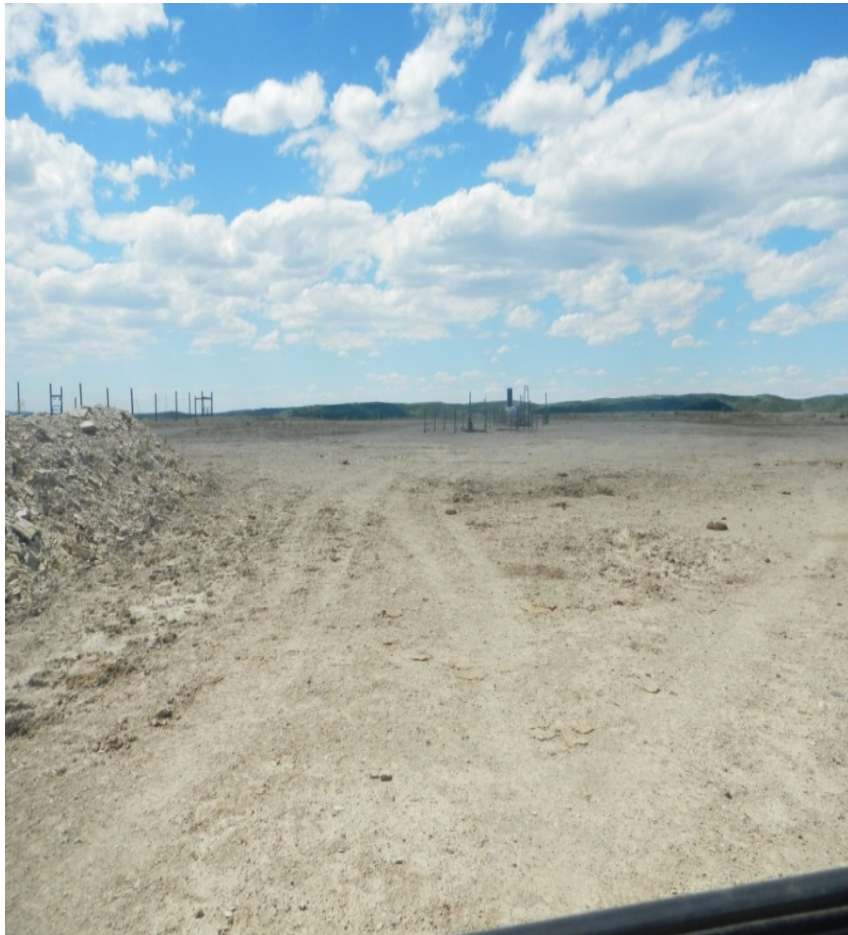
**Photo#2: Overview of location from Entry to West**

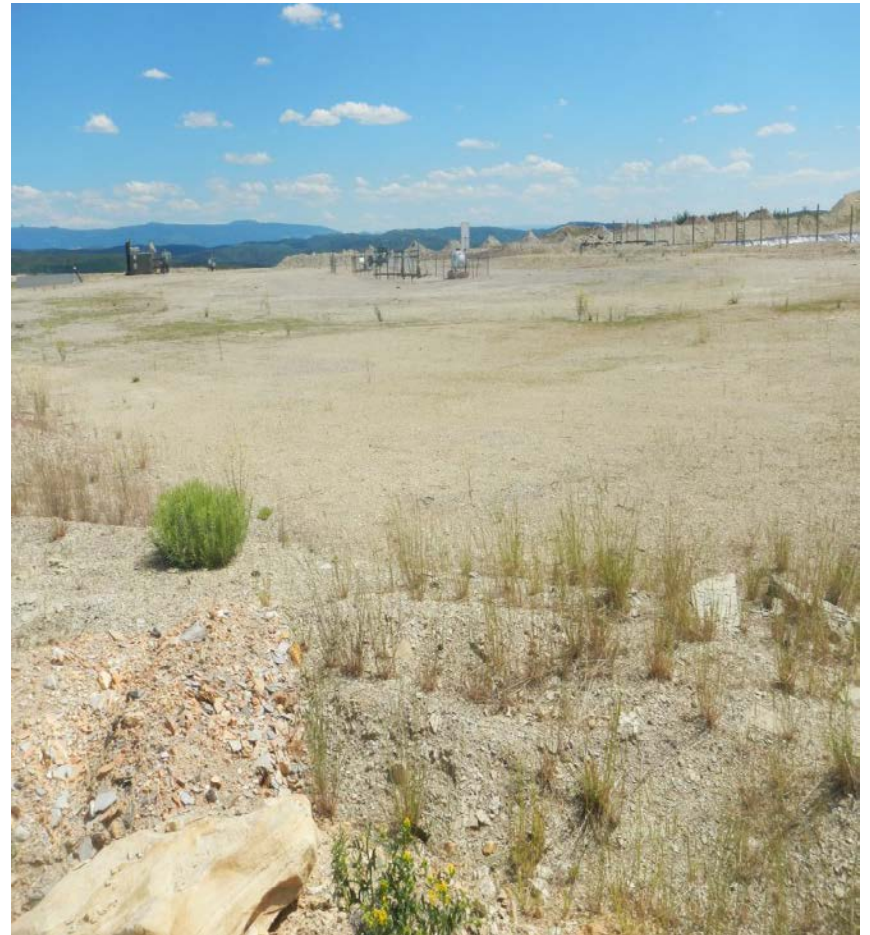
**Photo#3: Overview of Location to East**

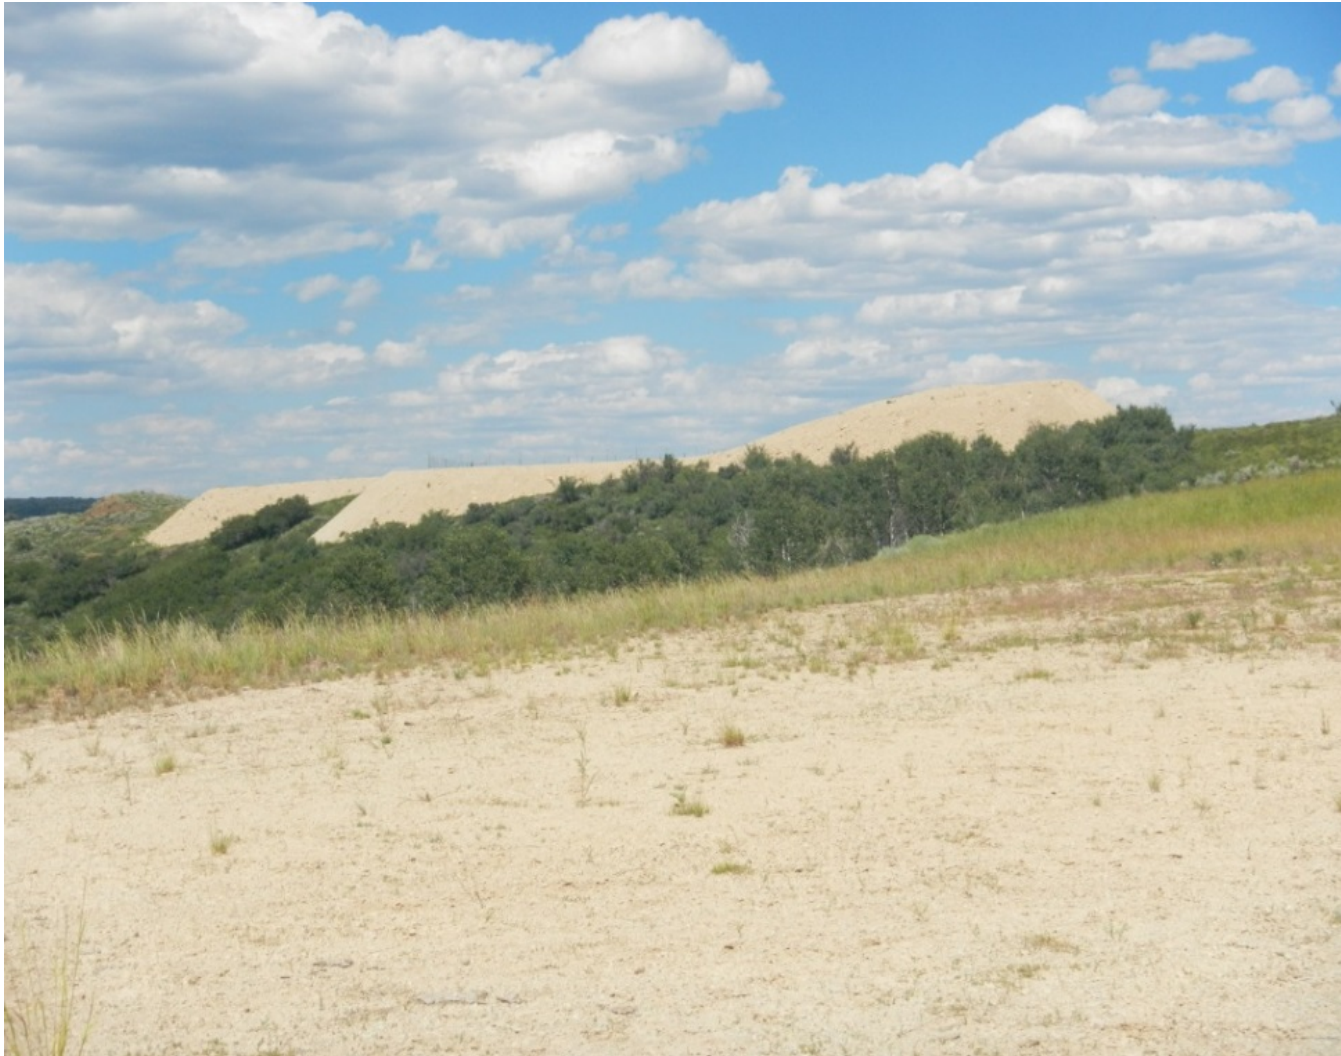
**Photo#4: View of Location disturbance from adjacent Pad to SW**

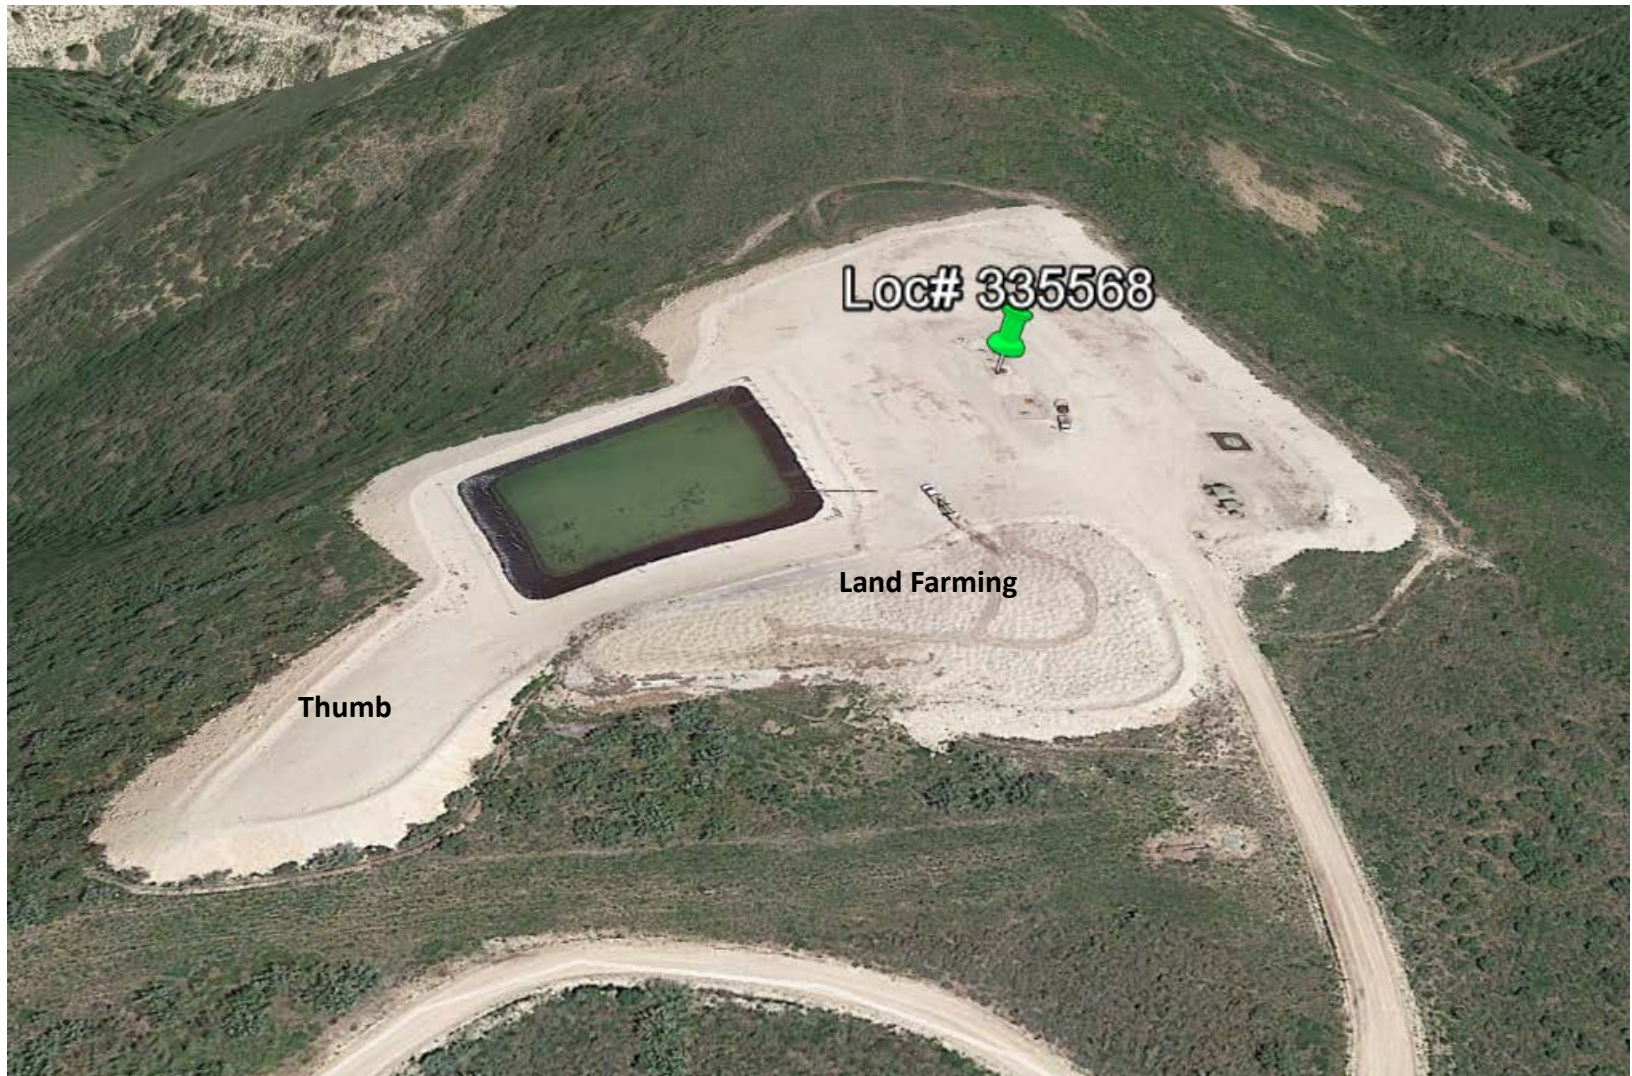
**Photo#5: Aerial View of Location**

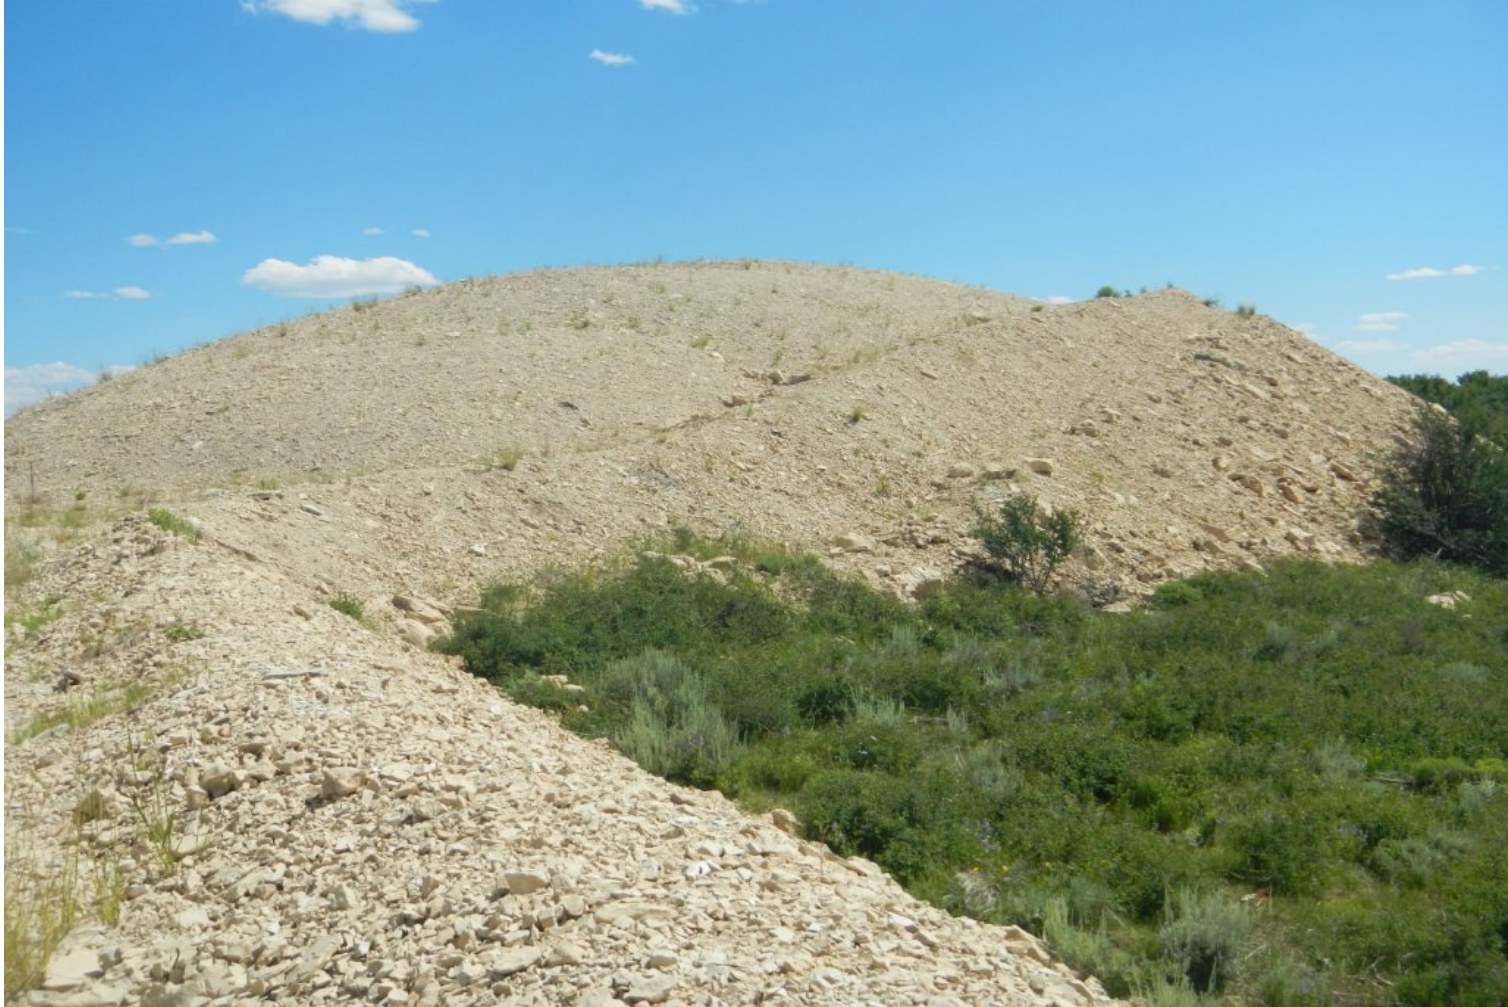
**Photo#6: Large Thumb of Rocky Material extends SW out of Location. Fill Material / Pit or Land Farm excavation Material? Where From & What?**

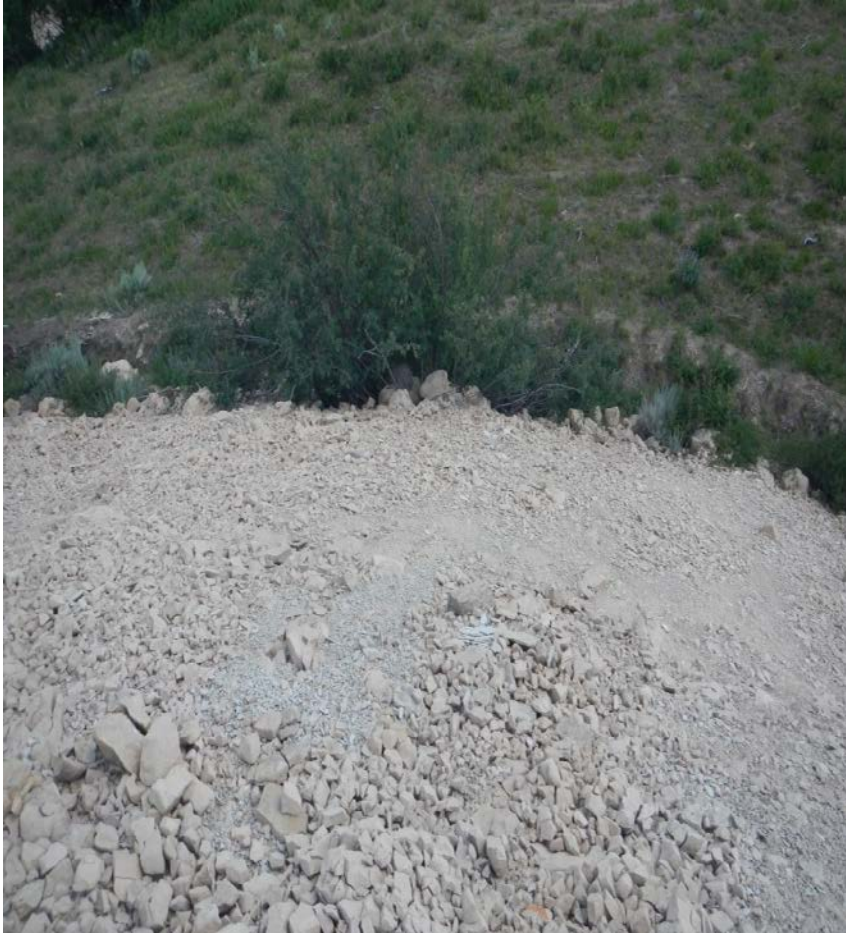
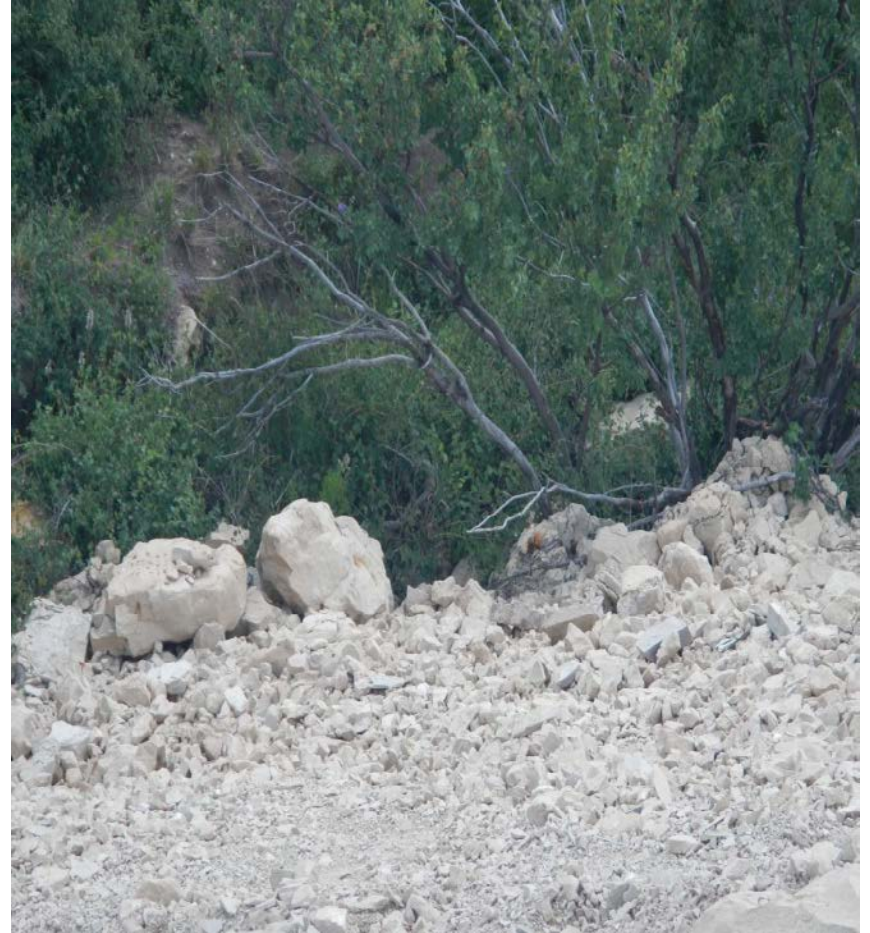
**Rocky, loose Fill Slope Material migrating, rattling down to overwhelm Native vegetation and SW BMPs**

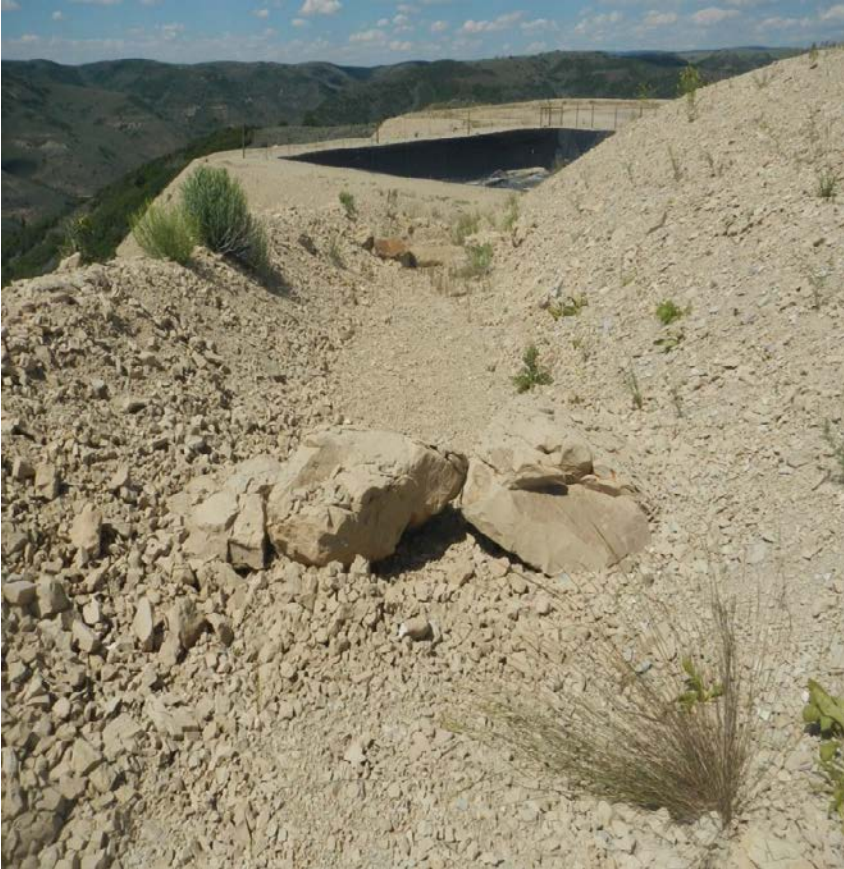
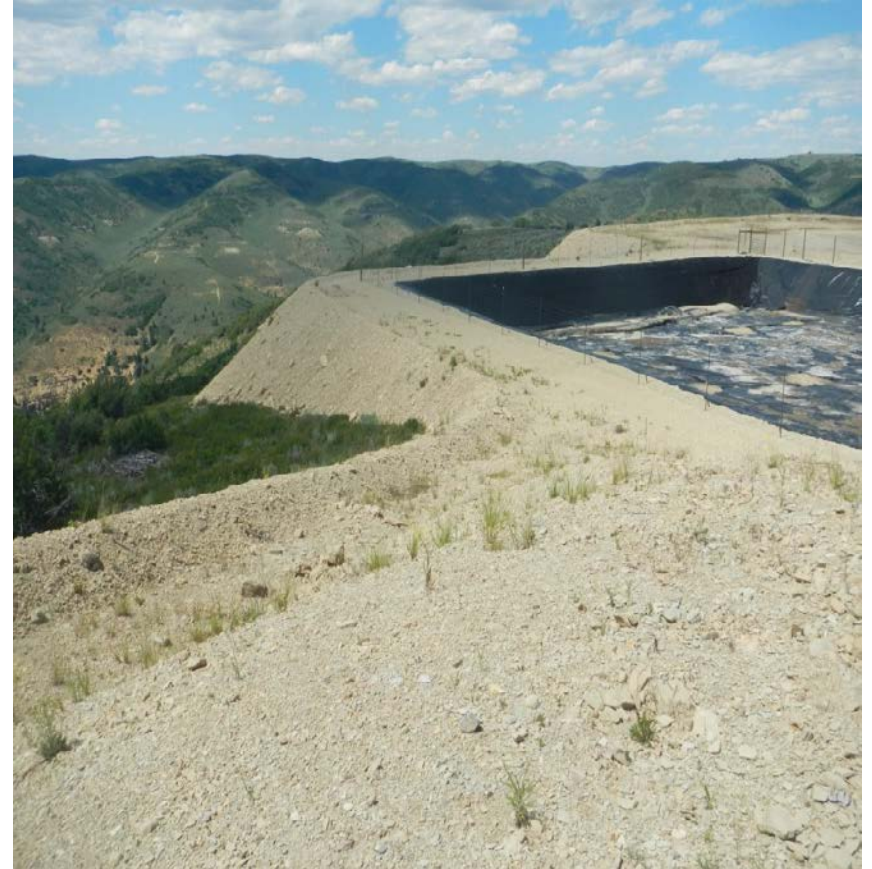
**Berms, Slopes, Ditches are not Stabilized or adequately revegetating.**

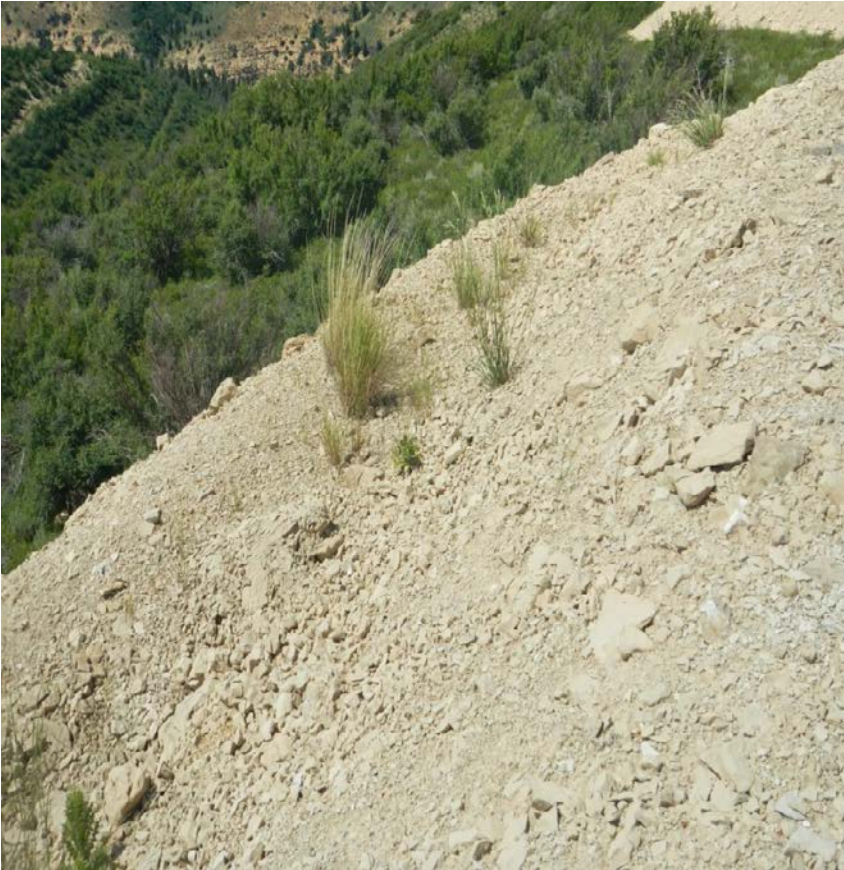
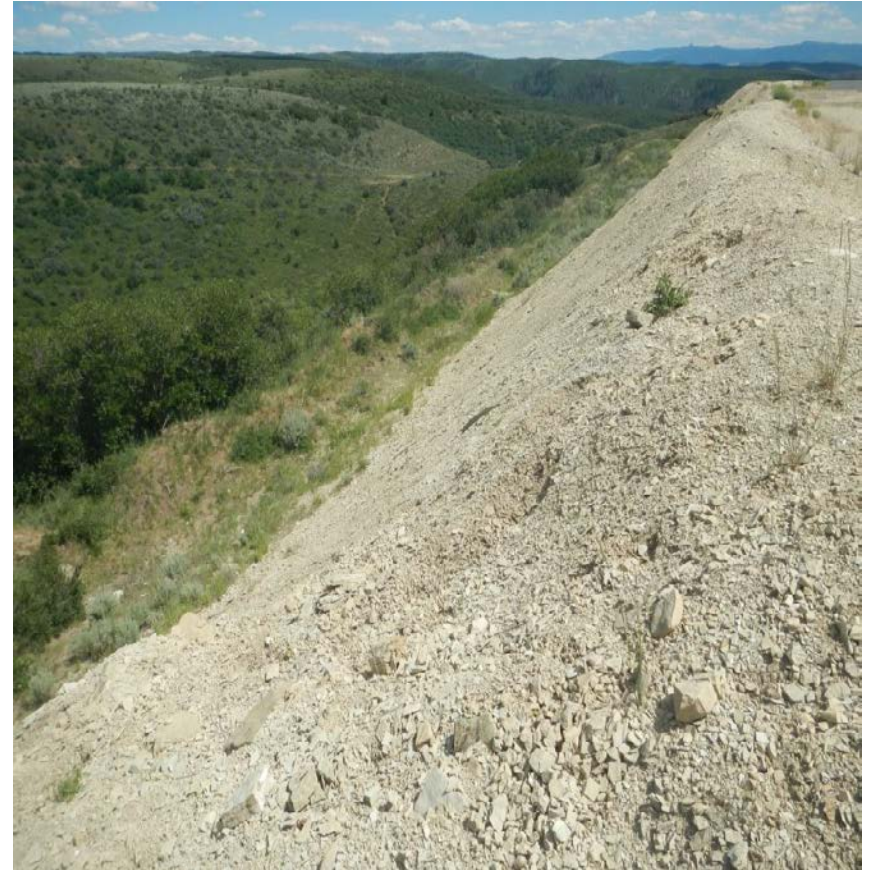
**Berms, Slopes, Benches are not Stabilized or adequately revegetating.**

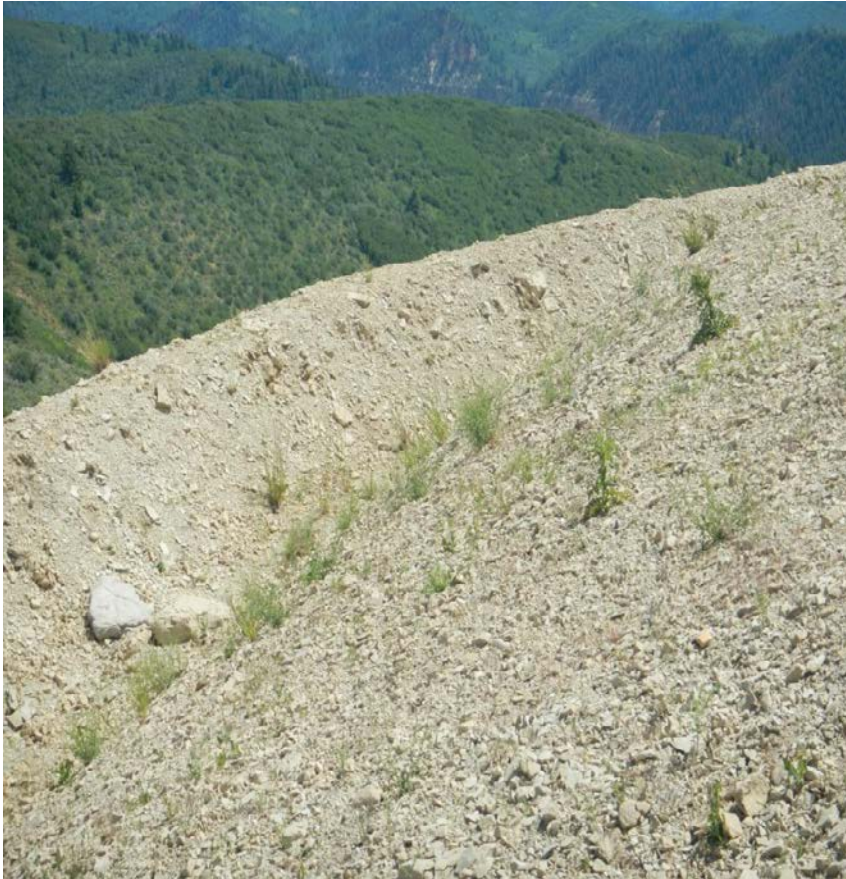
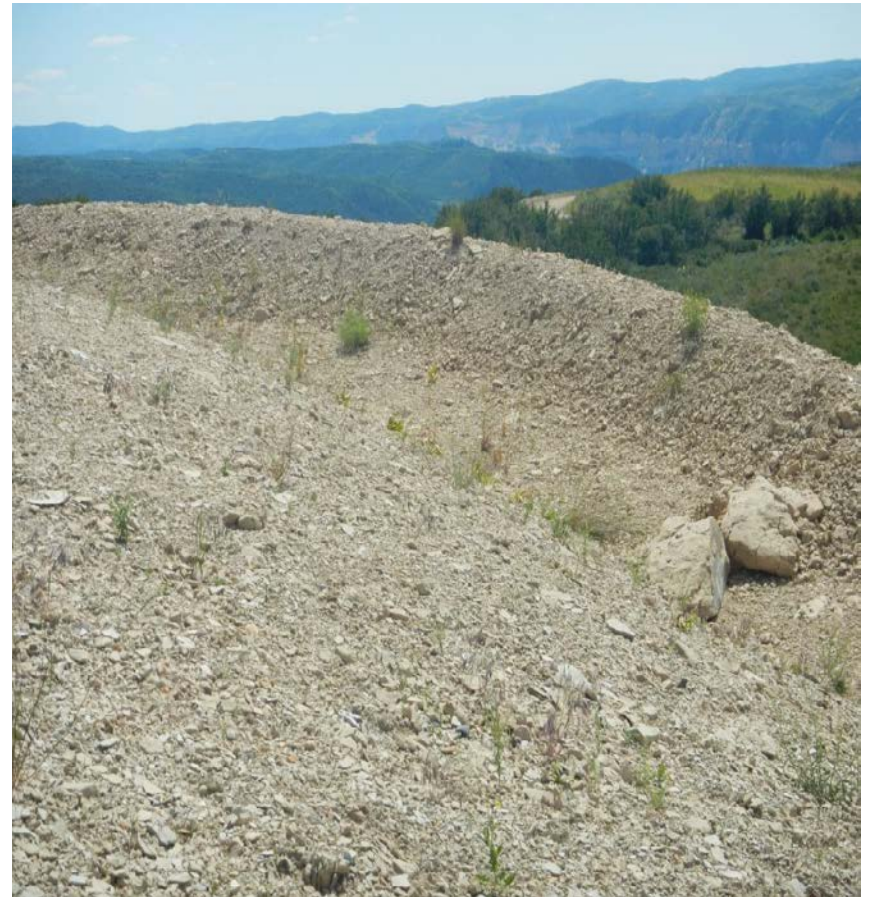
**Berm running along top of Thumb; view at point of Thumb at SW end.**

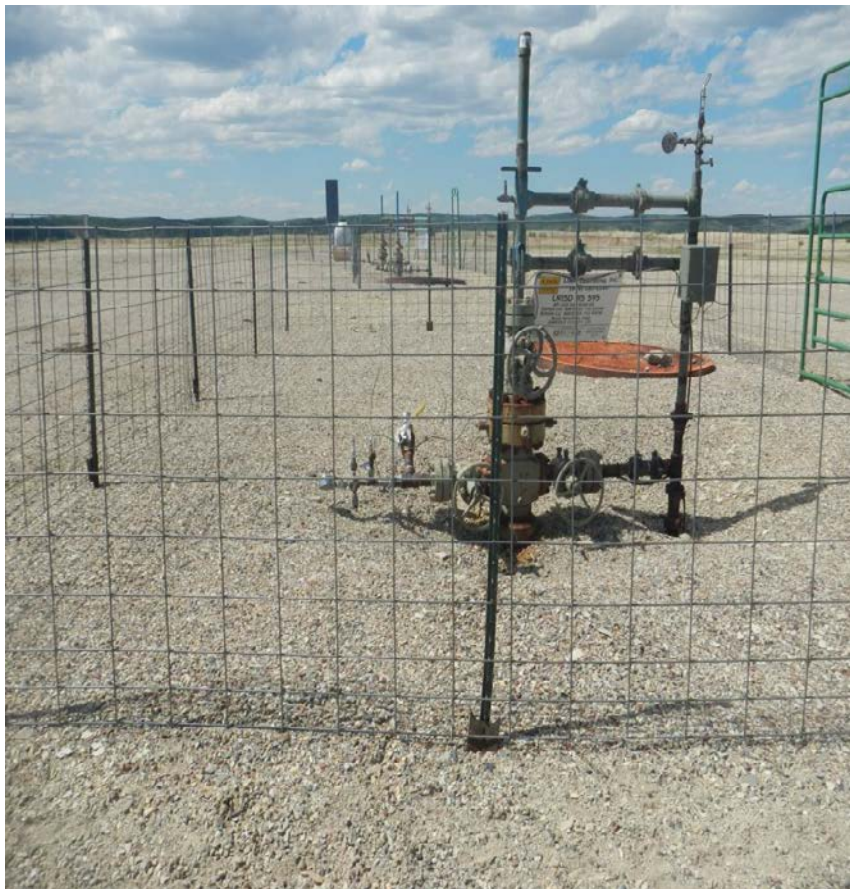
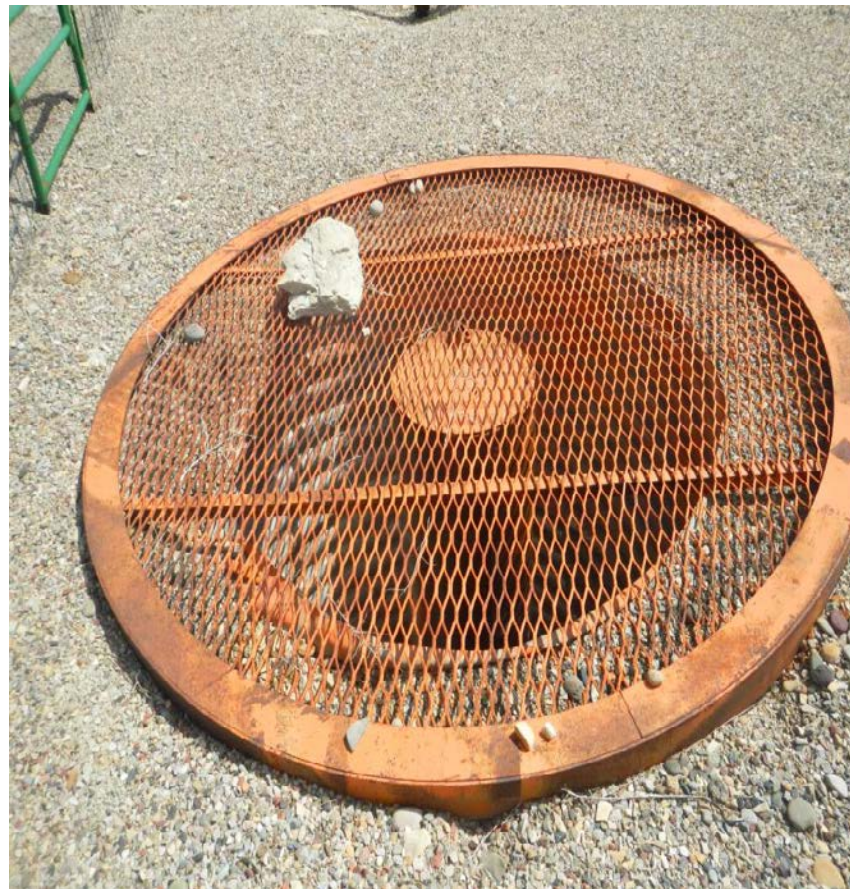
**View of Well Corral, 3 PR Wells and Two Conductors Set.**

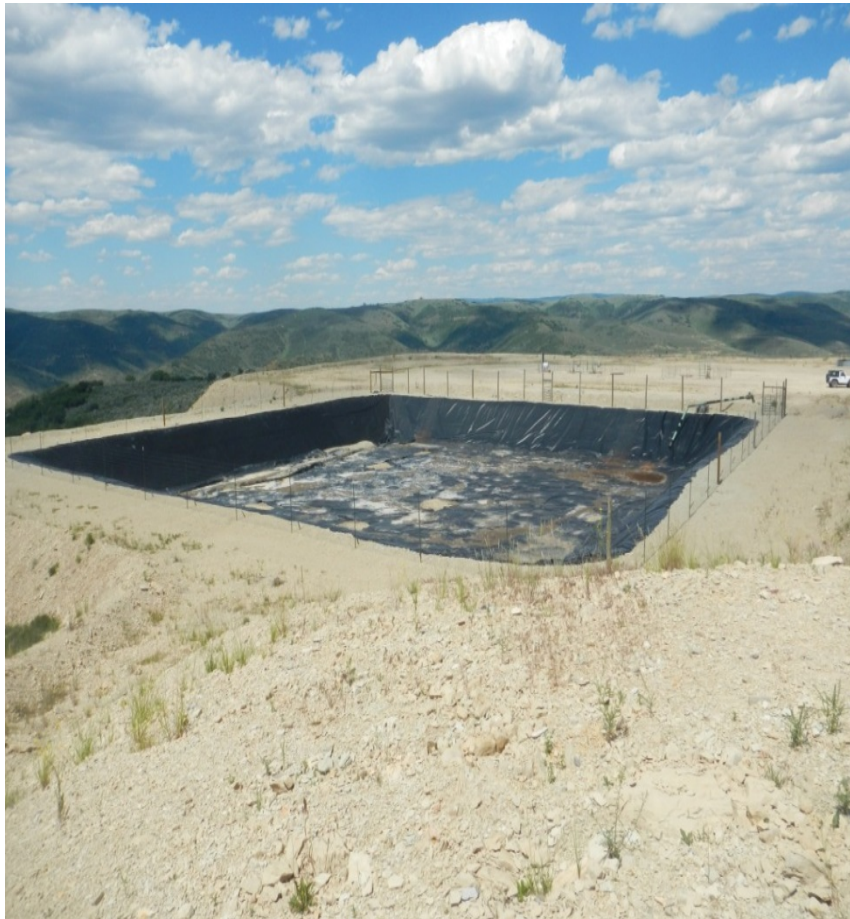
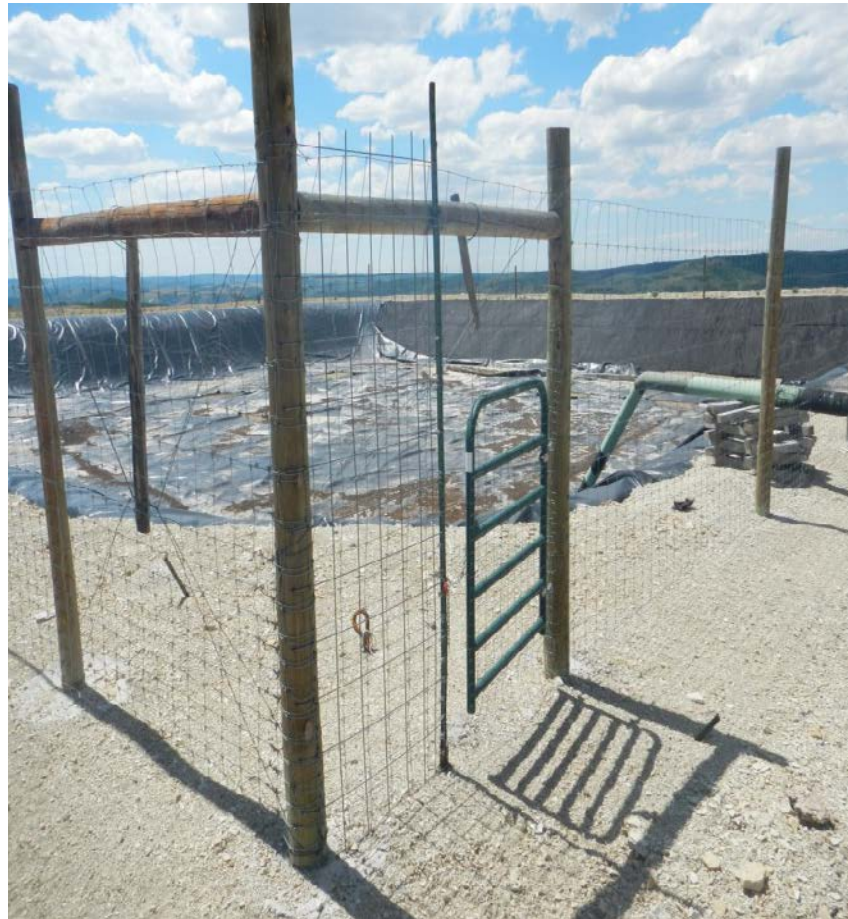
**Views of Pit Located at West side of Location.**

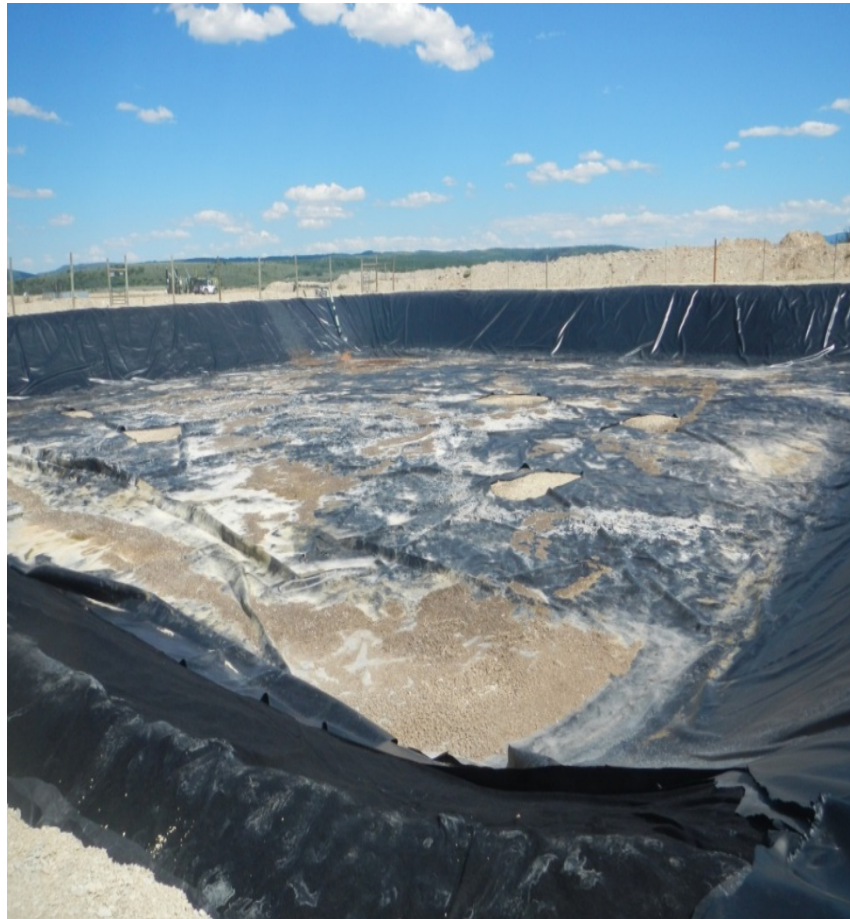
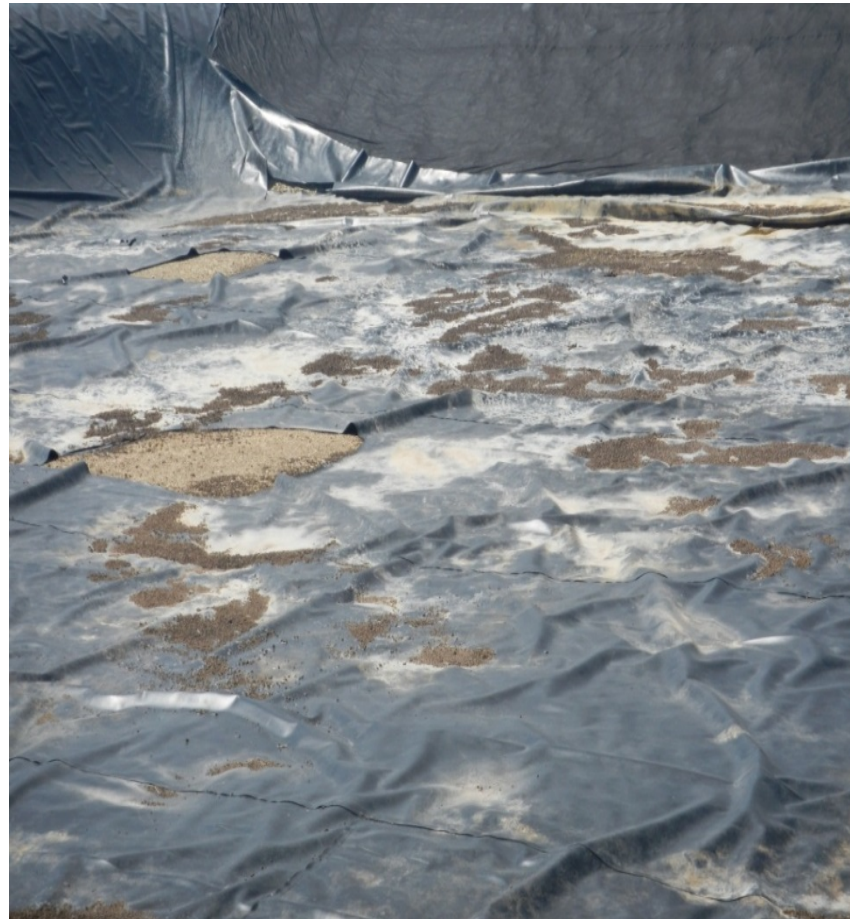
**Views of Pit Located at West side of Location.**

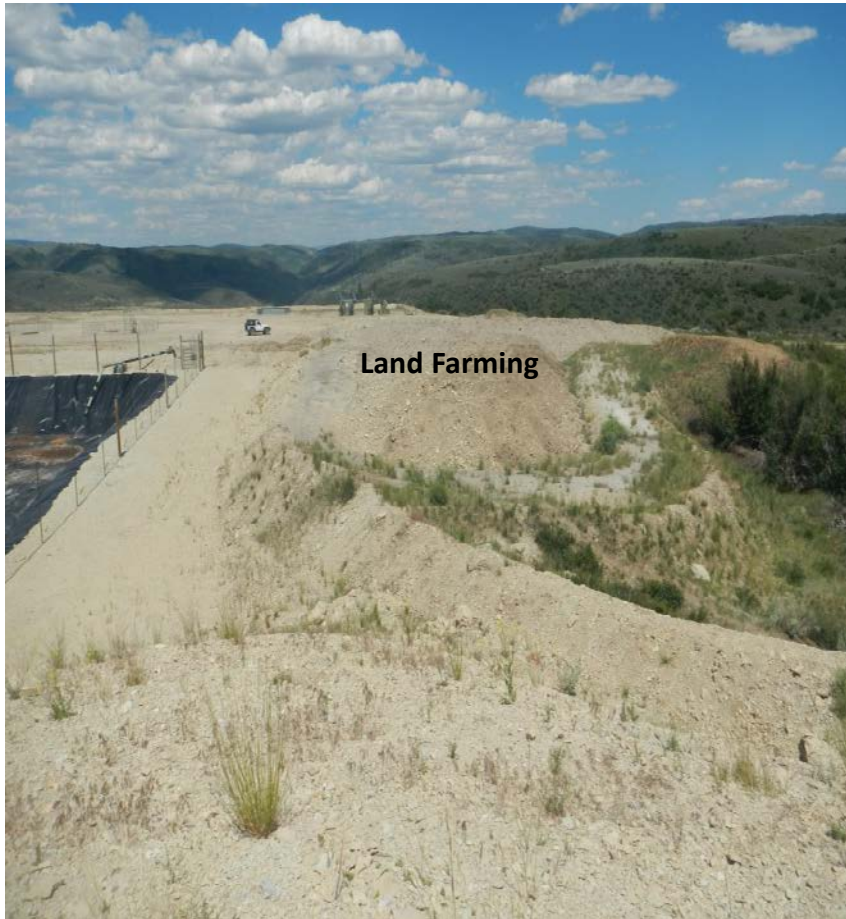
**Looking back at Land Farming Site  
as advancing up Thumb**

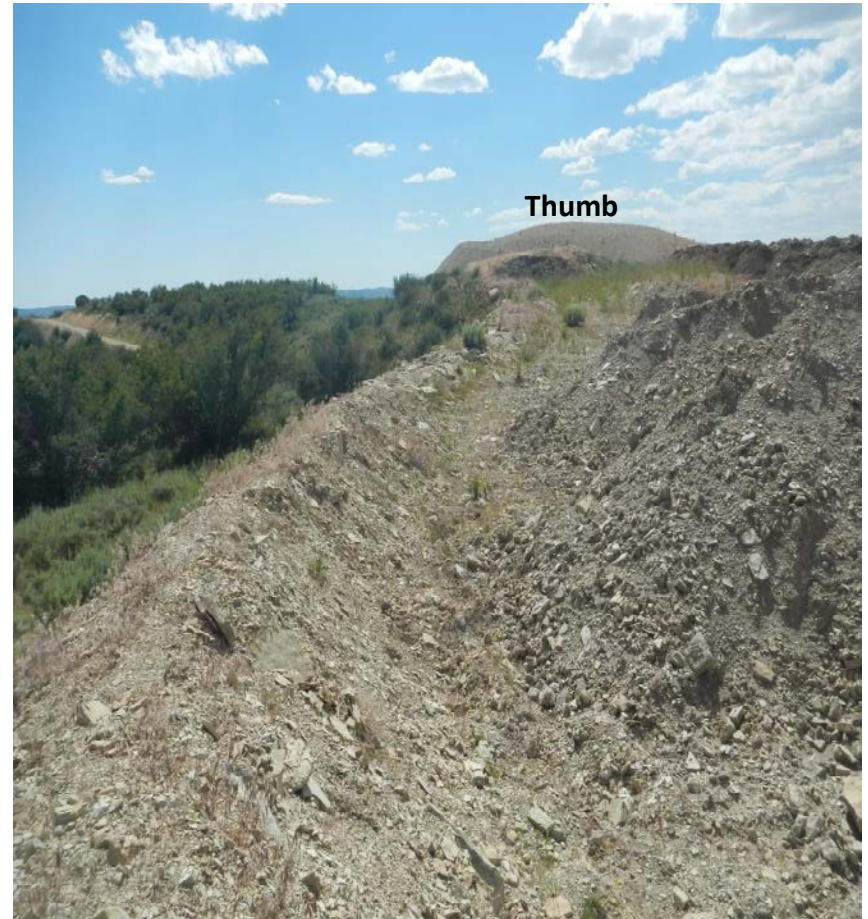
**View SW from outside Berm of Land Farming Site to Thumb.**

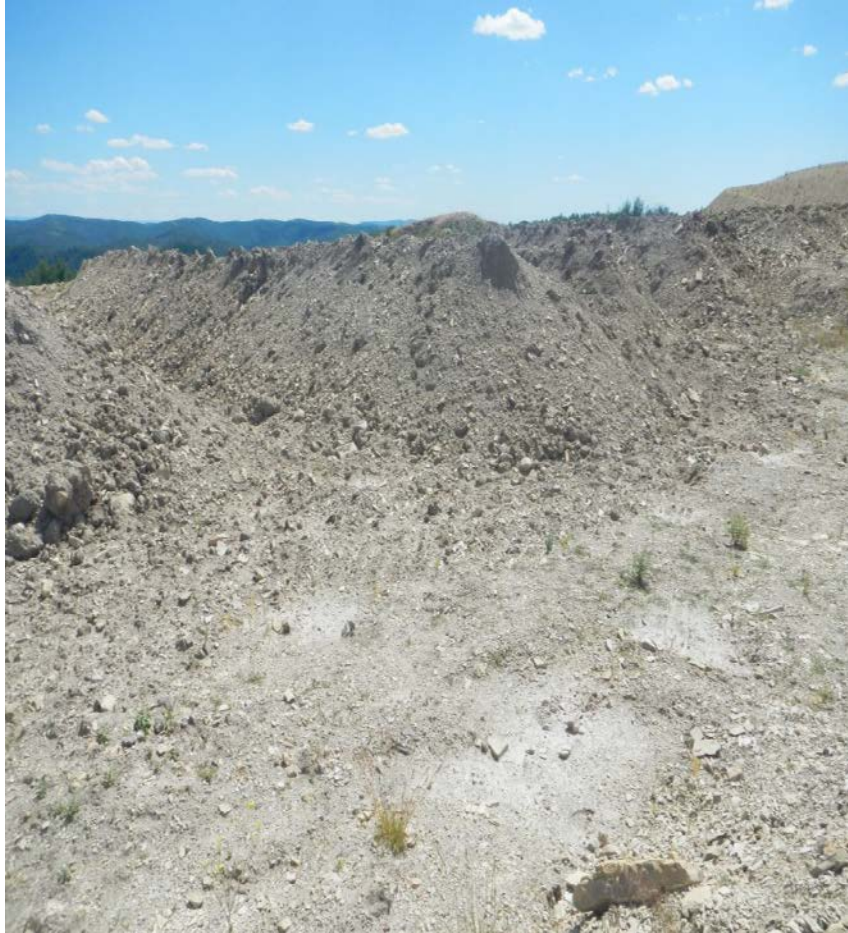
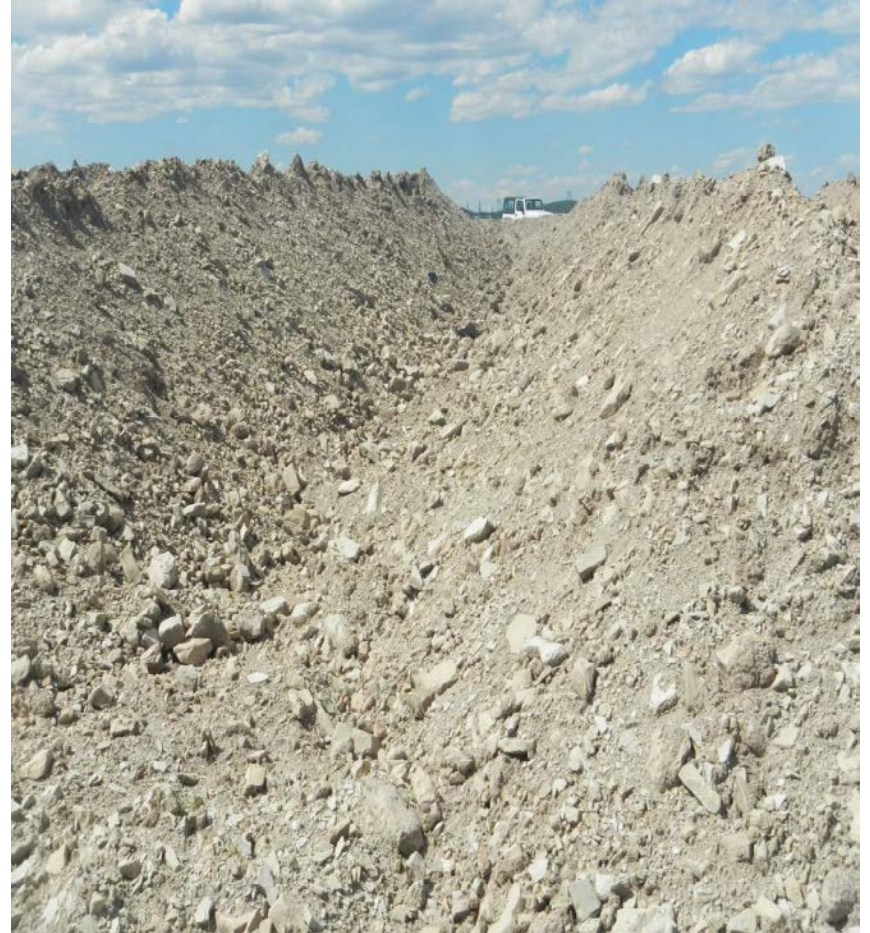
**Views of Land Farming Windrows.**

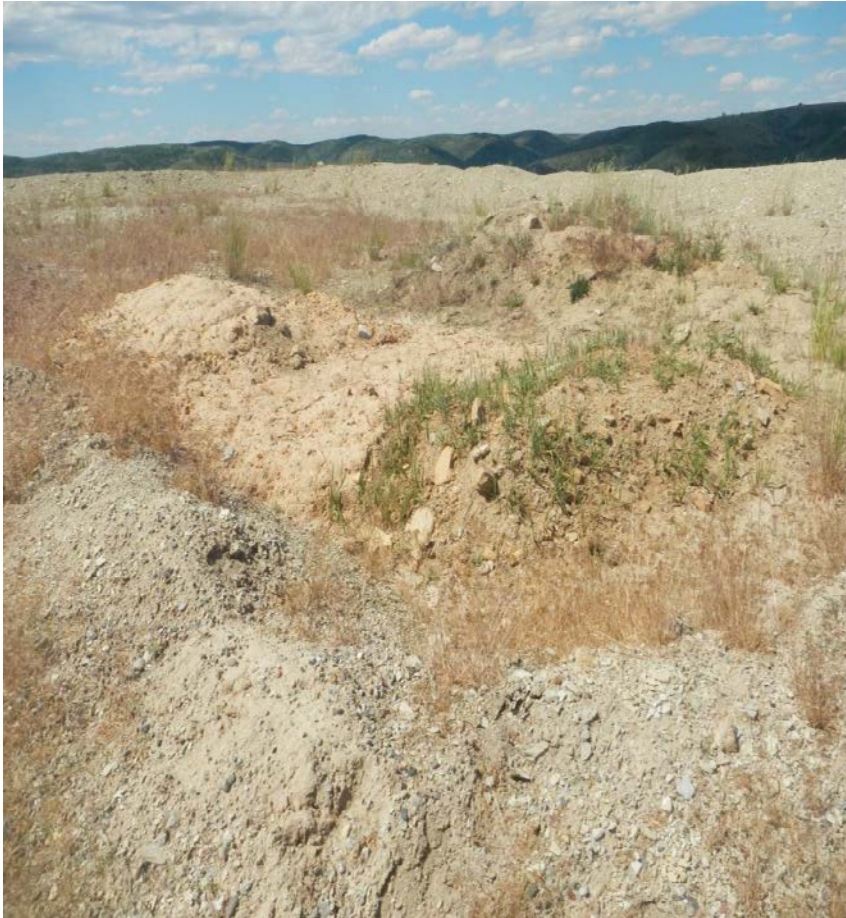
**Bermed Material at North side of Location.**

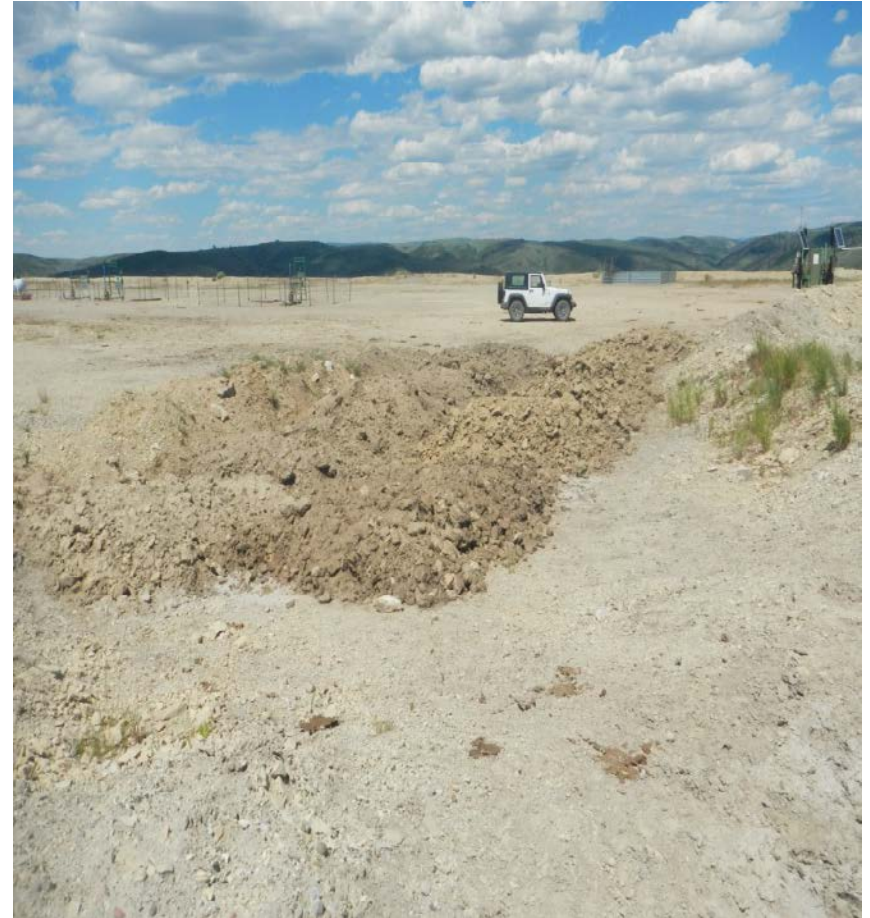
**Unknown Stock piles of Material**

**Material piled adjacent to Land Farming Site.**
