# Final Reclamation Inspection

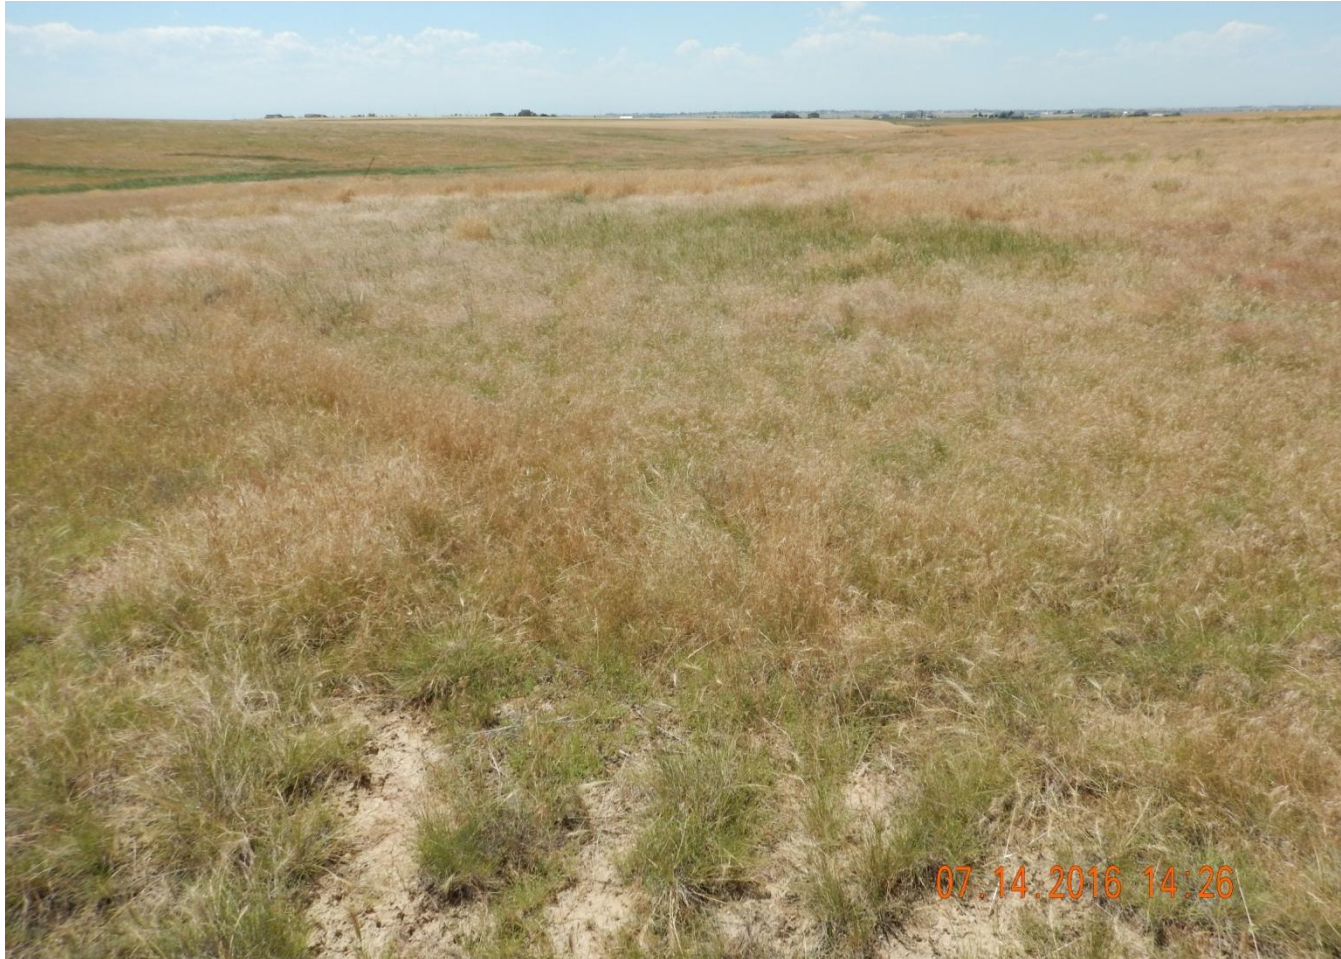
**Photo 1.** Photo taken from center of location, facing West. Vegetative growth appears to be reflective of reference areas. A number of native, perennial grass species were observed throughout location. However, location was not recontoured and 3 guy line anchors were left behind.

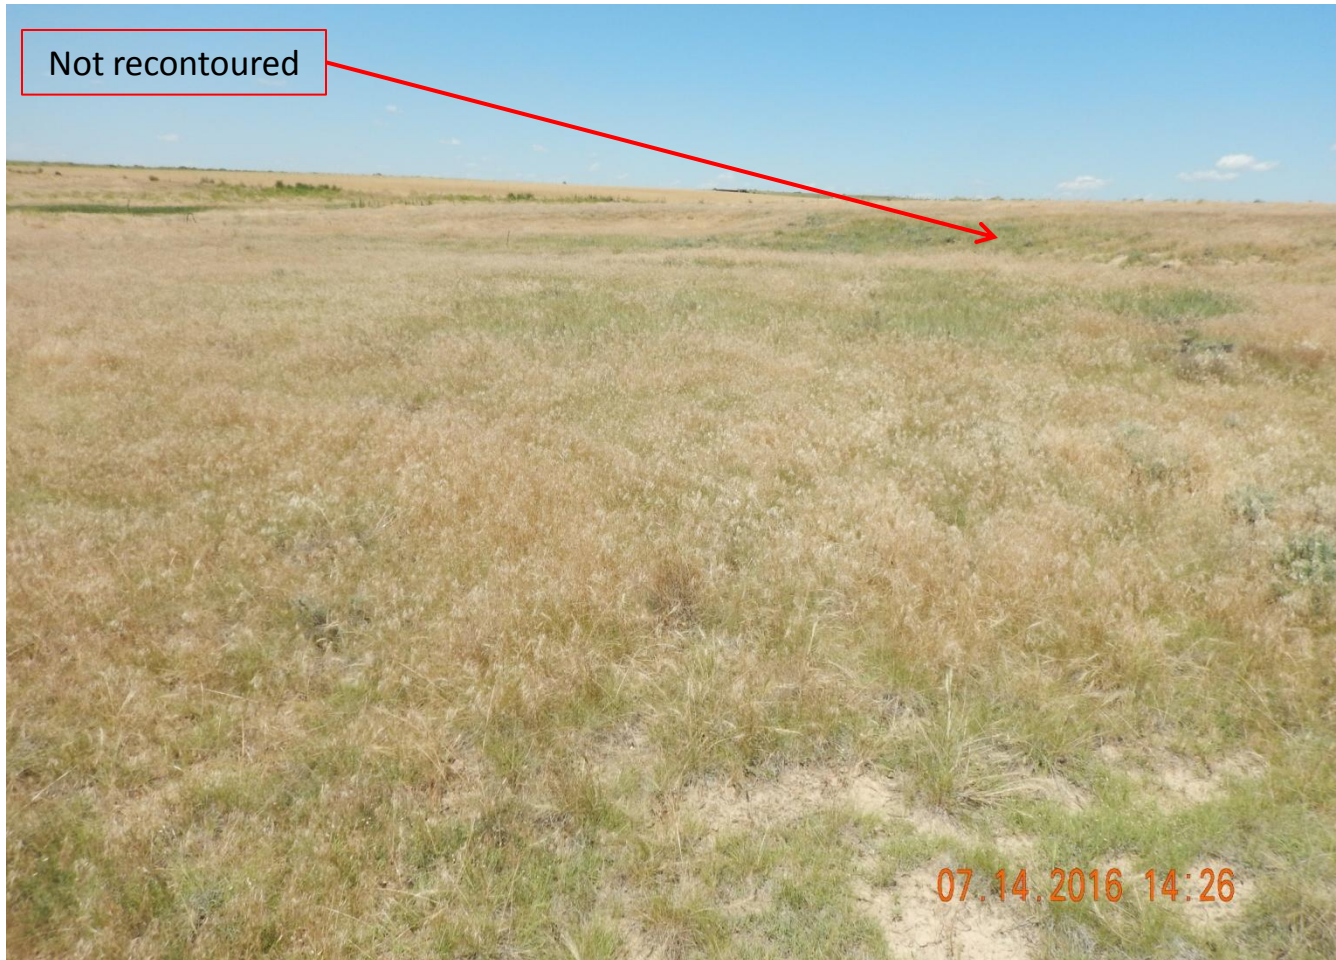
**Photo 2.** Photo taken from center of location, facing North. Vegetative growth appears to be reflective of reference areas. A number of native, perennial grass species were observed throughout location. However, location was not recontoured and 3 guy line anchors were left behind.

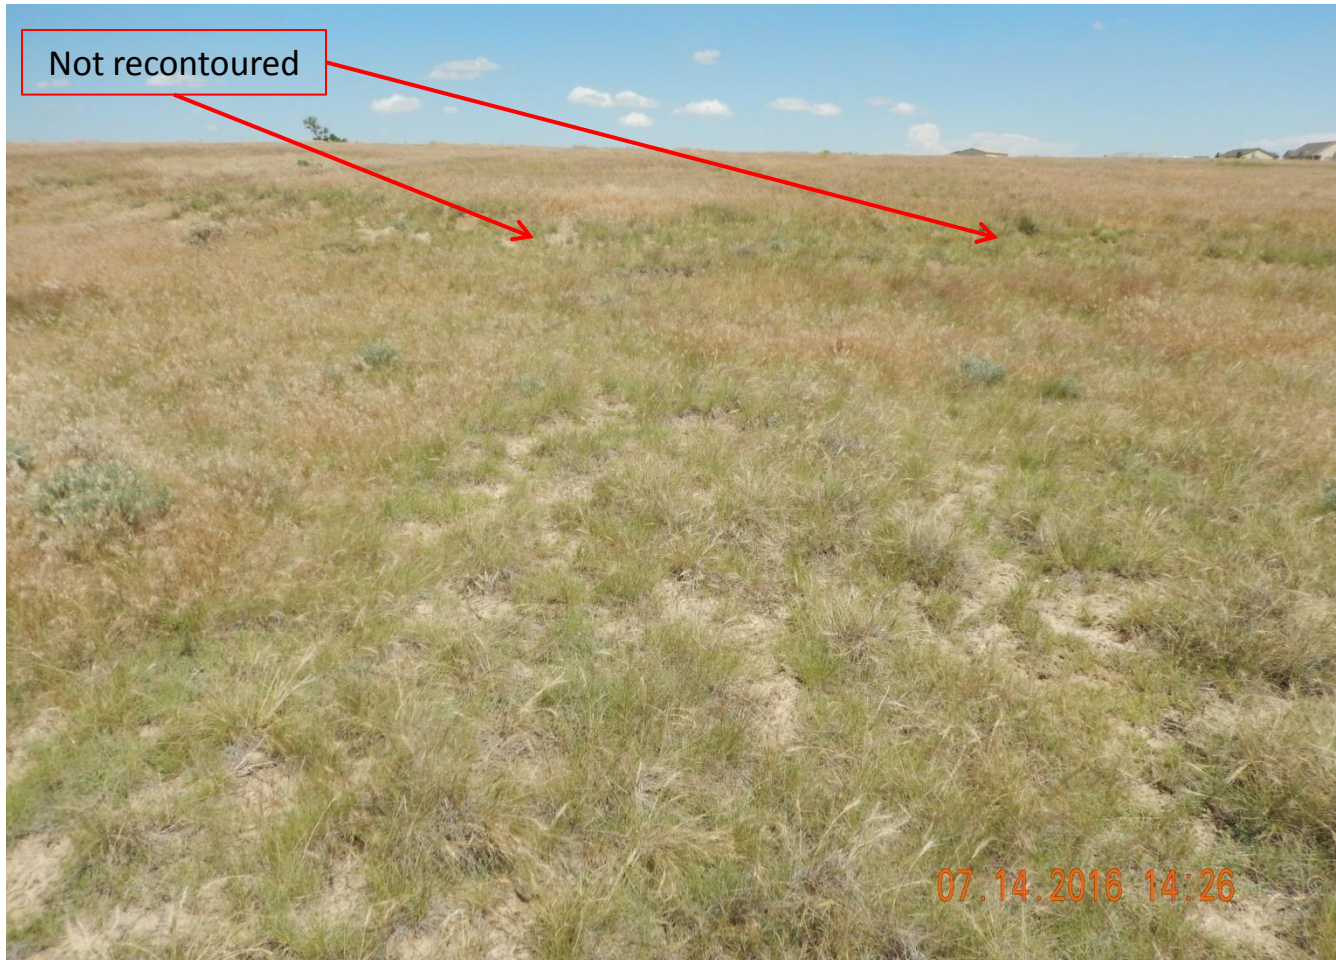
**Photo 3.** Photo taken from center of location, facing East. Vegetative growth appears to be reflective of reference areas. A number of native, perennial grass species were observed throughout location. However, location was not recontoured and 3 guy line anchors were left behind.

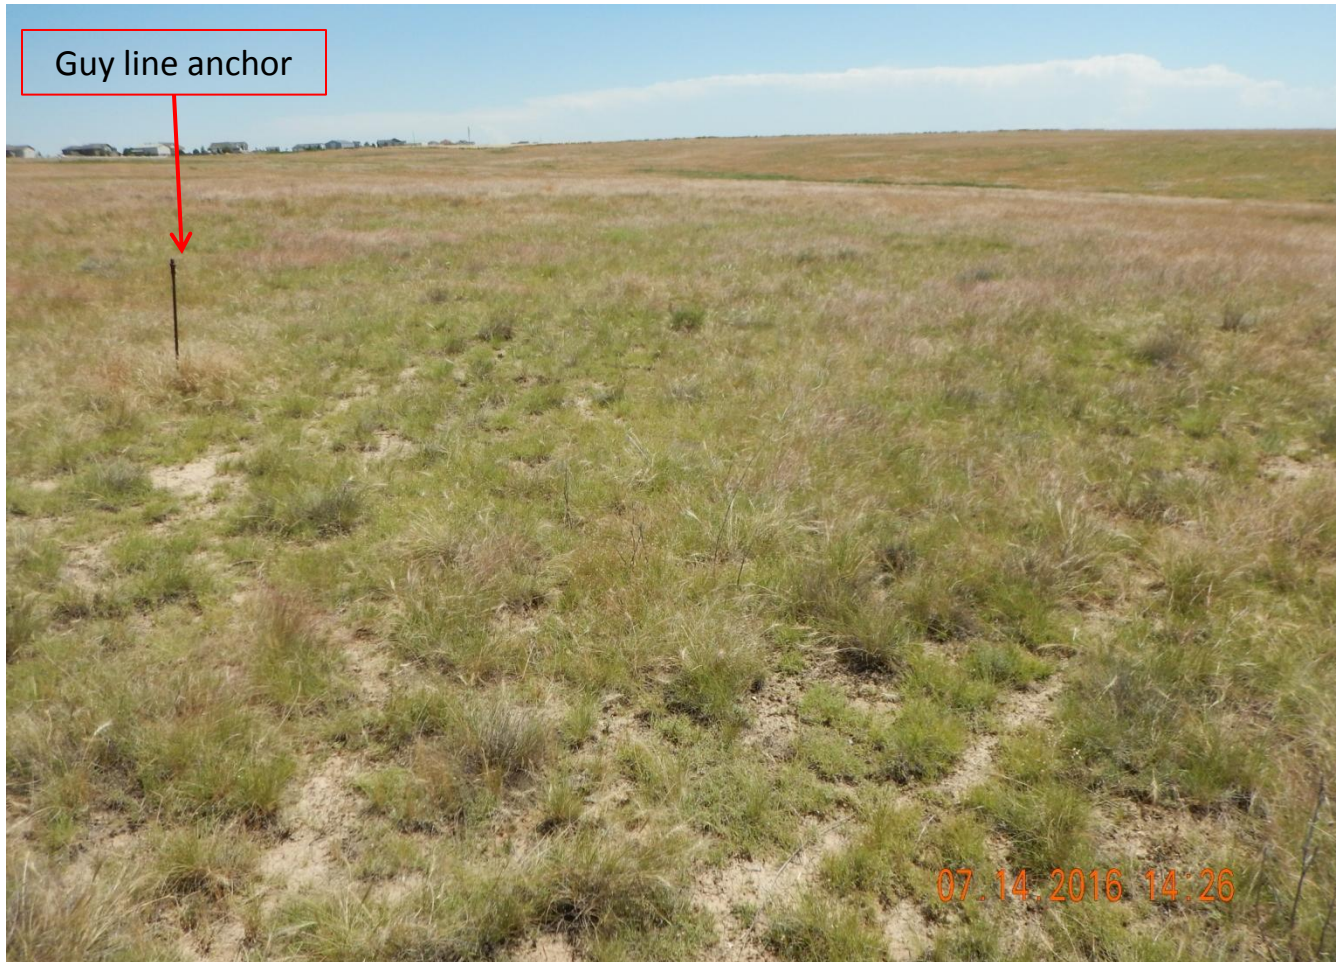
**Photo 4.** Photo taken from center of location, facing North. Vegetative growth appears to be reflective of reference areas. A number of native, perennial grass species were observed throughout location. However, location was not recontoured and 3 guy line anchors were left behind.
