Final Reclamation Inspection

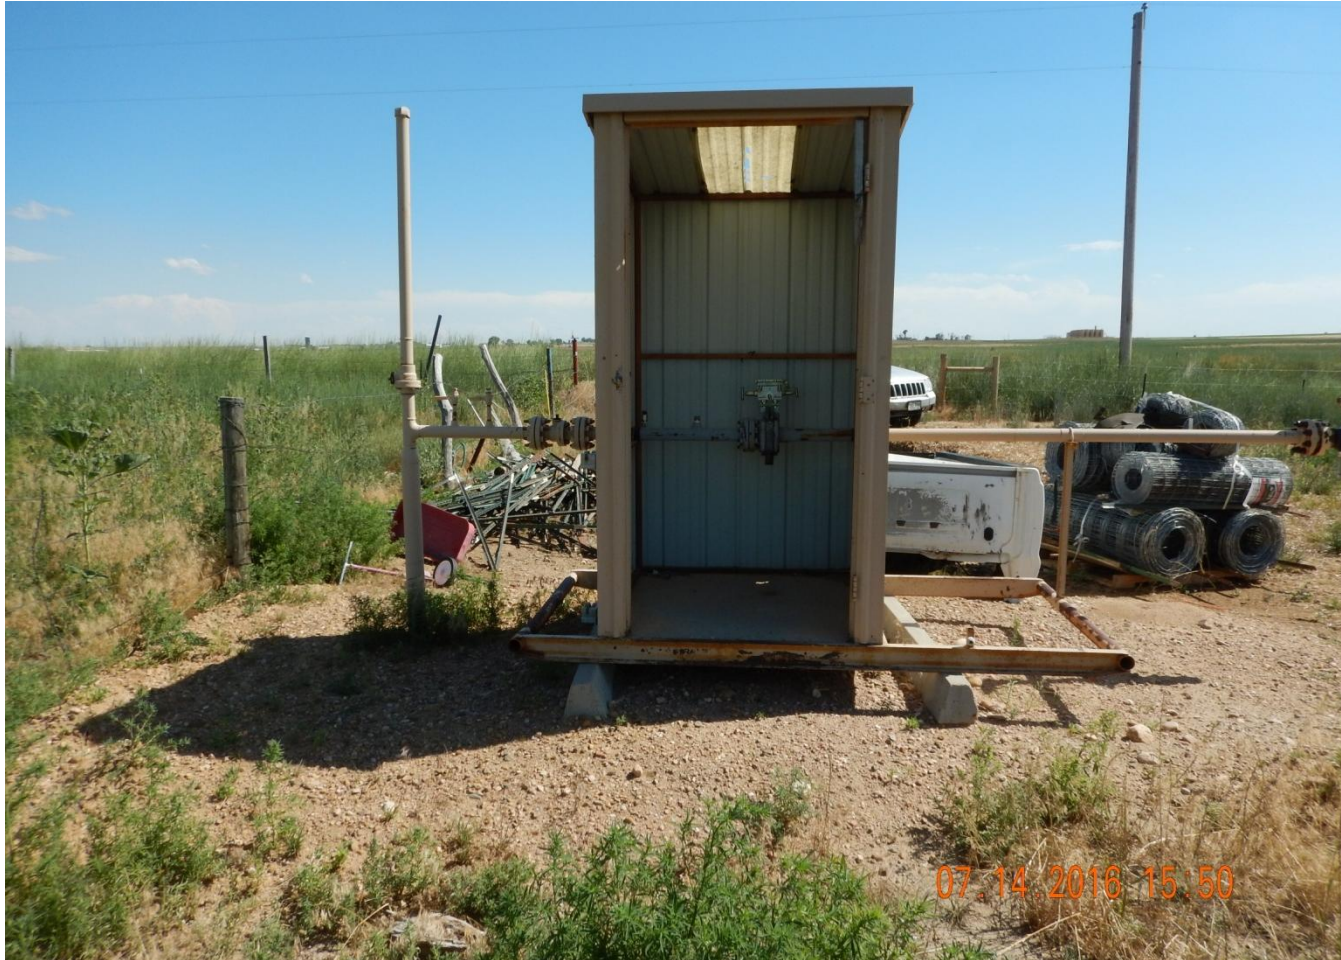
Photo 2. Photo taken of equipment which needs to be removed and reclaimed per Rule 1004.

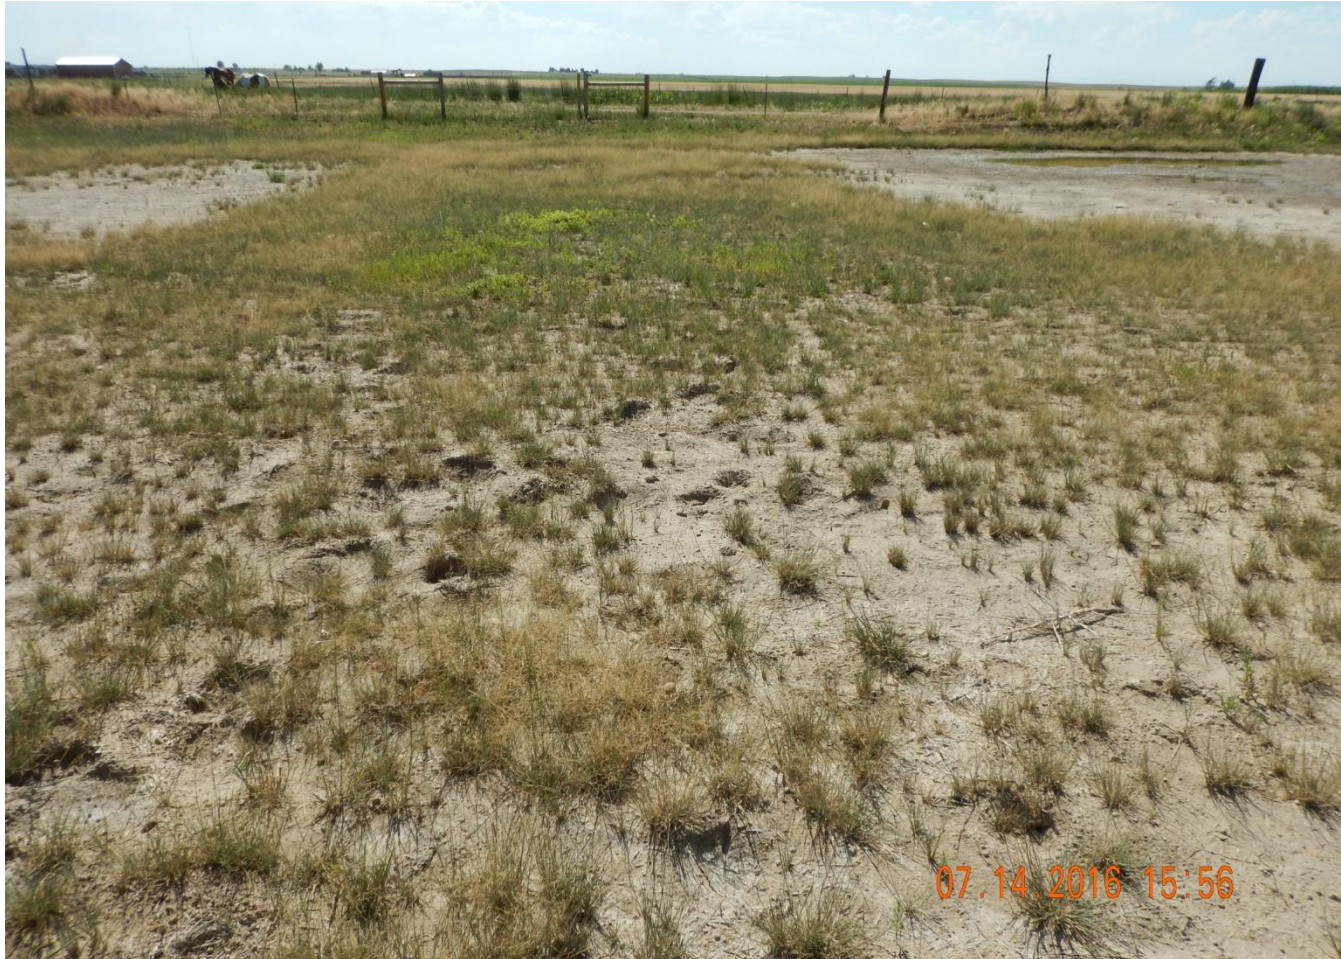
Photo 3. Photo taken from center of location, facing West. Vegetative plant cover is not consistent throughout area. Large areas have no plant growth. Evidence of seeding is noticeable.

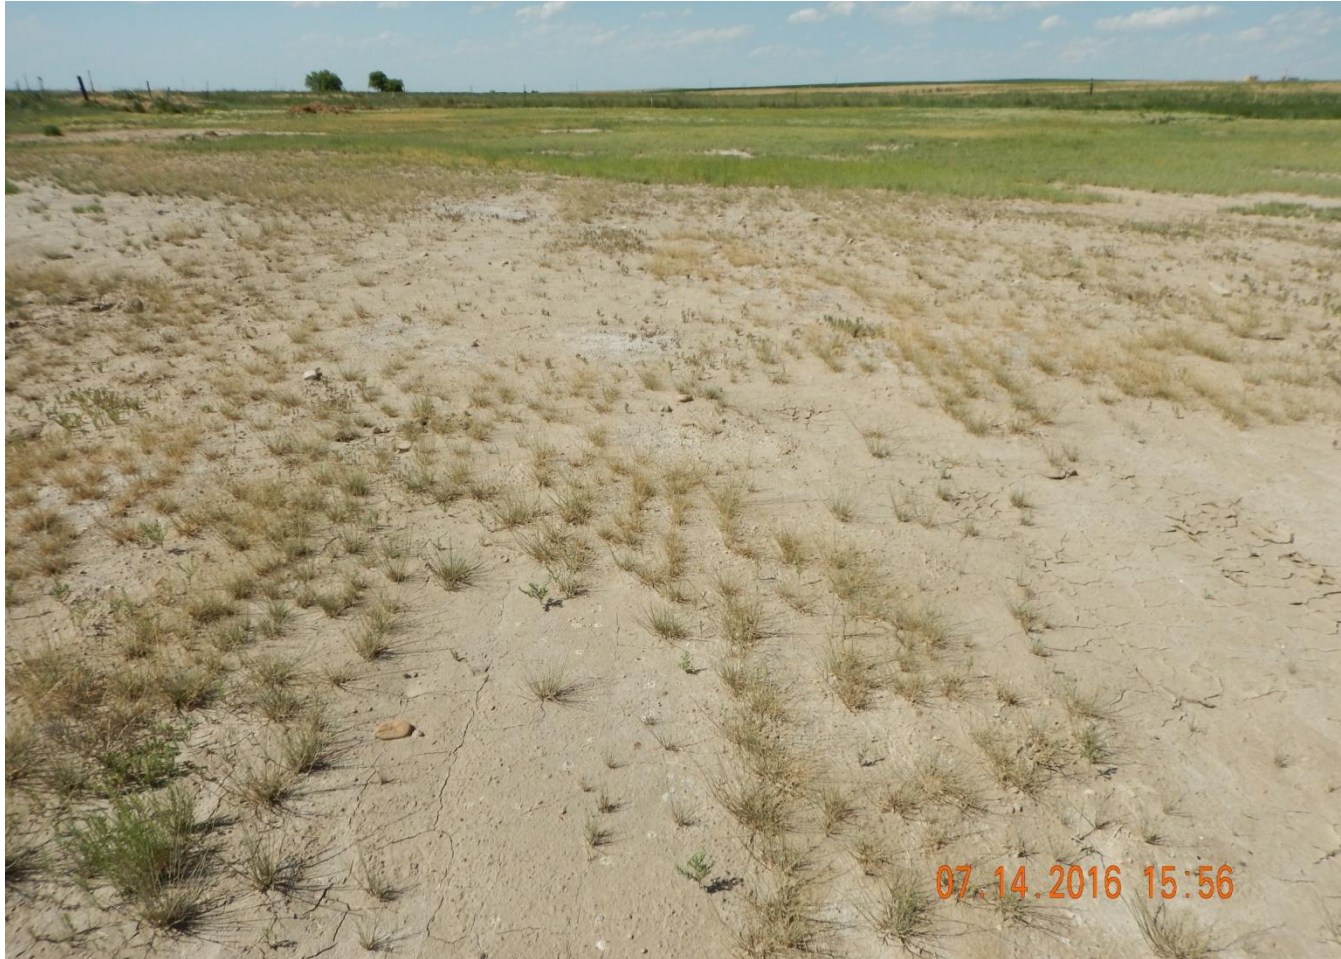
Photo 4. Photo taken from center of location, facing North. Vegetative plant cover is not consistent throughout area. Large areas have no plant growth as shown with this photo. Evidence of seeding is noticeable.

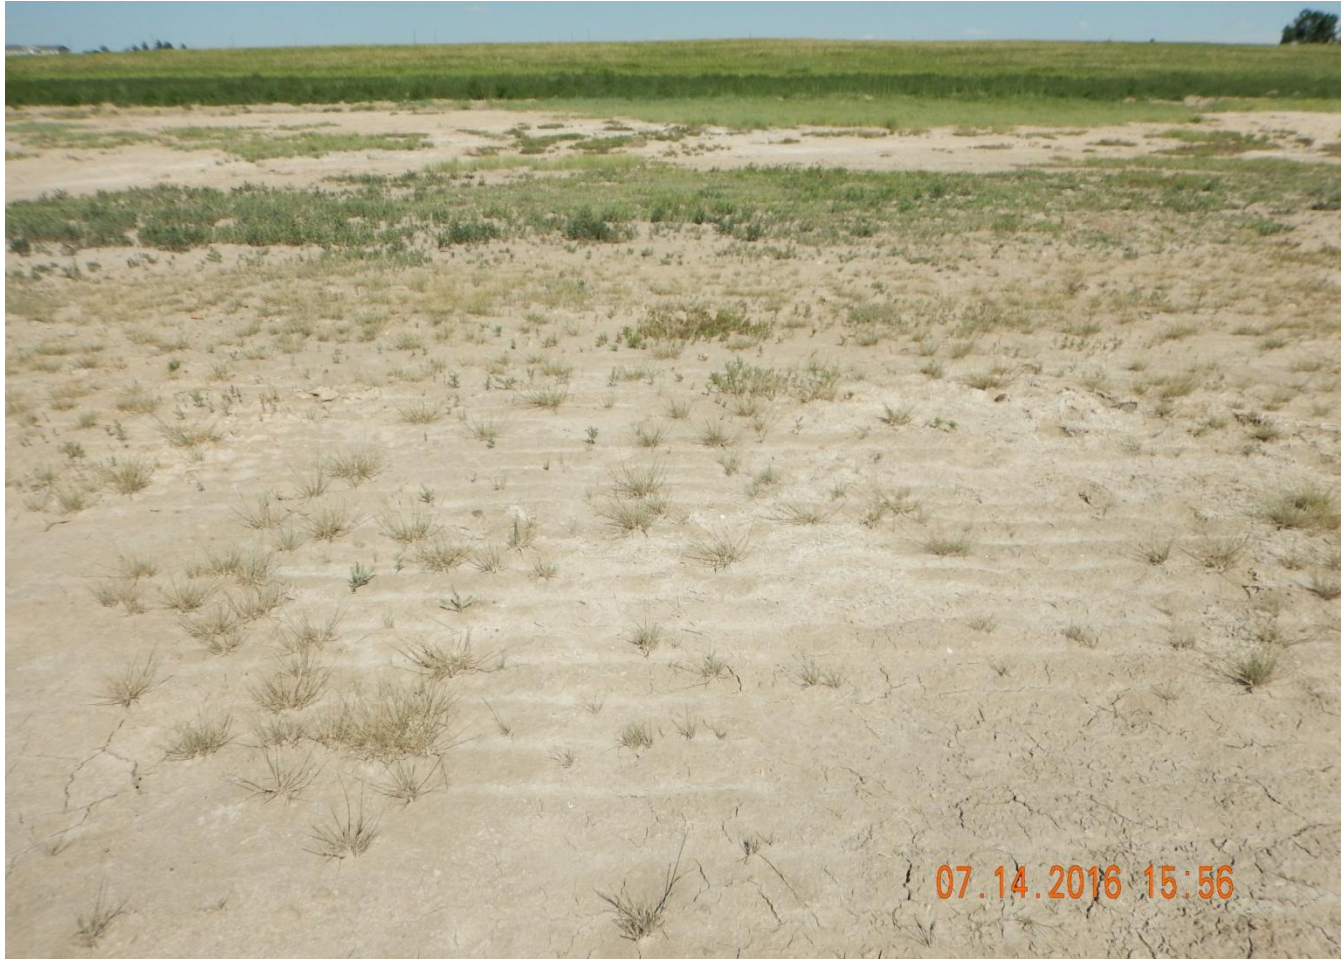
Photo 5. Photo taken from center of location, facing East. Vegetative plant cover is not consistent throughout area. Large areas have no plant growth as shown with this photo. Evidence of seeding is noticeable.

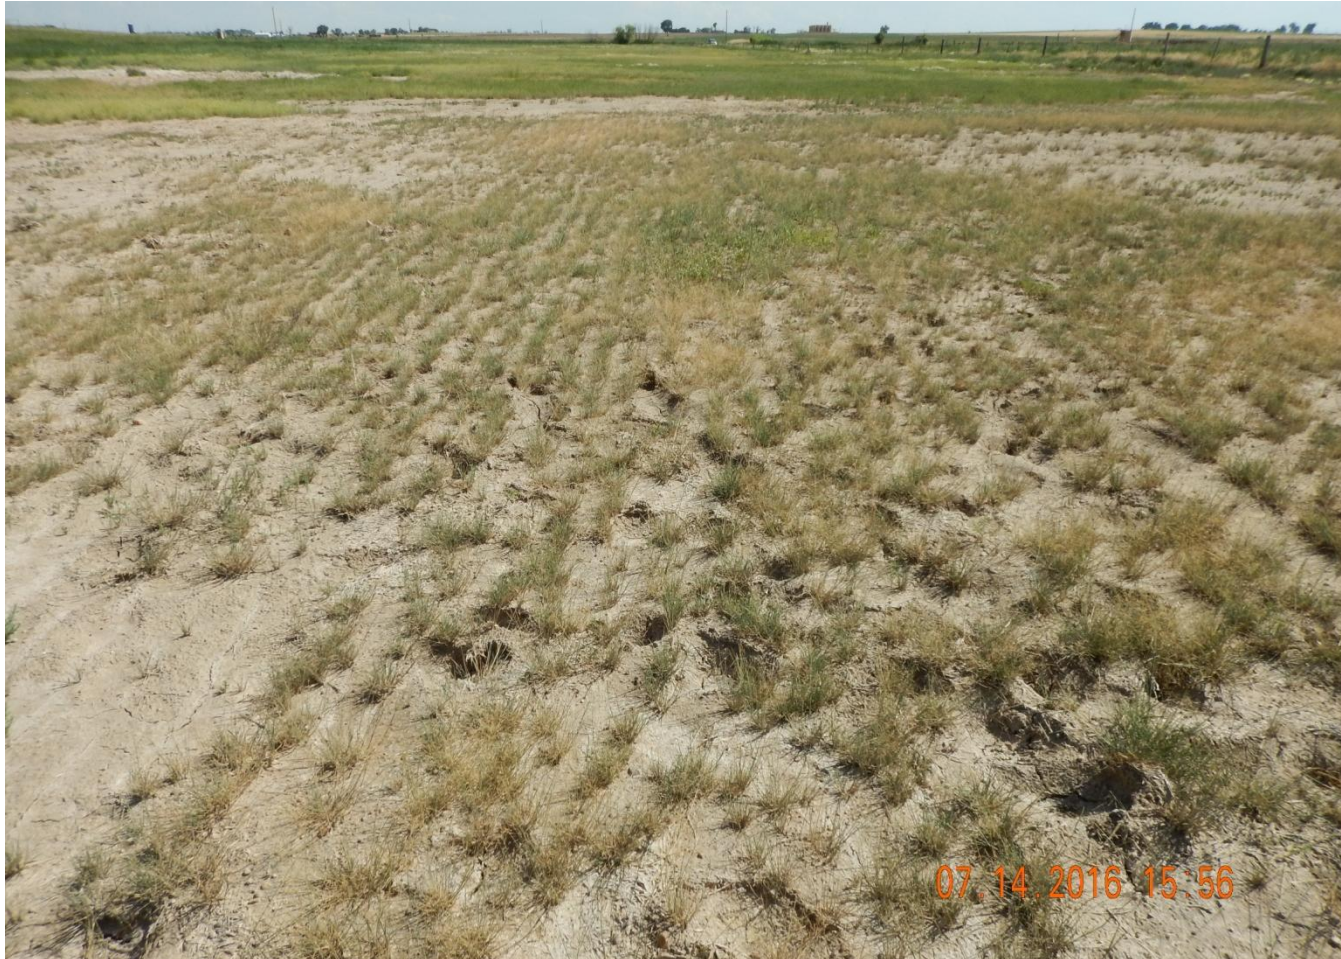
Photo 6. Photo taken from center of location, facing North. Vegetative plant cover is not consistent throughout area. Evidence of seeding is noticeable.

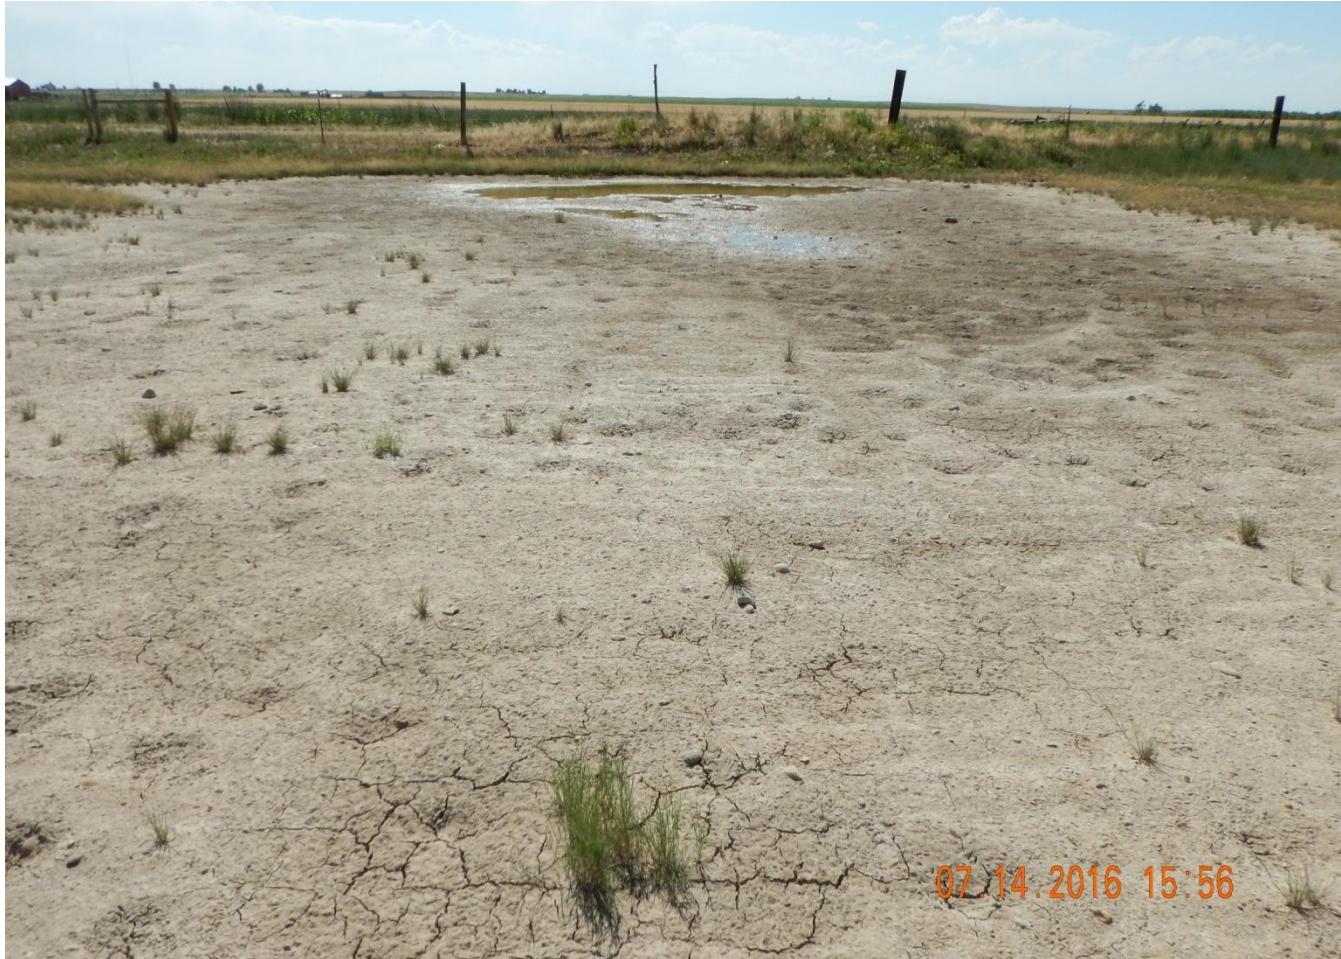
Photo 7. Photo taken from approximate center of location, facing West. Large areas have no plant growth as shown with this photo.

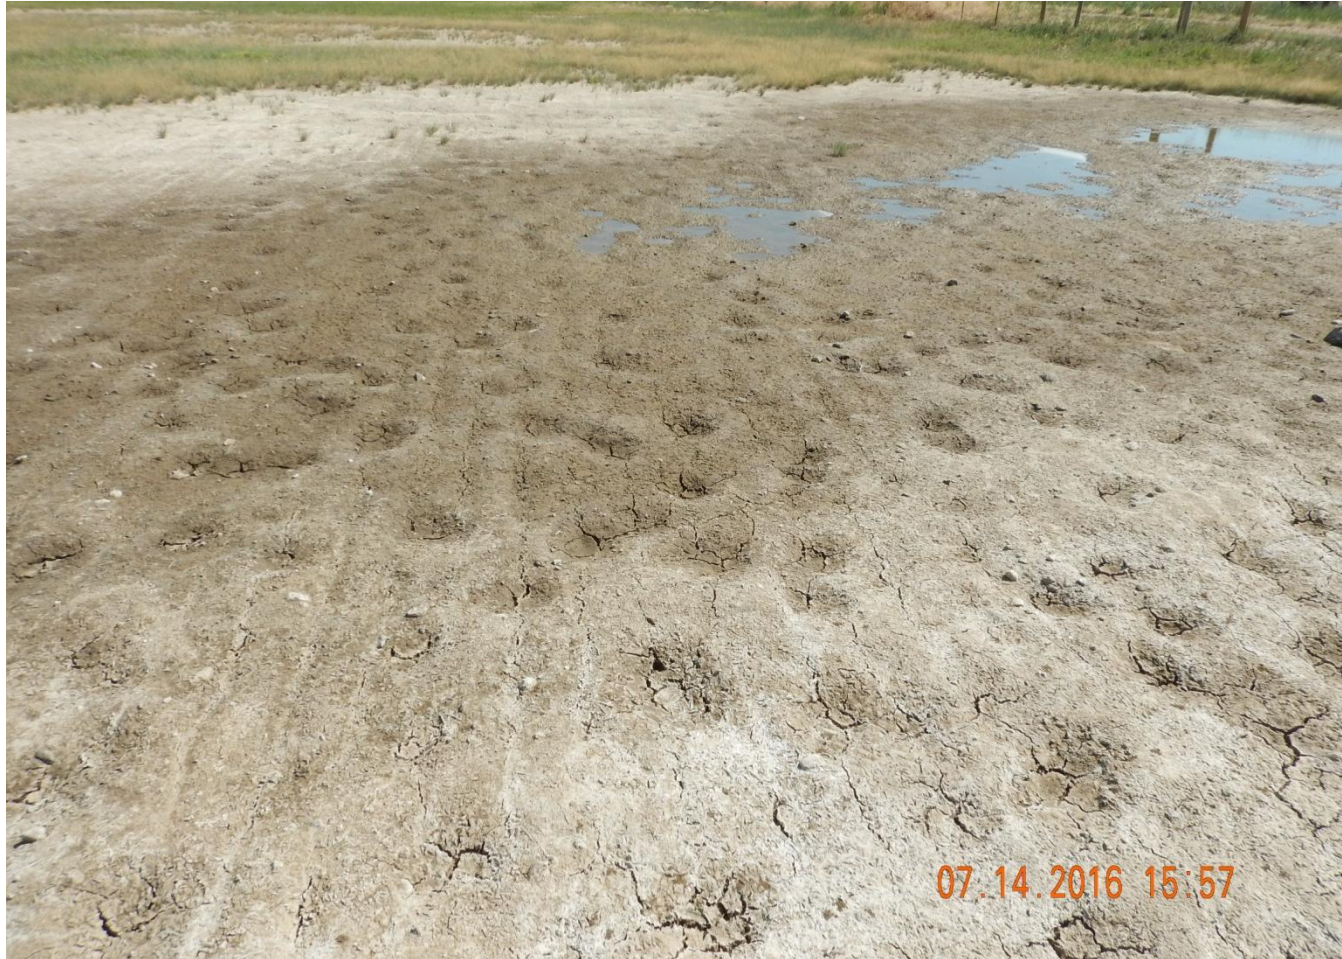
Photo 8. Photo taken from approximate center of location, facing South. Large areas have no plant growth as shown with this photo. Evidence of seeding is noticeable but no plant growth.
