Final Reclamation Inspection

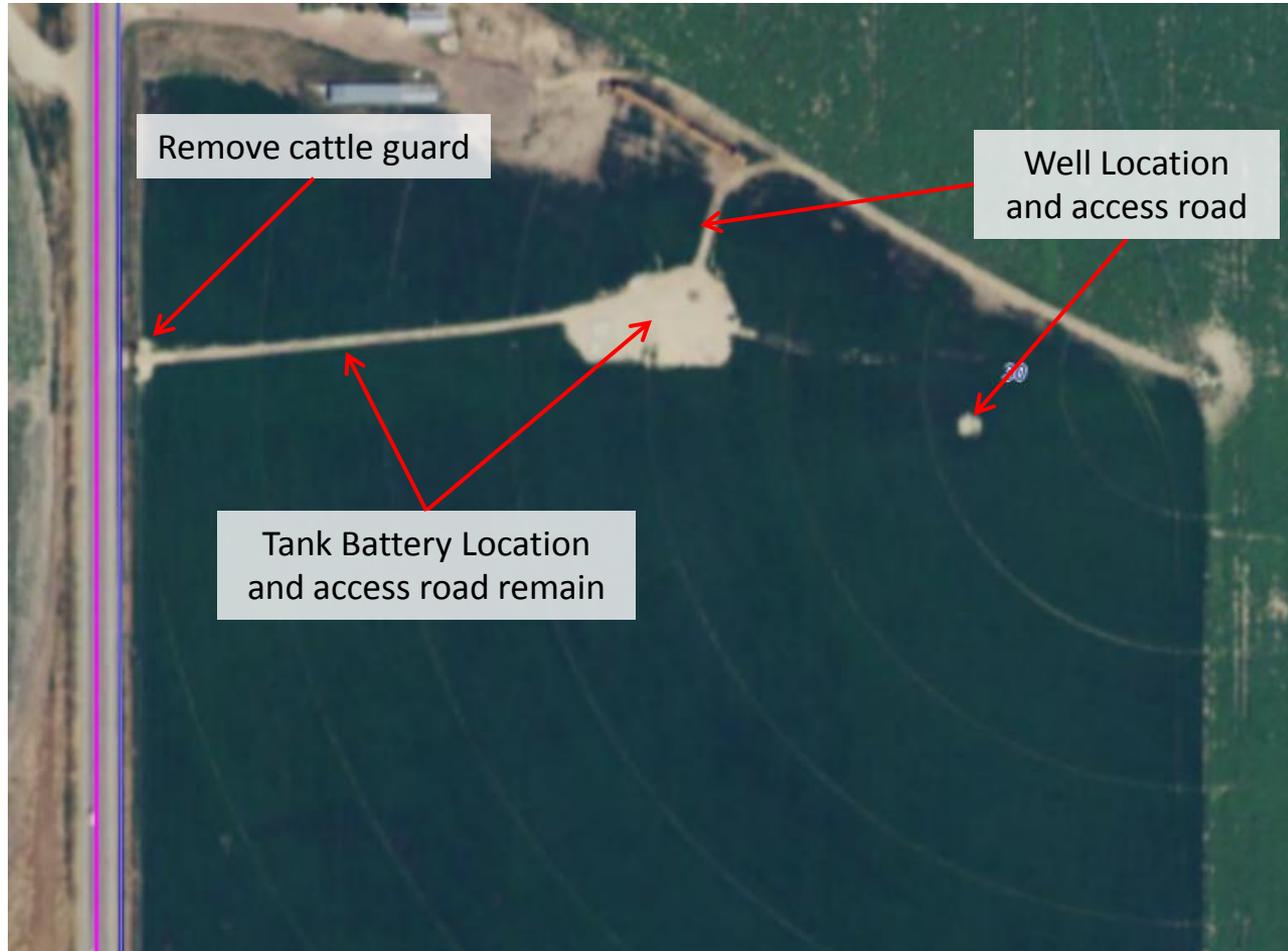
Photo 1. 2015 aerial imagery using COGCC GISOnline database, illustrating total areas that have not been reclaimed.

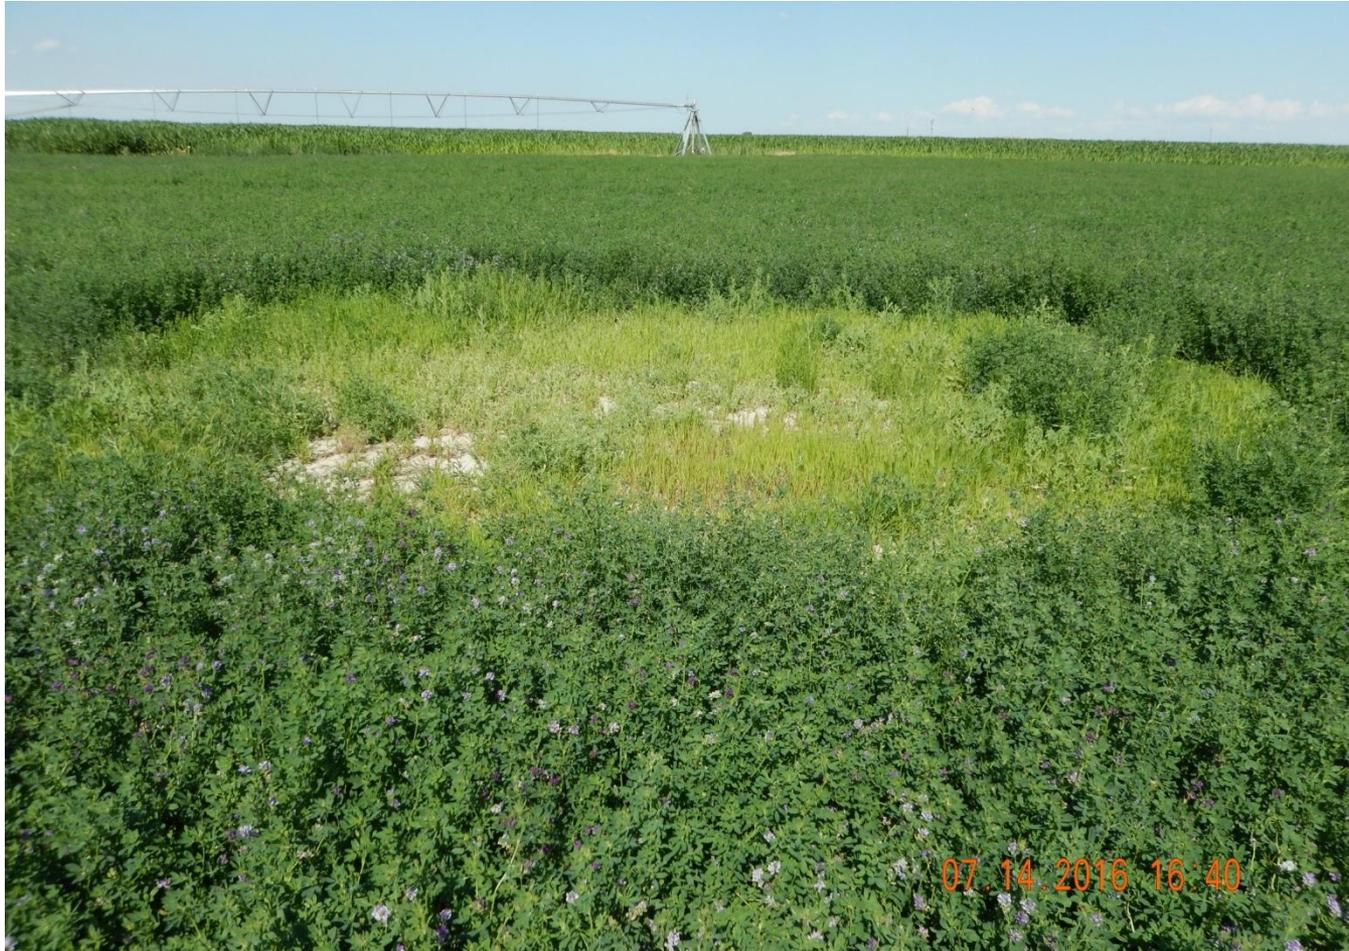
Photo 2. Photo taken from west of well location, facing East. Well location has not been properly reclaimed per Rule 1004.

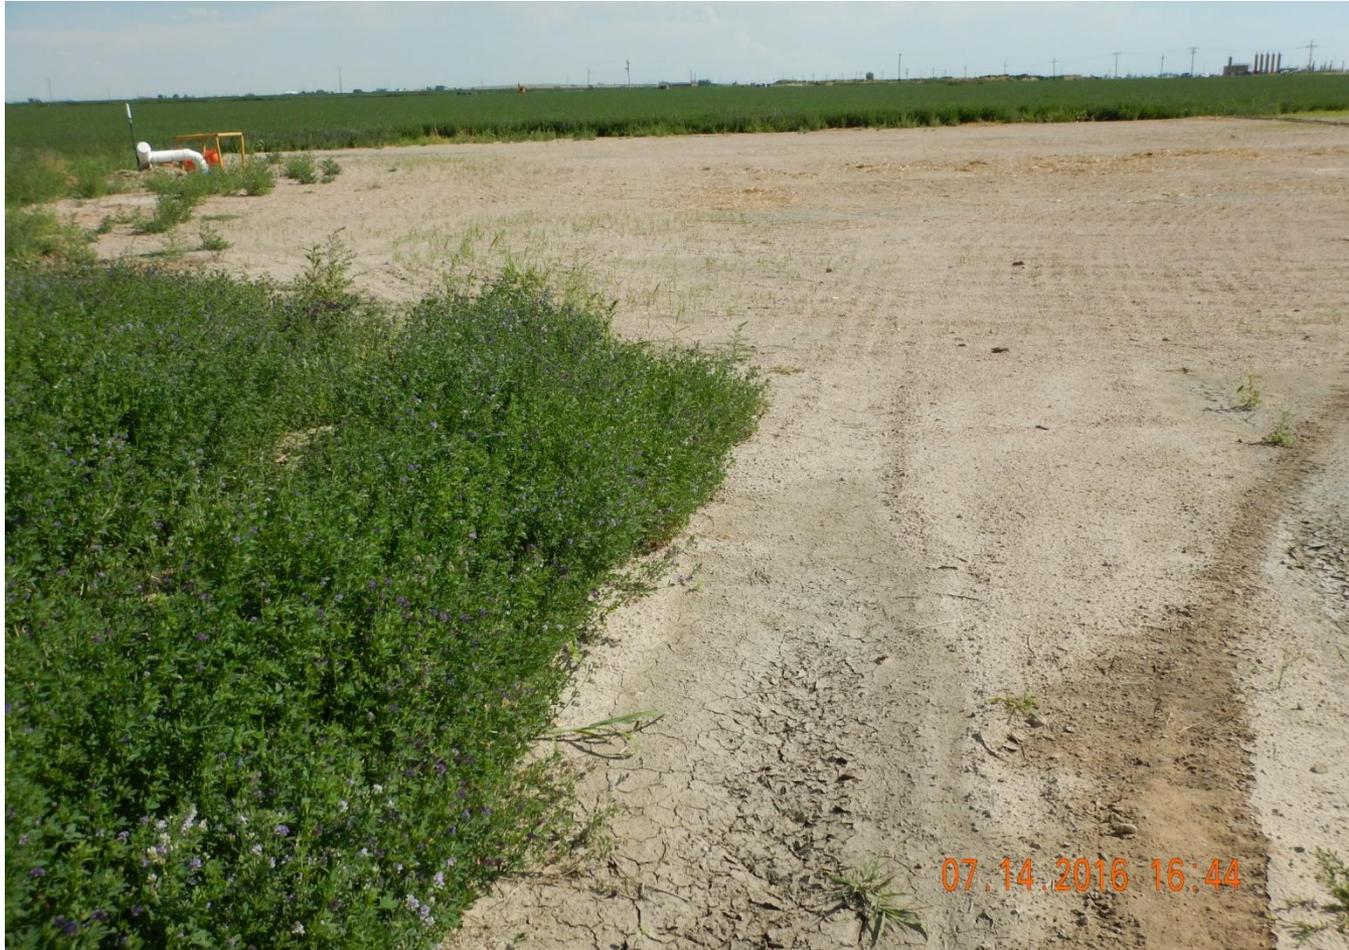
Photo 3. Photo taken from northern tank battery location, facing South. Evidence of seeding is noticeable. However, gravel remains and compaction alleviation was not completed making near impossible for anything to grow.

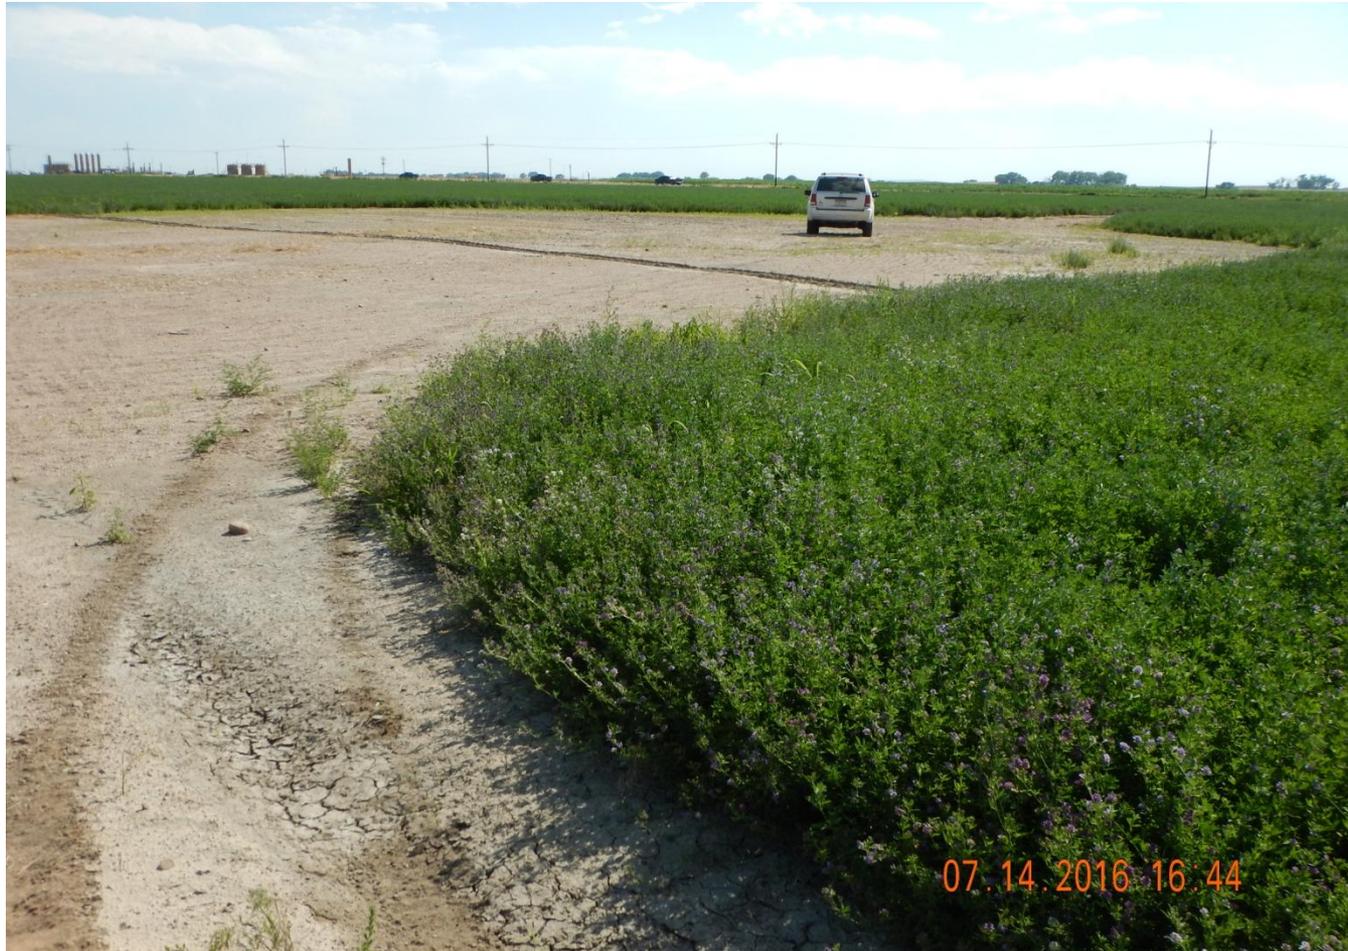
Photo 4. Photo taken from northern tank battery location, facing Southwest. Evidence of seeding is noticeable. However, gravel remains and compaction alleviation was not completed making near impossible for anything to grow.

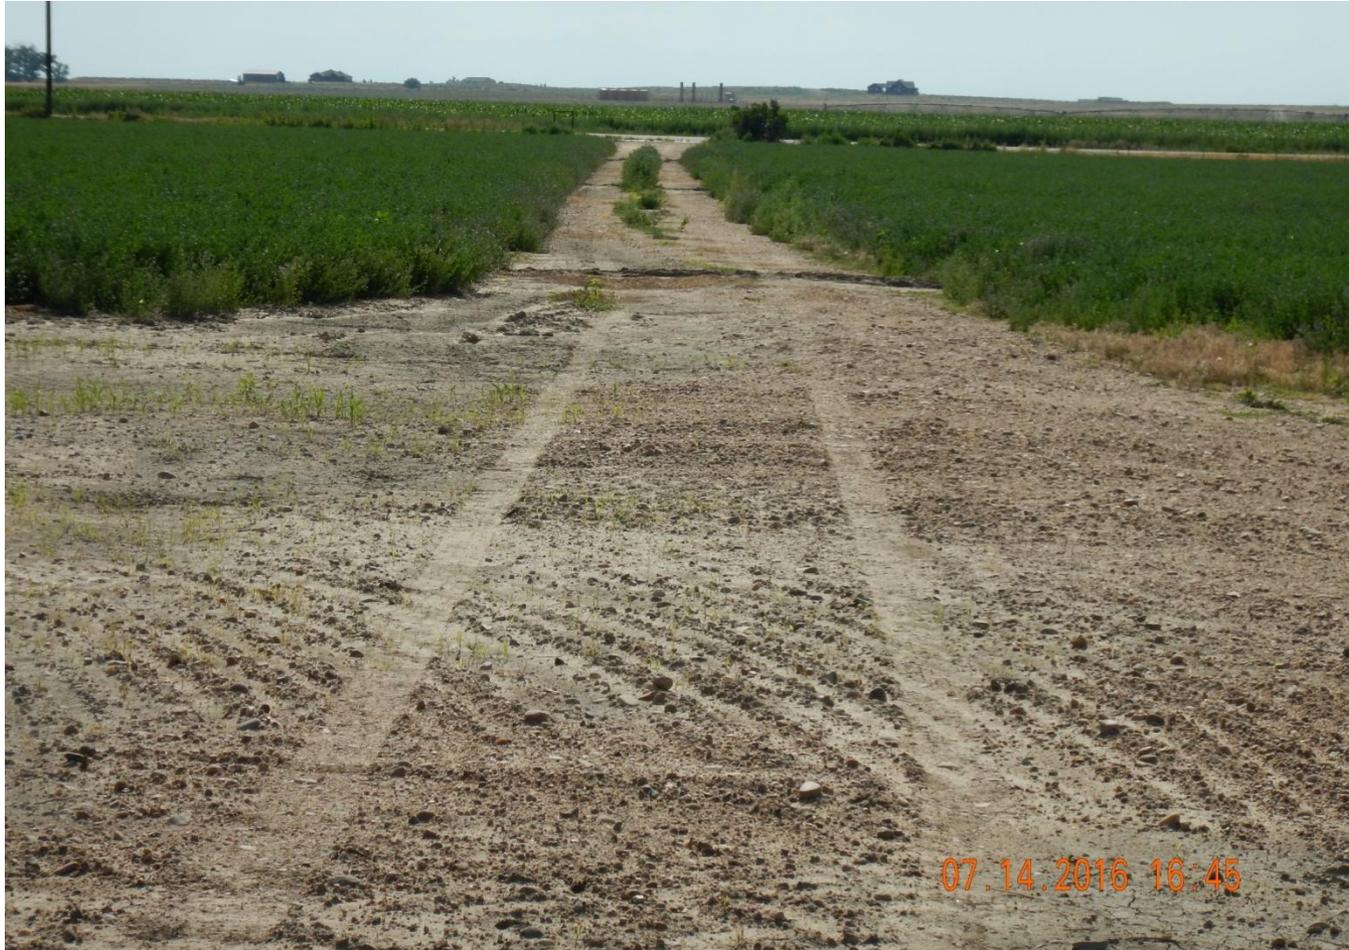
Photo 5. Photo taken from the central tank battery location, facing West. Evidence of seeding is noticeable. However, gravel remains and compaction alleviation was not completed making near impossible for anything to grow.

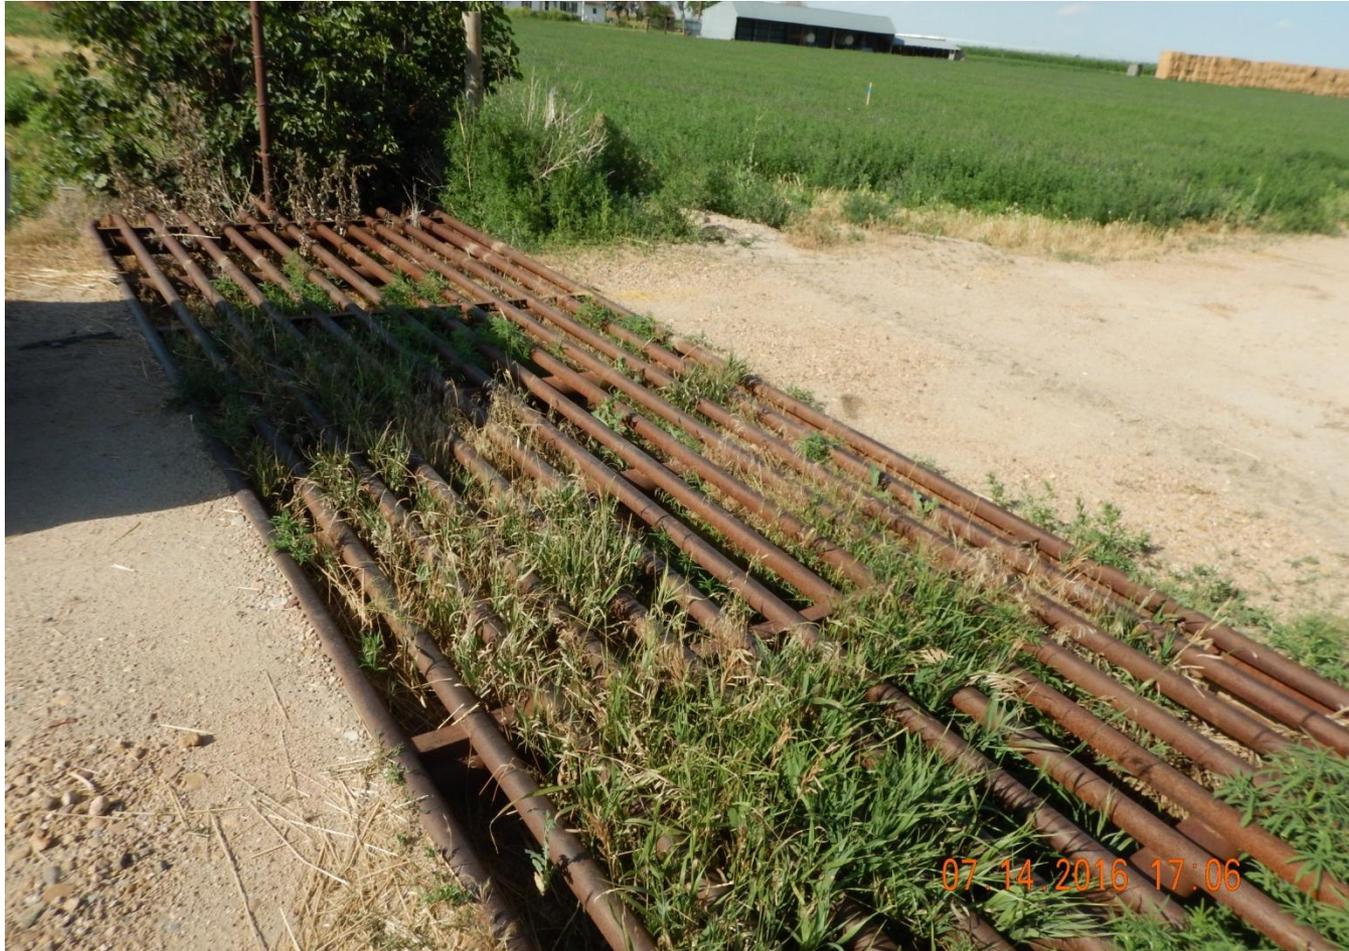
Photo 6. Photo taken from tank battery entrance. Need to remove cattle guard equipment.
