Final Reclamation Inspection

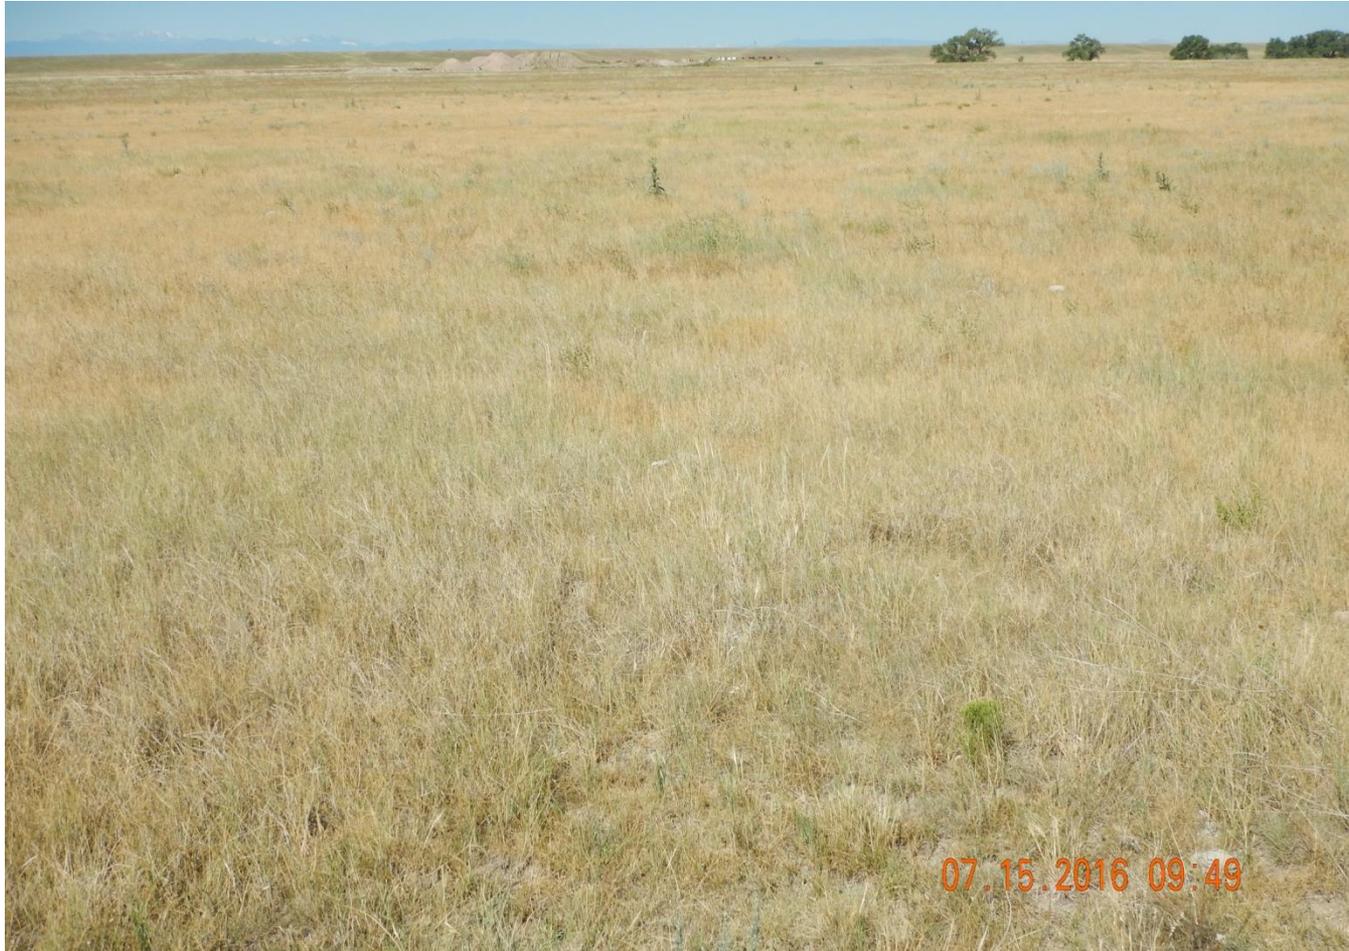
Photo 1. Photo taken from center of location, facing West. No evidence of disturbance. Uniform vegetative growth throughout location. Vegetative growth at location appears to be reflective or reference areas.

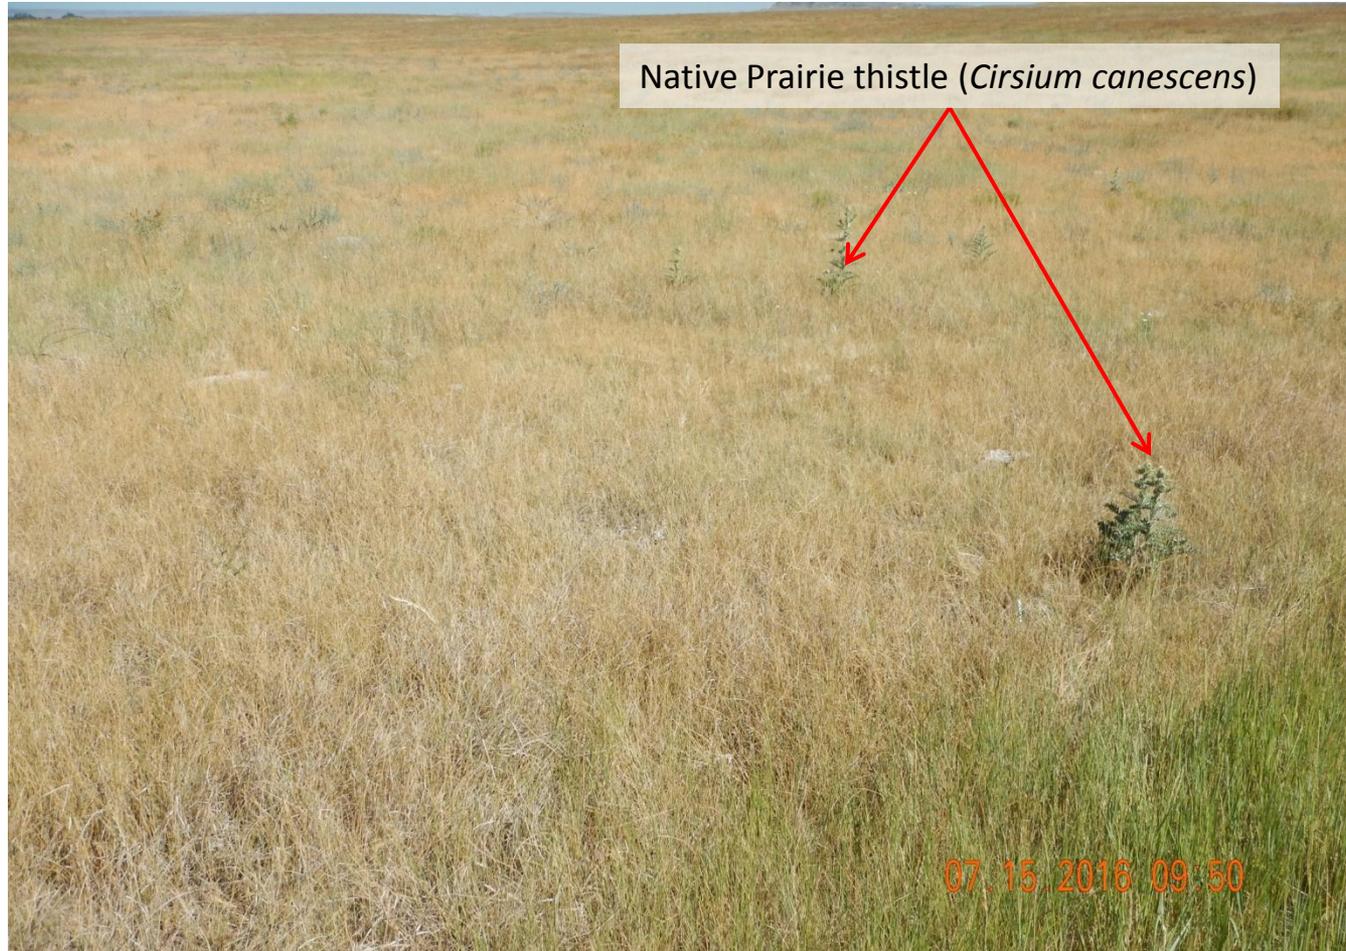
Photo 2. Photo taken from center of location, facing North. No evidence of disturbance. Uniform vegetative growth throughout location. Vegetative growth at location appears to be reflective or reference areas.

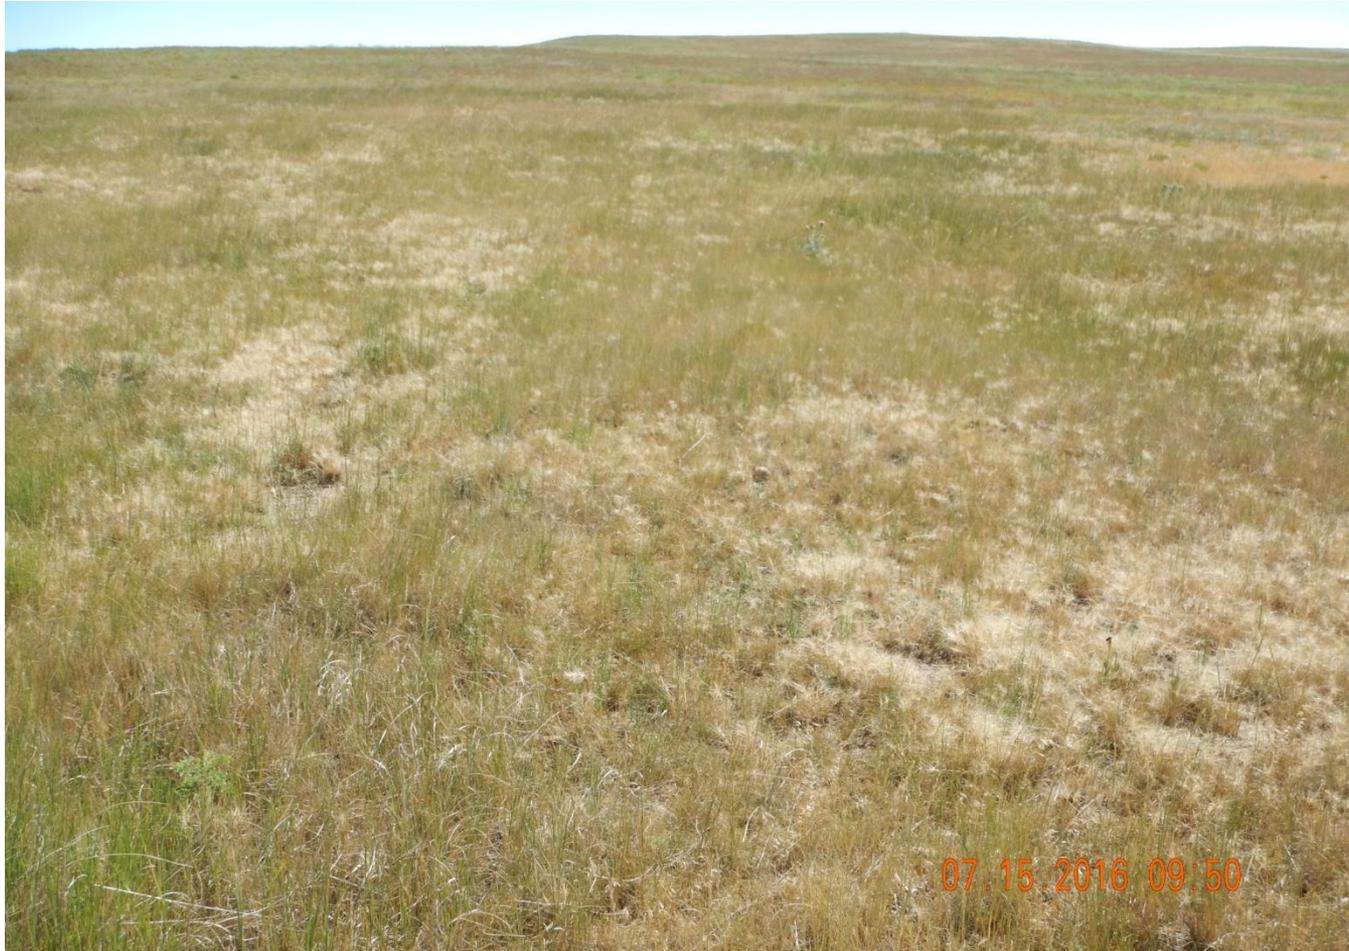
Photo 3. Photo taken from center of location, facing East. No evidence of disturbance. Uniform vegetative growth throughout location. Vegetative growth at location appears to be reflective or reference areas.

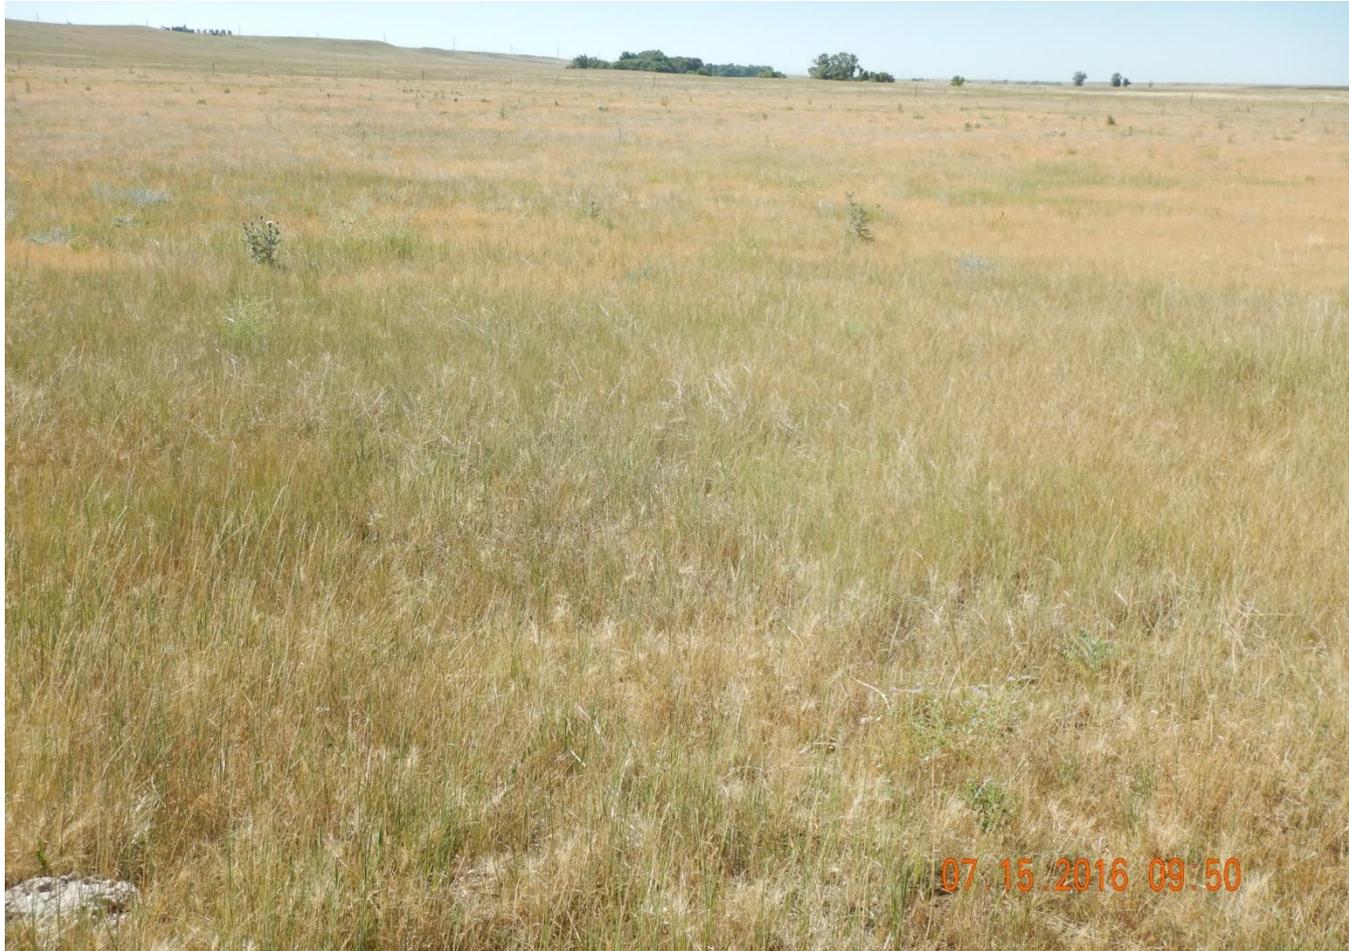
Photo 4. Photo taken from center of location, facing South. No evidence of disturbance. Uniform vegetative growth throughout location. Vegetative growth at location appears to be reflective or reference areas.
