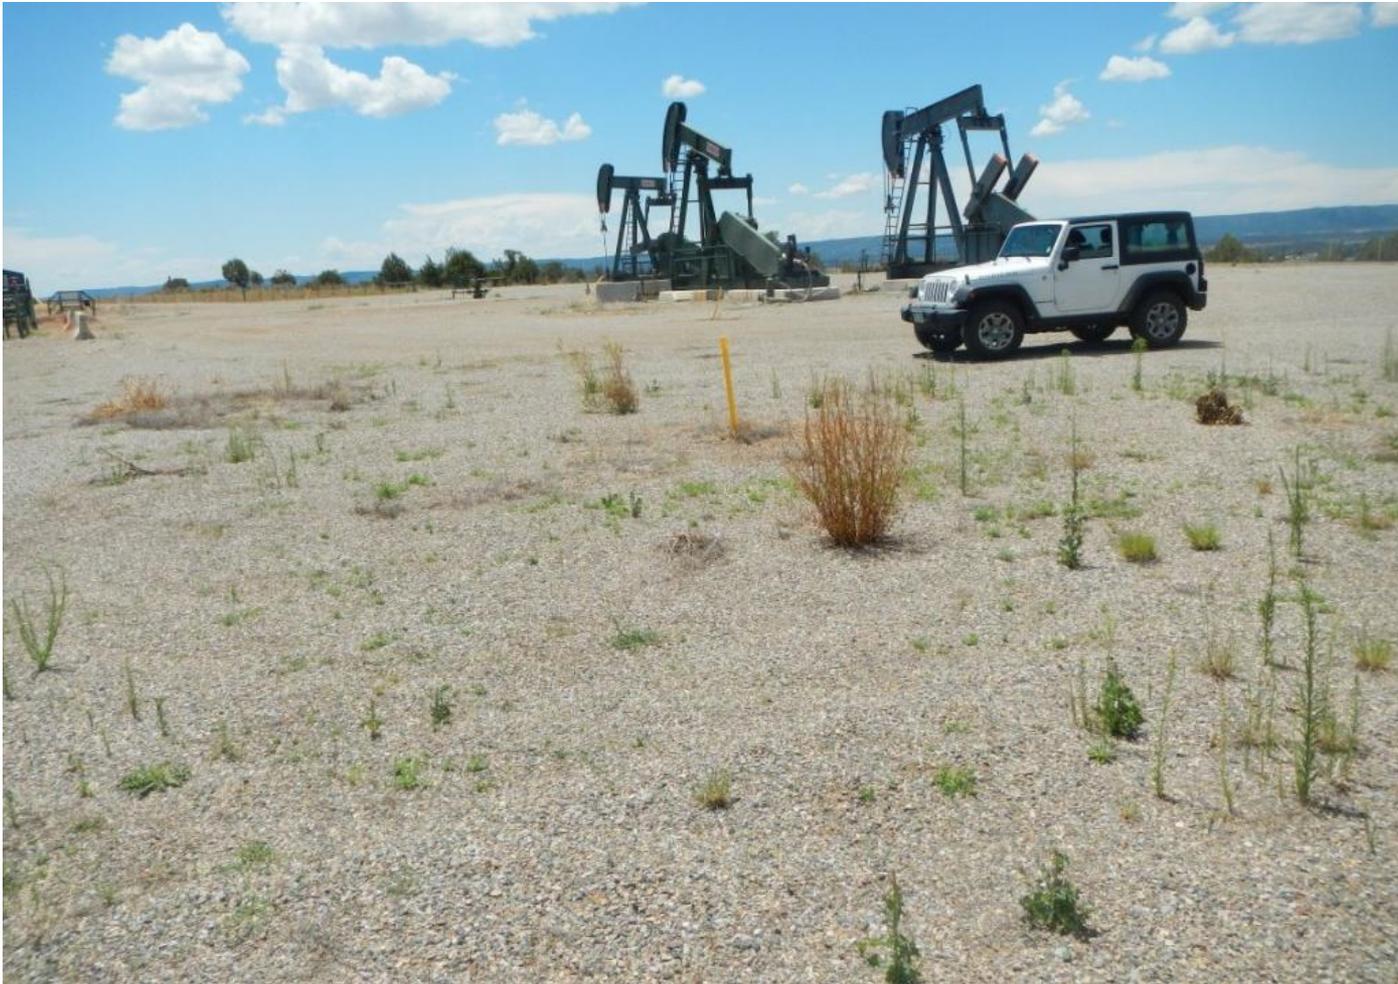
Photo 1. View of the project area from the northeastern corner facing center.

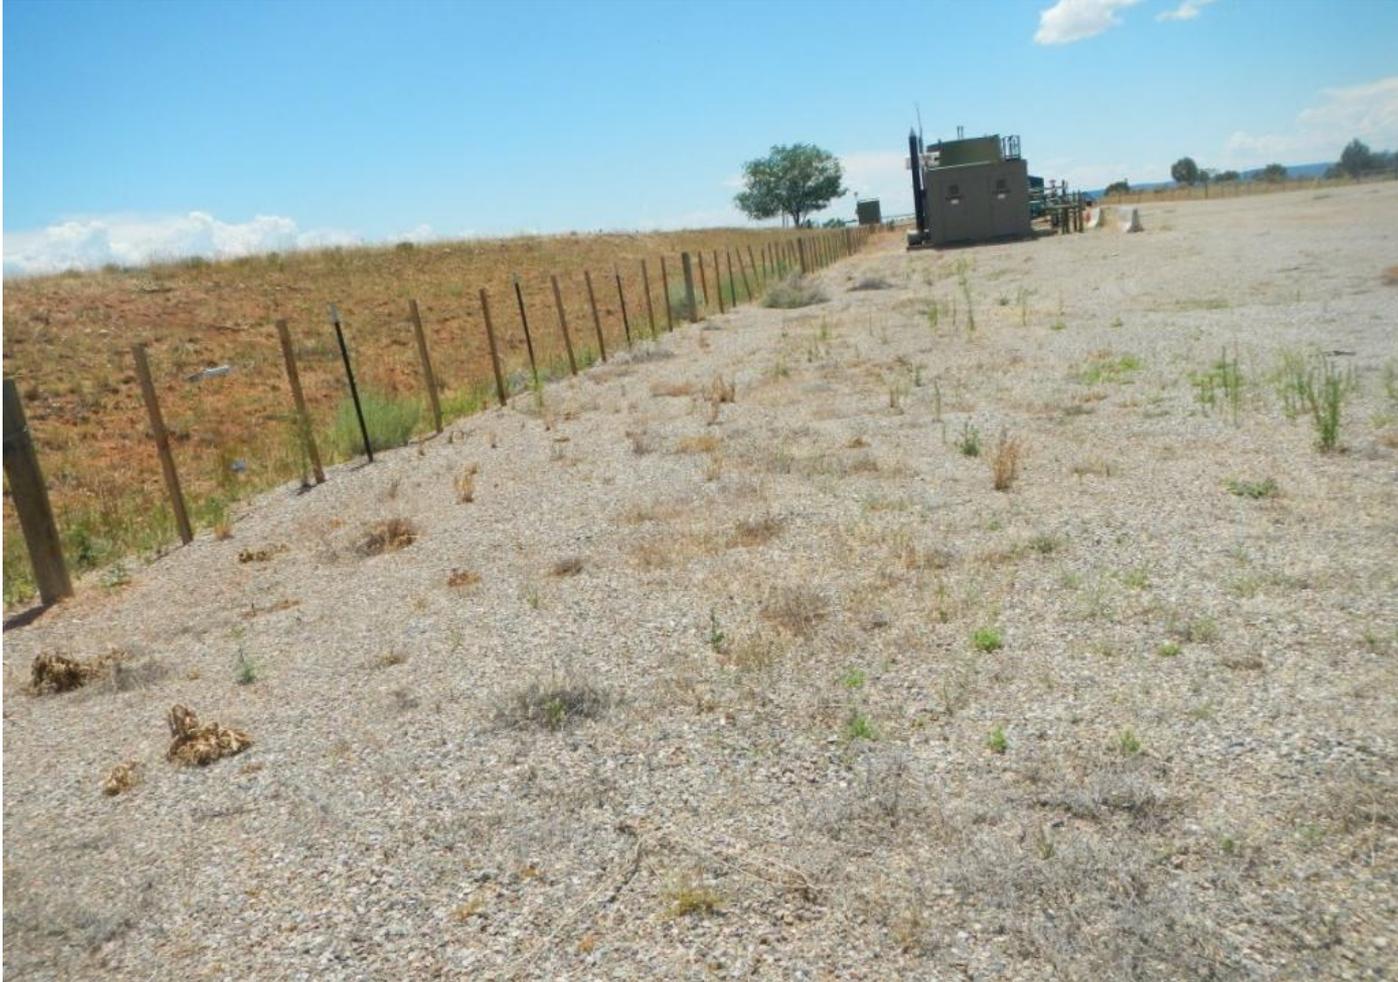
Photo 2. View of the eastern portion of the project area from the northeastern portion of the project area facing southward. Weeds within the fenced area have largely been treated.

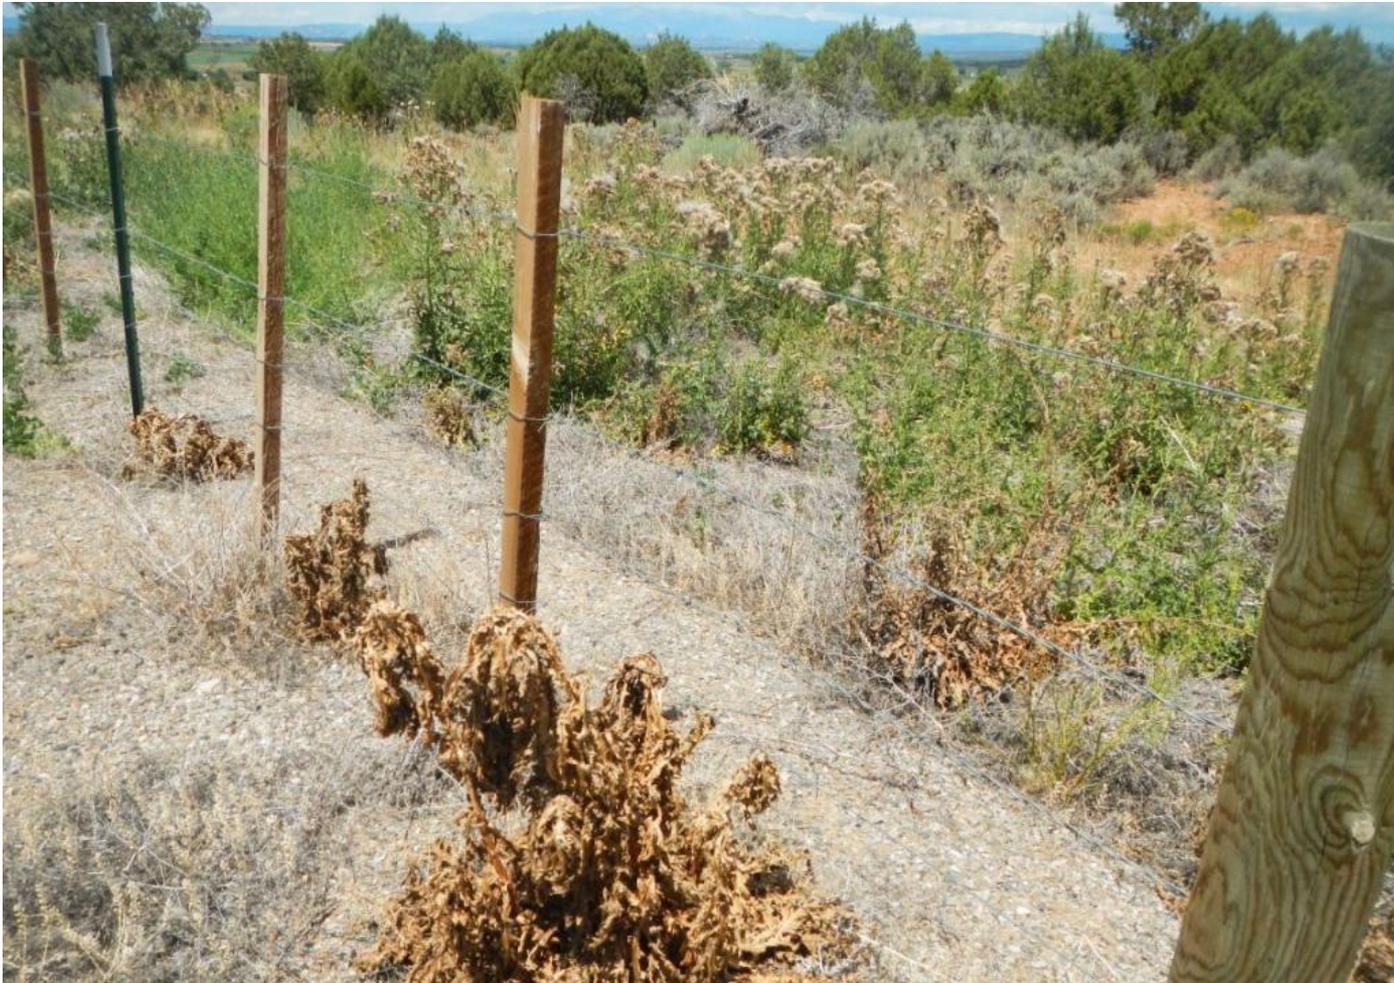
Photo 3. View of infestation of approximately 1000 Canada thistle (*Cirsium arvense*) outside of the northern fenceline, but still within the project disturbance.

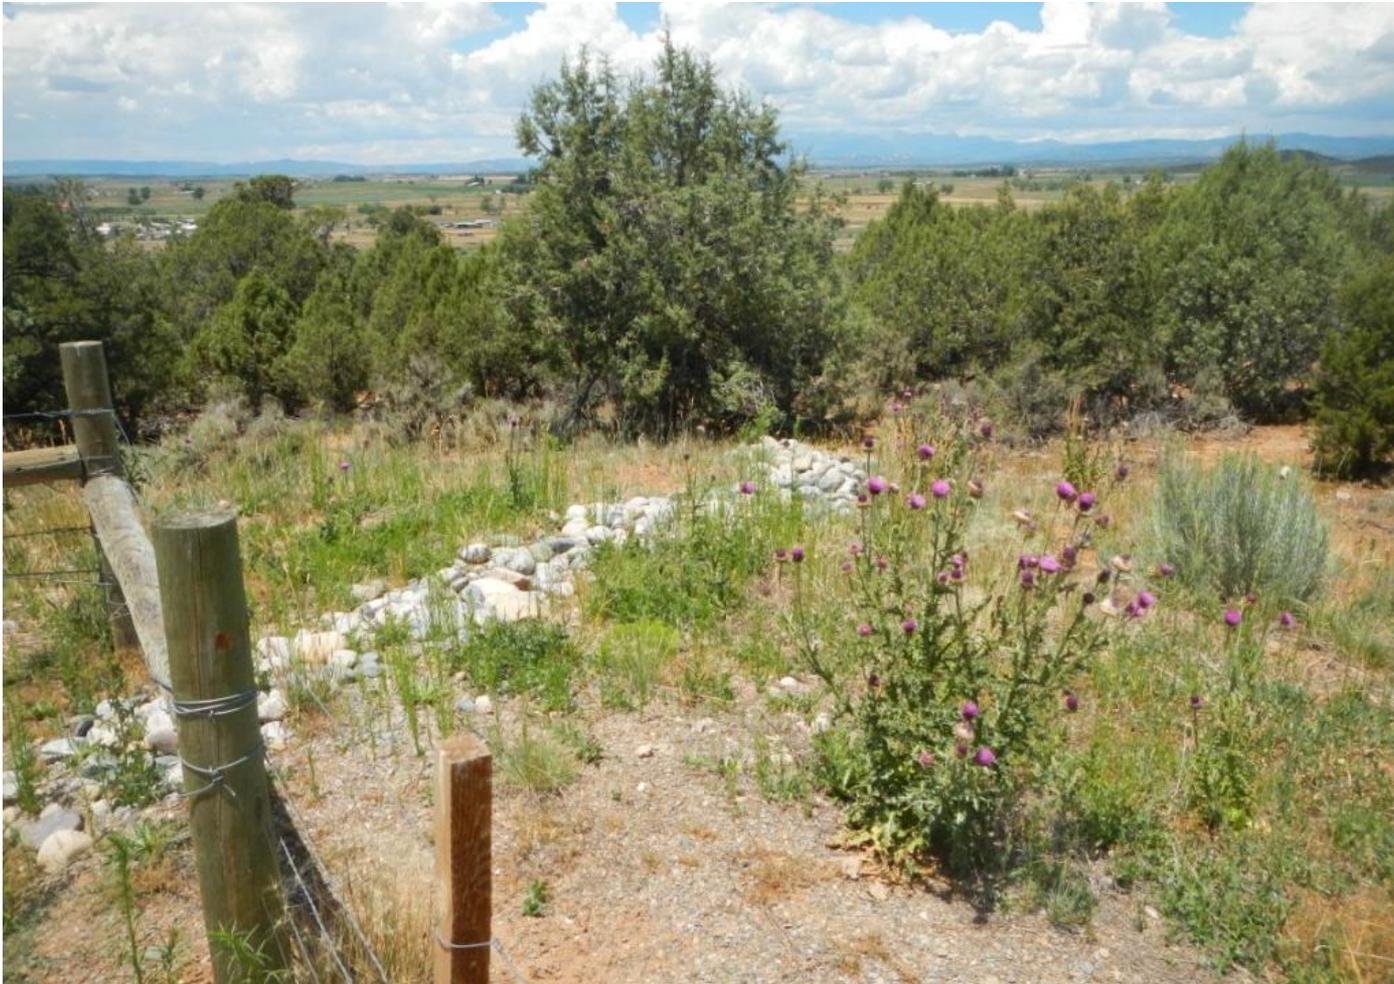
Photo 4. View of cobble run-down BMP and tall flowering musk thistles (*Carduus nutans*) outside of the fence but within the project disturbance in the northwestern corner.

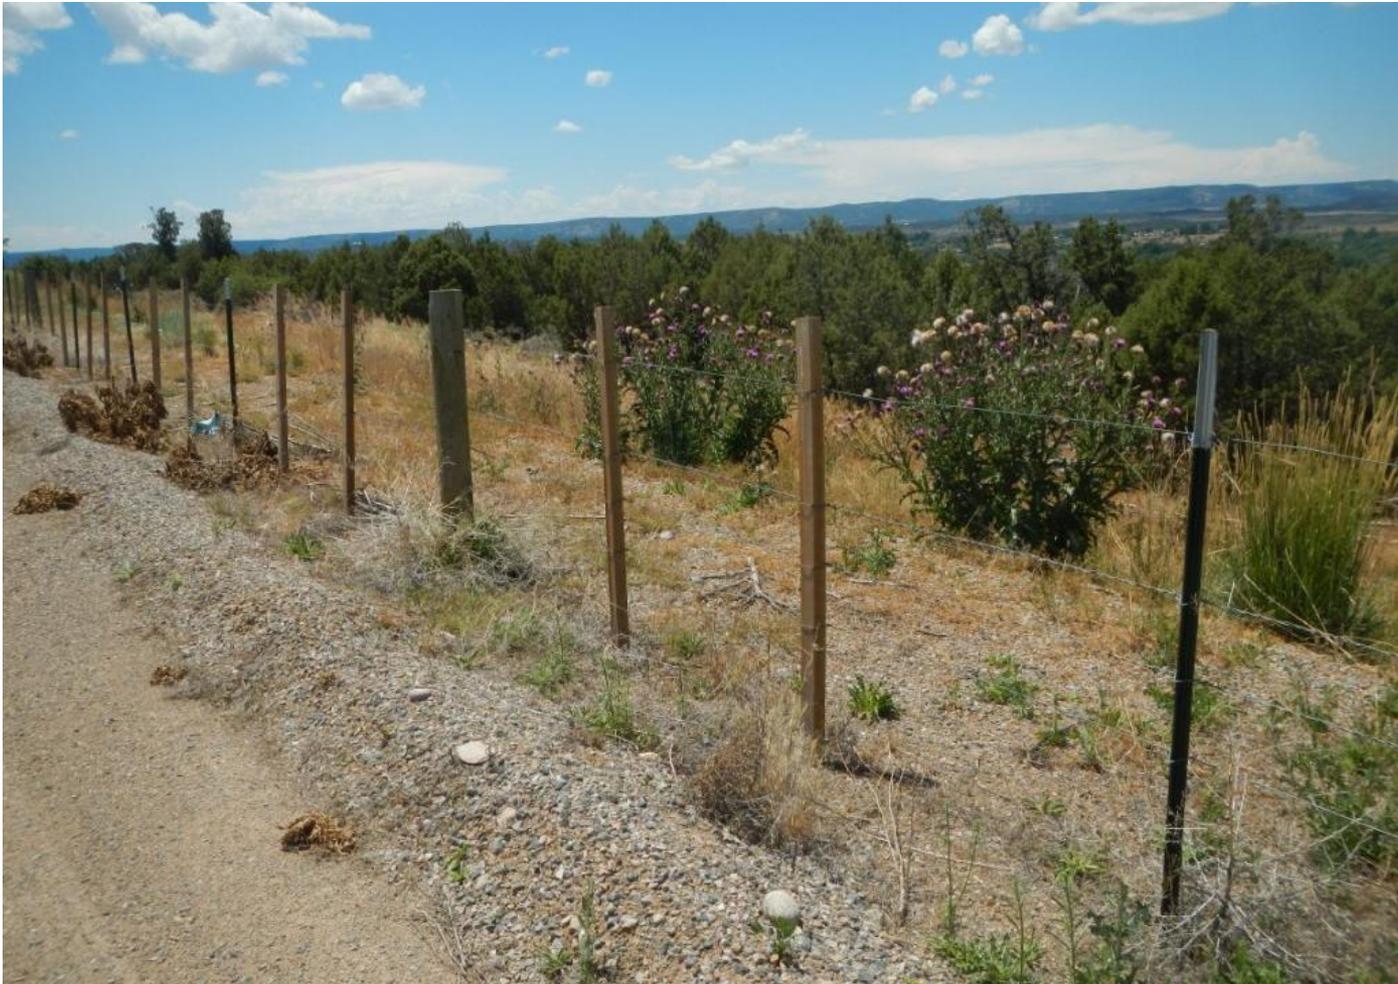
Photo 5. View of large flowering and seeding musk thistles in the western portion of the project area outside of the fence.

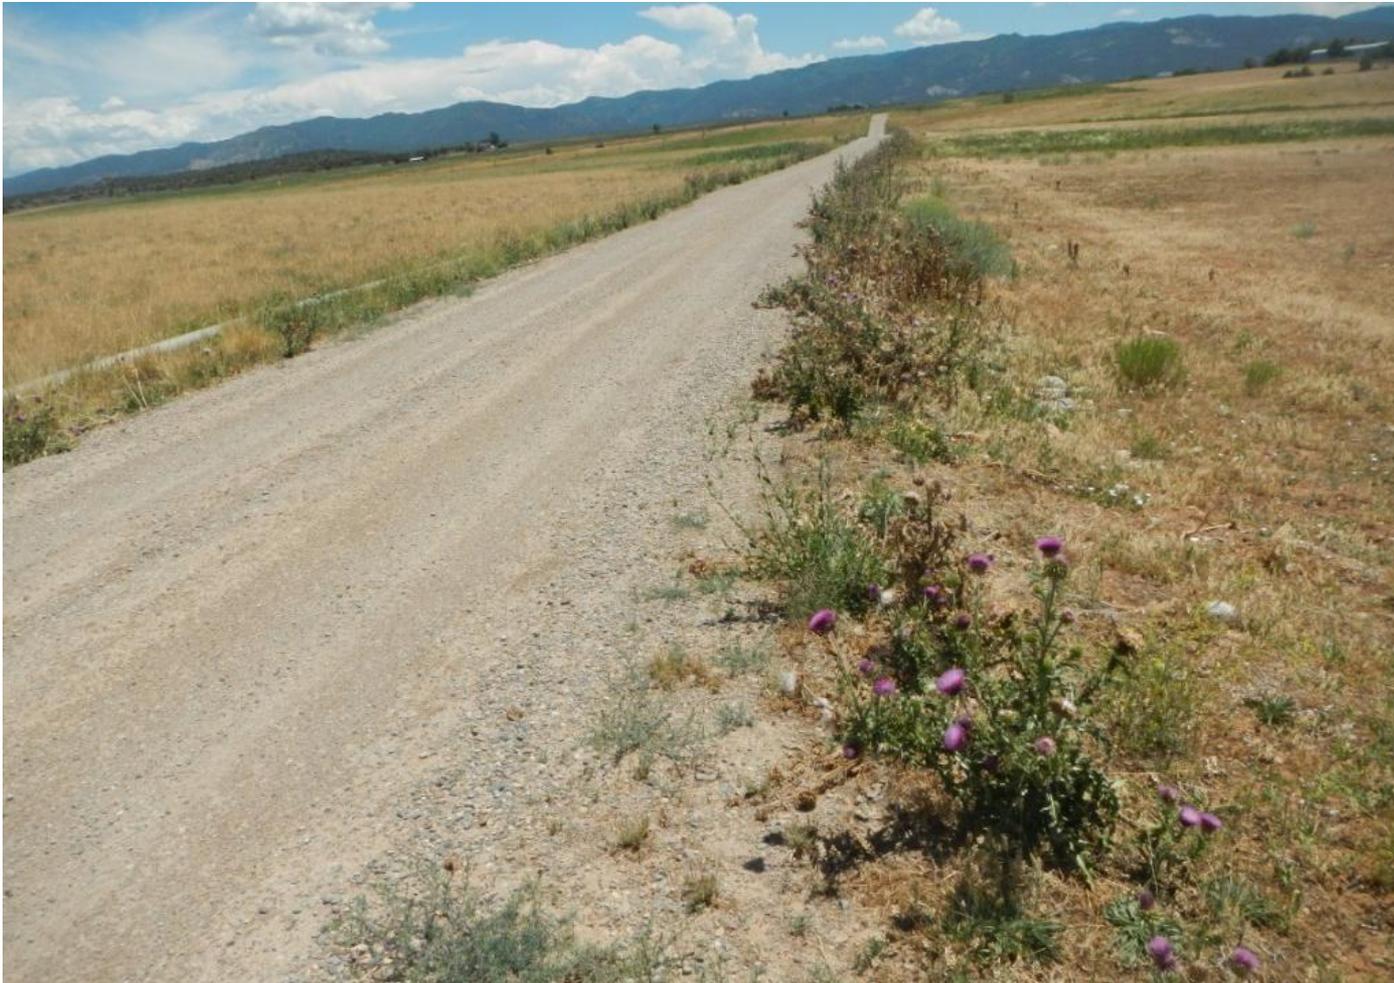
Photo 6. View of the access road near the well pad entrance facing eastward. Thousands of musk thistle are growing along the access road and need to be controlled.
