July 24, 2016

Inspection Photos: TEP Loc# 413683 Youberg SR 43-12

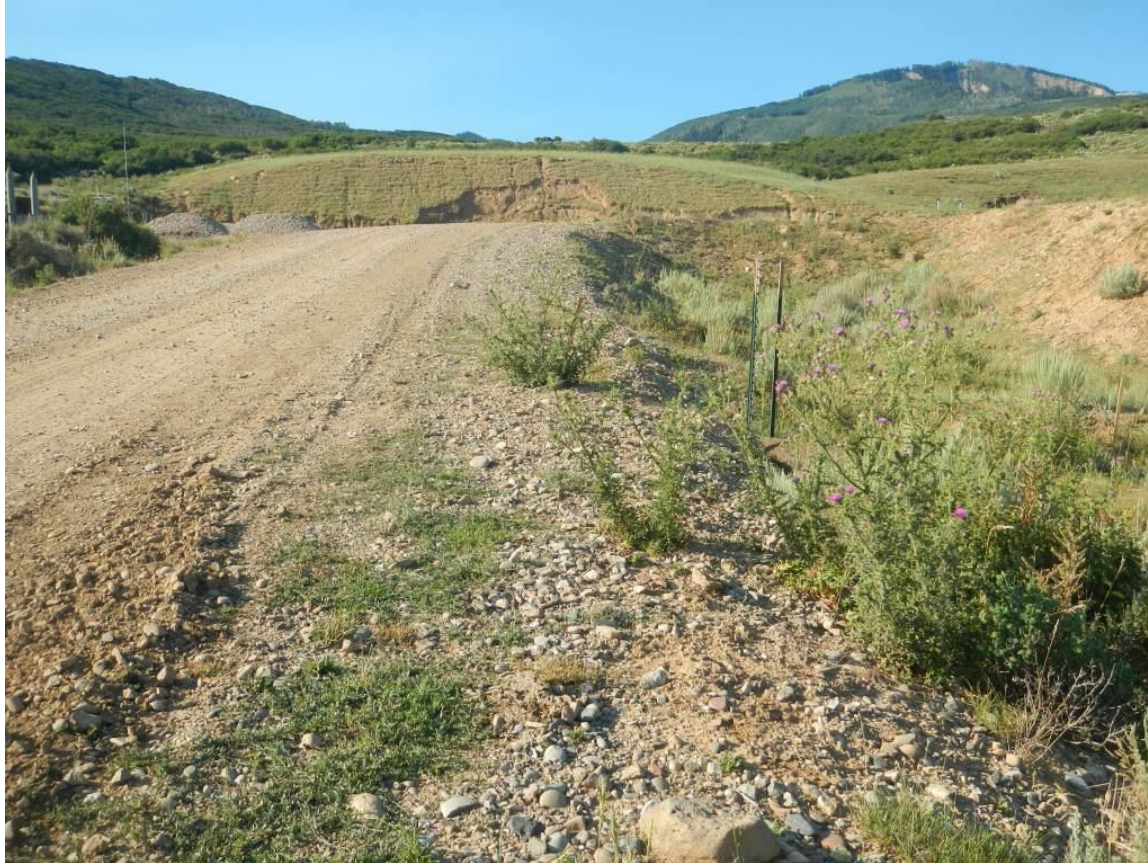
Photo#1: Access Road Entry into Location ; Blooming Musk Thistle lining Road.

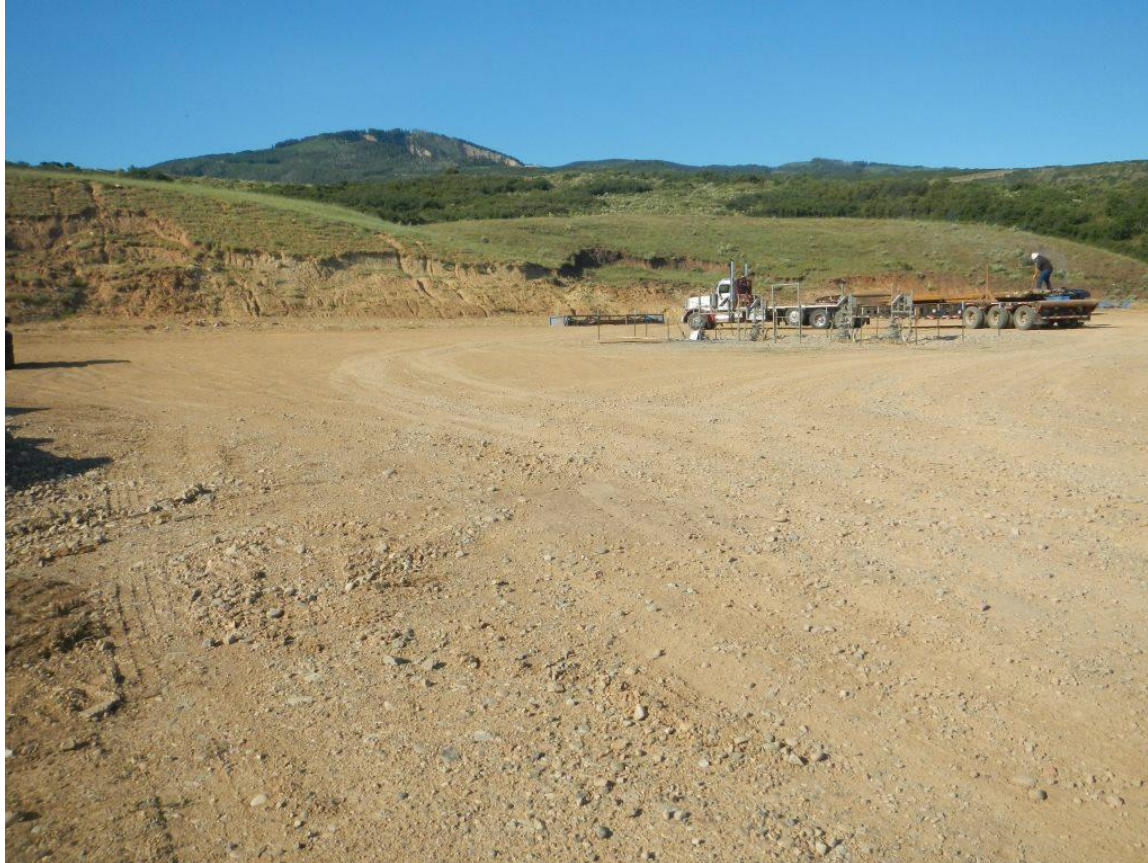
Photo#2: Overview of Location to SE; showing Cut Slope Sloughing /Riling/Channeling SW Concerns.

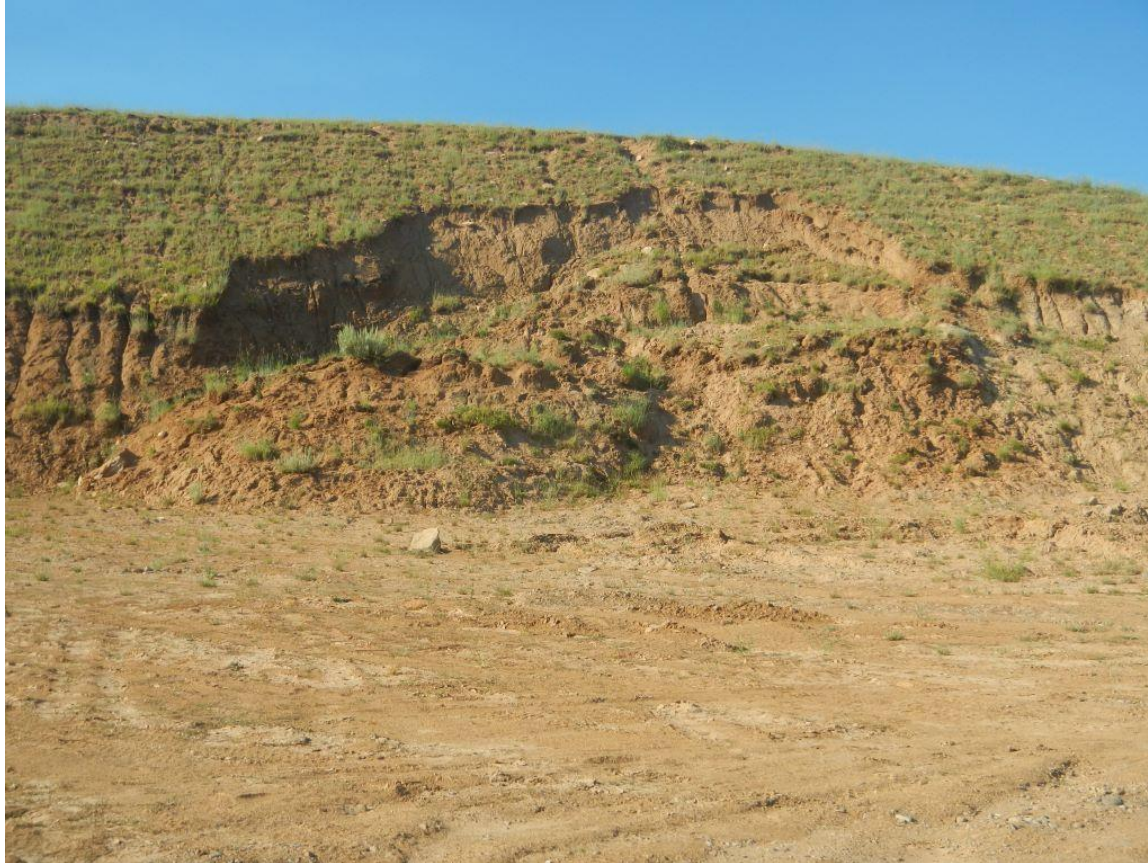
Photo#3: View of one Sloughed area of Cut Slope.

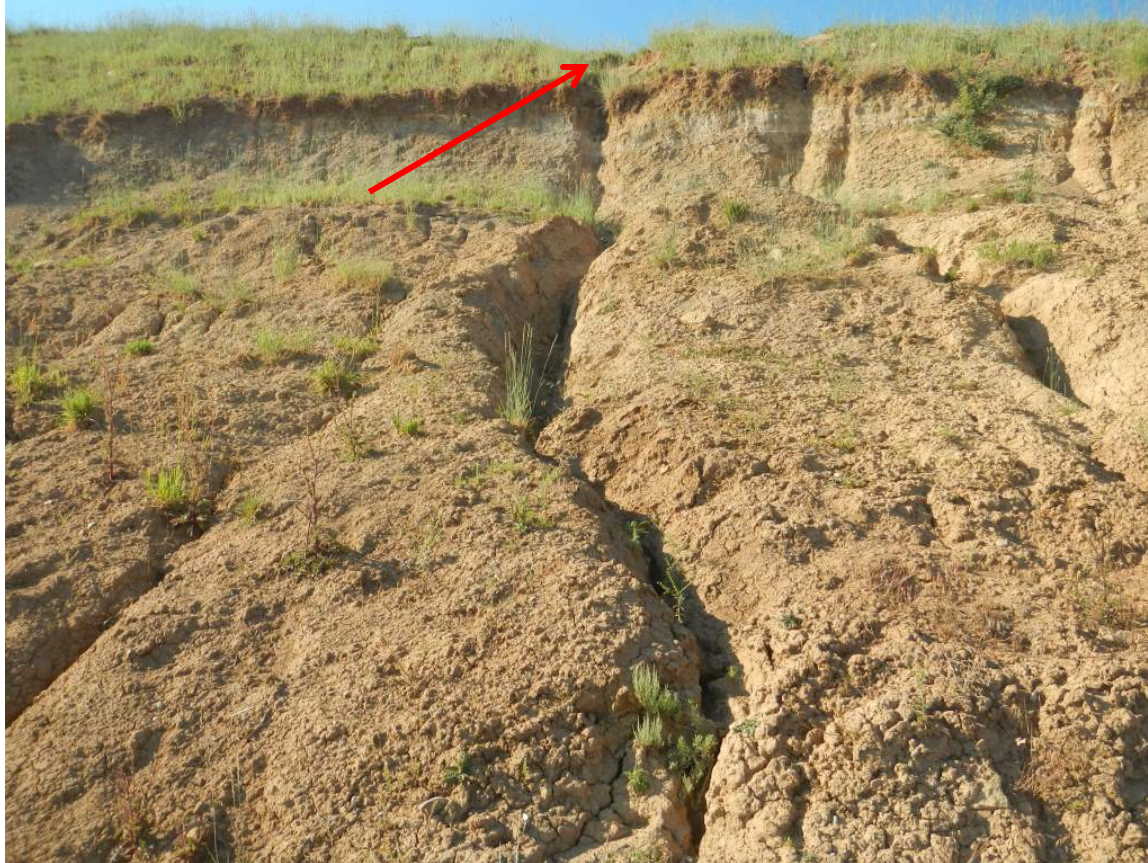
Photo#4: View showing entry point of water causing erosion Channel of sloughed Cut Slope.

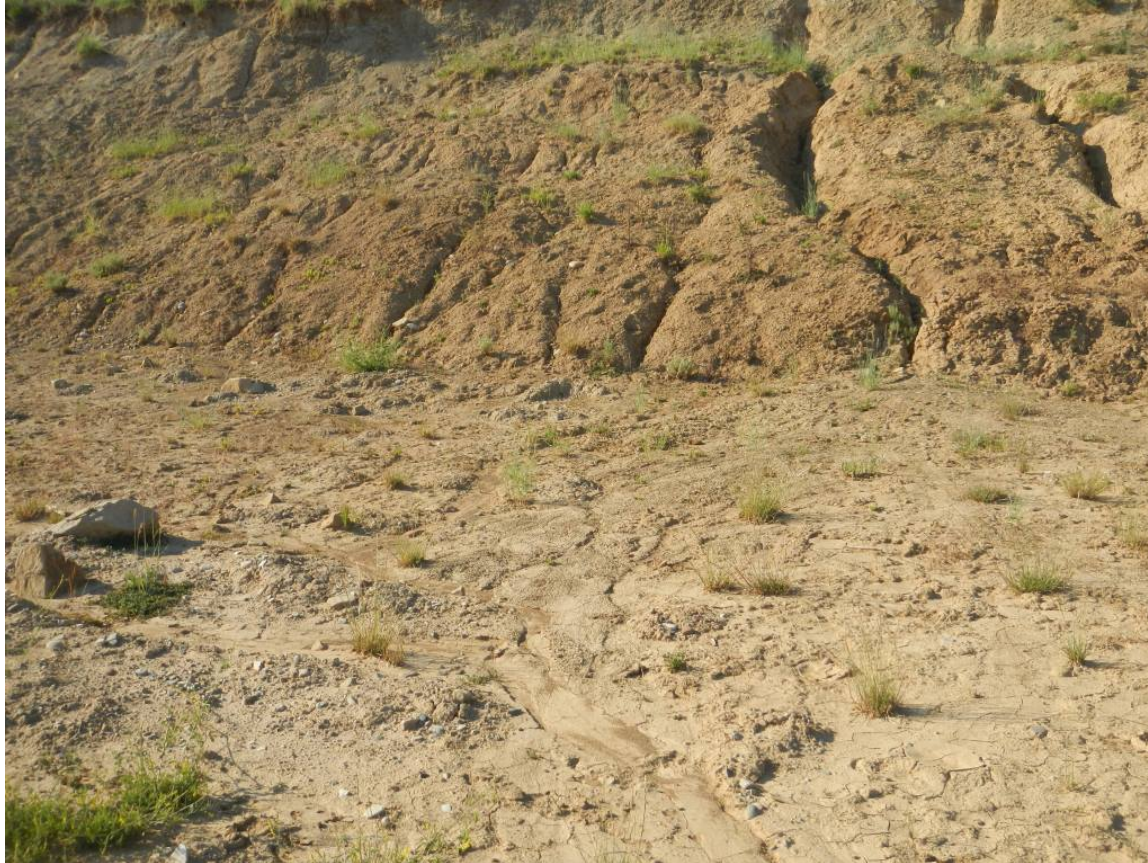
Photo#5: View of Cut Slope Riling, Channeling and Sediment run –On.

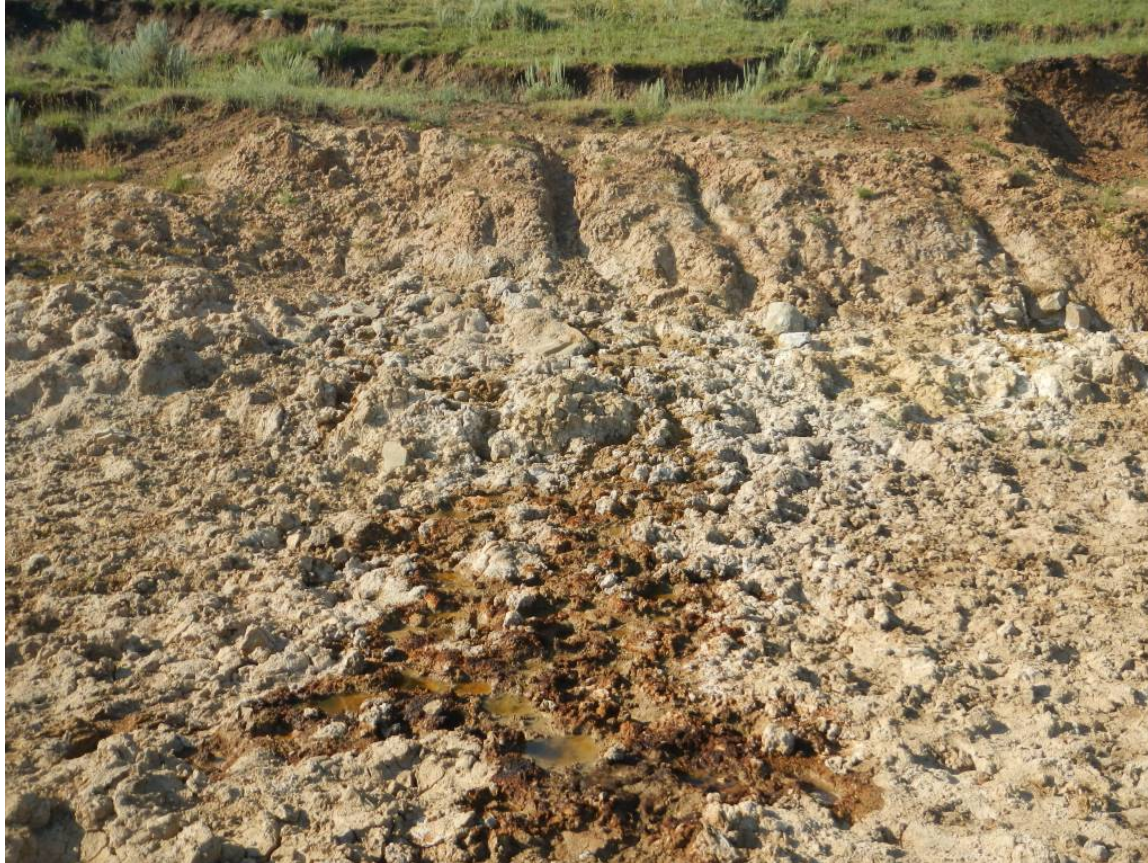
Photo#6: Seep at base of Cut Slope.

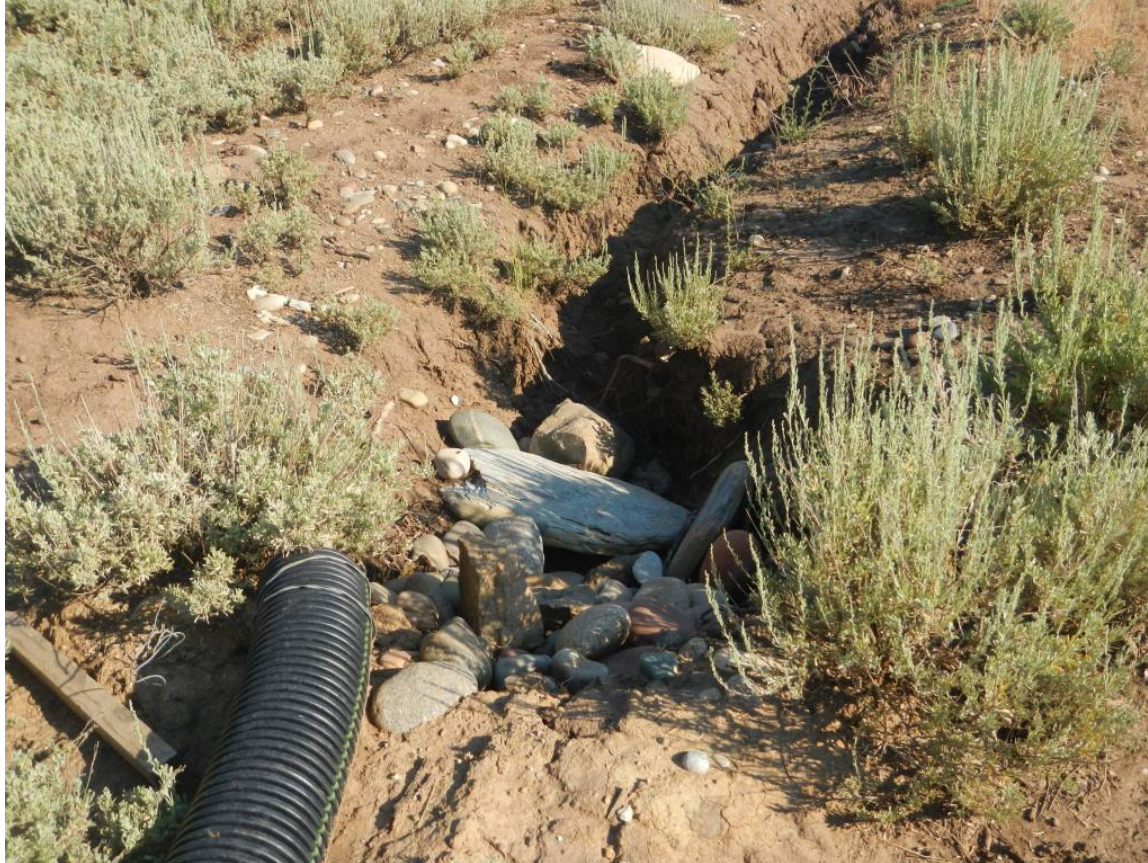
Photo#7: Drain at SW corner at base of Fill deeply into ditch that drains to settlement Pond to NW.

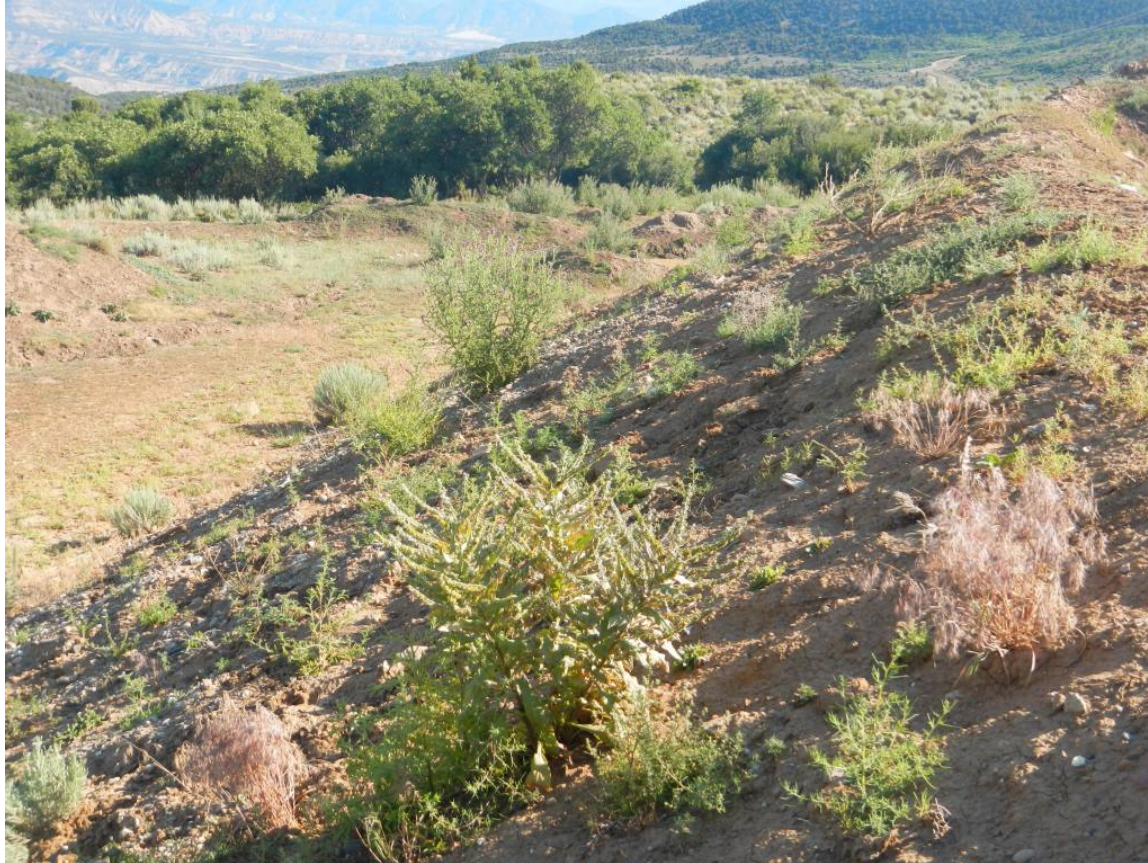
Photo#8: Houndstongue and Musk thistle populating Fill Slope.

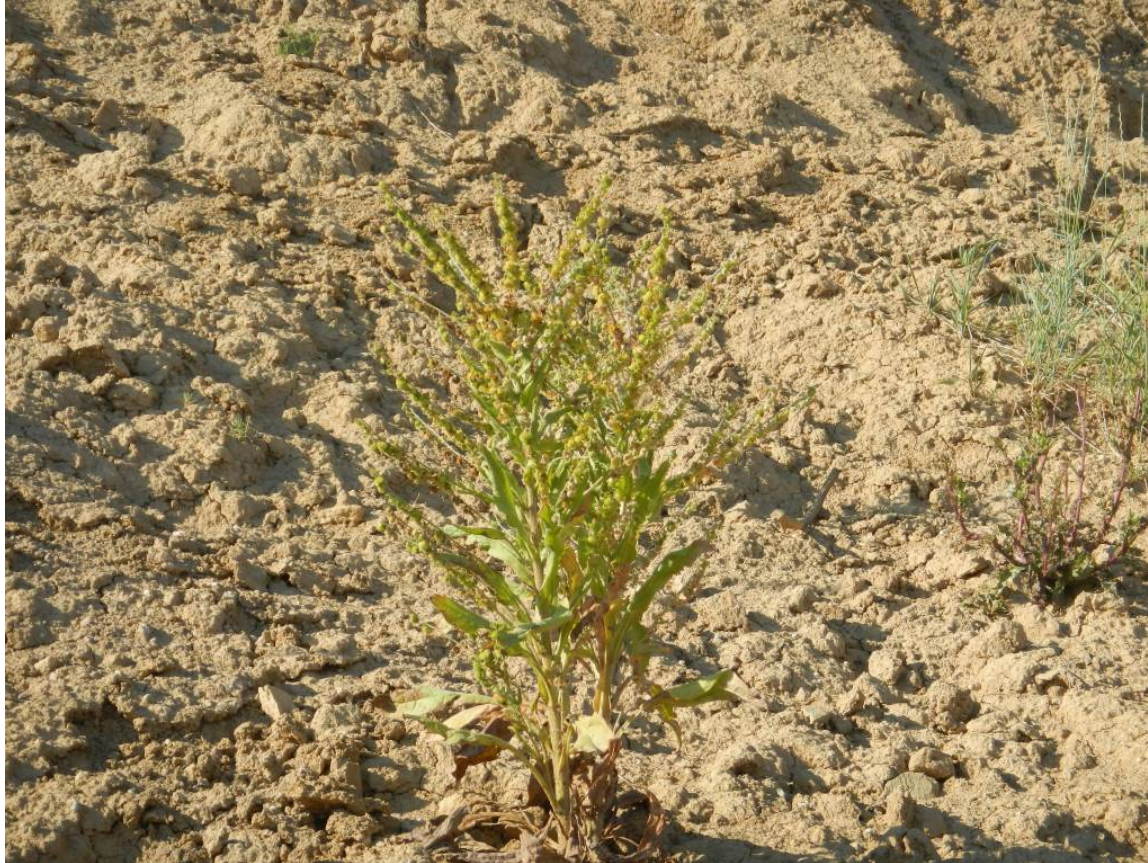
Photo#9: Houndstongue is setting Seed.
