Inspection Photo: Laramie Hooker Loc#335165

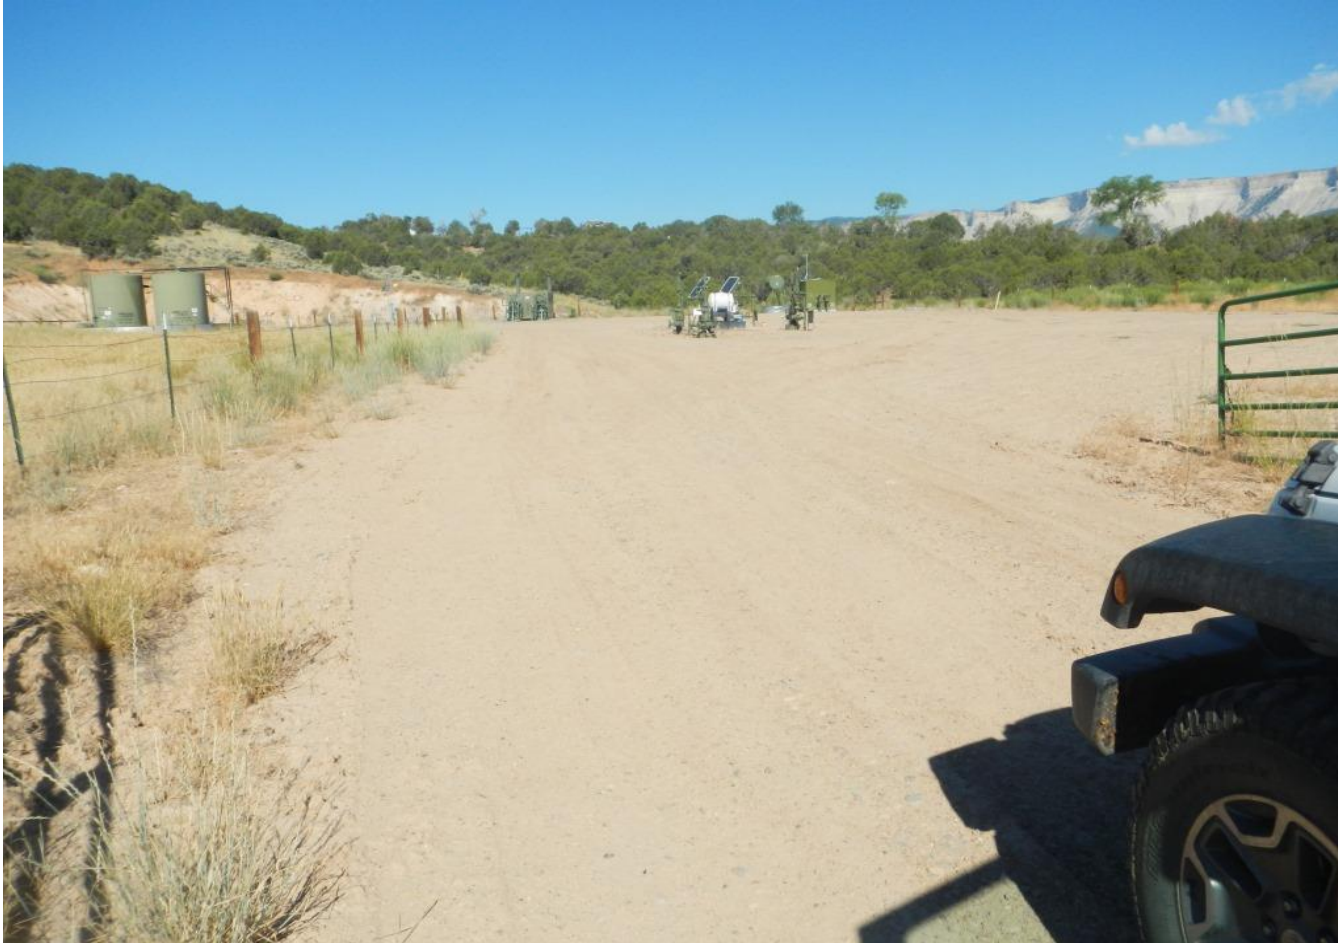
Photo#1: Over view of Location from Entry.

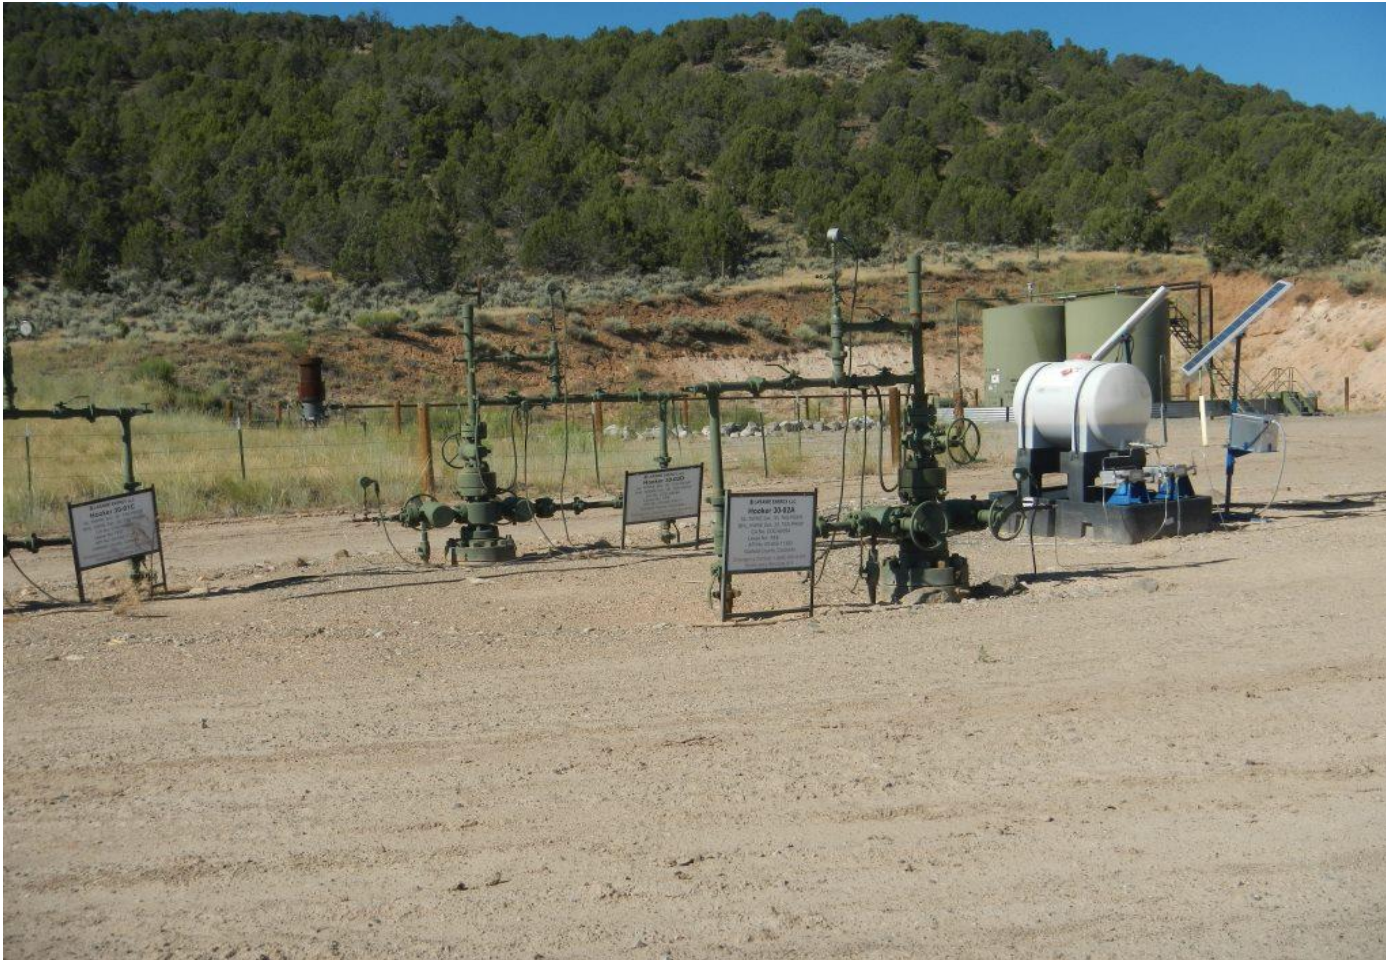
Photo#2: Overview of Wells

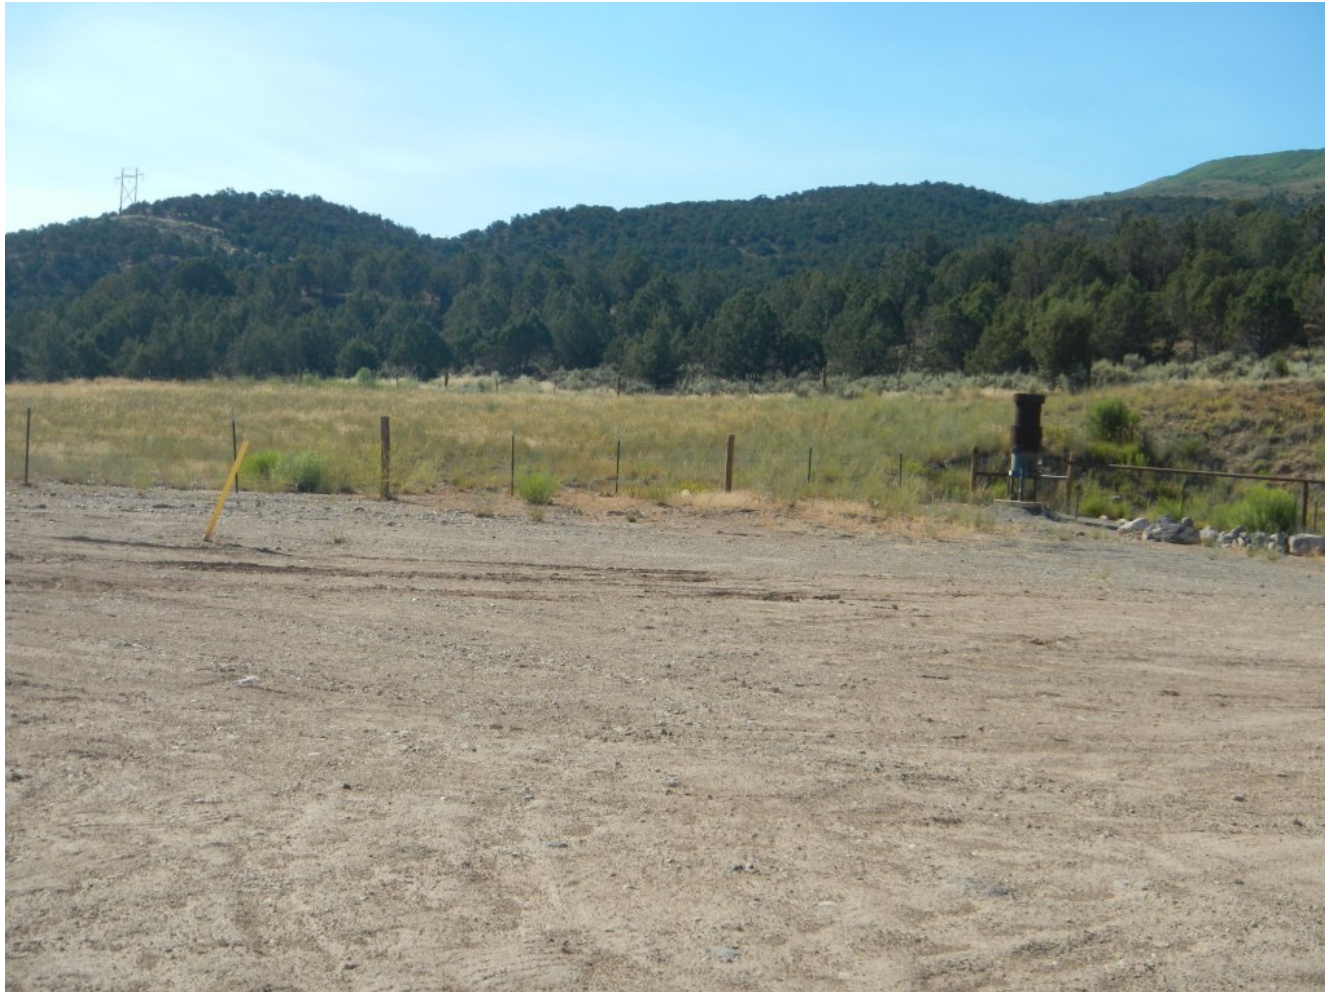
Photo#3: Fenced Interim Reclamation area on East side of Location.

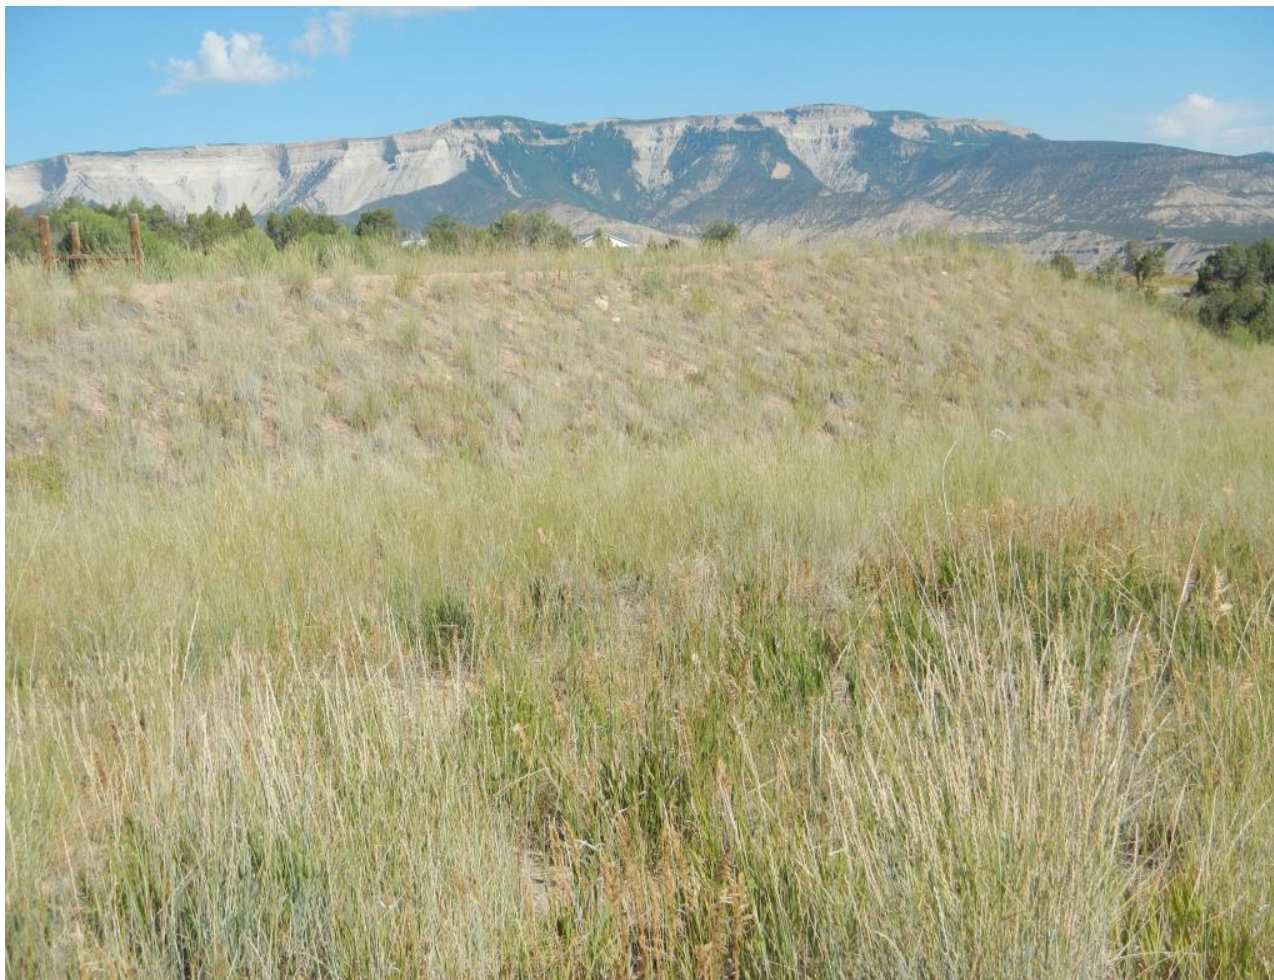
Photo#4: Interim Reclamation Vegetation establishing well in Fill Slope area.
