Construction Inspection

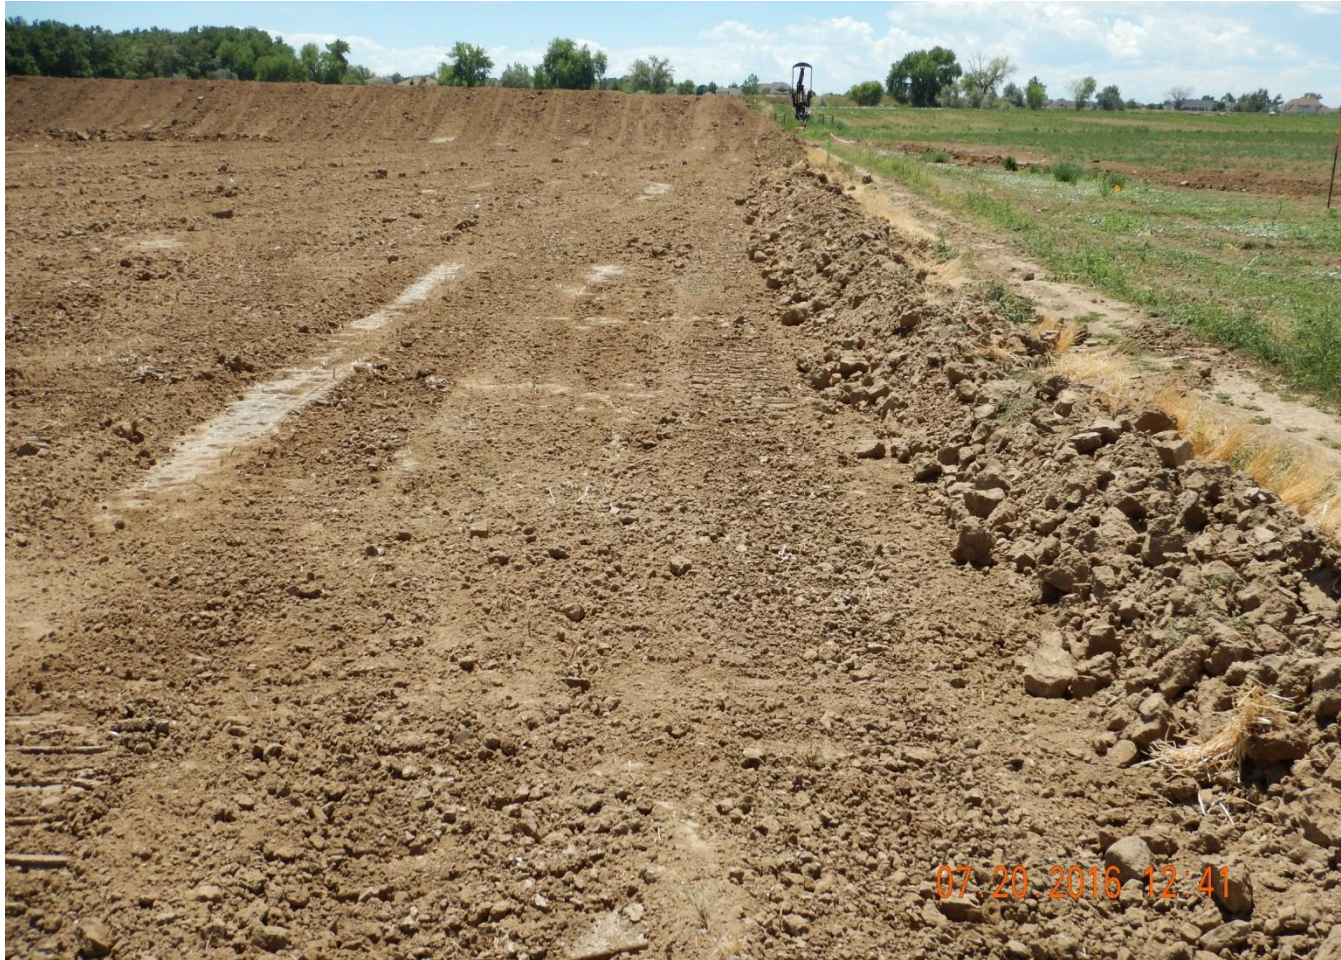
Photo 1. Photo taken from western location, facing South towards topsoil stockpile. Need to stabilize topsoil stockpile upon completion of salvage operations. Unconsolidated berms along perimeter of location need to be compacted.

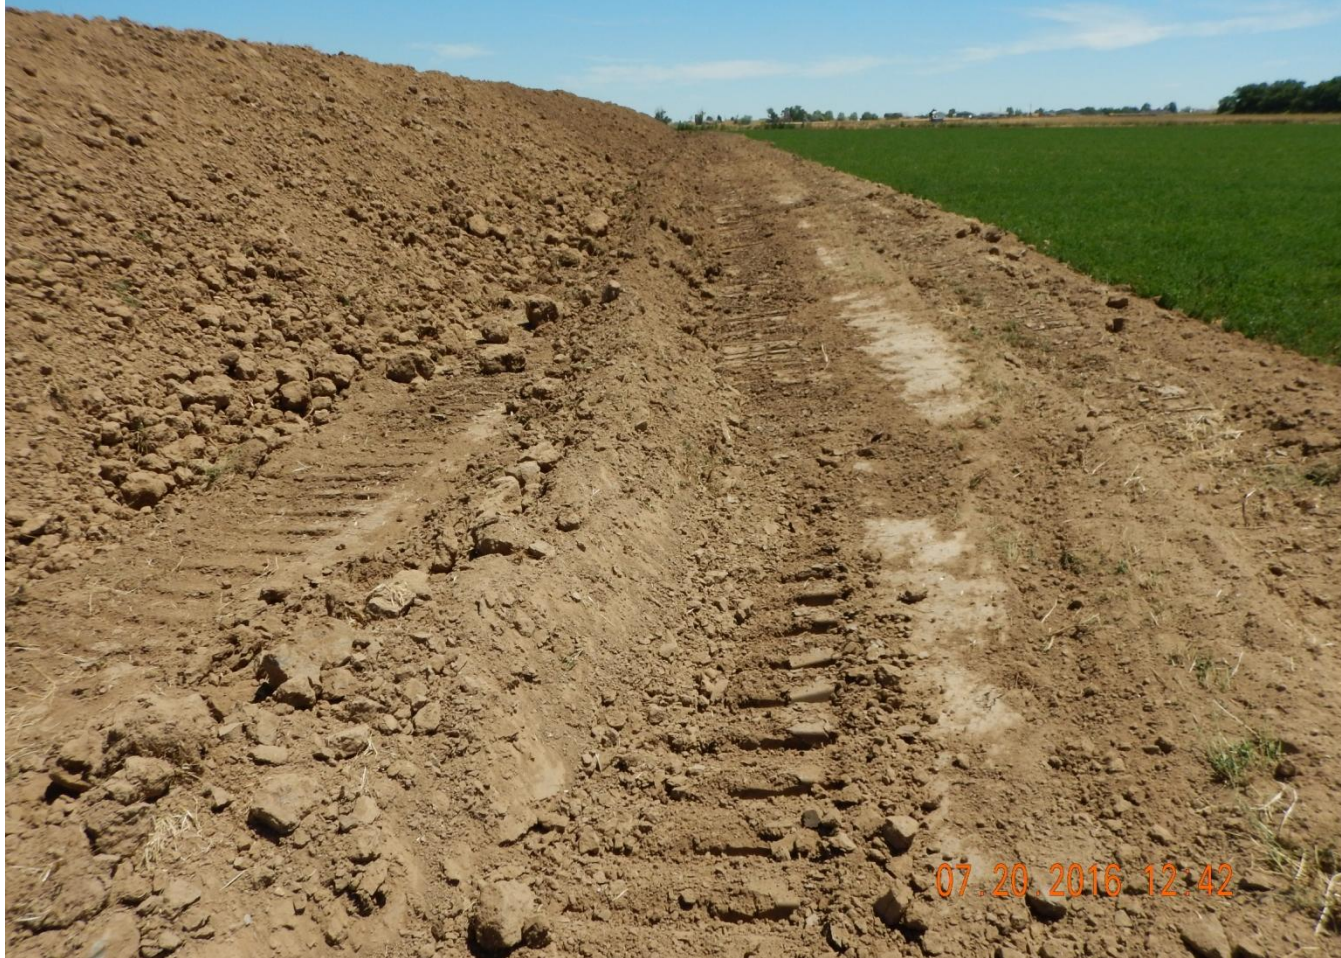
Photo 2. Photo taken from southwest location, facing East. Need to stabilize topsoil stockpile upon completion of salvage operations. Unconsolidated berms along perimeter of location need to be compacted.

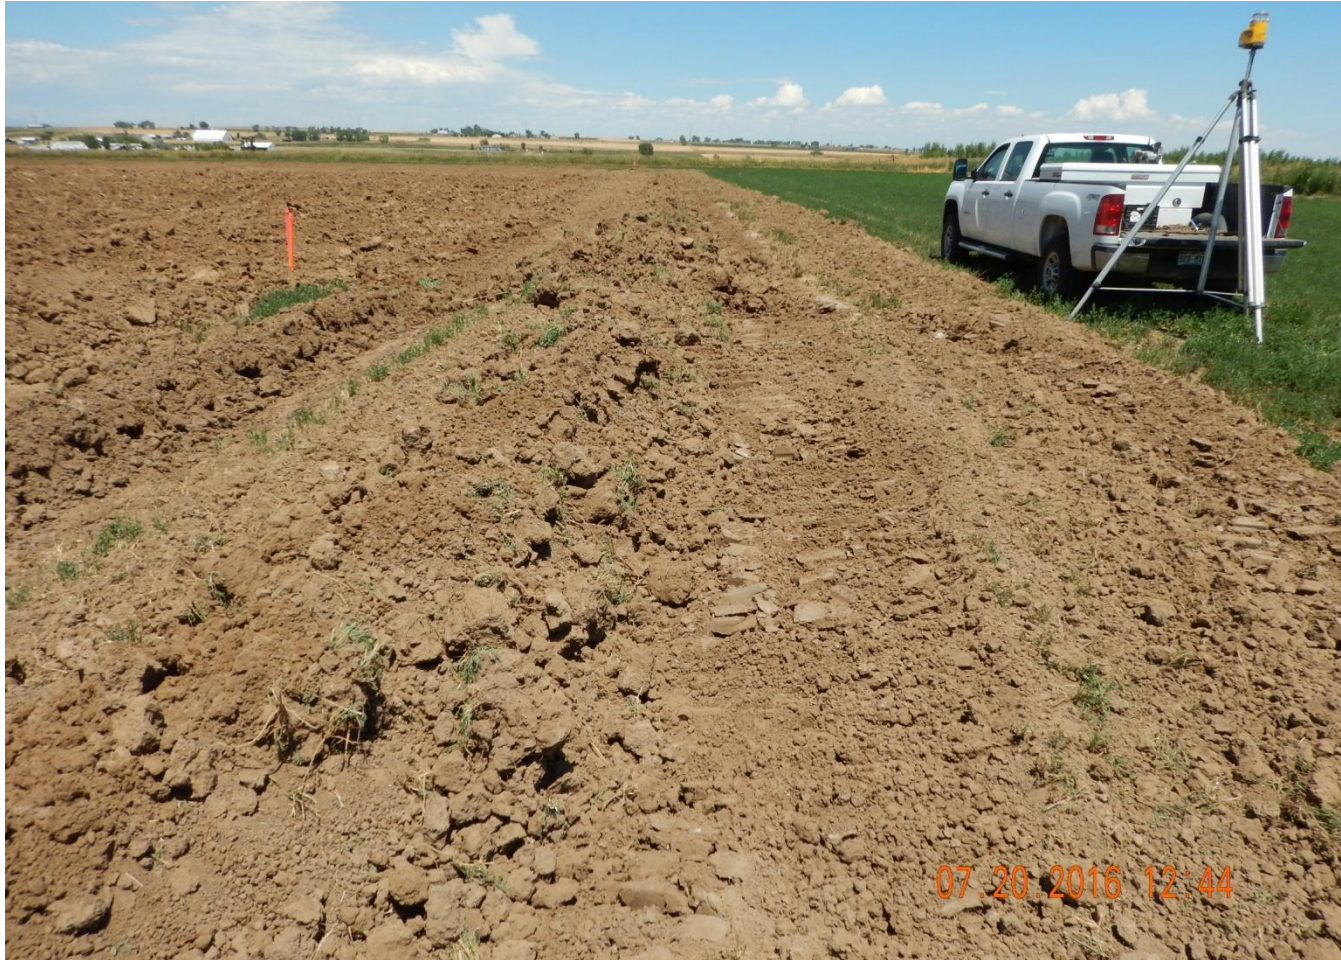
Photo 3. Photo taken from southeast location, facing North. Unconsolidated berms along perimeter of location need to be compacted.

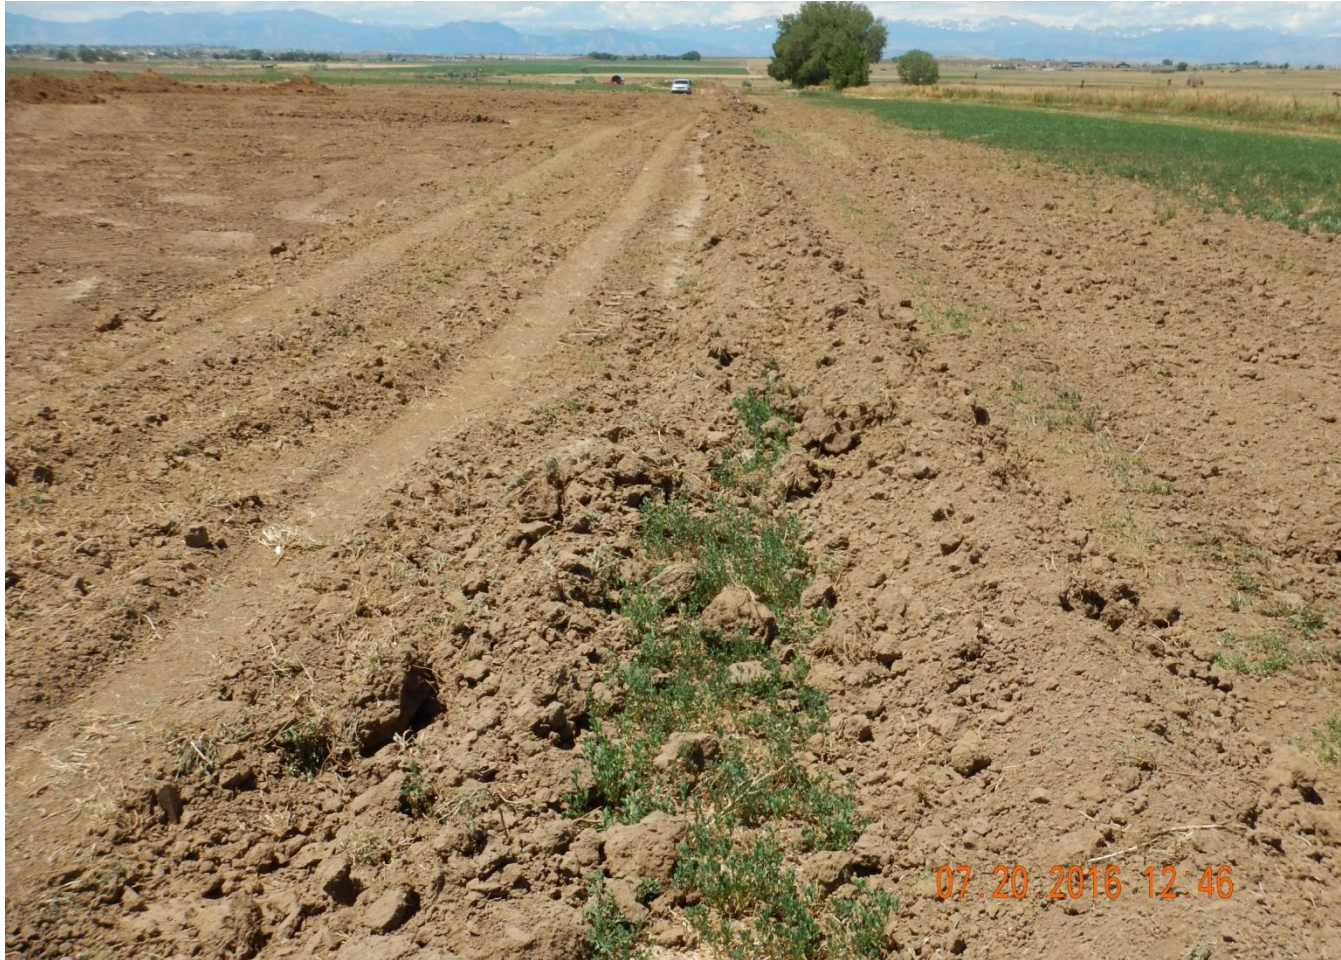
Photo 4. Photo taken from northeast location, facing West. Unconsolidated berms along perimeter of location need to be compacted.
