## Location ID 438023- Follow up inspection

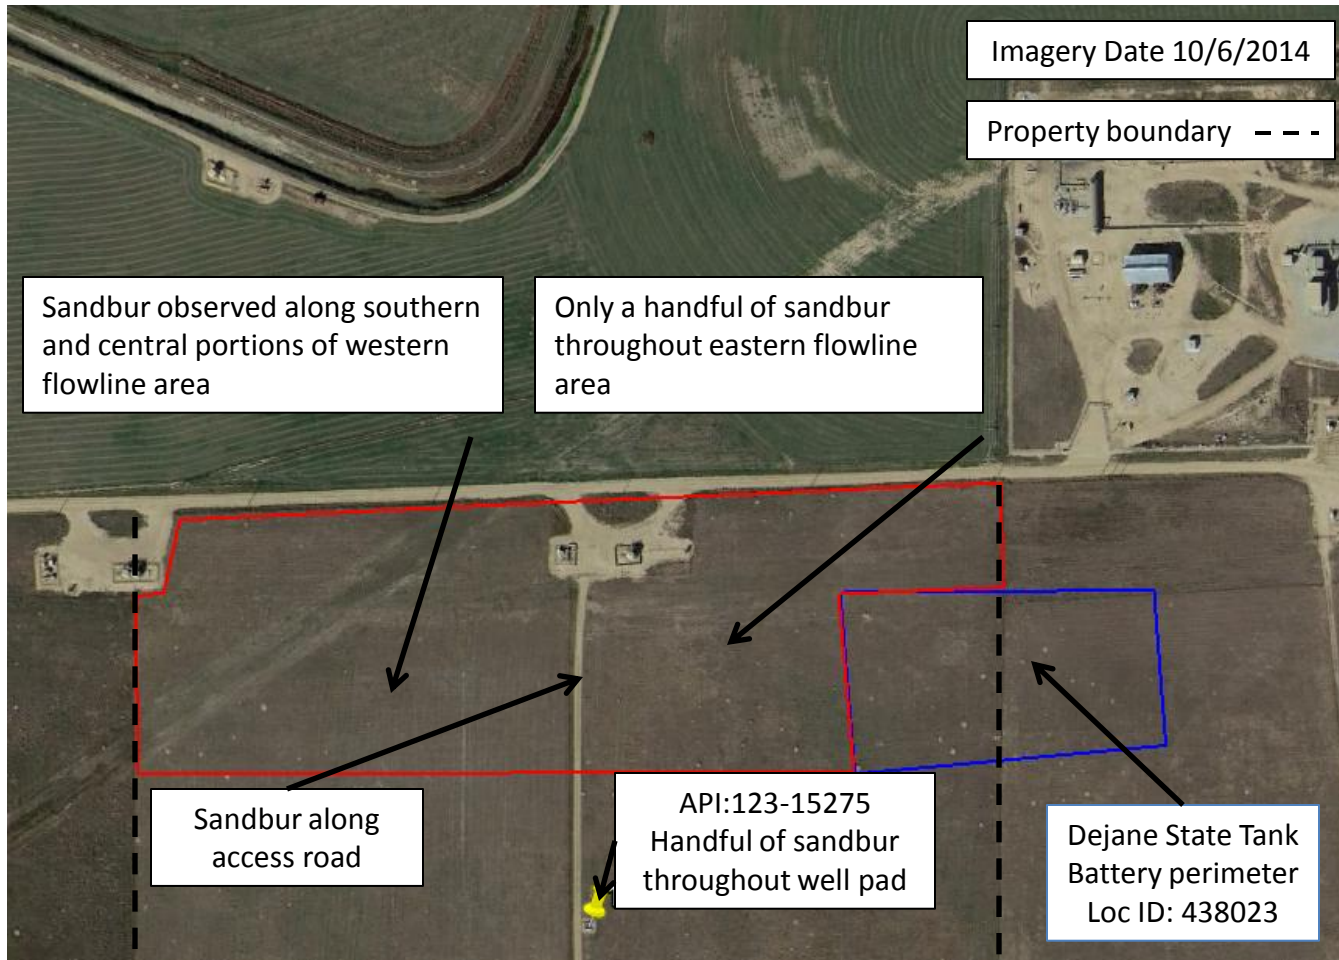
**Photo 1.** Flowline interim reclamation, highlighted in red, is the area of concern regarding the control of longspine sandbur (*Cenchrus longispinus*). Western flowline has patches of sandbur along the southern and central area that need to be controlled ASAP. Also, sandbur was found along the access road to the well pad (API: 123-15275), and only a small handful of individual observed throughout the eastern flowline and well pad area.

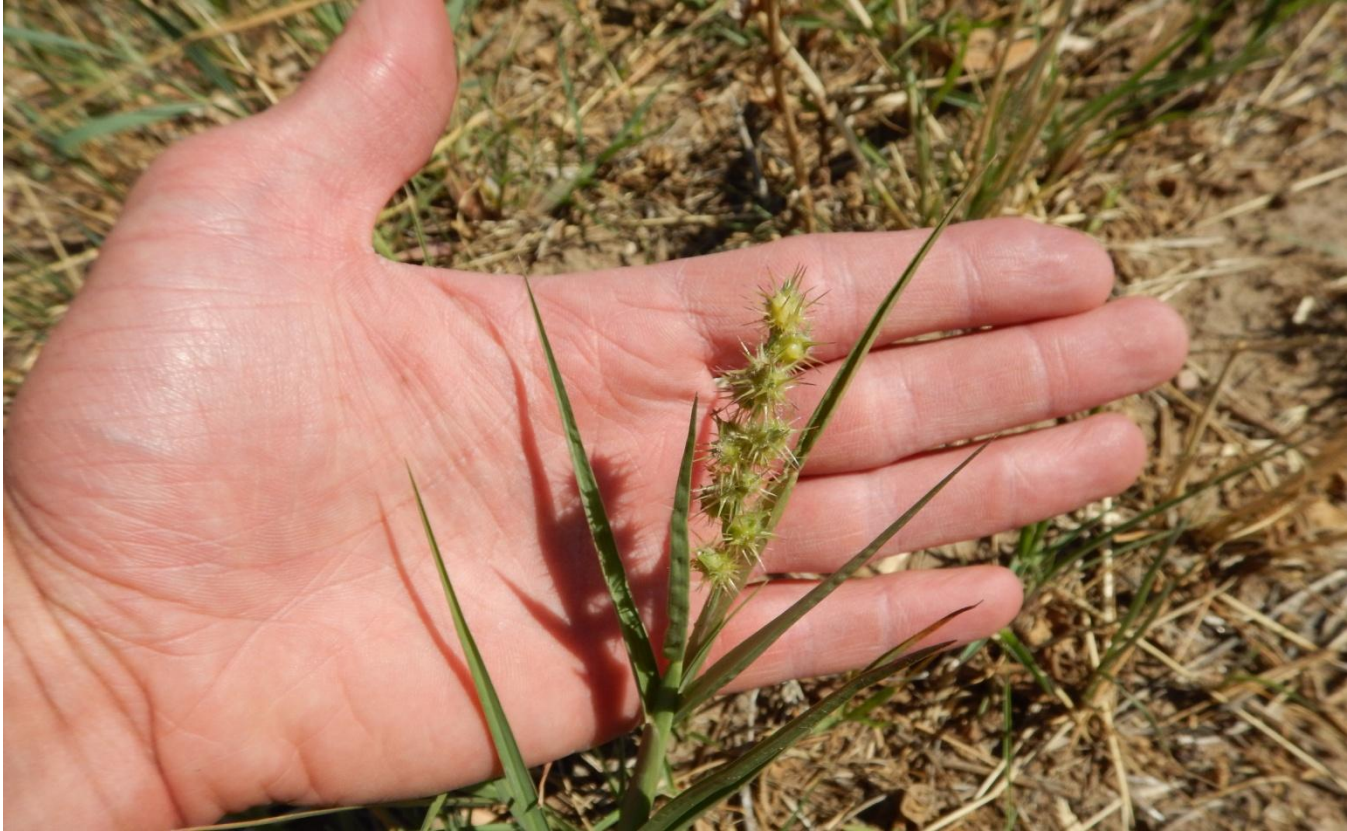
**Photo 2.** Close up photo taken from western flowline area of an individual sandbur.

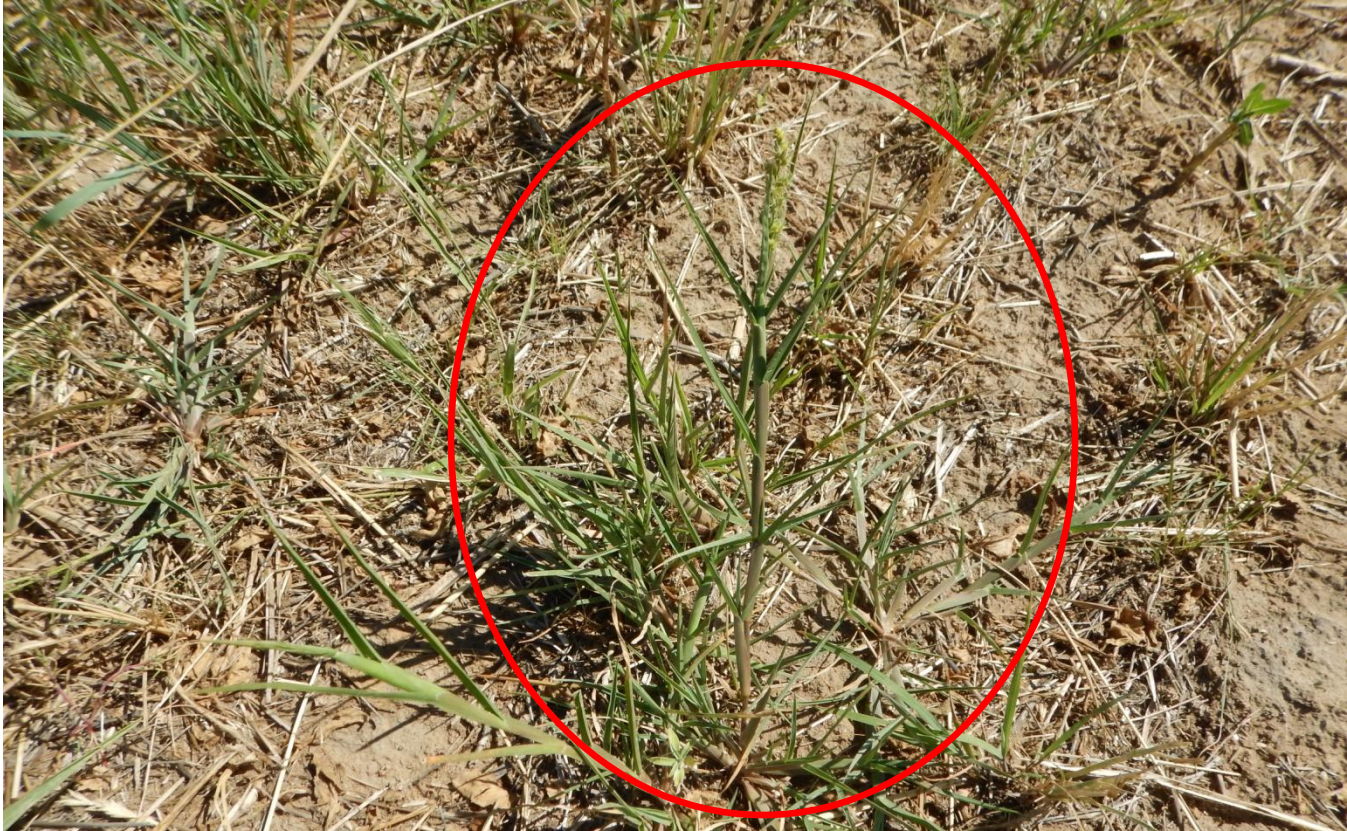
**Photo 3.** Photo taken from western flowline area of an individual sandbur.

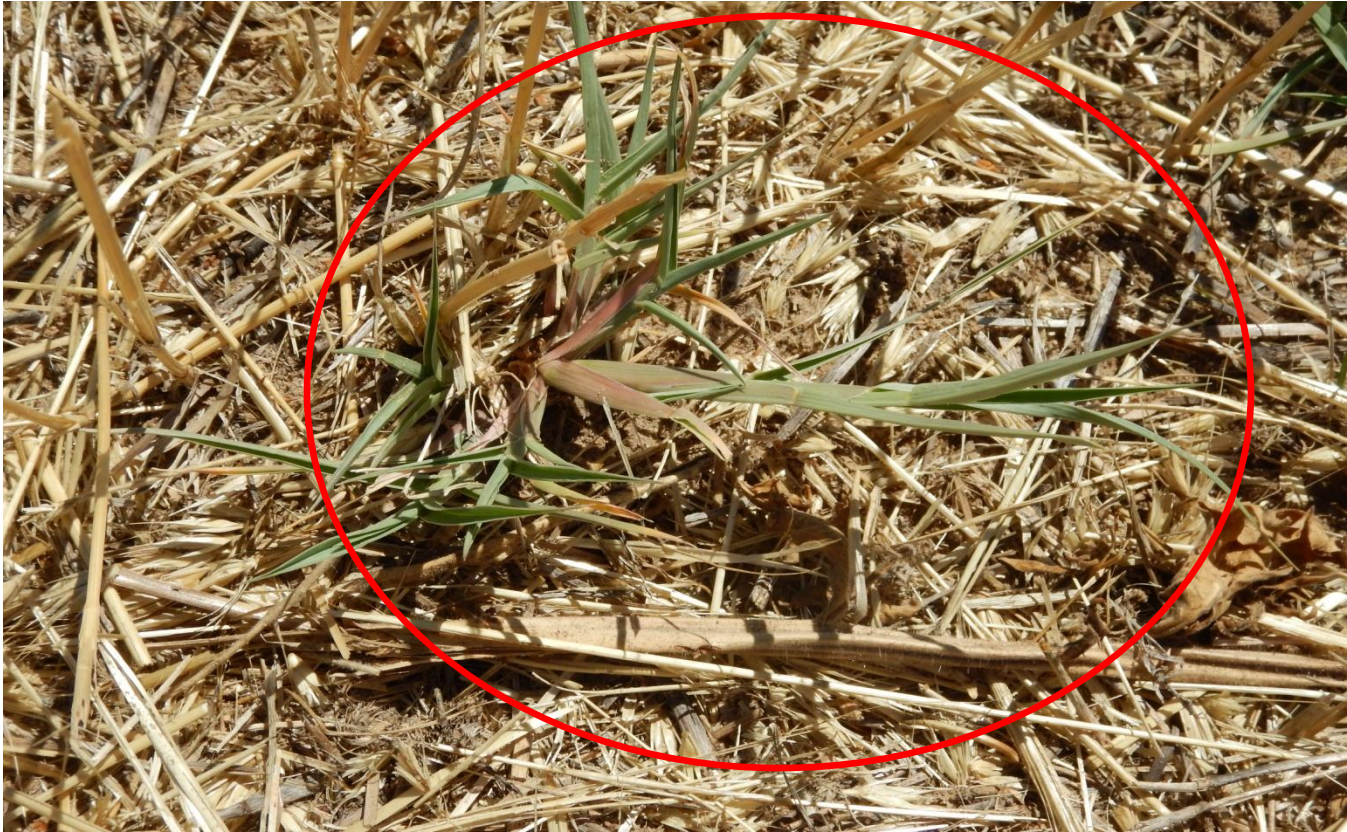
**Photo 4.** Photo taken from the well pad (API: 123-15275) area of an individual sandbur.

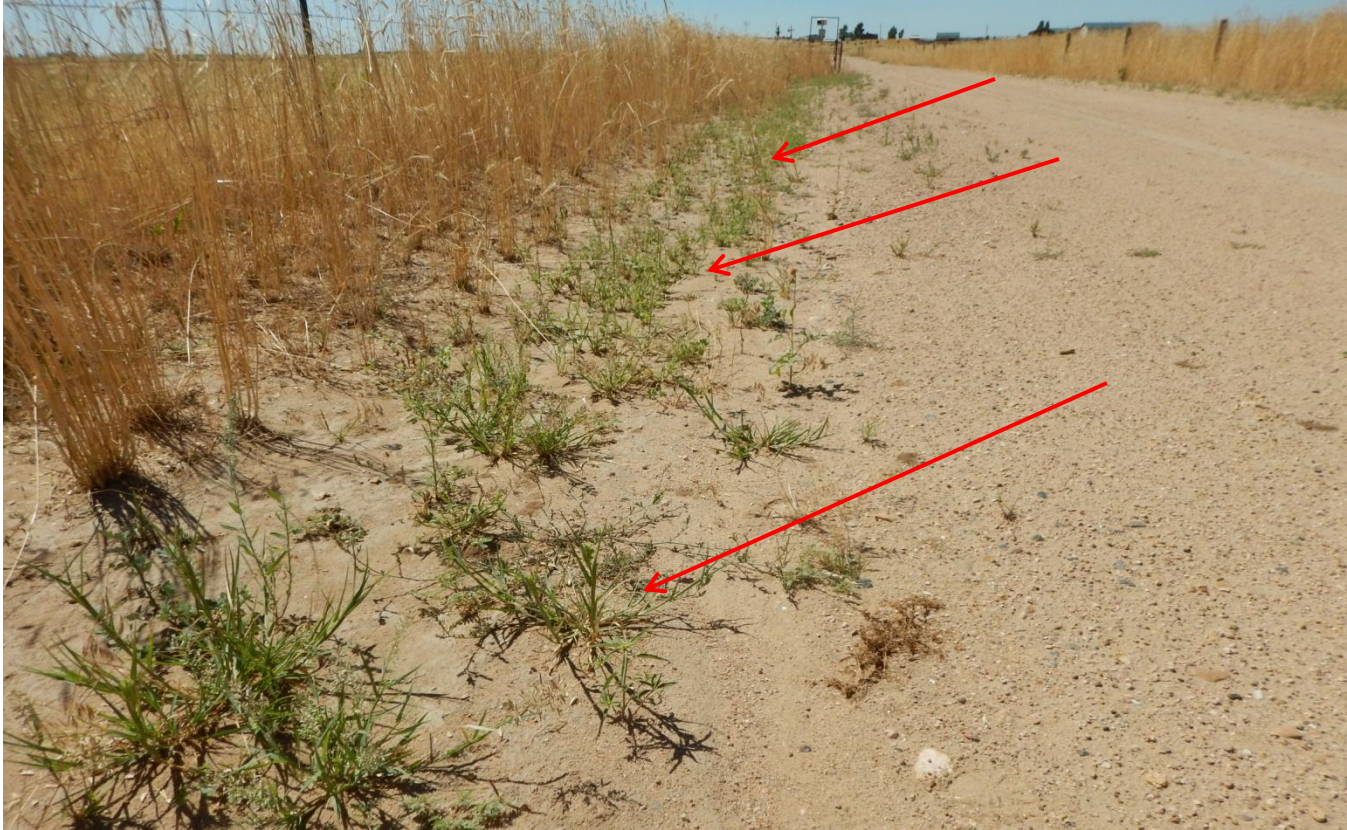
**Photo 5.** Photo taken along the eastern side of the access road, facing South, illustrating longspine sandbur establishment.
