# Final Reclamation Inspection

07/19/2016

Operator: Denver East Machinery co

Location ID: 390528

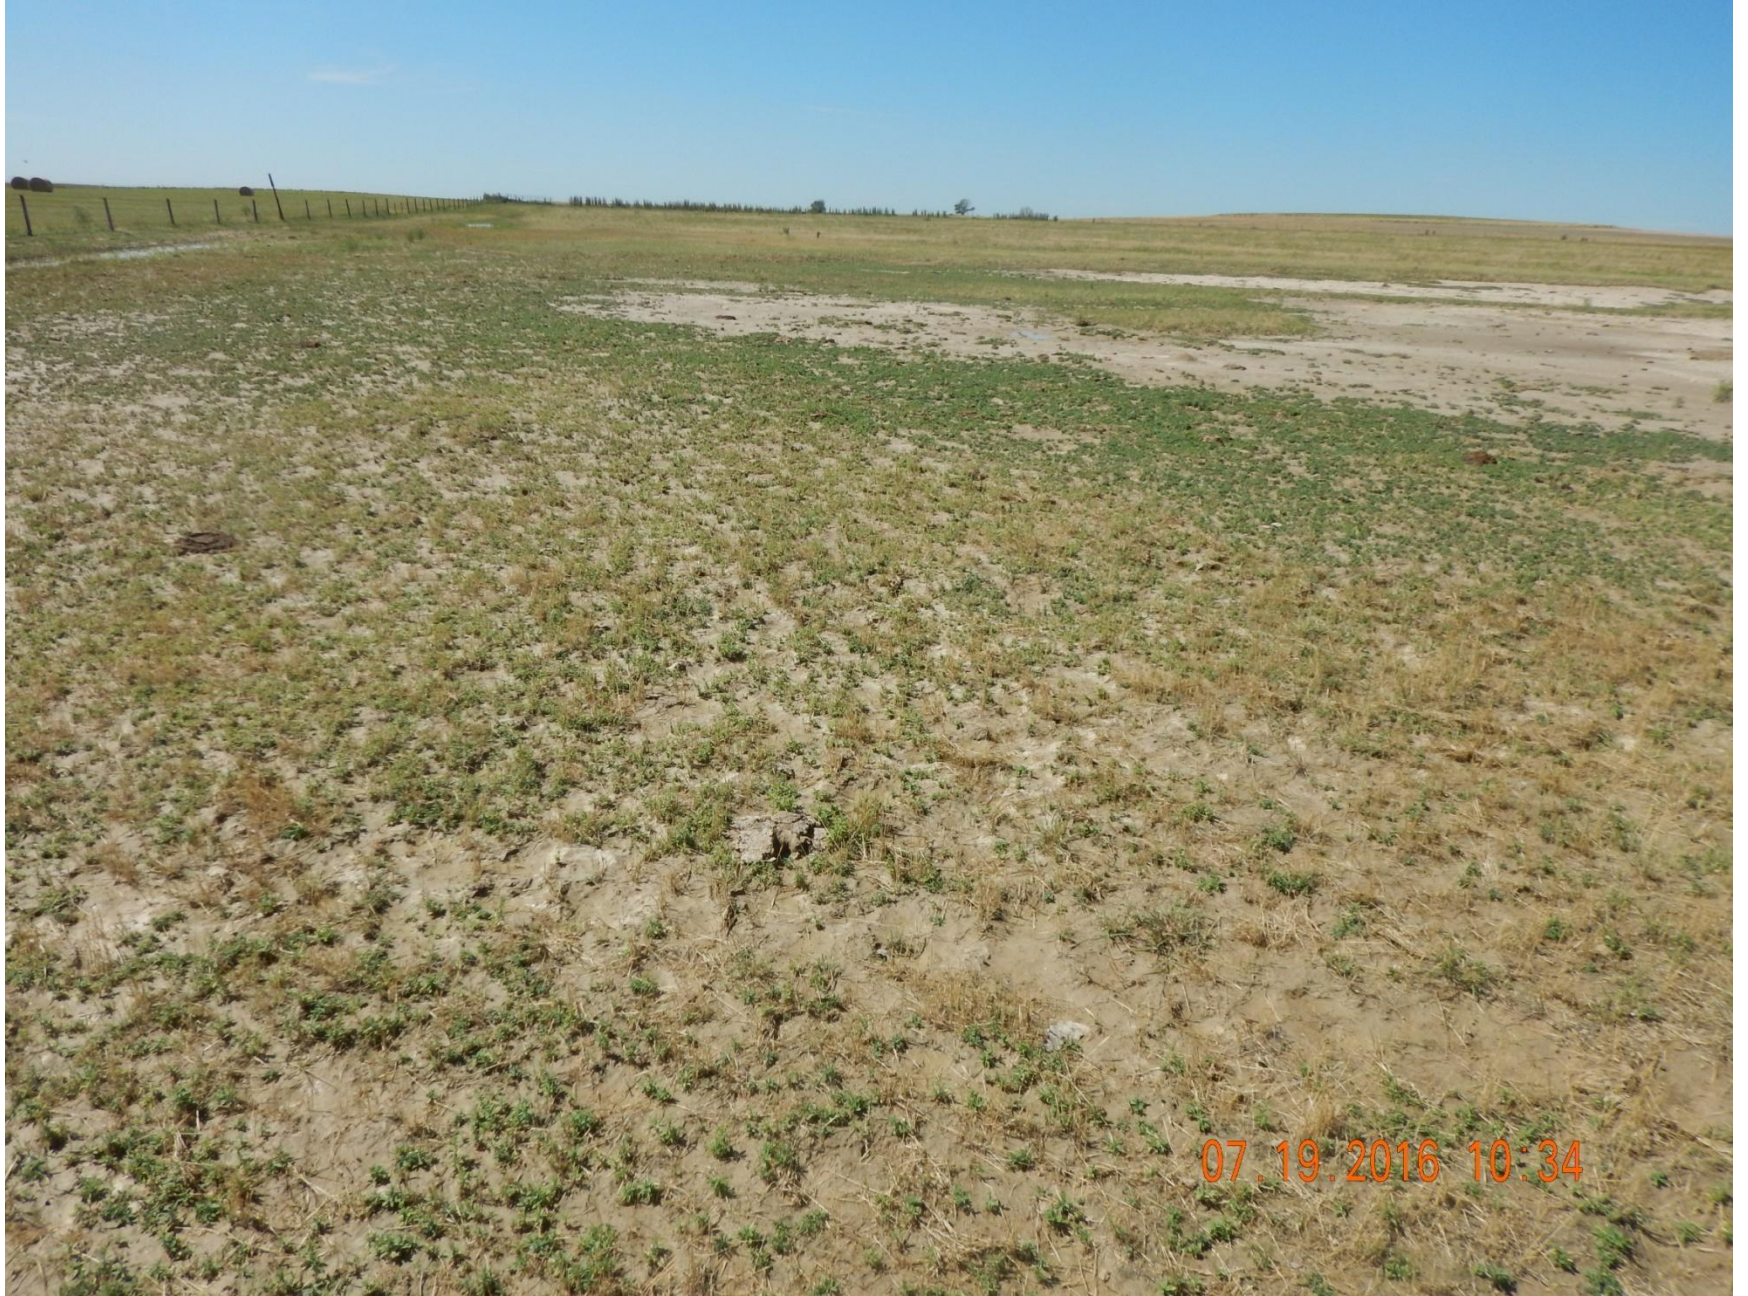
**Figure 1:** Photo taken from the east end of the degradation area, facing south. Photo shows areas of degradation due to possible salt kill from the location.

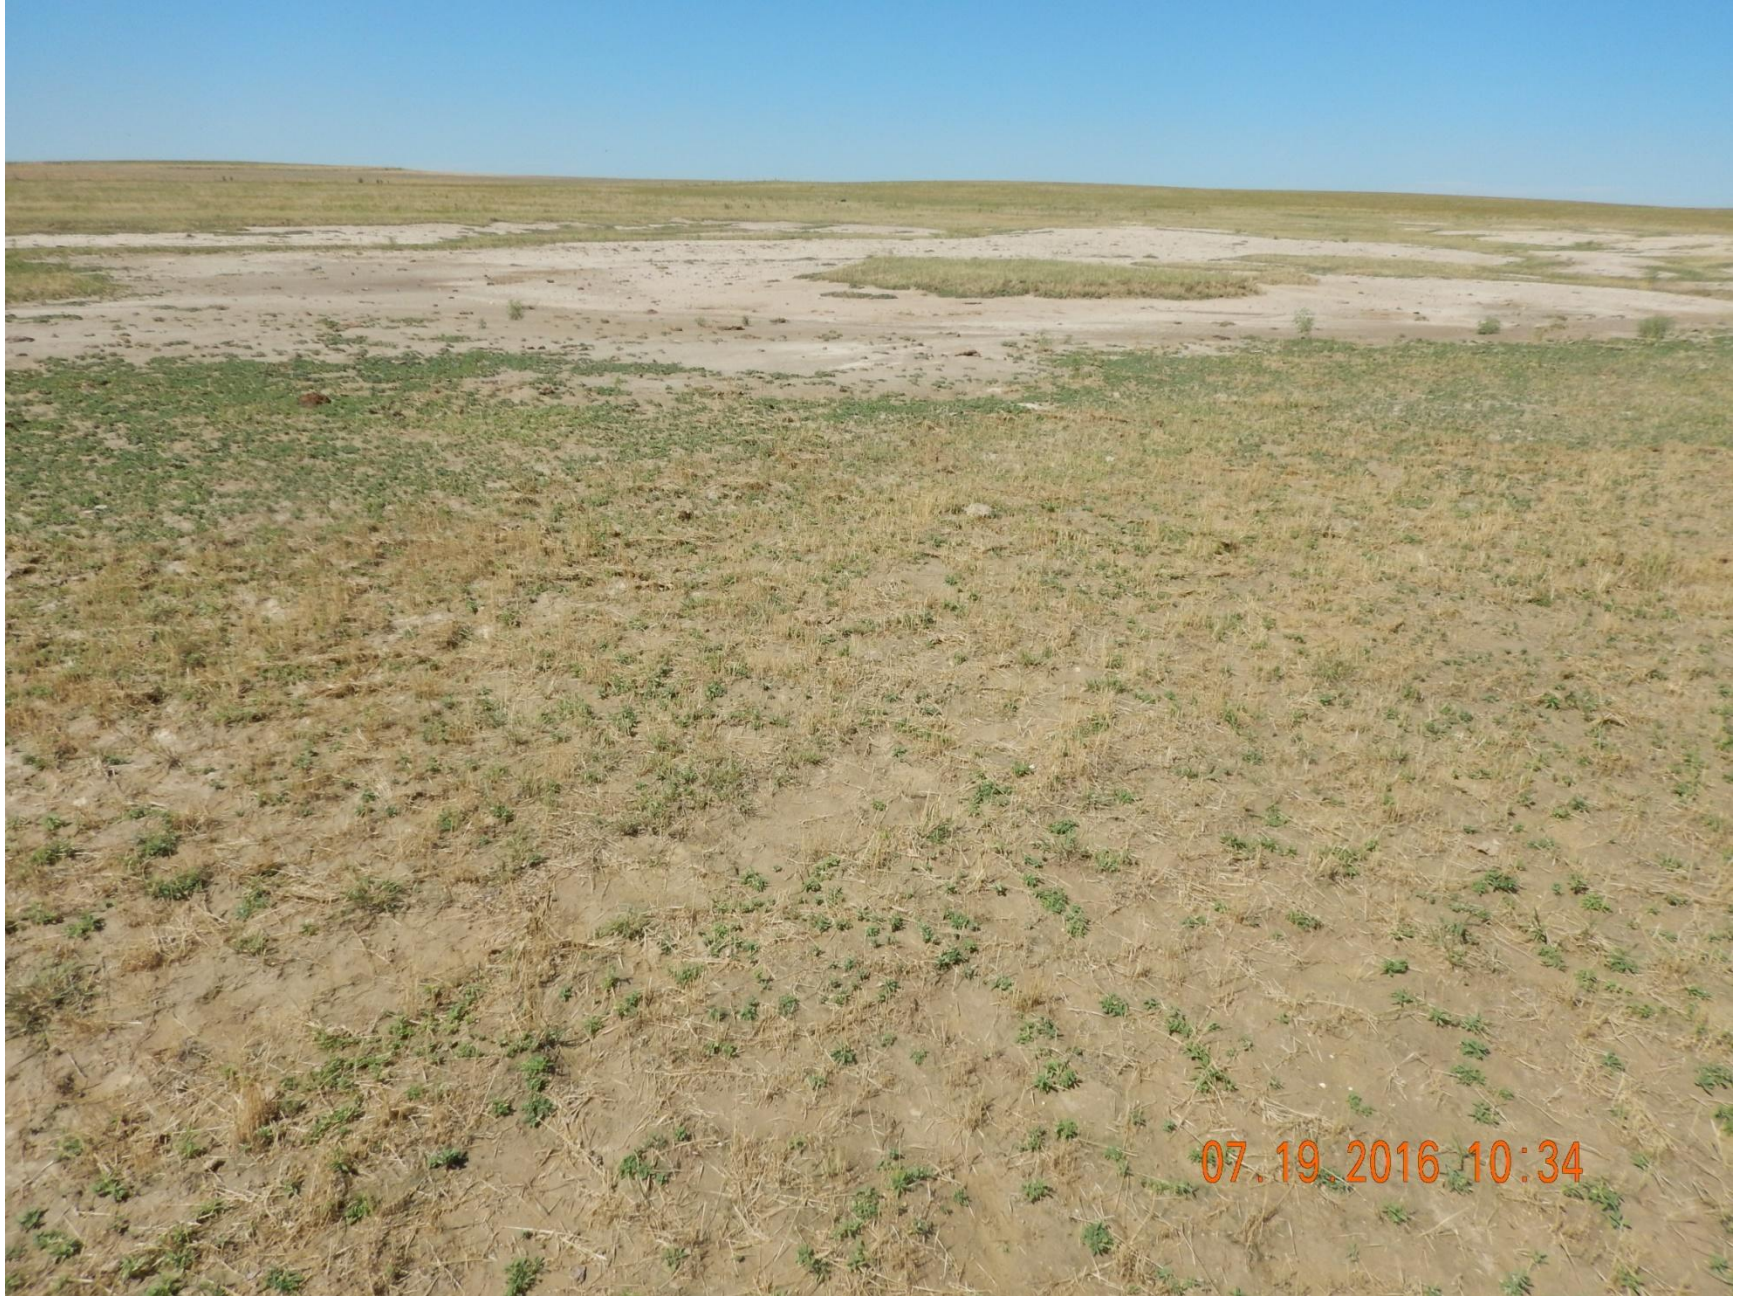
**Figure 2:** Photo taken from the east end of the degradation area, facing west. Photo shows areas of degradation due to possible salt kill from the location.

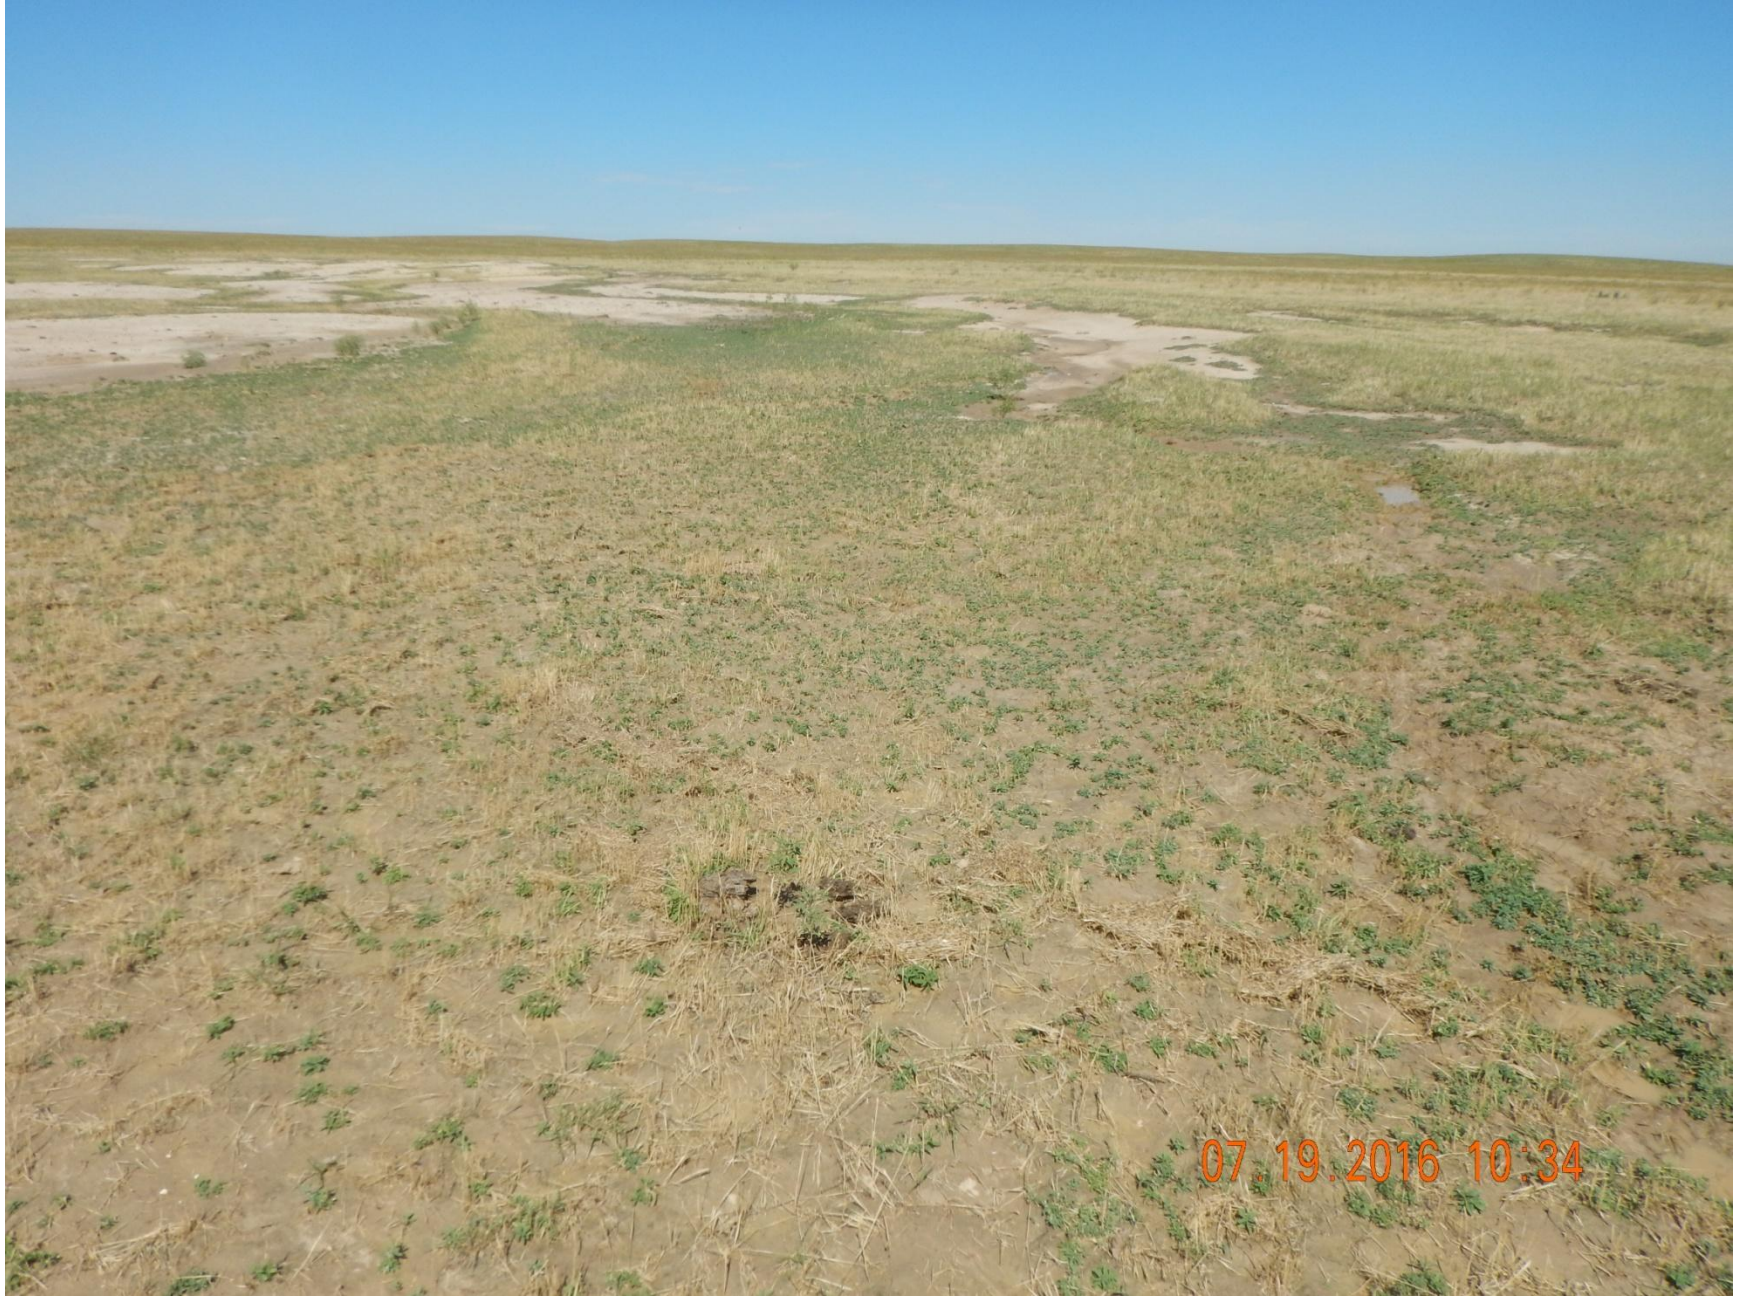
**Figure 3:** Photo taken from the east end of the degradation area, facing northwest. Photo shows areas of degradation due to possible salt kill from the location.

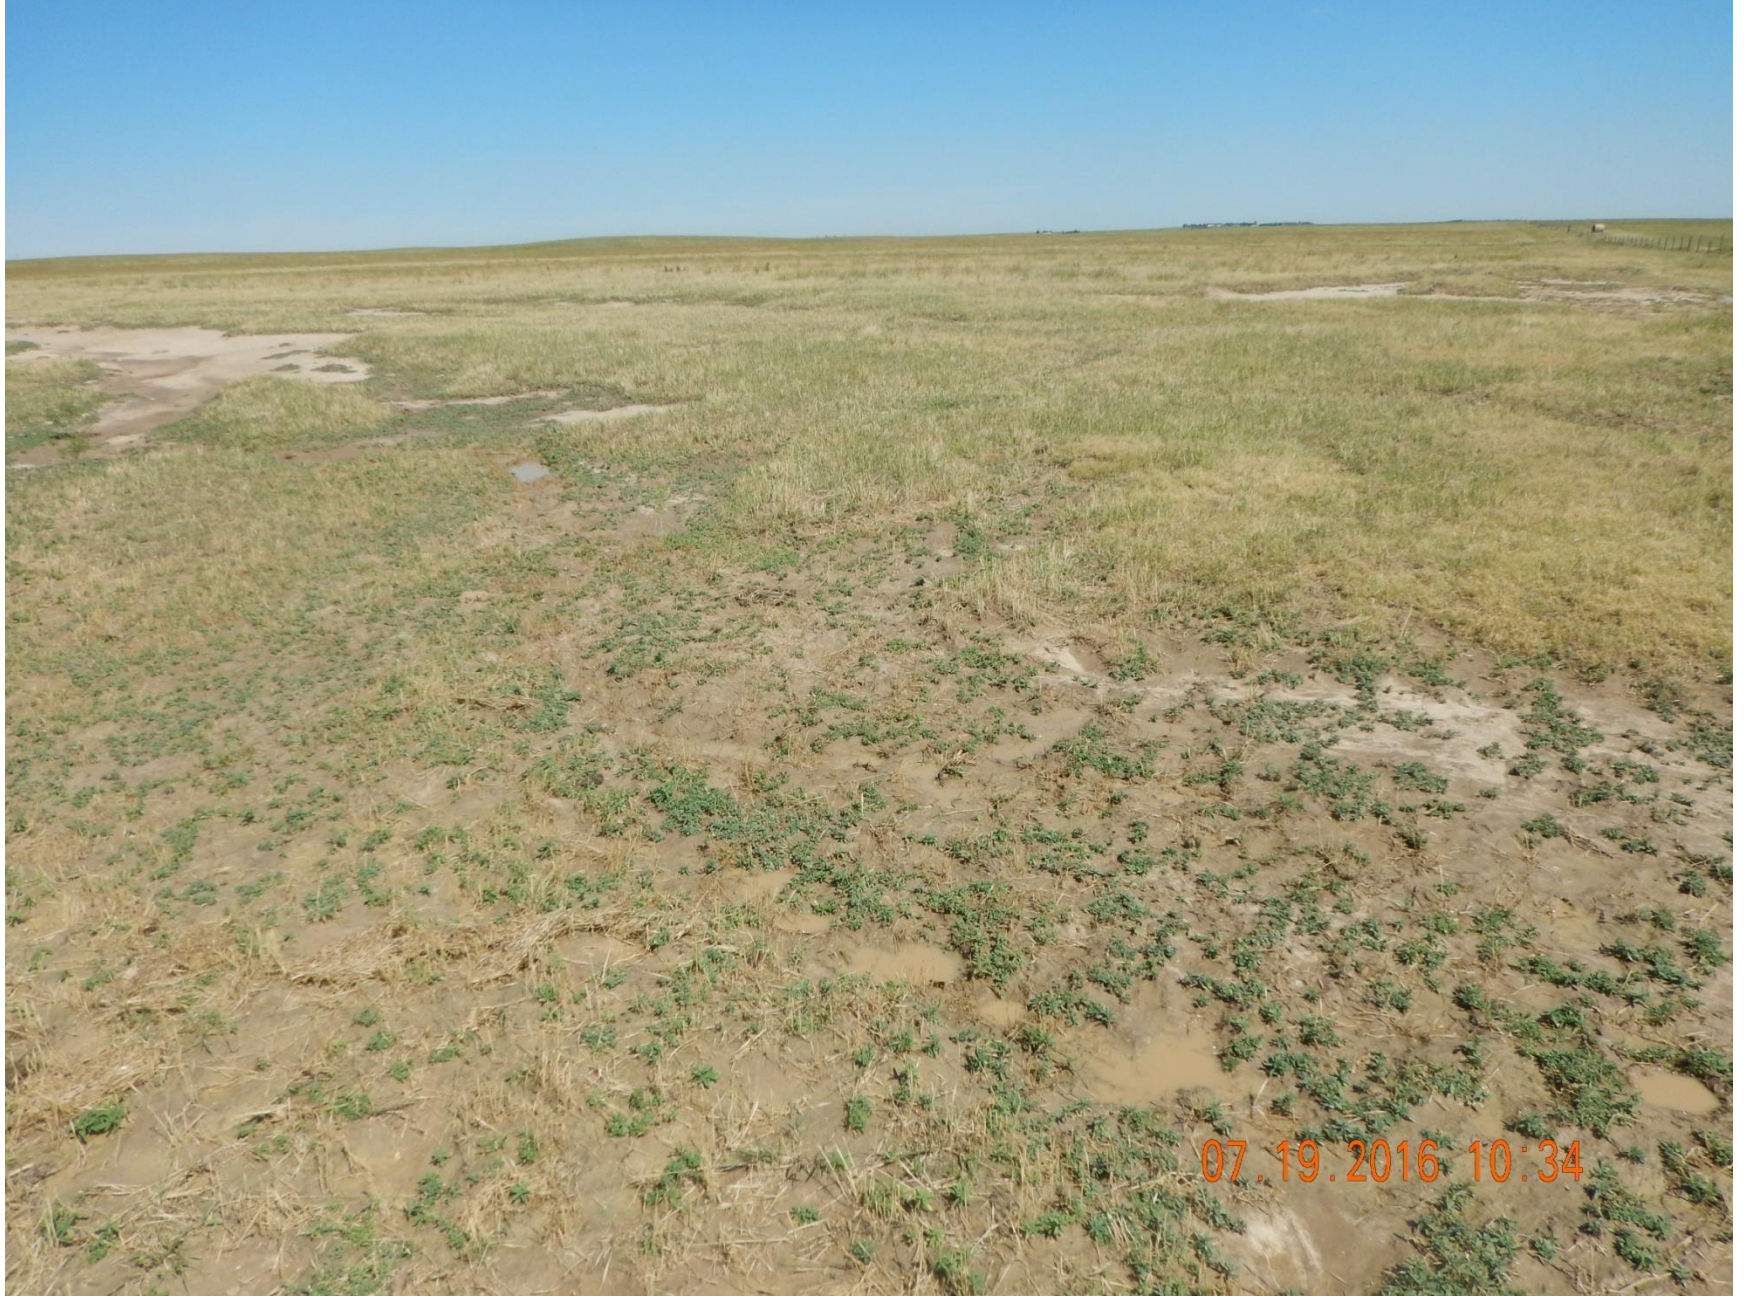
**Figure 4:** Photo taken from the east end of the degradation area, facing north. Photo shows areas of degradation due to possible salt kill from the location.

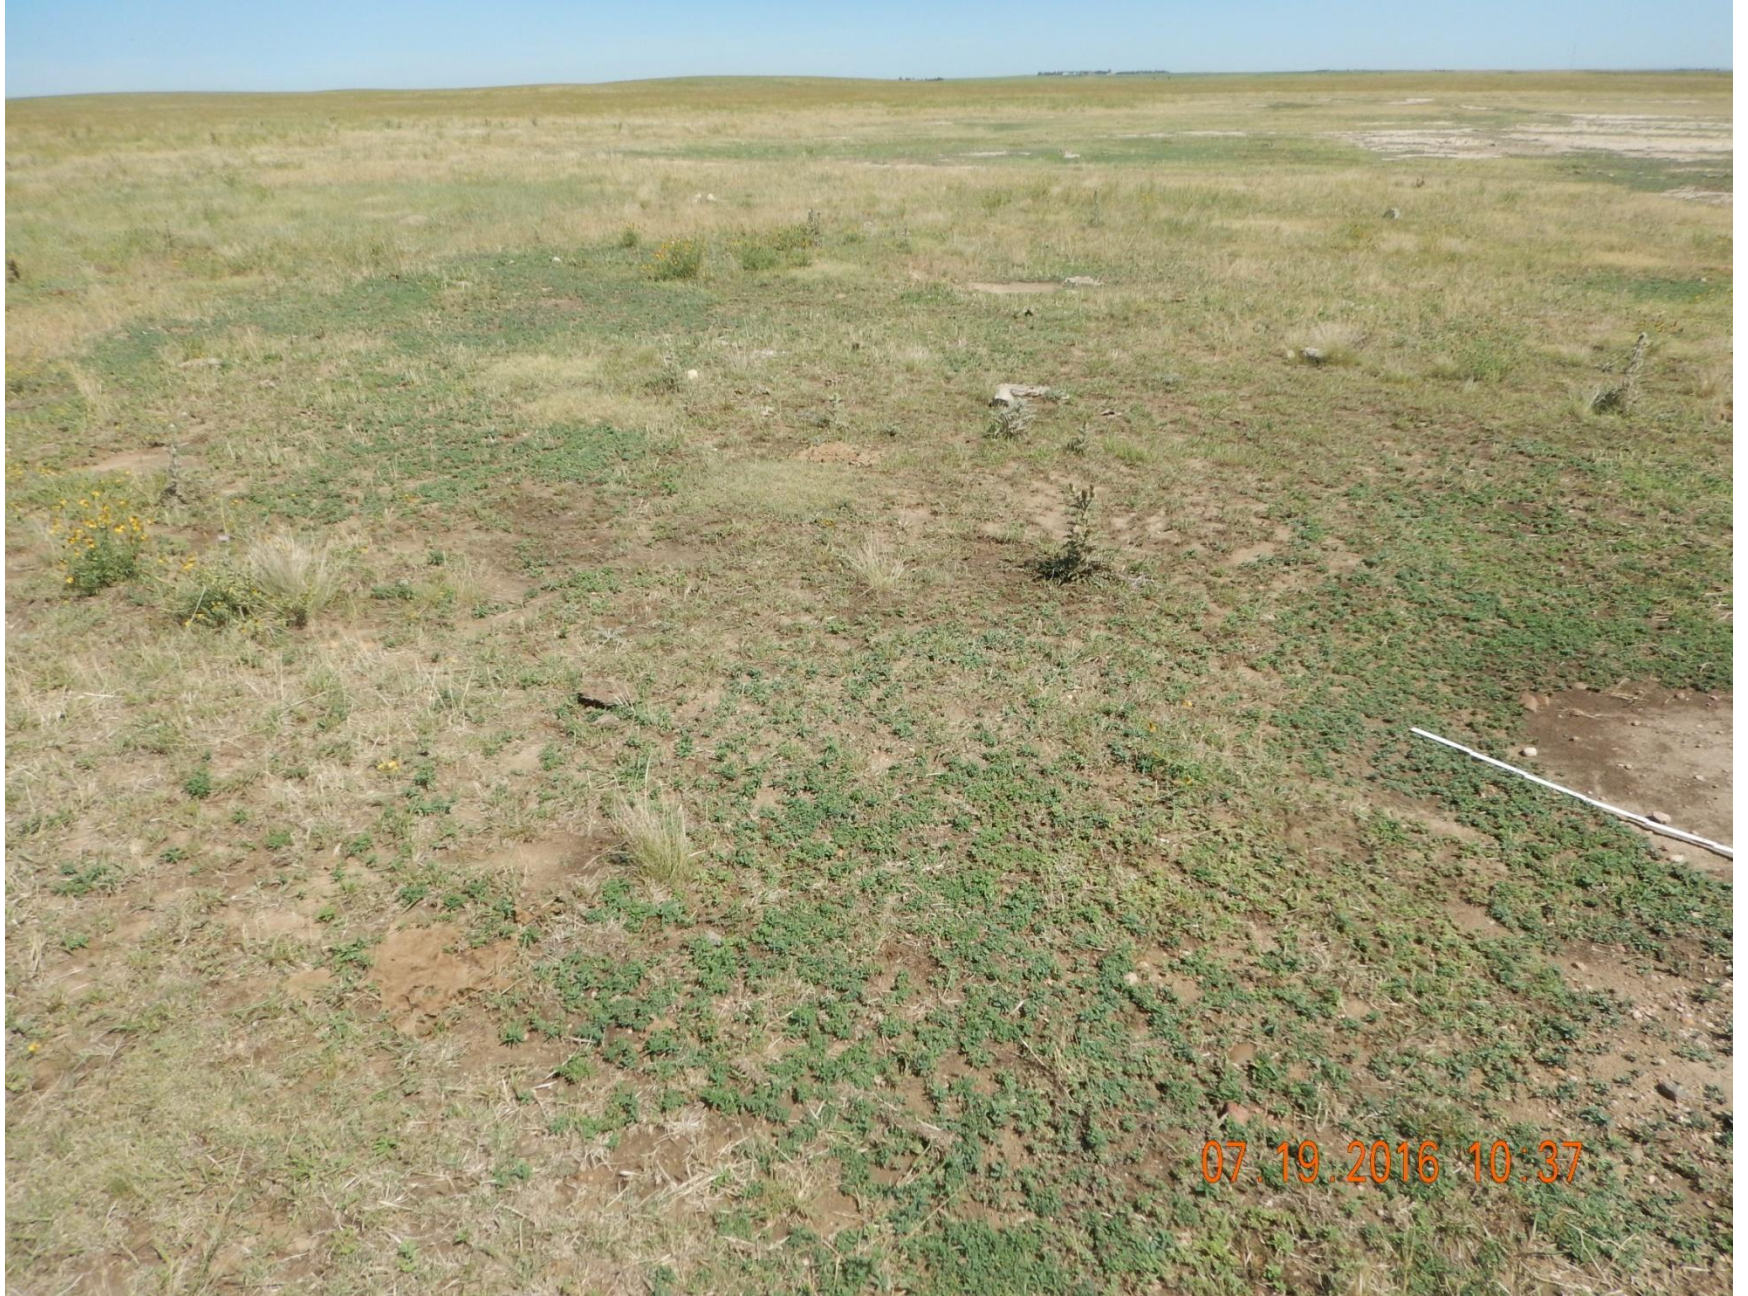
**Figure 6:** Photo taken from the well site, on the southwest end of the location, facing north. Vegetation over well site predominantly undesirable plant species.

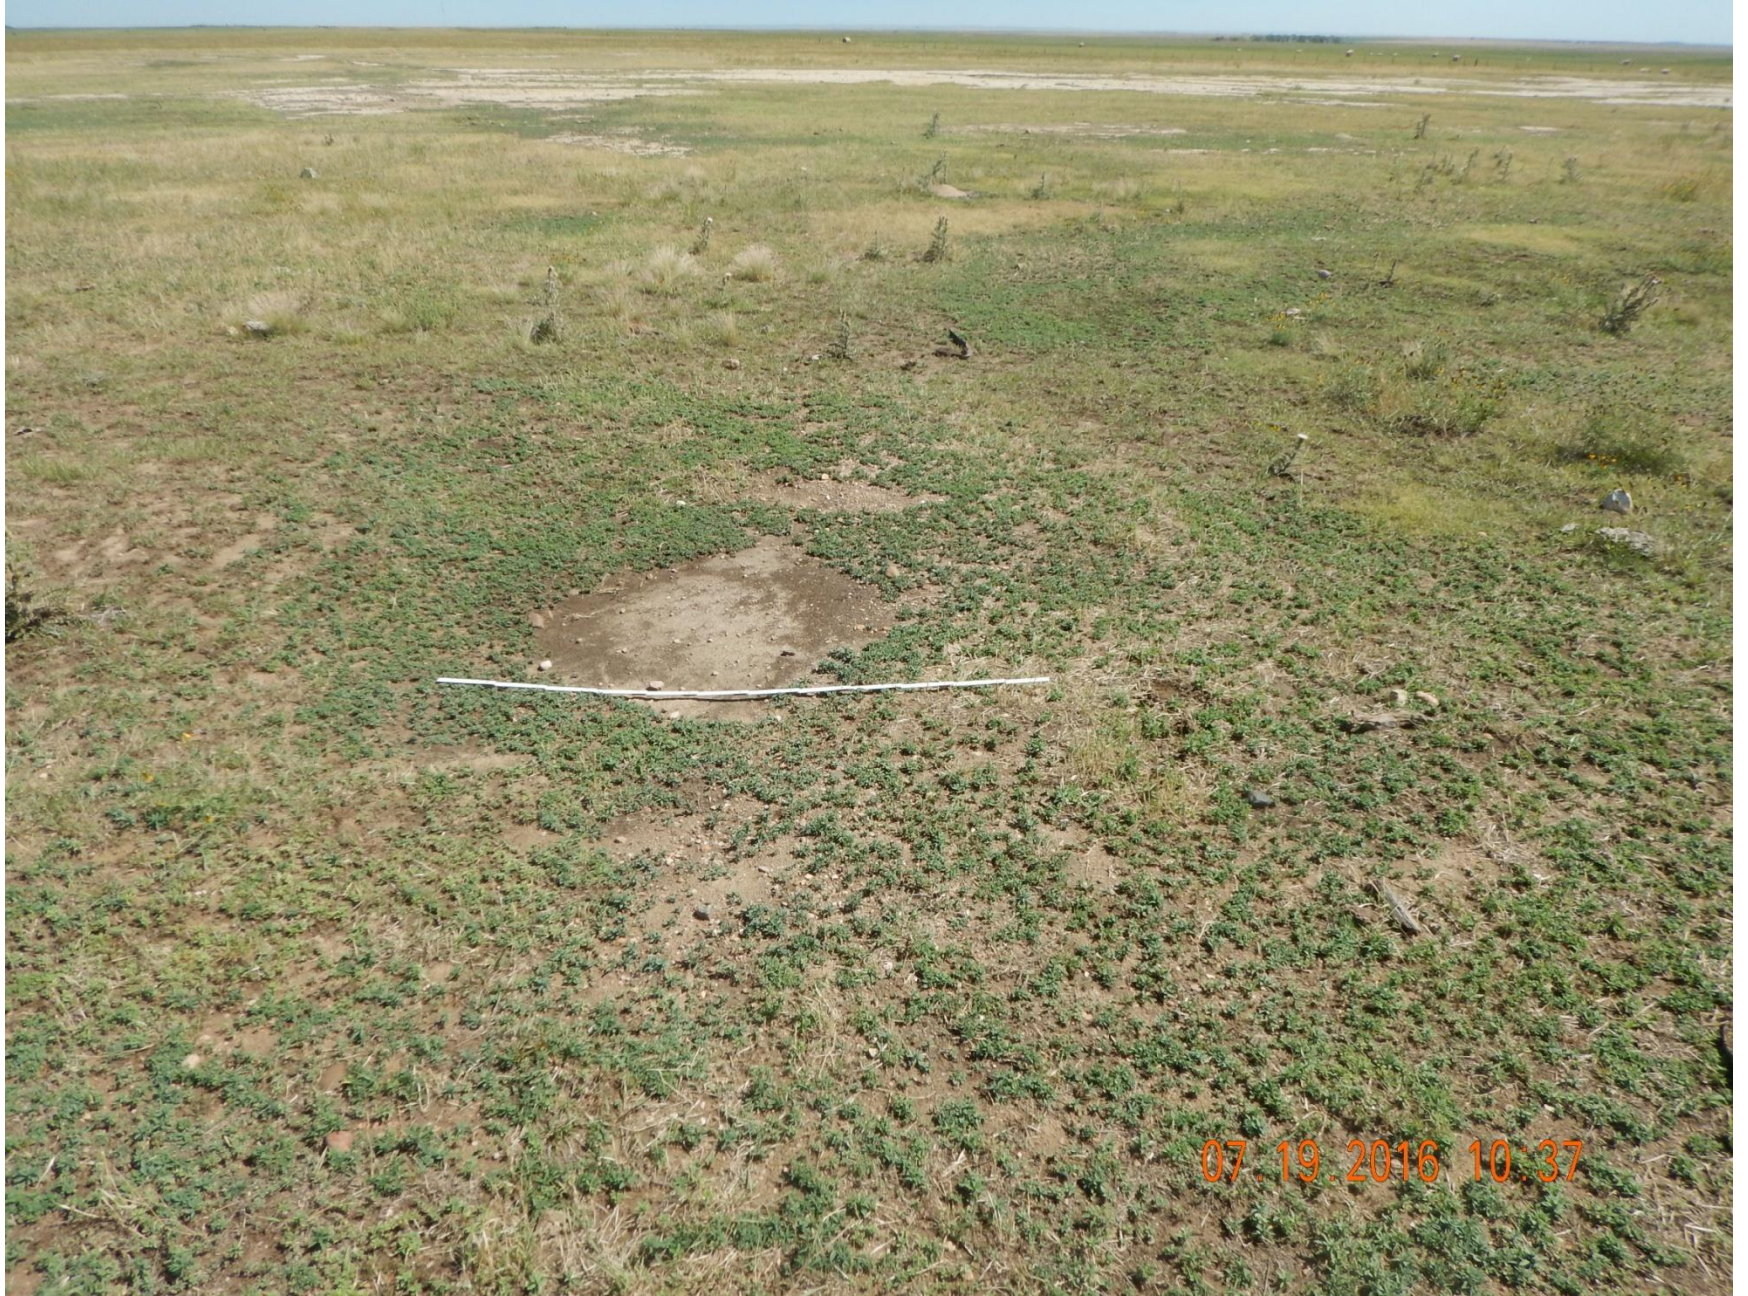
**Figure 7:** Photo taken from the well site, on the southwest end of the location, facing northeast. Vegetation over well site predominantly undesirable plant species. 6' measuring stick for reference.

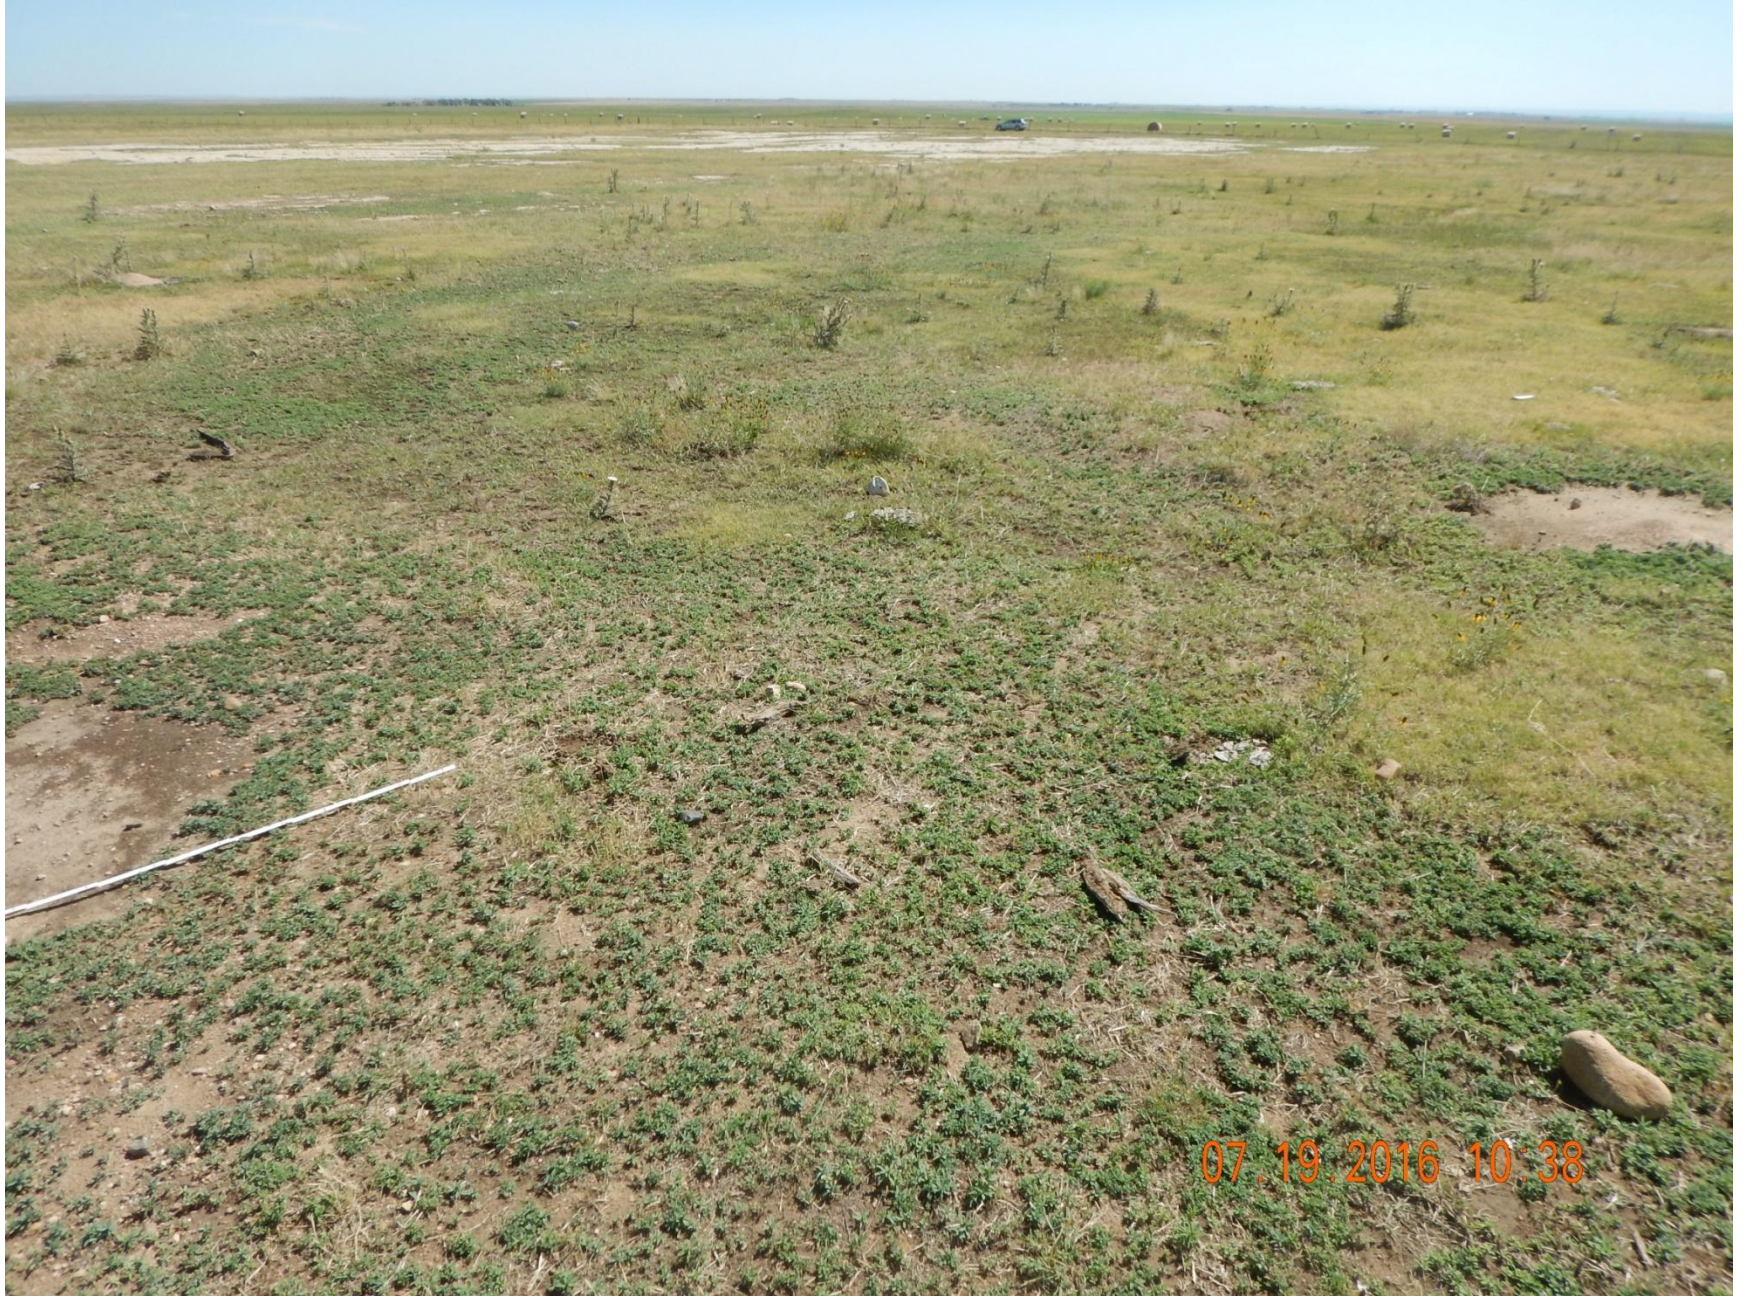
**Figure 8:** Photo taken from the well site, on the southwest end of the location, facing east. Vegetation over well site predominantly undesirable plant species.

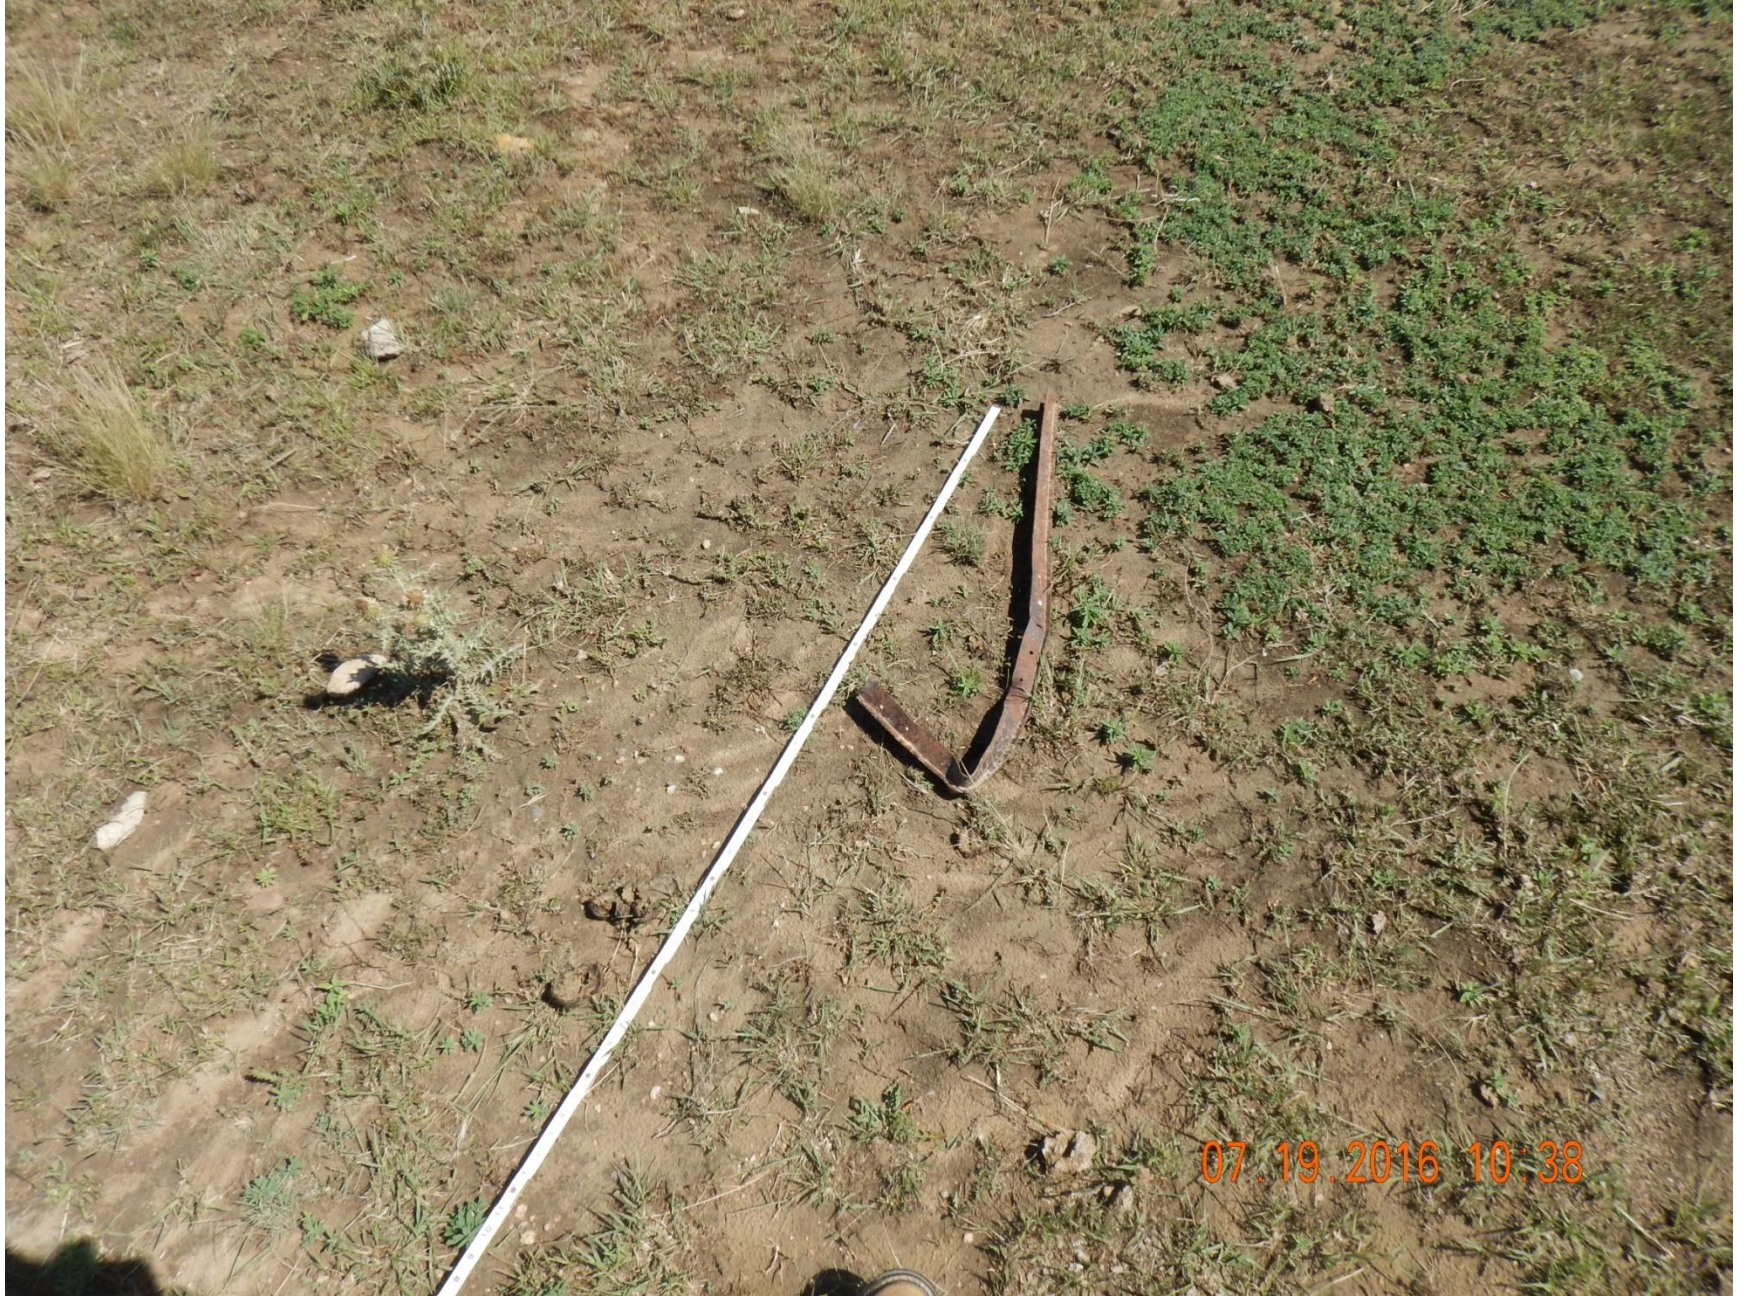
**Figure 9:** Photo taken from the well site, on the southwest end of the location. Photo of debris, 6' measuring stick for reference. Note vegetation has not achieved uniform distribution and is predominantly undesirable plant species.

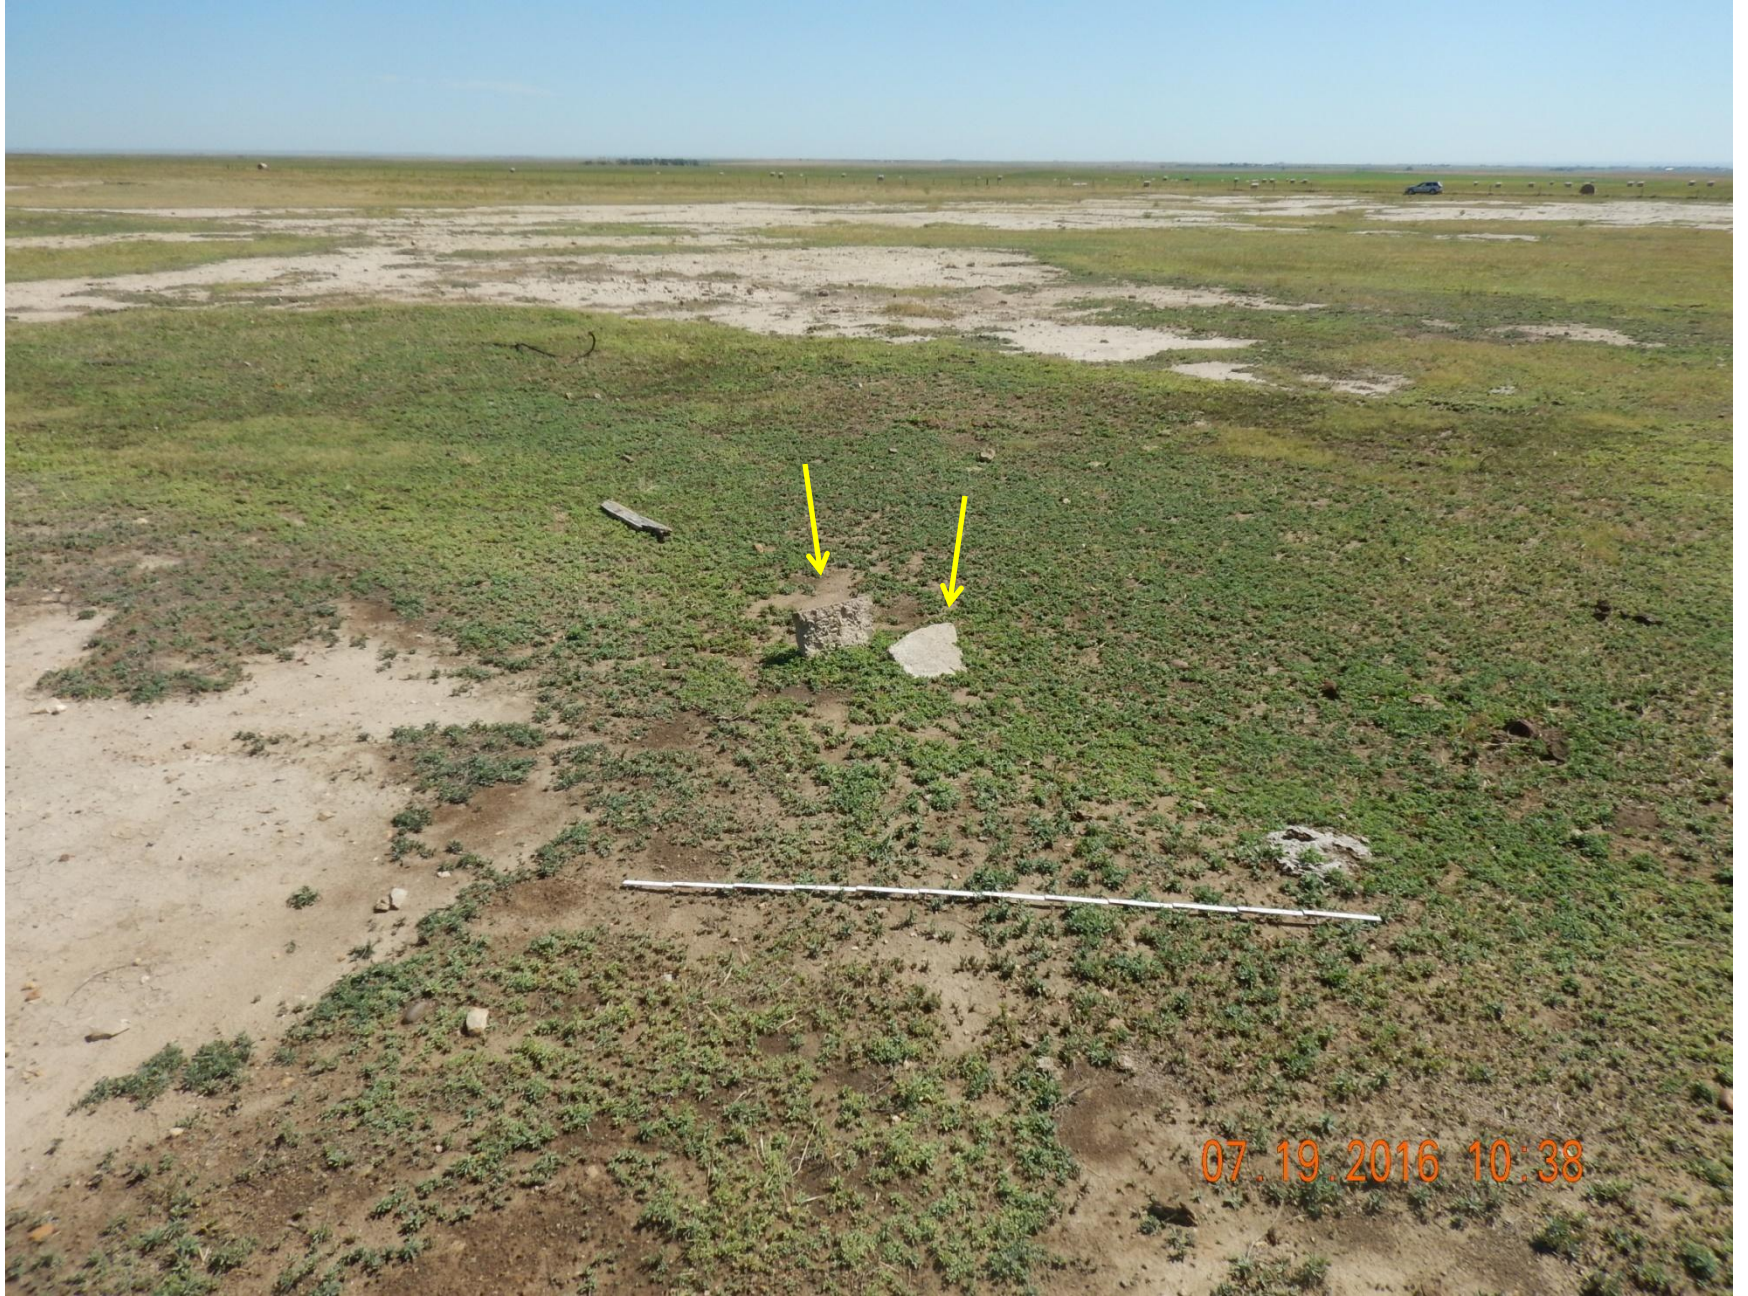
**Figure 10:** Photo taken from the well site, on the southwest end of the location, facing northeast. Photo shows concrete debris remaining on location. 6' measuring stick for reference.

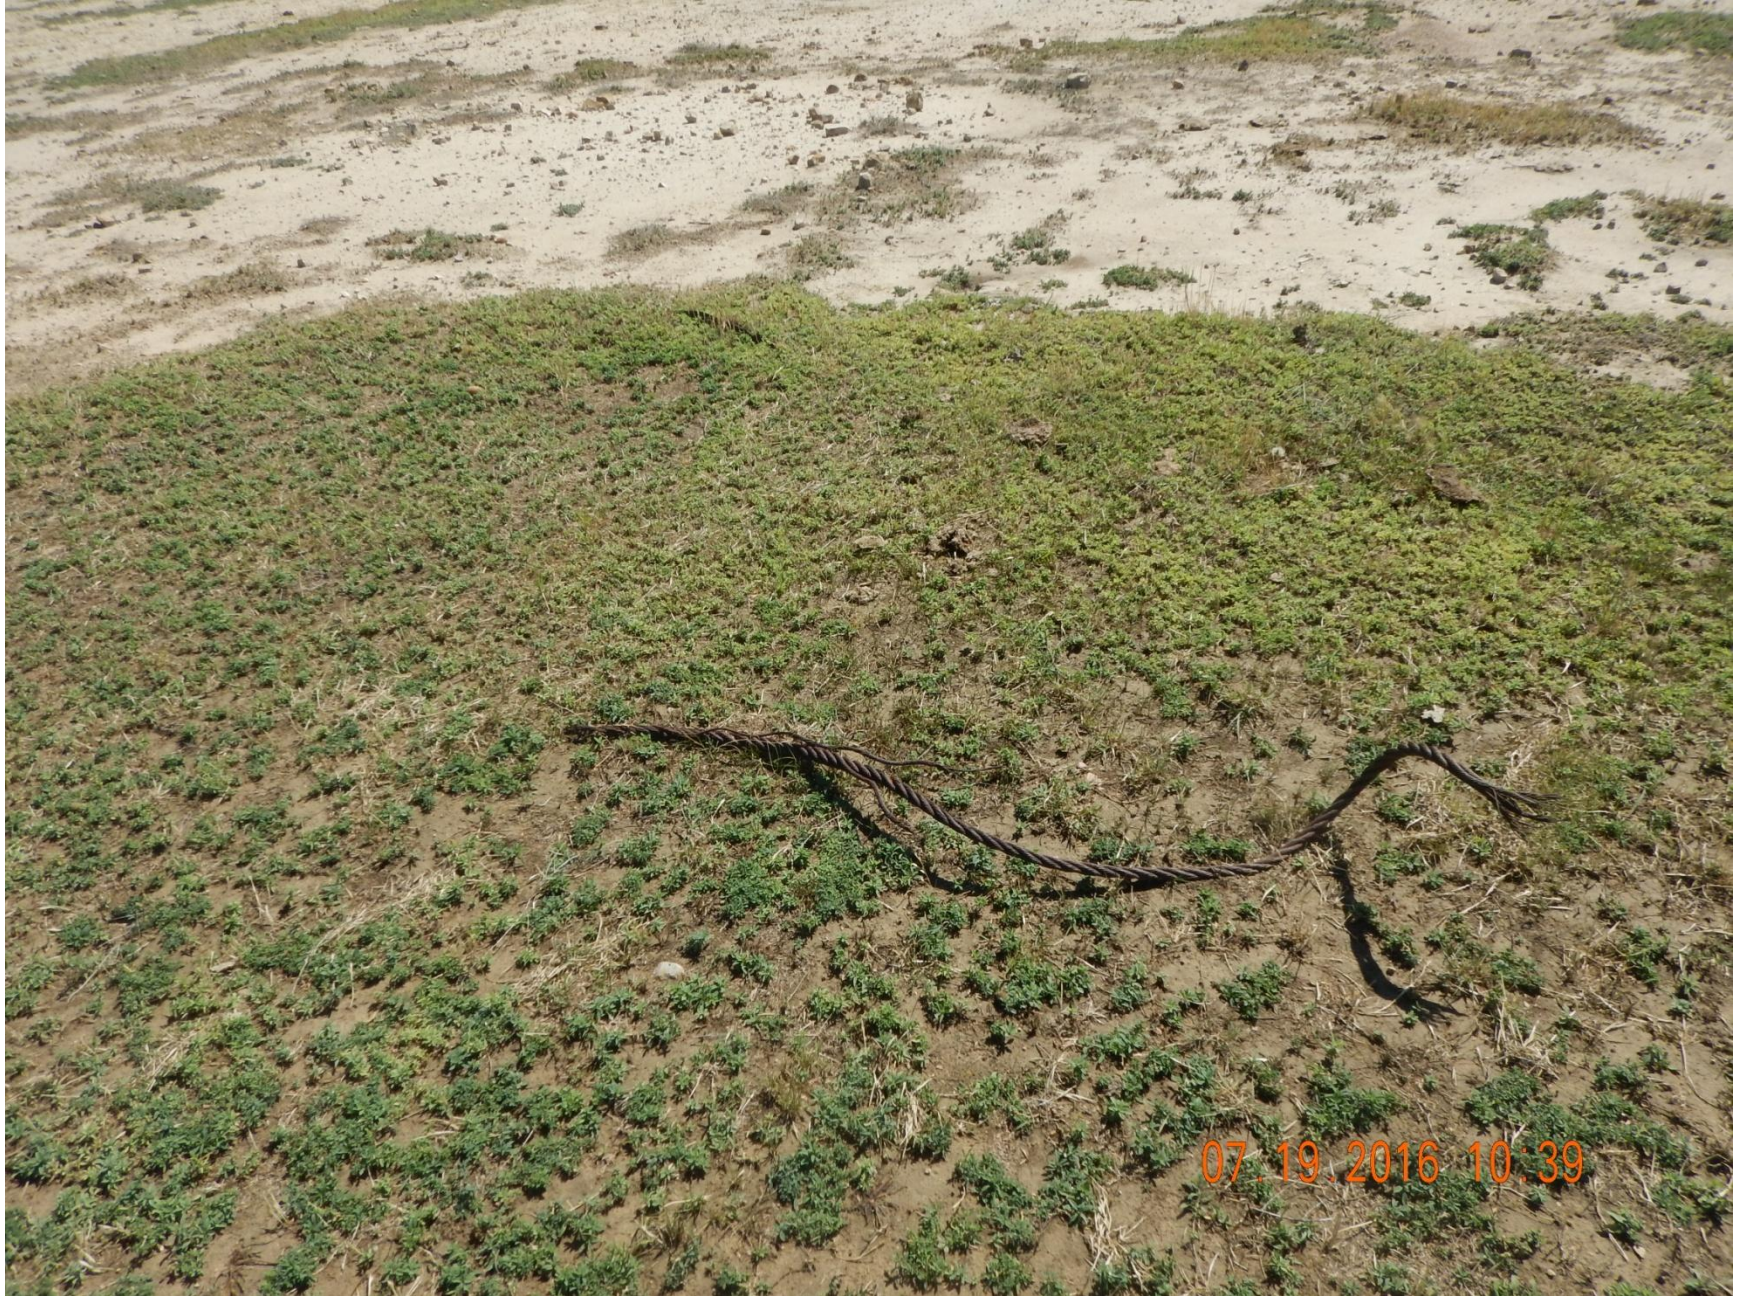
**Figure 11:** Photo taken from the well site, on the southwest end of the location. Photo shows cable debris remaining on location.
