# Final Reclamation Inspection

07/19/2016

Operator: Denver East Machinery co

Location ID: 390528

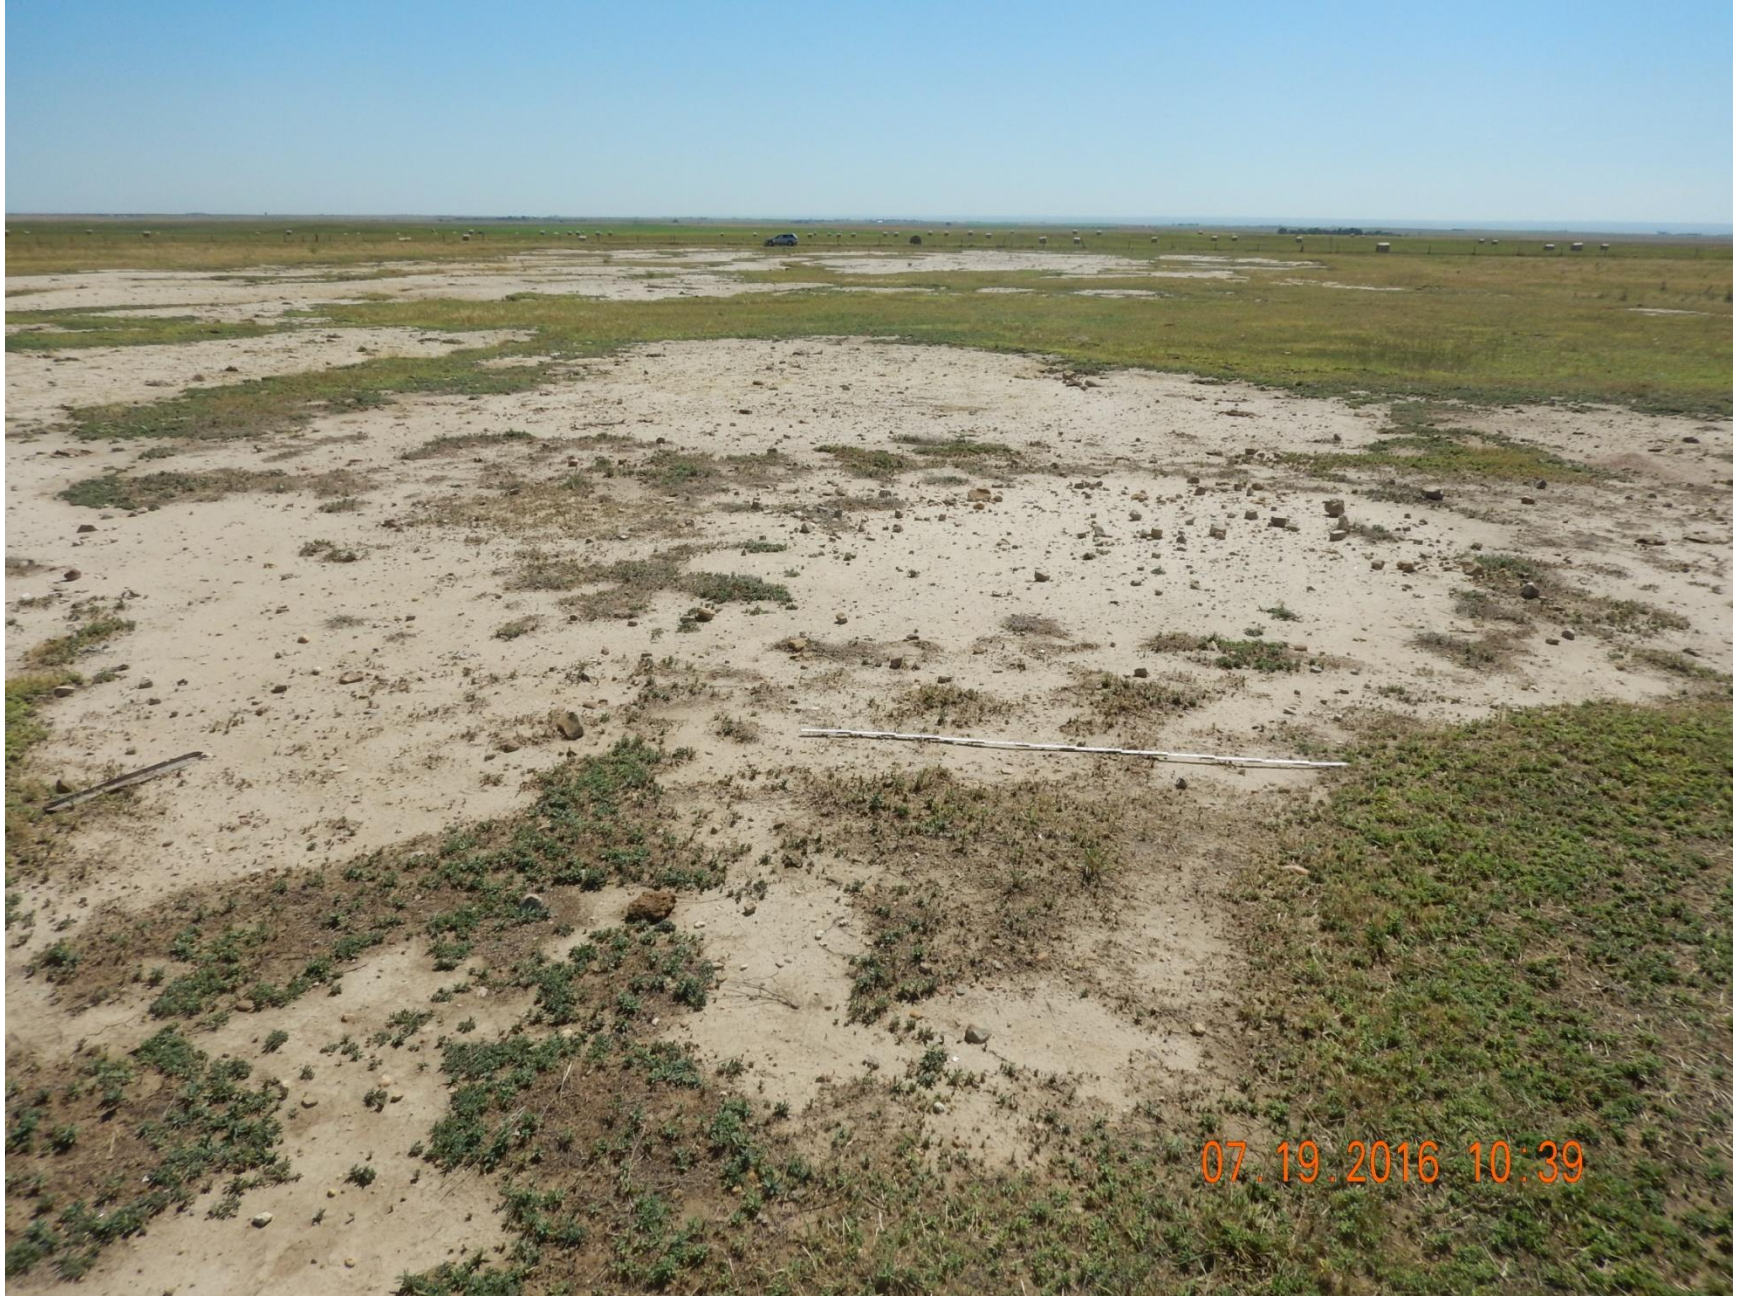
**Figure 12:** Photo taken from the southwest end of the location, facing east. Photo shows areas of degradation due to possible salt kill from the location. 6' measuring stick for reference

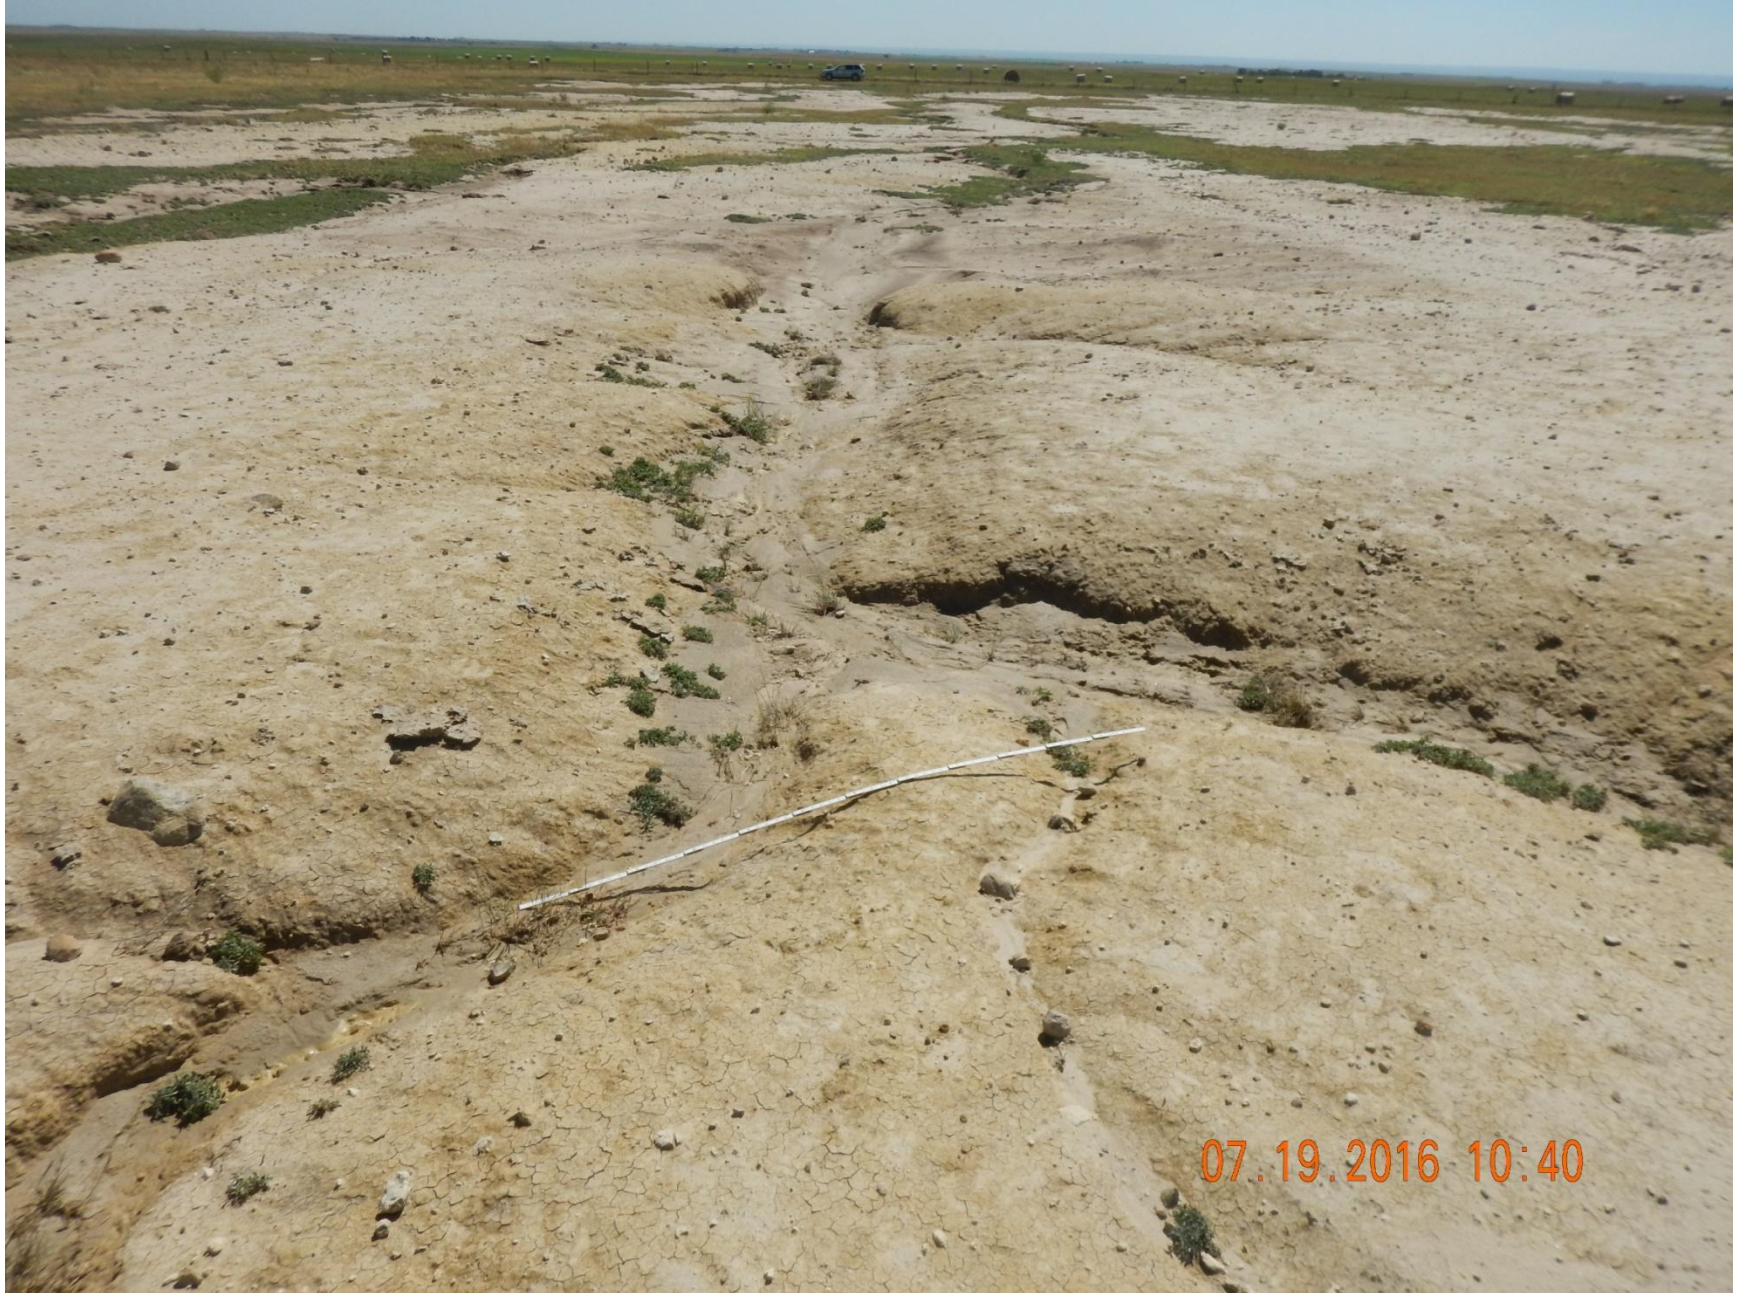
**Figure 13:** Photo taken from the west end of the location, facing east. Photo shows areas of degradation due to stormwater erosion and possible salt kill from the location. 6' measuring stick for reference

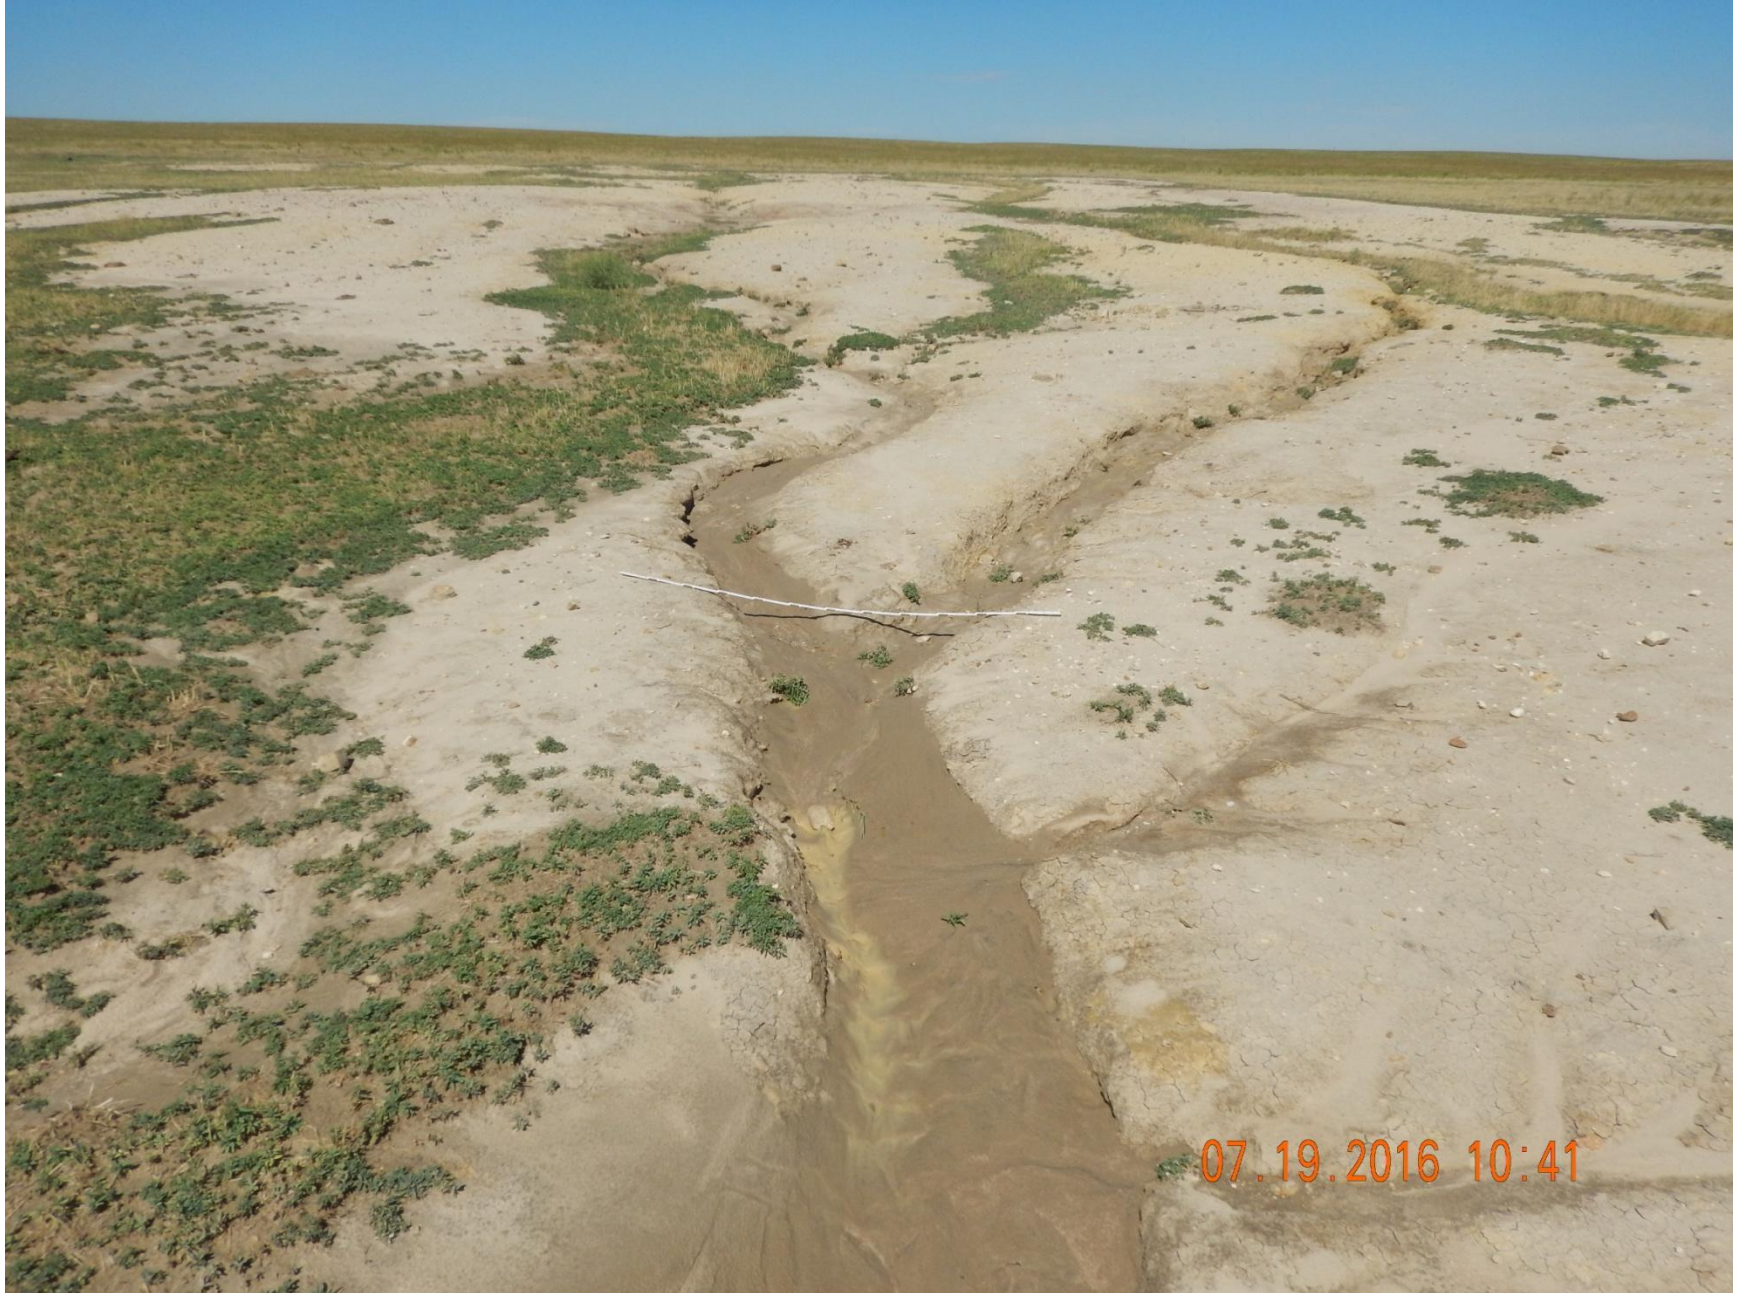
**Figure 14:** Photo taken from the south central area of the location, facing west. Photo shows areas of degradation due to stormwater erosion and possible salt kill from the location. 6' measuring stick for reference

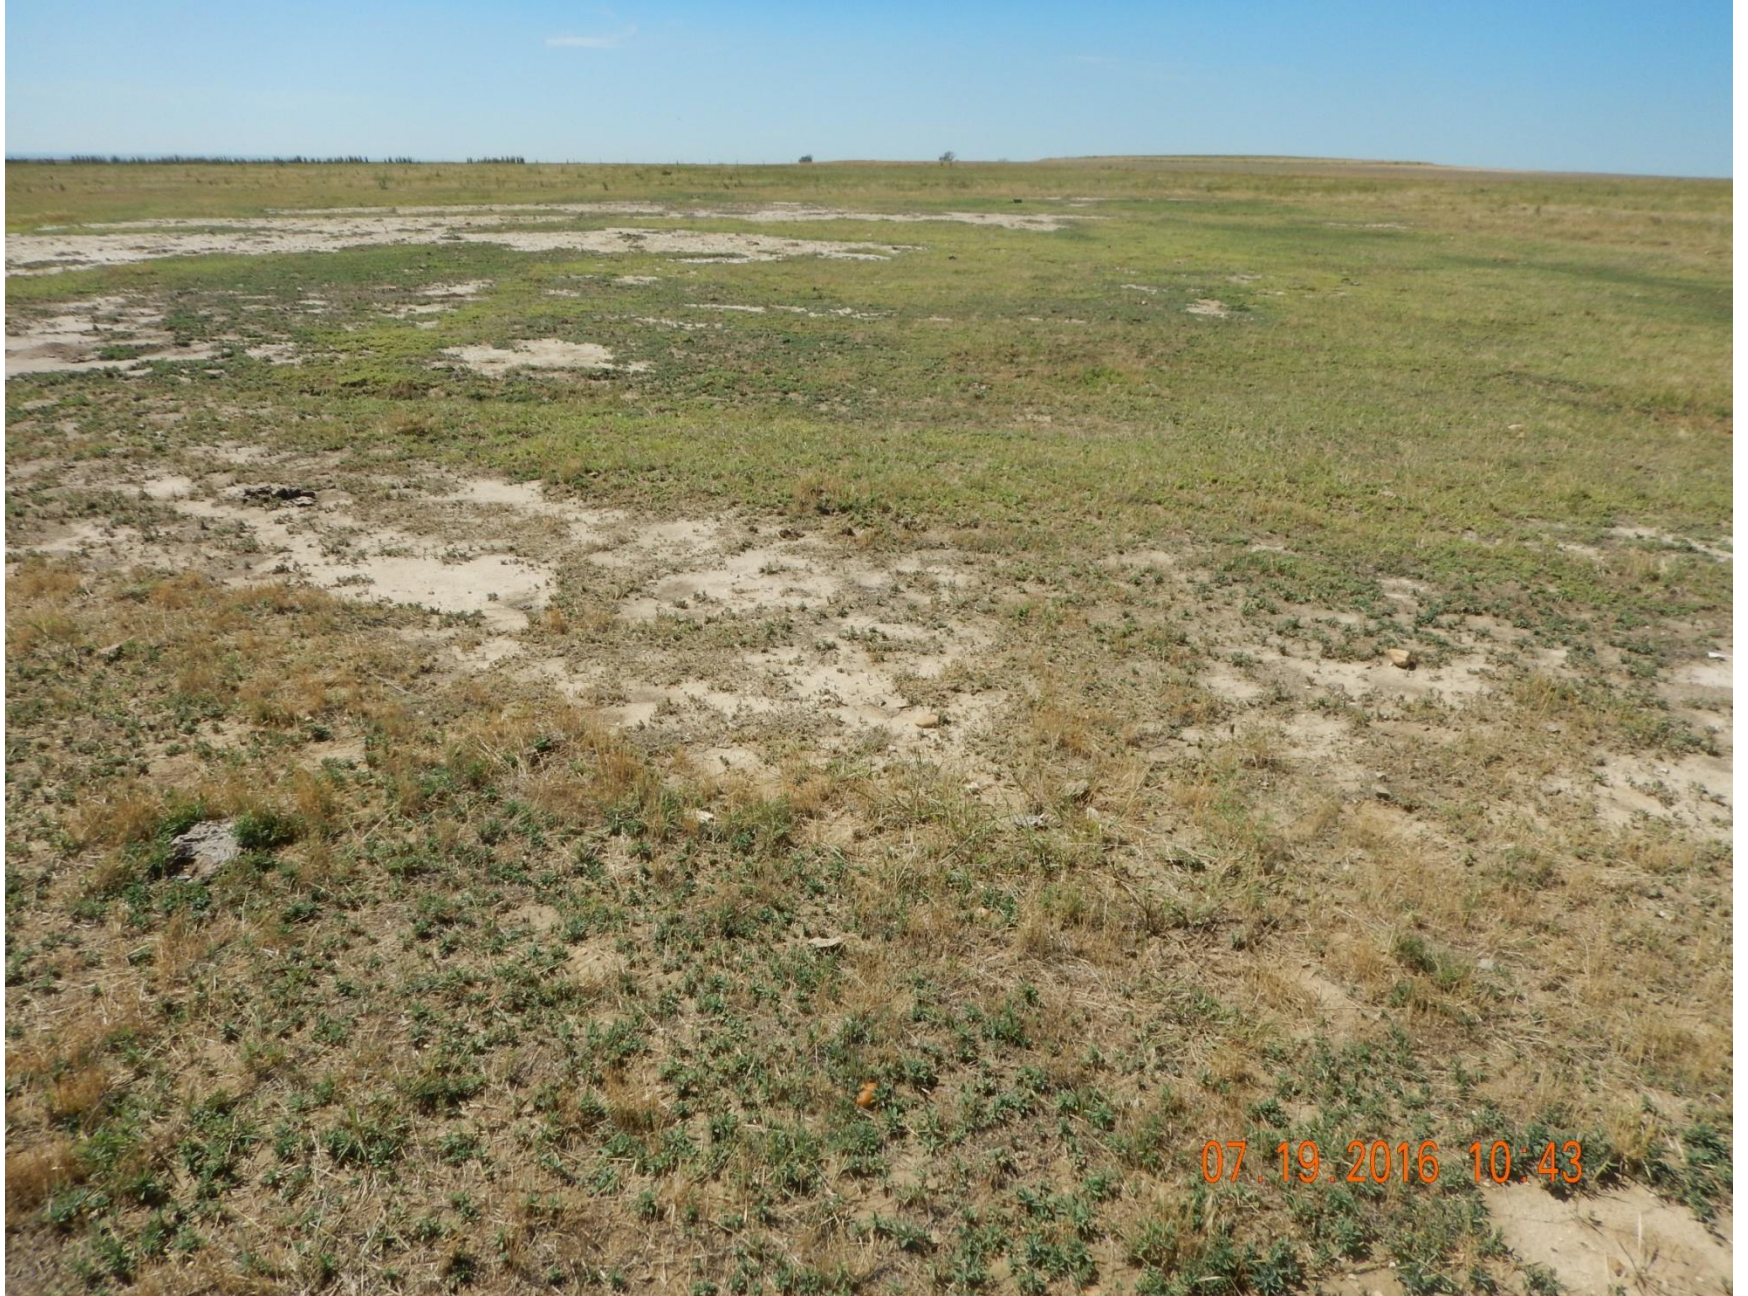
**Figure 15:** Photo taken from the west end of the location, facing south. Photo shows areas of degradation due to stormwater erosion and possible salt kill from the location.

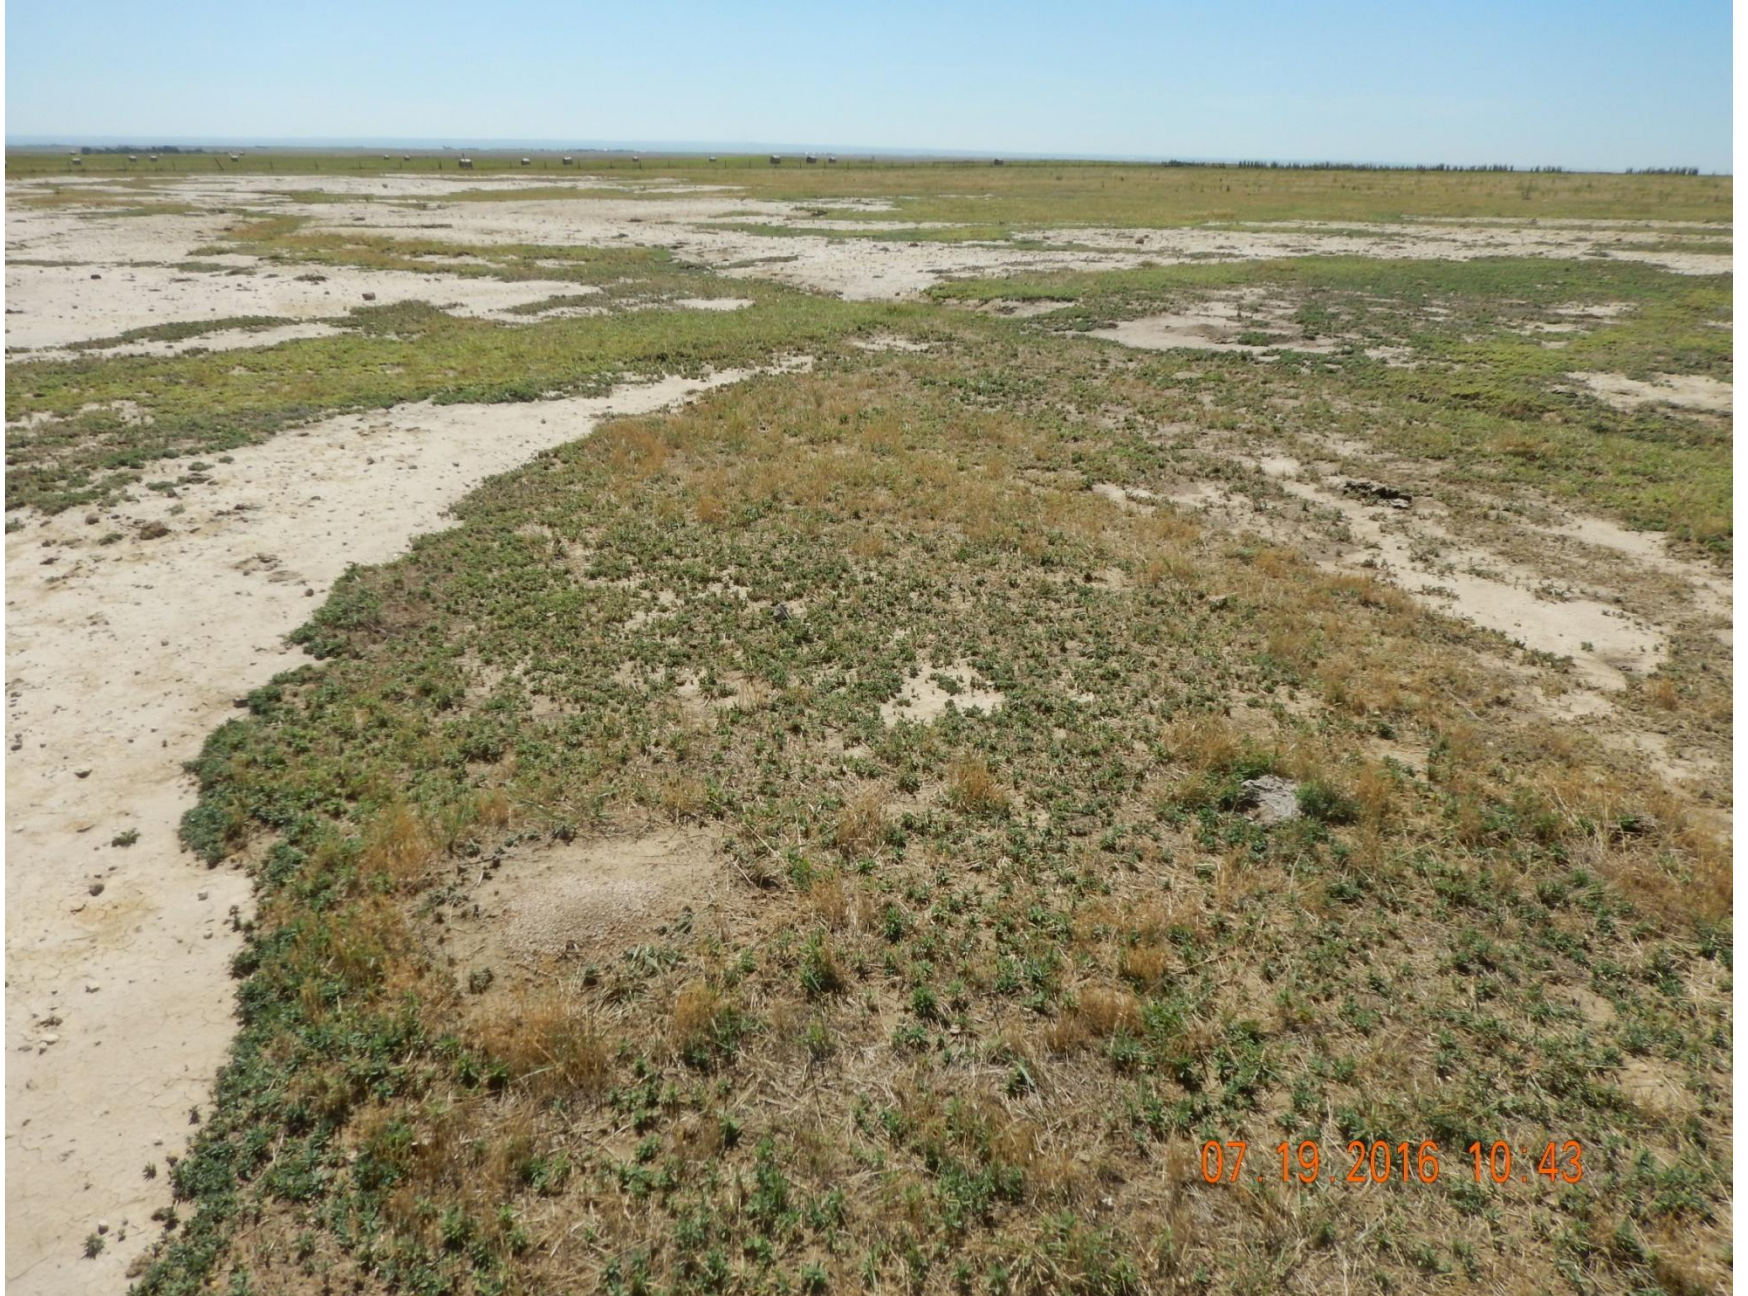
**Figure 16:** Photo taken from the west end of the location, facing southeast. Photo shows areas of degradation due to stormwater erosion and possible salt kill from the location.

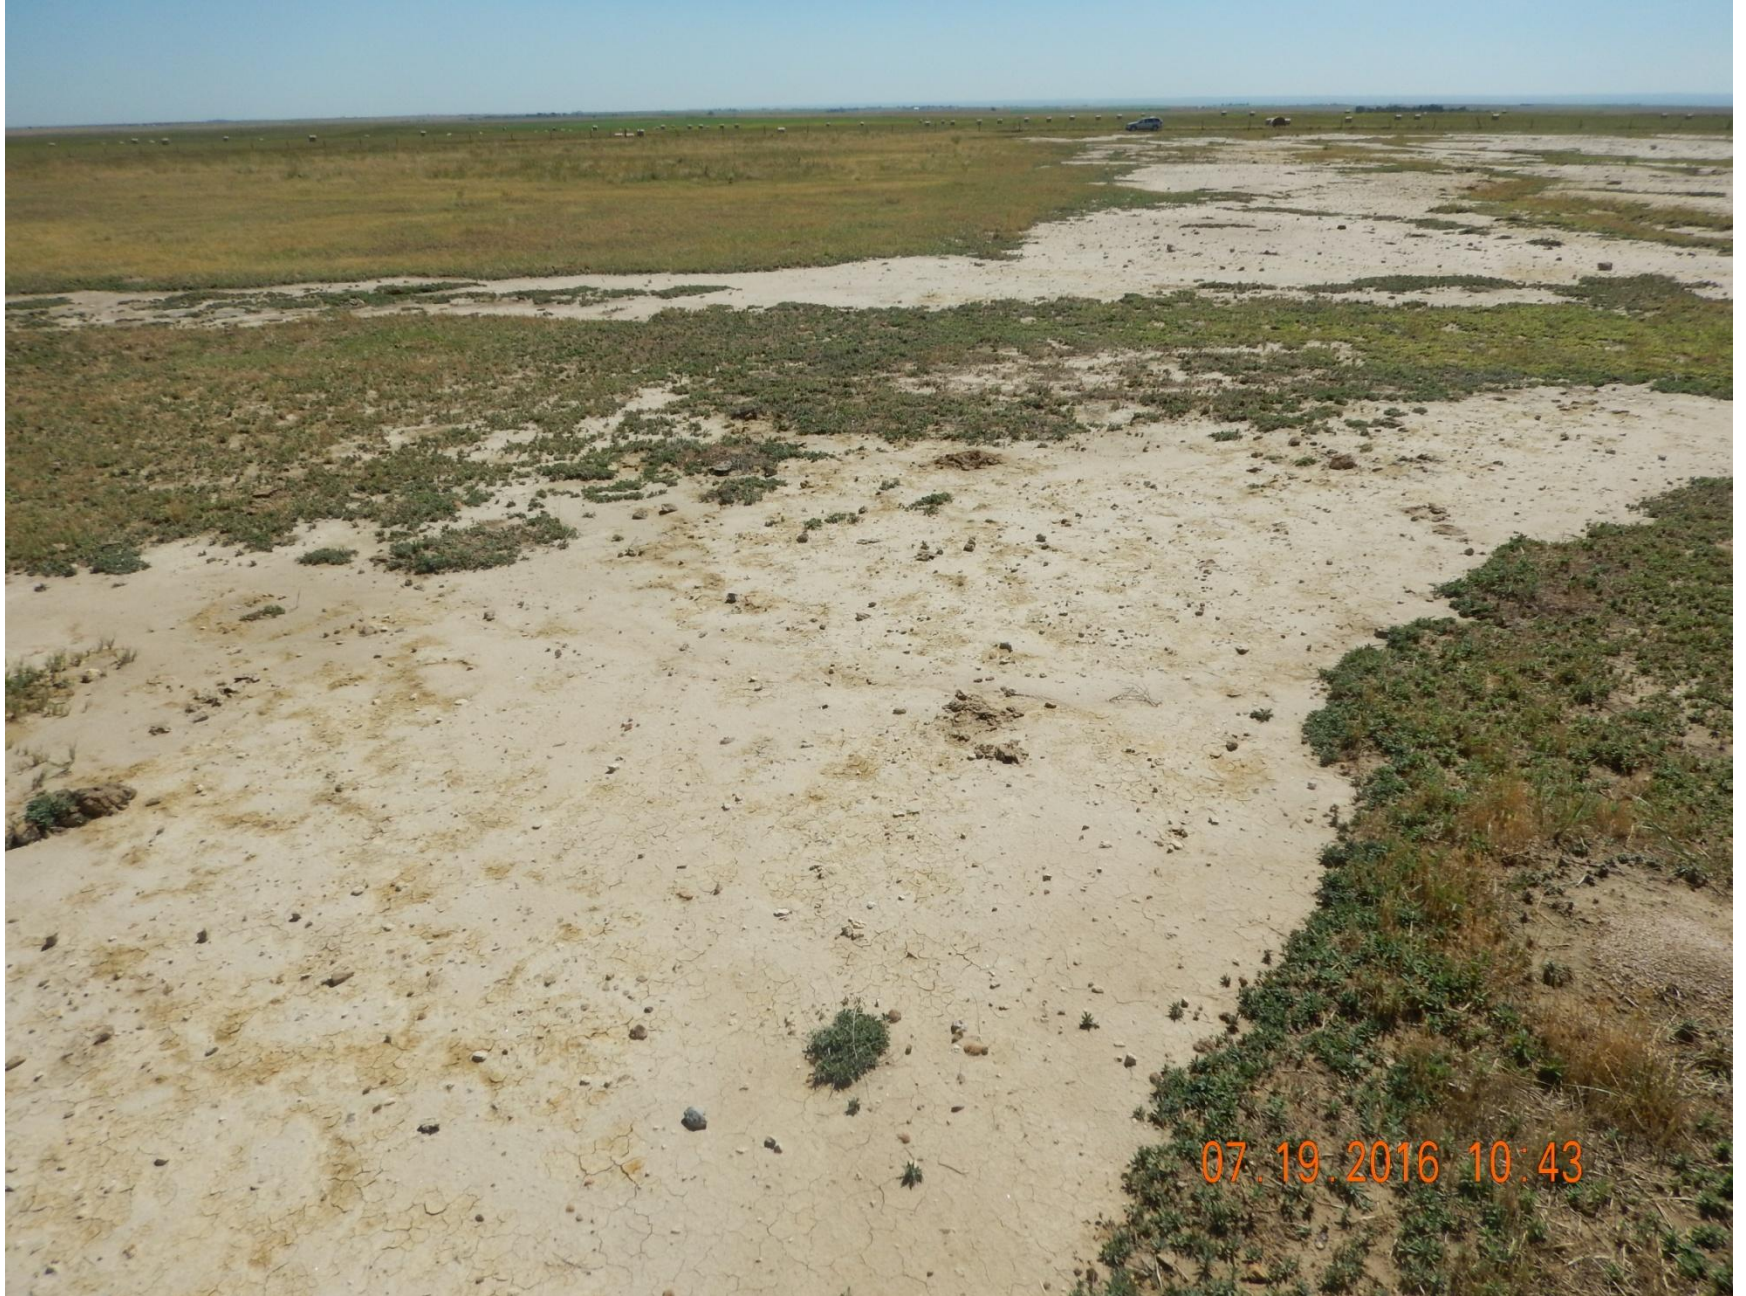
**Figure 17:** Photo taken from the west end of the location, facing east. Photo shows areas of degradation due to stormwater erosion and possible salt kill from the location.

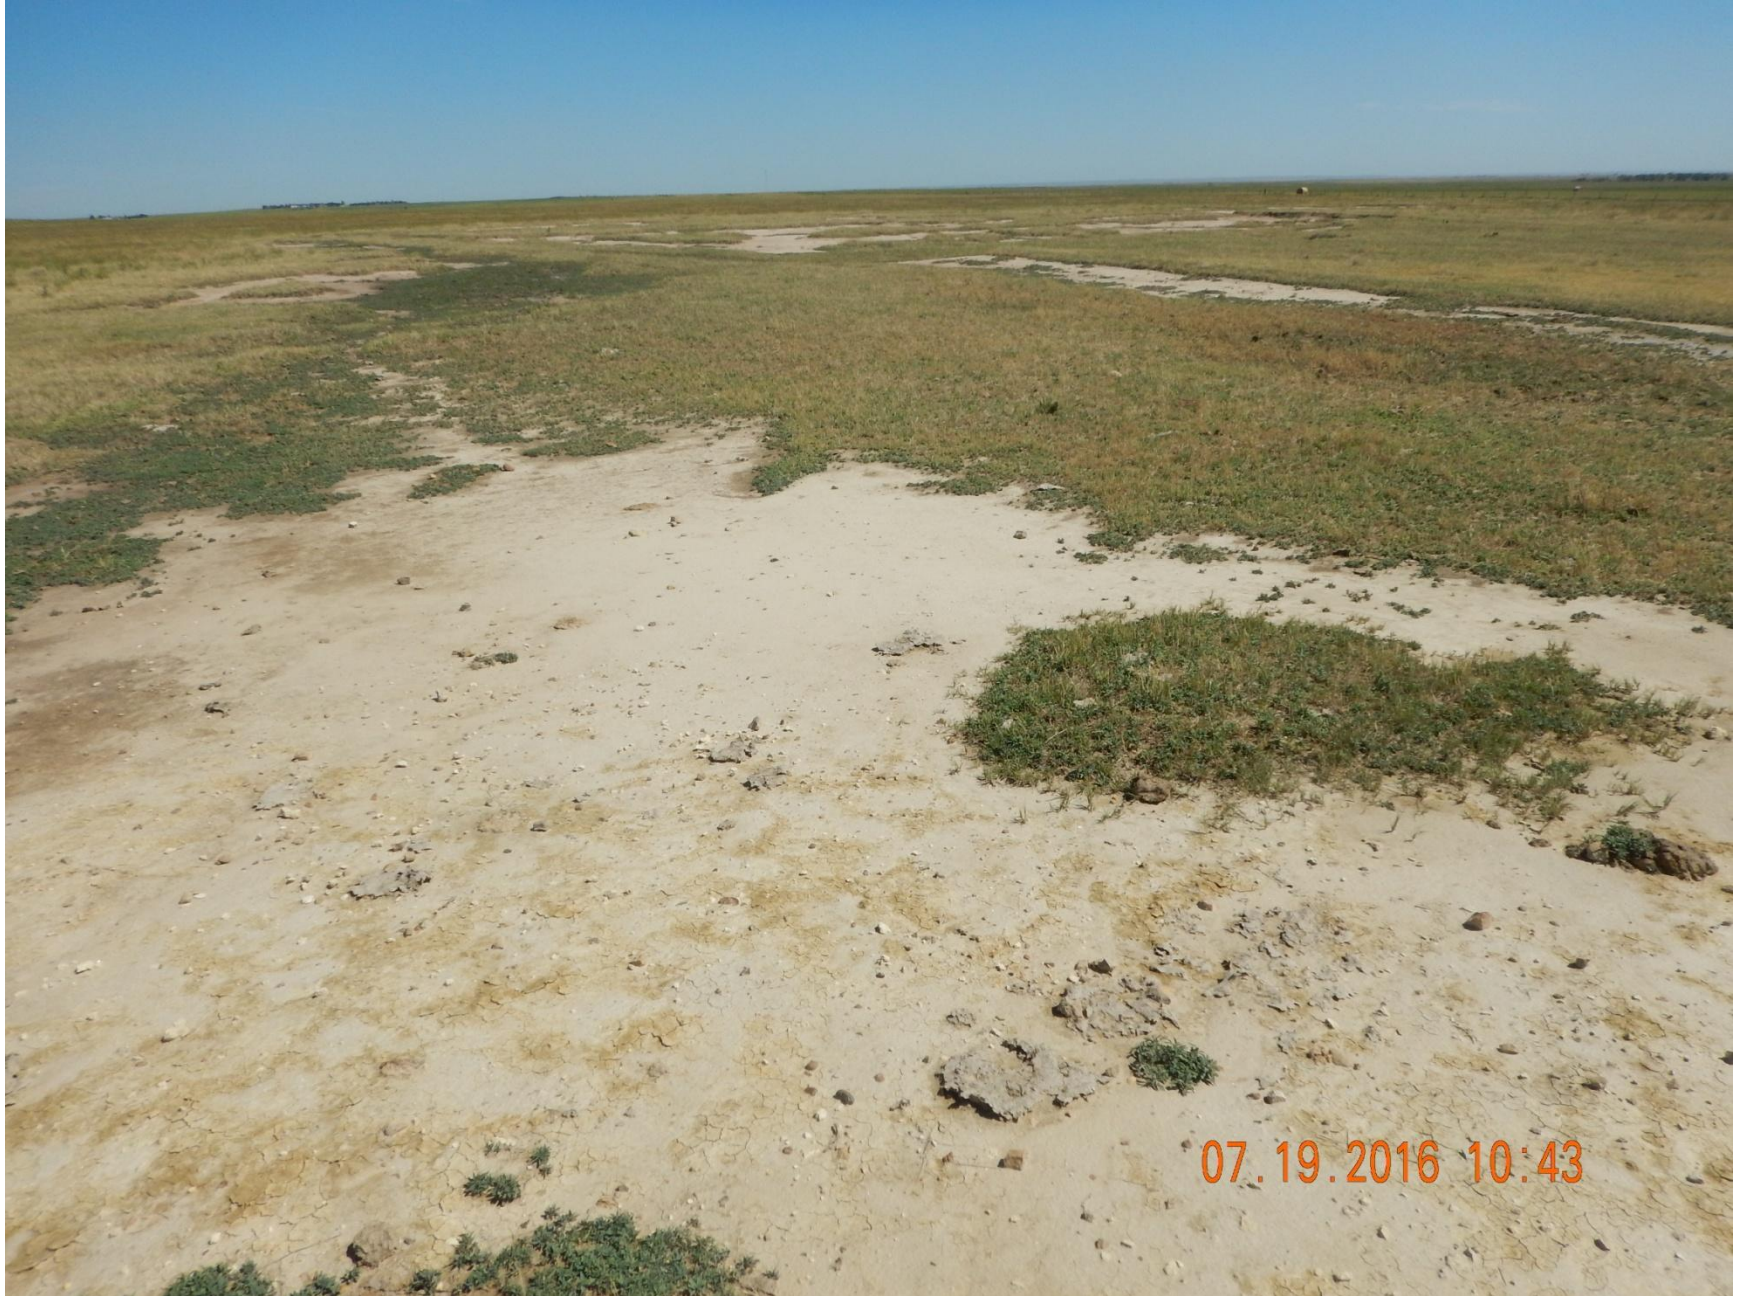
**Figure 18:** Photo taken from the west end of the location, facing northeast. Photo shows areas of degradation due to stormwater erosion and possible salt kill from the location.

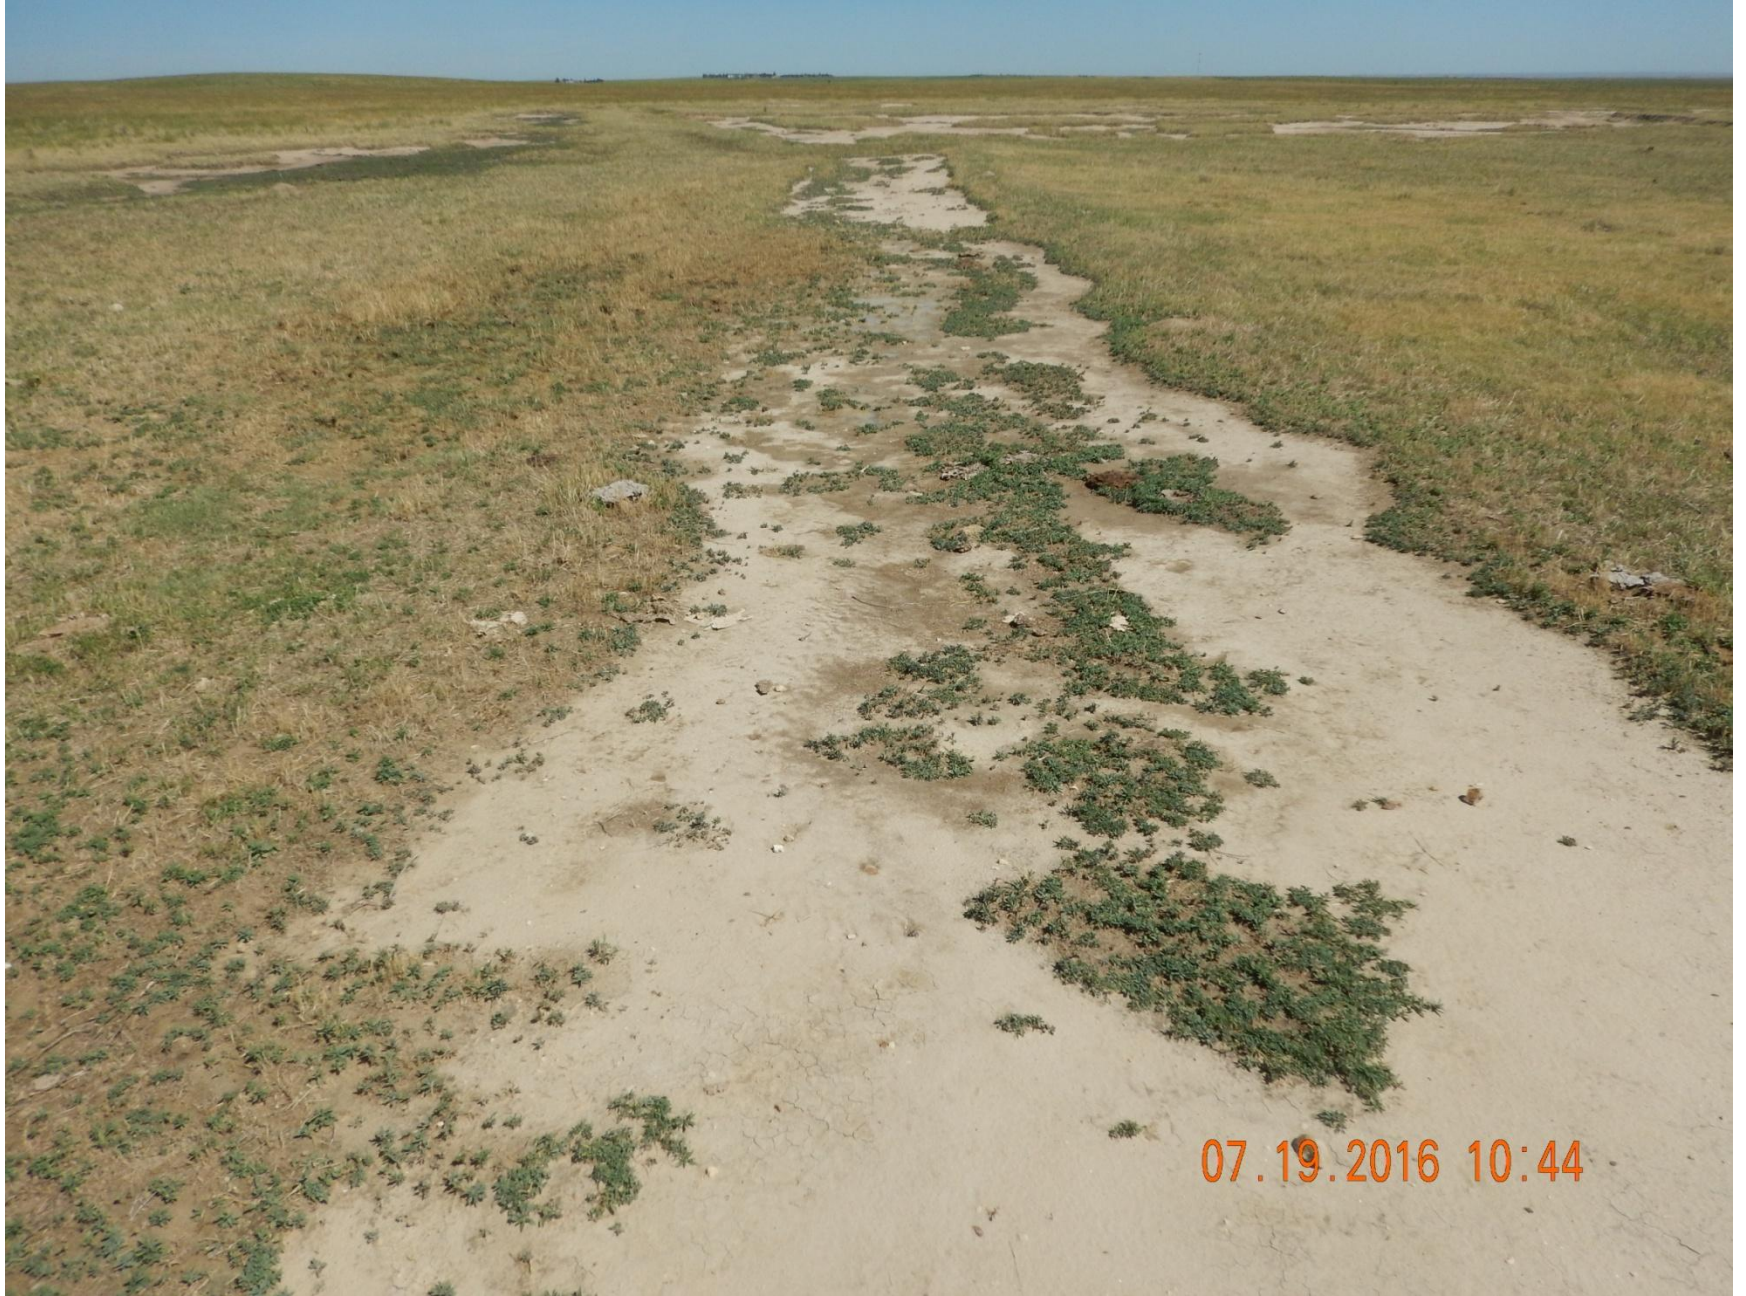
**Figure 19:** Photo taken from the west end of the location, facing northeast. Photo shows areas of degradation due to stormwater erosion and possible salt kill from the location.

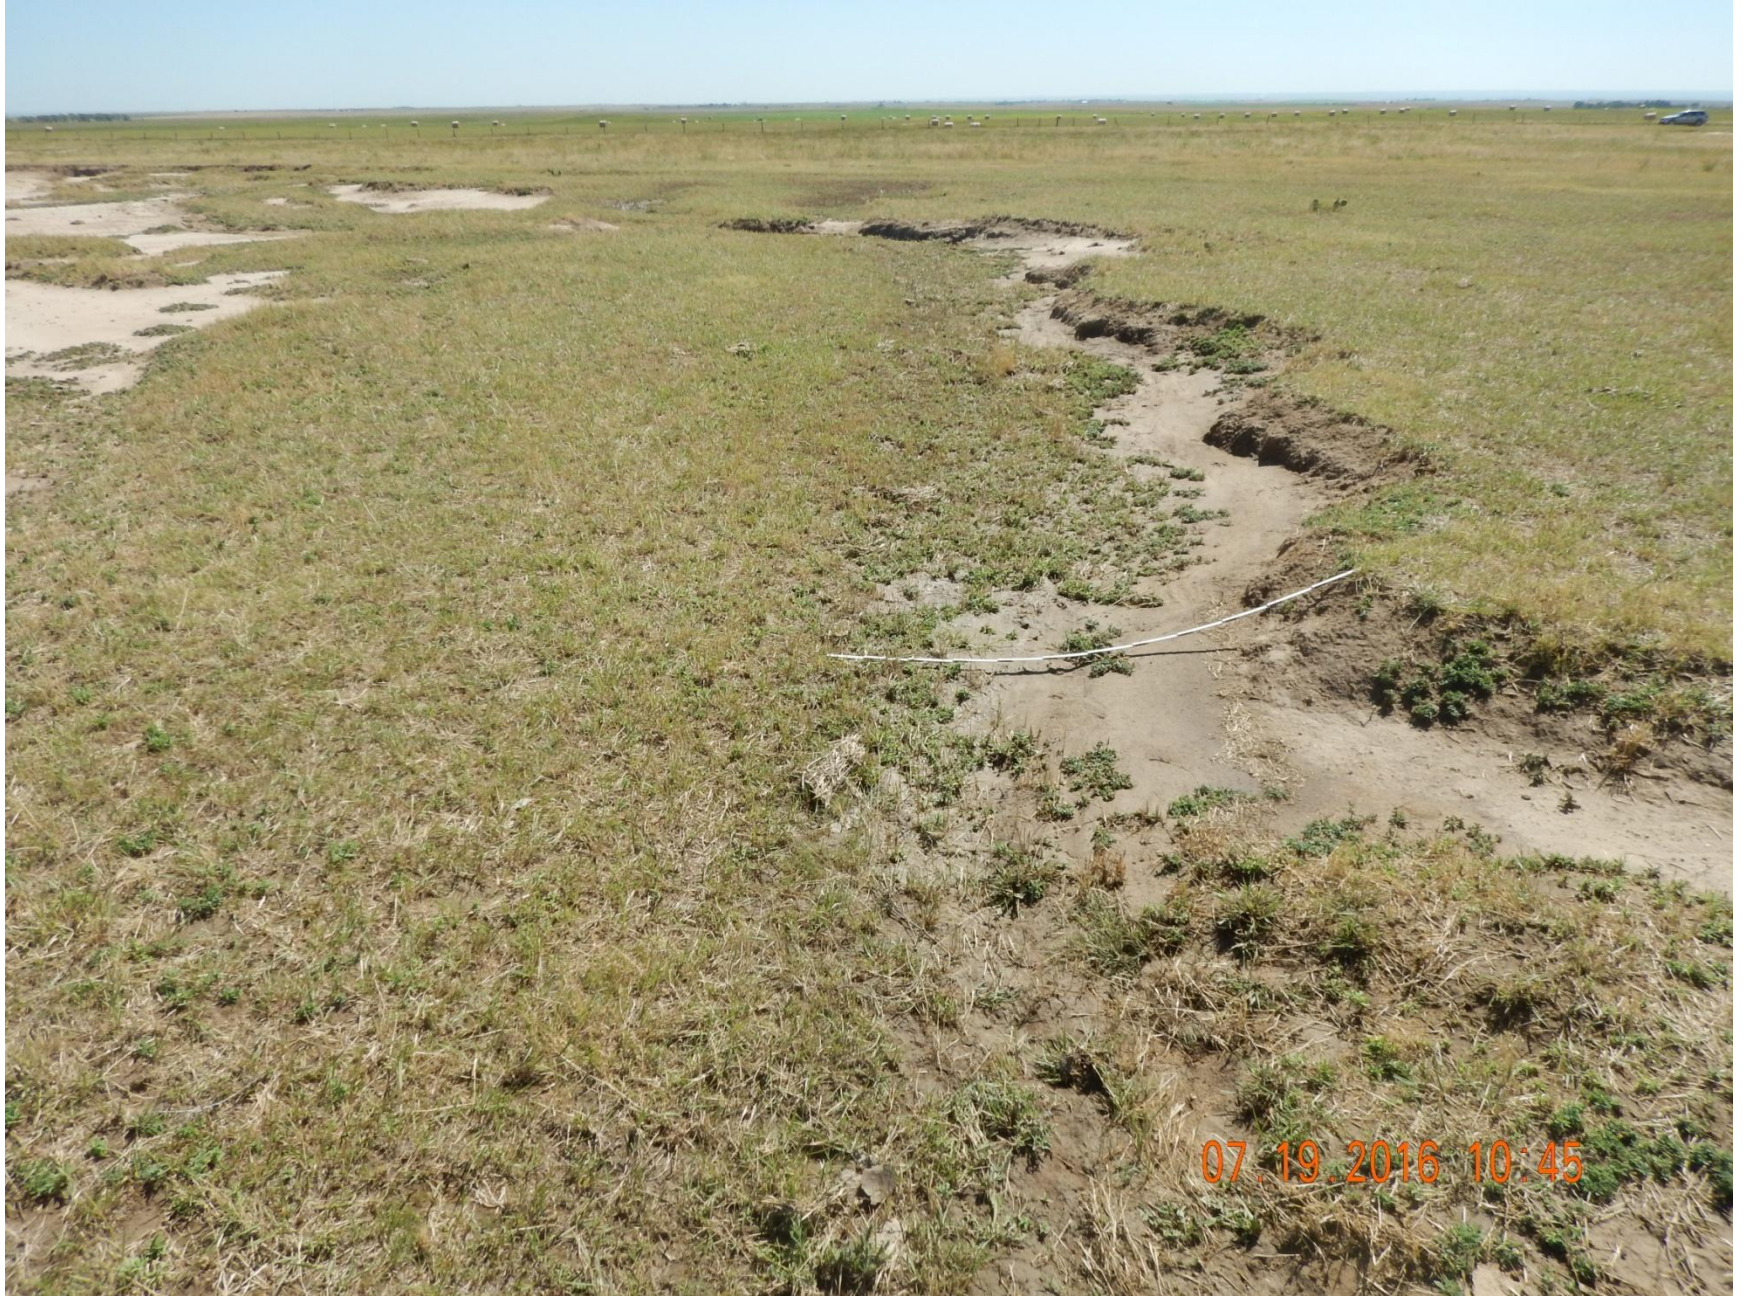
**Figure 20:** Photo taken from the north central area of the location, facing east. Photo shows areas of degradation due to stormwater erosion and possible salt kill from the location. 6' measuring stick for reference

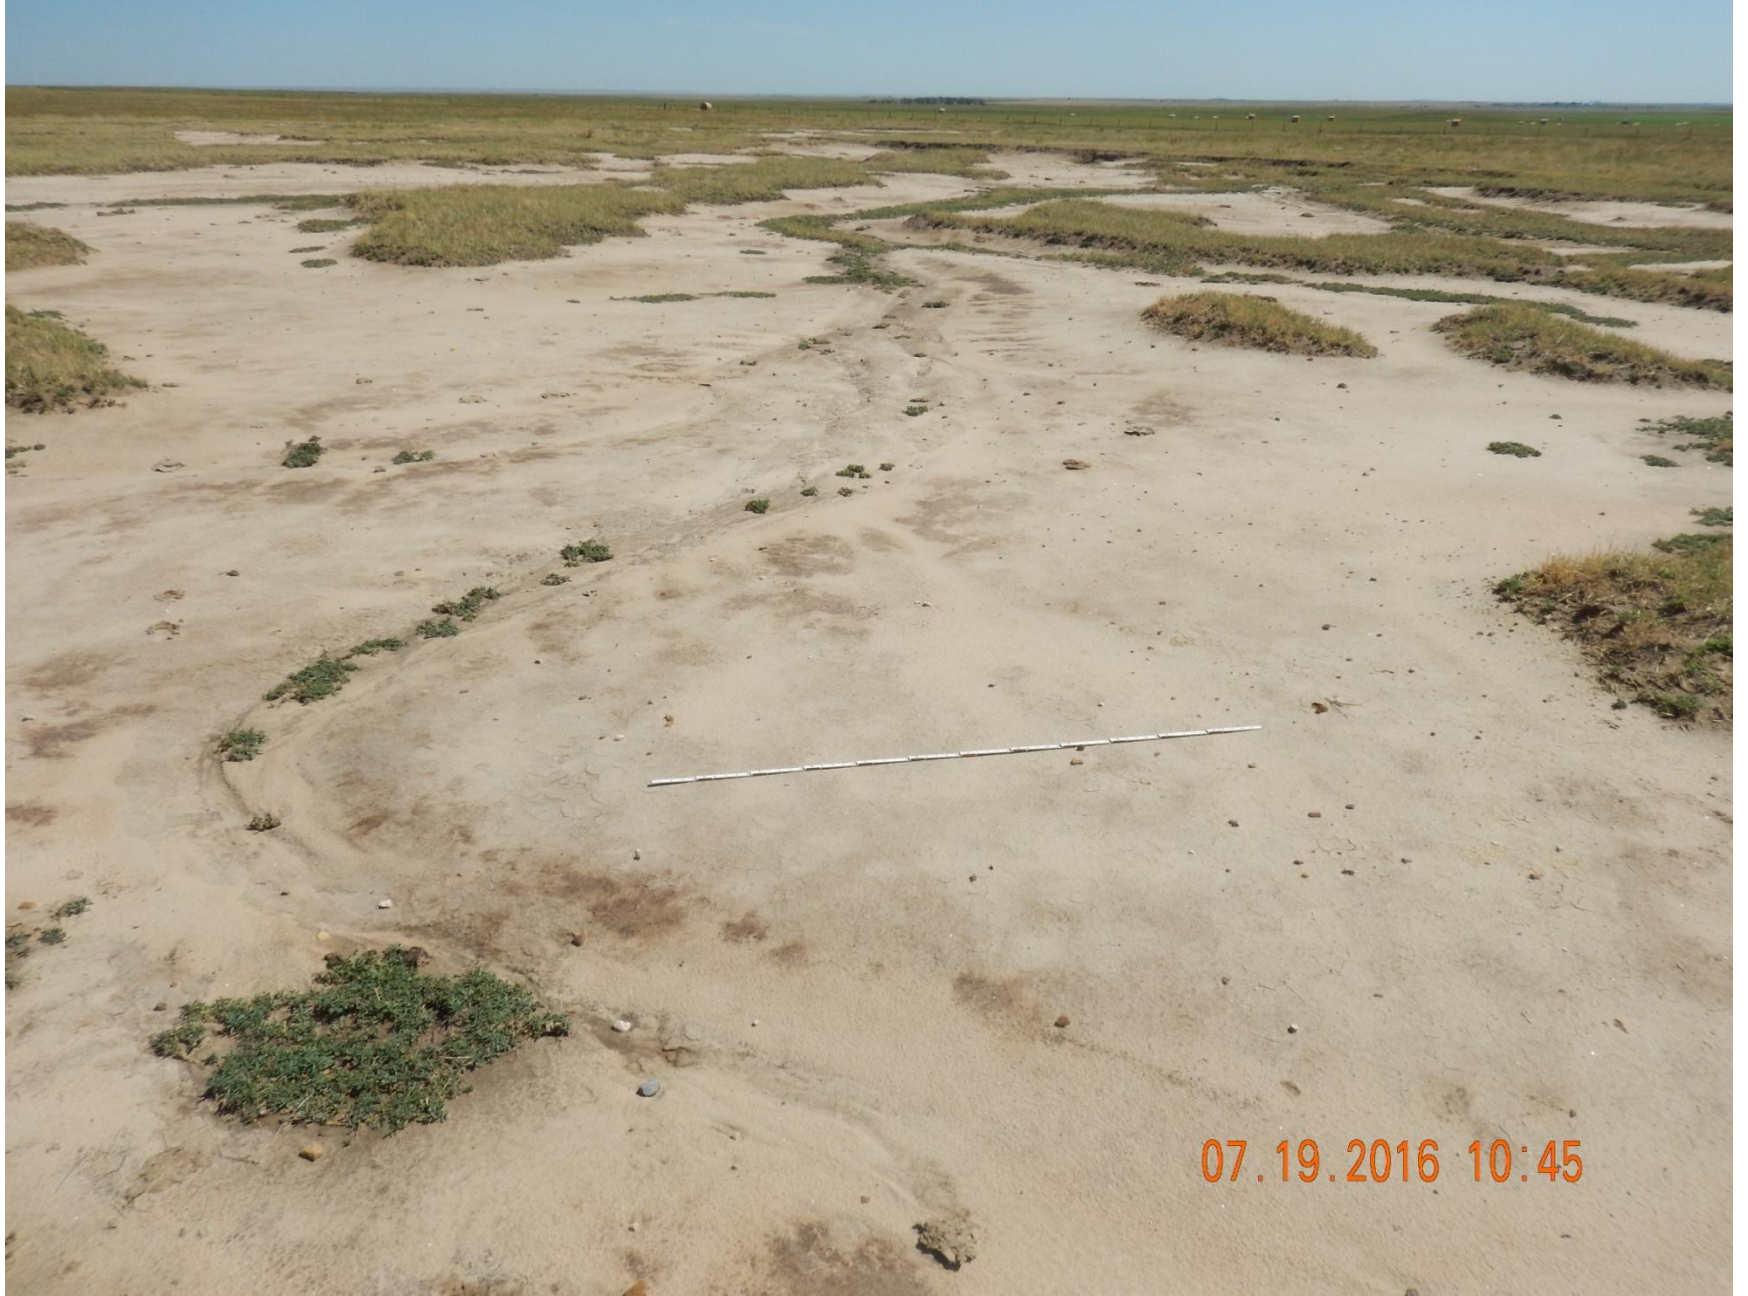
**Figure 21:** Photo taken from the north central area of the location, facing east. Photo shows areas of degradation due to stormwater erosion and possible salt kill from the location. 6' measuring stick for reference
