# Final Reclamation Inspection

07/19/2016

Operator: Denver East Machinery co

Location ID: 390528

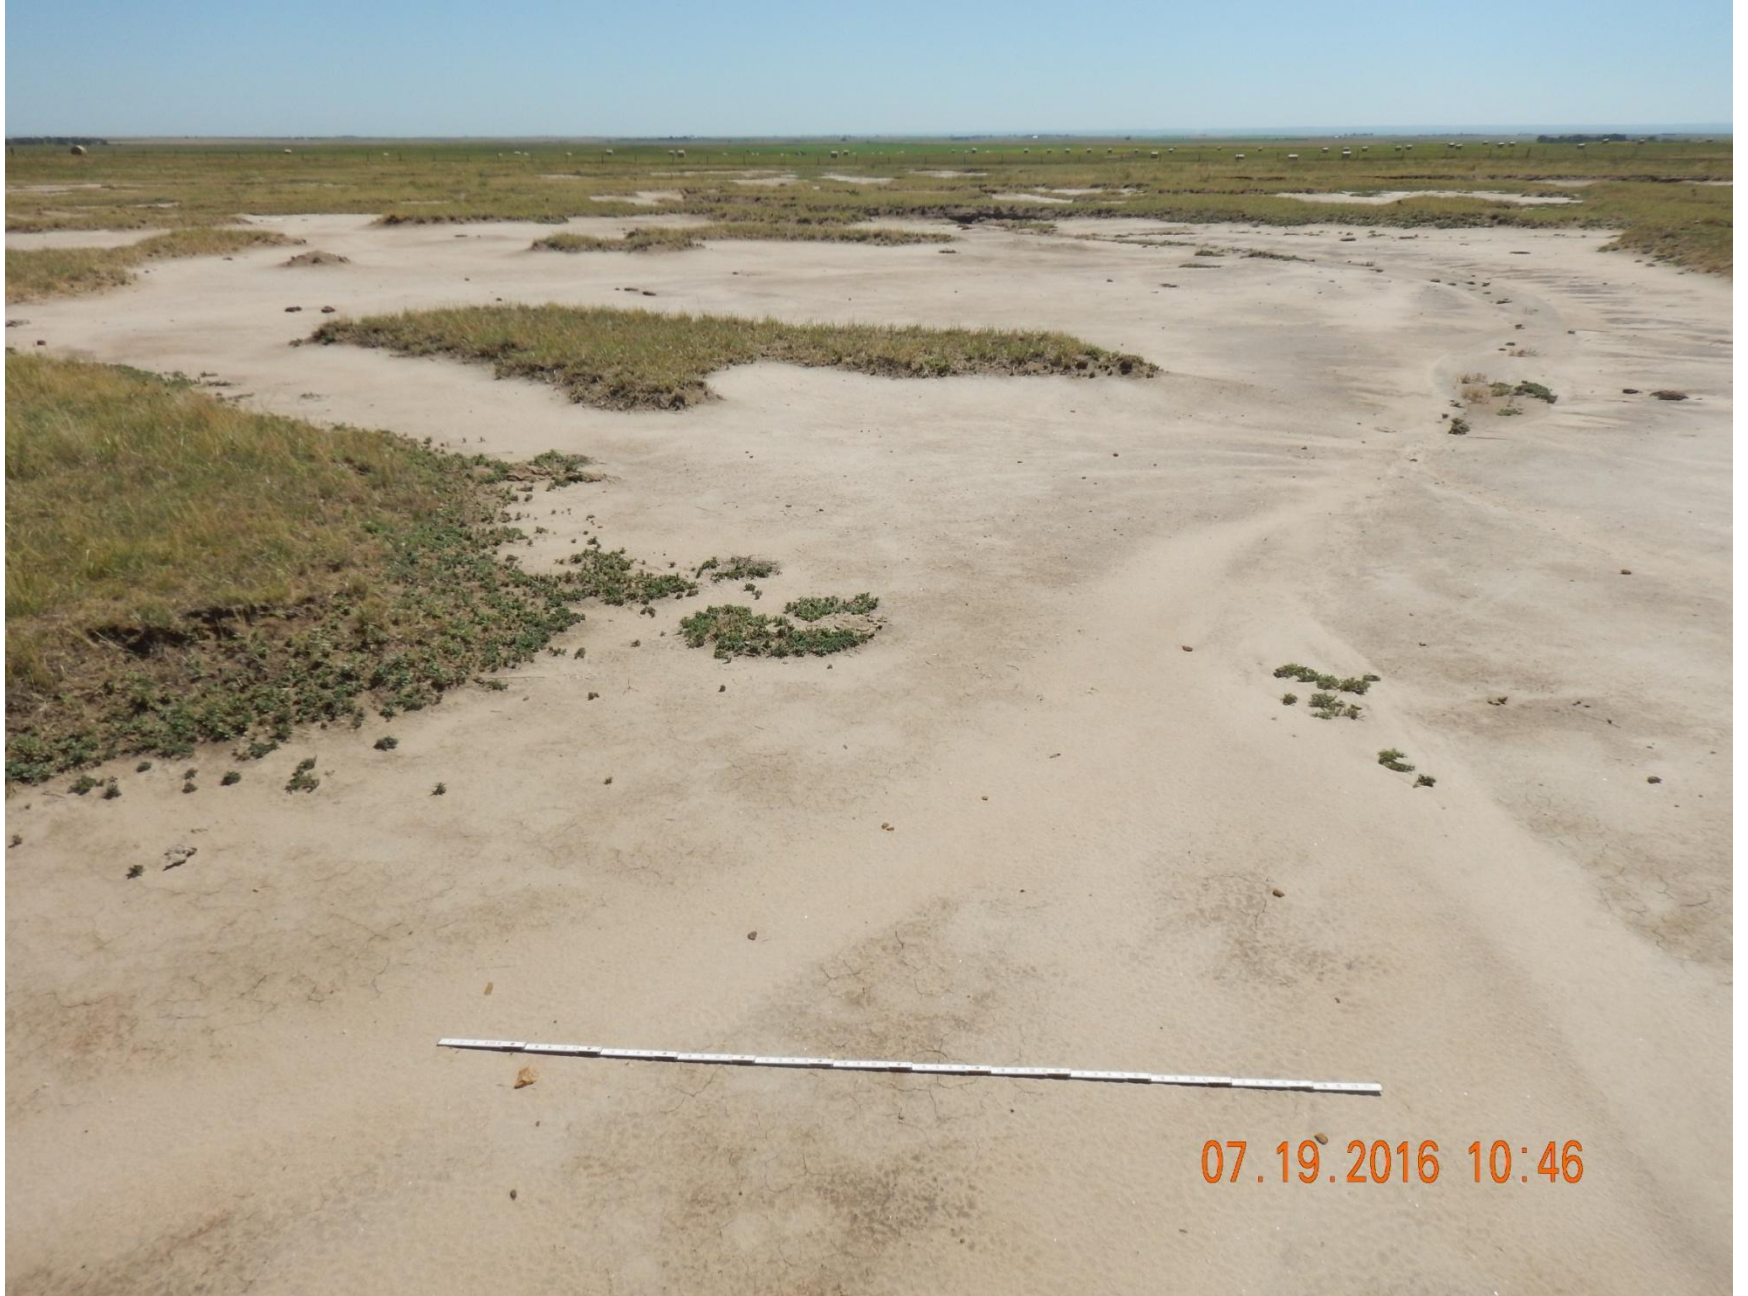
**Figure 22:** Photo taken from the south central area of the location, facing east. Photo shows areas of degradation due to stormwater erosion and possible salt kill from the location. 6' measuring stick for reference

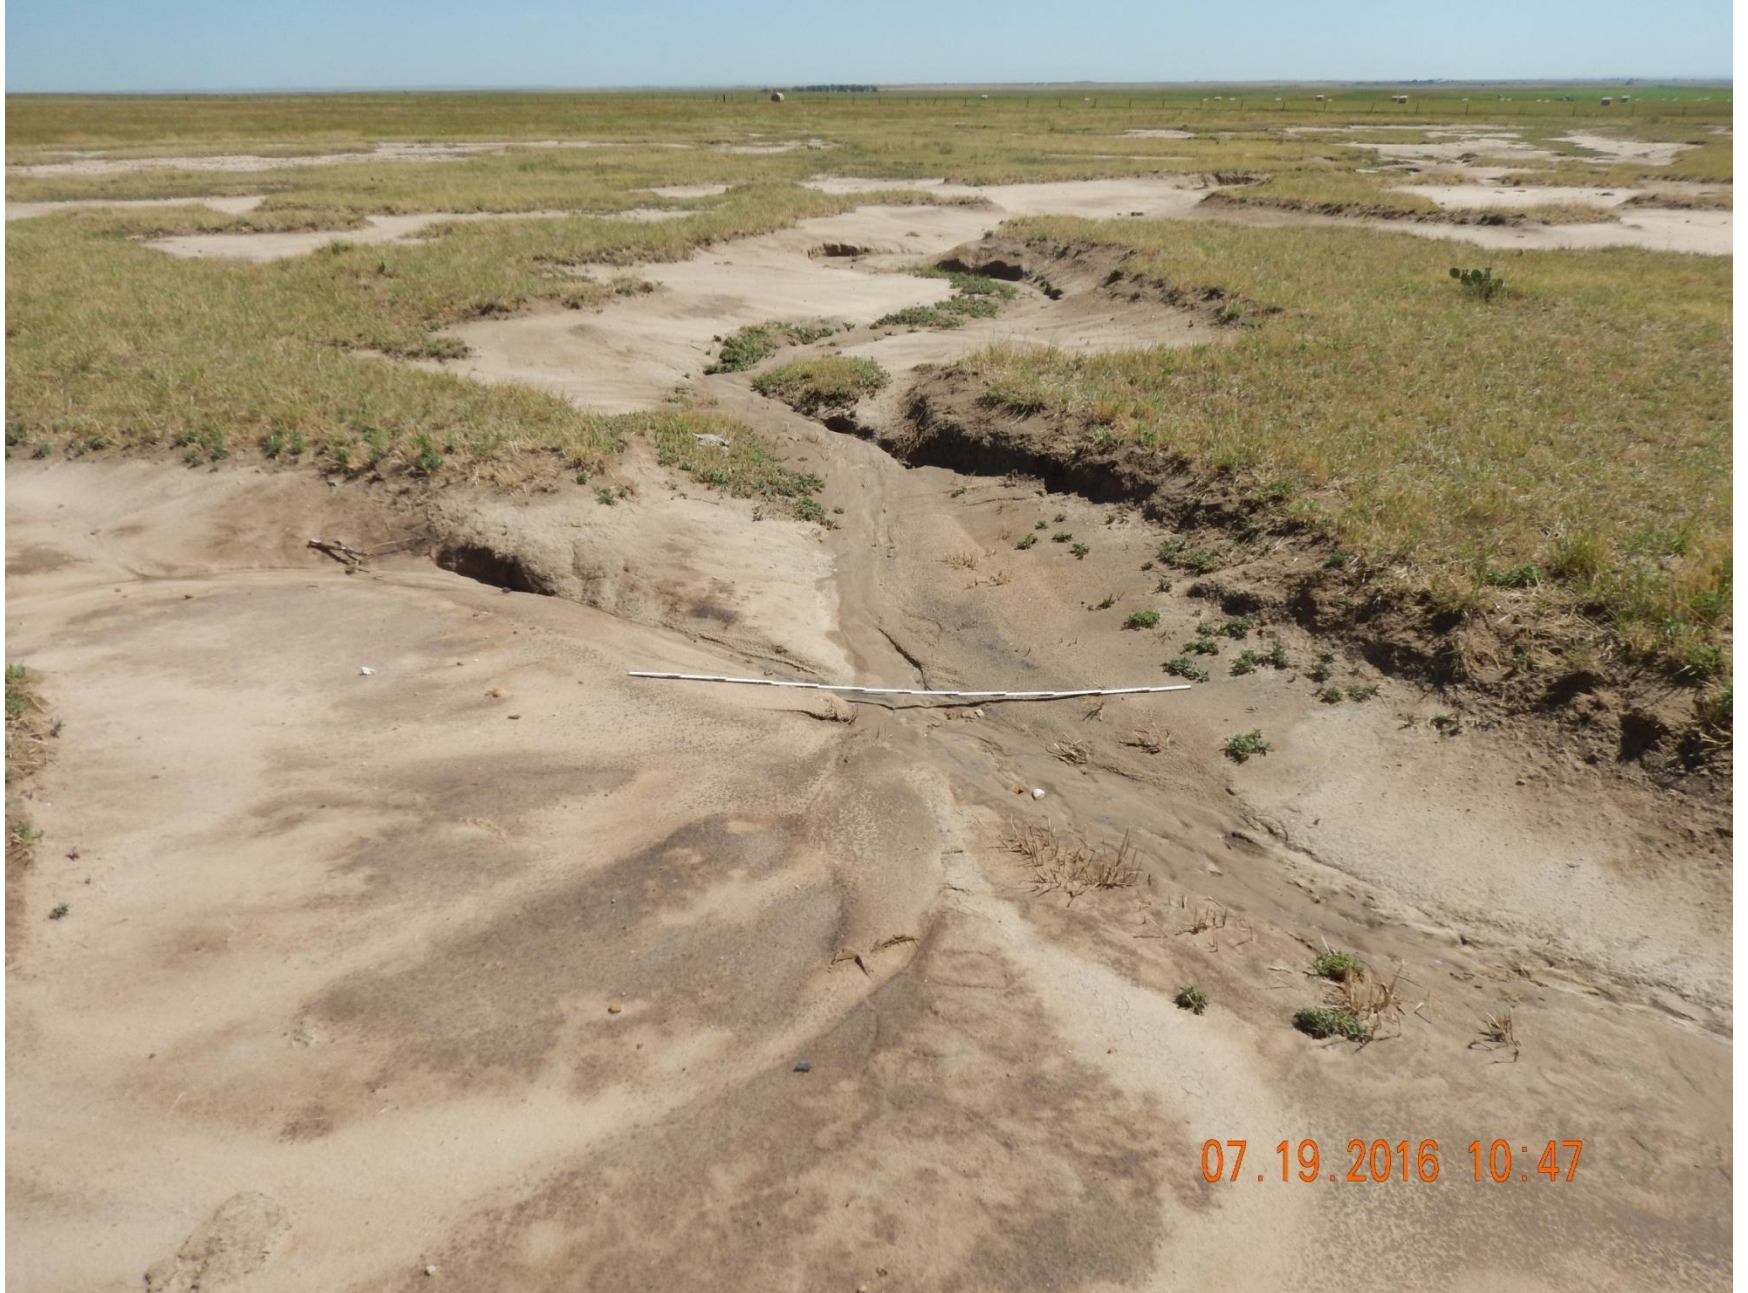
**Figure 23:** Photo taken from the south central area of the location, facing northeast. Photo shows areas of degradation due to stormwater erosion and possible salt kill from the location. 6' measuring stick for reference

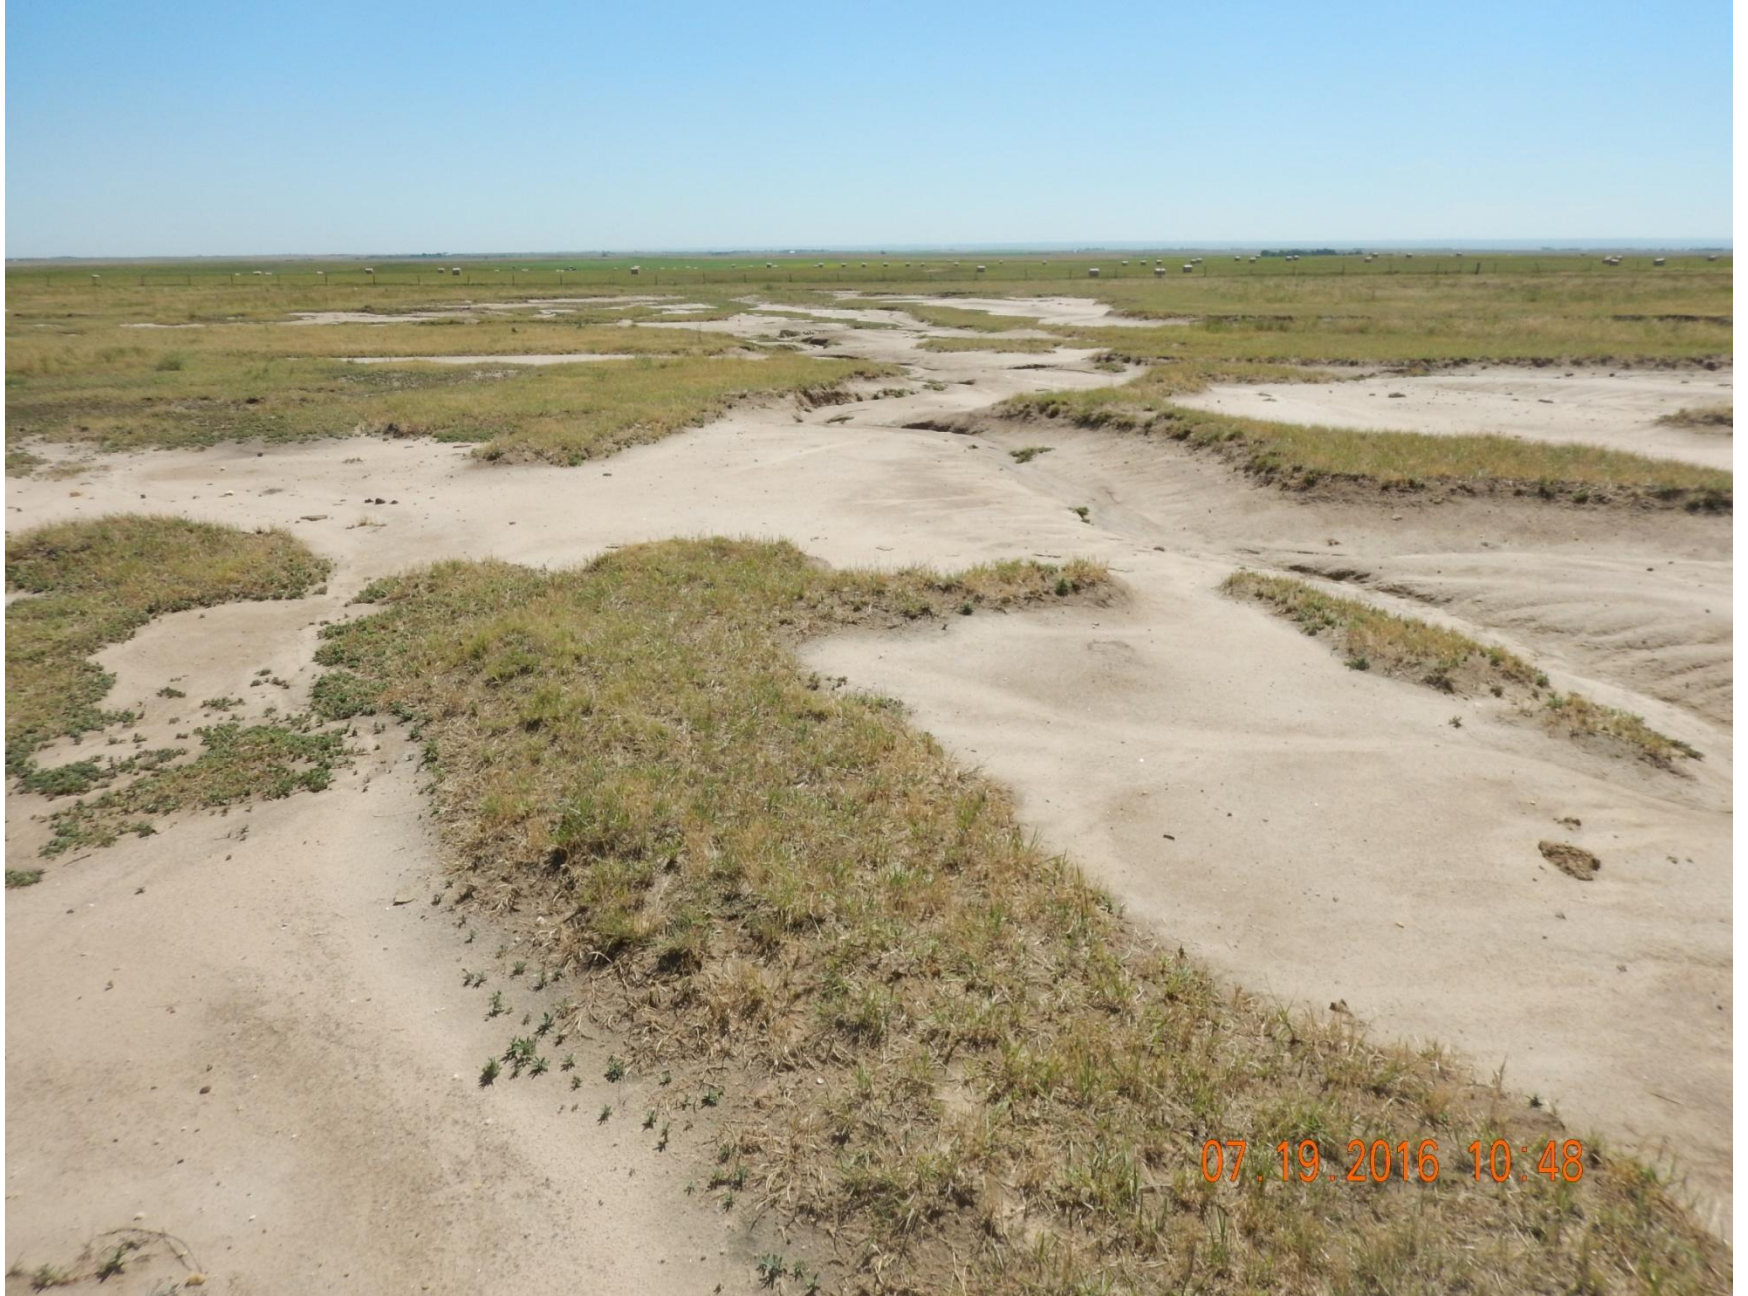
**Figure 24:** Photo taken from the northwest end of the location, facing east. Photo shows areas of degradation due to stormwater erosion and possible salt kill from the location.

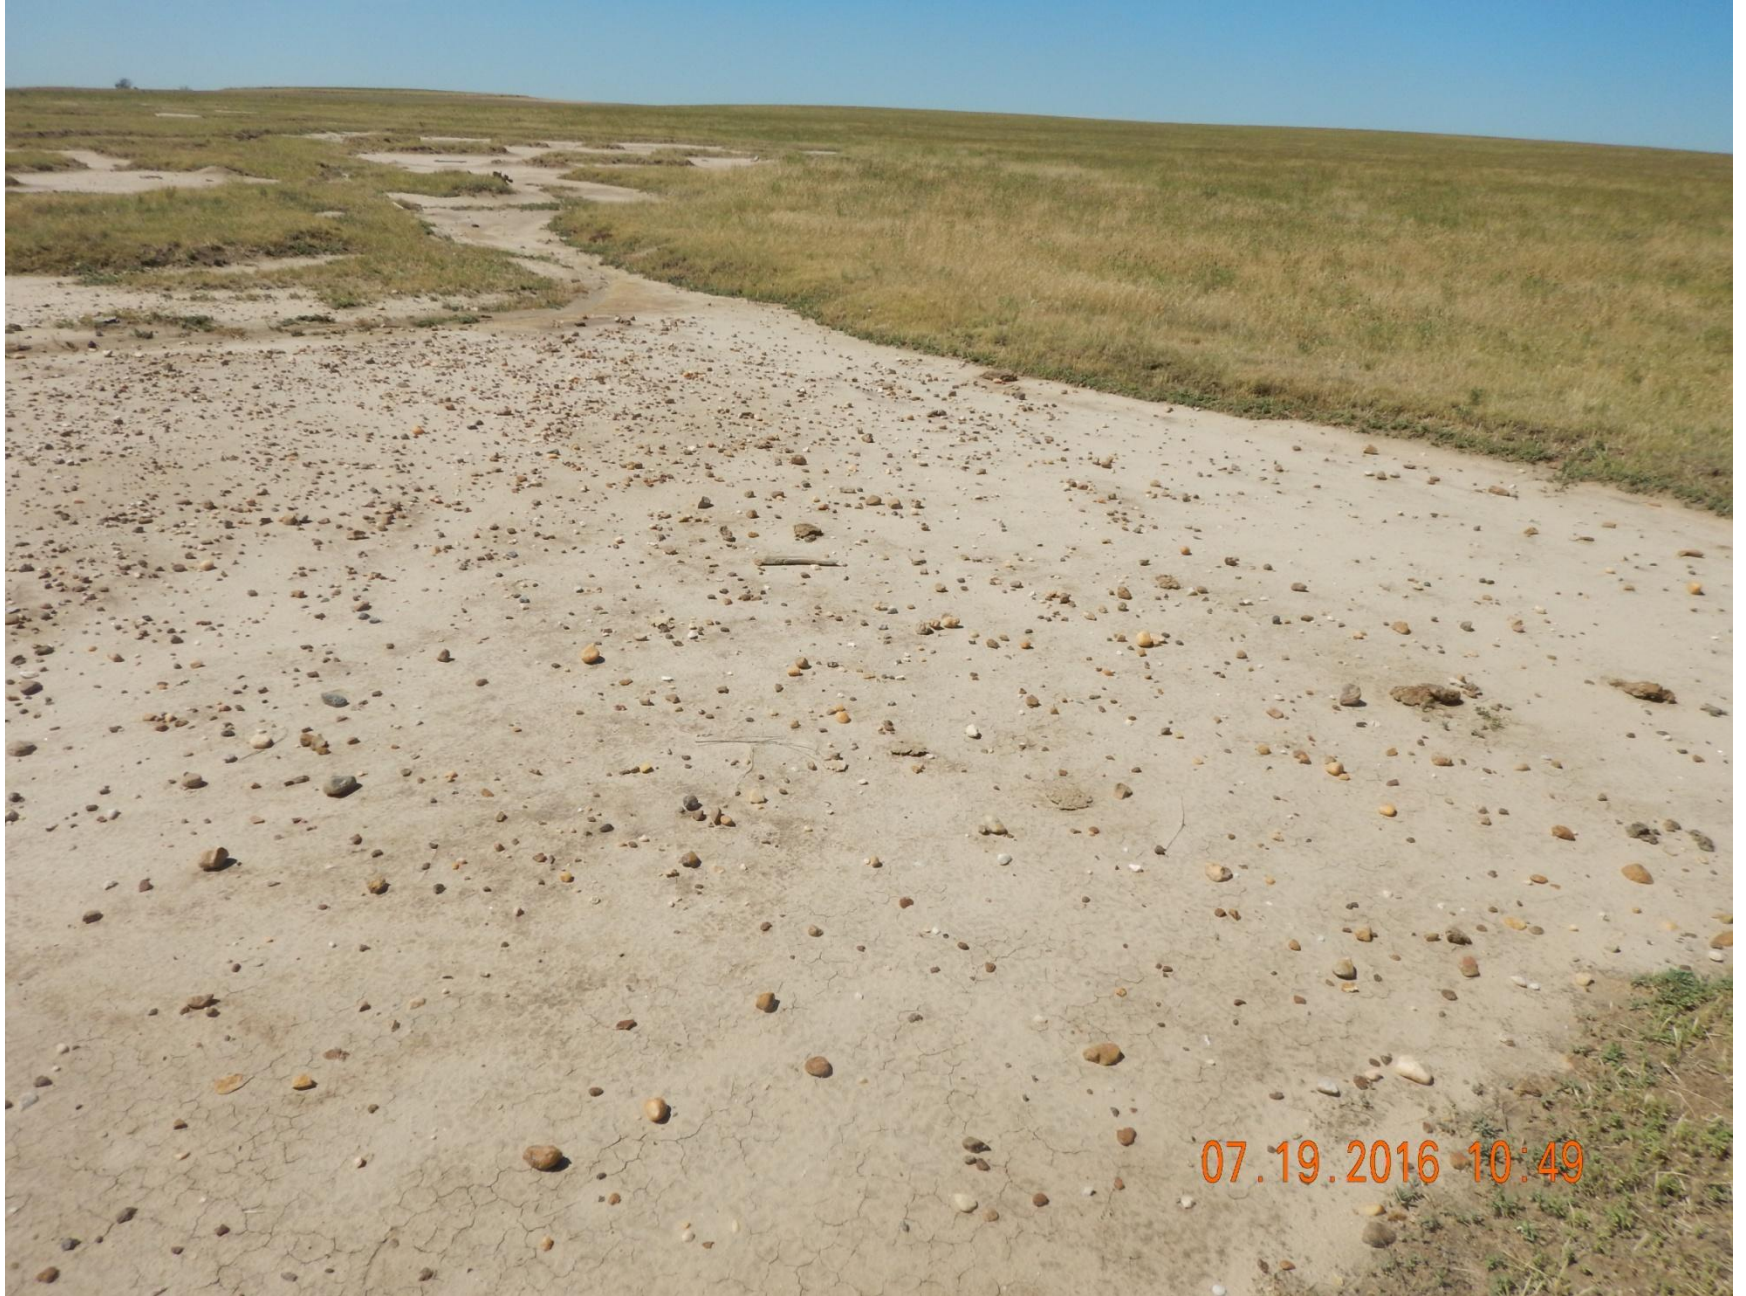
**Figure 25:** Photo taken from the north end of the location, facing southwest. Photo shows areas of degradation due to stormwater erosion and possible salt kill from the location. Note larger rock aggregate likely washed “upstream” from location and deposited here.

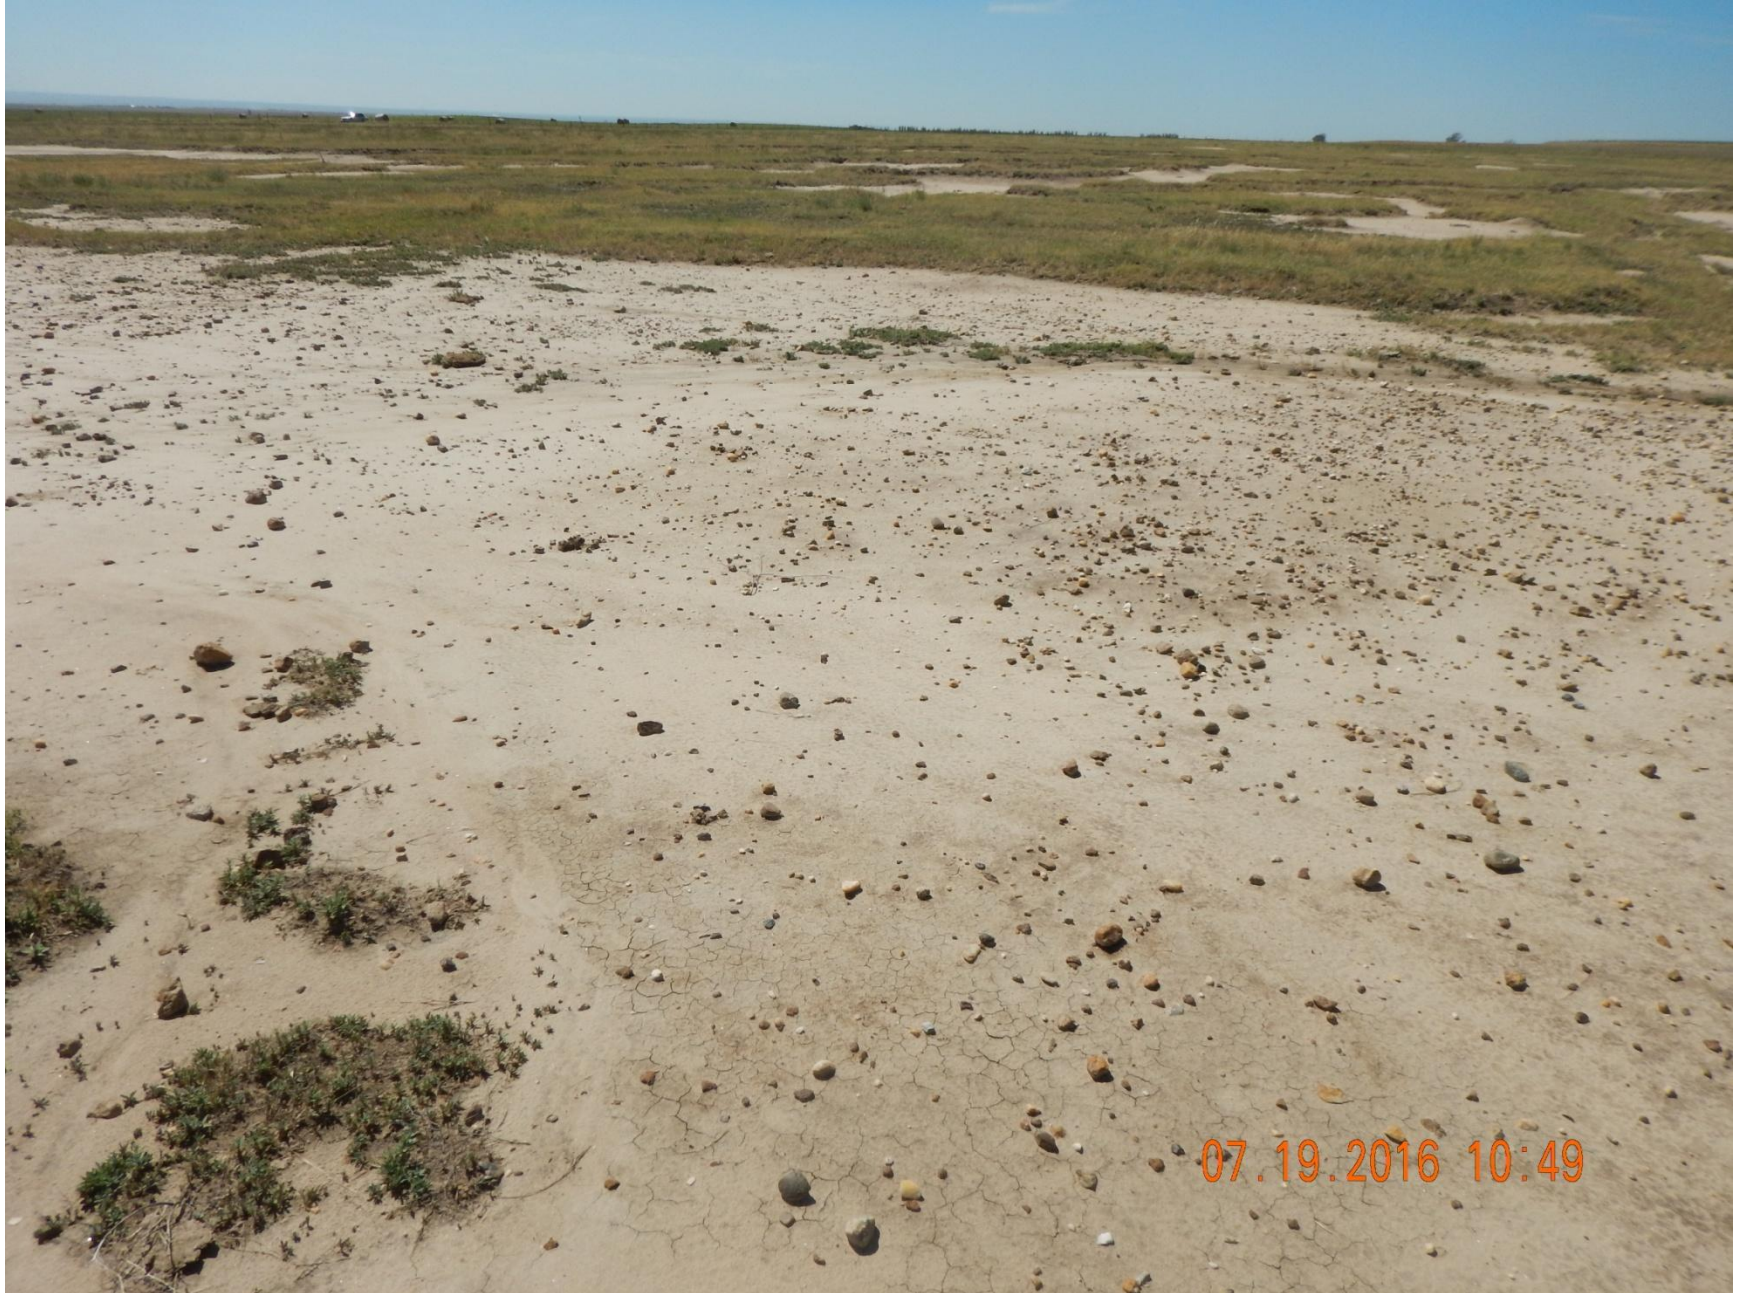
**Figure 26:** Photo taken from the north end of the location, facing south. Photo shows areas of degradation due to stormwater erosion and possible salt kill from the location. Note larger rock aggregate likely washed “upstream” from location and deposited here.

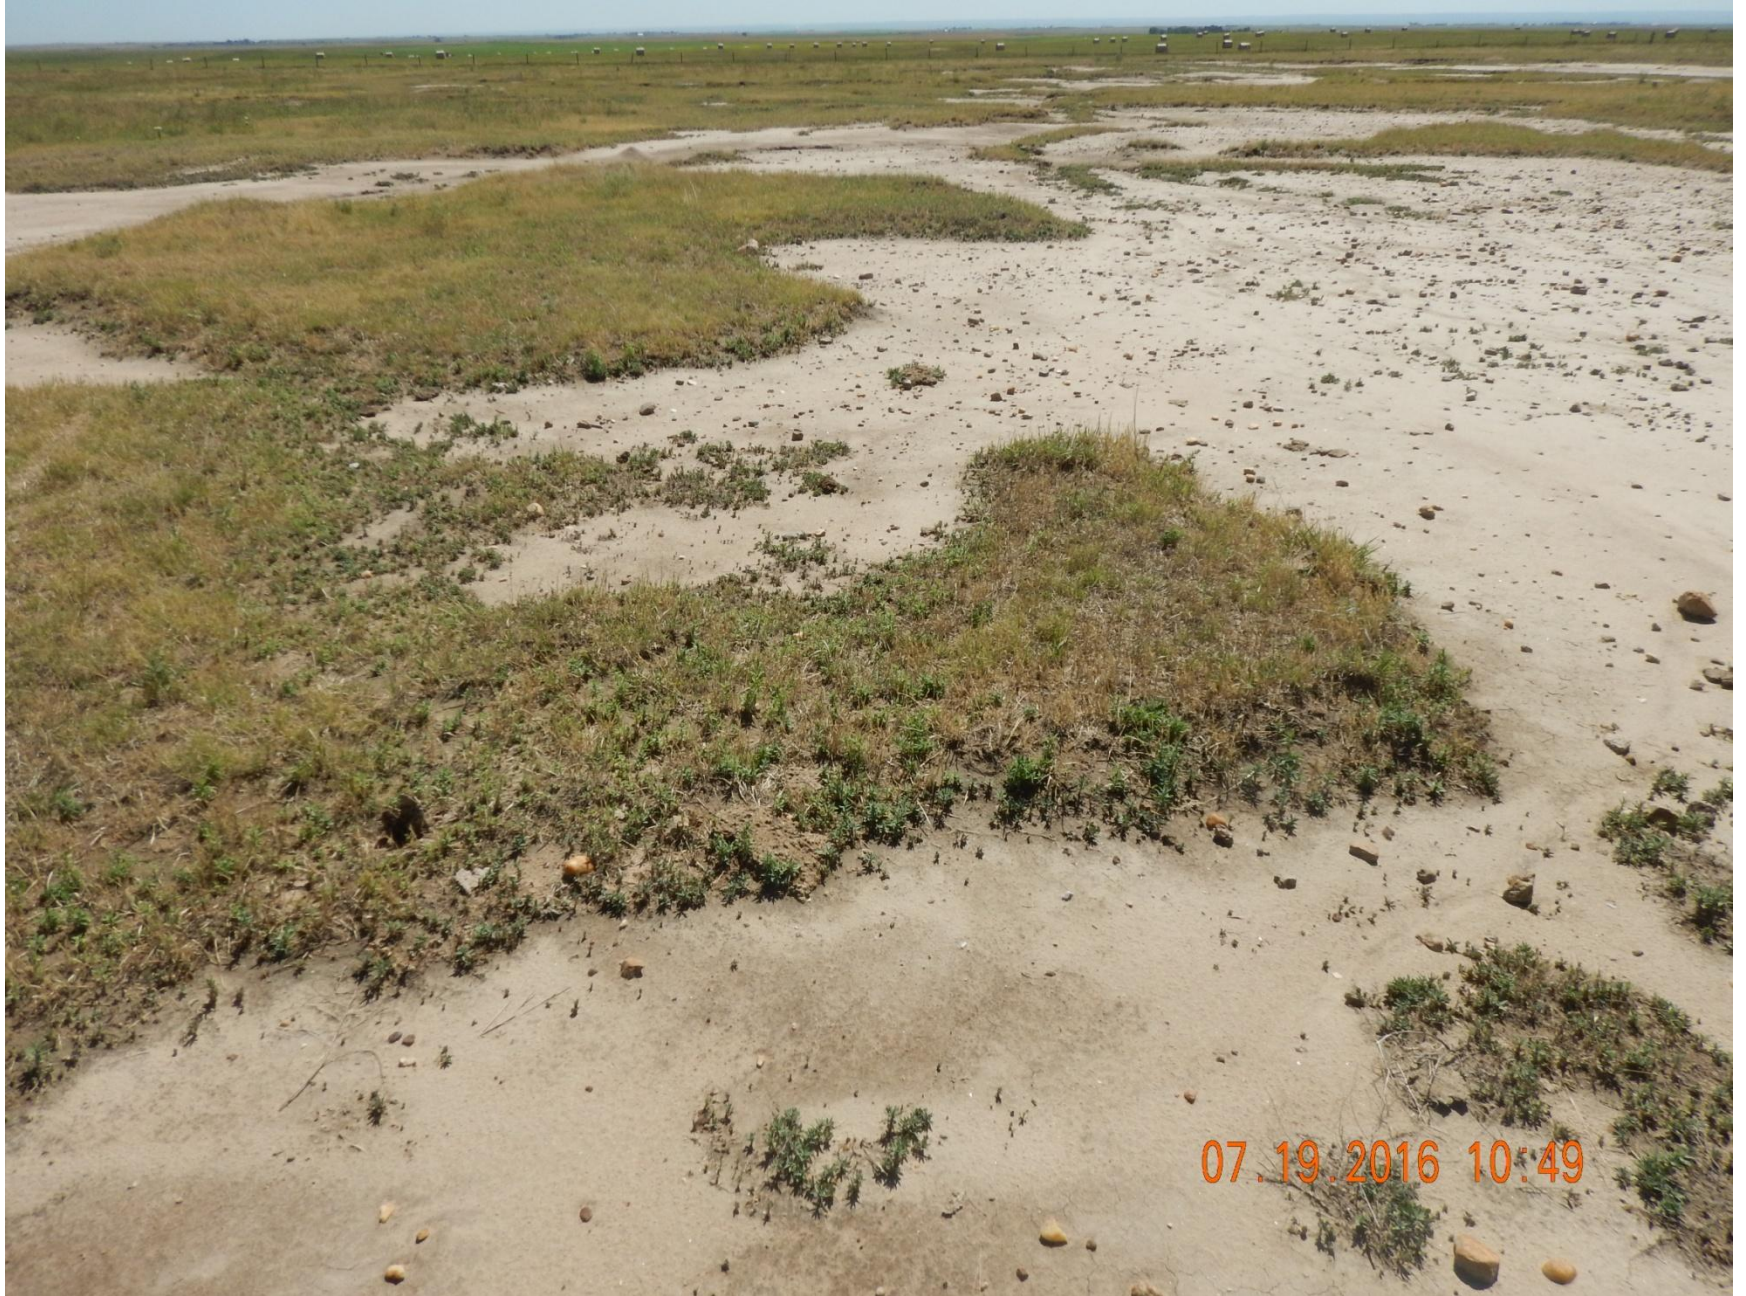
**Figure 27:** Photo taken from the north end of the location, facing southeast. Photo shows areas of degradation due to stormwater erosion and possible salt kill from the location. Note larger rock aggregate likely washed “upstream” from location and deposited here.

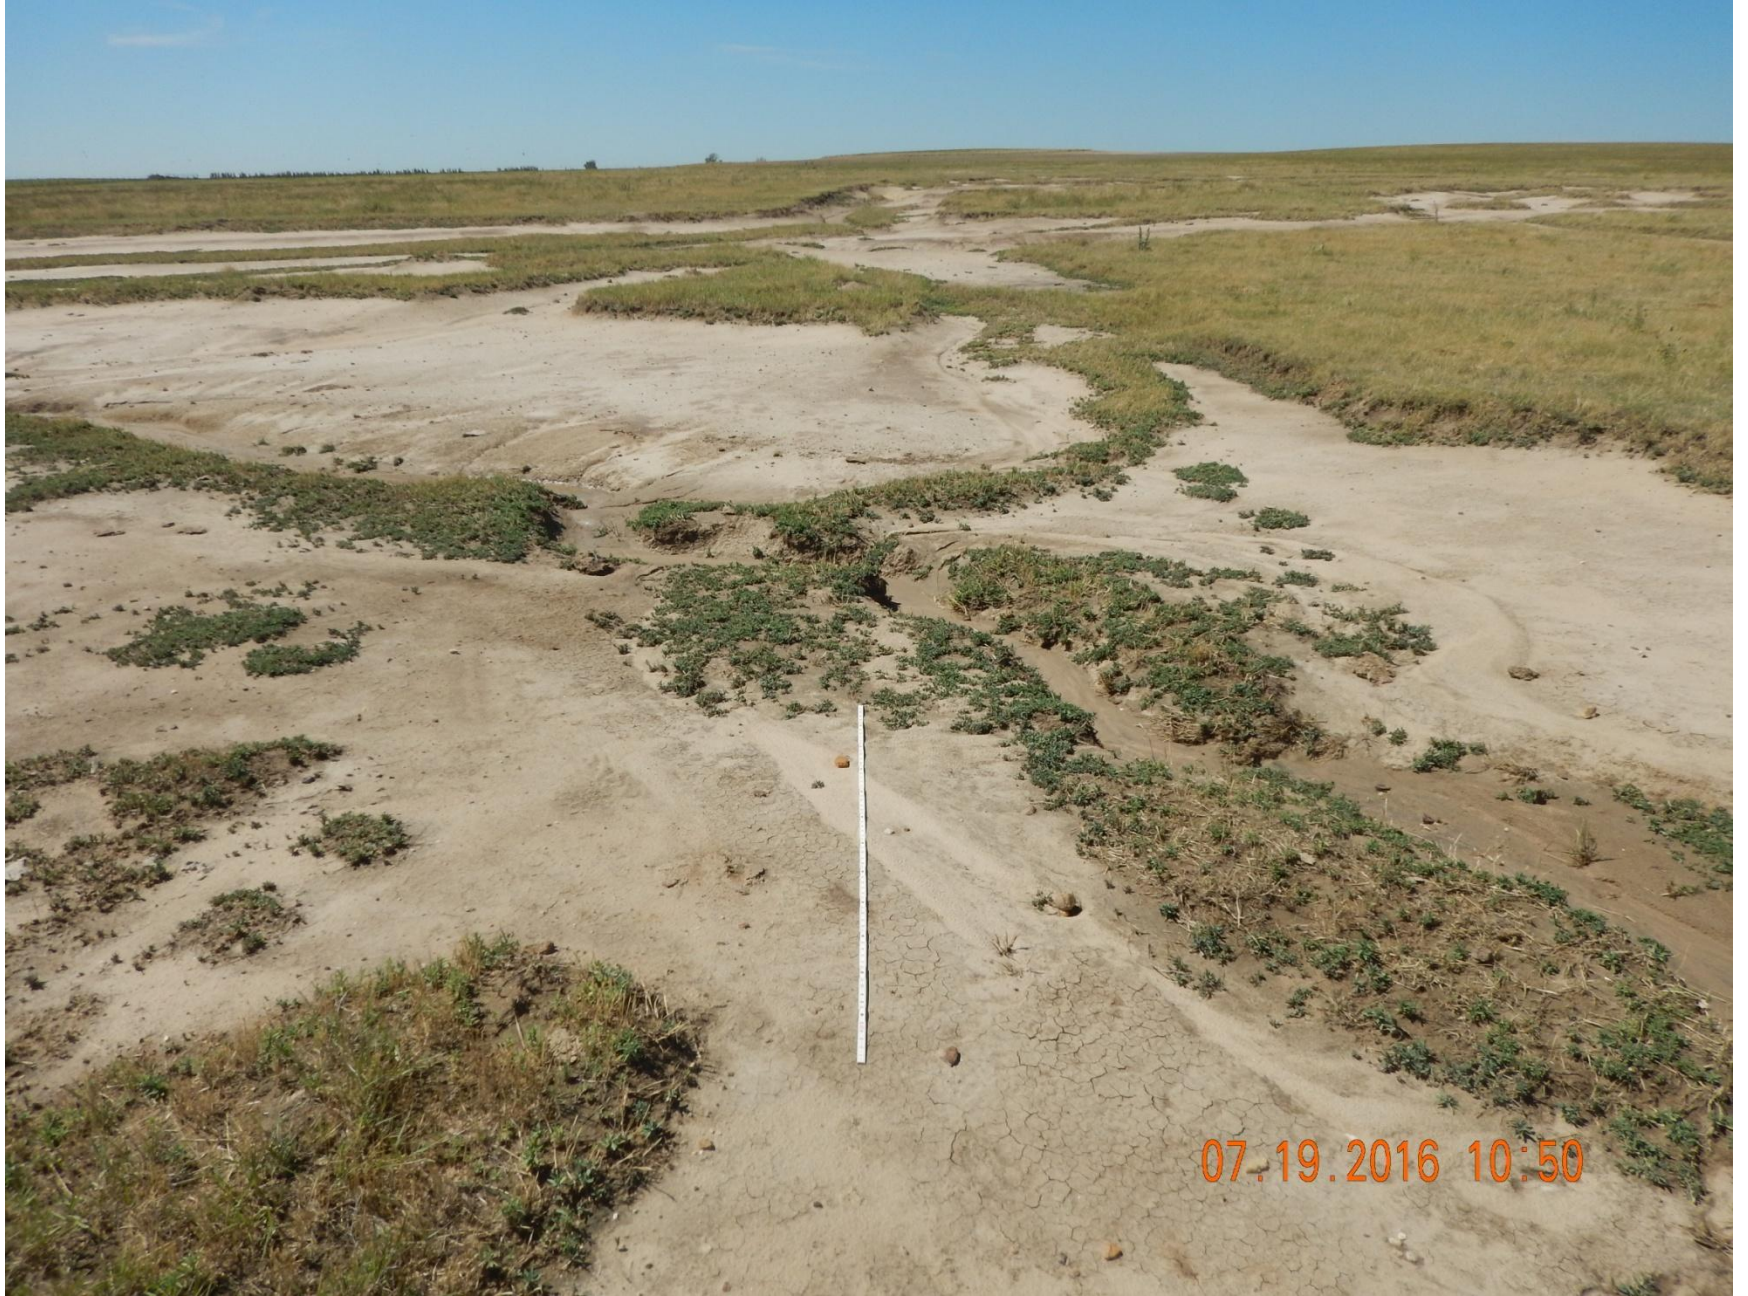
**Figure 28:** Photo taken from the north end of the location, facing south. Photo shows areas of degradation due to stormwater erosion and possible salt kill from the location. 6' measuring stick for reference.

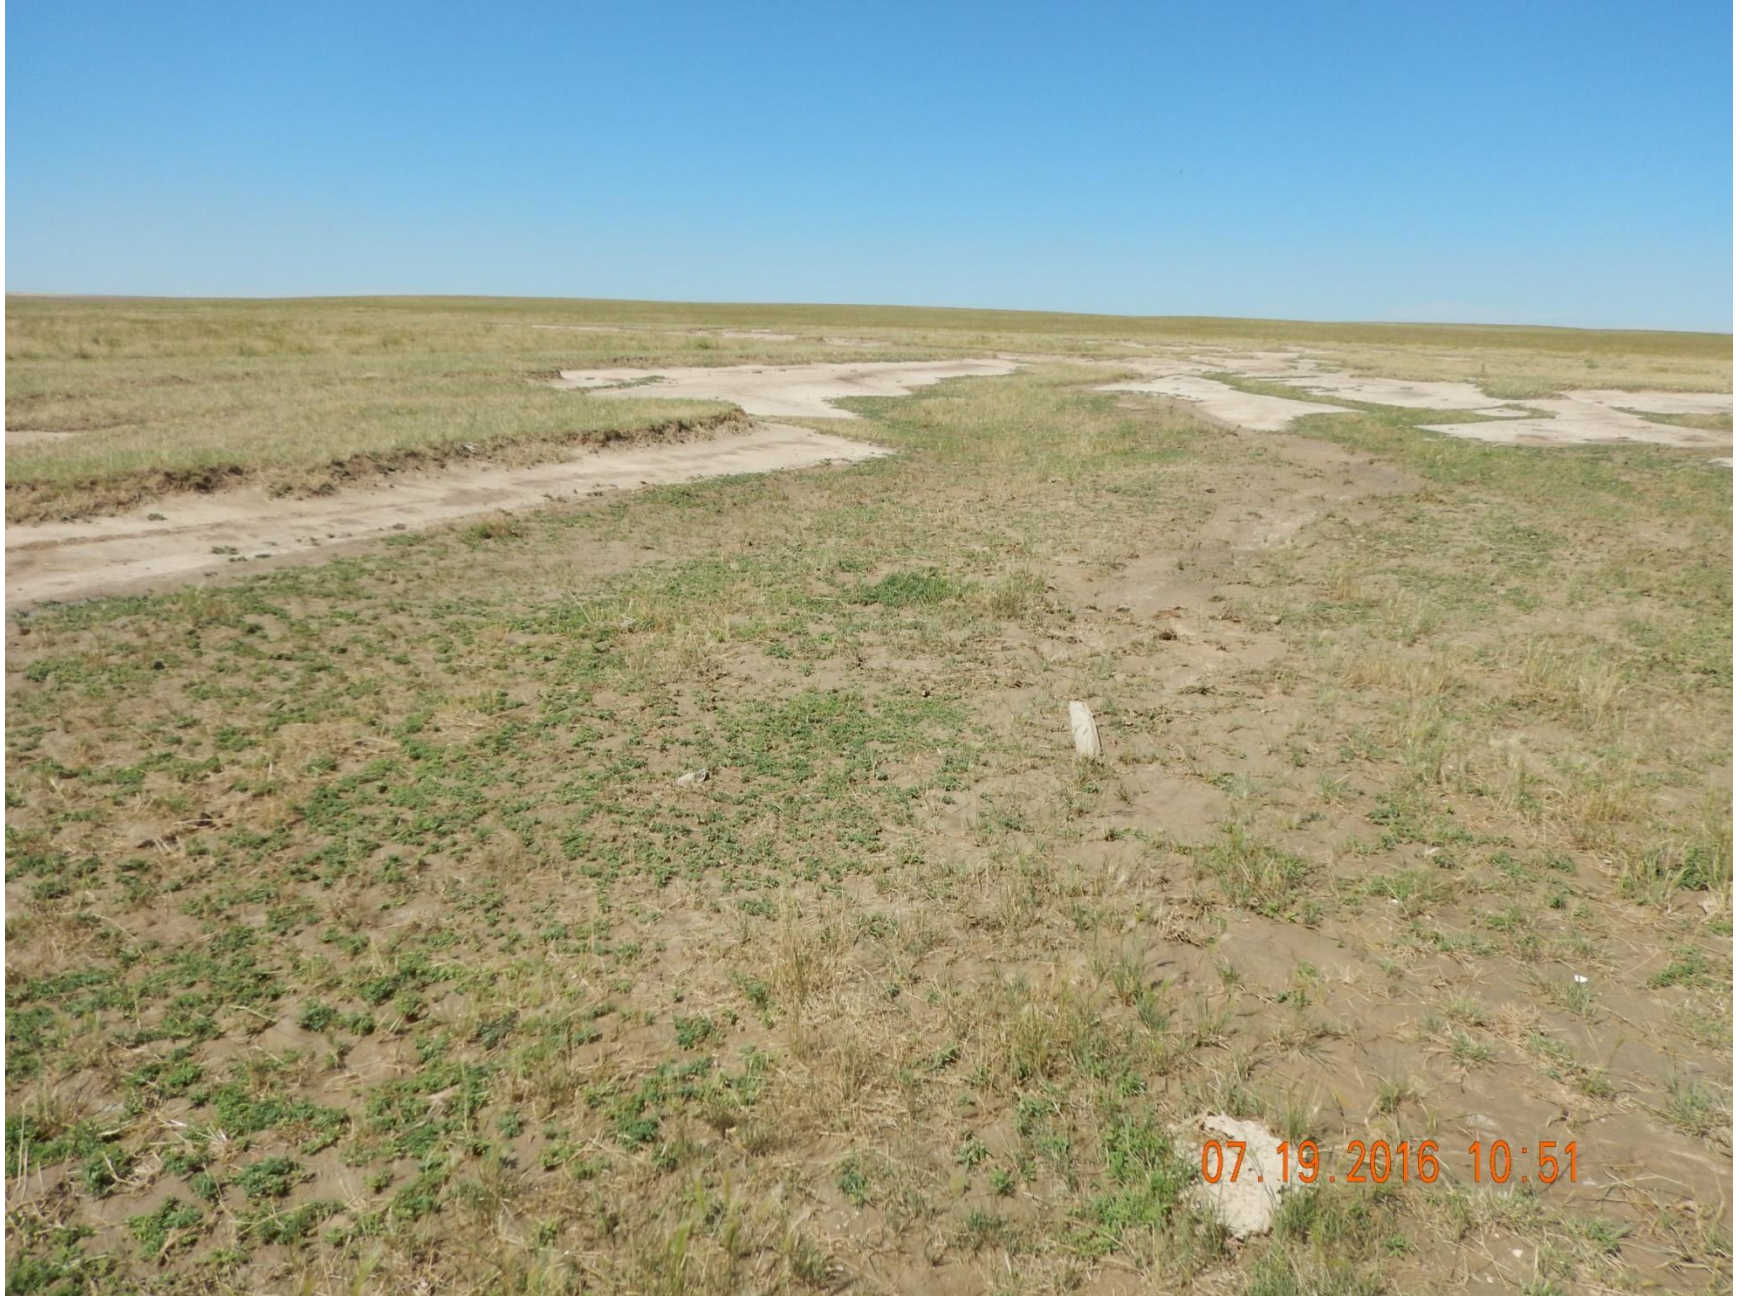
**Figure 29:** Photo taken from the northeast end of the location, facing west. Photo shows areas of degradation due to stormwater erosion and possible salt kill from the location.

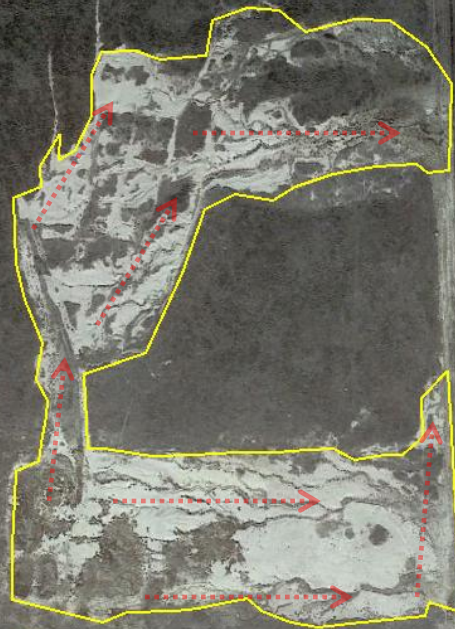
**Figure 30:** 2015 aerial imagery. Image shows location of well and size of the degradation. Approximate size of the degradation area is 7.8 acres. Arrows represent direction of water travel
