**Reference Area Photographs**

**Inspection Conducted on July 19, 2016**

**Hunter Ridge Energy Services**

## Hunter Ridge A27 Spill

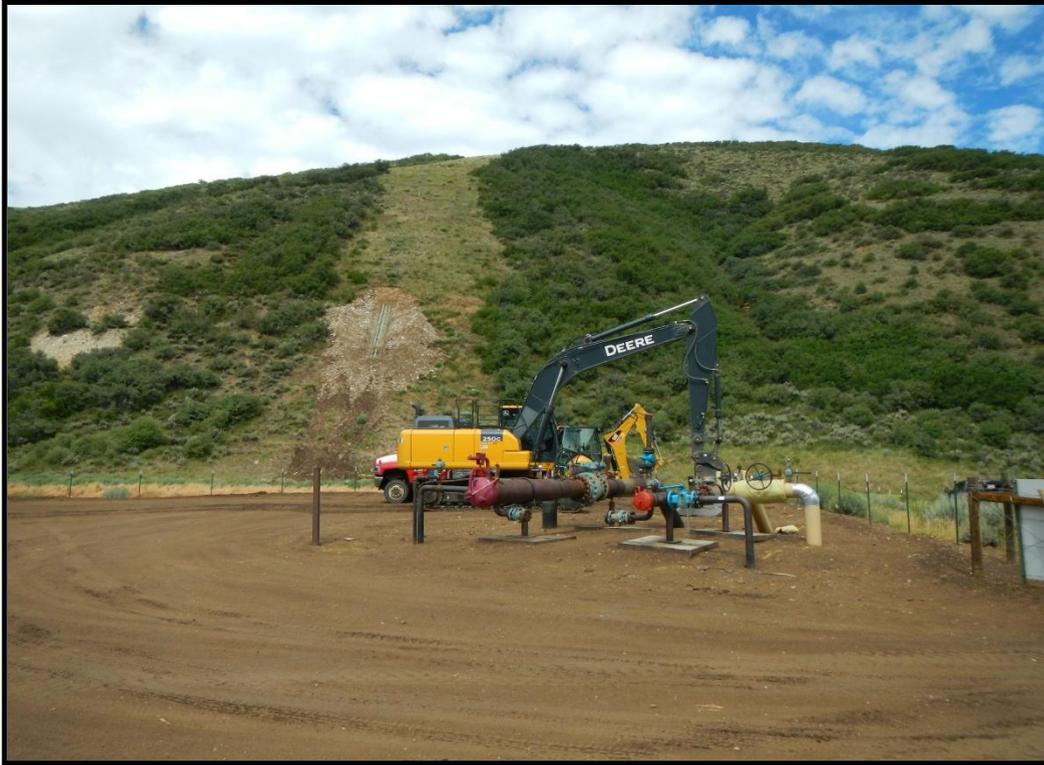
From A27 CDP looking west. Pipeline leak identified at the bottom of exposed pipeline

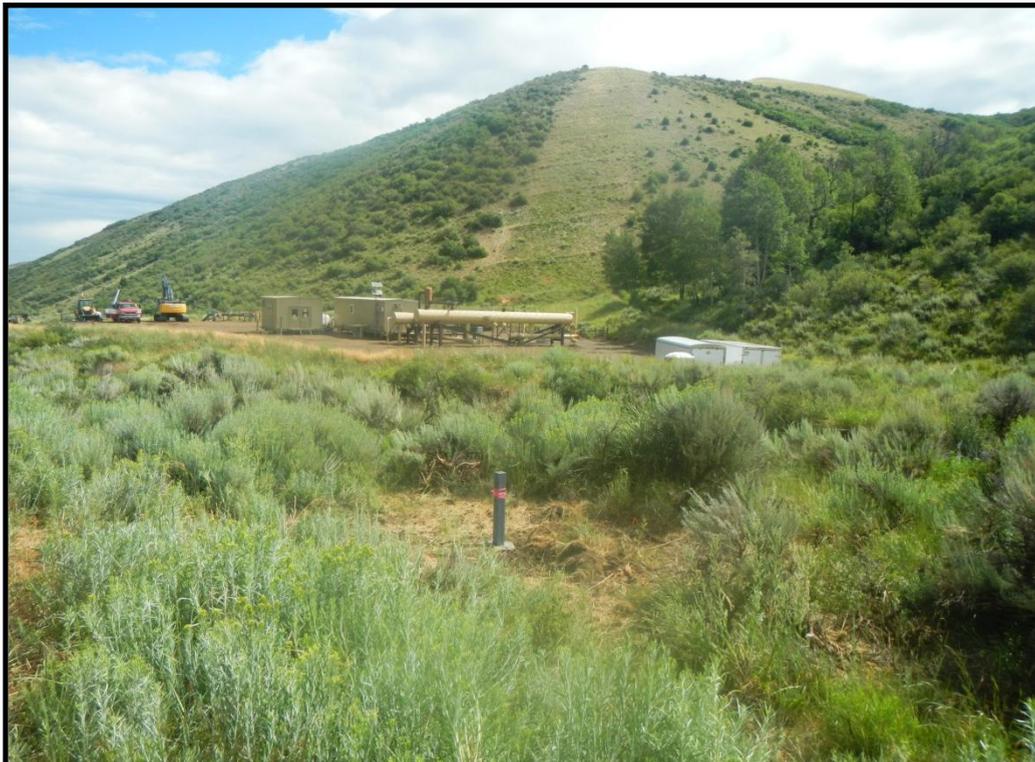
Up gradient monitoring well. Looking northeast to A27 CDP

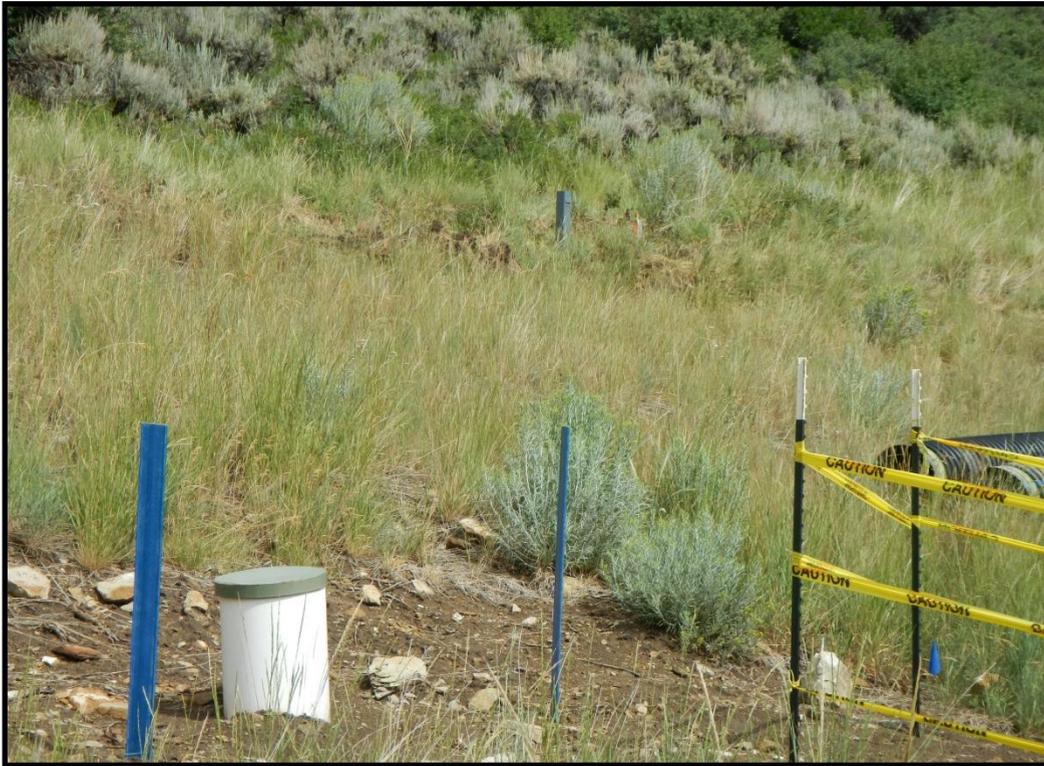
Large diameter white vertical pipe installed on the path of buried pipeline to determine if hydrocarbon flow followed the pipeline. No Hcs were detected. Monitoring well (top of photo) located cross-gradient of release point had free product.

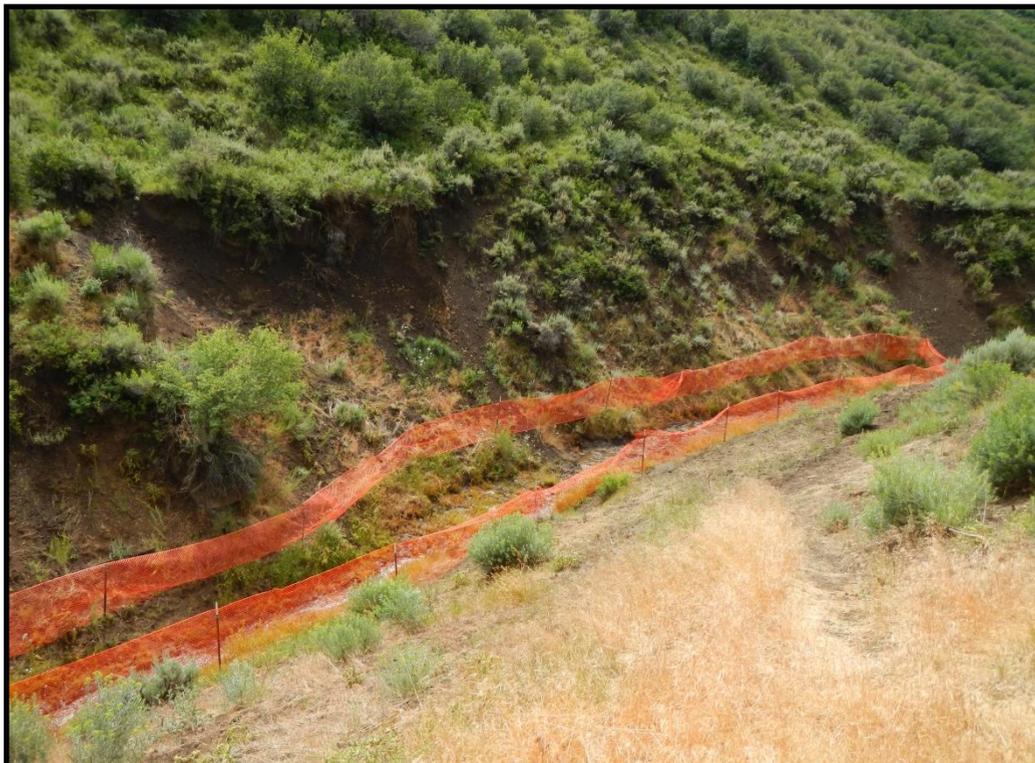
Half a mile down gradient (north of release point). Springs discharging water and condensate

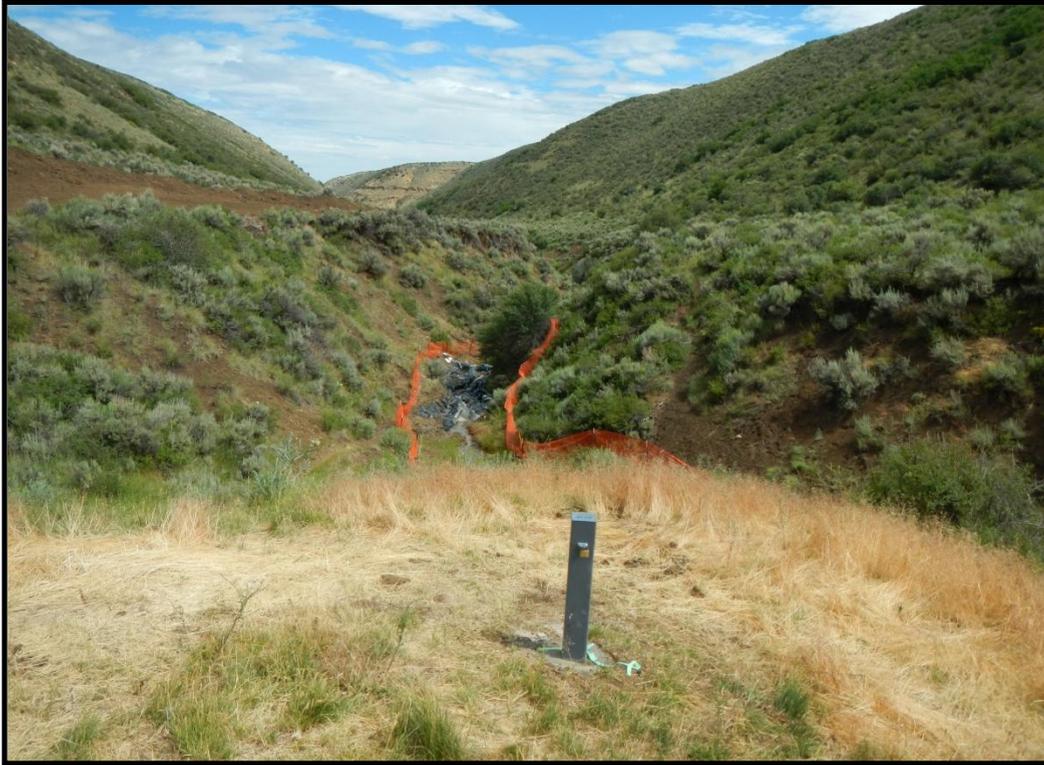
Fluid from springs collected a short distance downstream of springs and diverted via PVC pipe to separator tanks. See monitoring well installed down gradient of springs

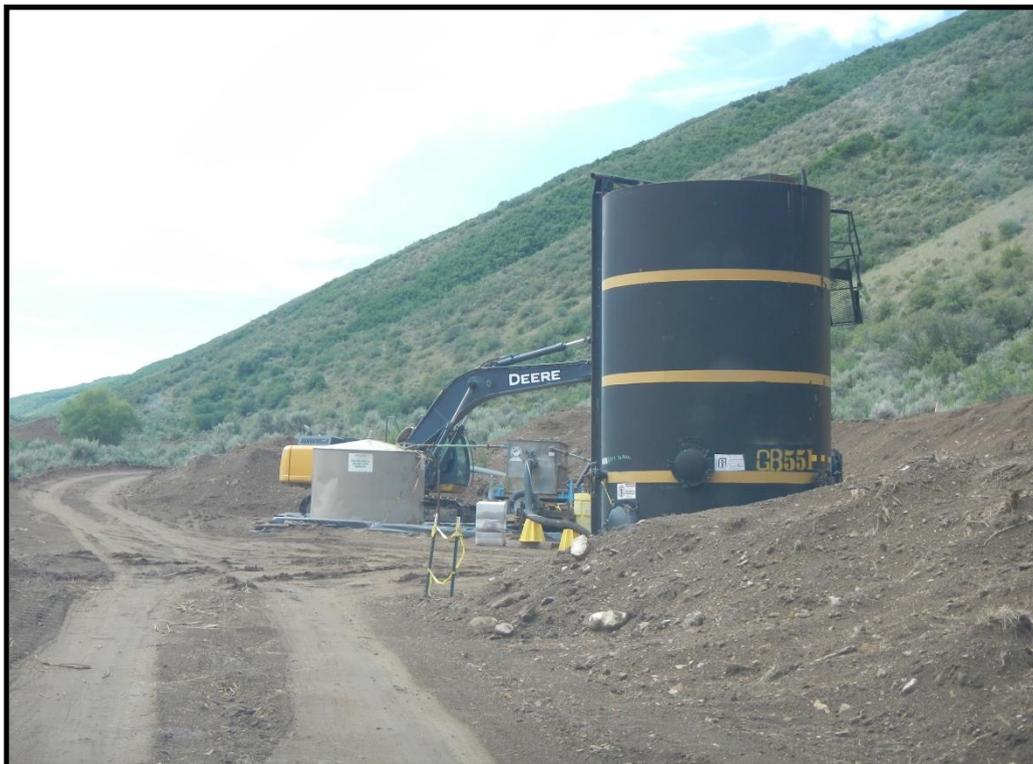
Oil/water separator tanks. The black one is a gun barrel.

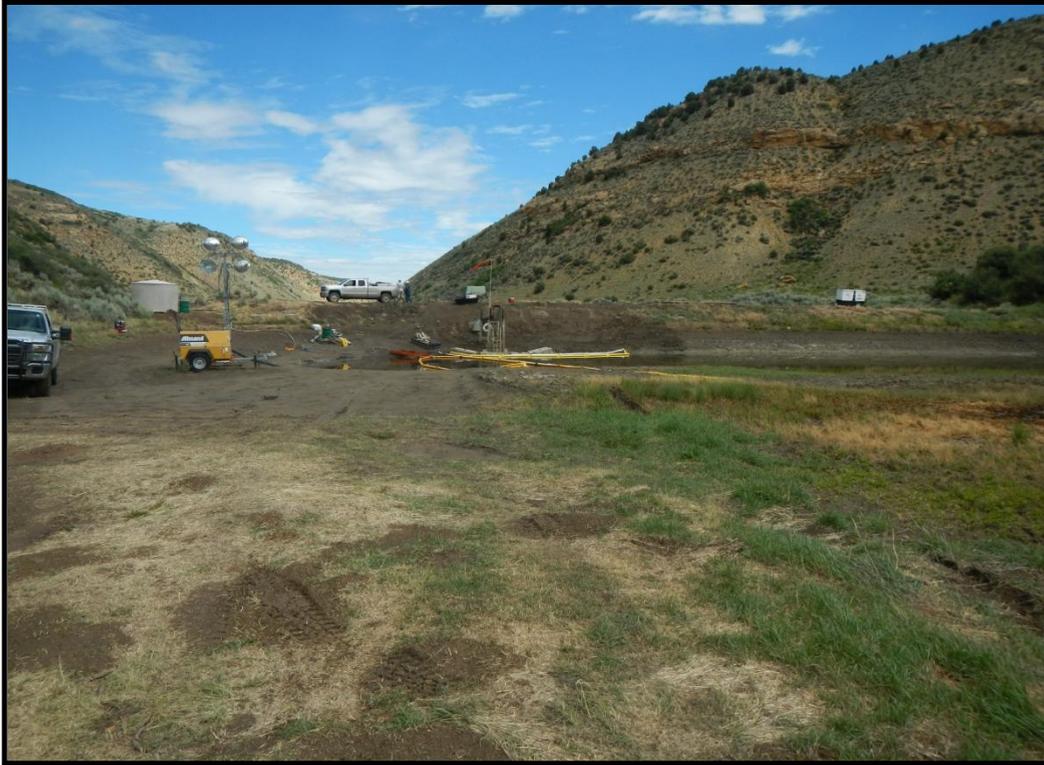
Stock Pond and skimming system.

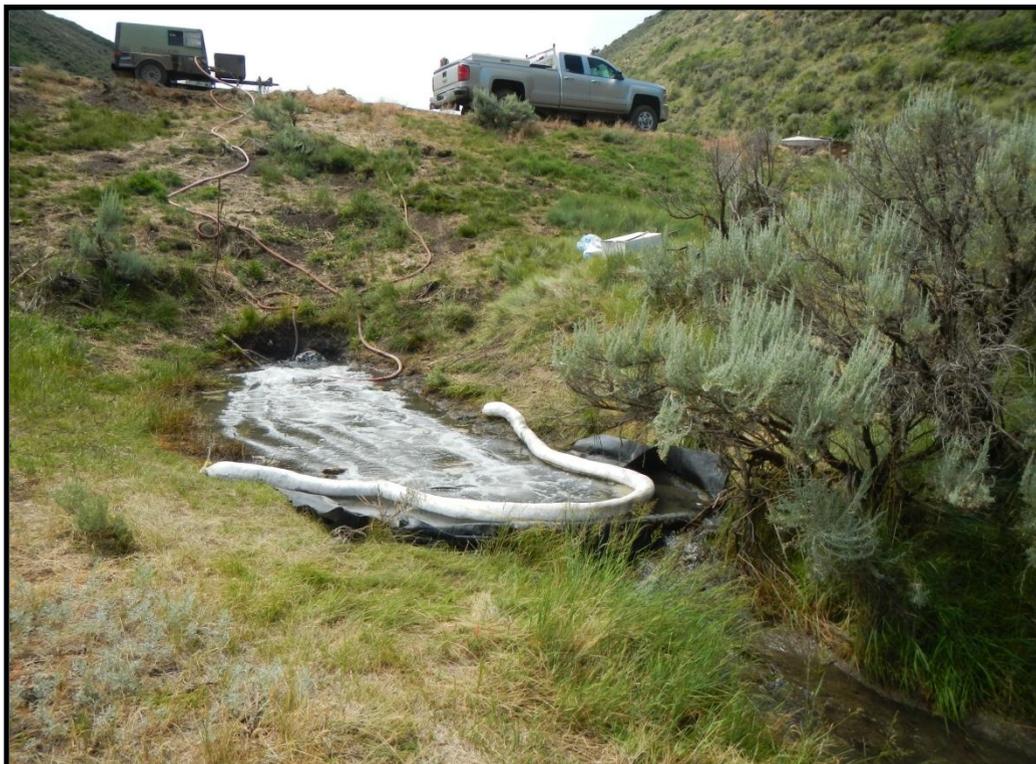
Aeration system installed to remove VOCs.
