# Follow-up Stormwater Inspection

08/03/2016

Operator: Grand Mesa Operating

Location ID: 446515

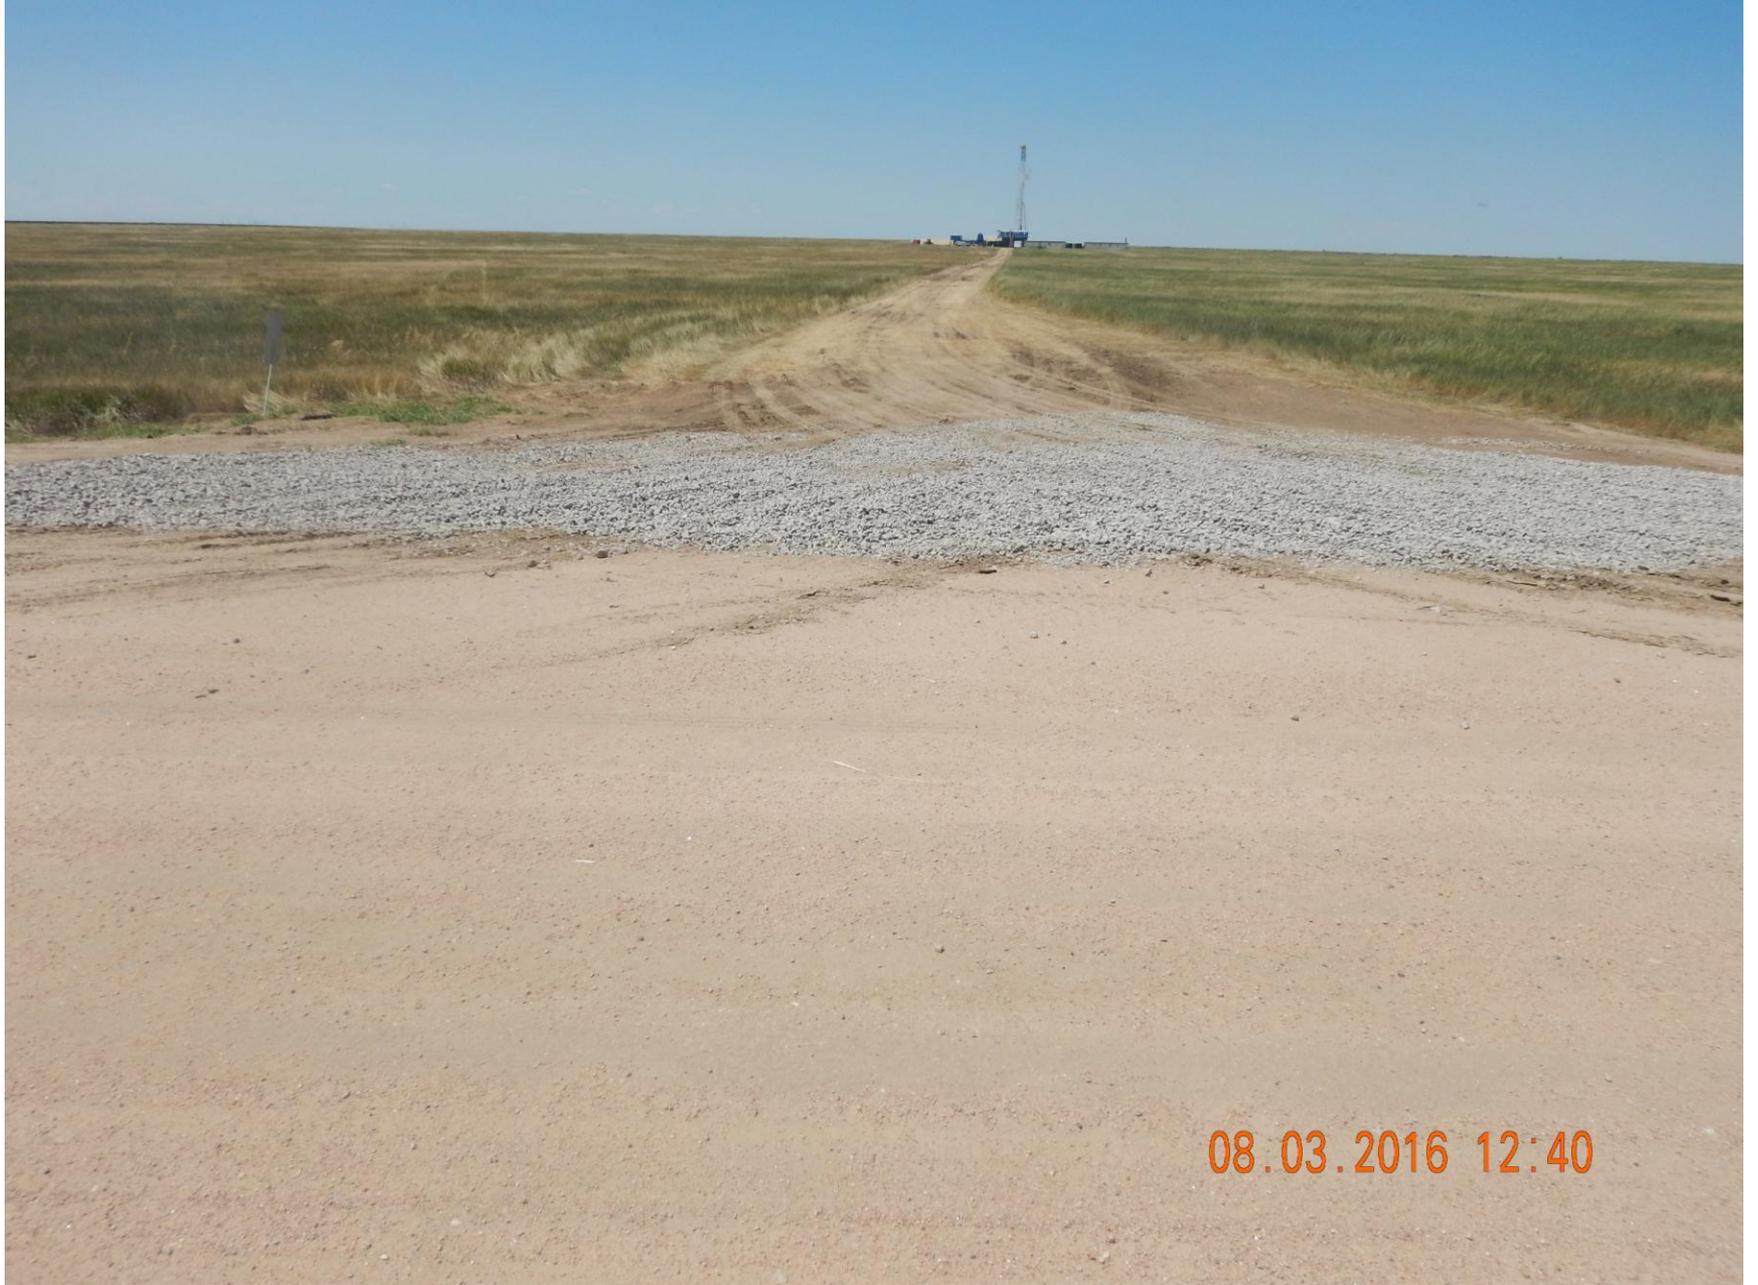
**Figure 1:** Photo taken from access road entrance, facing west towards location. Photo shows vehicle tracking BMP at access road.

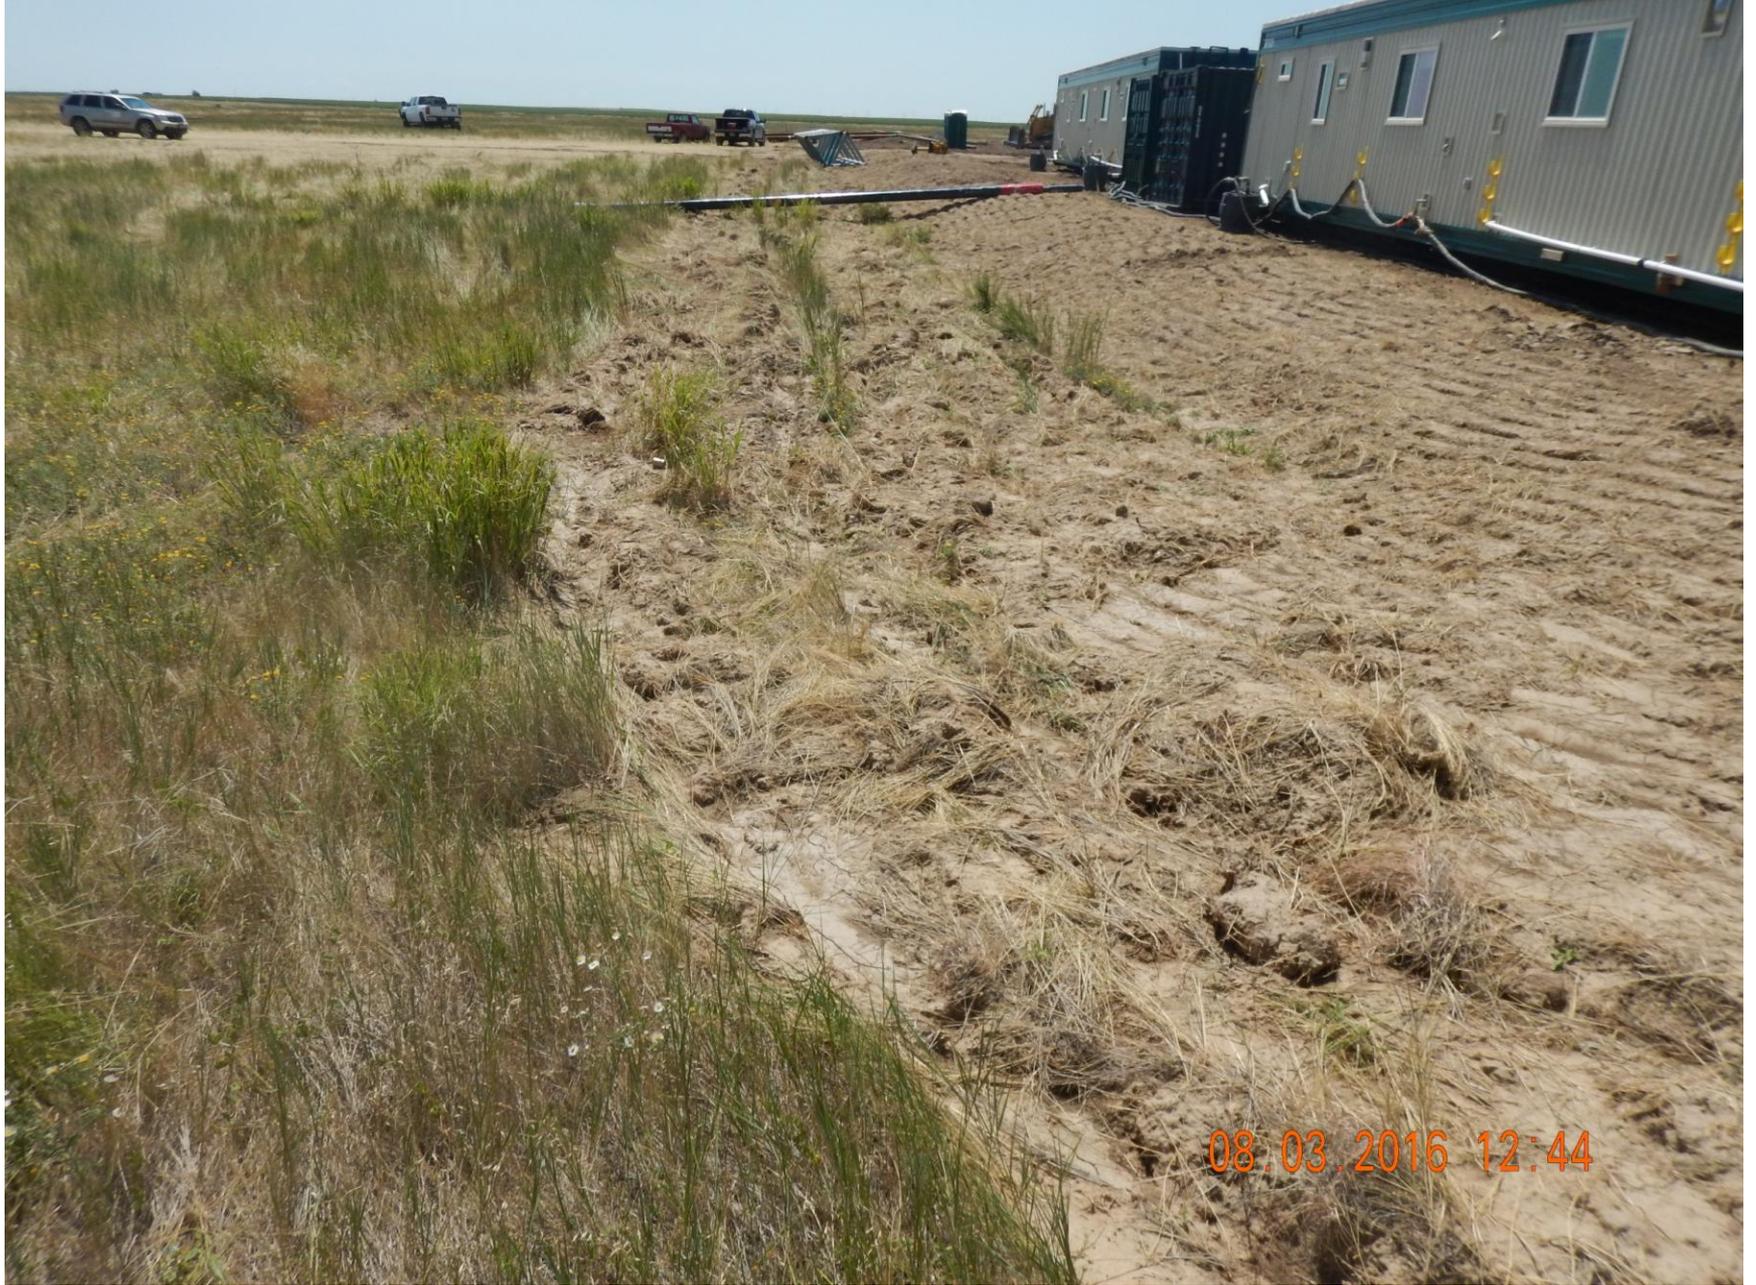
**Figure 2:** Photo taken from the northeast corner of the location, facing south. Photo shows berms adequately built and tracked, and surface roughening used in conjunction.

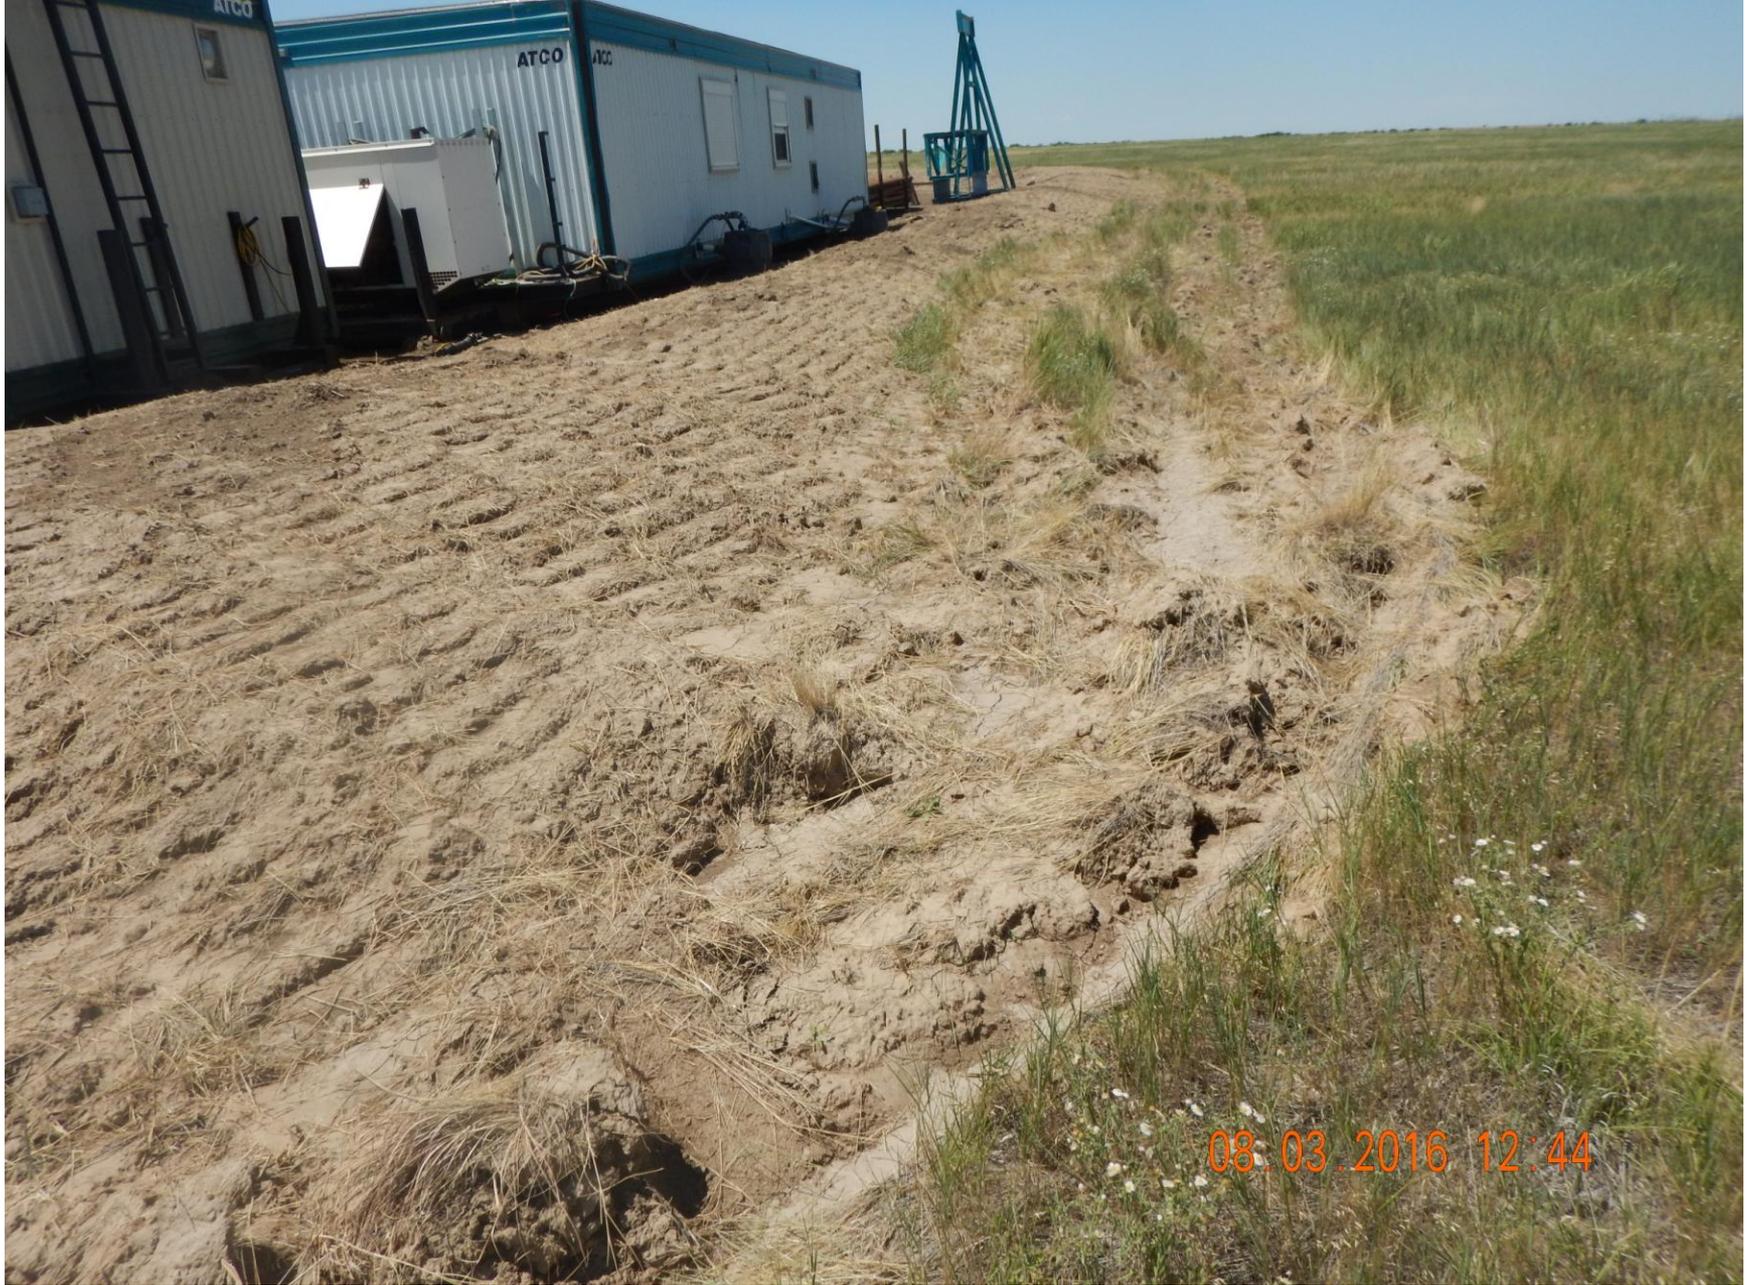
**Figure 3:** Photo taken from the northeast corner of the location, facing west. Photo shows berms adequately built and tracked, and surface roughening used in conjunction.

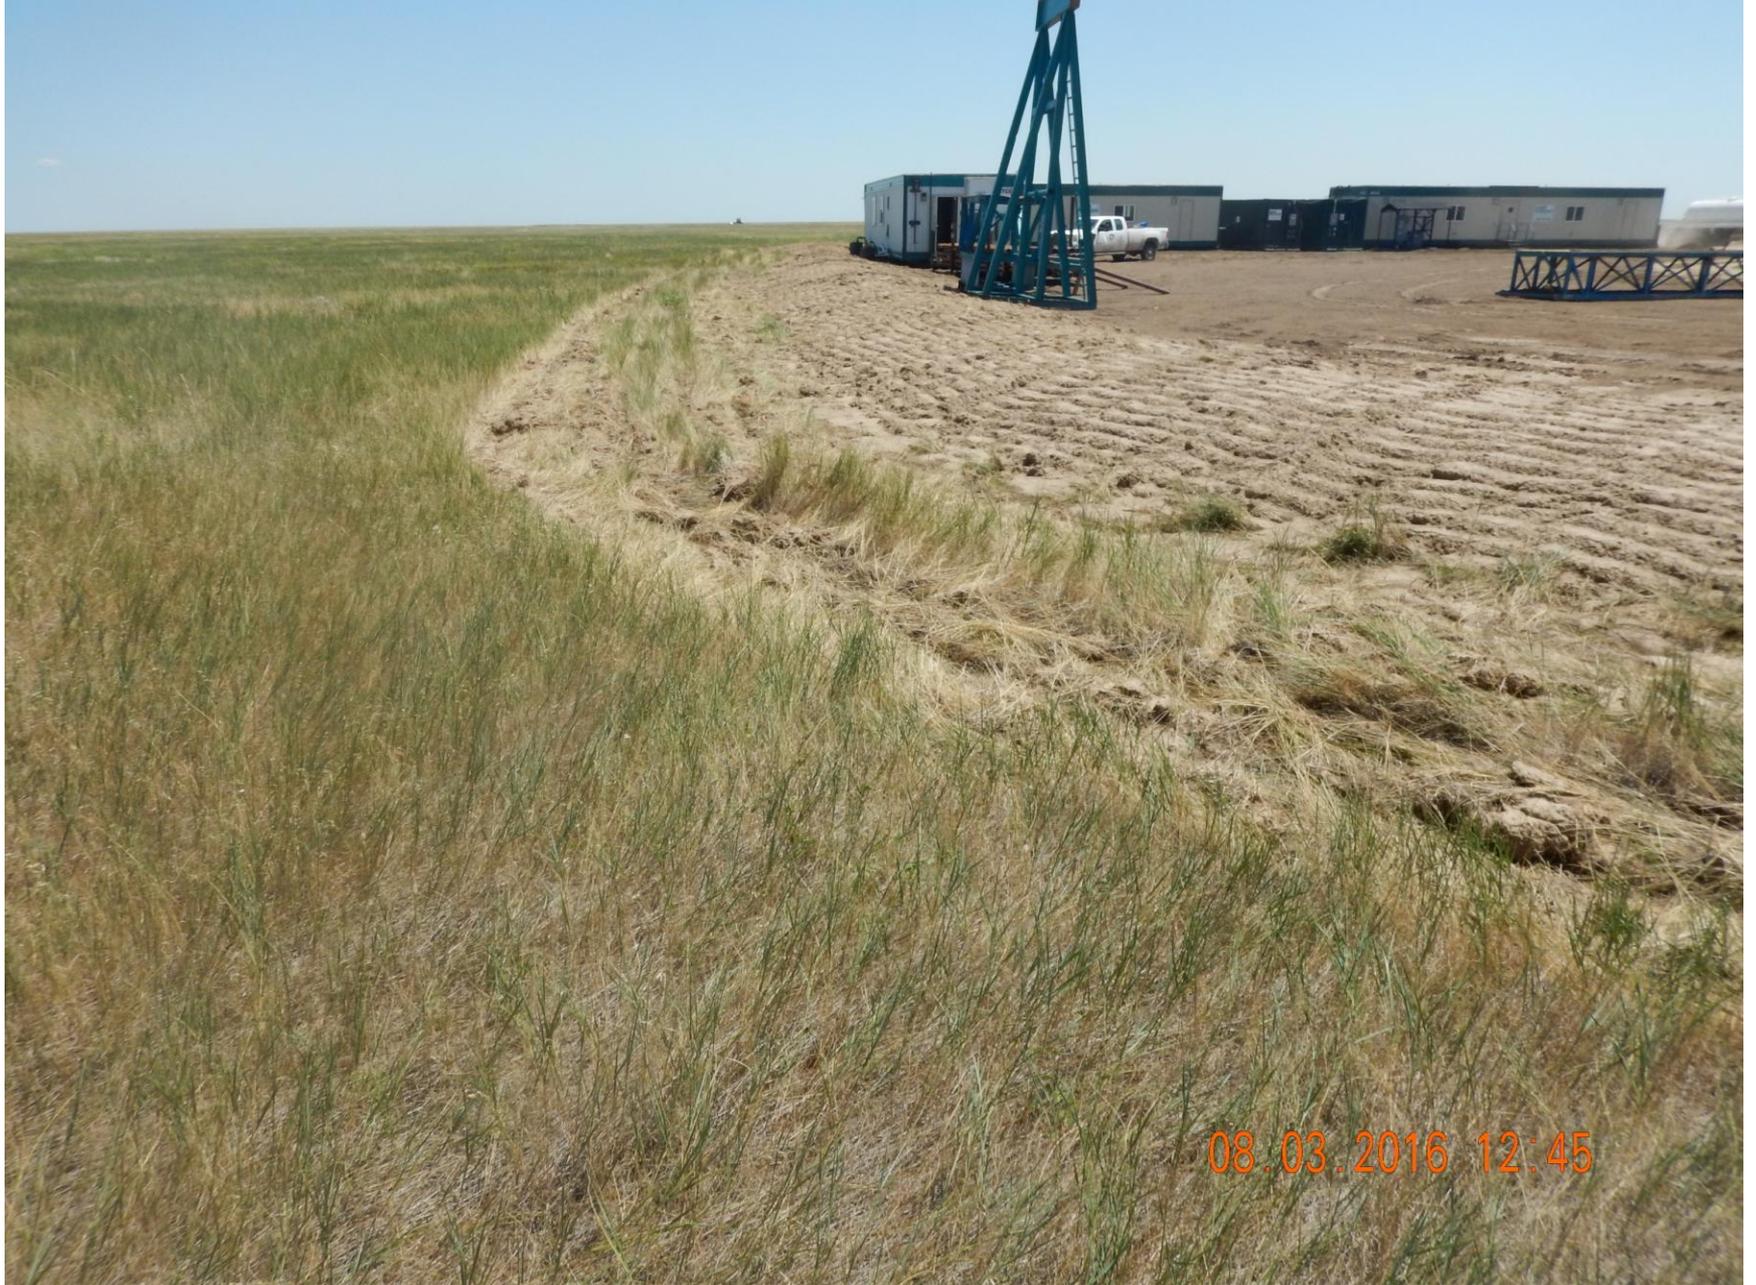
**Figure 4:** Photo taken from the north end of the location, facing east. Photo shows berms adequately built and tracked, and surface roughening used in conjunction.

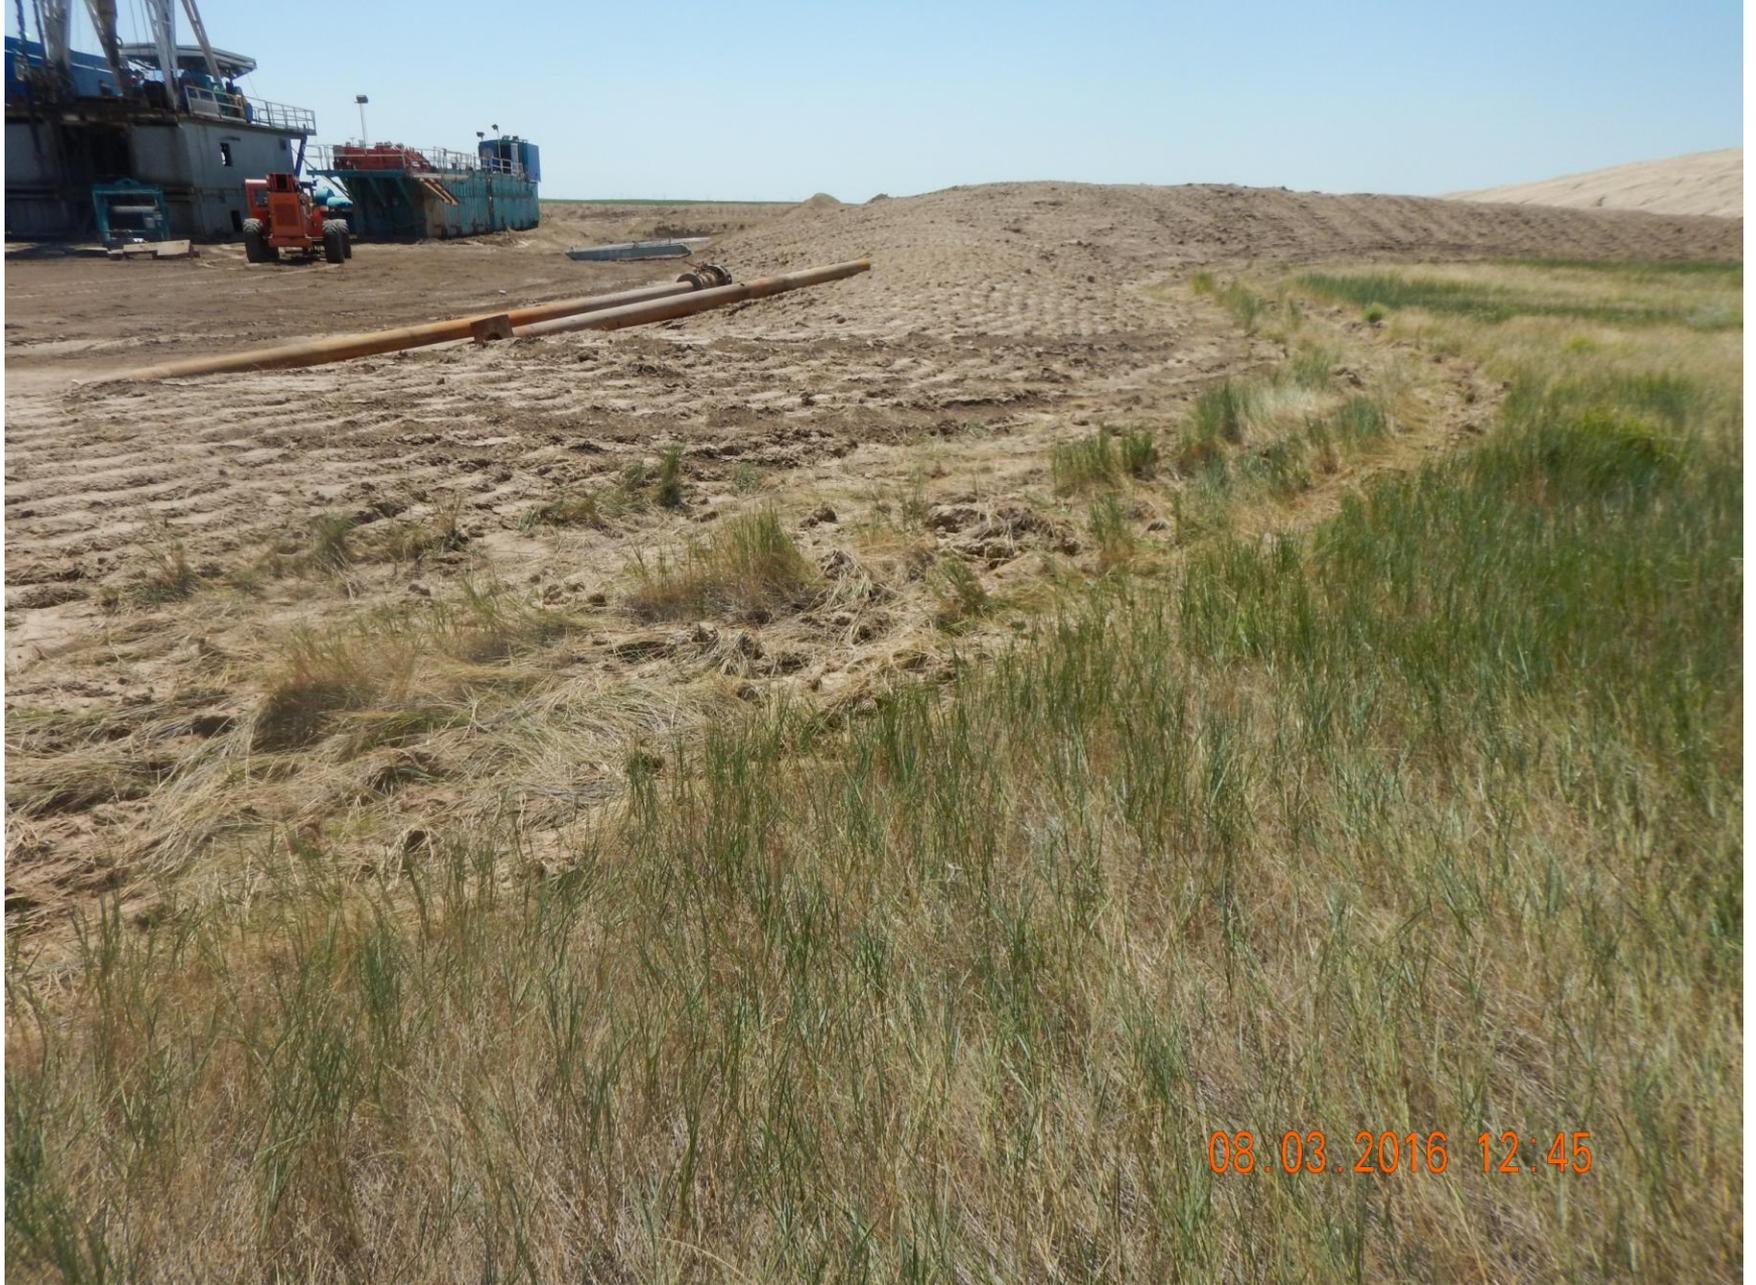
**Figure 5:** Photo taken from the north end of the location, facing south. Photo shows berms adequately built and tracked, and surface roughening used in conjunction.

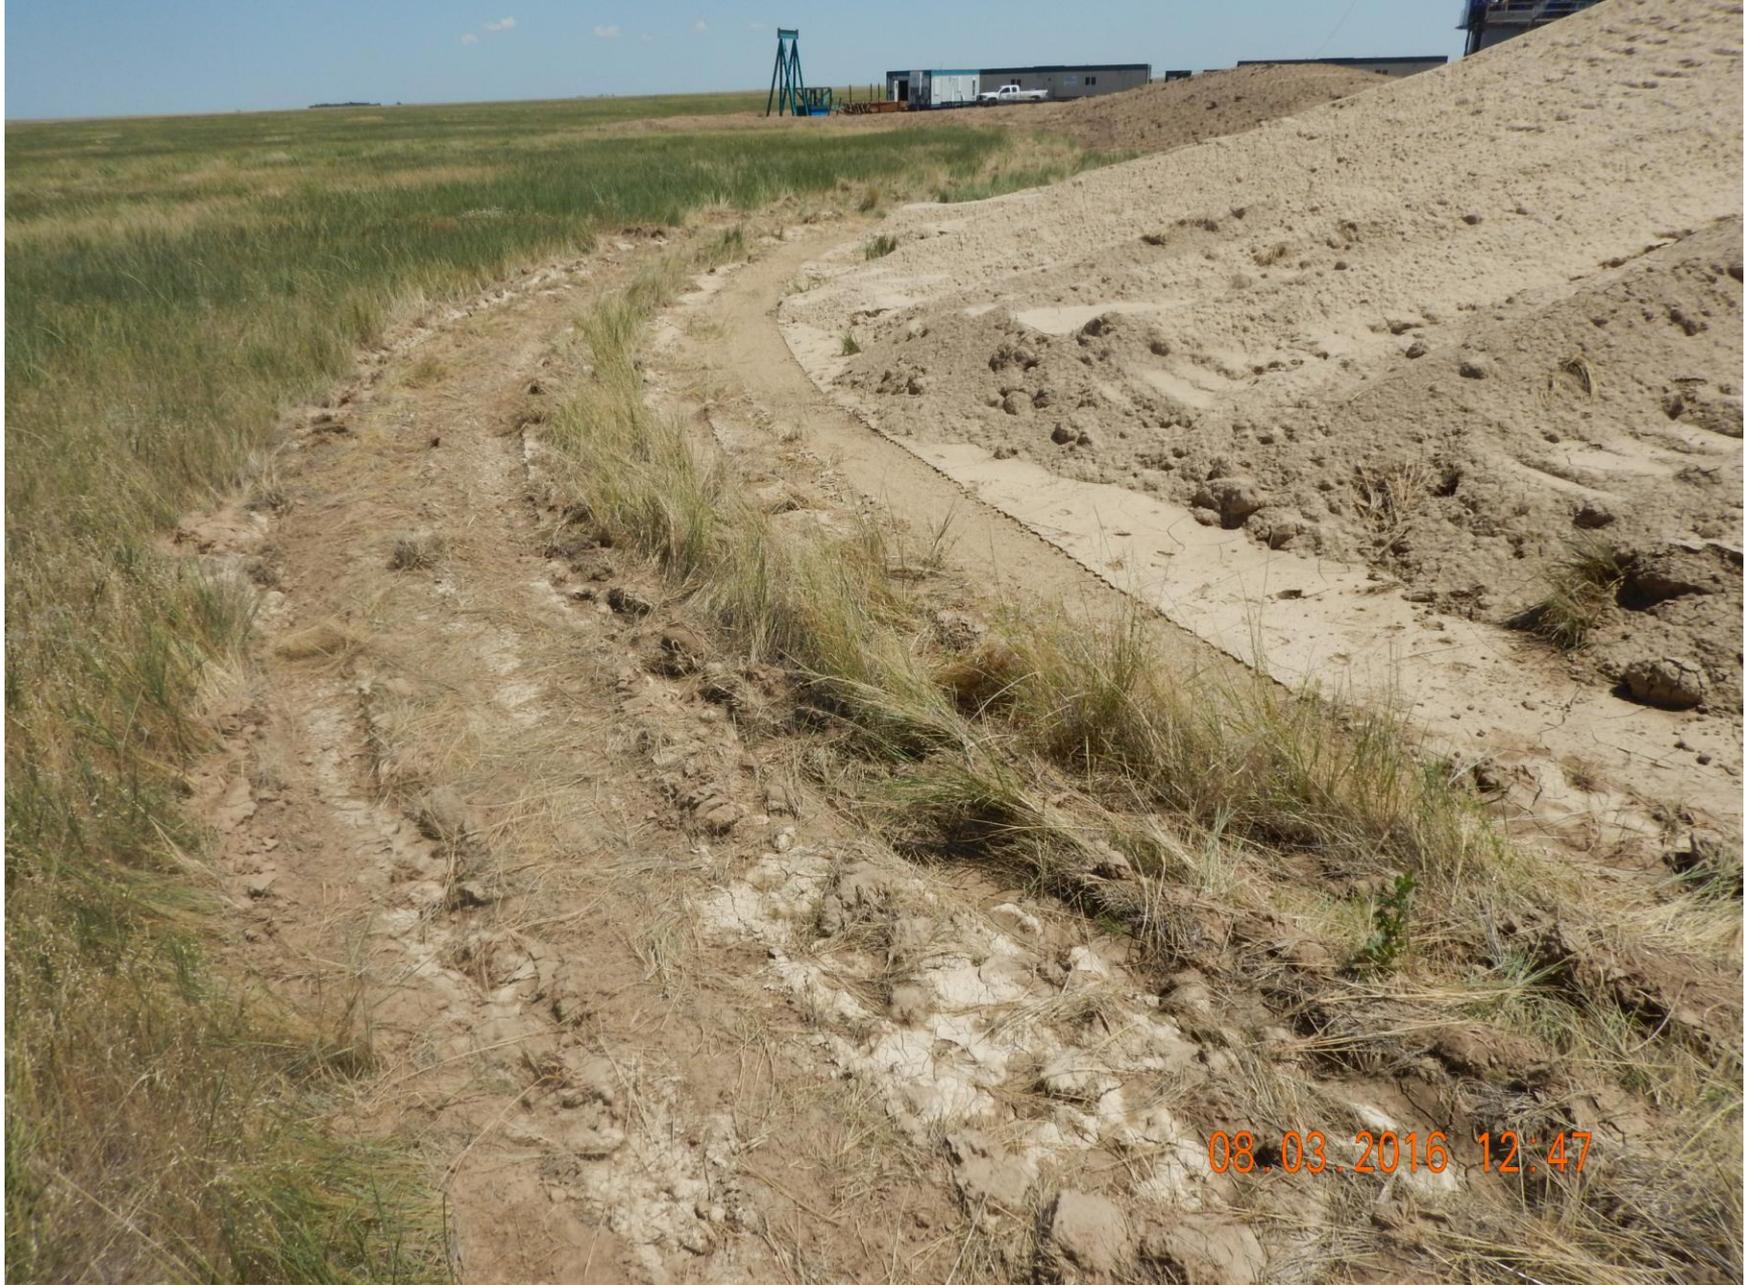
**Figure 7:** Photo taken from the northwest corner of the location, facing east. Photo shows surface roughening appears to have been traveled over. Vehicle traffic may re-compact the surface roughening, and prevent the BMP from properly functioning

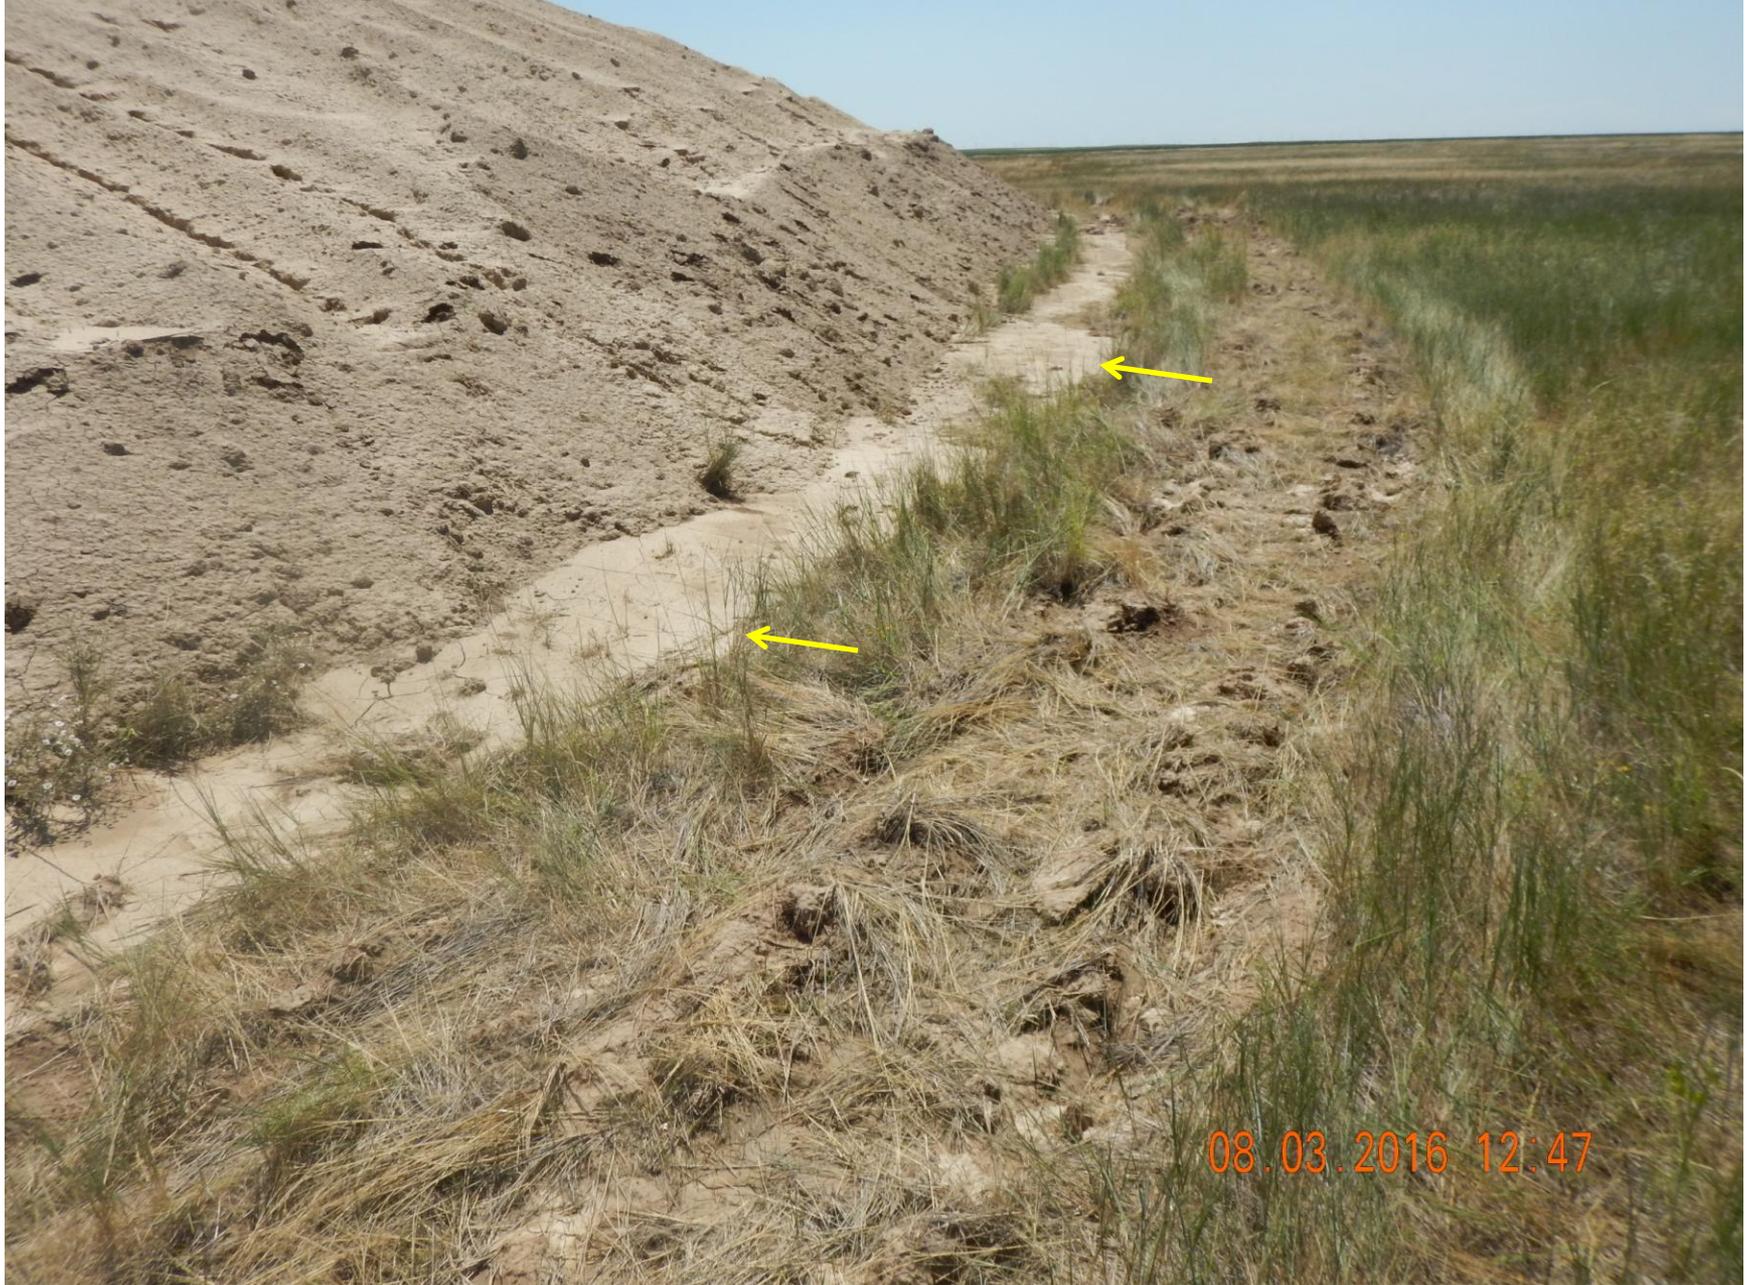
**Figure 8:** Photo taken from the northwest corner of the location, facing east. Photo shows surface roughening. Note sediment build up to left that was caught by BMP. These areas will need to be monitored, if sediment continues to fill BMP, maintenance will be required.

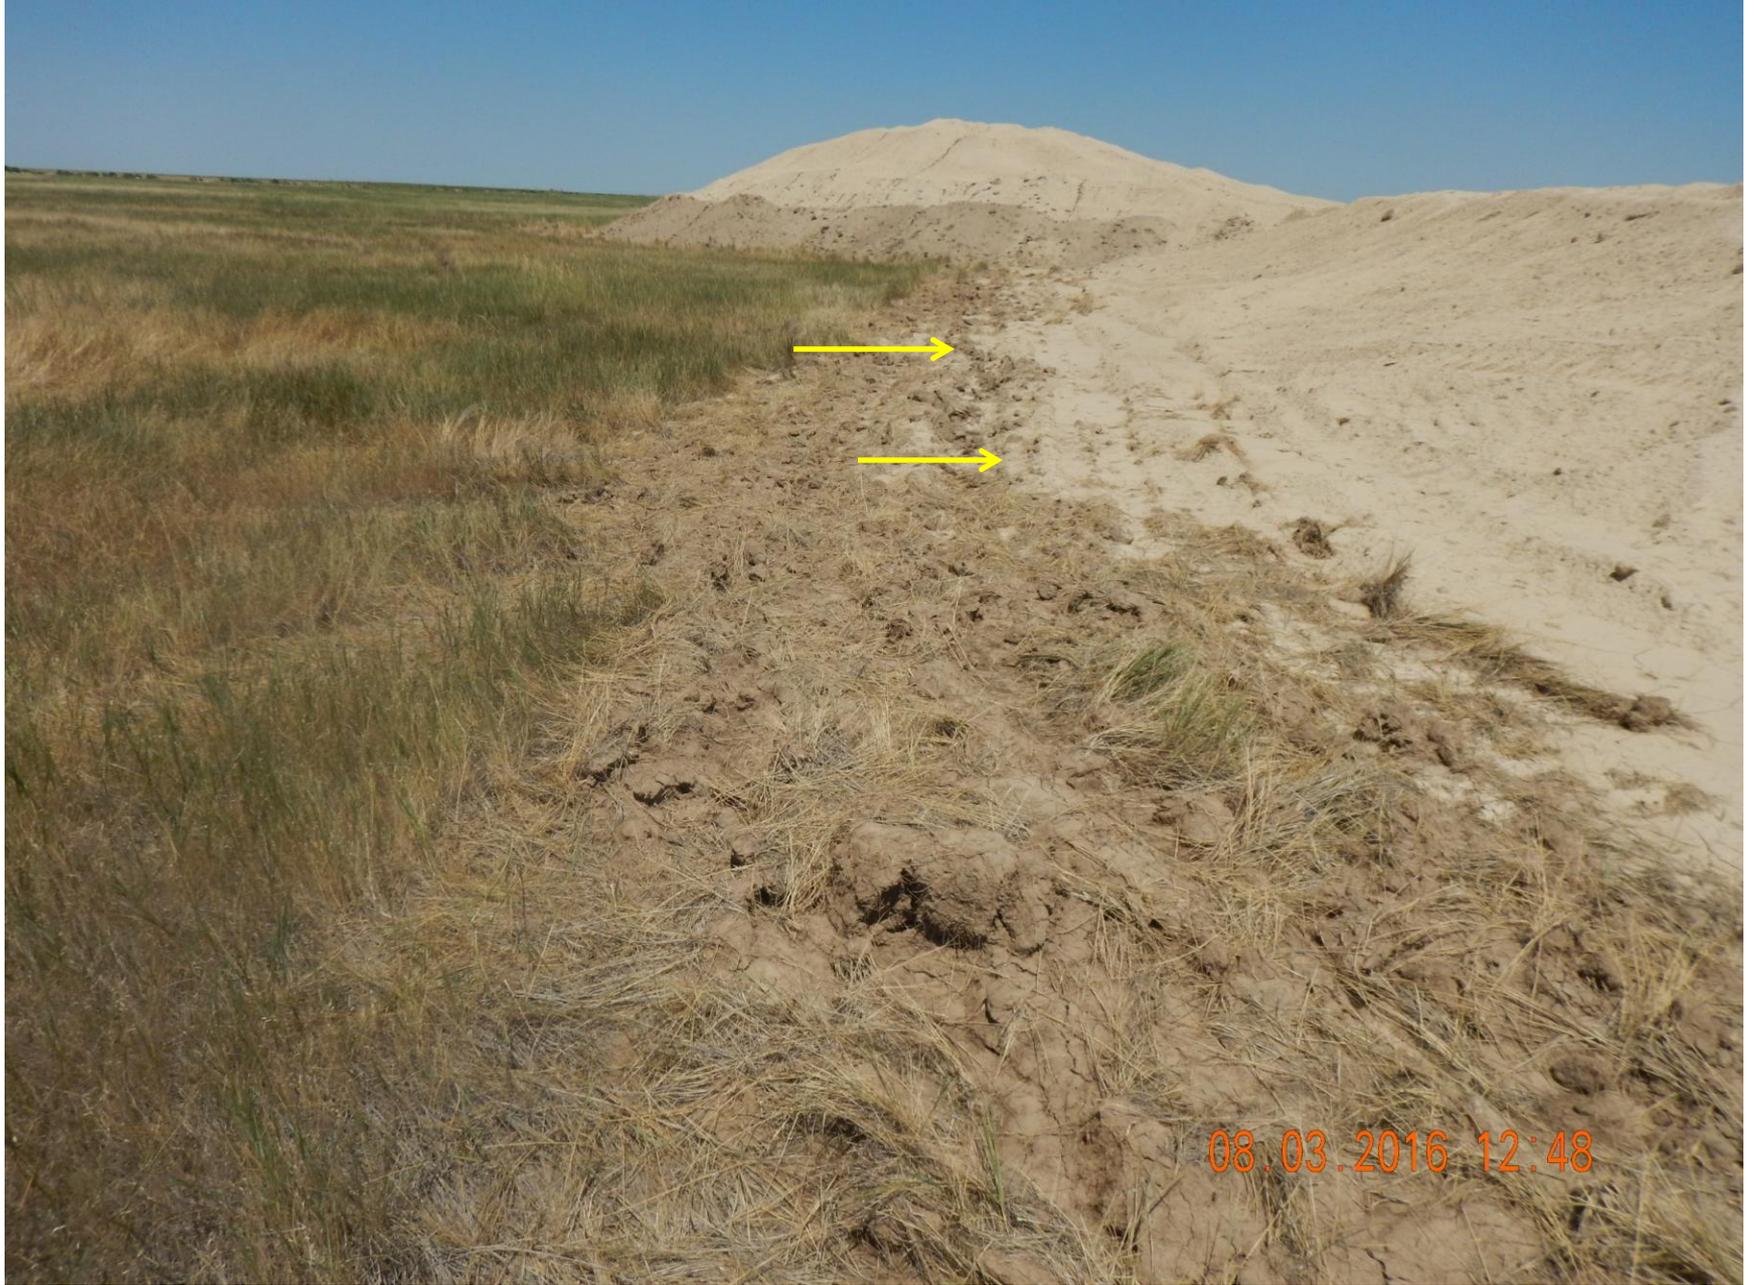
**Figure 9:** Photo taken from the northwest corner of the location, facing east. Photo shows surface roughening. Note sediment build up to right that was caught by BMP. These areas will need to be monitored, if sediment continues to fill BMP, maintenance will be required.

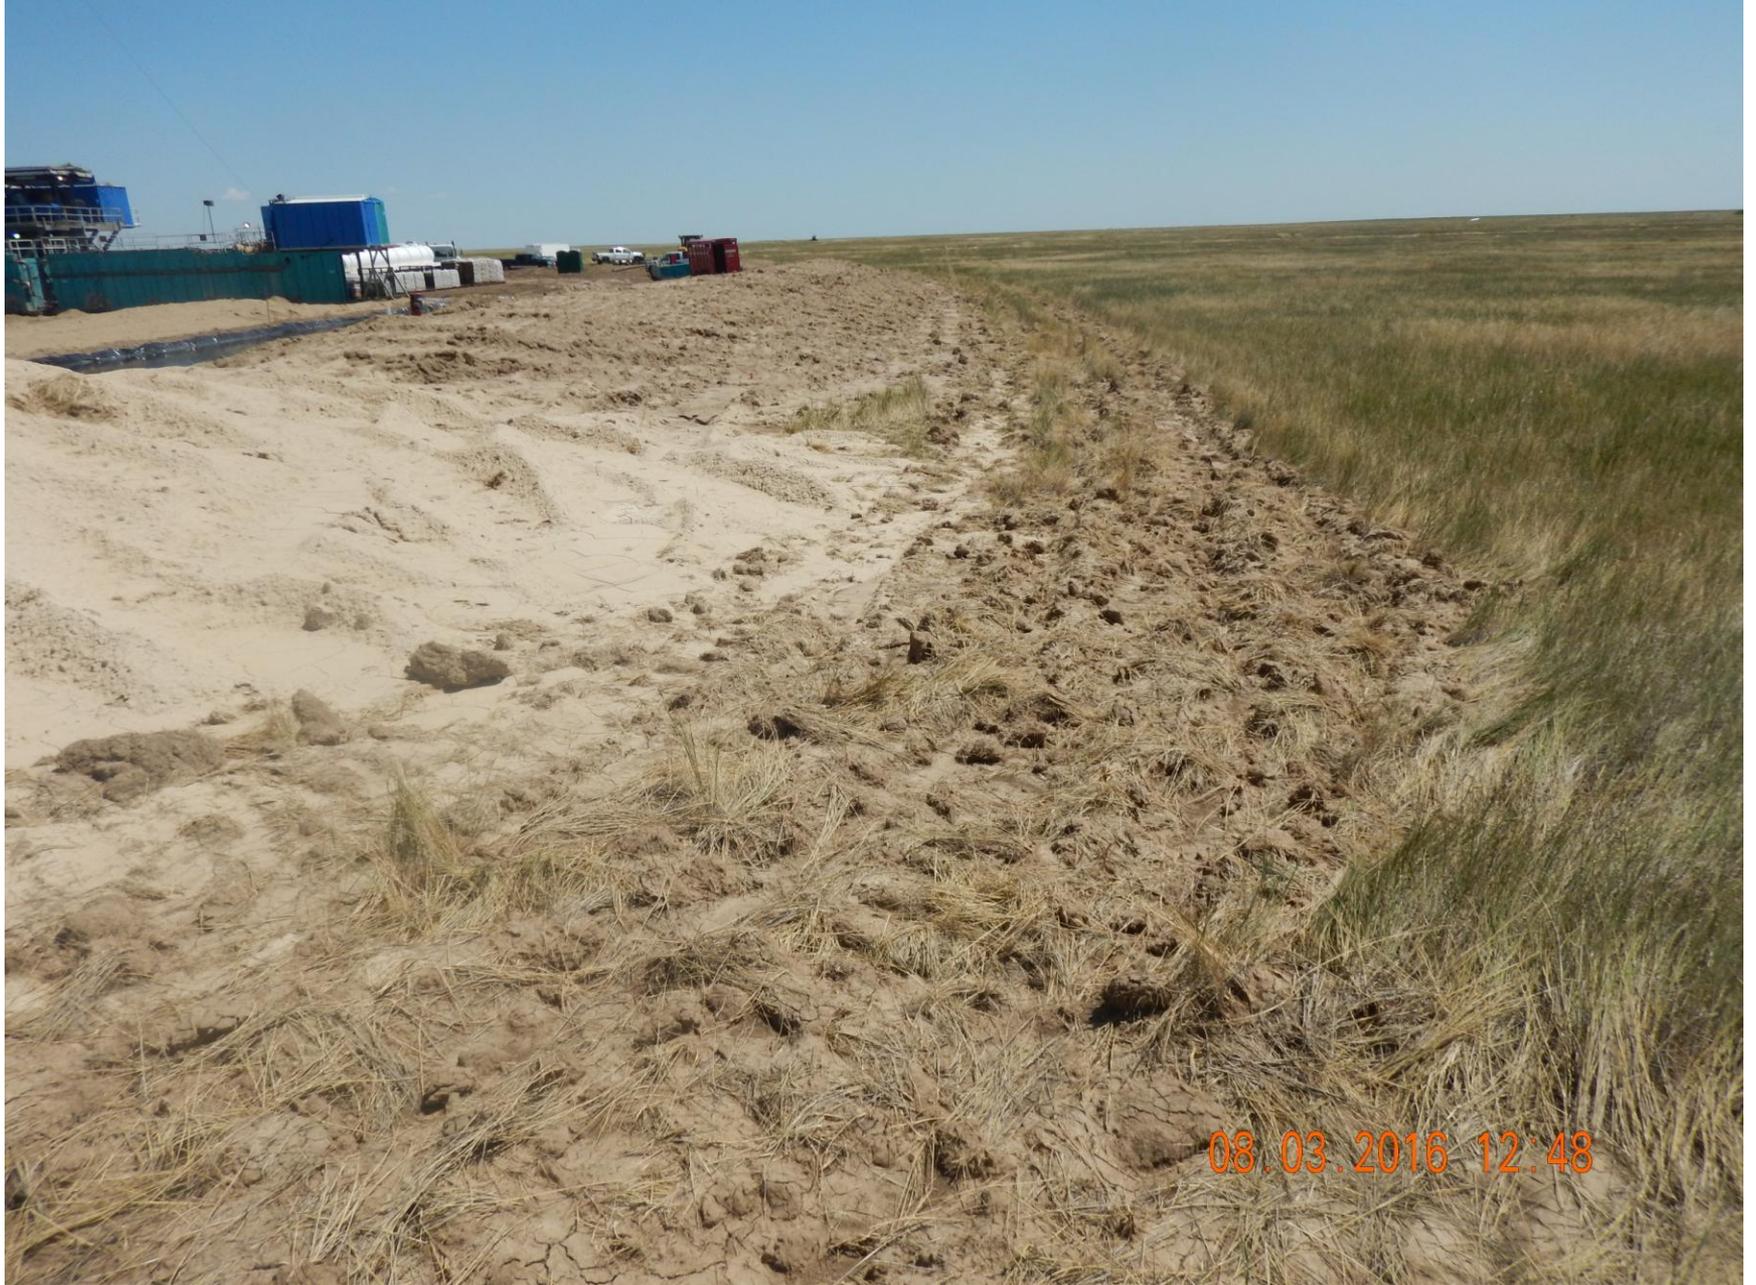
**Figure 10:** Photo taken from the southwest corner of the location, facing east. Photo shows berms adequately built and tracked, and surface roughening used in conjunction.

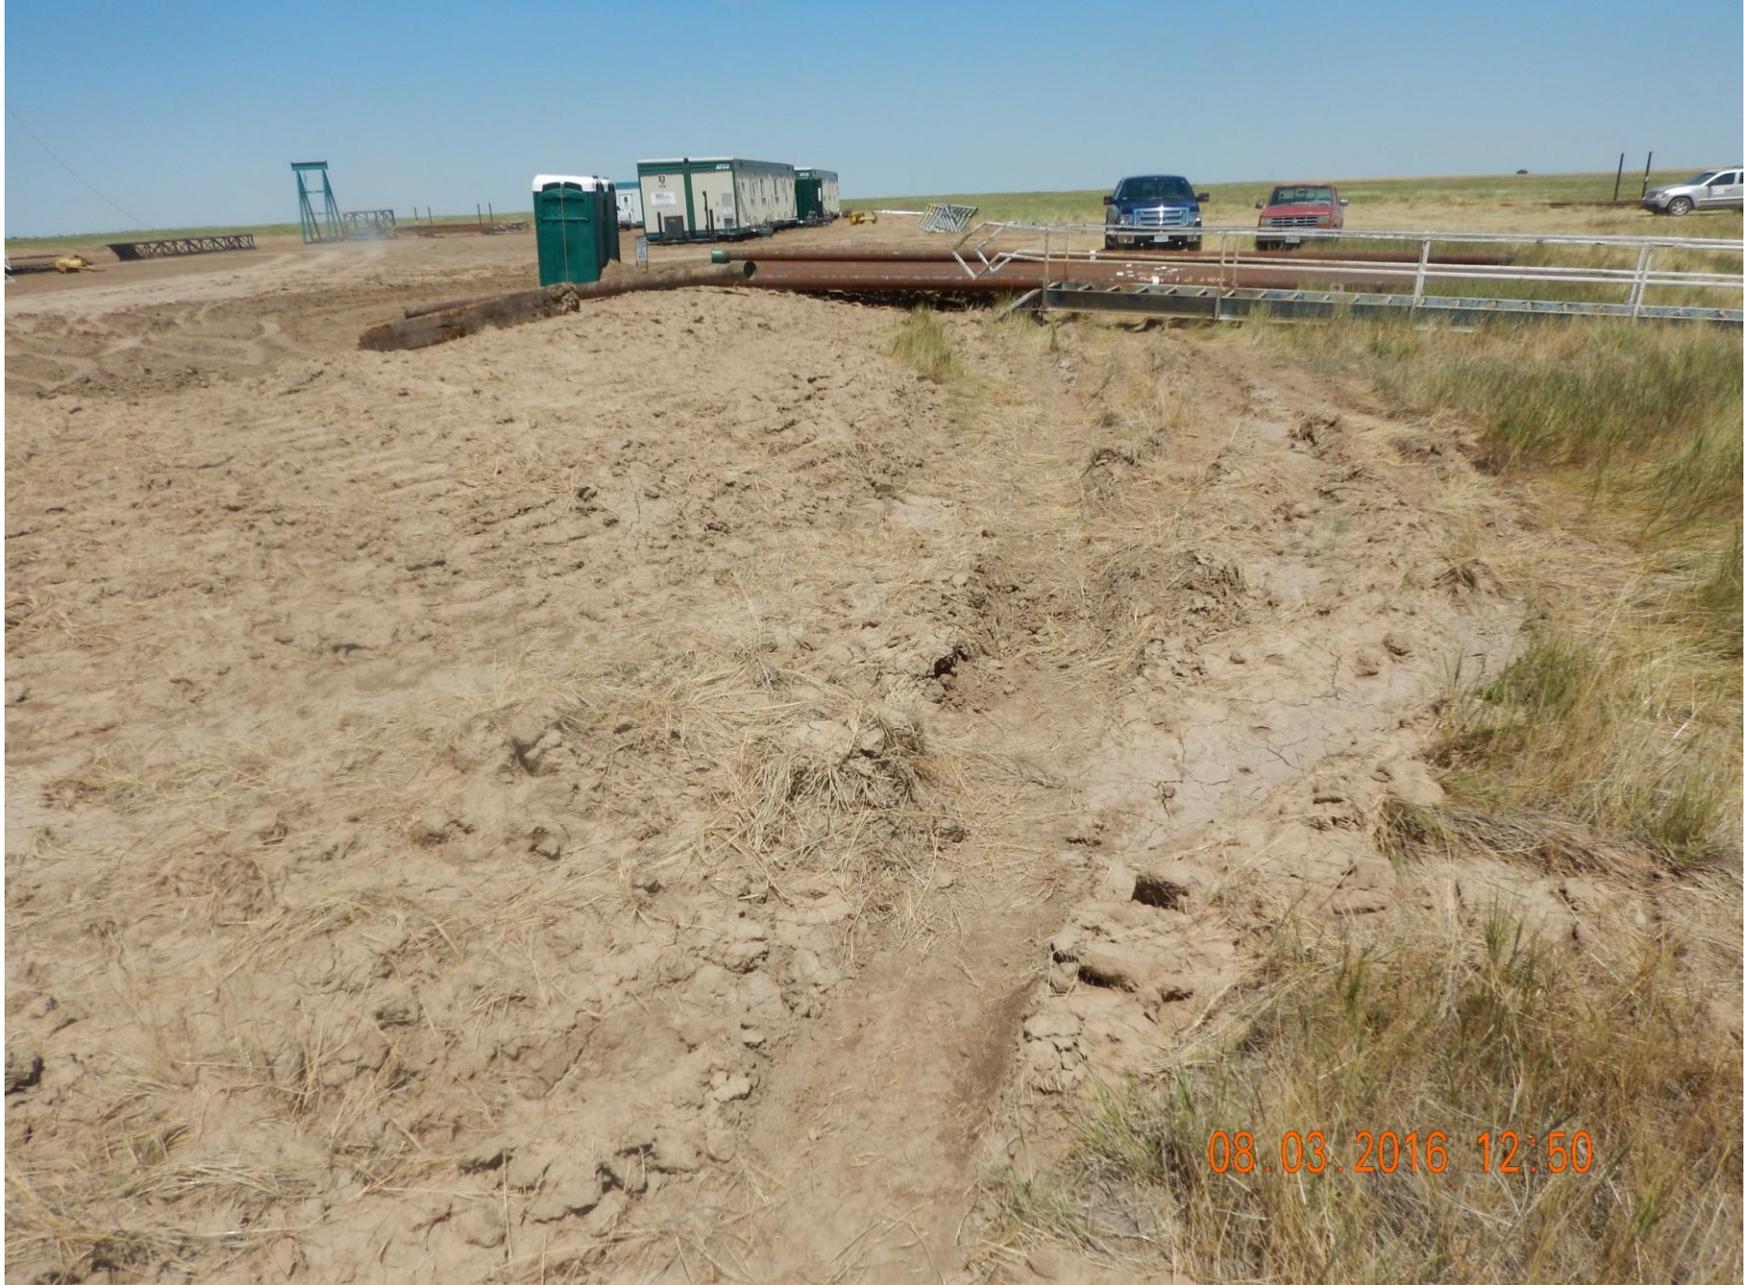
**Figure 11:** Photo taken from the southeast corner of the location, facing north. surface roughening appears to have been traveled over. Vehicle traffic may re-compact the surface roughening, and prevent the BMP from properly functioning
