# Follow-up Stormwater Inspection

08/03/2016

Operator: Grand Mesa Operating

Location ID: 446515

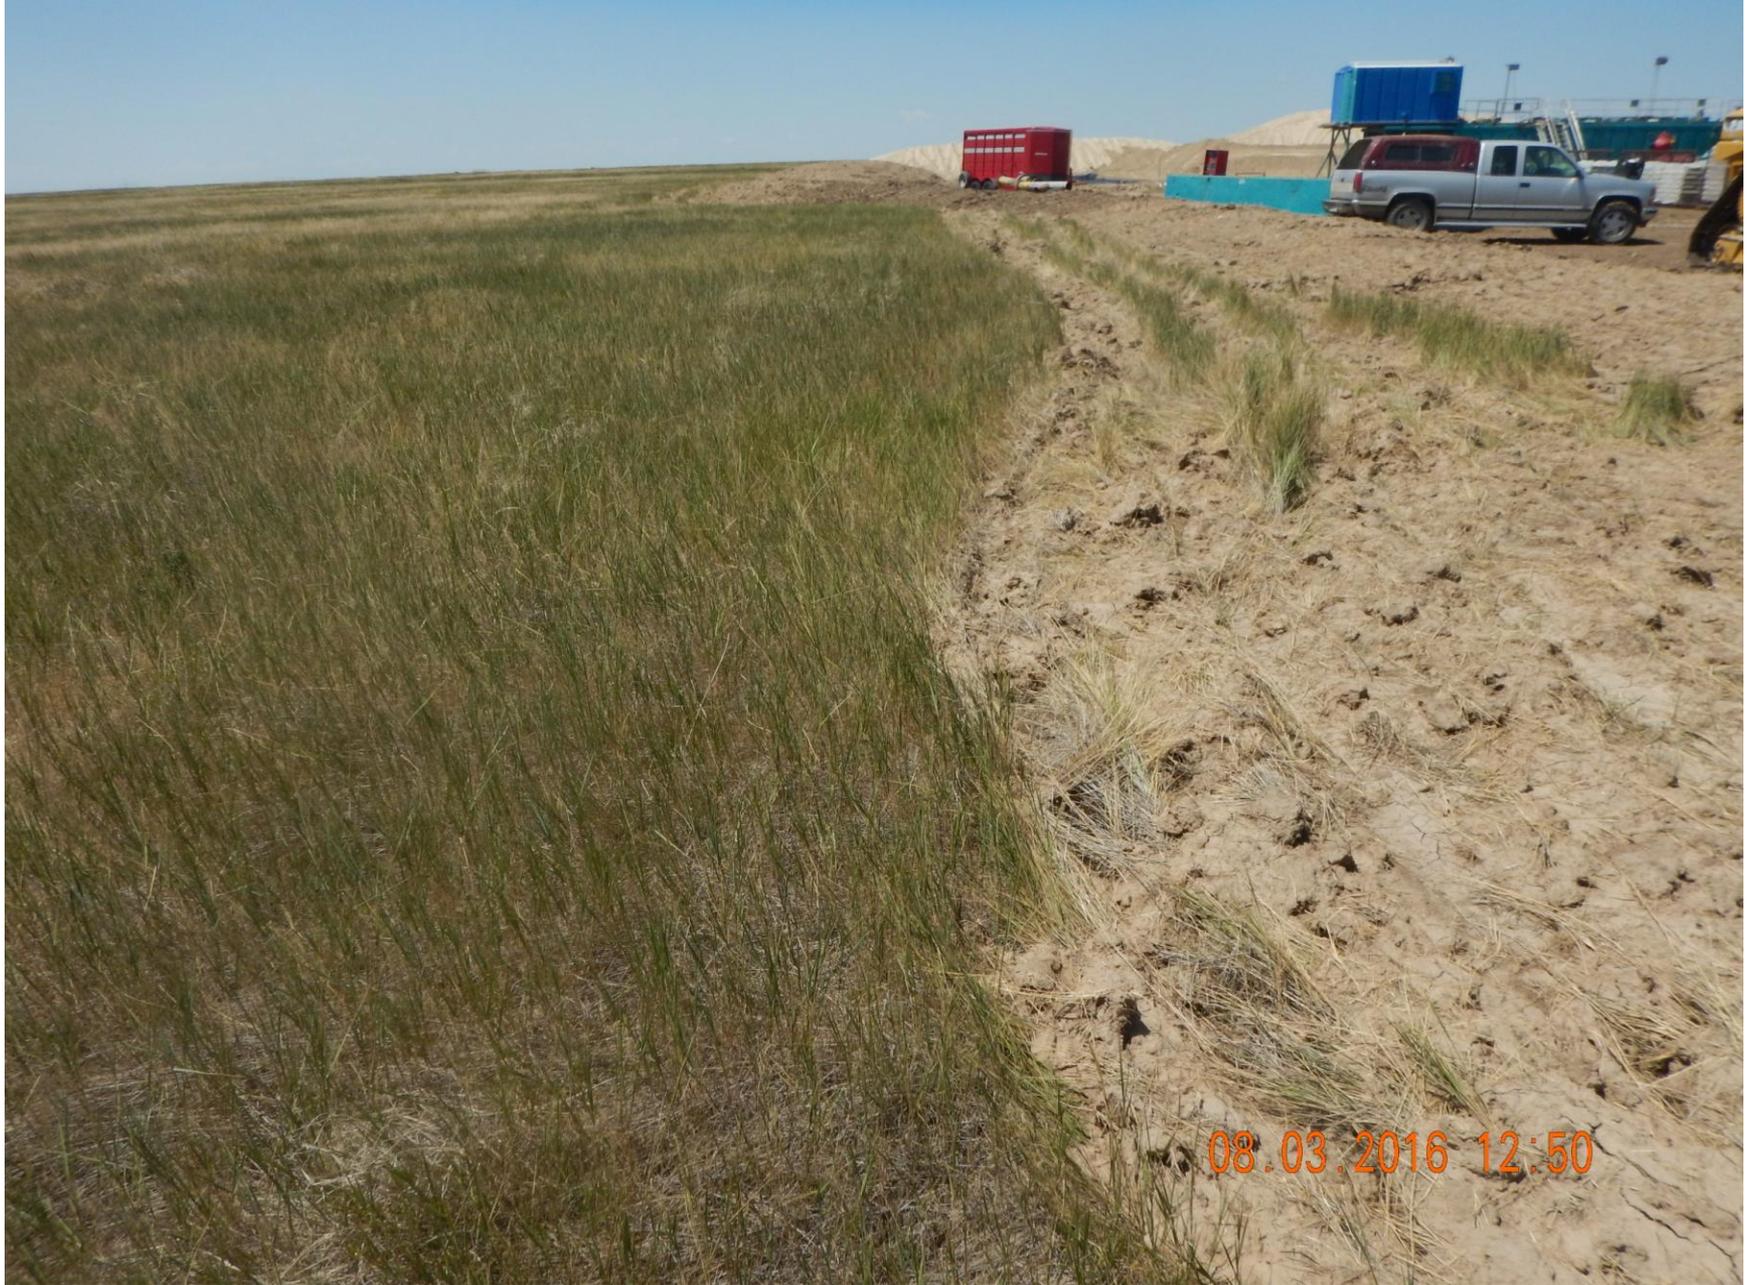
**Figure 12:** Photo taken from the southeast corner of the location, facing west. Photo shows berms adequately built and tracked, and surface roughening used in conjunction.
