Final Reclamation Inspection

08/03/2016

Operator: Oilfield Salvage & Service #65550

Location ID: 311709

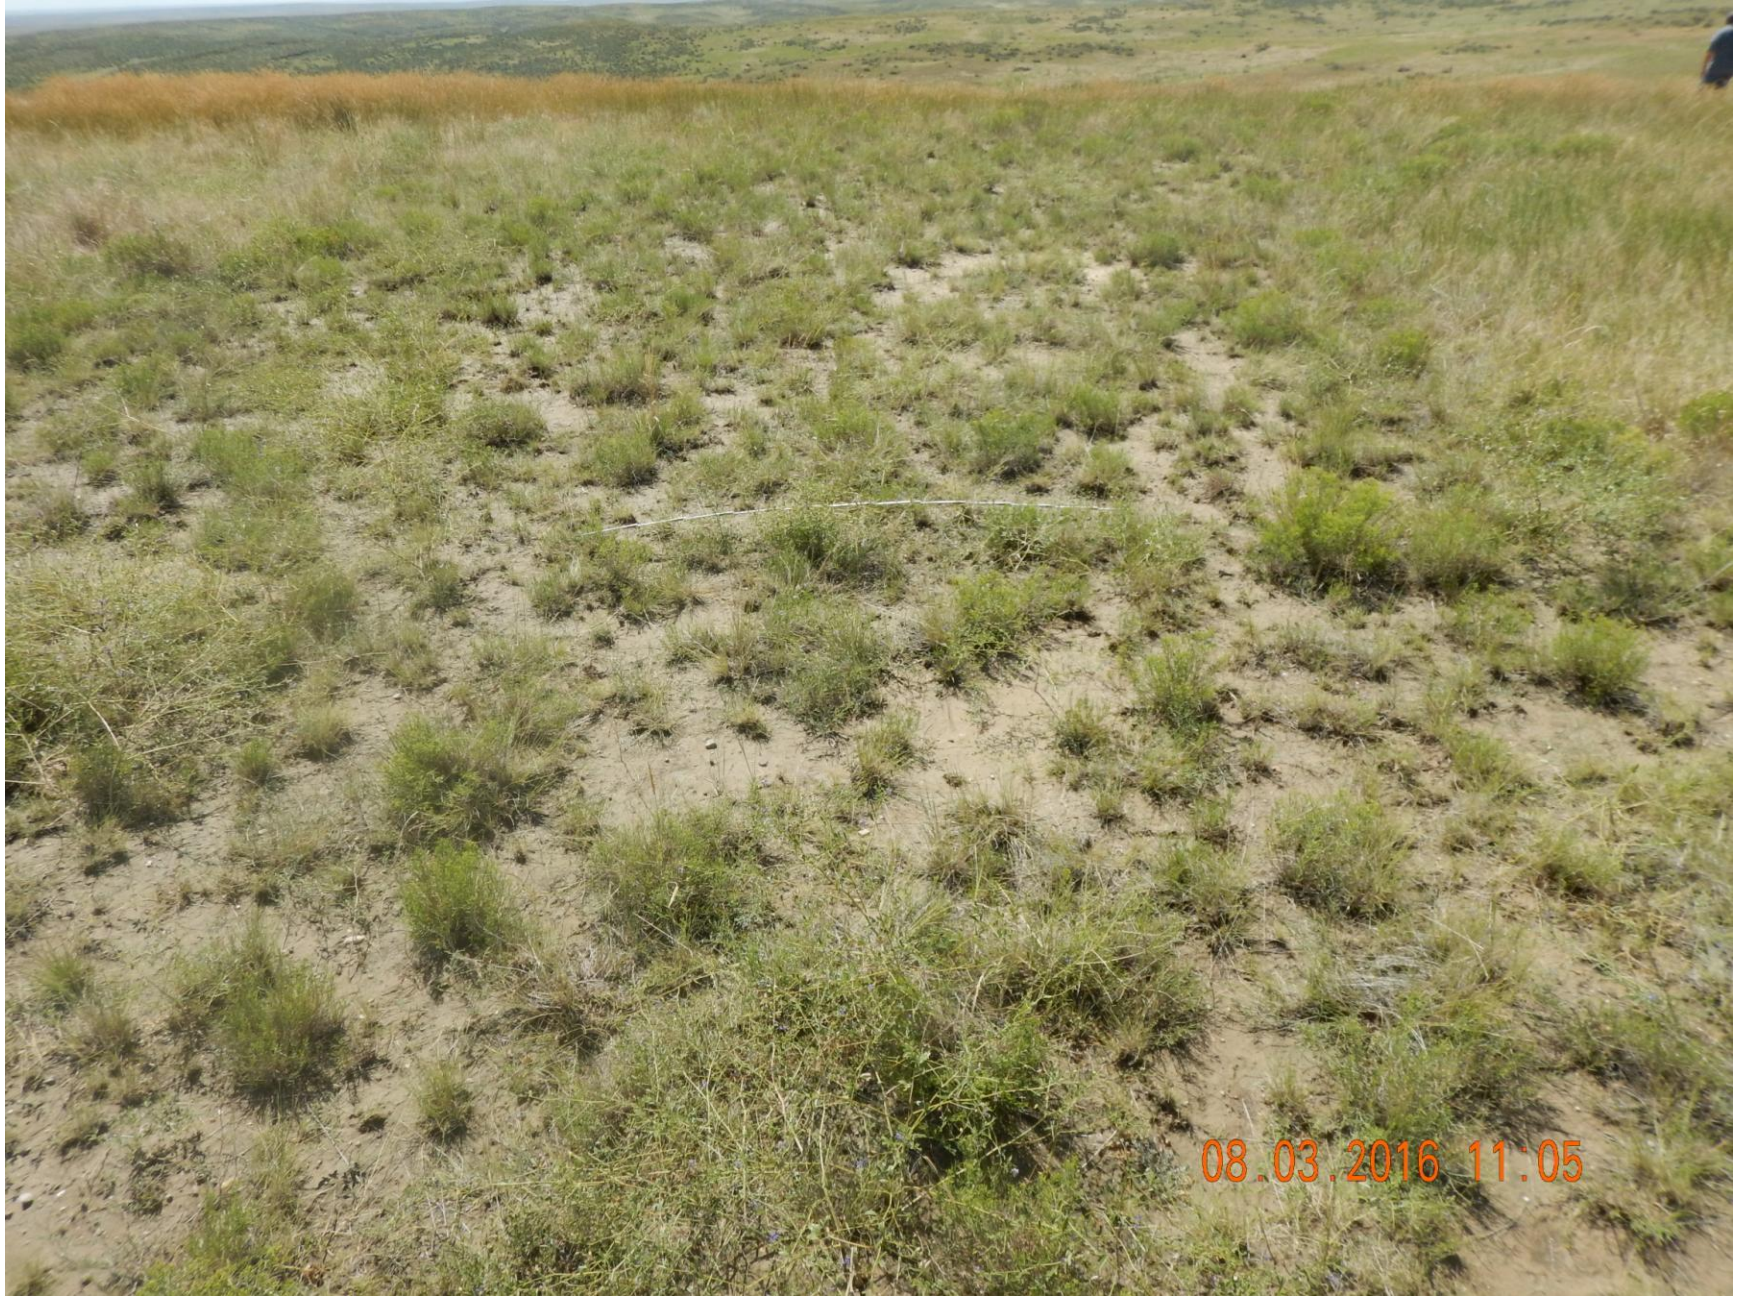
Figure 1: Photo taken from the location, facing south. Photo shows vegetation over the reclamation area.

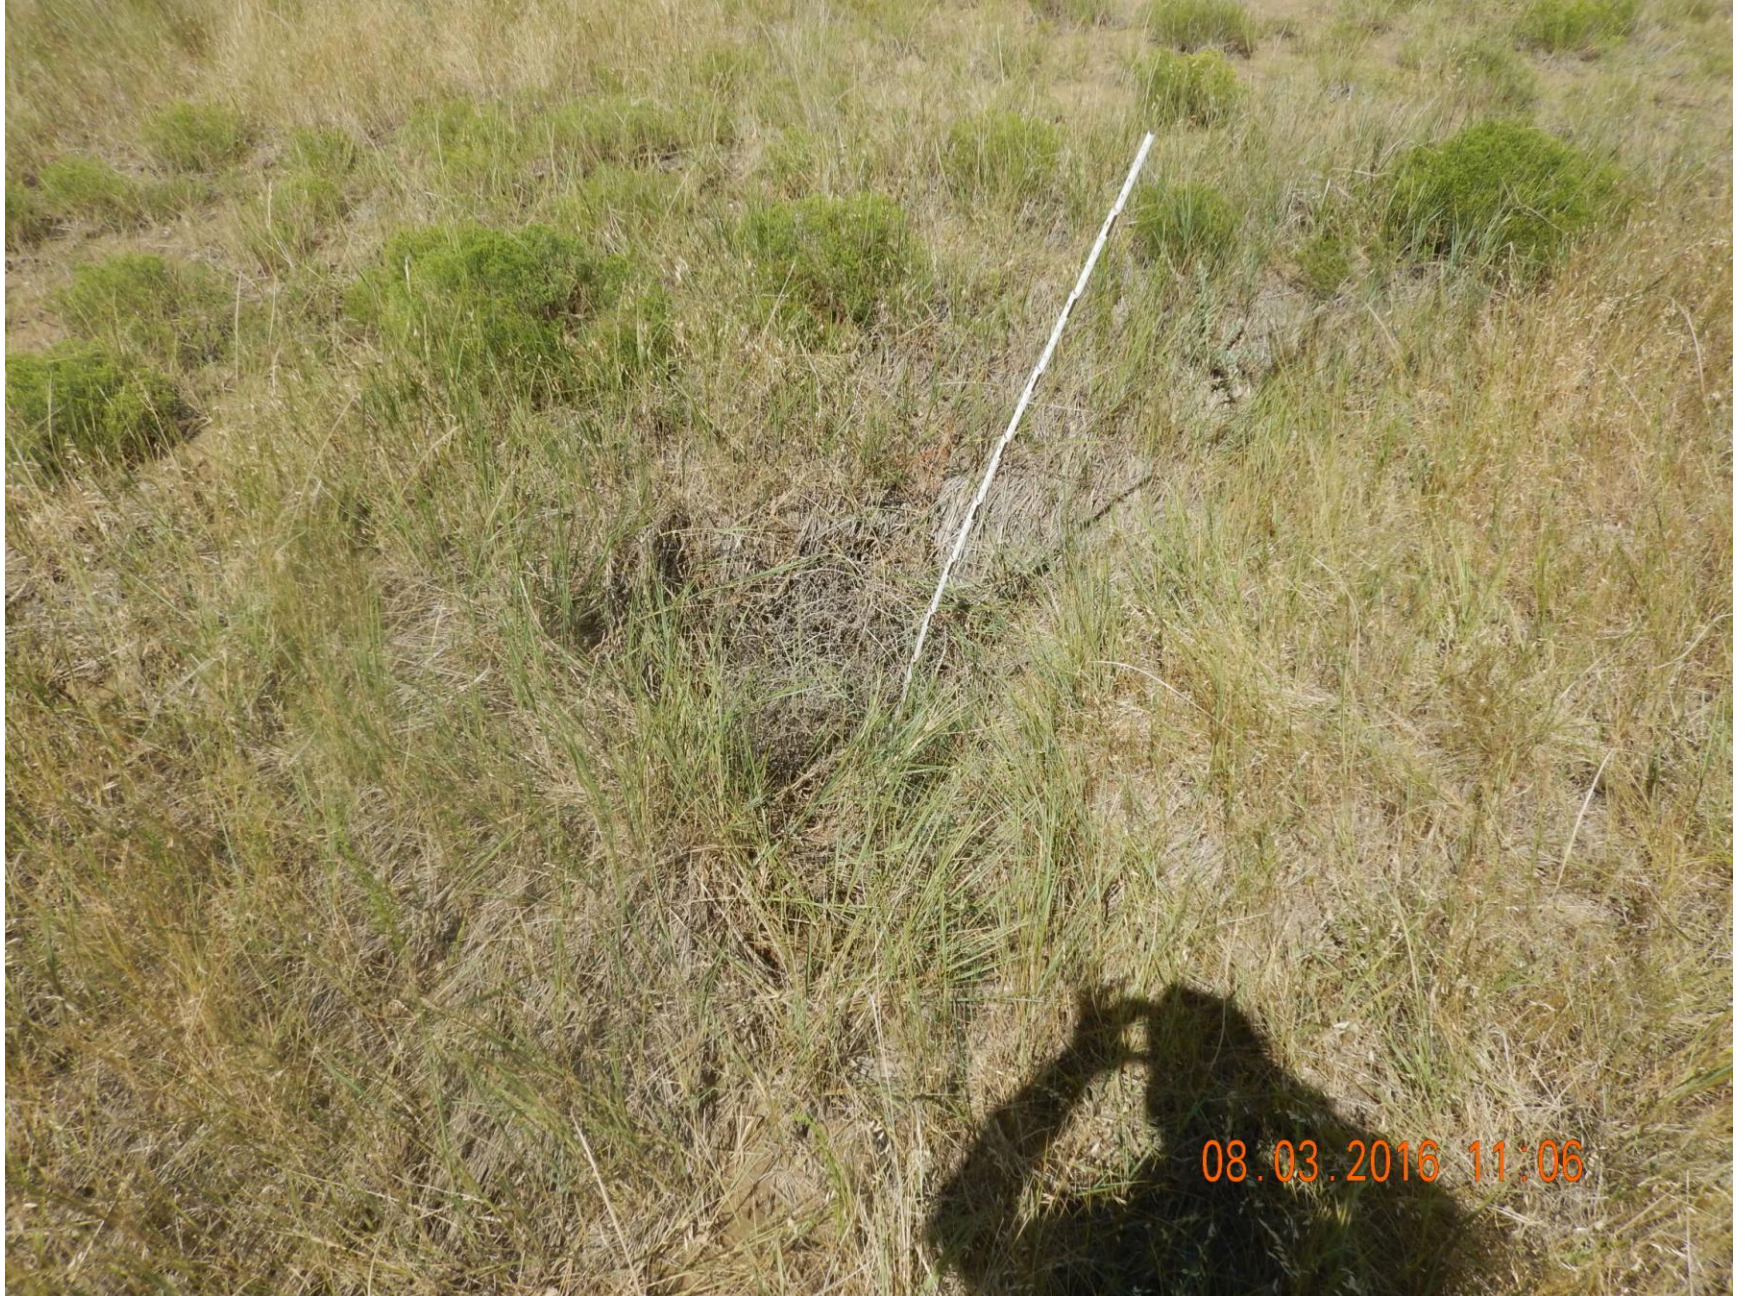
Figure 2: Photo taken from the south end of the location. Photo shows large hole on location, likely same hole identified in inspection doc. #200089436

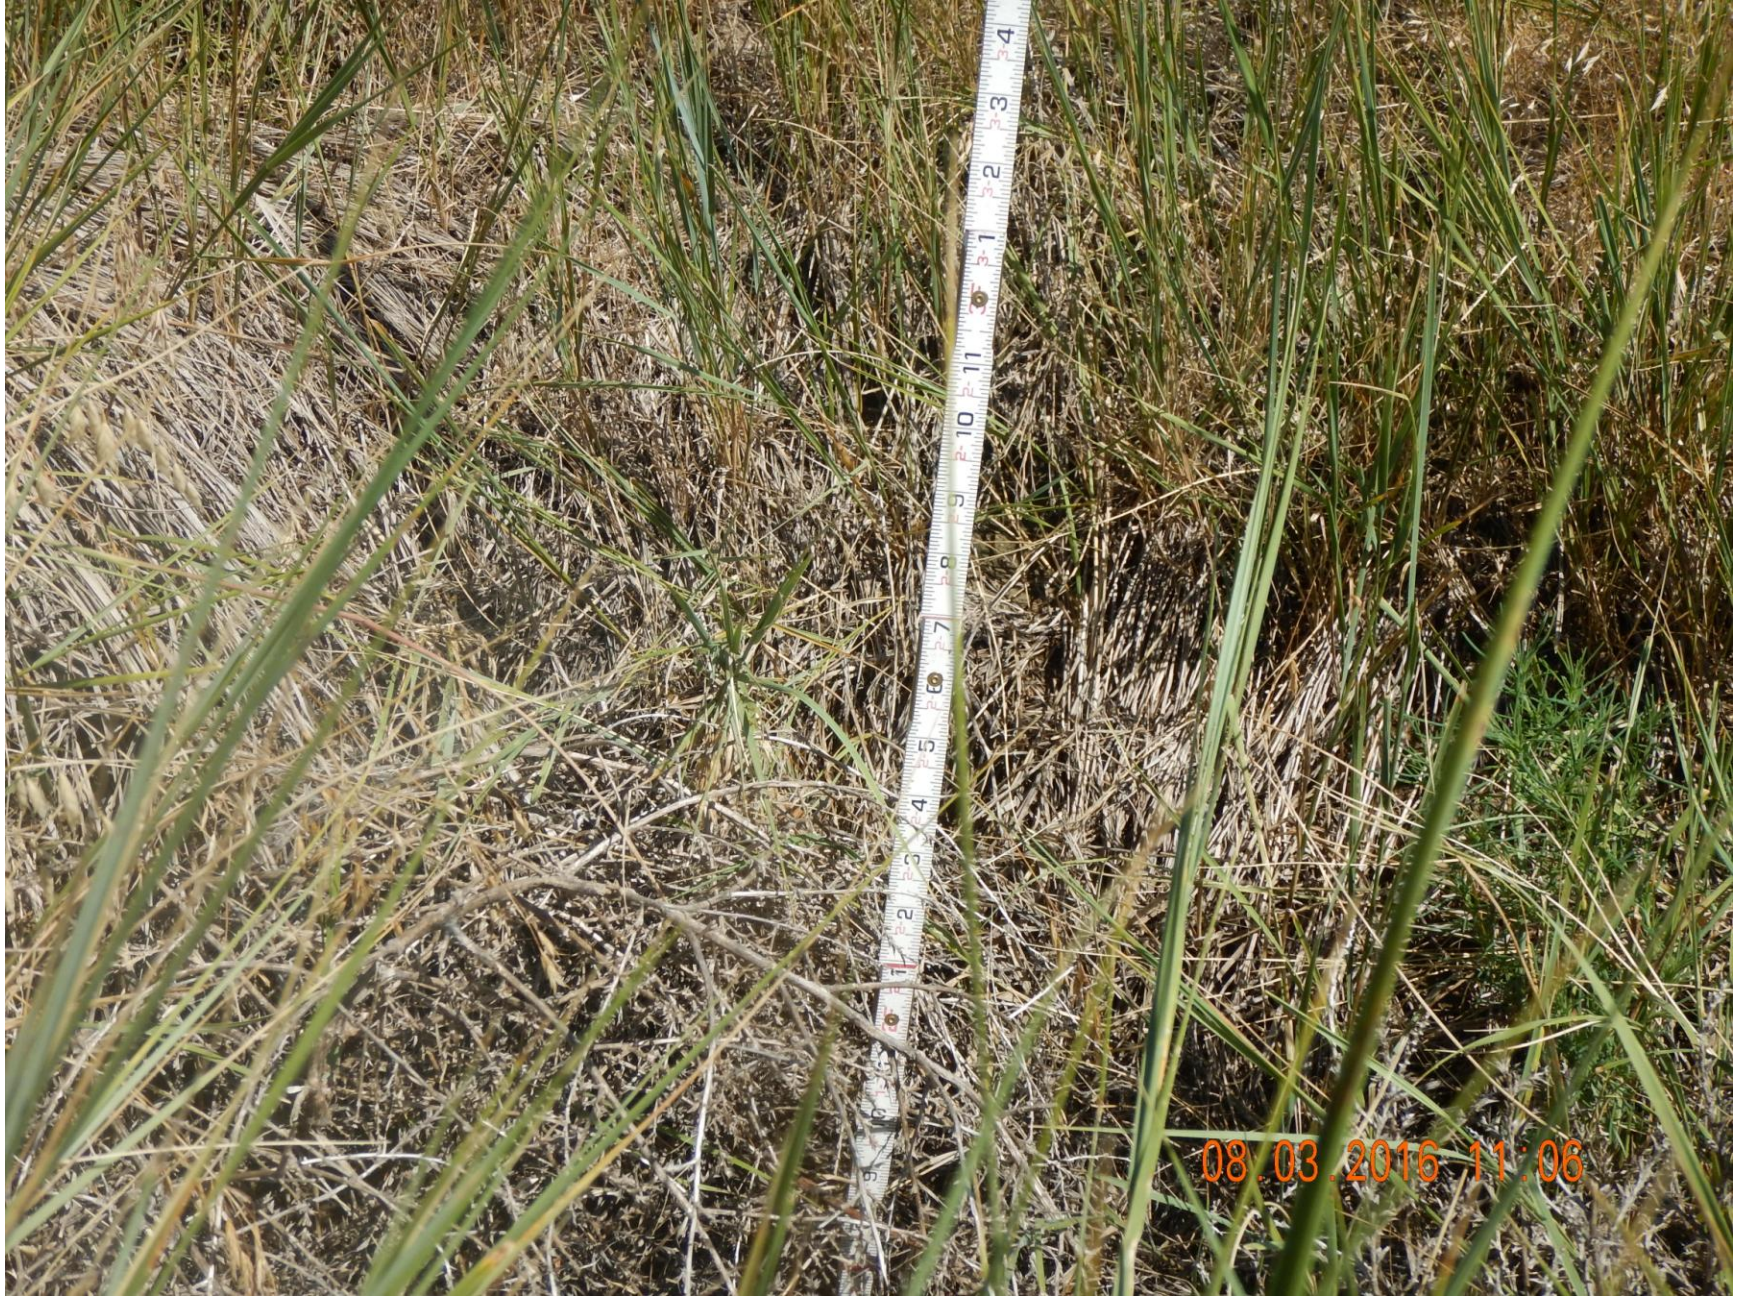
Figure 3: Photo shows large hole found on location is approximately 2 feet deep.

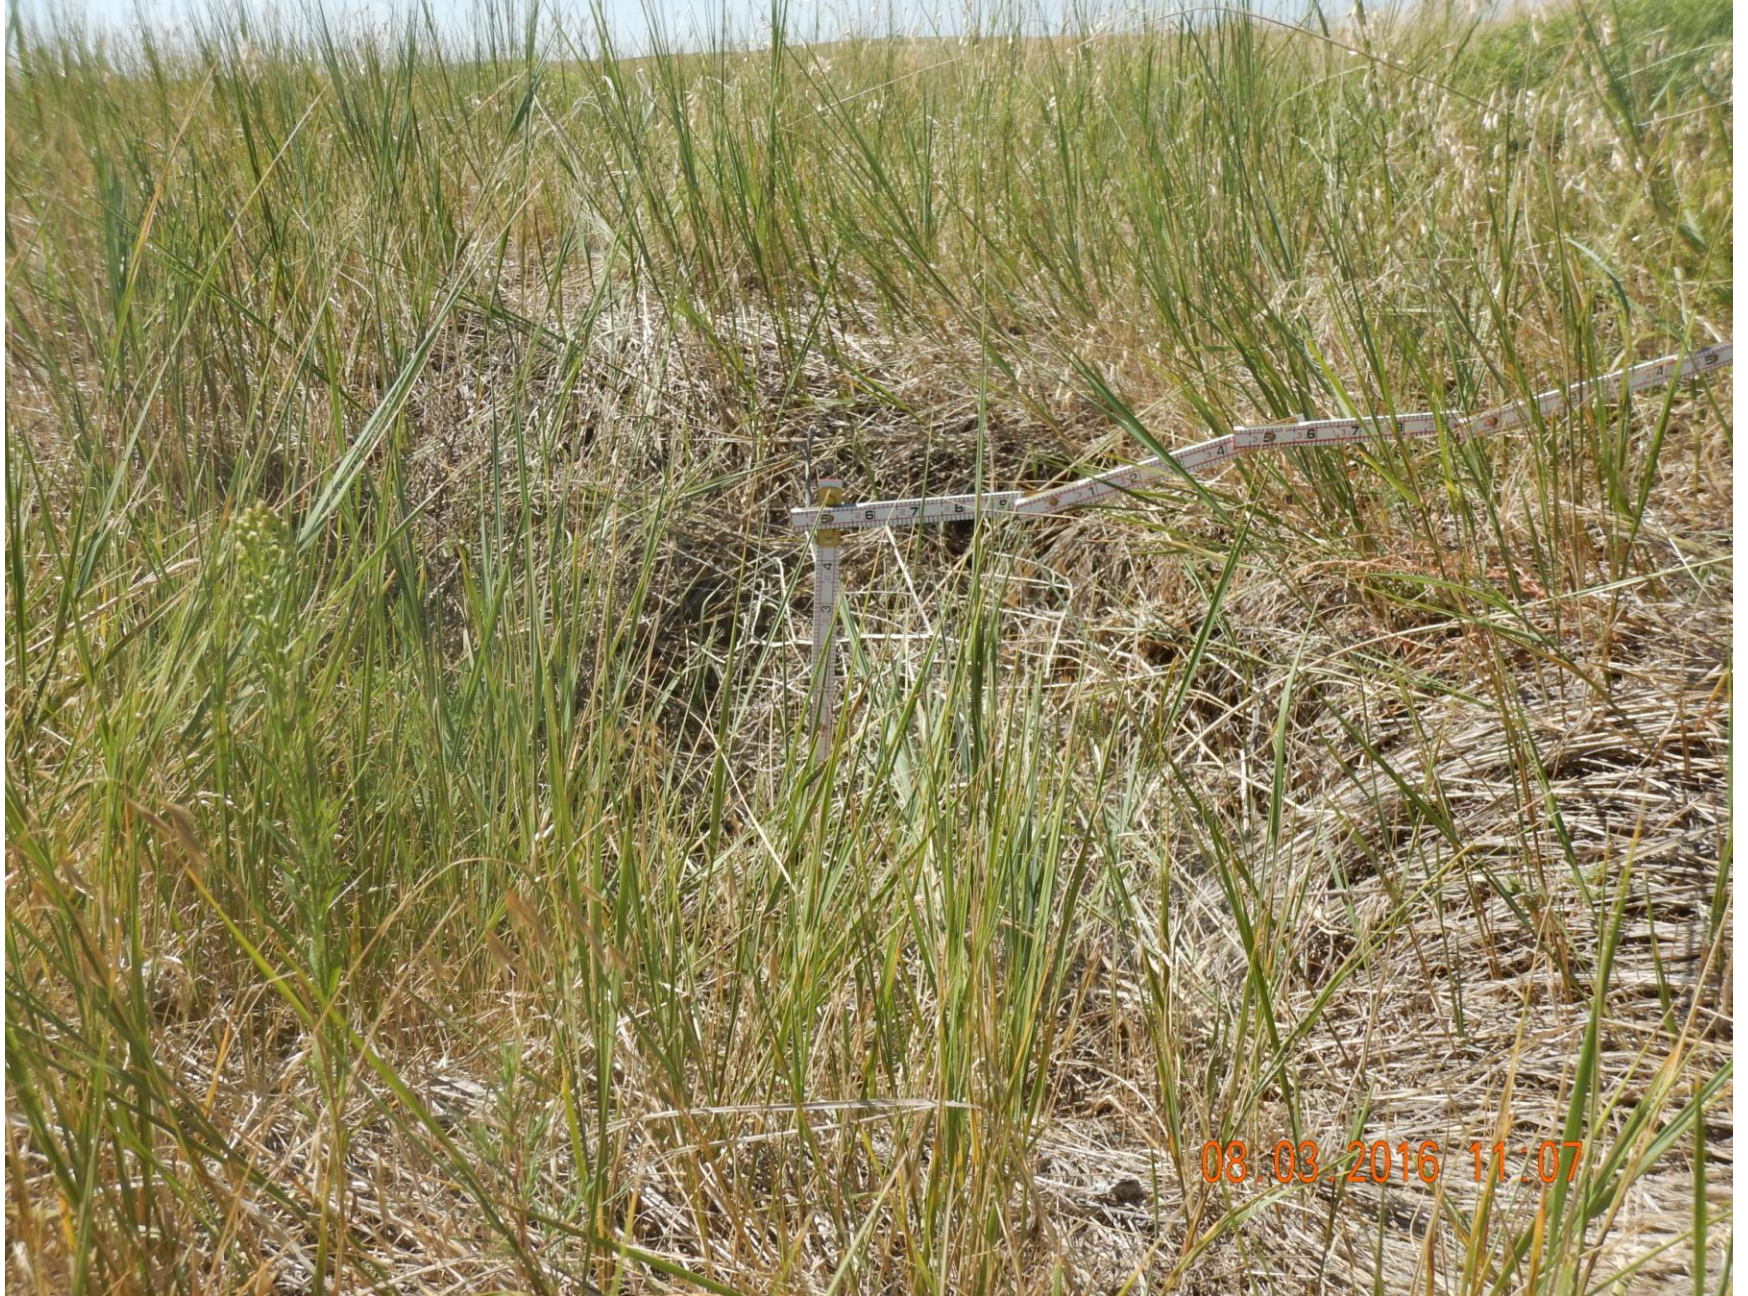
Figure 4: Photo shows large hole found on location is approximately 2 feet deep.

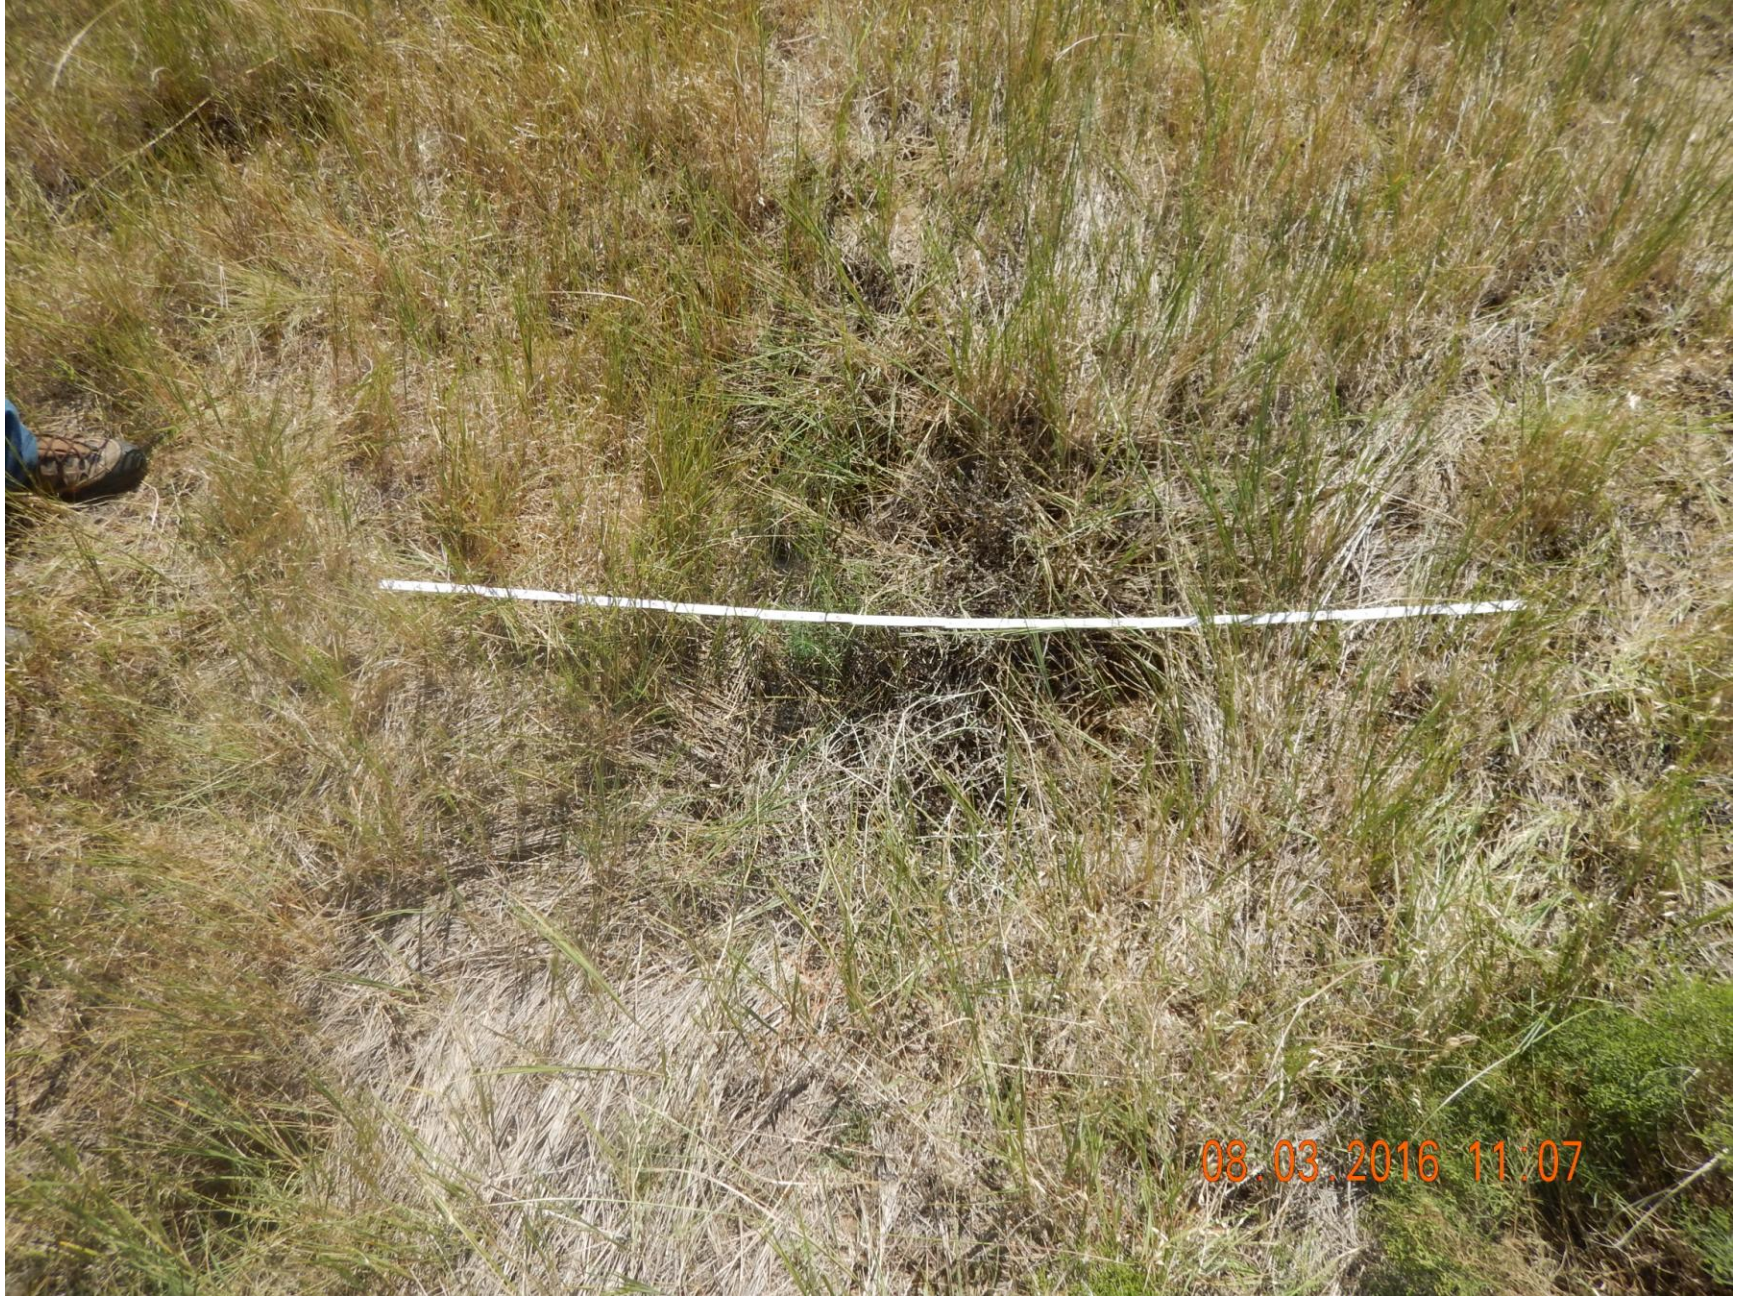
Figure 5: Photo shows width of hole on location. 6' measuring stick for reference.

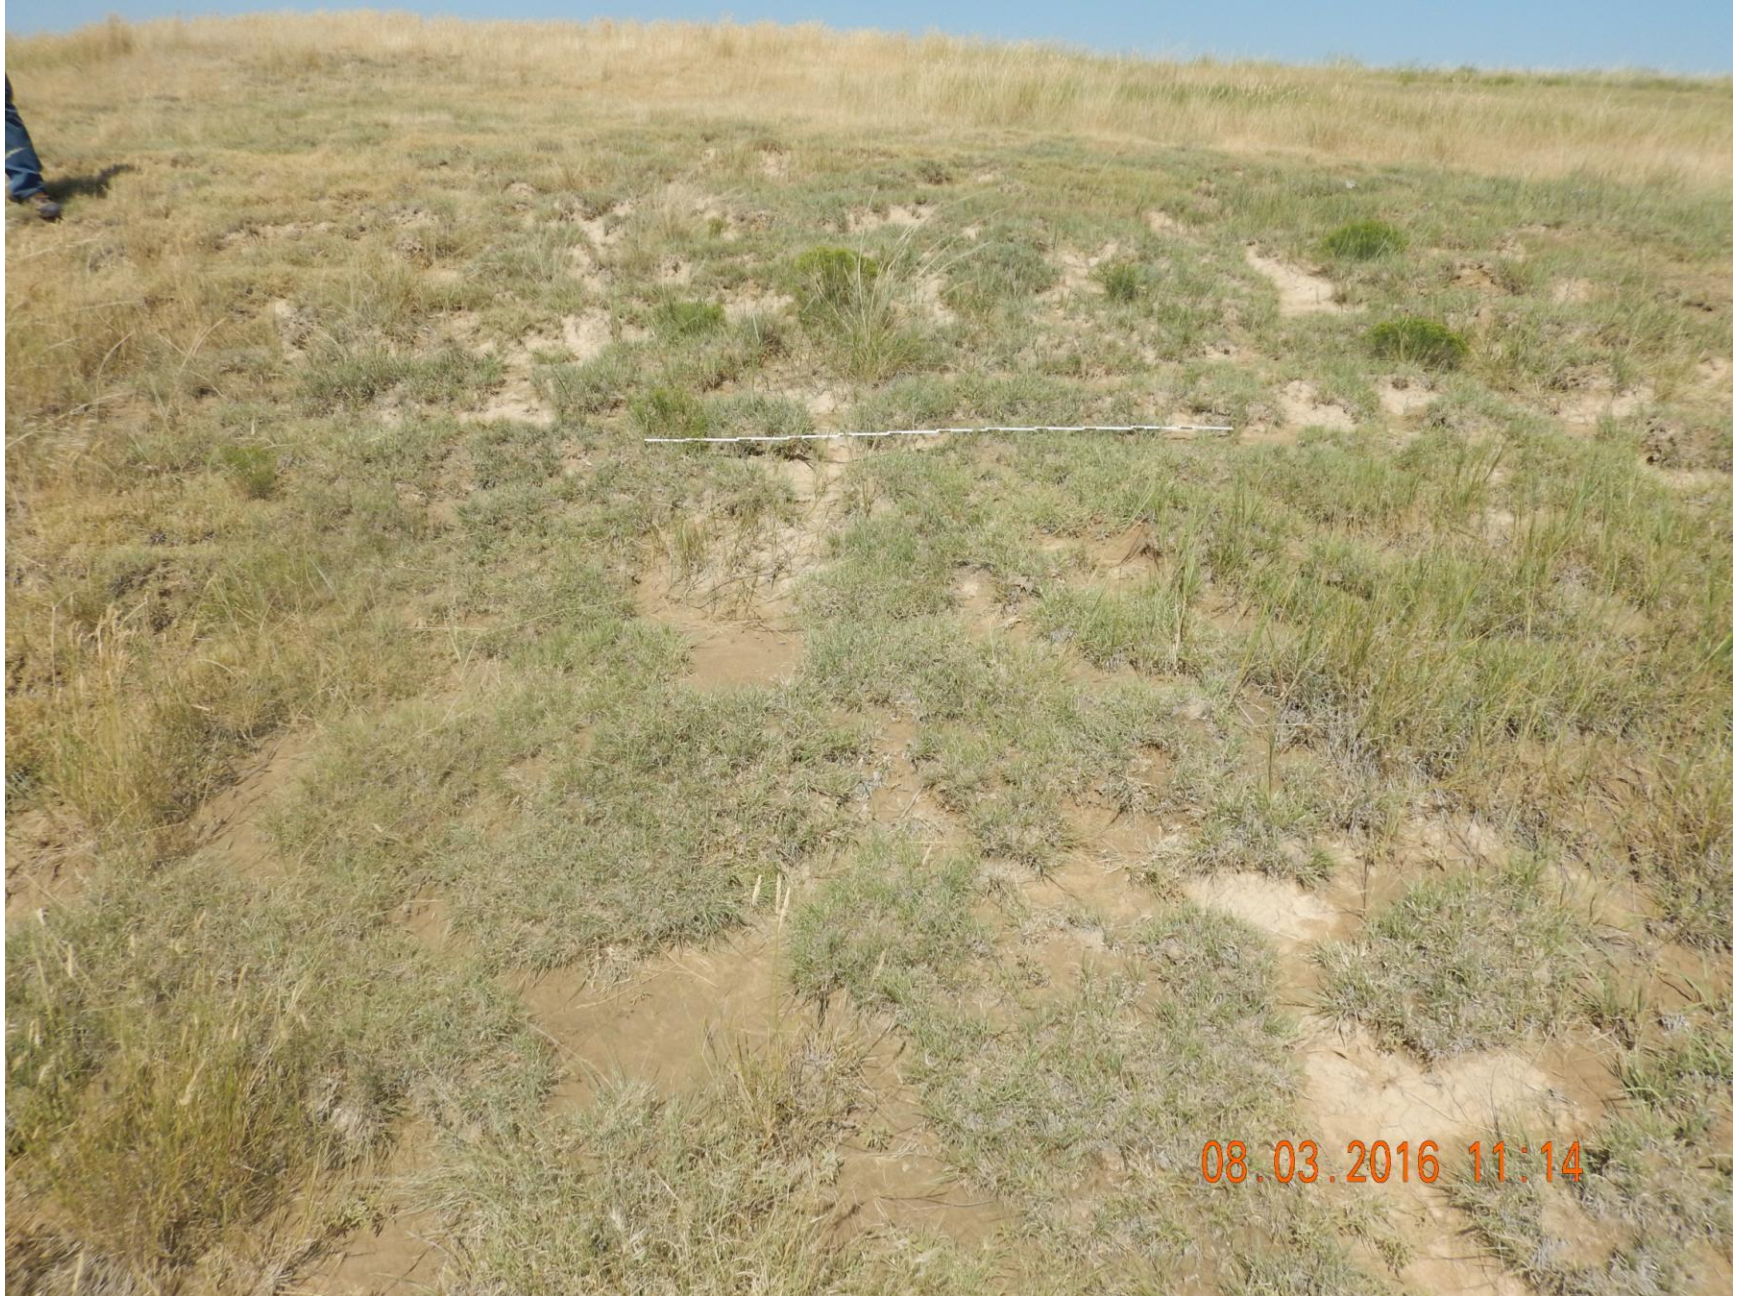
Figure 6: Photo taken from the east end of the location, facing west. Photo shows vegetation over the reclamation area. 6' measuring stick for reference.

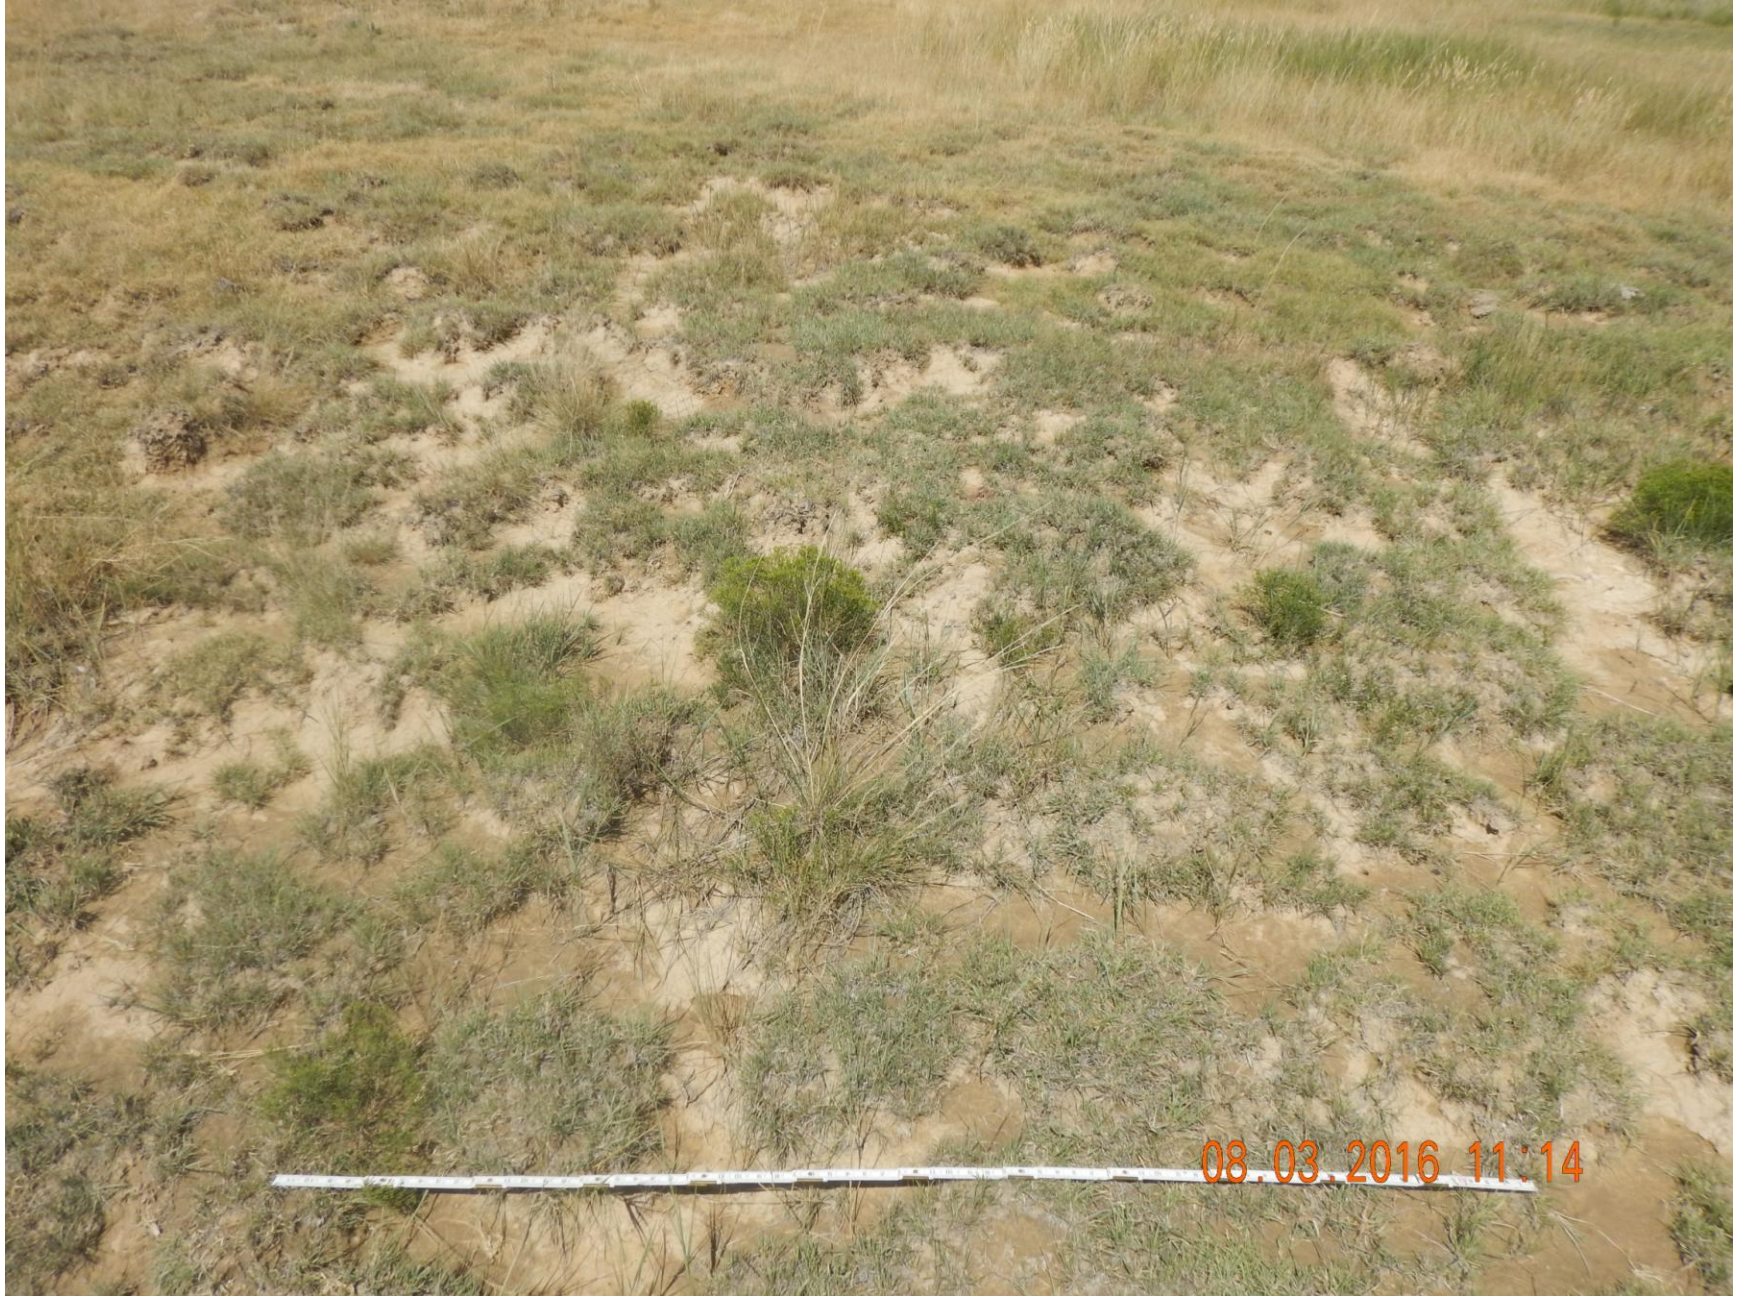
Figure 7: Photo taken from the east end of the location, facing west. Photo shows vegetation over the reclamation area. 6' measuring stick for reference.

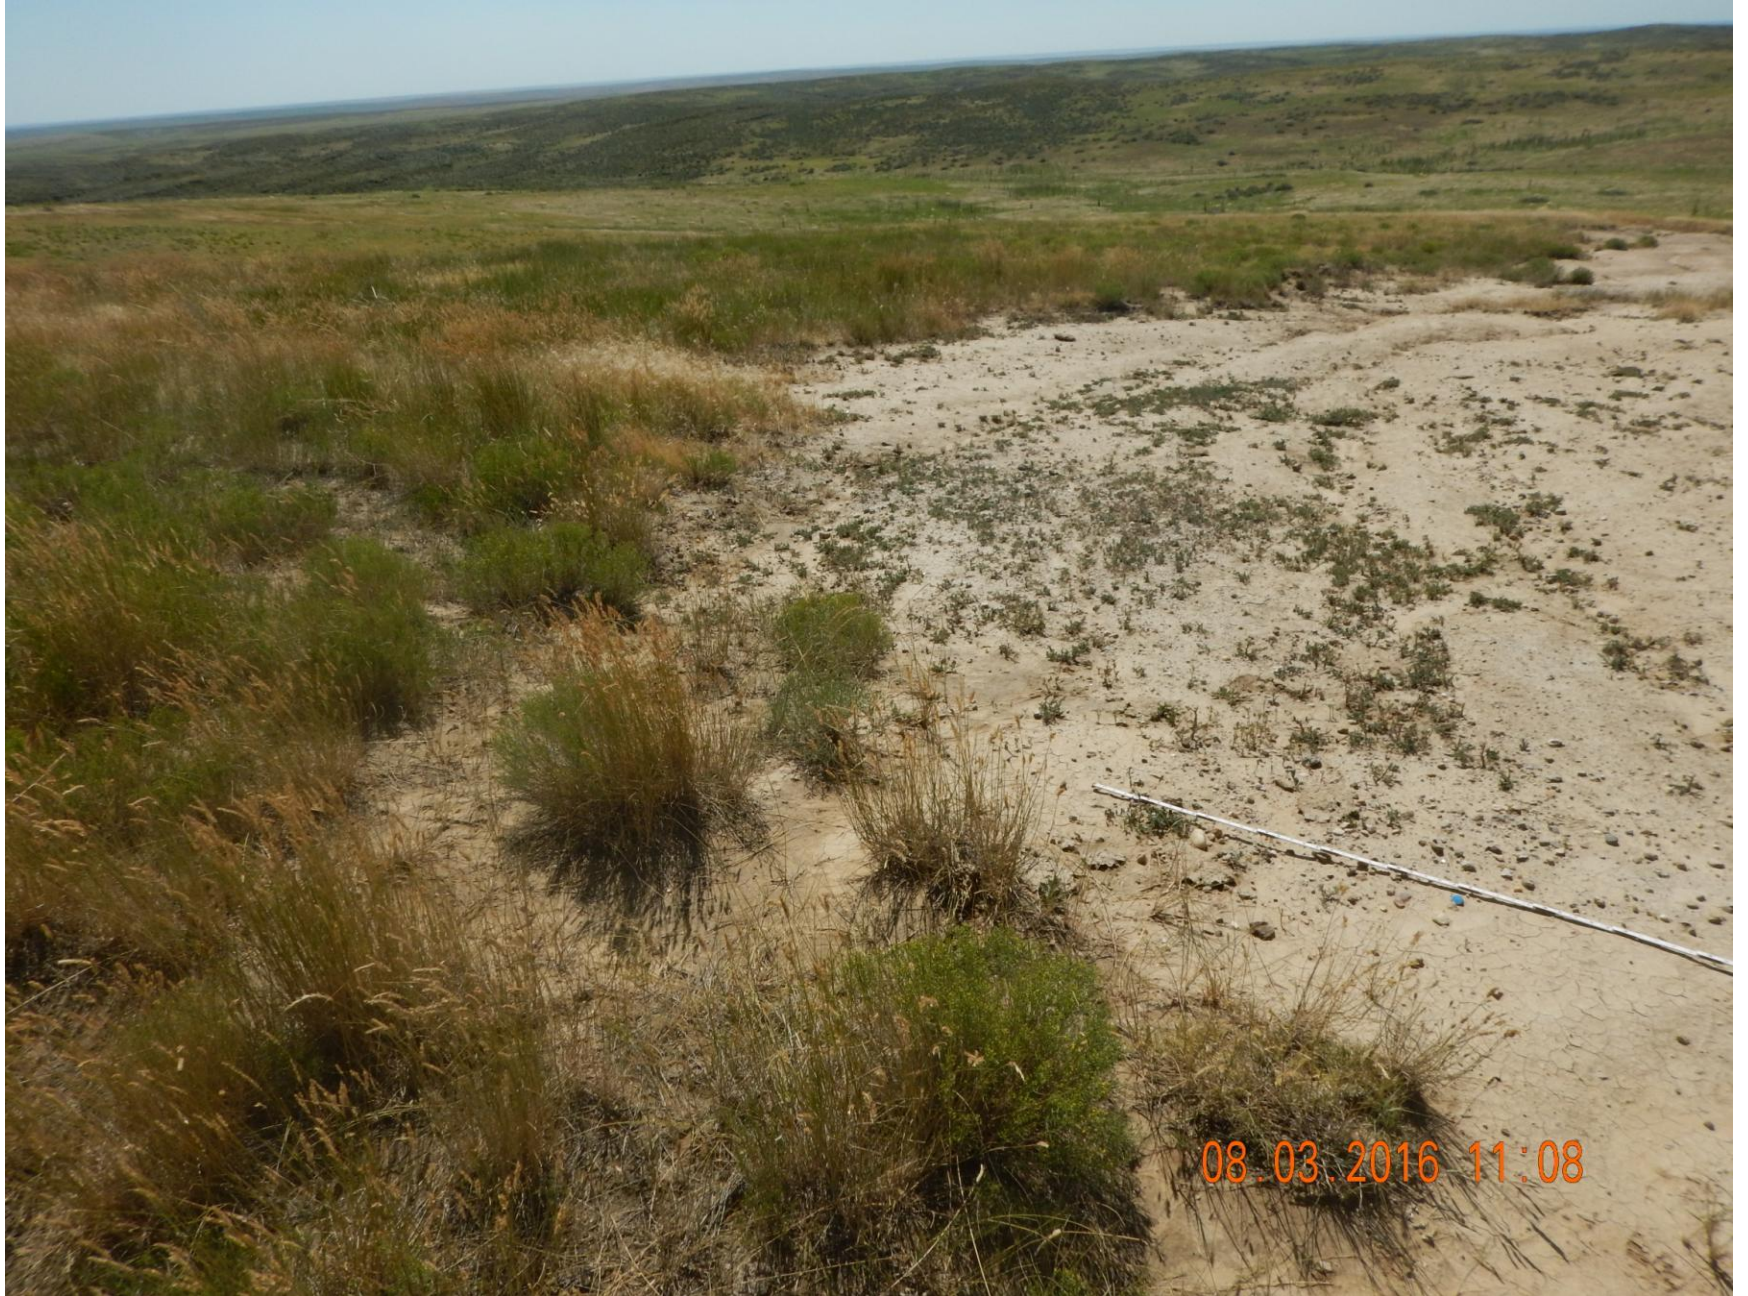
Figure 8: Photo taken from the south end of the location, facing southeast. Photo shows large un-vegetated area experiencing erosion. Area the result of a produced water spill. 6' measuring stick for reference.

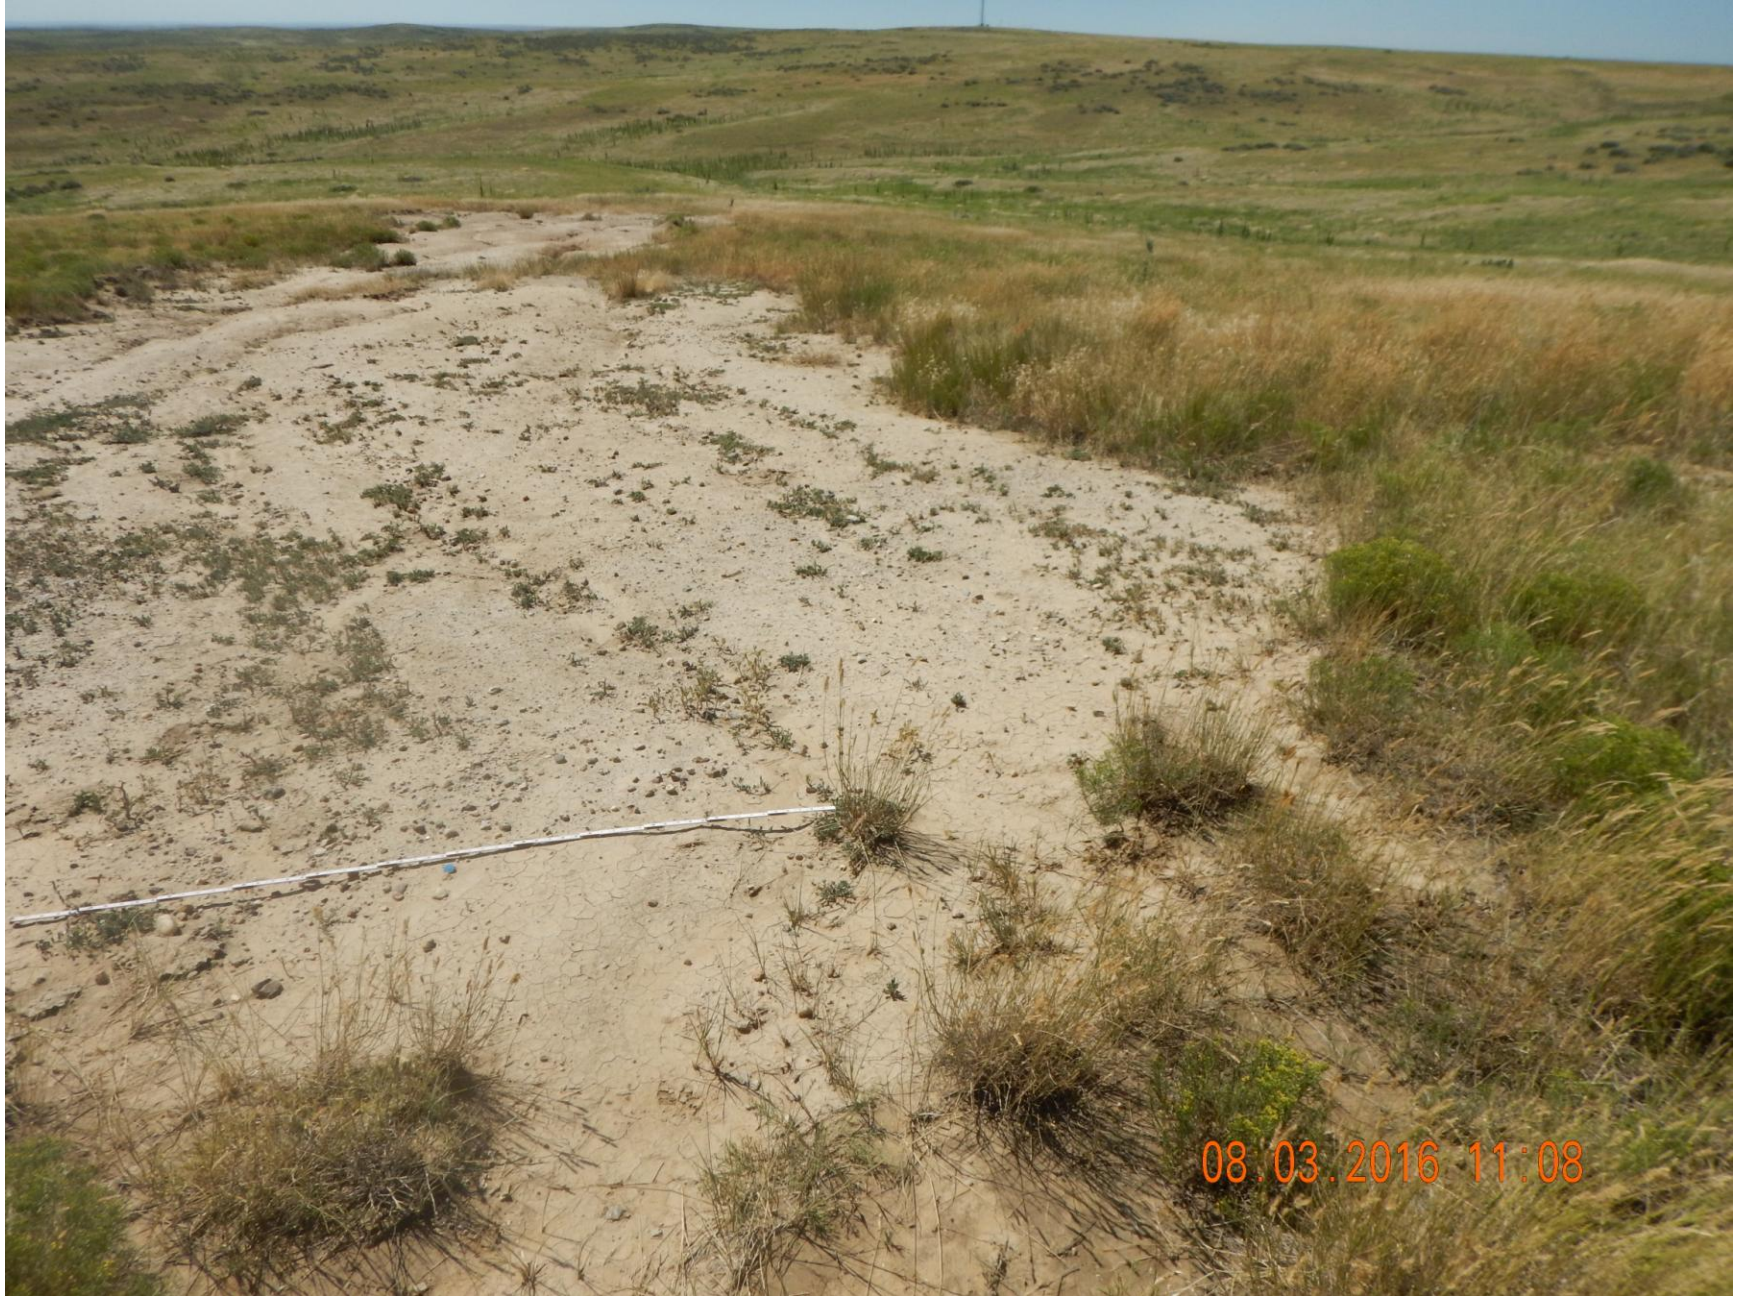
Figure 9: Photo taken from the south end of the location, facing south. Photo shows large un-vegetated area experiencing erosion. Area the result of a produced water spill. 6' measuring stick for reference.

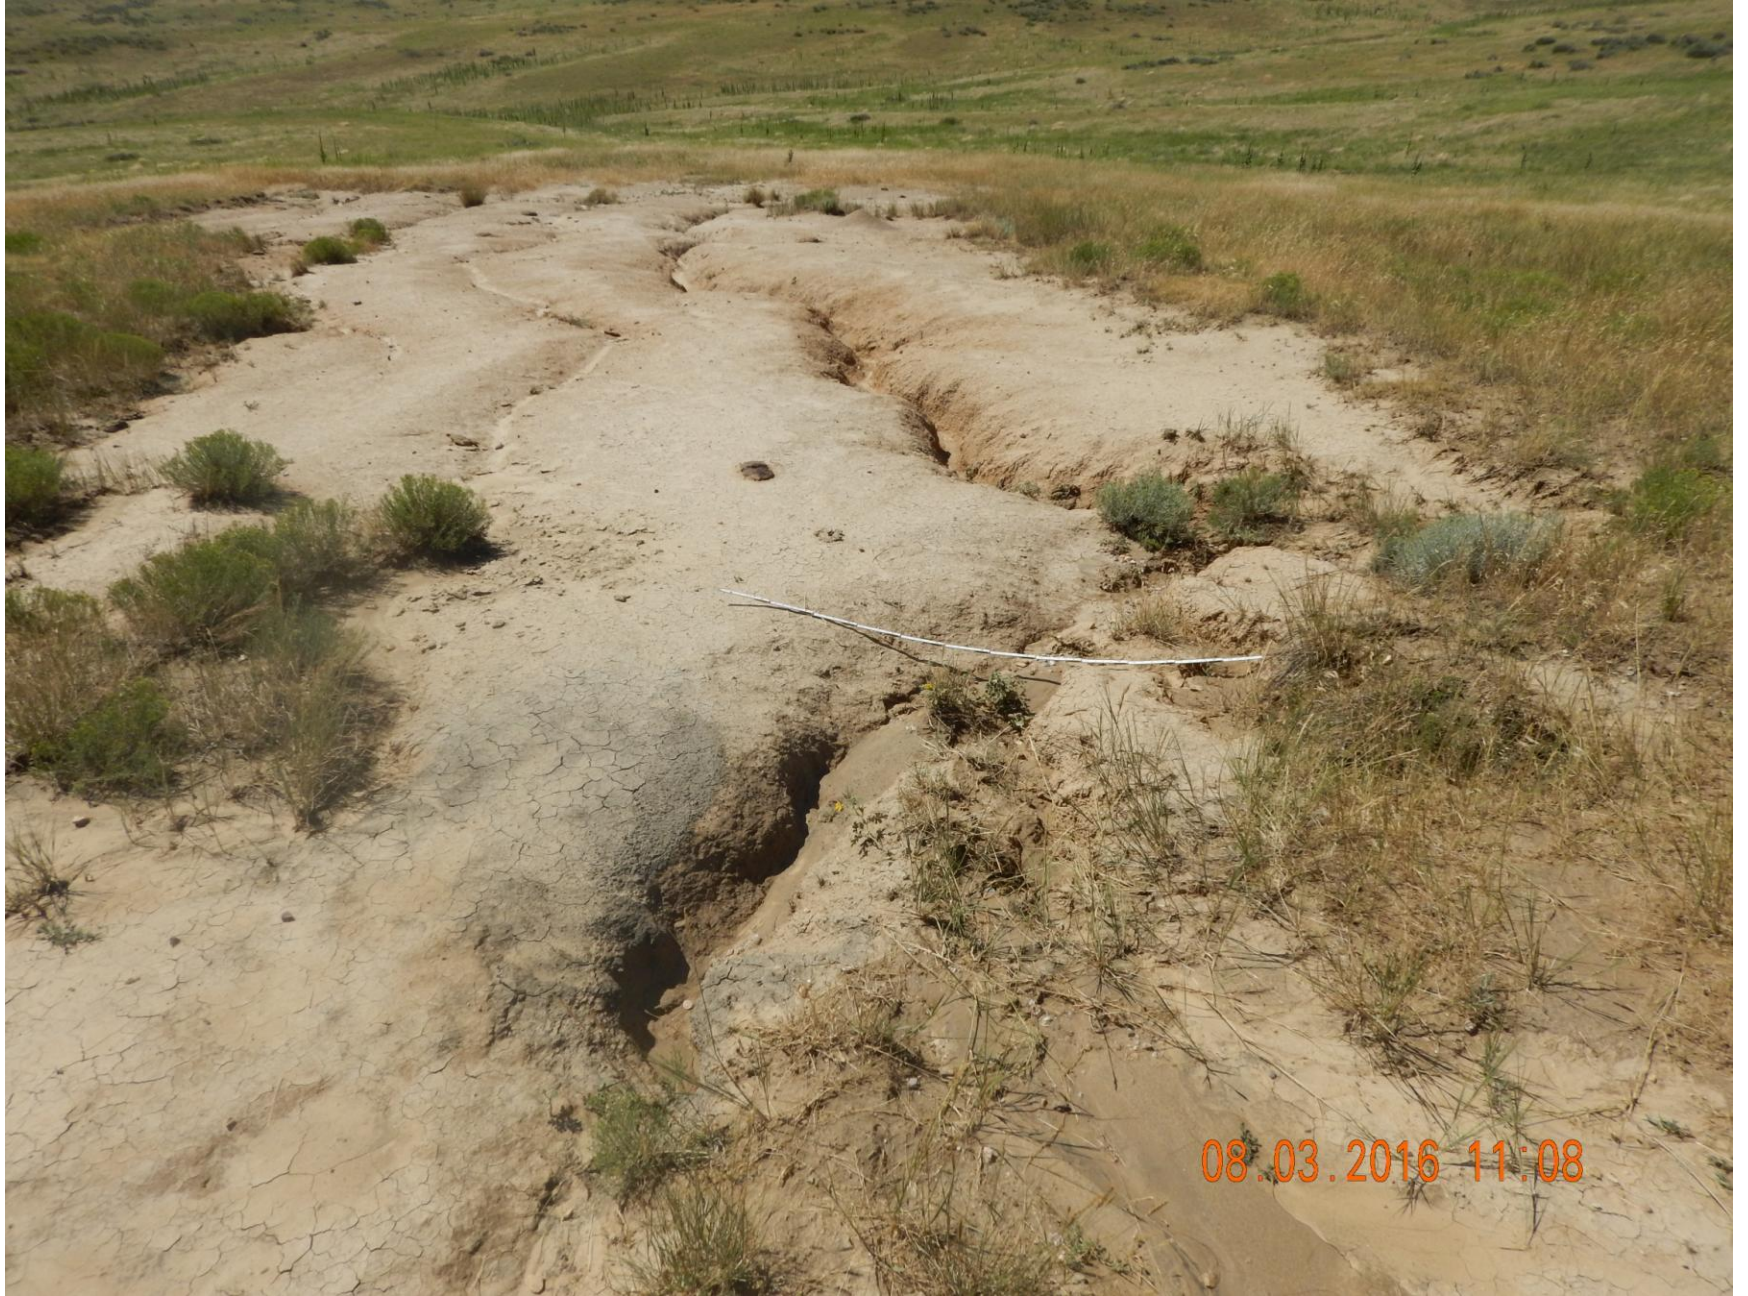
Figure 10: Photo taken from the south end of the location, facing south. Photo shows degradation caused by stormwater erosion over spill area.
