Final Reclamation Inspection

08/03/2016

Operator: Oilfield Salvage & Service #65550

Location ID: 311709

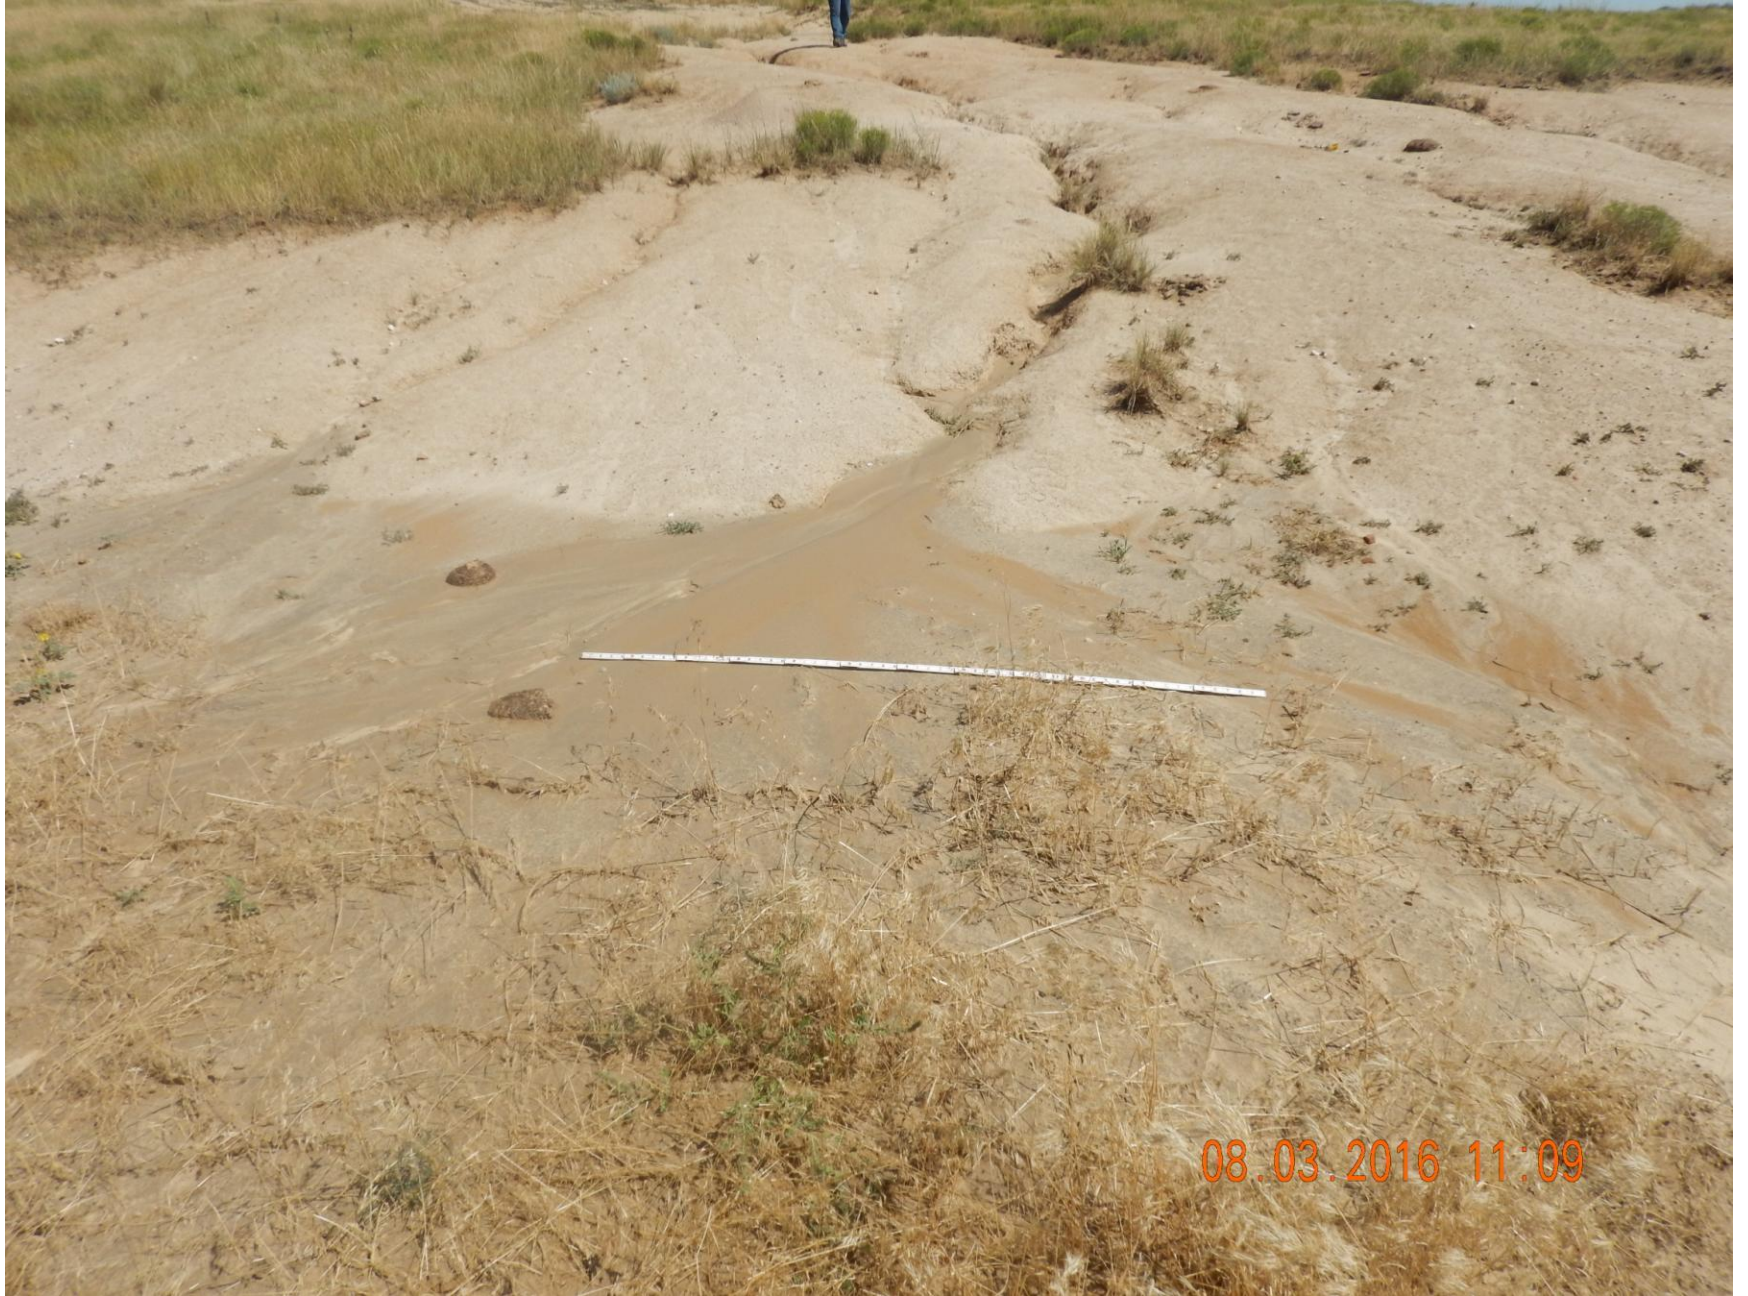
Figure 11: Photo taken from the south end of the spill area, facing north. Photo shows degradation caused by stormwater erosion over spill area.

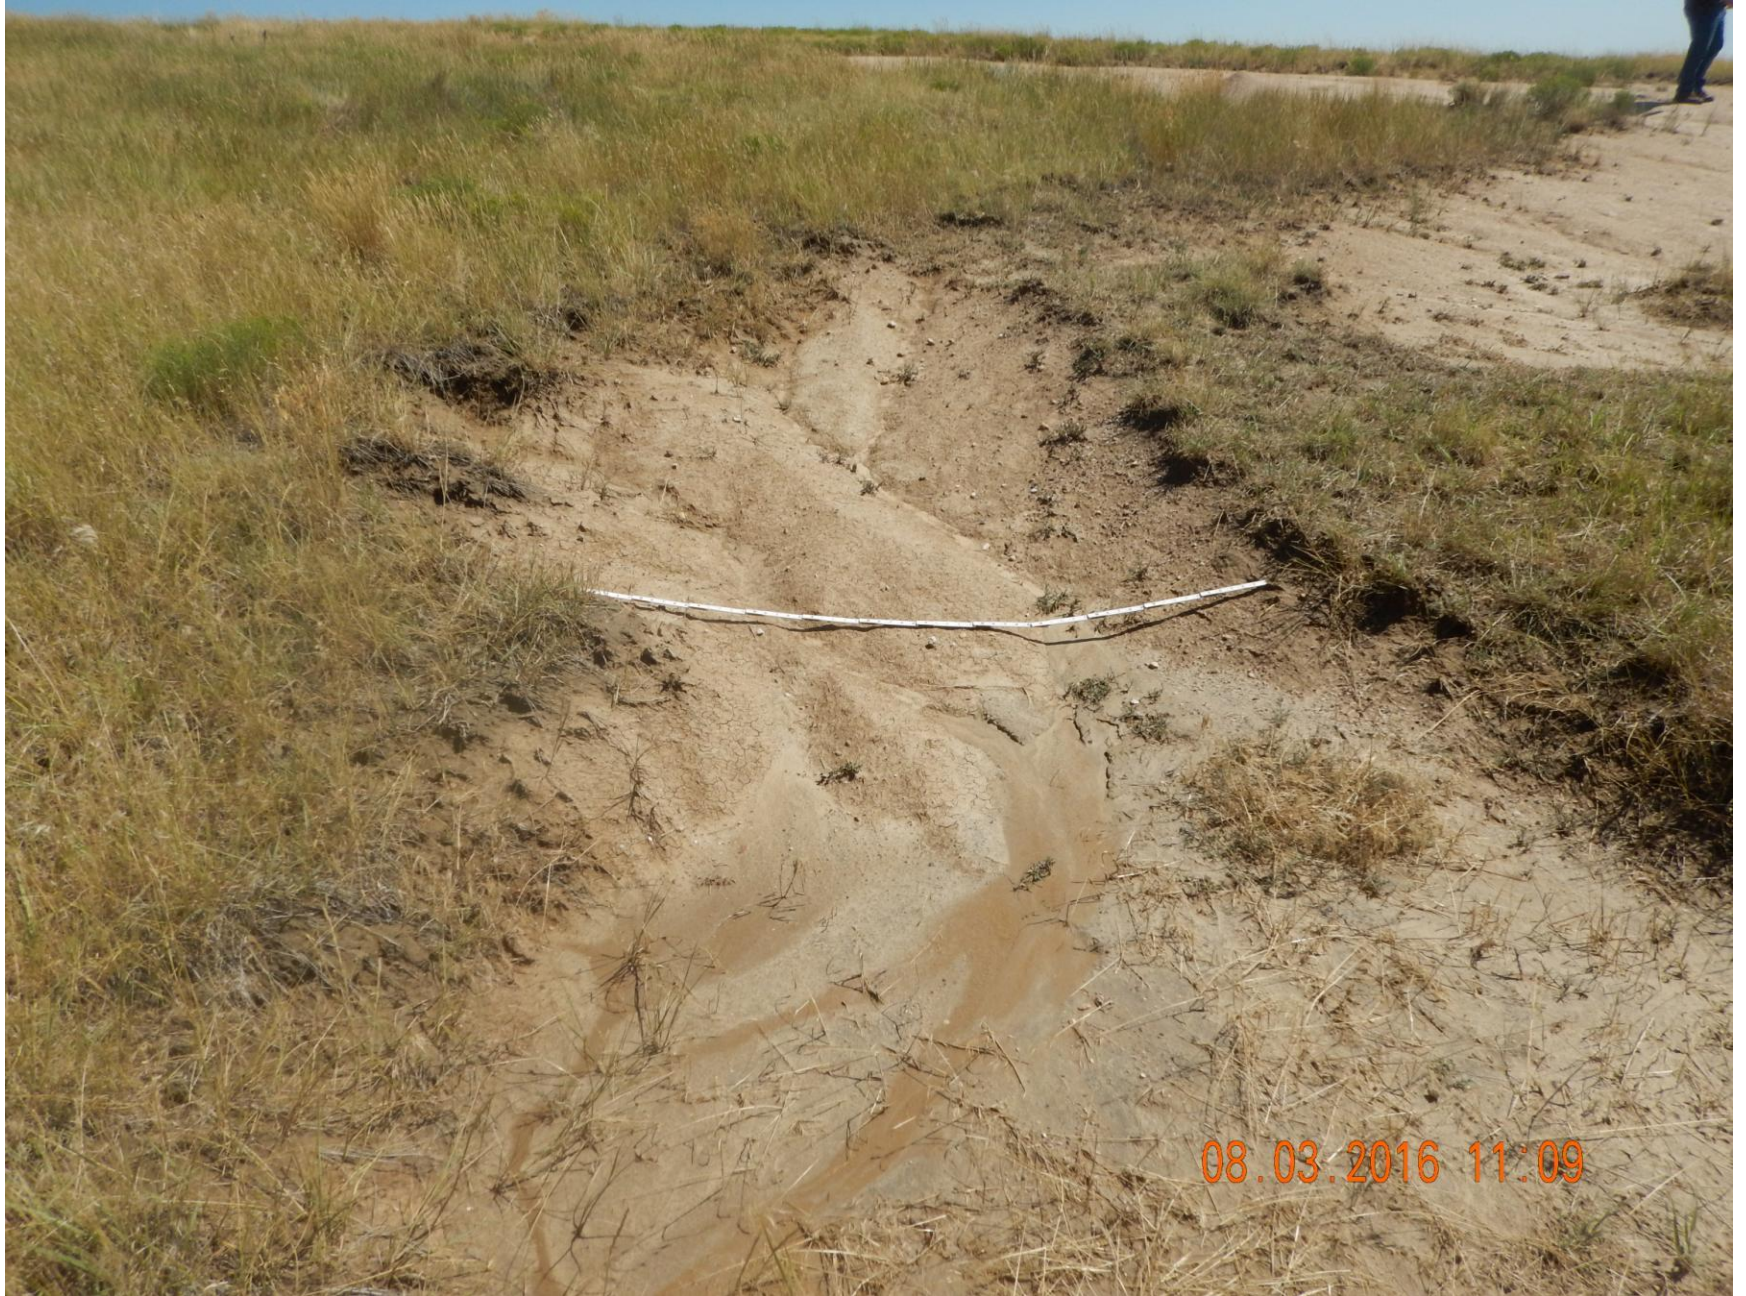
Figure 12: Photo taken from the south end of the spill area, facing north. Photo shows degradation caused by stormwater erosion over spill area.

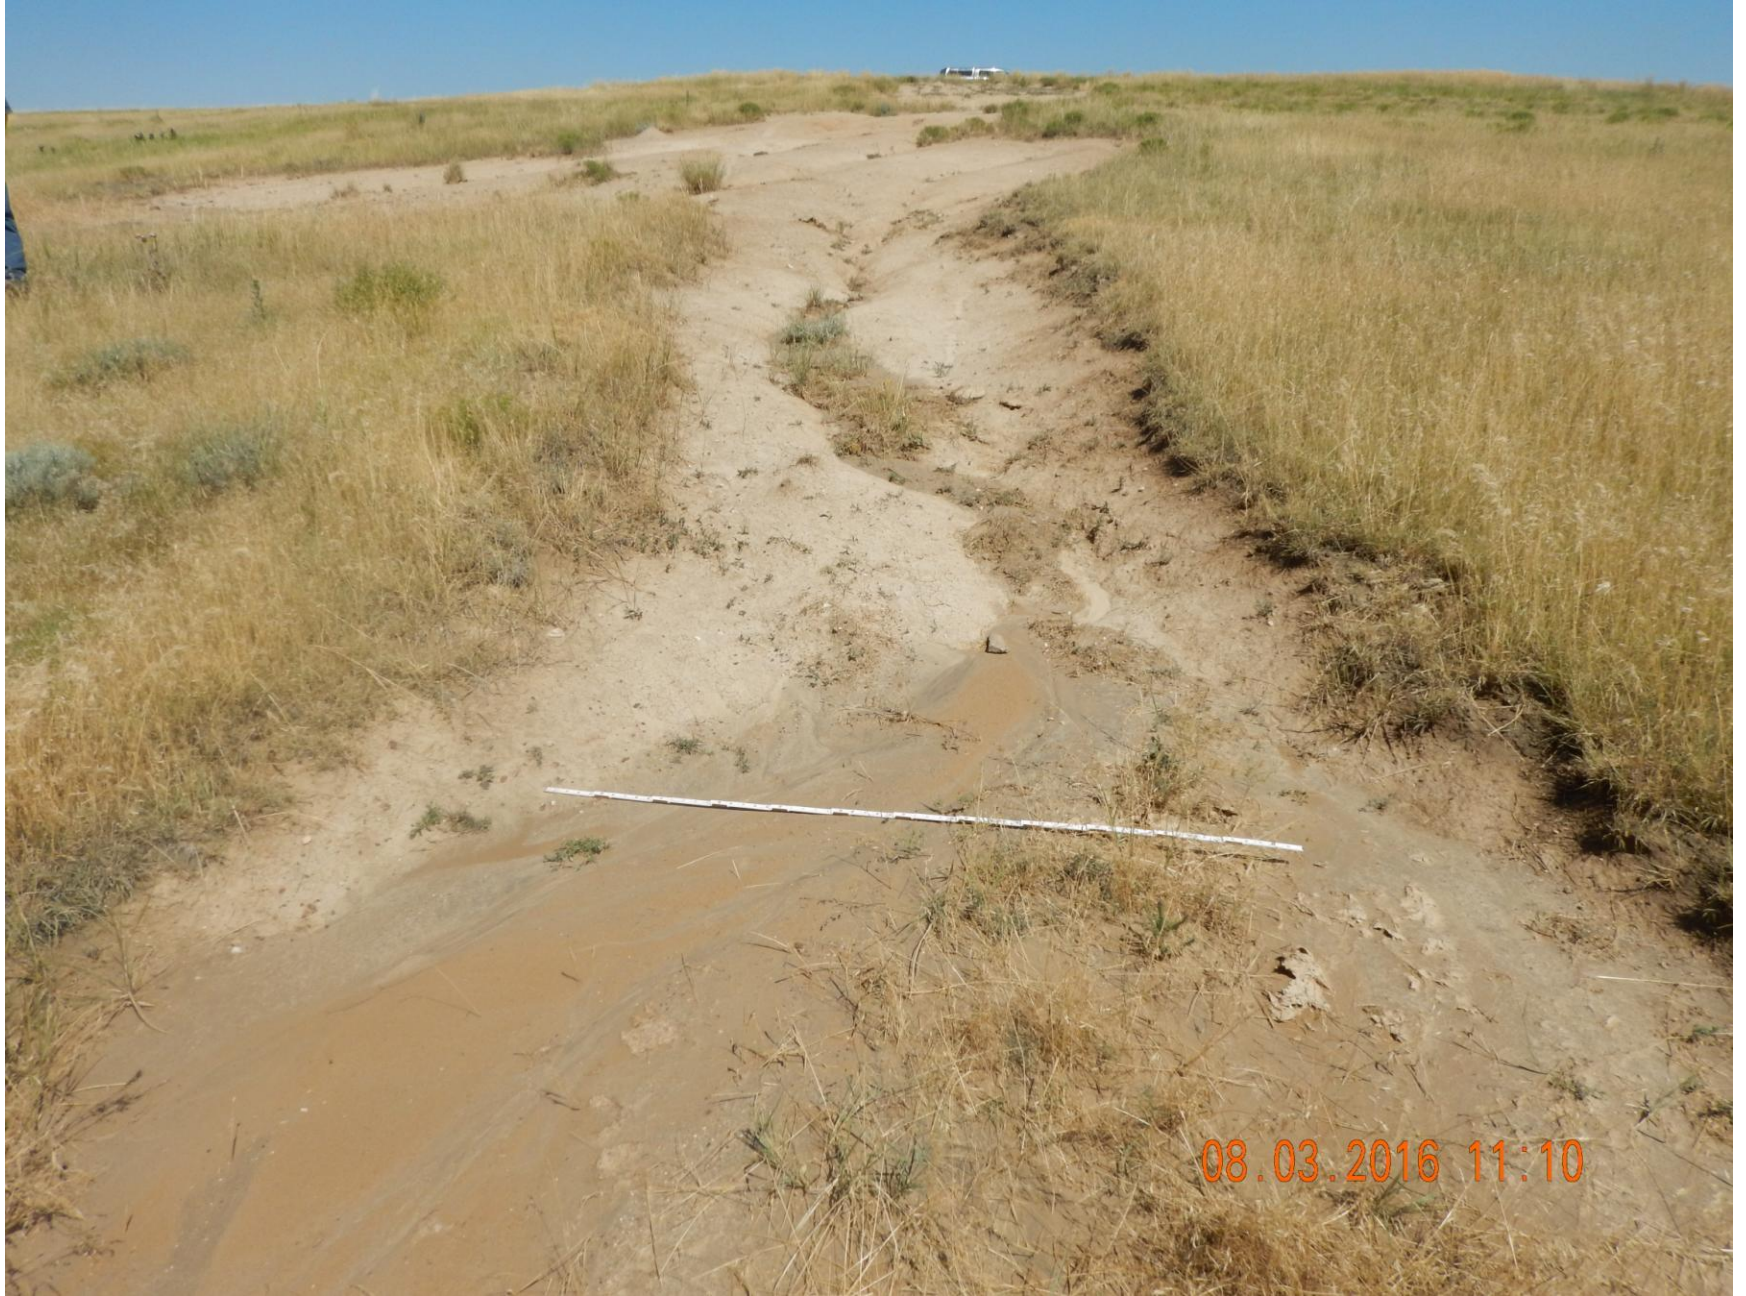
Figure 13: Photo taken from the south end of the spill area, facing north. Photo shows degradation caused by stormwater erosion over spill area.

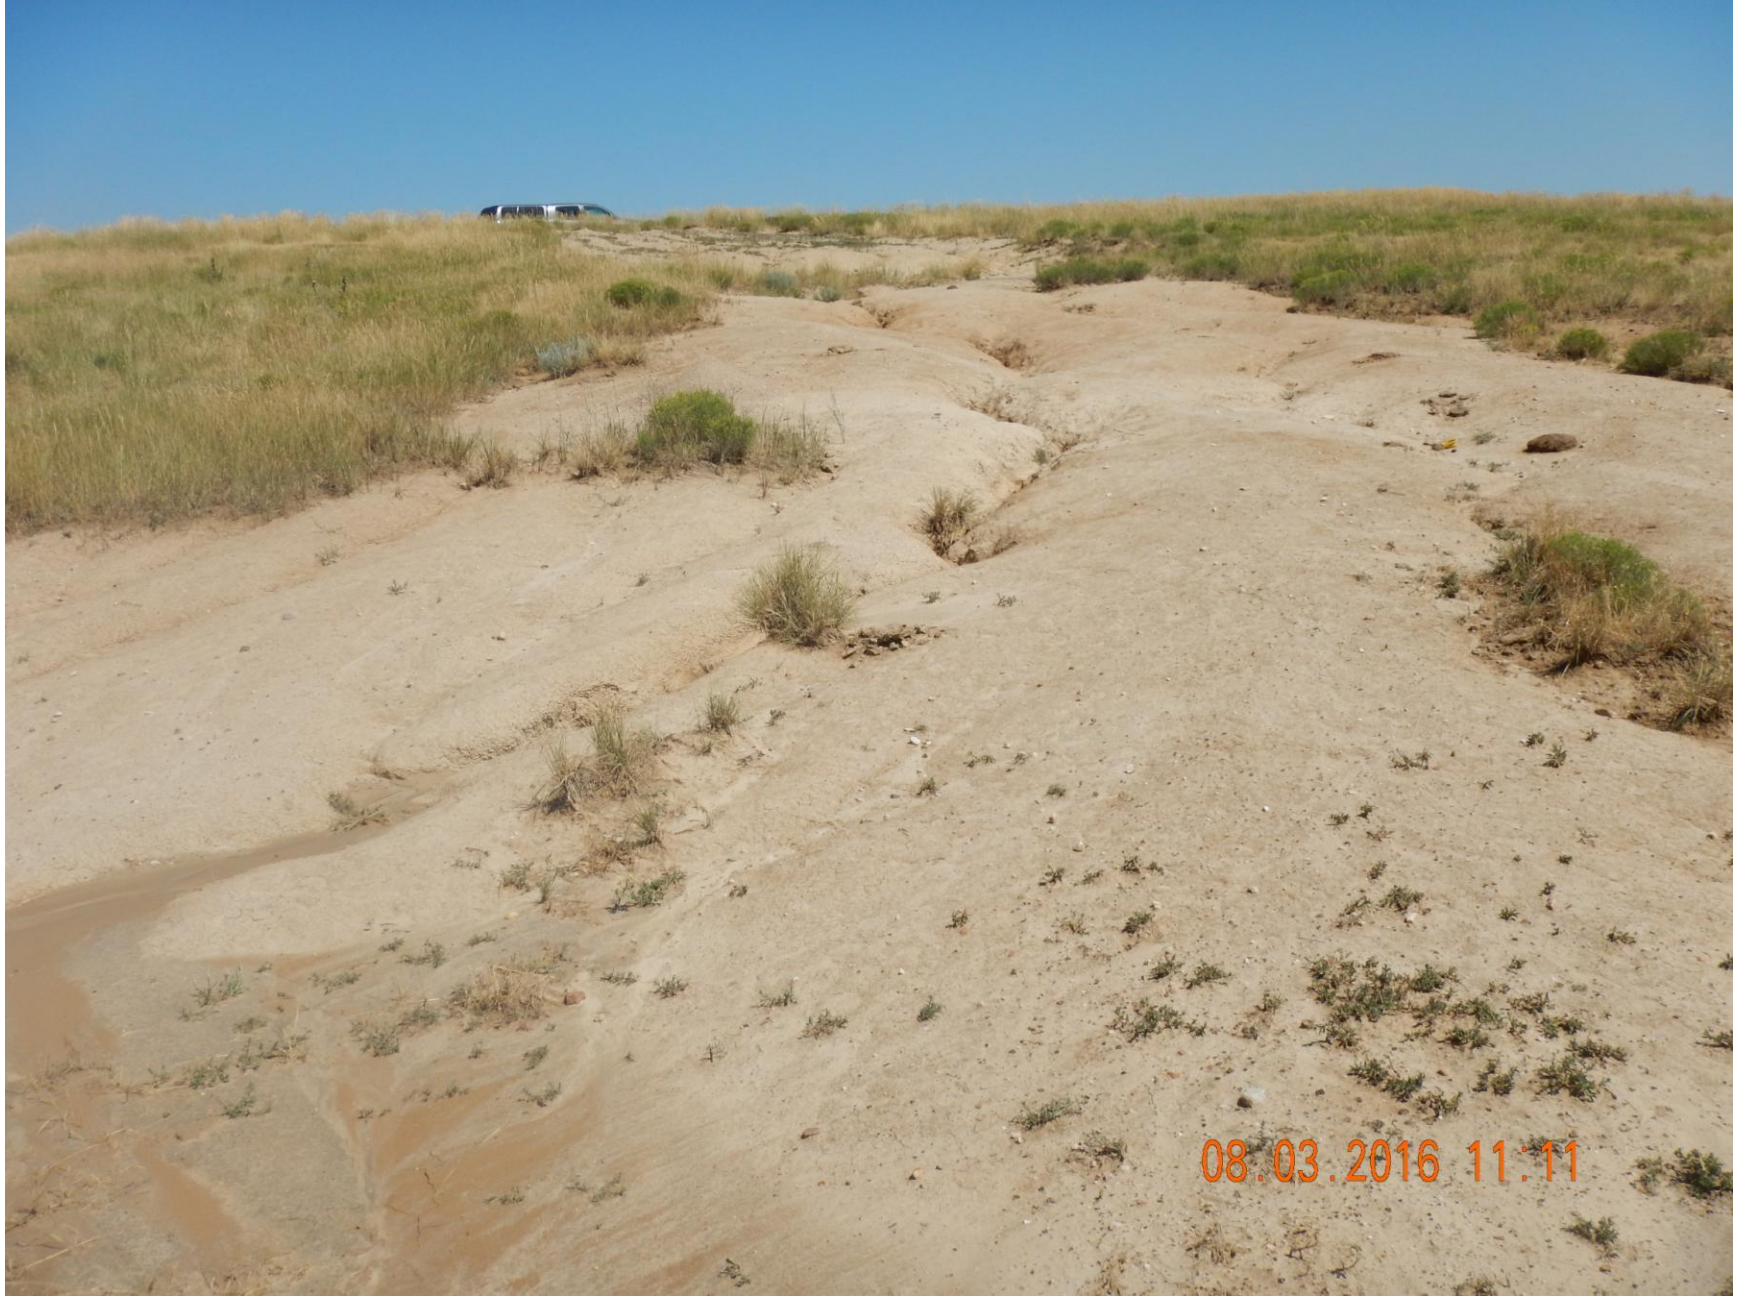
Figure 14: Photo taken from the south end of the spill area, facing north. Photo shows degradation caused by stormwater erosion over spill area.
