Final Reclamation Inspection

06/28/2016

Operator: Petro-Canada

Location ID: 311664

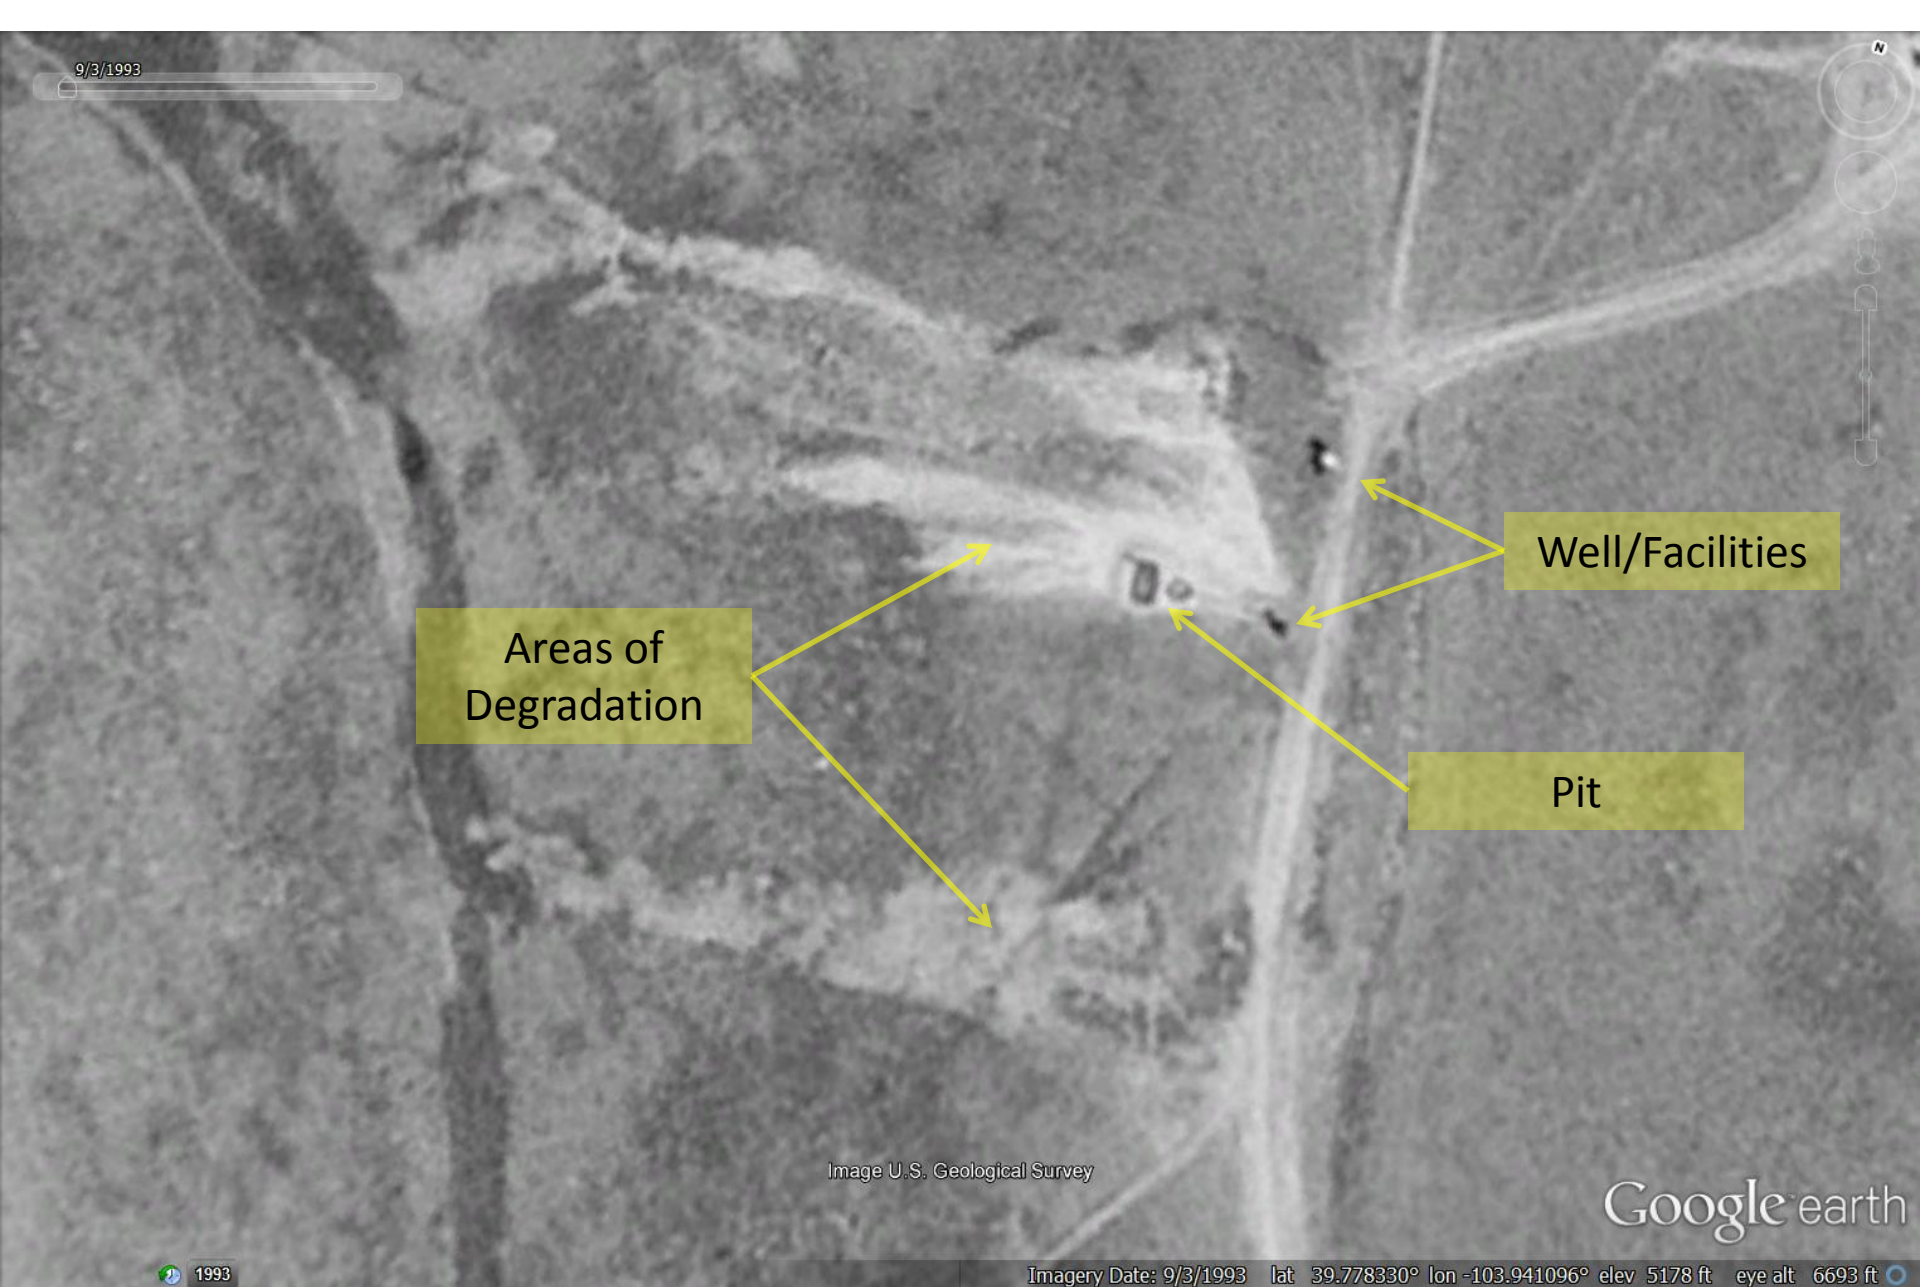
Figure 1: 1933 Aerial imagery showing location of Pit, facilities and well. Note the two large areas of degradation

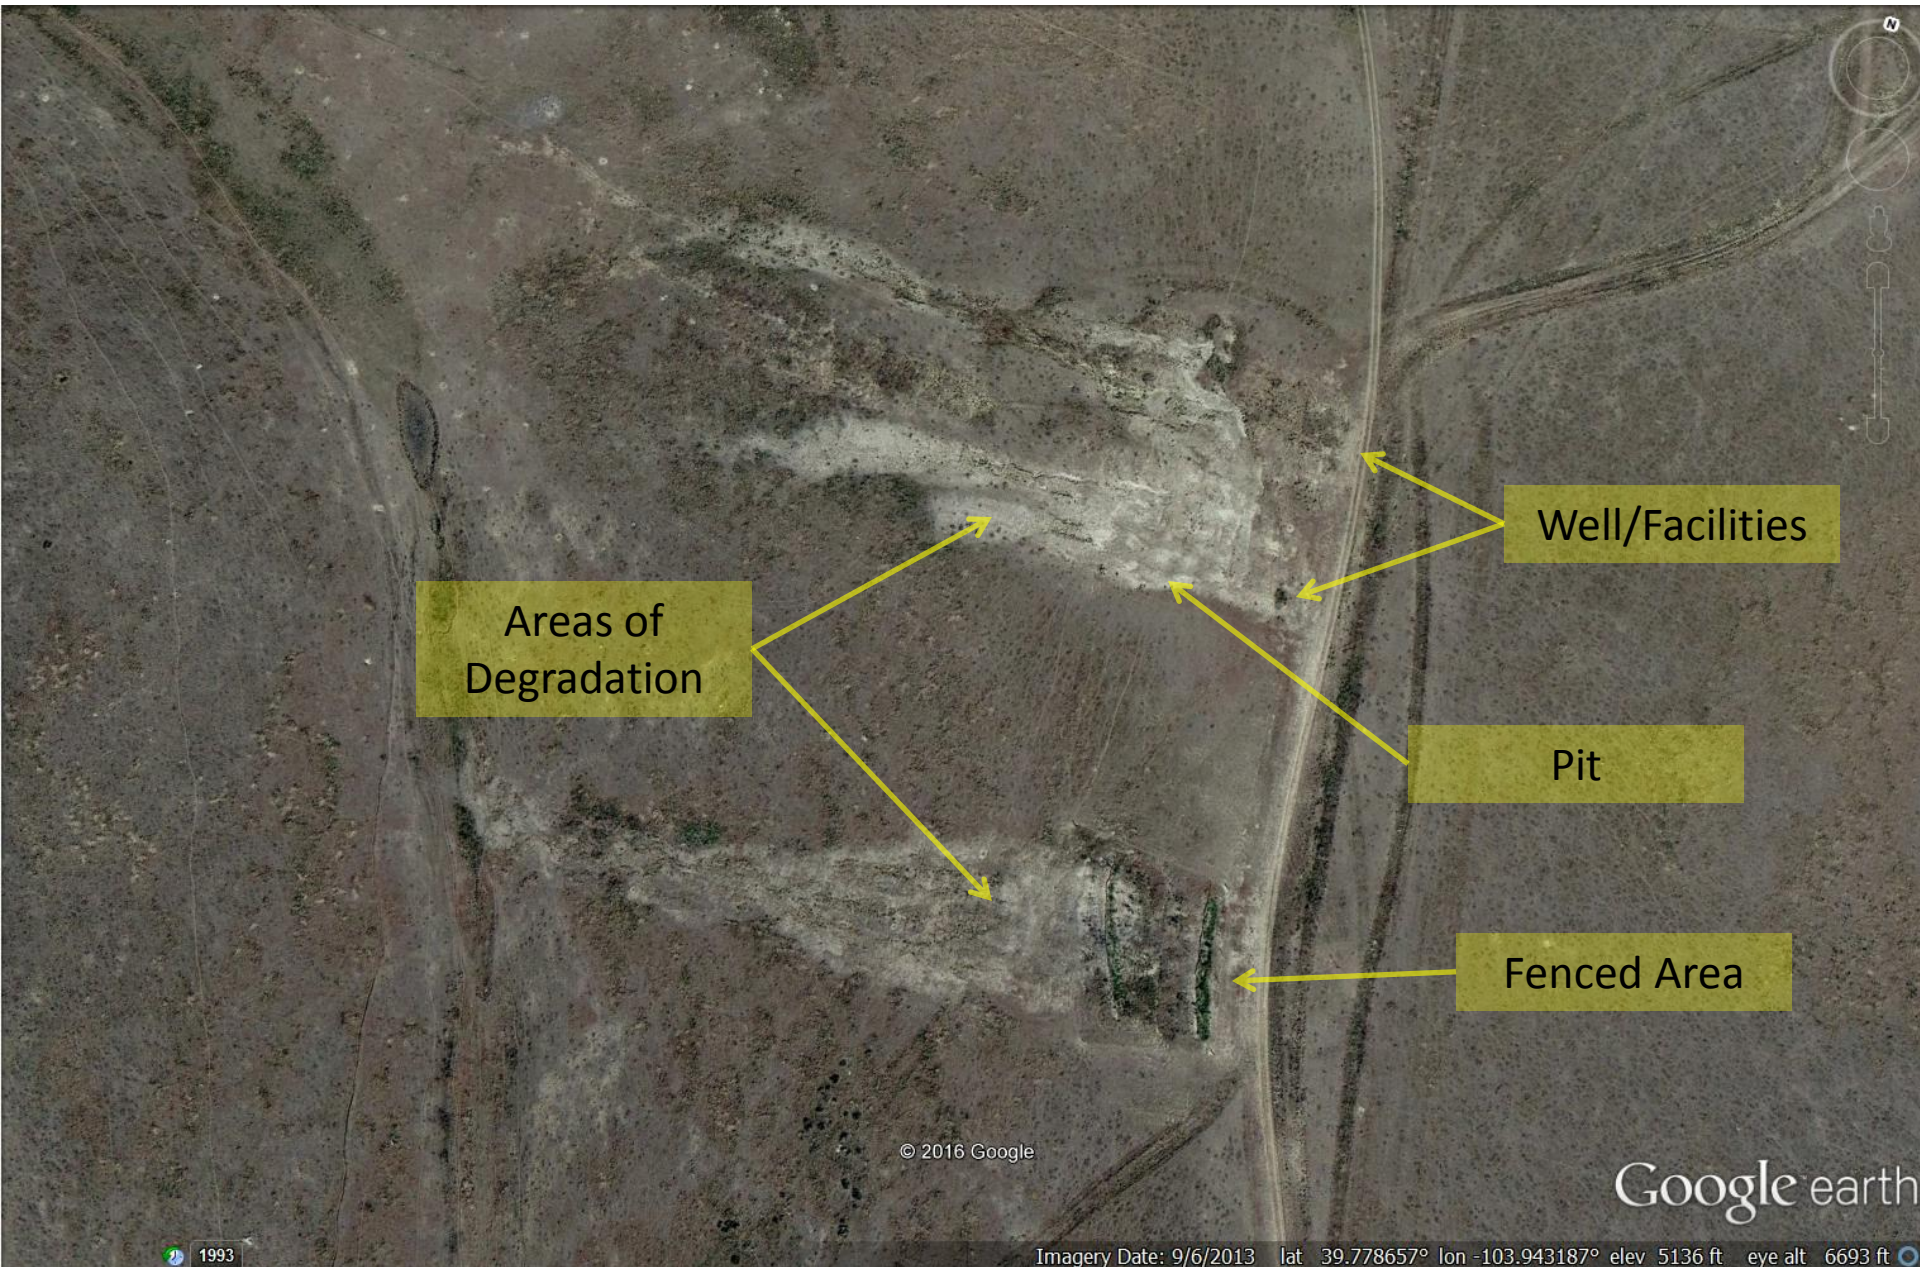
Figure 2: 9/6/2013 aerial imagery of location. Note areas of degradation (southern and northern), and an area that has been fenced off

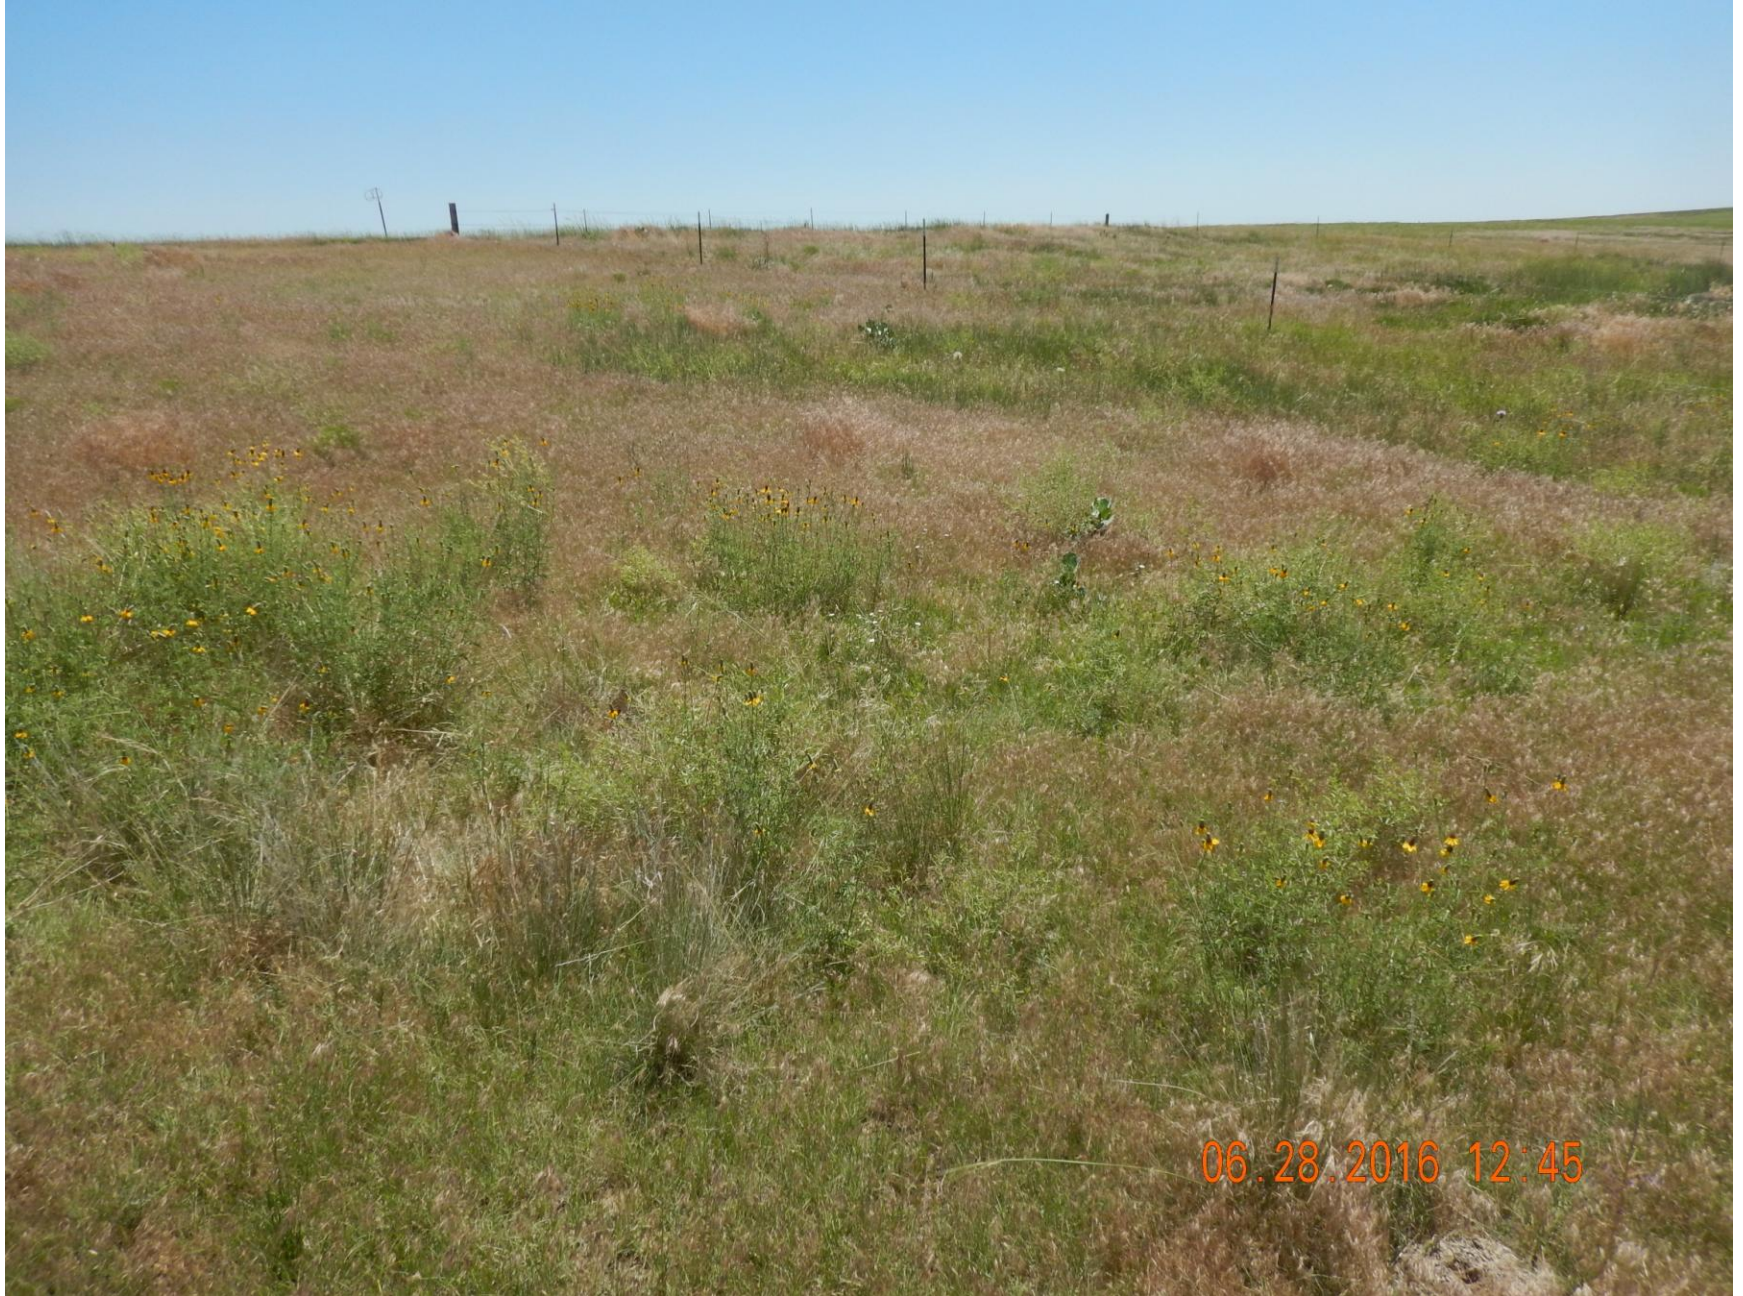
Figure 3: Photo taken between the two areas of degradation, facing south towards a portion southern degradation area (DA) that has been fenced off. Note vegetation predominantly cheat grass.

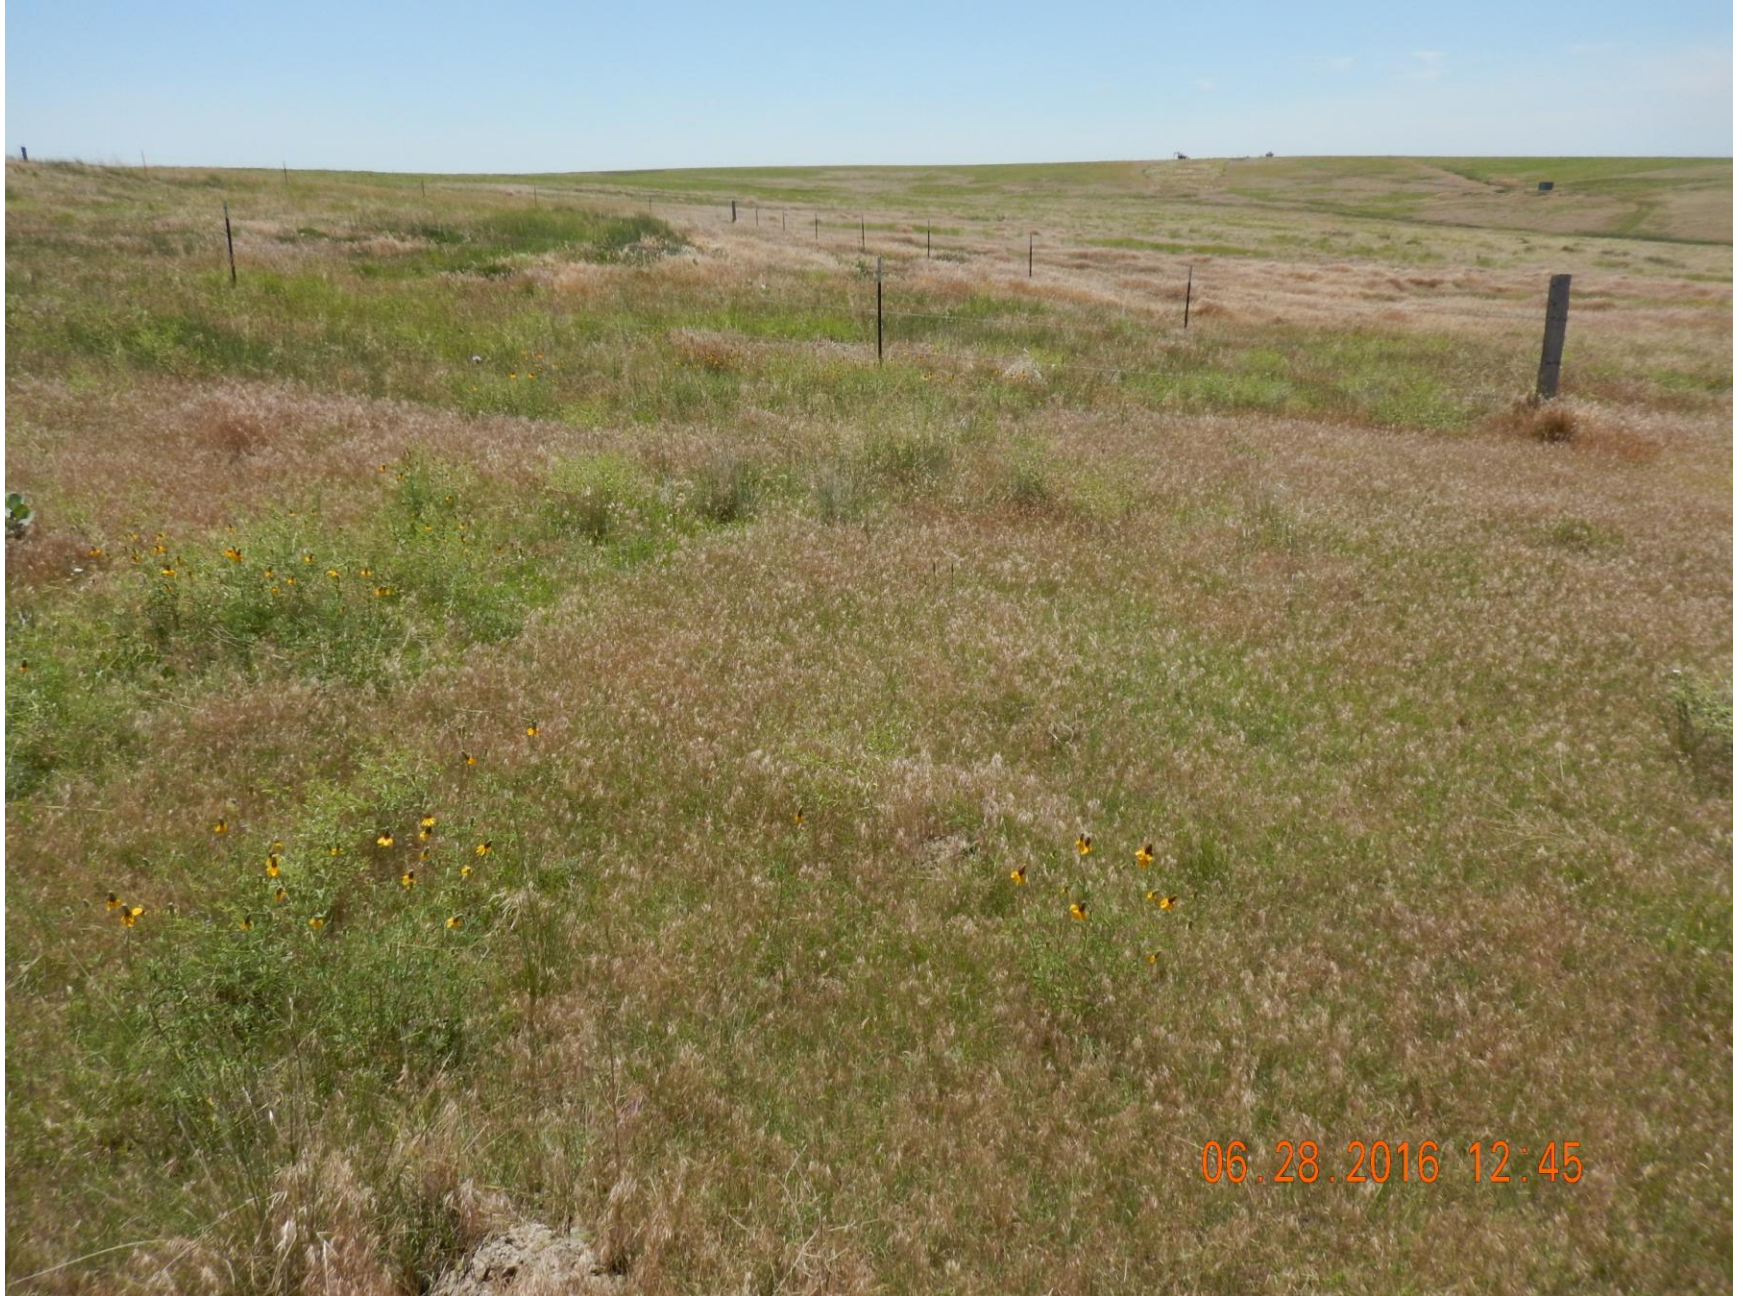
Figure 4: Photo taken between the two areas of degradation, facing southwest towards a portion southern DA that has been fenced off. Note vegetation predominantly cheat grass.

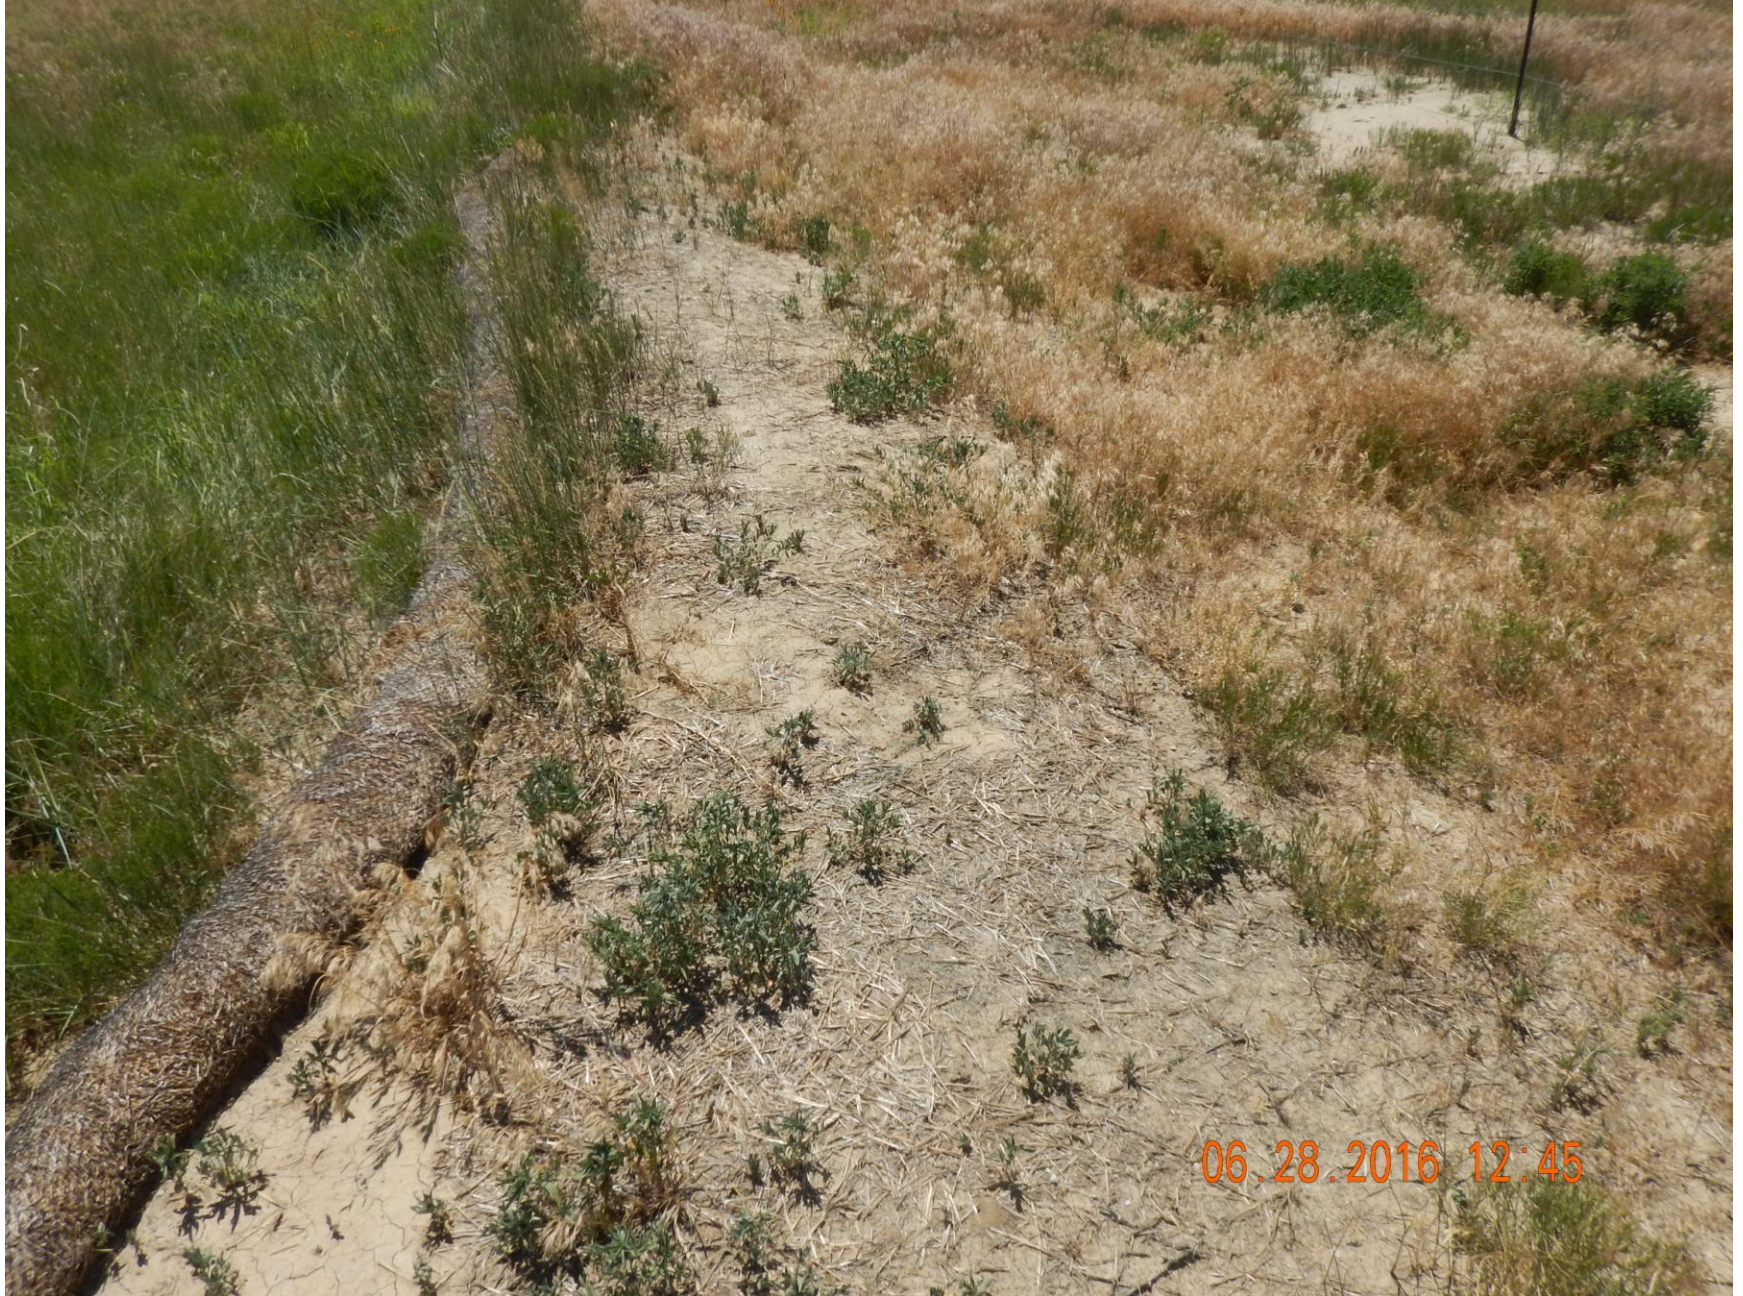
Figure 5: Photo taken from the fenced off, southern DA. Note vegetation has not achieved uniform cover, and is predominantly cheat grass.

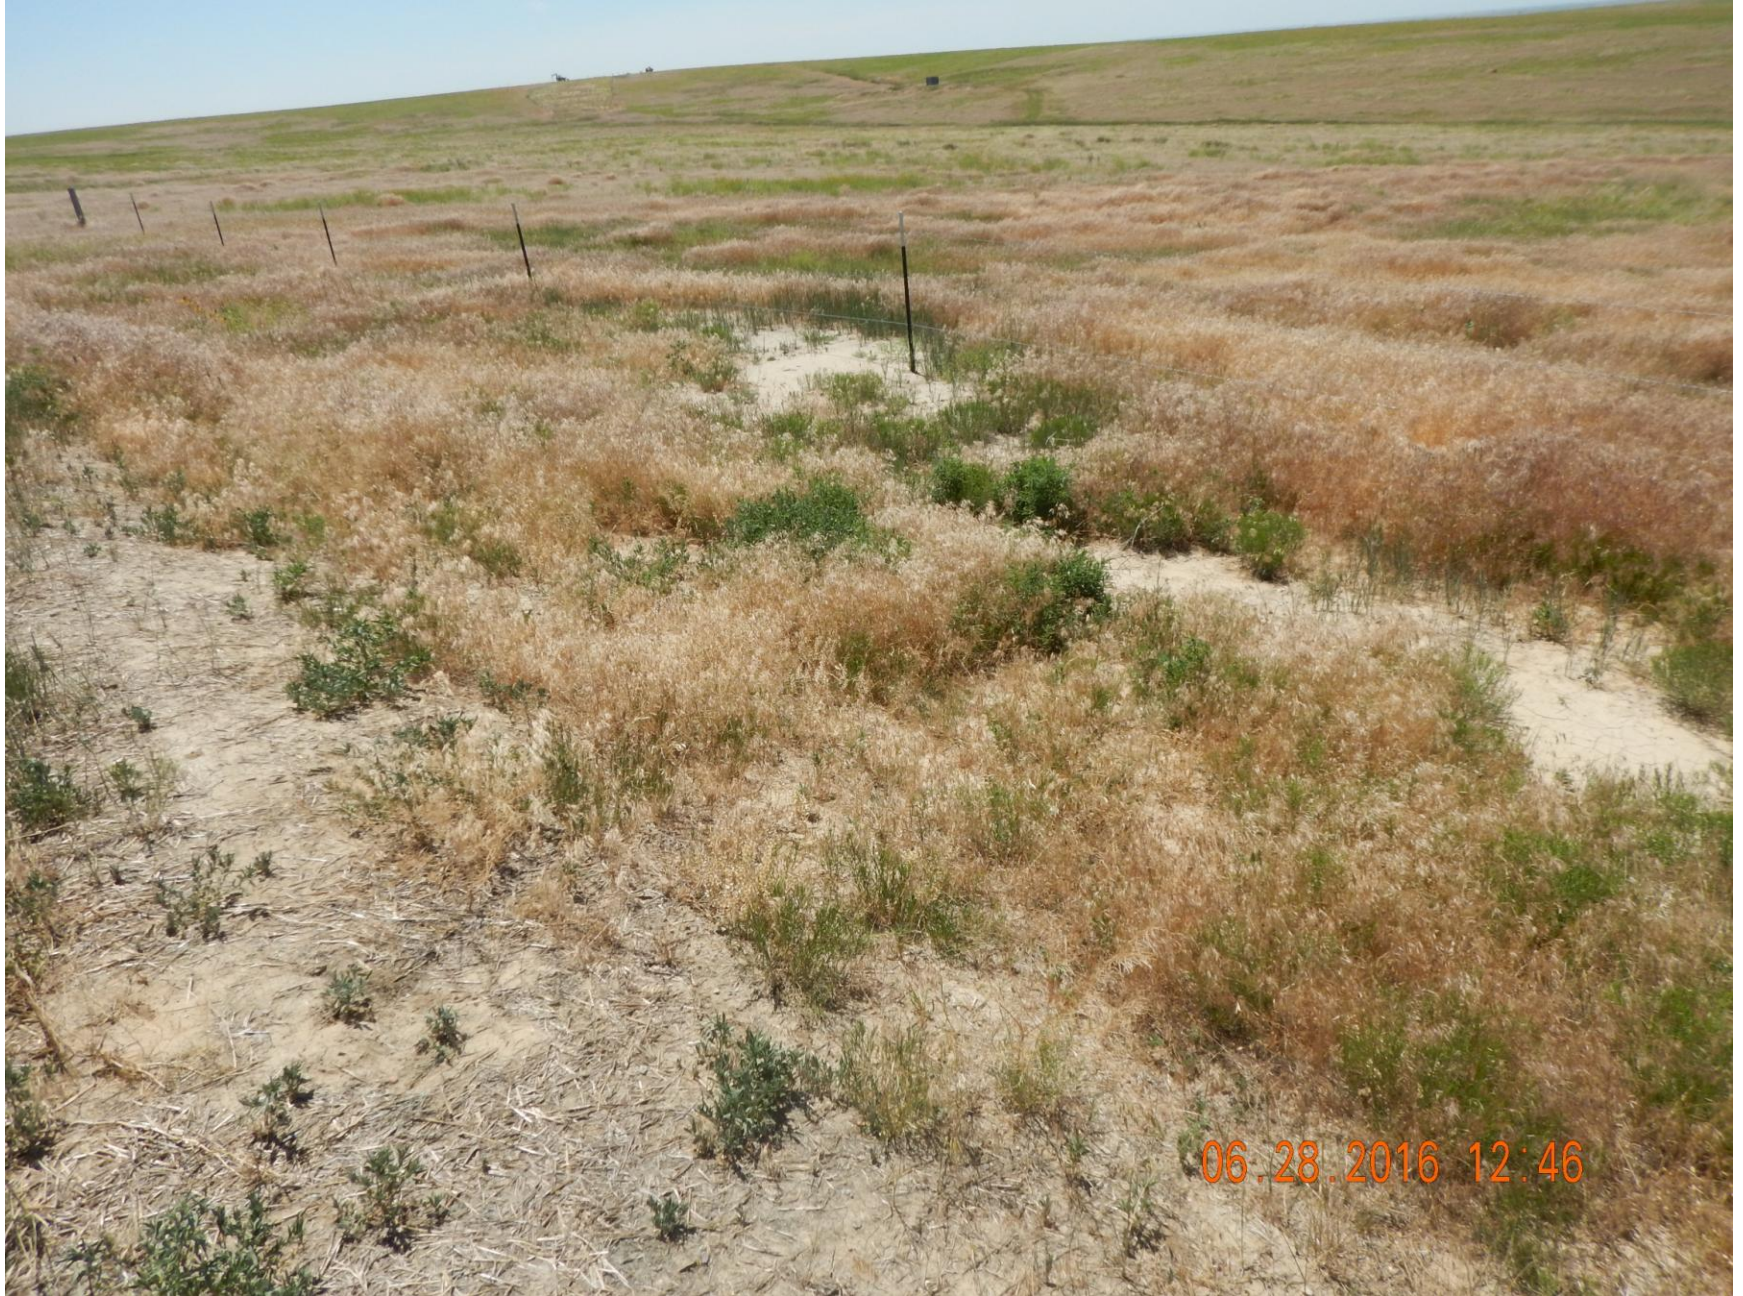
Figure 6: Photo taken from the fenced off, southern DA, facing southwest. Note vegetation has not achieved uniform cover, and is predominantly cheat grass.

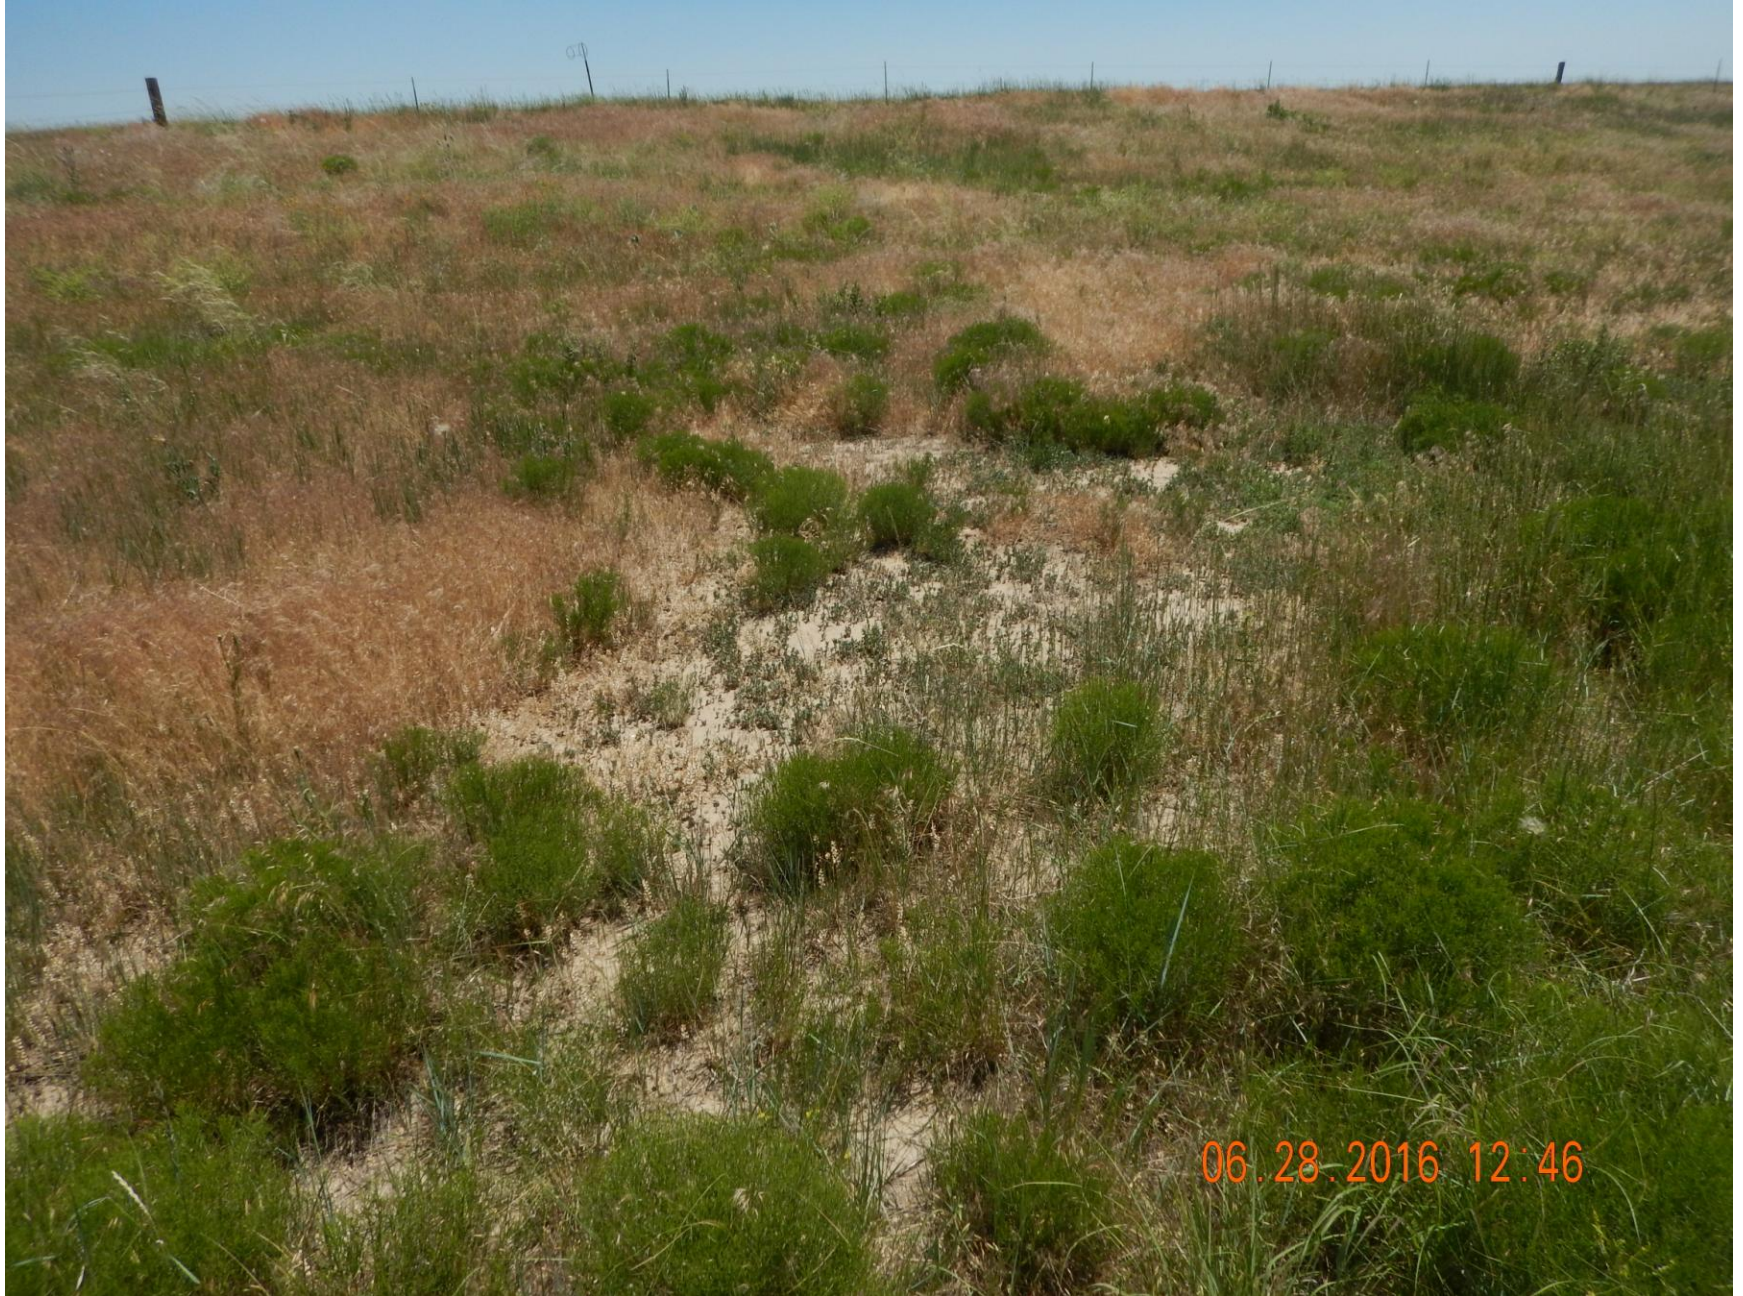
Figure 7: Photo taken from the southern DA, facing east towards the fenced area. Photo shows large unvegetated areas, and vegetation predominantly cheat grass.

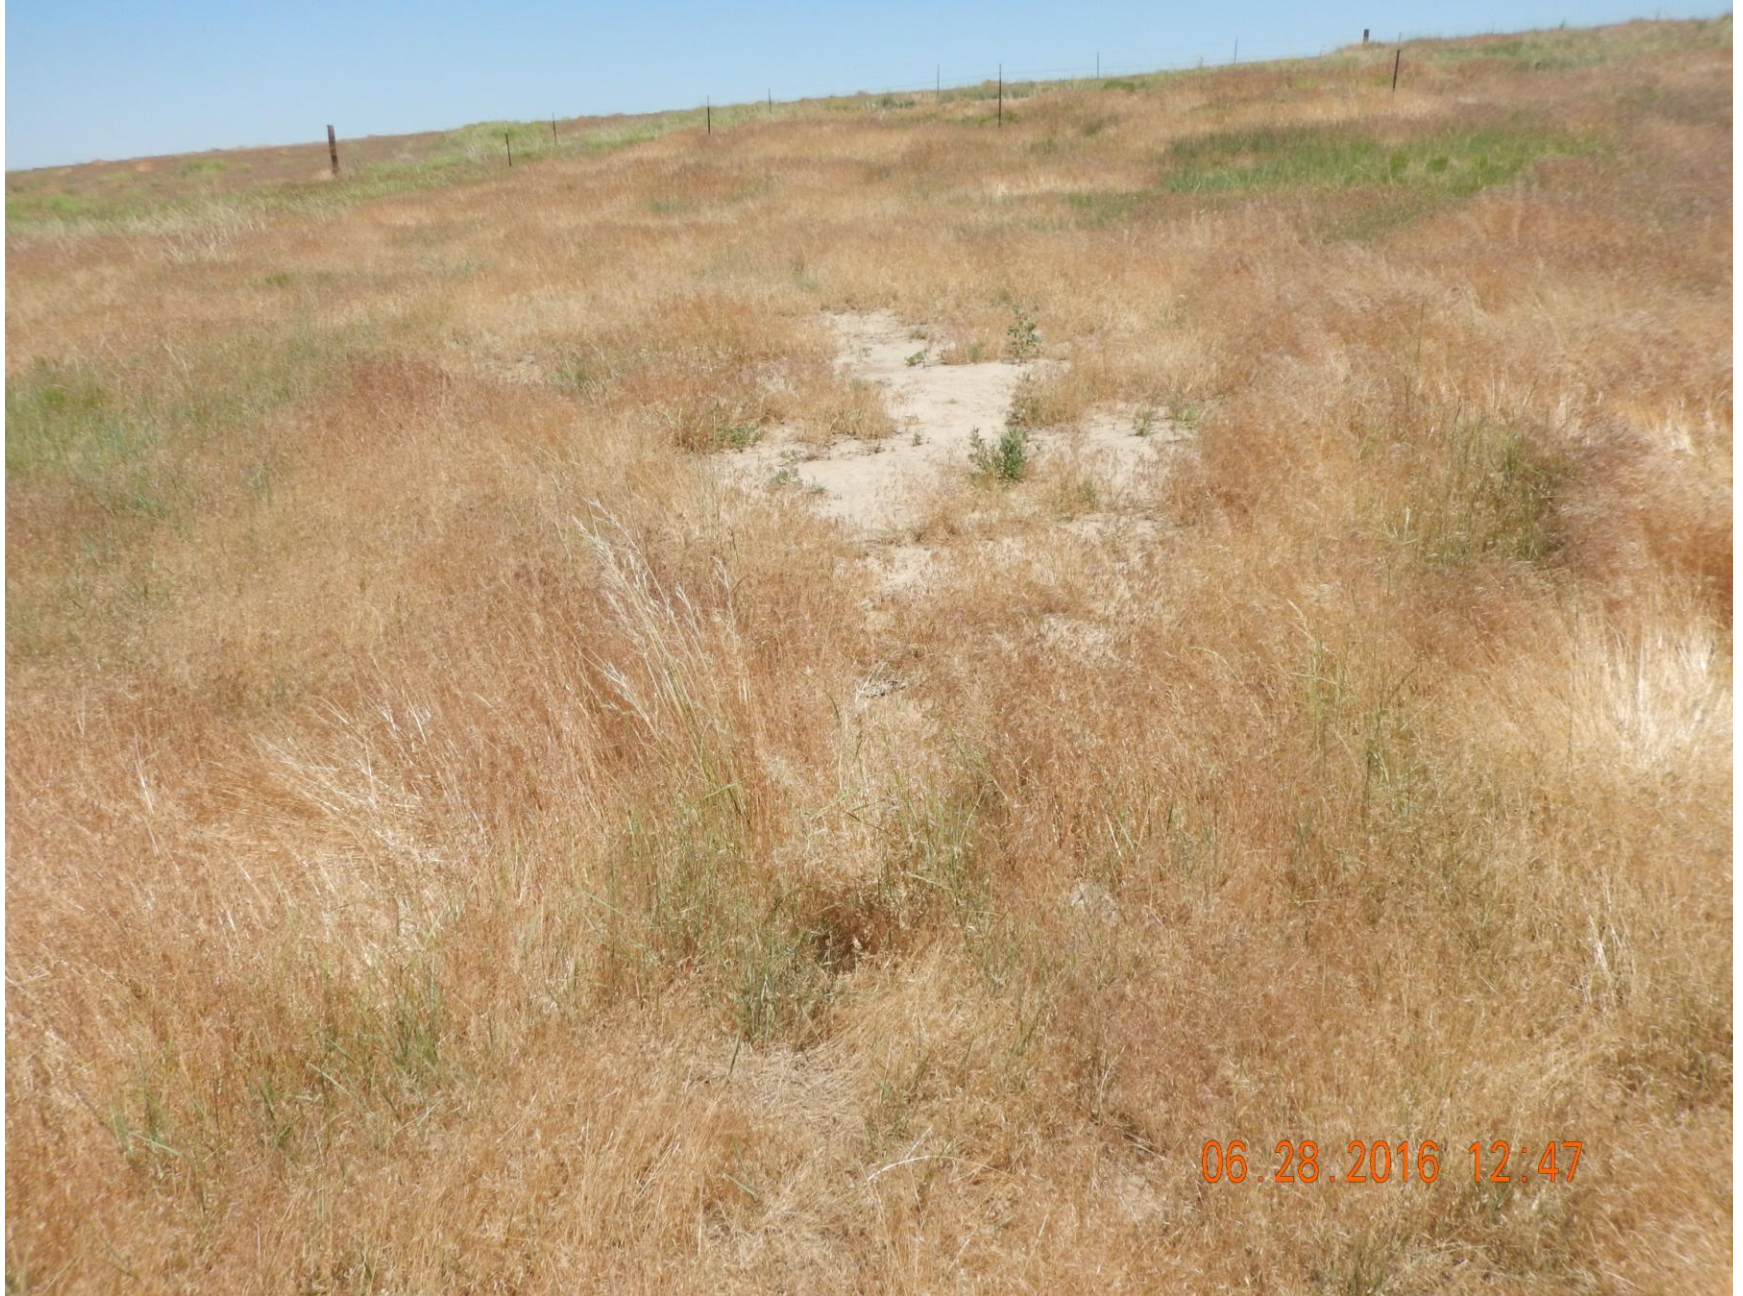
Figure 8: Photo taken from the southern DA, facing east towards the fenced area. Photo shows large unvegetated areas, and vegetation predominantly cheat grass

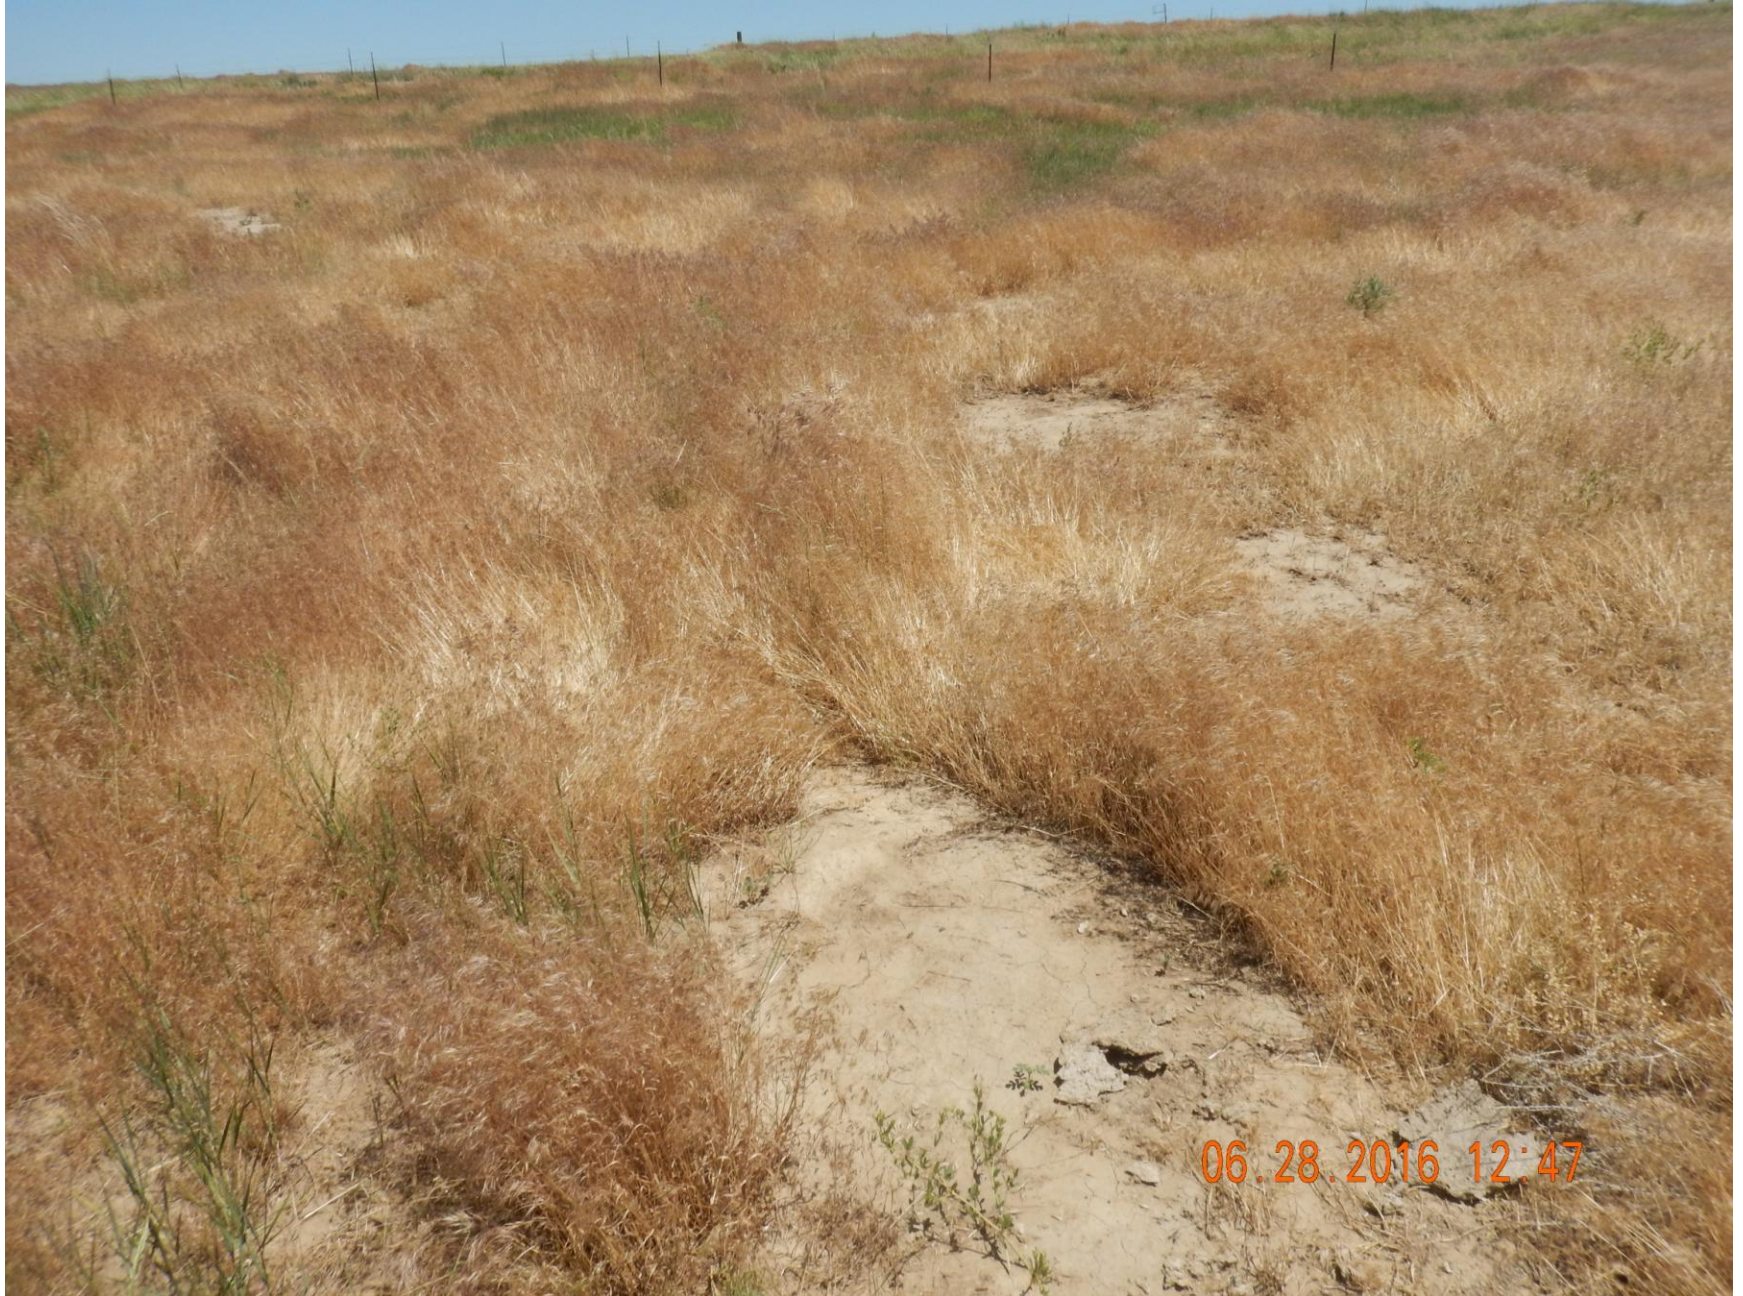
Figure 9: Photo taken from the southern DA, facing east towards the fenced area. Photo shows large unvegetated areas, and vegetation predominantly cheat grass

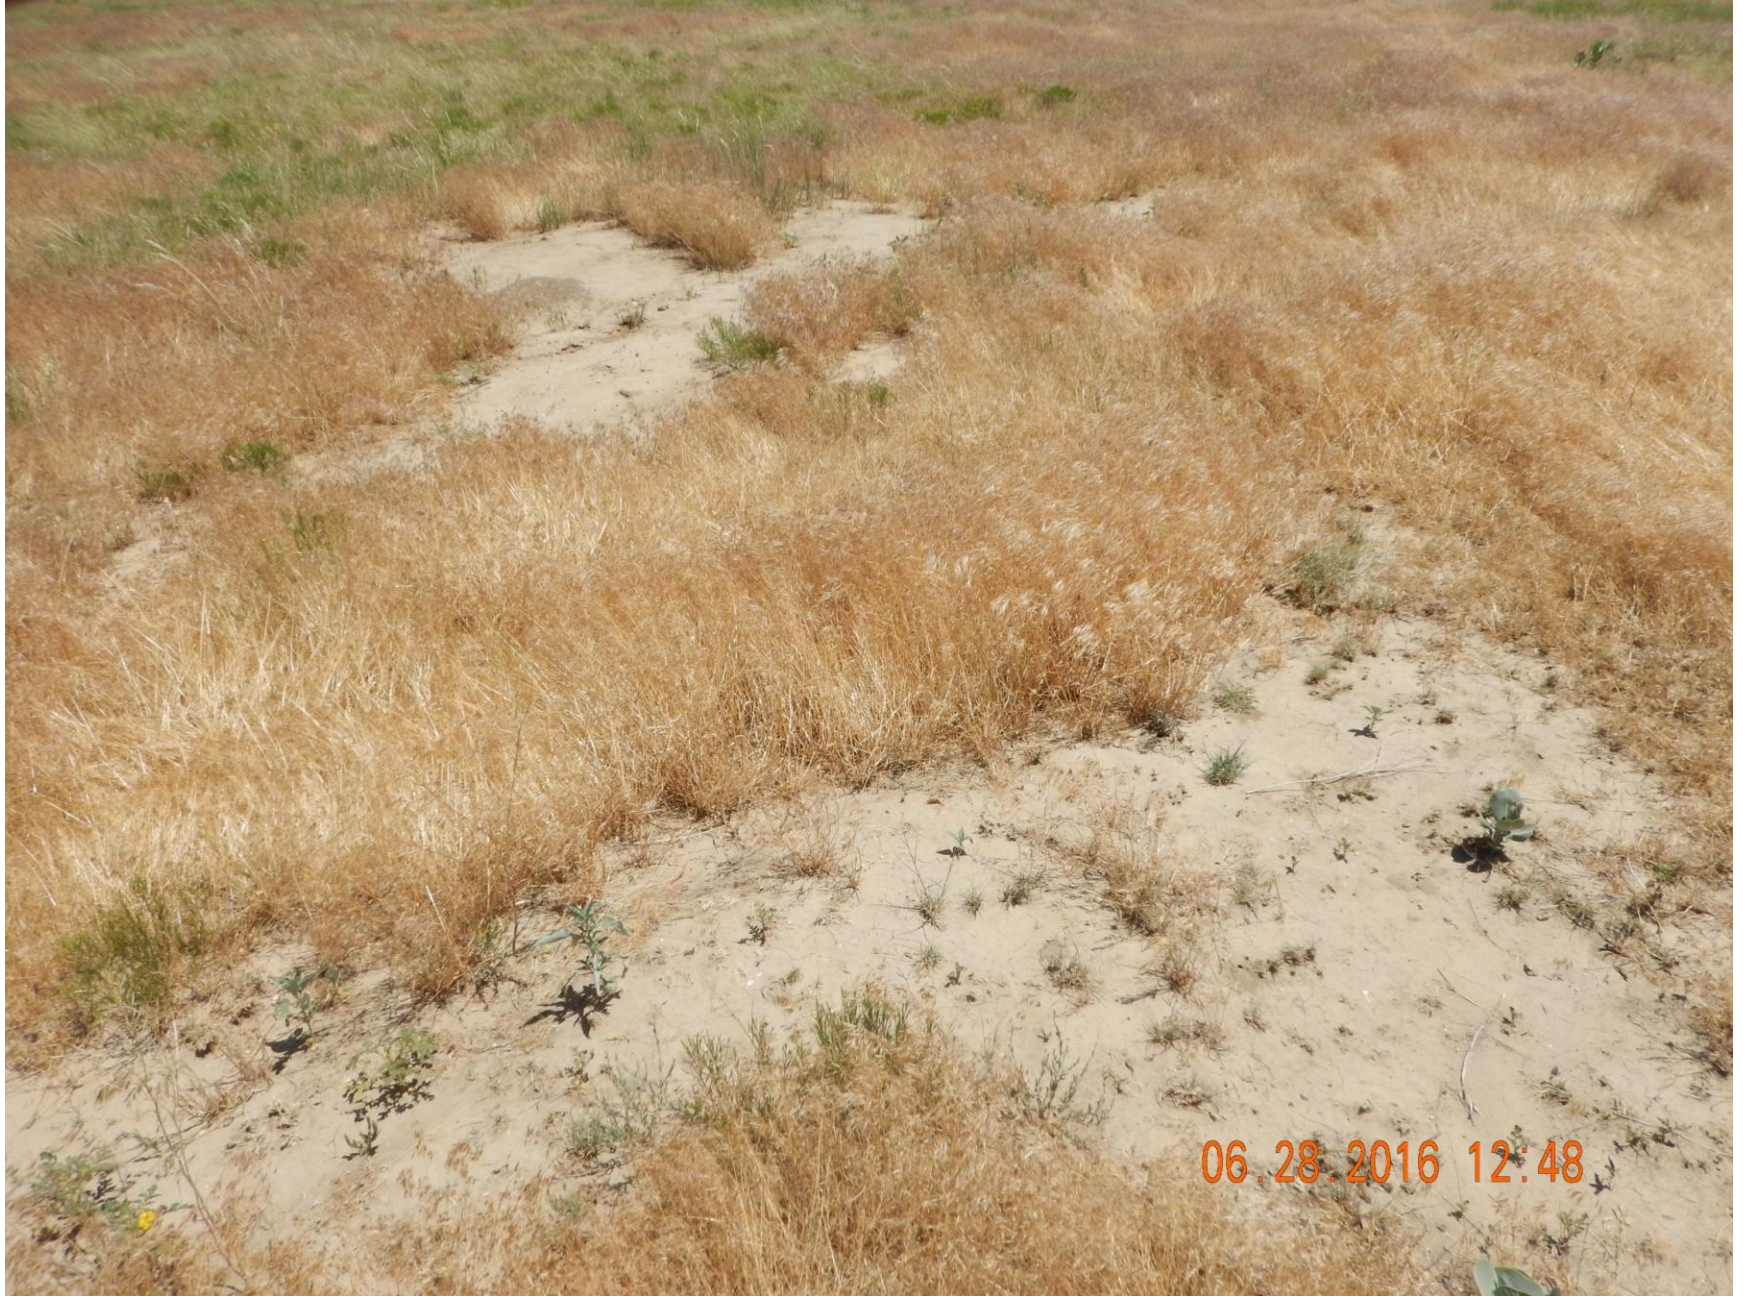
Figure 10: Photo taken from the southern DA, facing east towards the fenced area. Photo shows large unvegetated areas, and vegetation predominantly cheat grass
