Final Reclamation Inspection

06/28/2016

Operator: Petro-Canada

Location ID: 311664

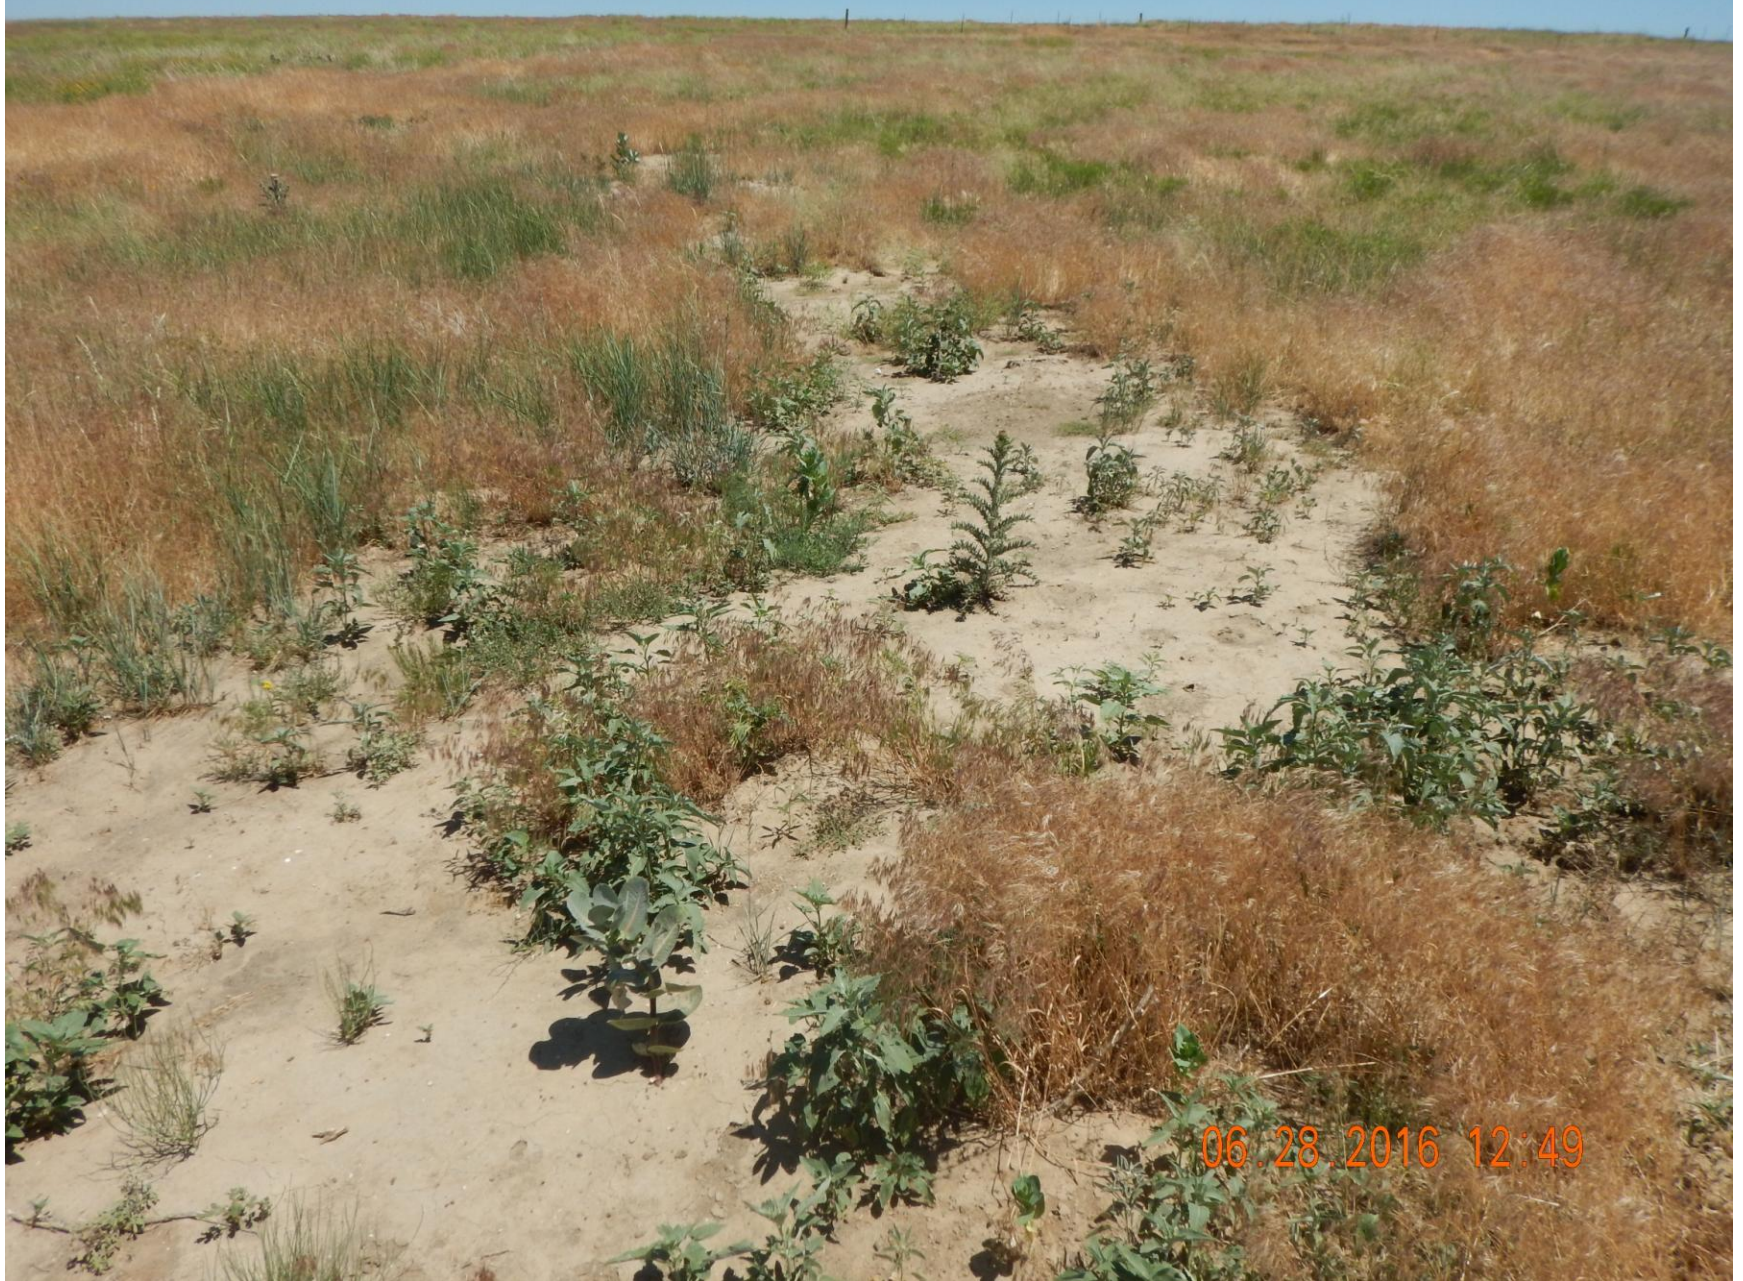
Figure 11: Photo taken from the southern DA, facing east towards the fenced area. Photo shows large unvegetated areas, and vegetation predominantly cheat grass

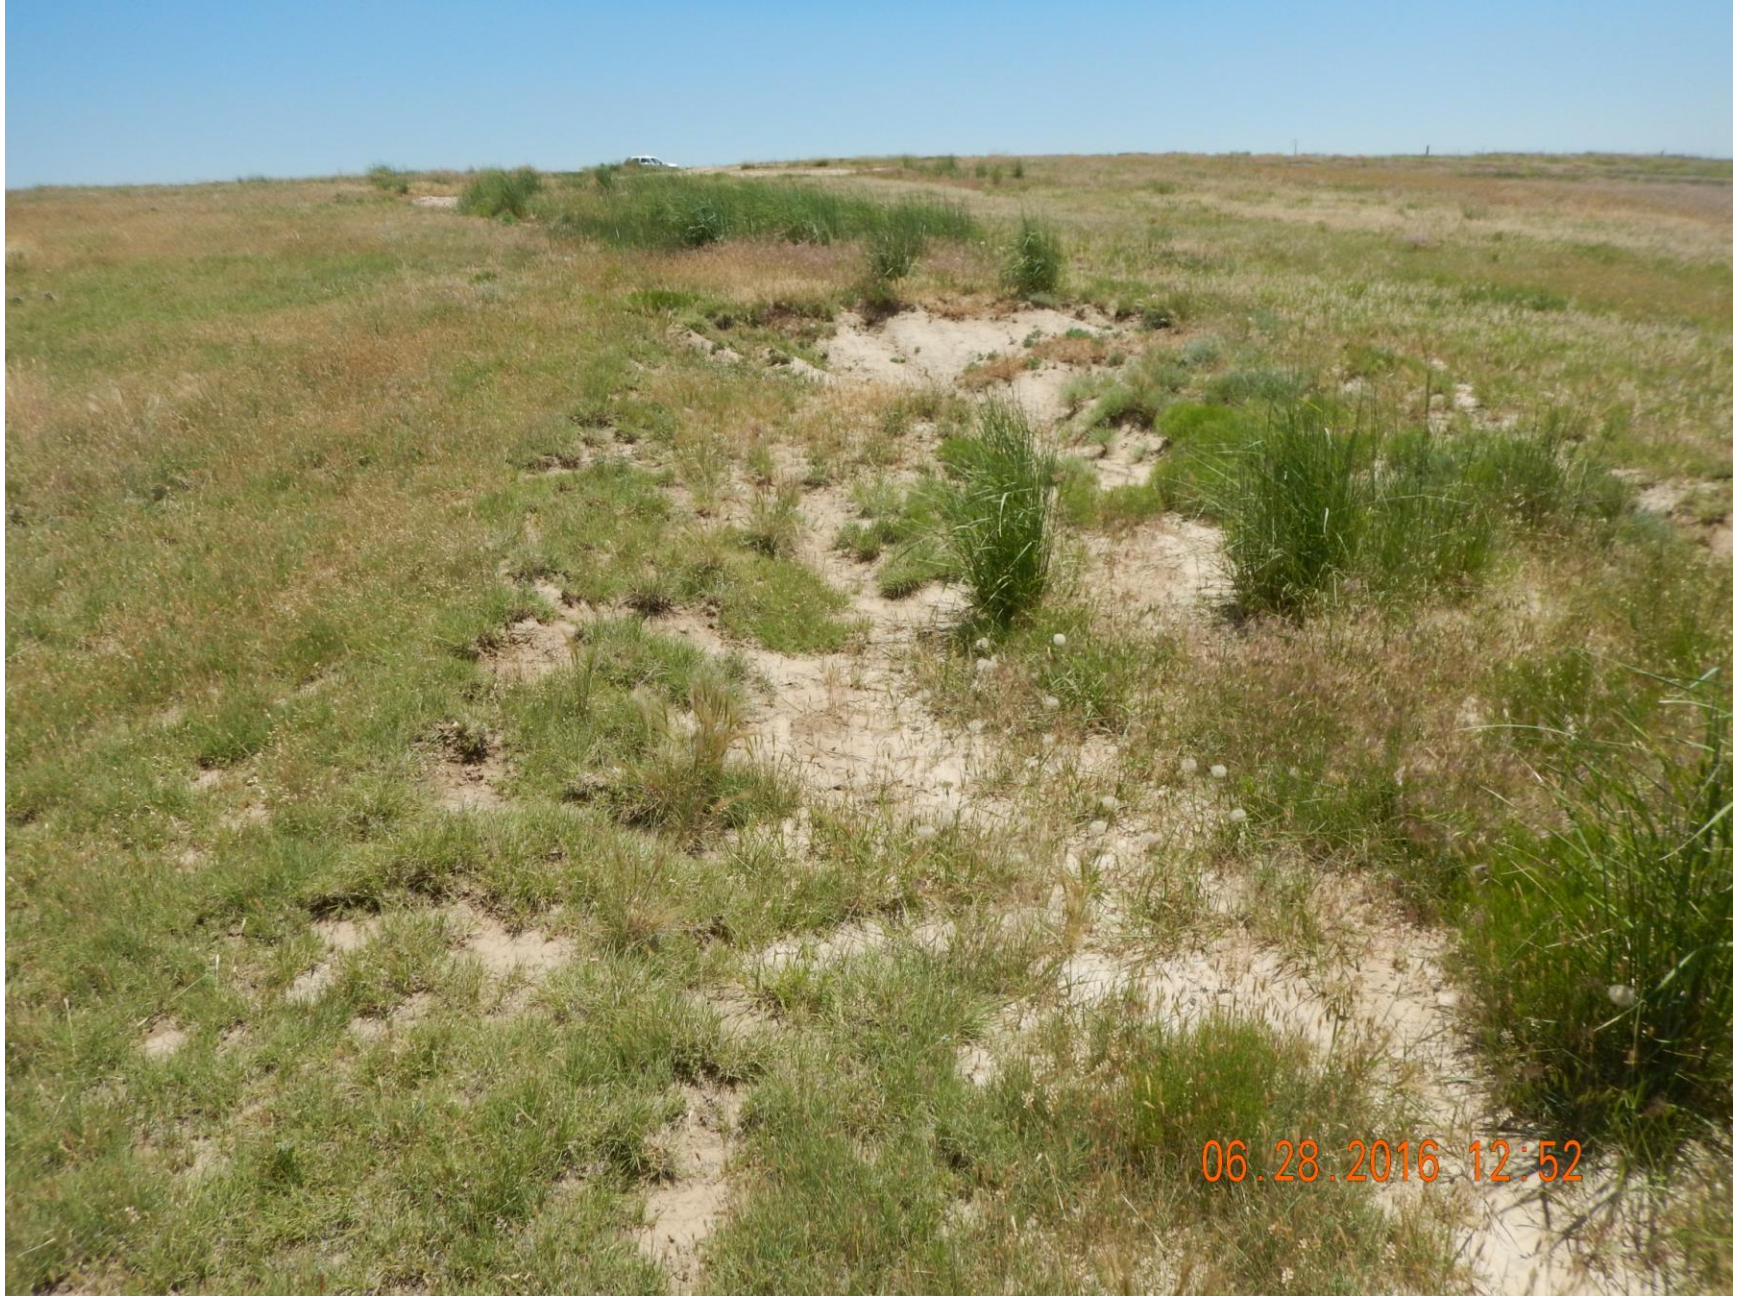
Figure 12: Photo taken from the NORTHERN DA, facing east towards the access road. Photo shows large unvegetated areas, and degradation due to erosion.

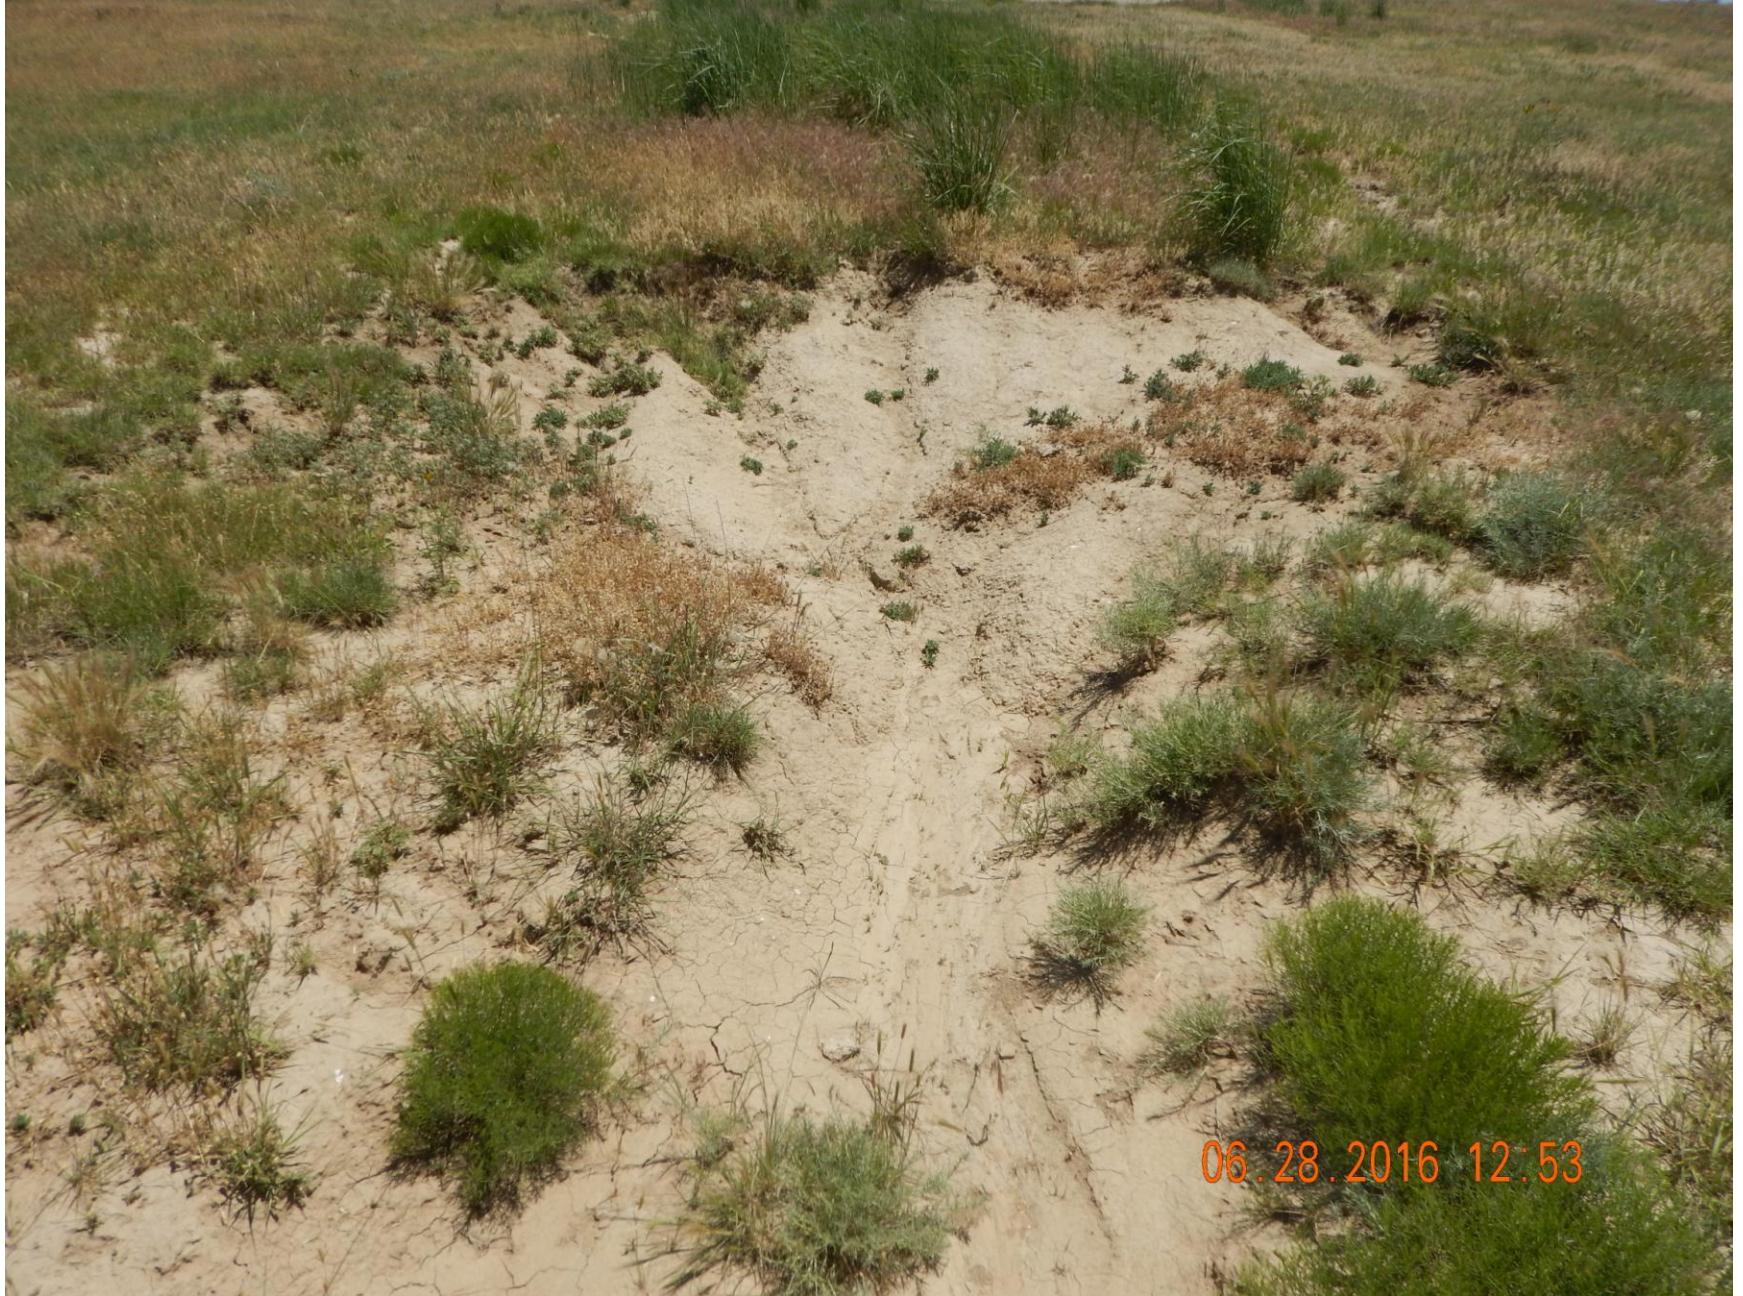
Figure 13: Photo taken from the NORTHERN DA, facing east towards the access road. Photo shows large unvegetated areas, and degradation due to erosion.

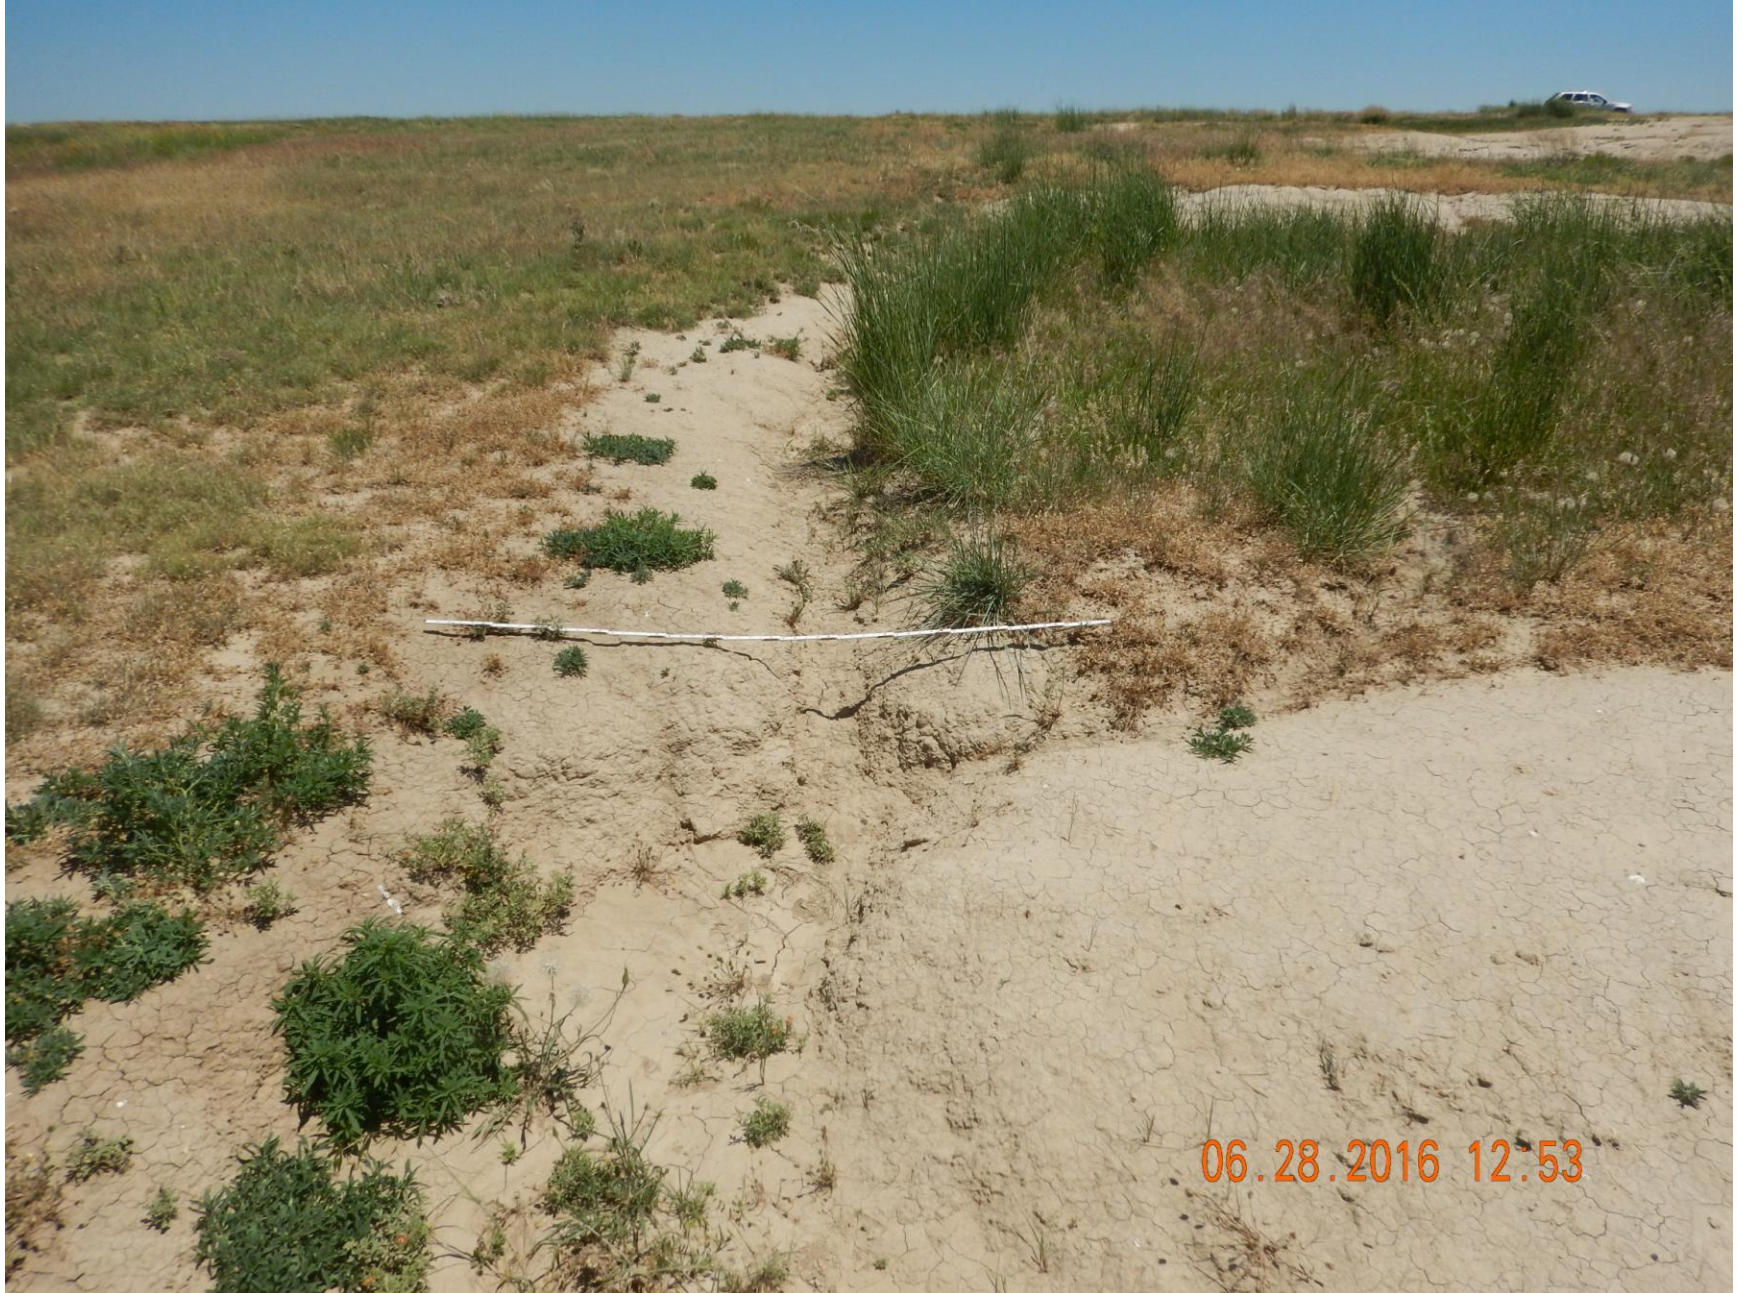
Figure 14: Photo taken from the NORTHERN DA, facing east towards the access road. Photo shows large unvegetated areas, and degradation due to erosion. 6' measuring stick for reference.

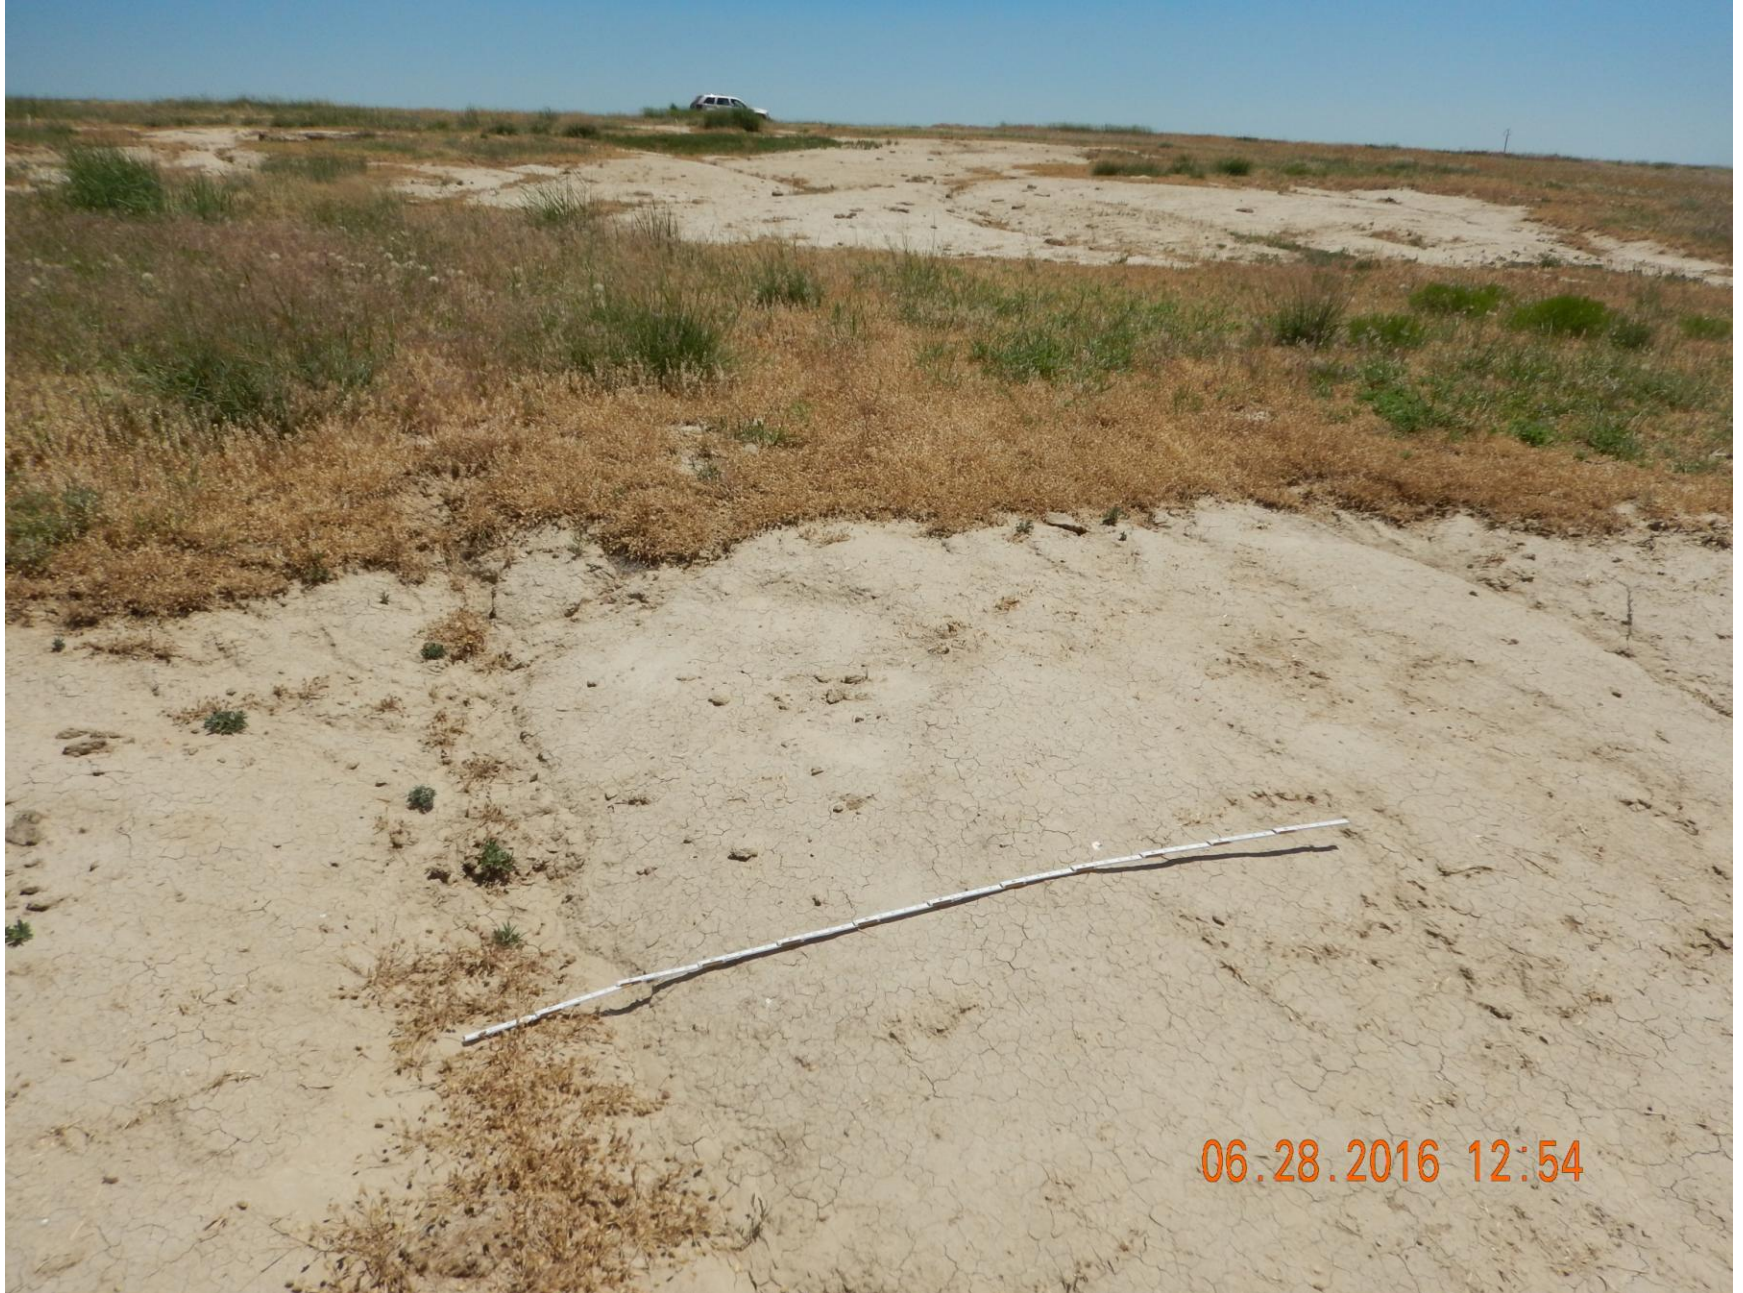
Figure 15: Photo taken from the NORTHERN DA, facing east towards the access road. Photo shows large unvegetated areas, and degradation due to erosion. 6' measuring stick for reference.

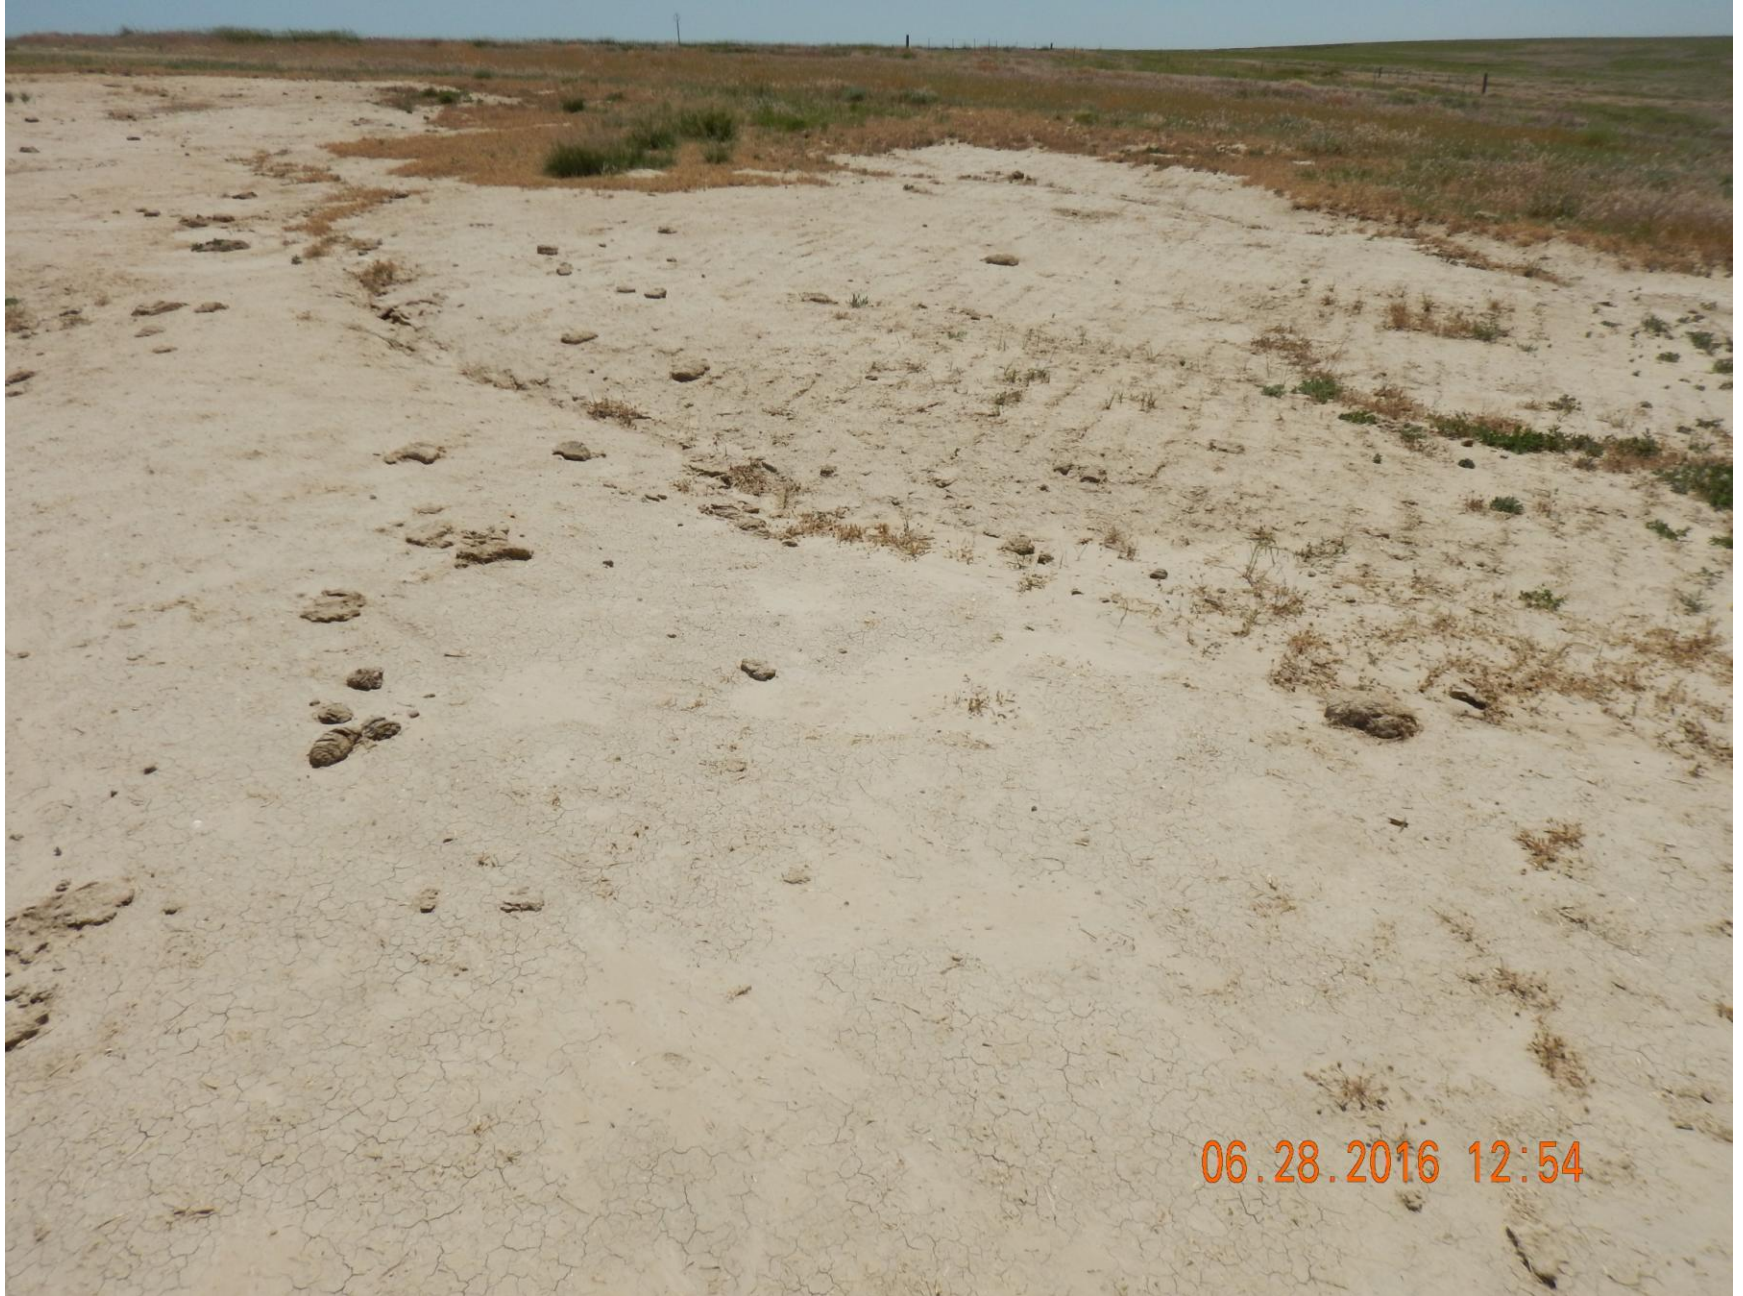
Figure 16: Photo taken from the NORTHERN DA, facing south. Photo shows large unvegetated areas. Striations in soil suggestion reseeding had been attempted in this area.

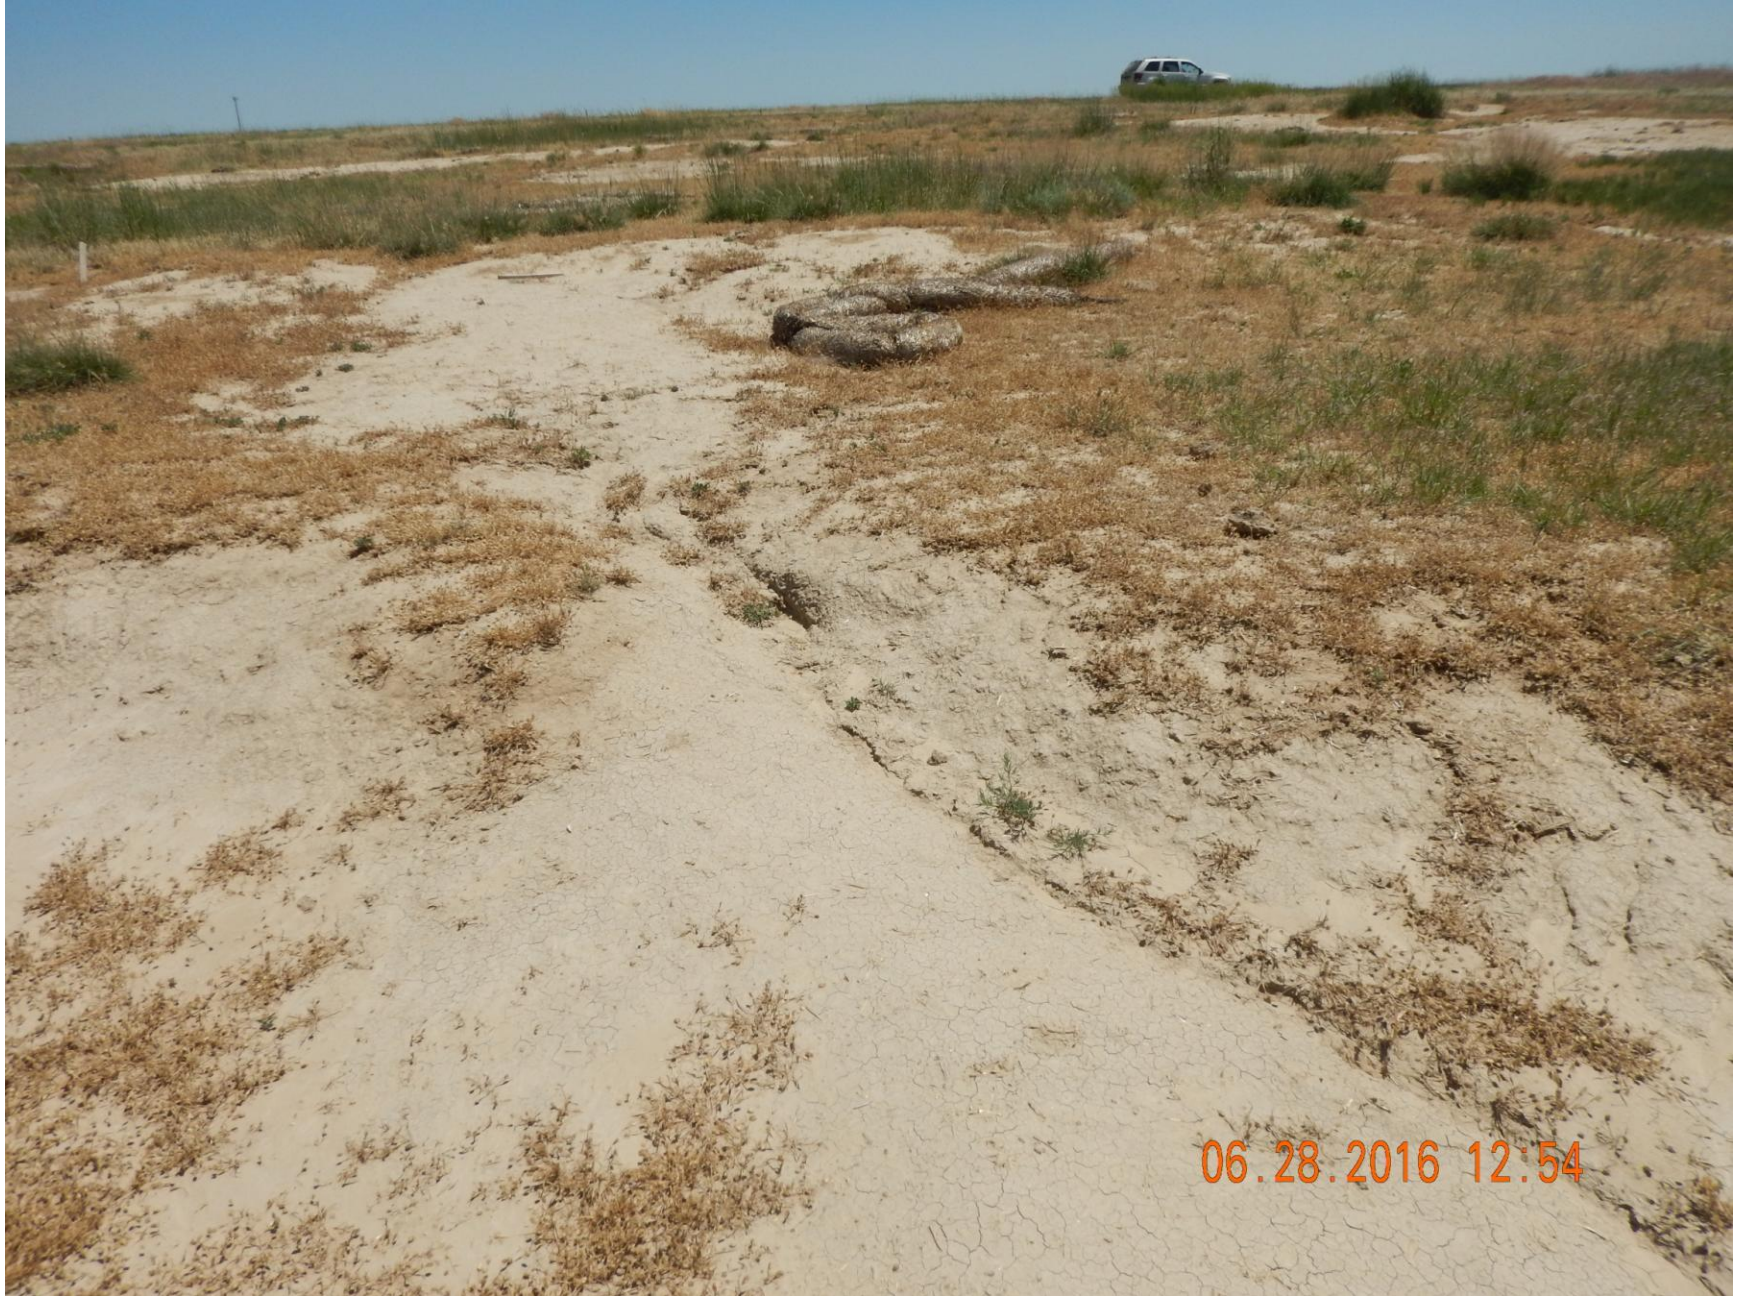
Figure 17: Photo taken from the Northern DA, facing east towards the access road. Photo shows stormwater control wattles in disrepair.

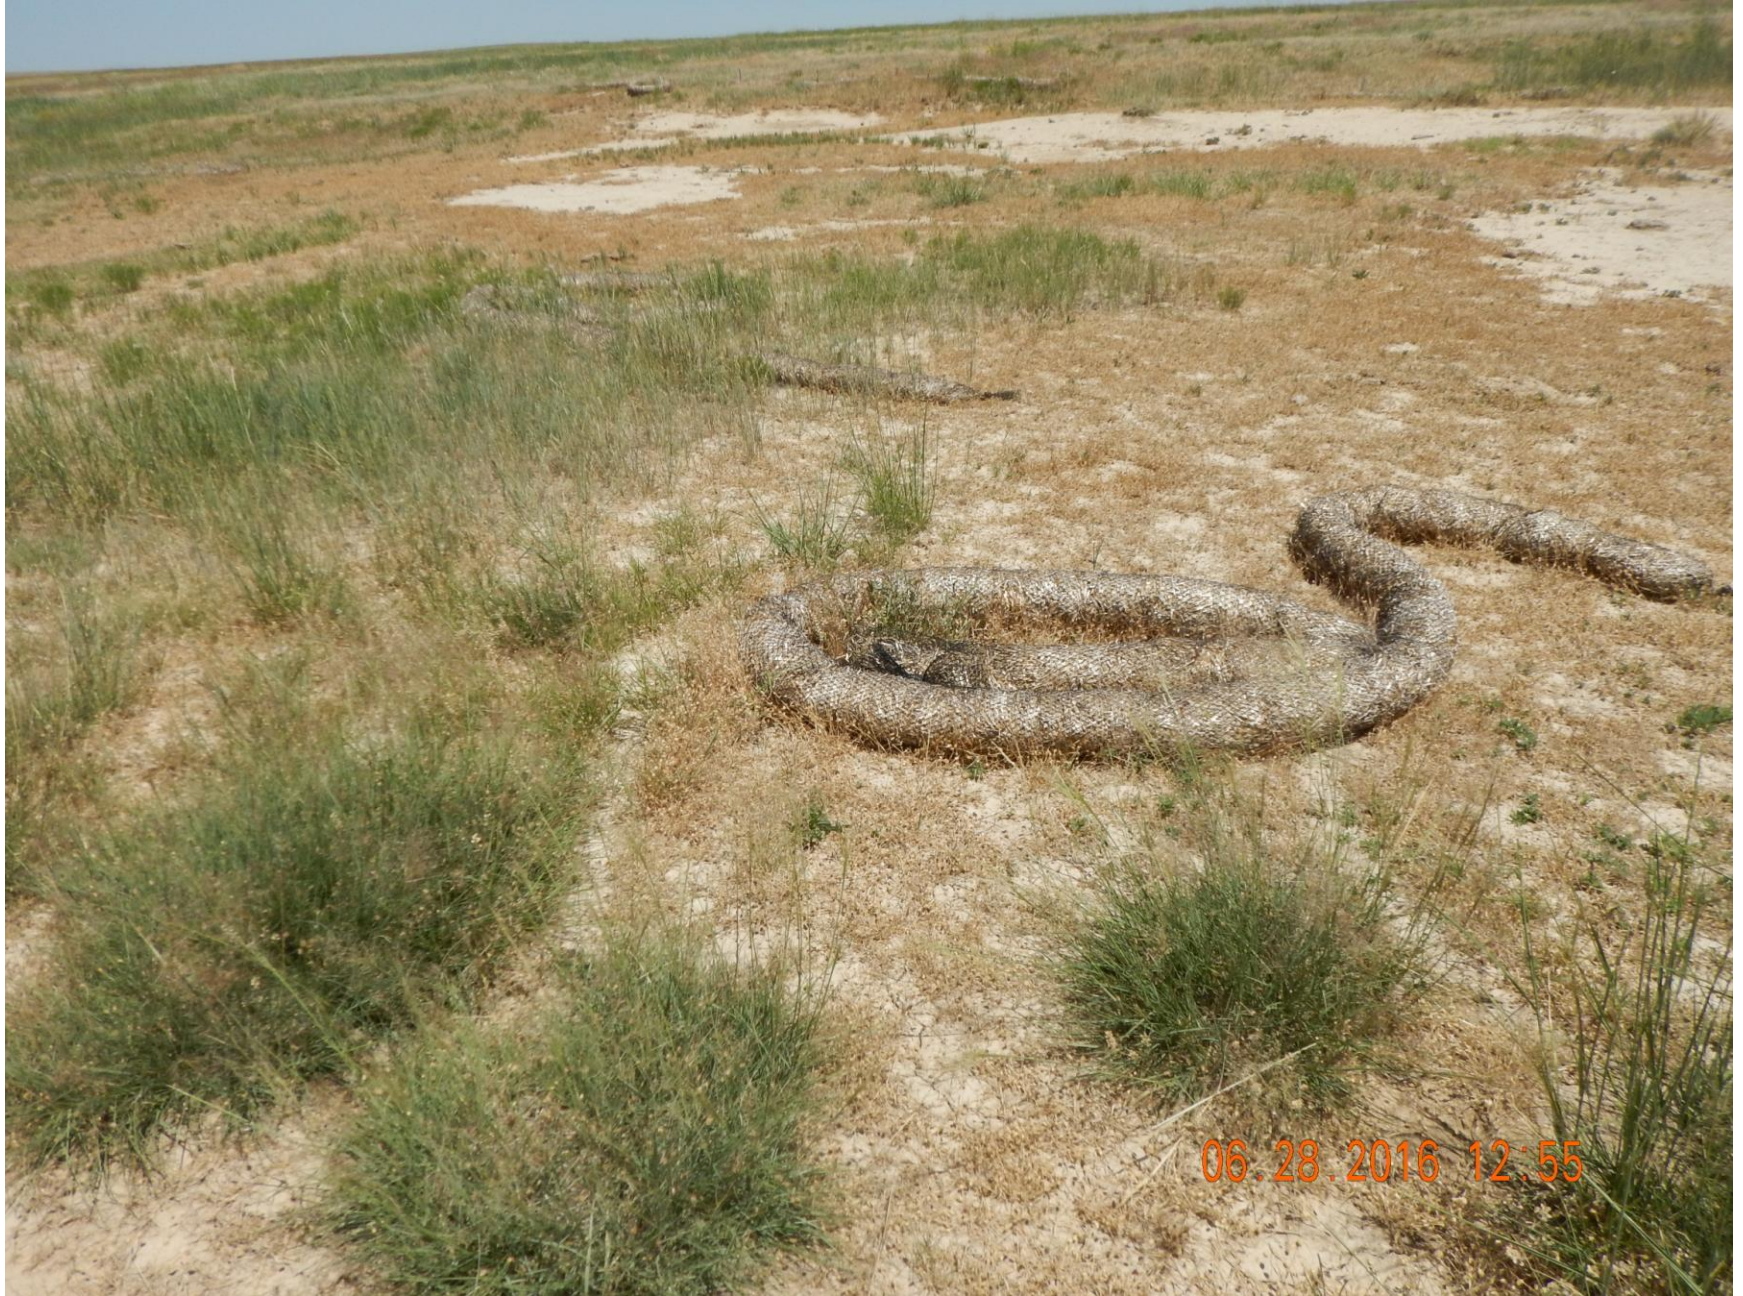
Figure 18: Photo taken from the Northern DA, facing north. Photo shows stormwater control wattles in disrepair.

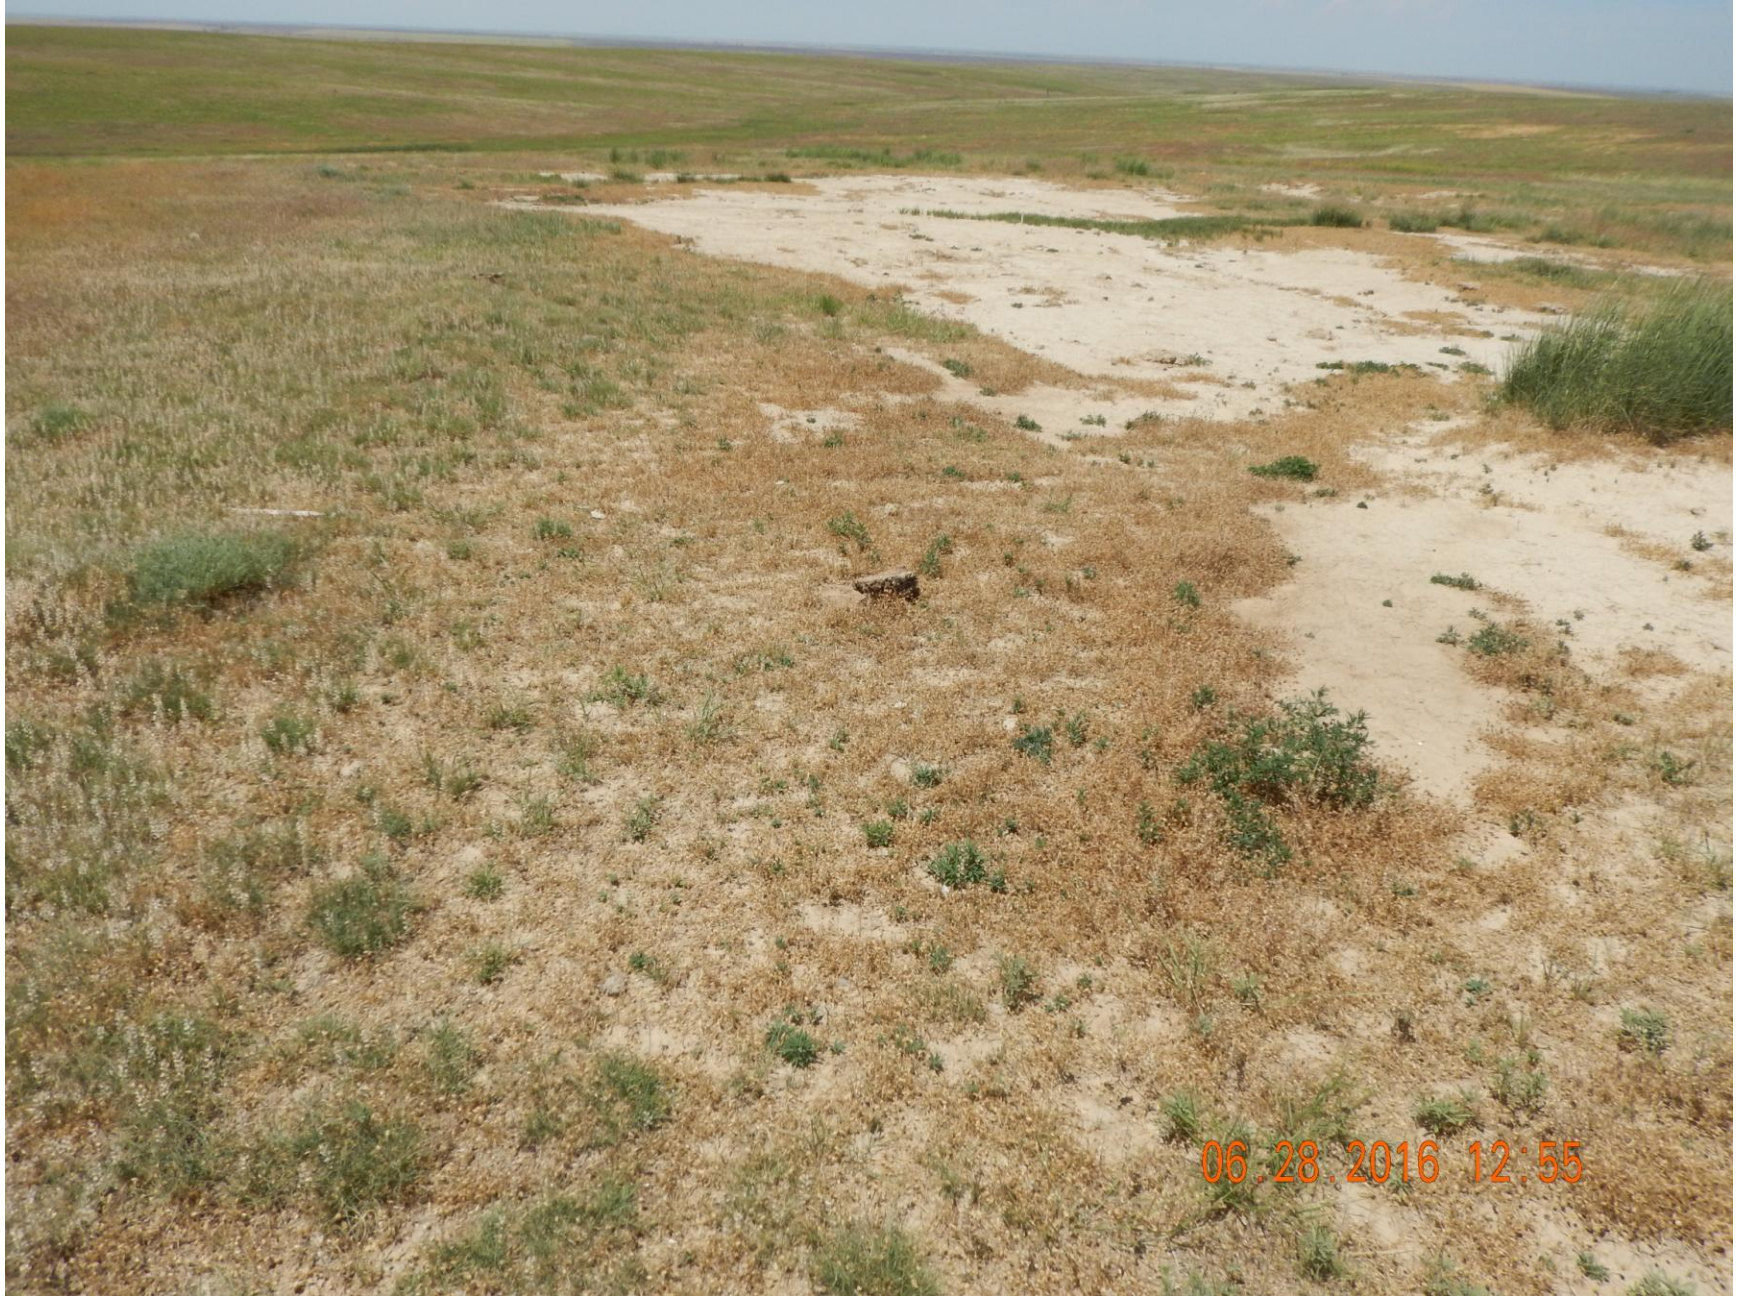
Figure 19: Photo taken from the NORTHERN DA, facing northwest. Photo shows large unvegetated areas, and degradation due to erosion.

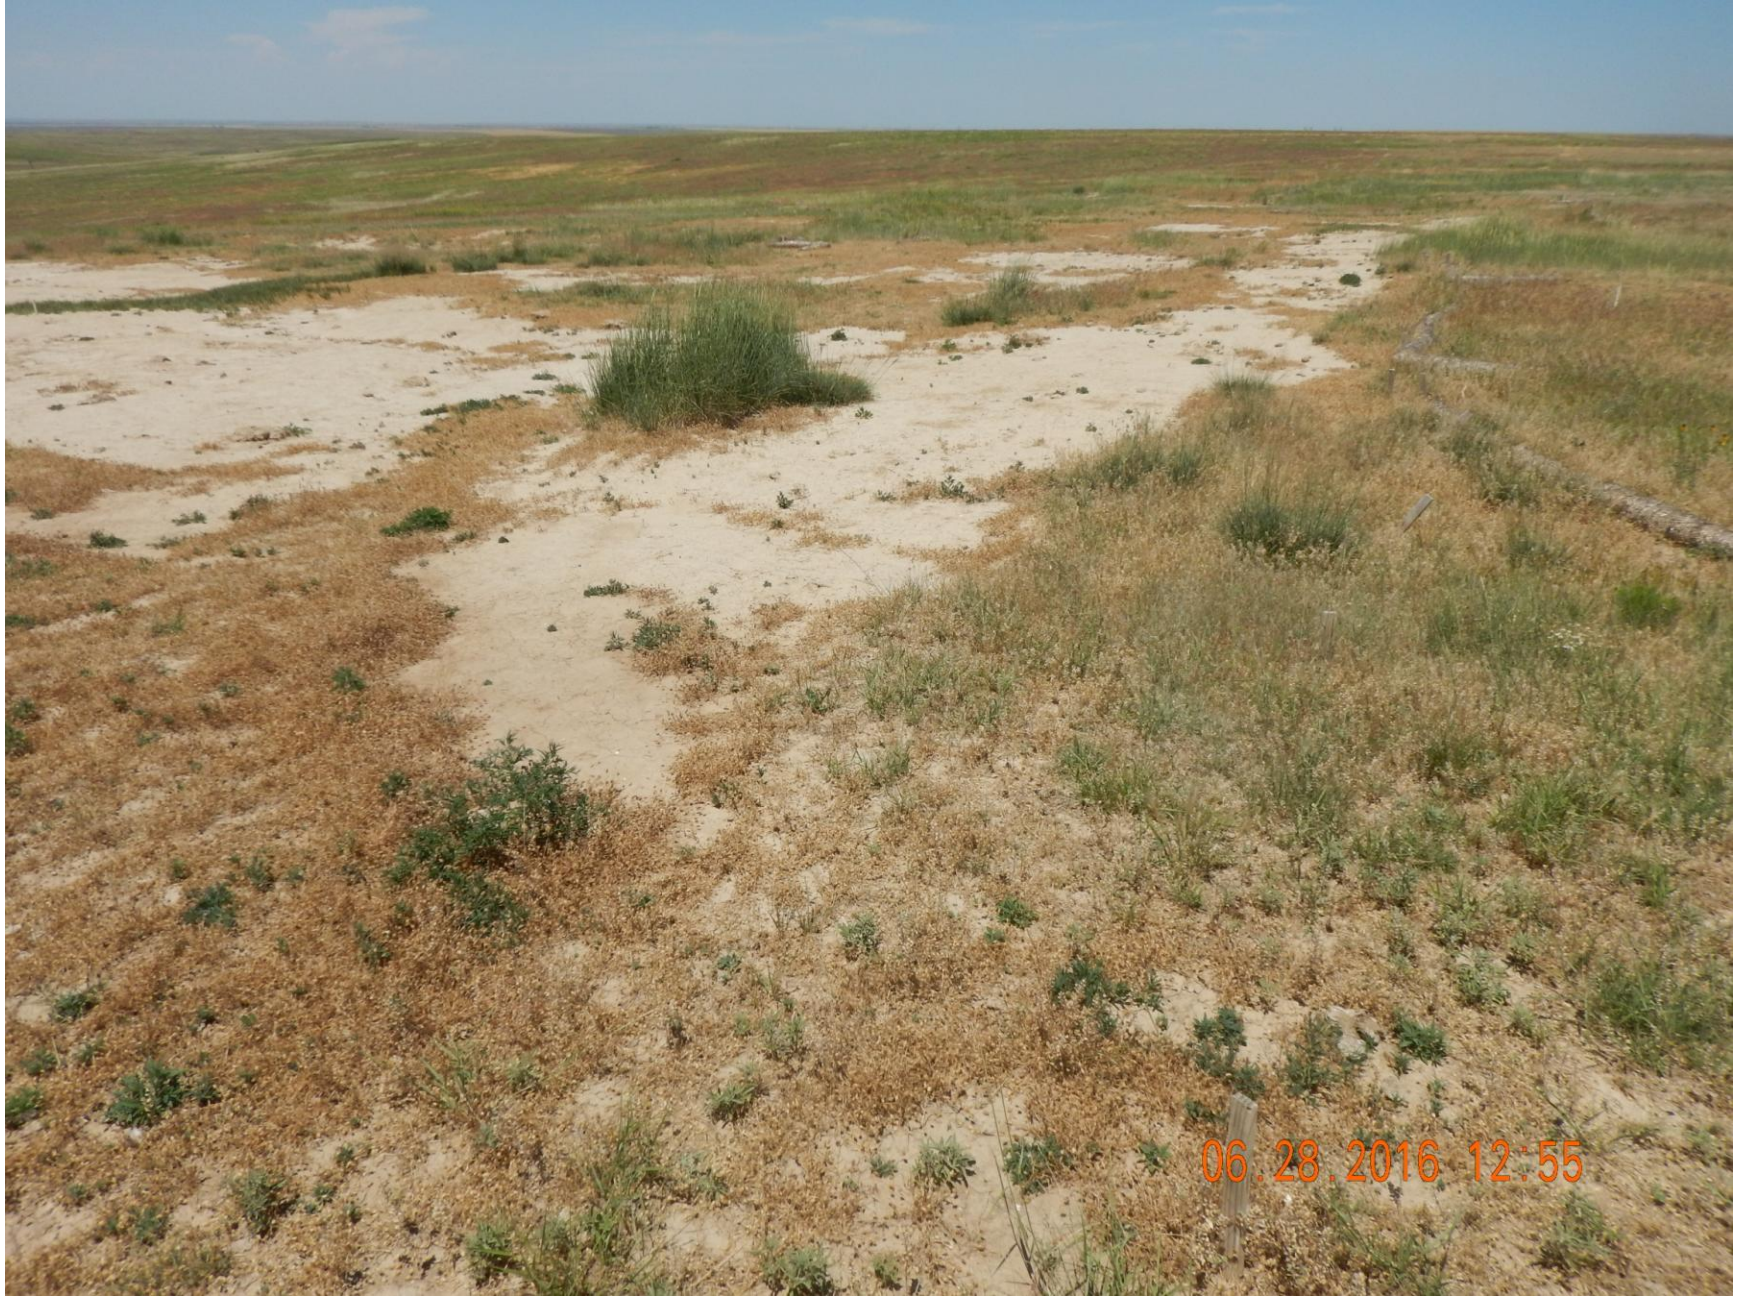
Figure 20: Photo taken from the NORTHERN DA, facing northwest. Photo shows large unvegetated areas, and degradation due to erosion.
