Final Reclamation Inspection

06/28/2016

Operator: Petro-Canada

Location ID: 311664

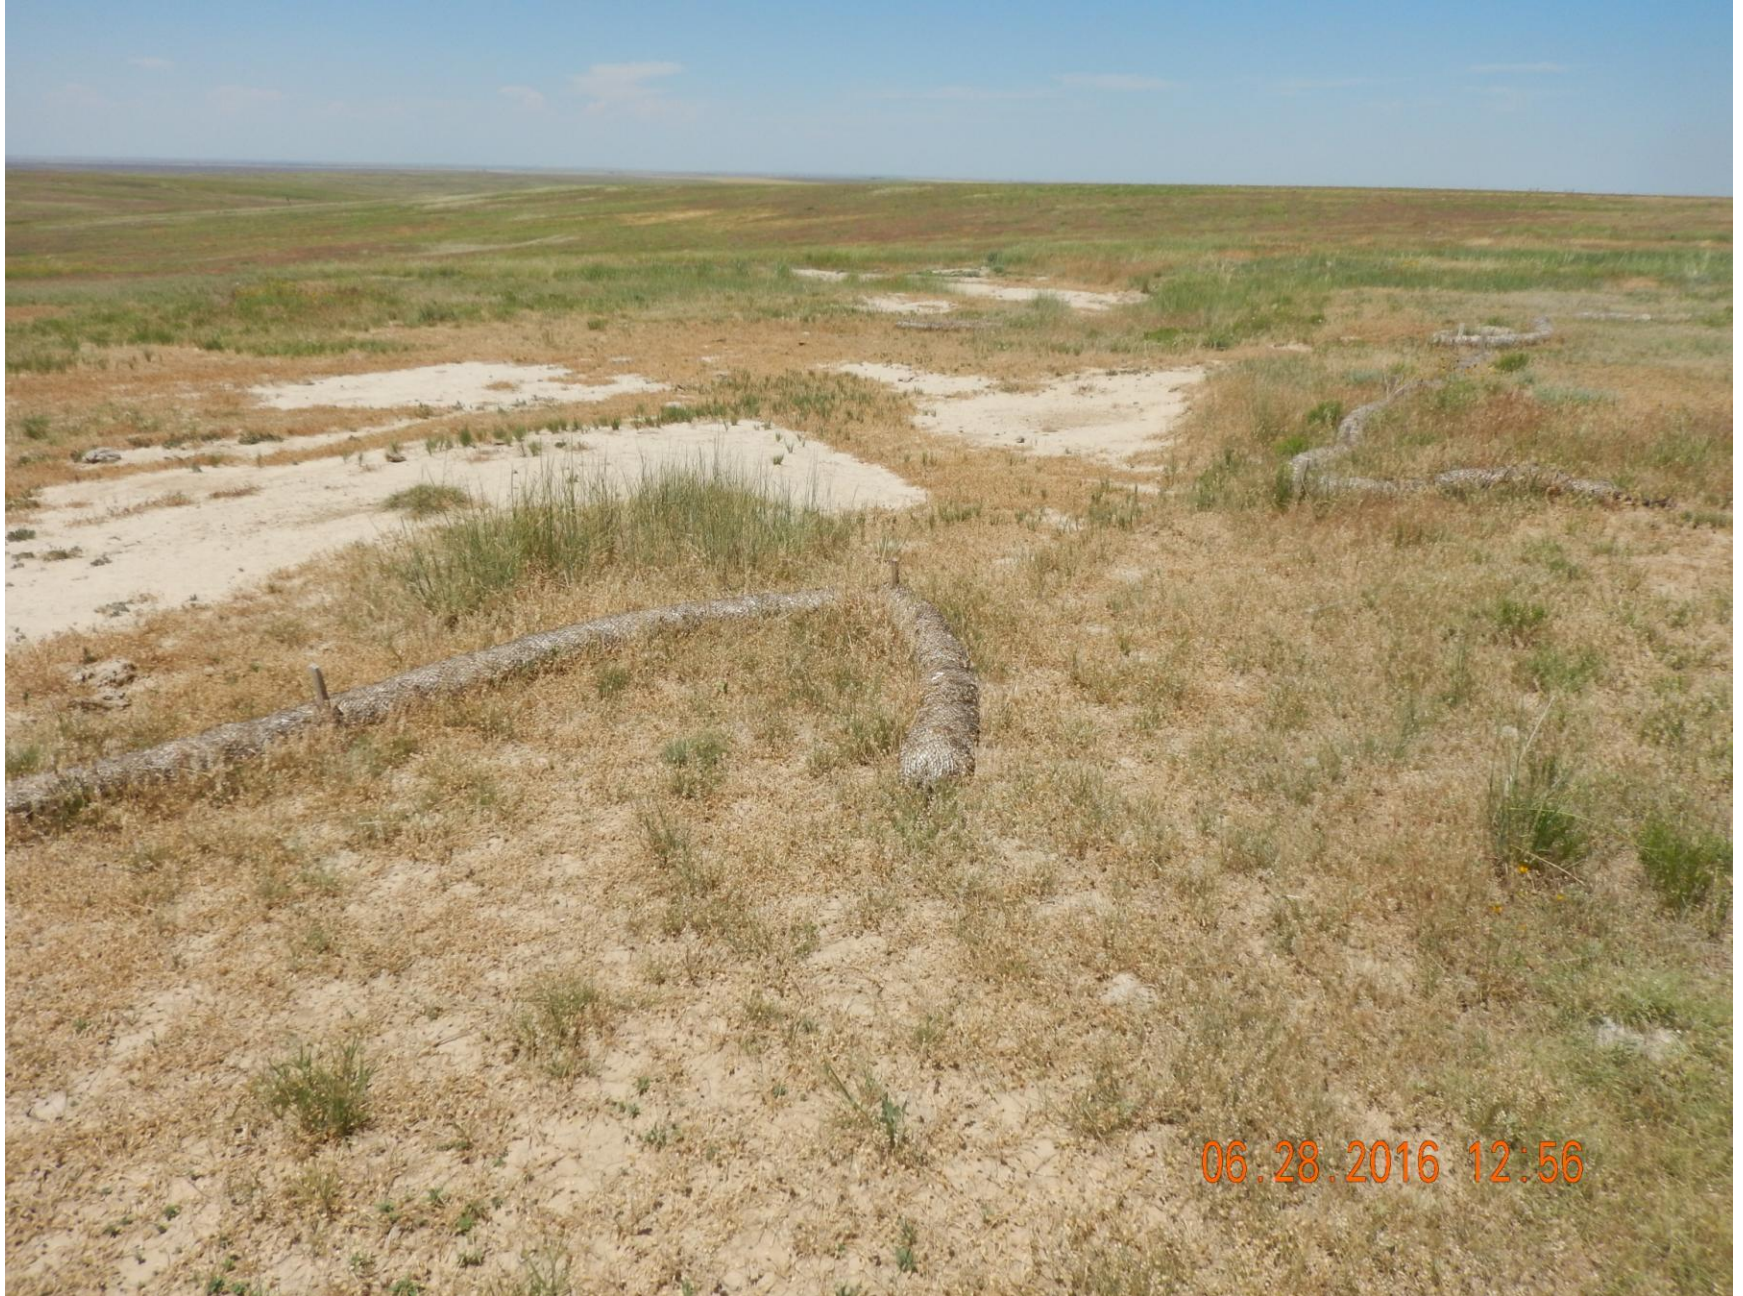
Figure 21: Photo taken from the Northern DA, facing northwest. Photo shows stormwater control wattles in disrepair.

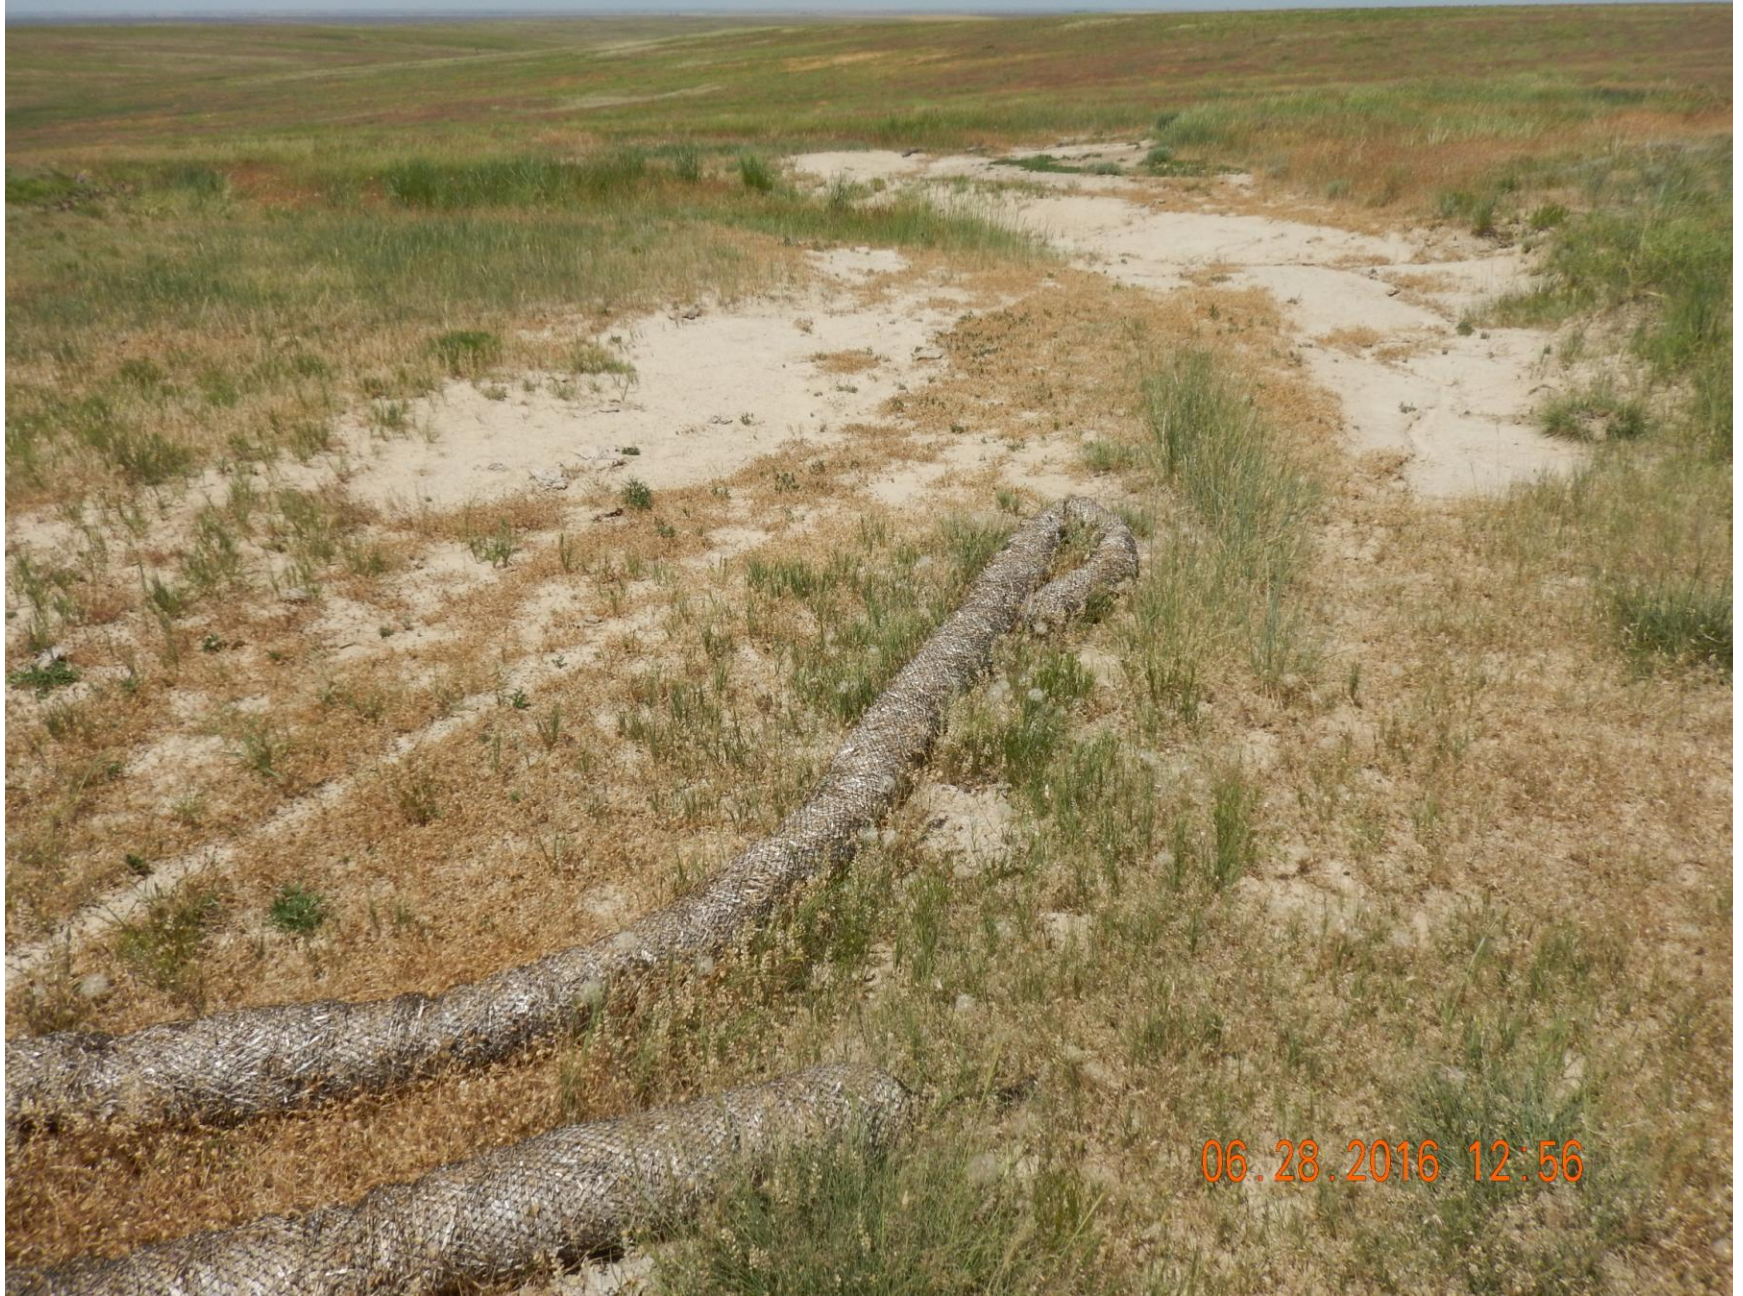
Figure 22: Photo taken from the Northern DA, facing northwest. Photo shows stormwater control wattles in disrepair.

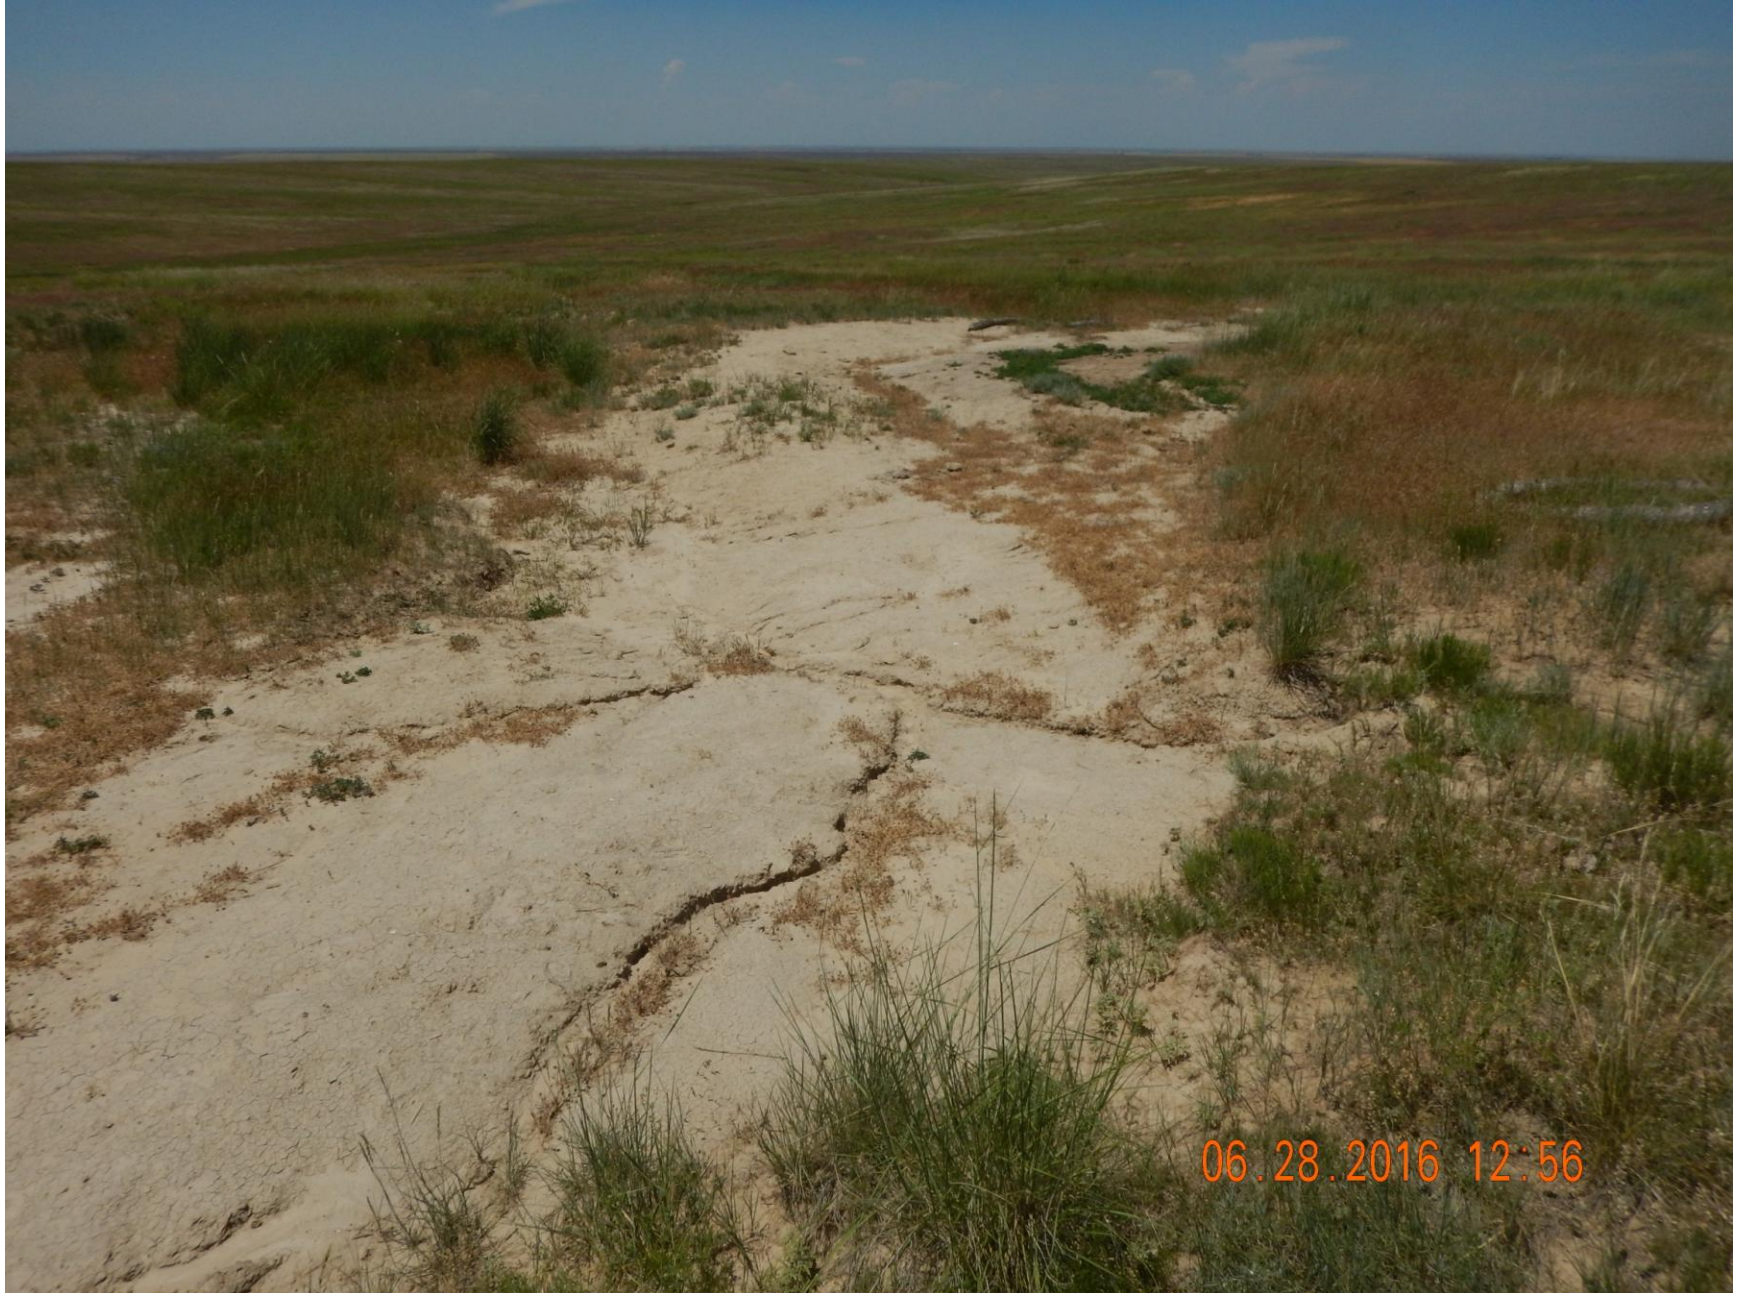
Figure 23: Photo taken from the NORTHERN DA, facing northwest. Photo shows large unvegetated areas, and degradation due to erosion.

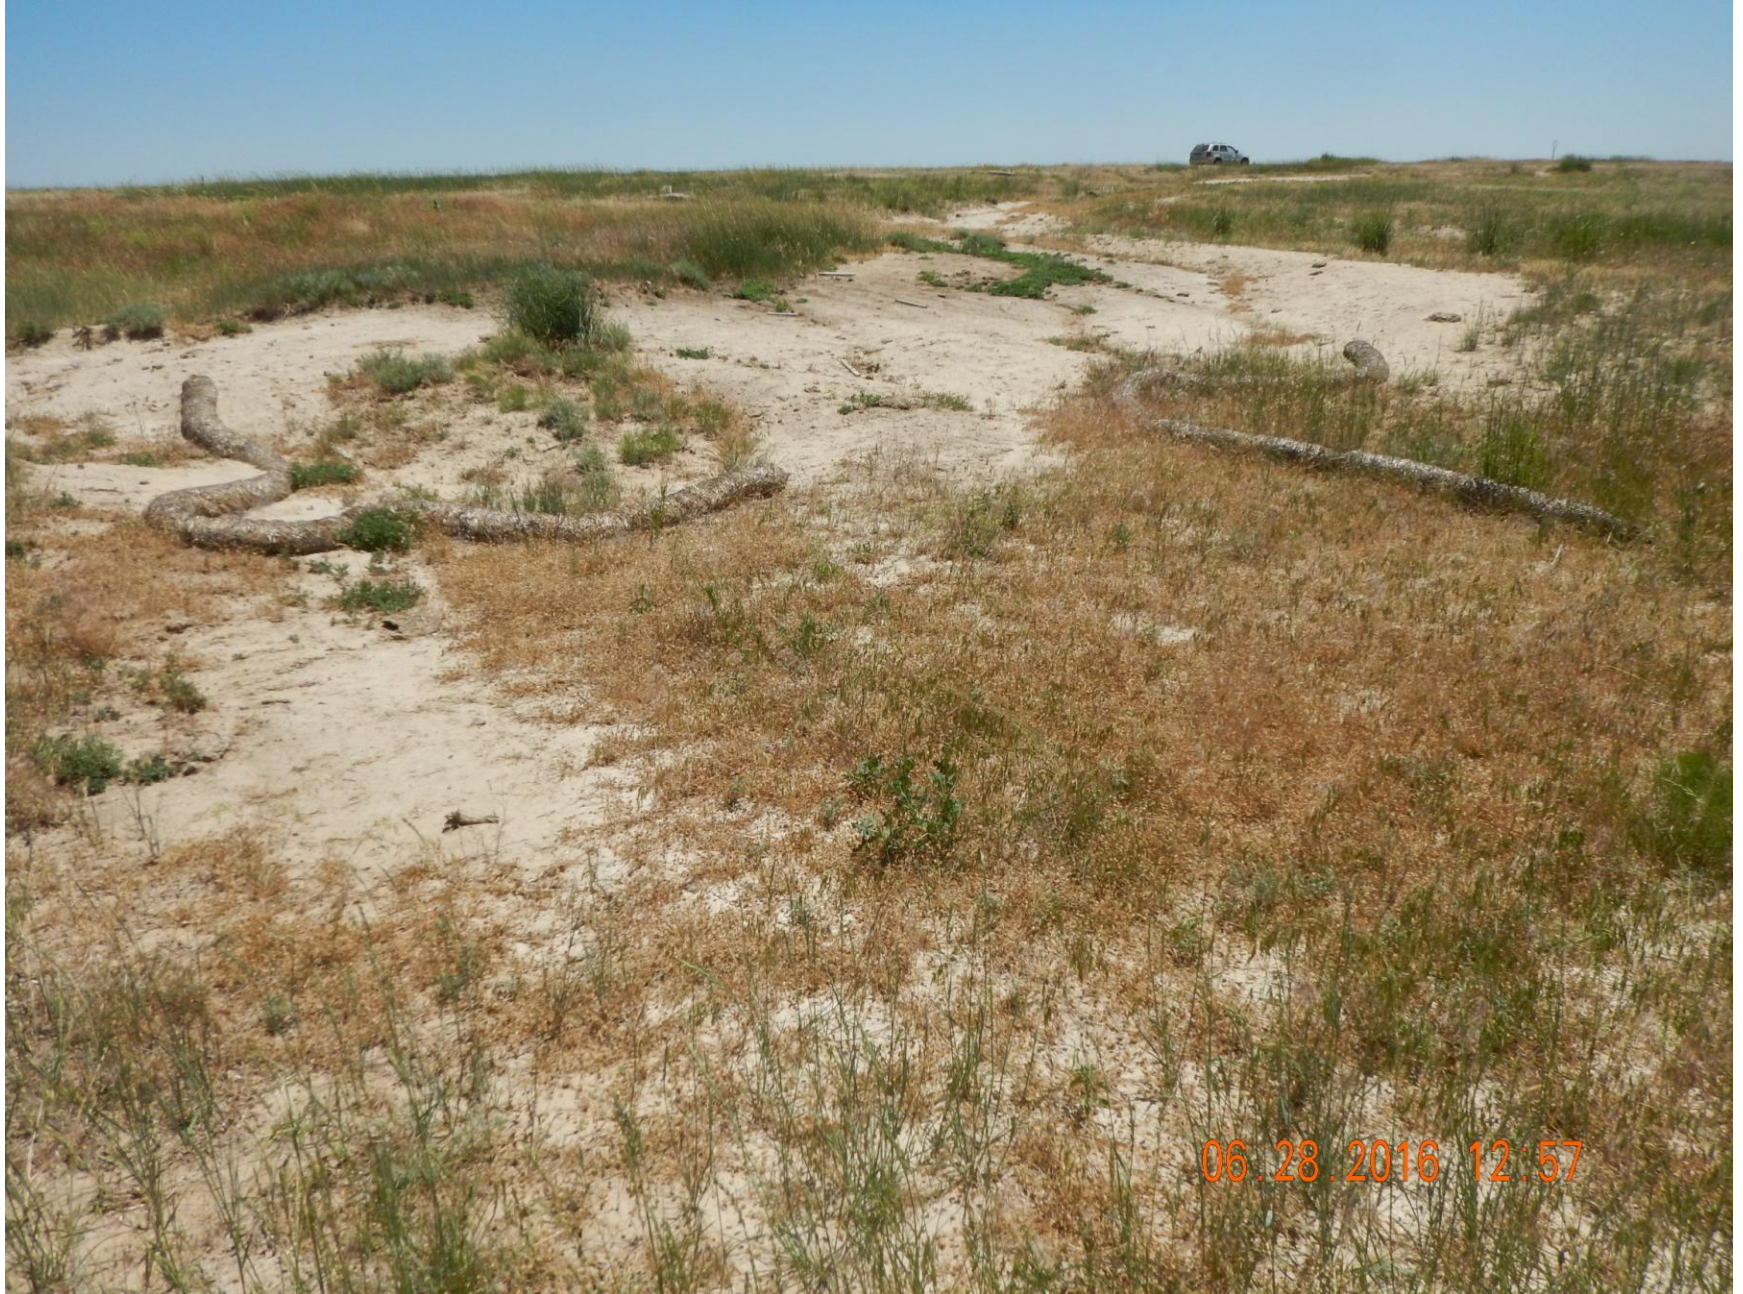
Figure 24: Photo taken from the Northern DA, facing southeast. Photo shows degradation and stormwater control wattles in disrepair.
