Federal 4-35

Inspection# 673403472

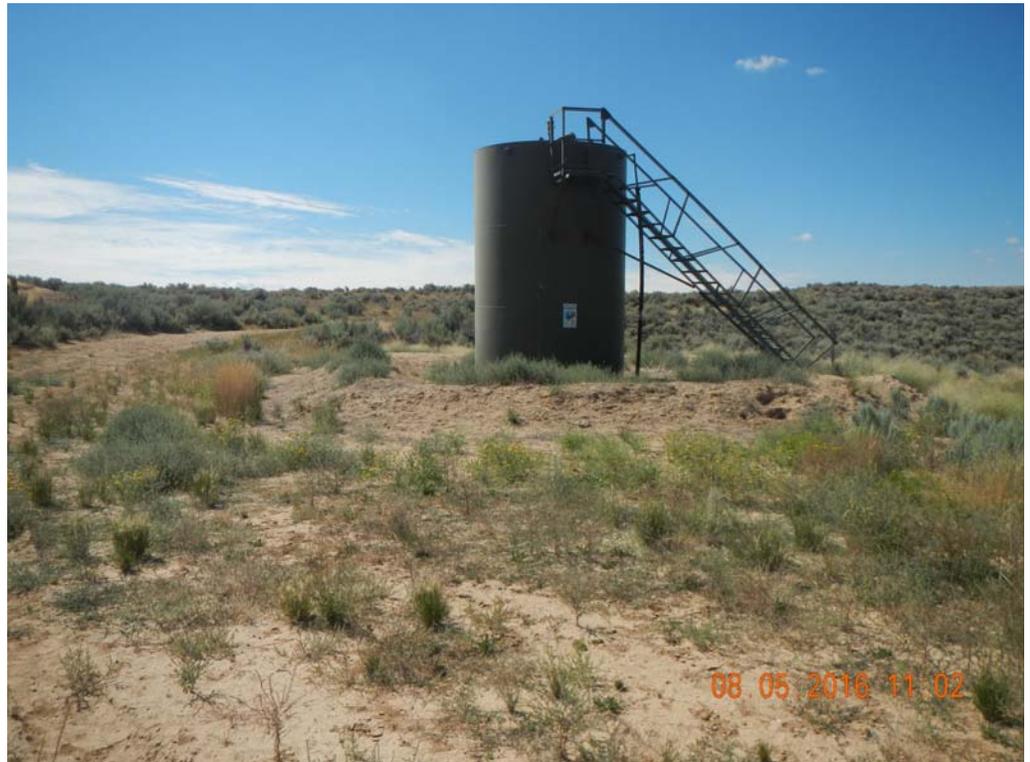
Low berm with weeds growing on and in it. Tank label missing capacity.

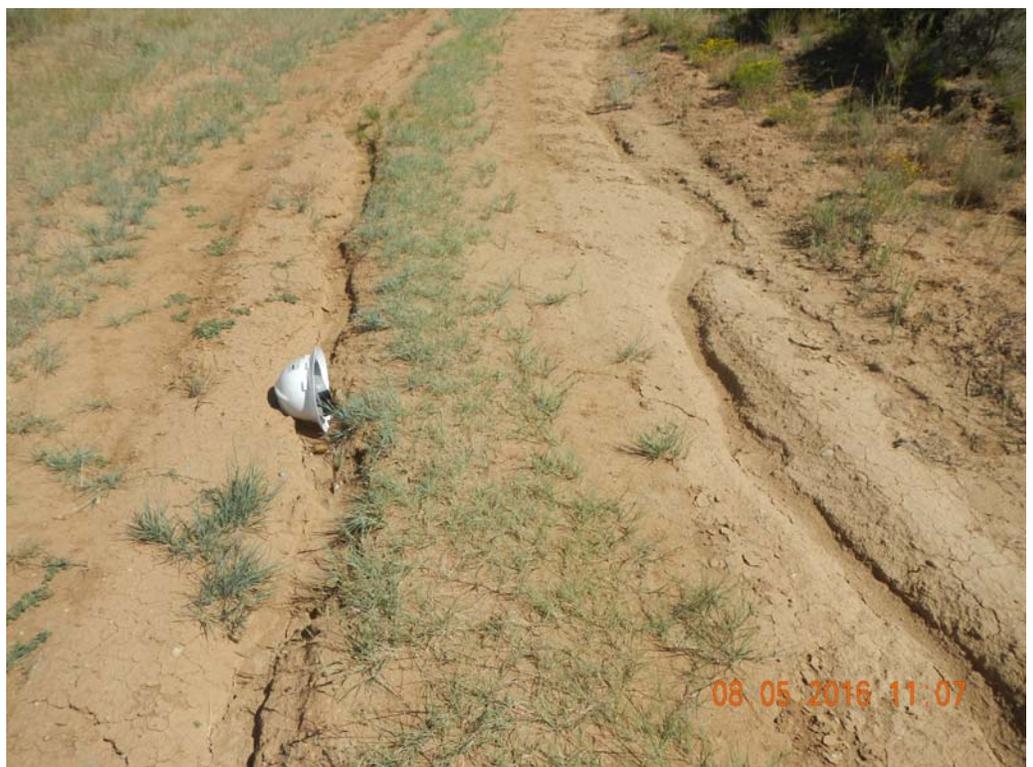
Ruts in access road. Hard hat for scale.

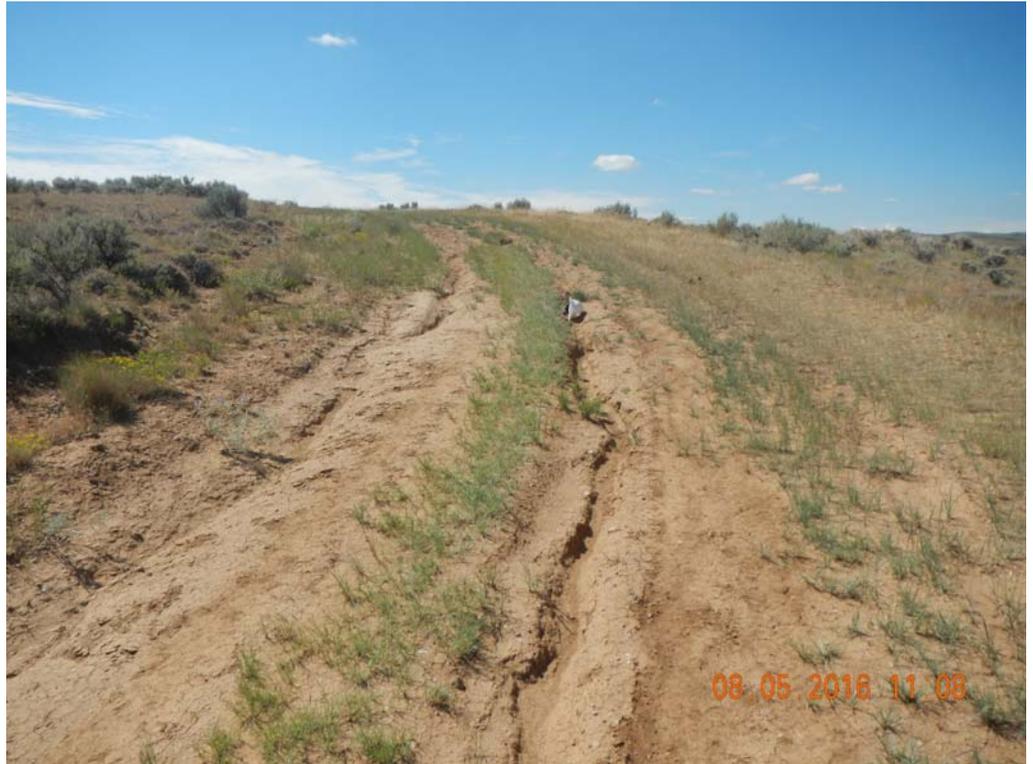
Ruts in access road. Hard hat for scale.

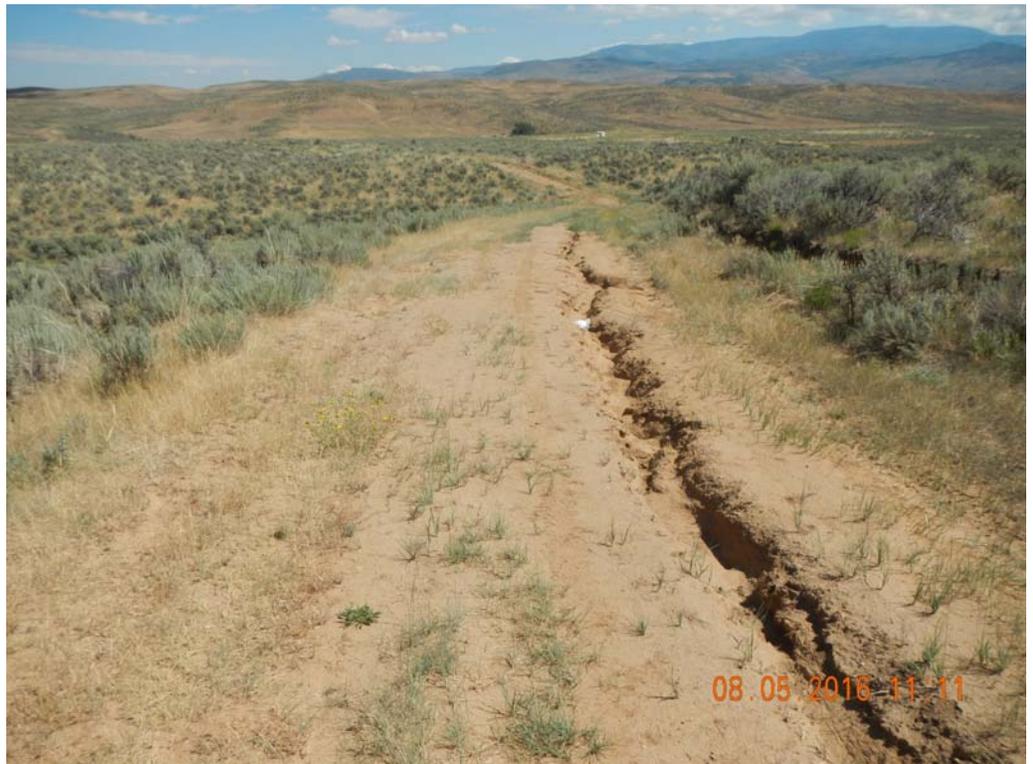
Ruts in access road. Hard hat for scale. Drainage crossing in background.

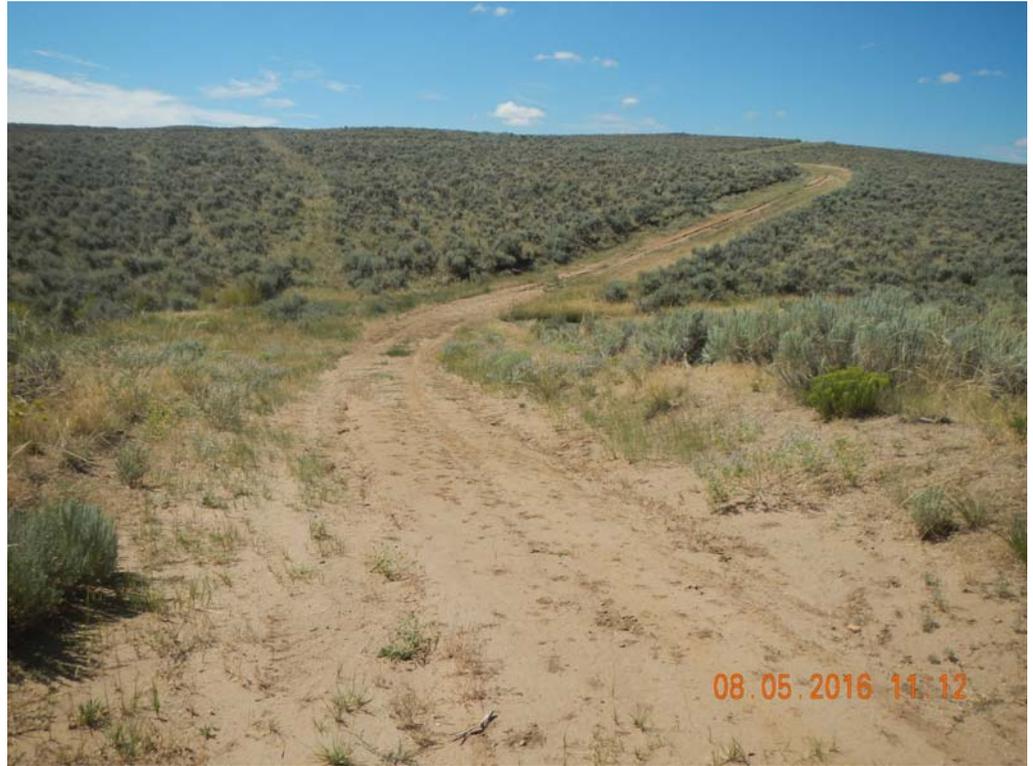
On opposite side of drainage from previous picture.

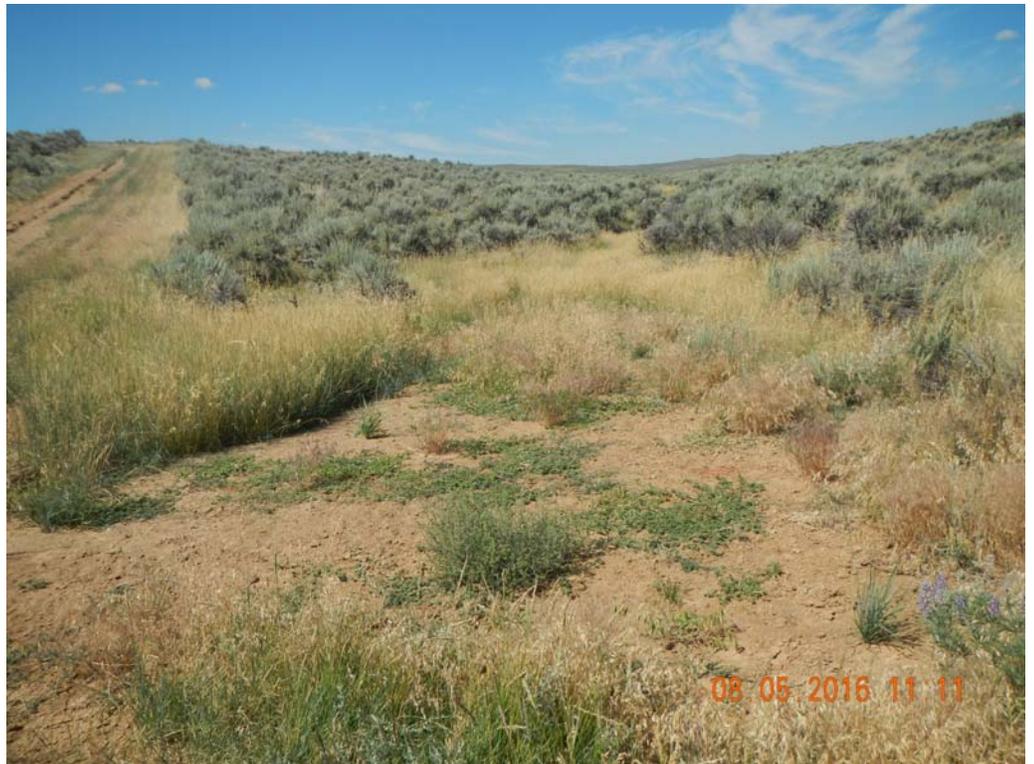
Evidence of sediment entering drainage at road crossing.
