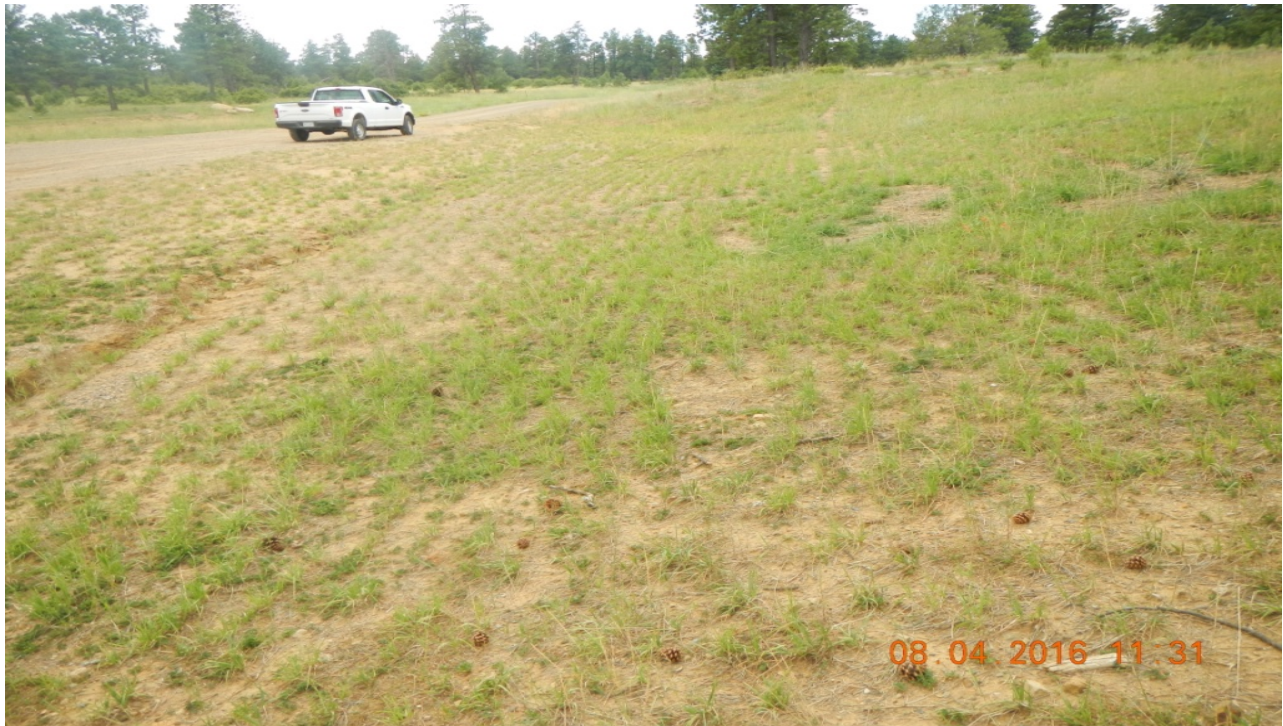
photo 1: Northwest side of the location facing south, west side of the road.

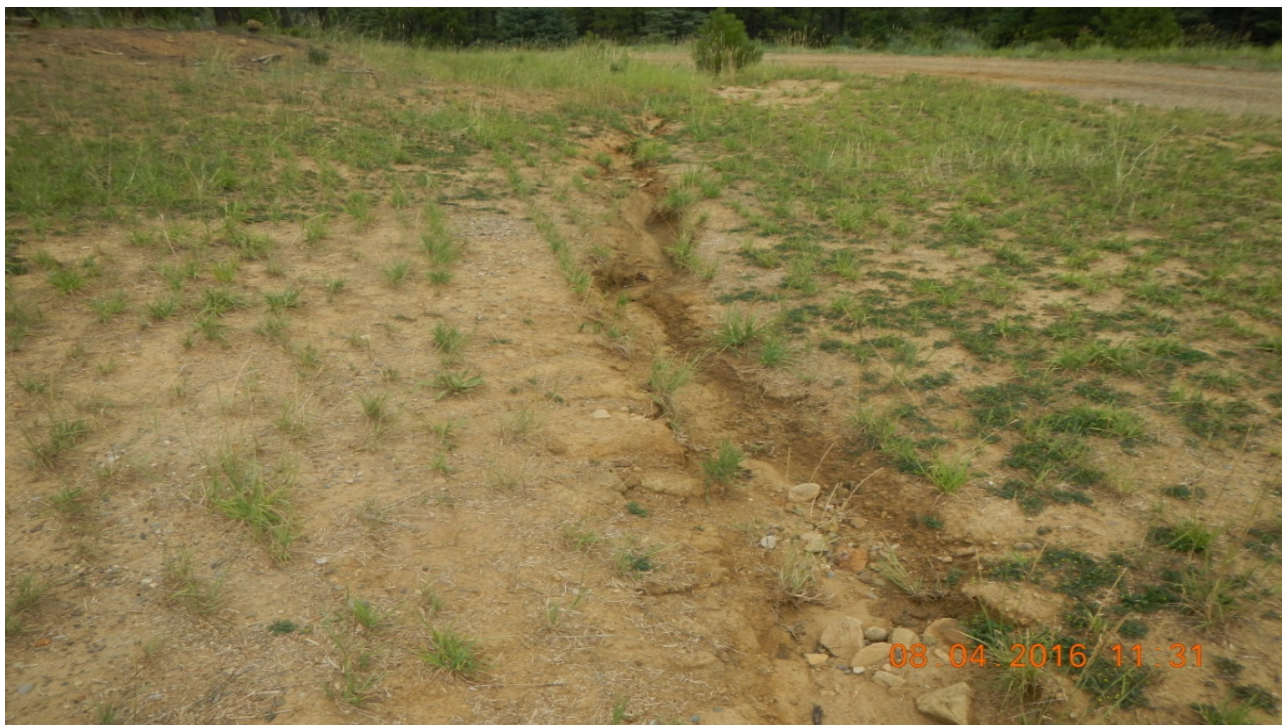
photo 2: There is an erosion channel at the northwest side of the location from stormwater directed from the access road.

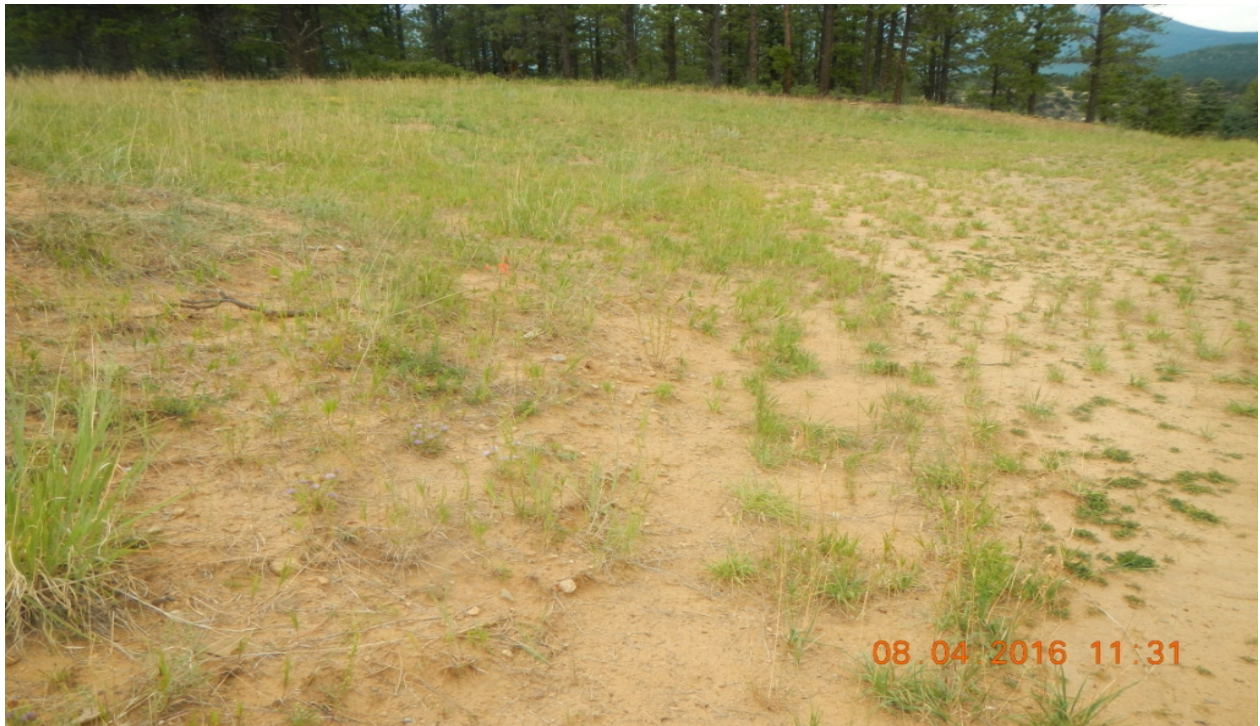
photo 3: Southwest side of the location facing north, west side of the road.

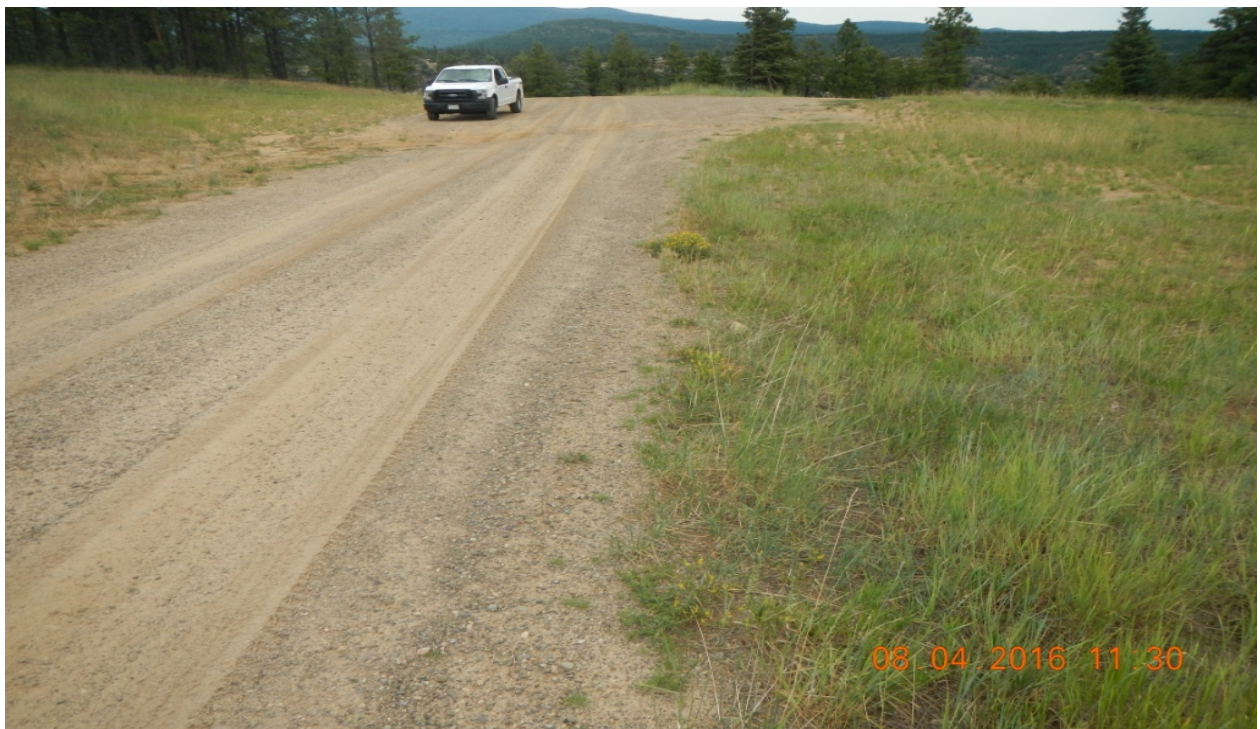
photo 4: Facing north toward the main road which splits the location in half.

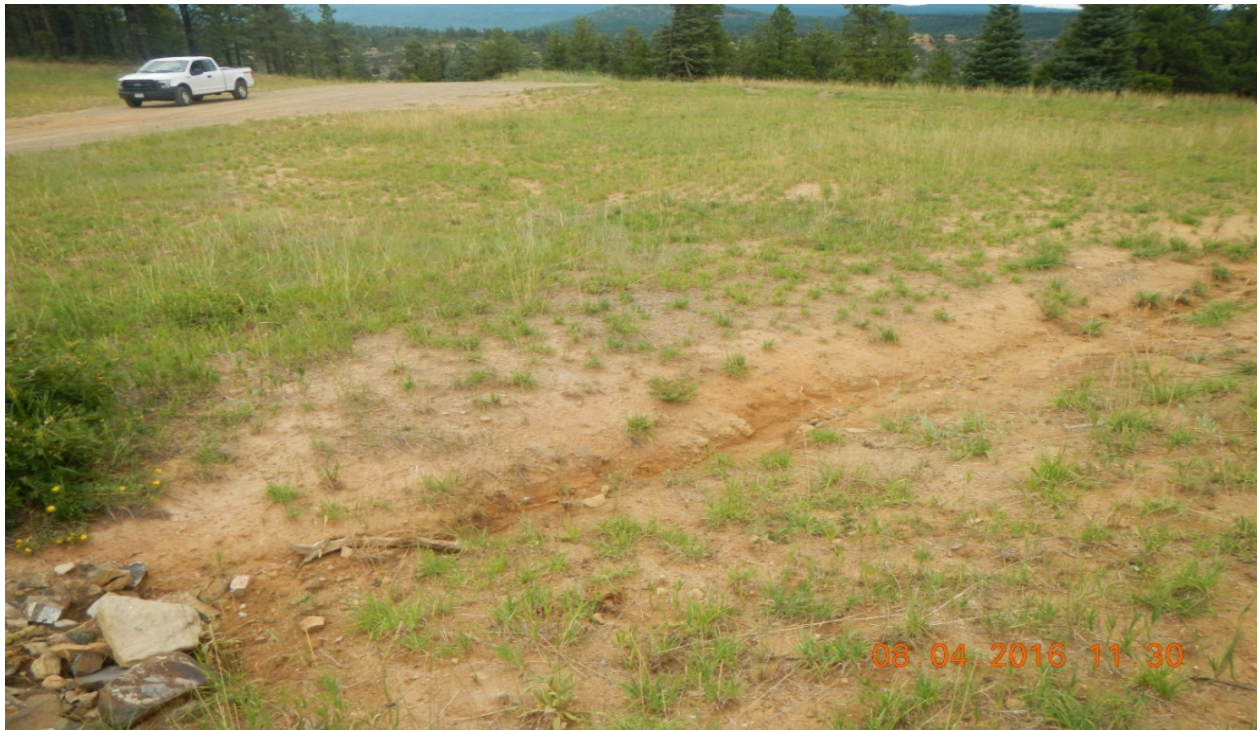
photo 5: Southeast side of the location facing north, east side of the road.

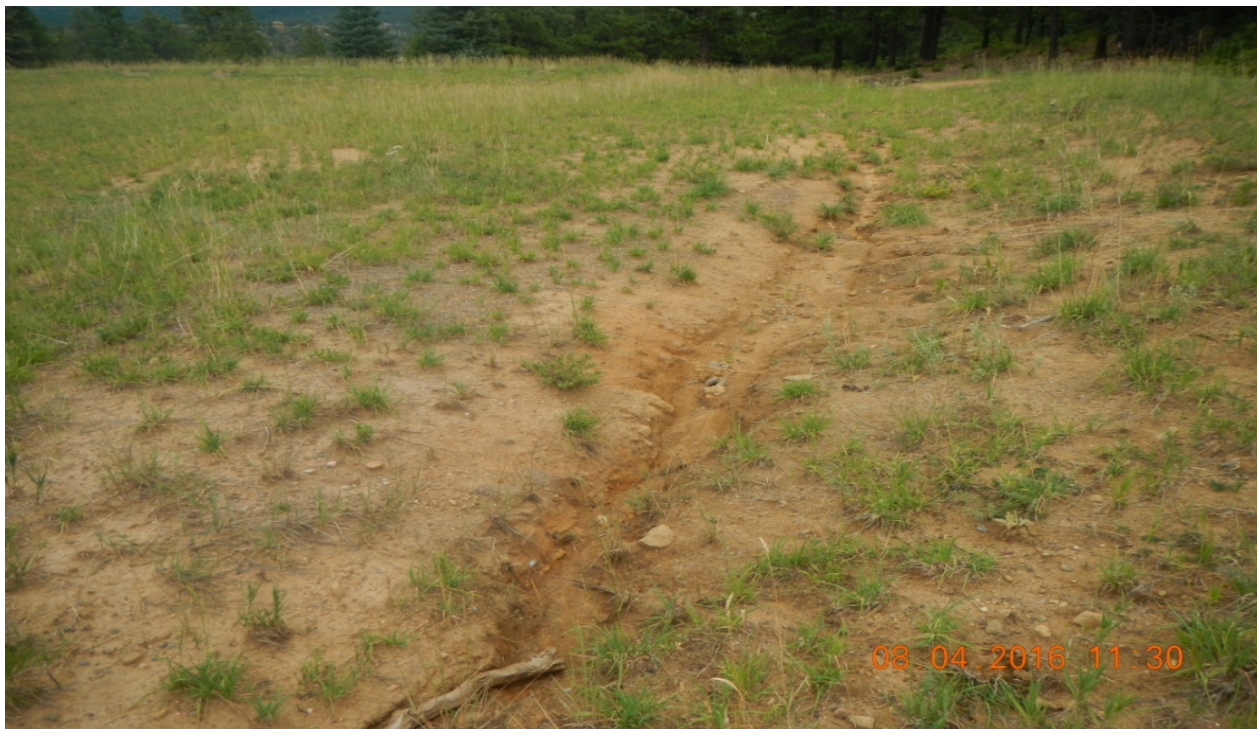
photo 6: There is an erosion channel at the southeast side of the location from stormwater directed from the access road.

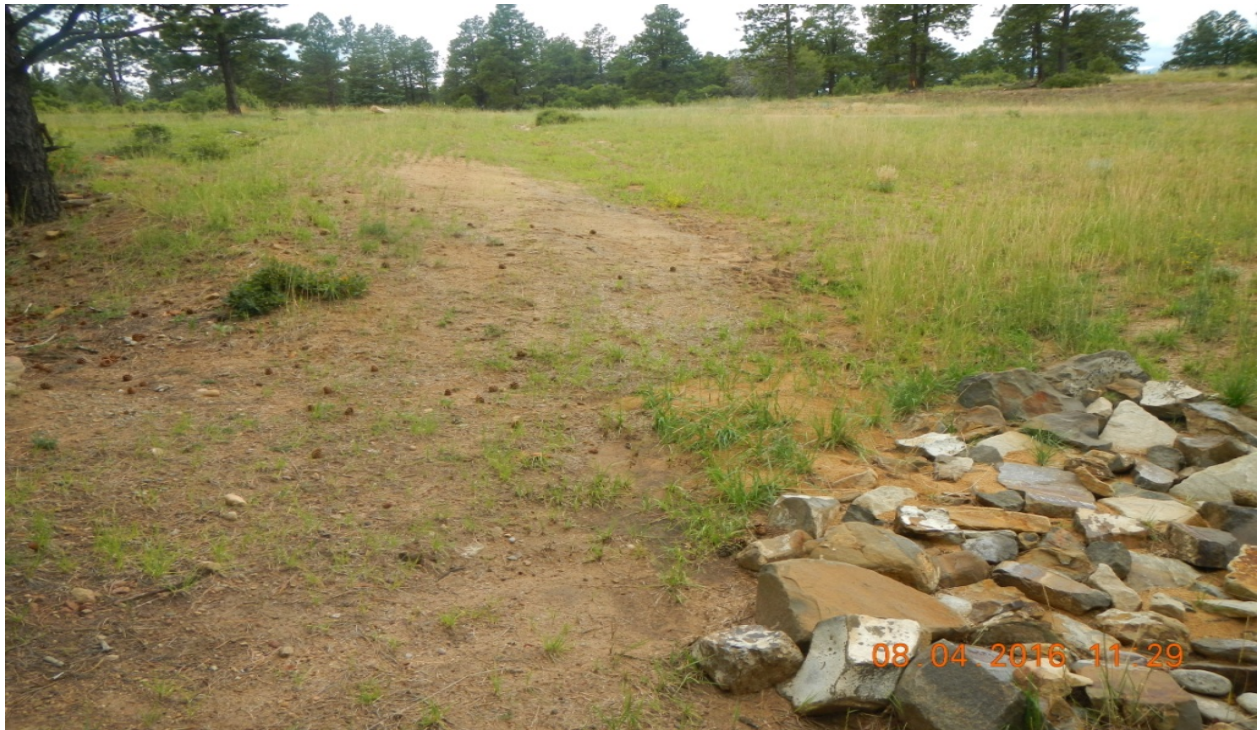
photo 7: Northeast side of the location facing southwest.

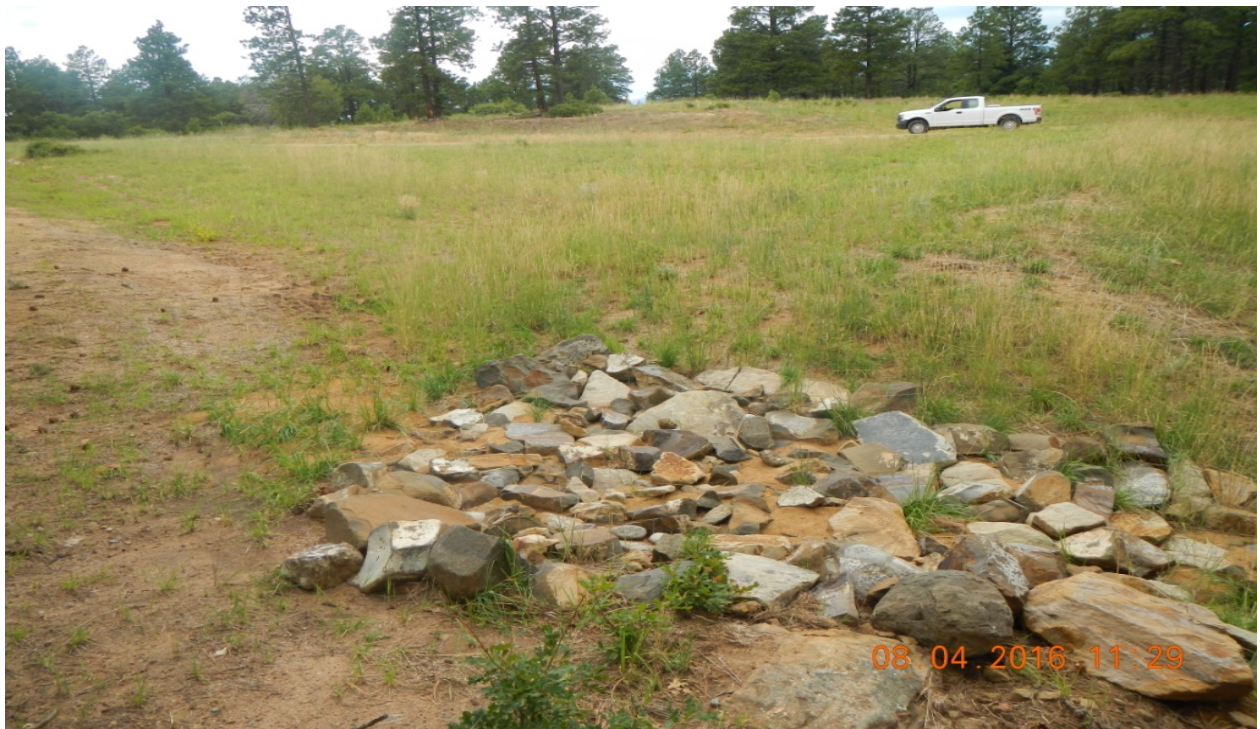
photo 8: Northeast side of the location facing west.
