Stormwater Inspection

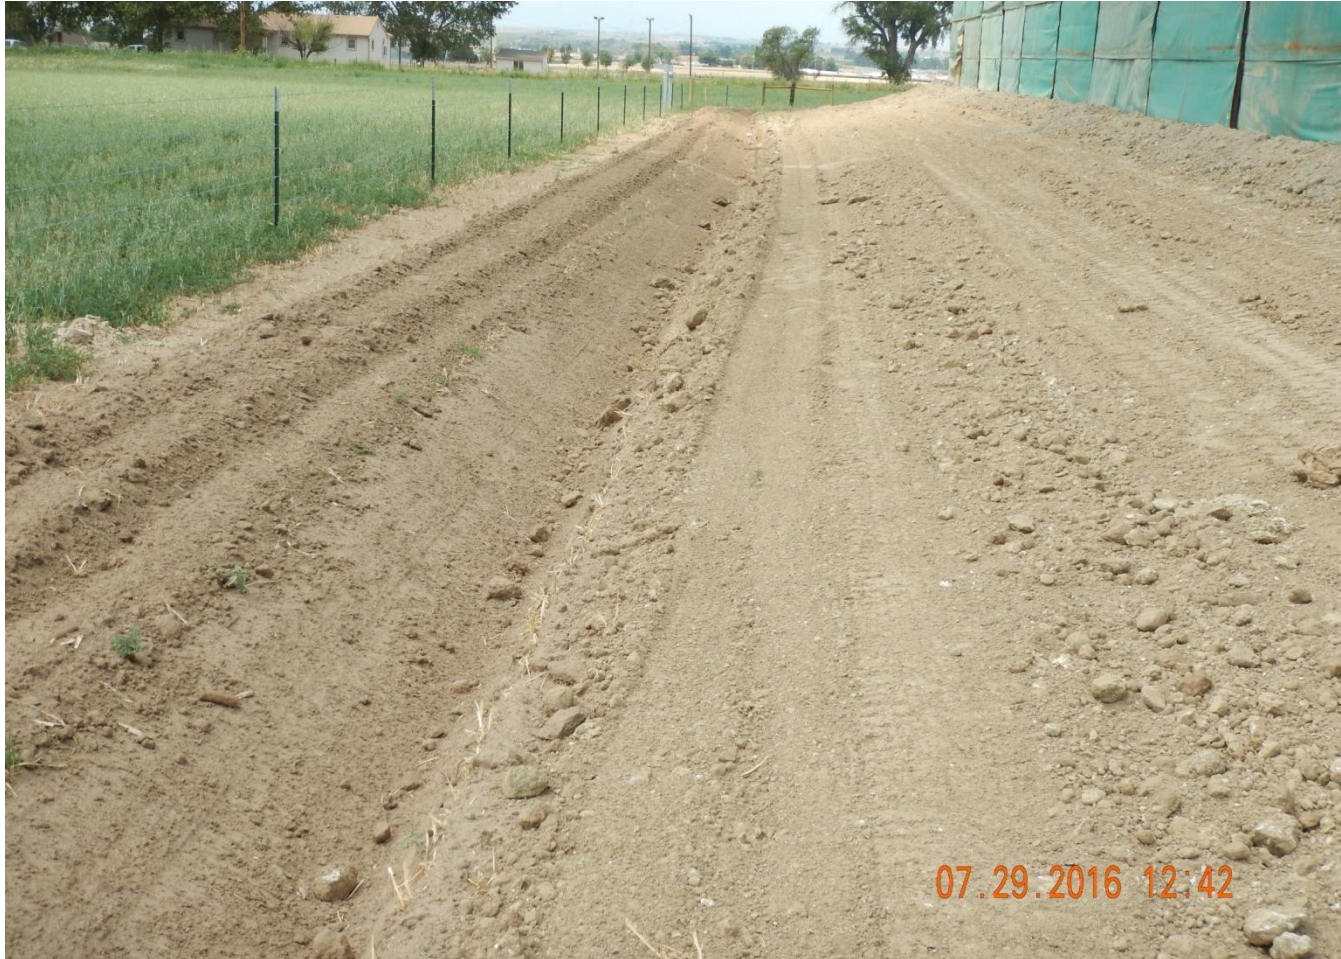
Photo 1. Photo taken from southern location, facing West. BMP installed in center of the photo.

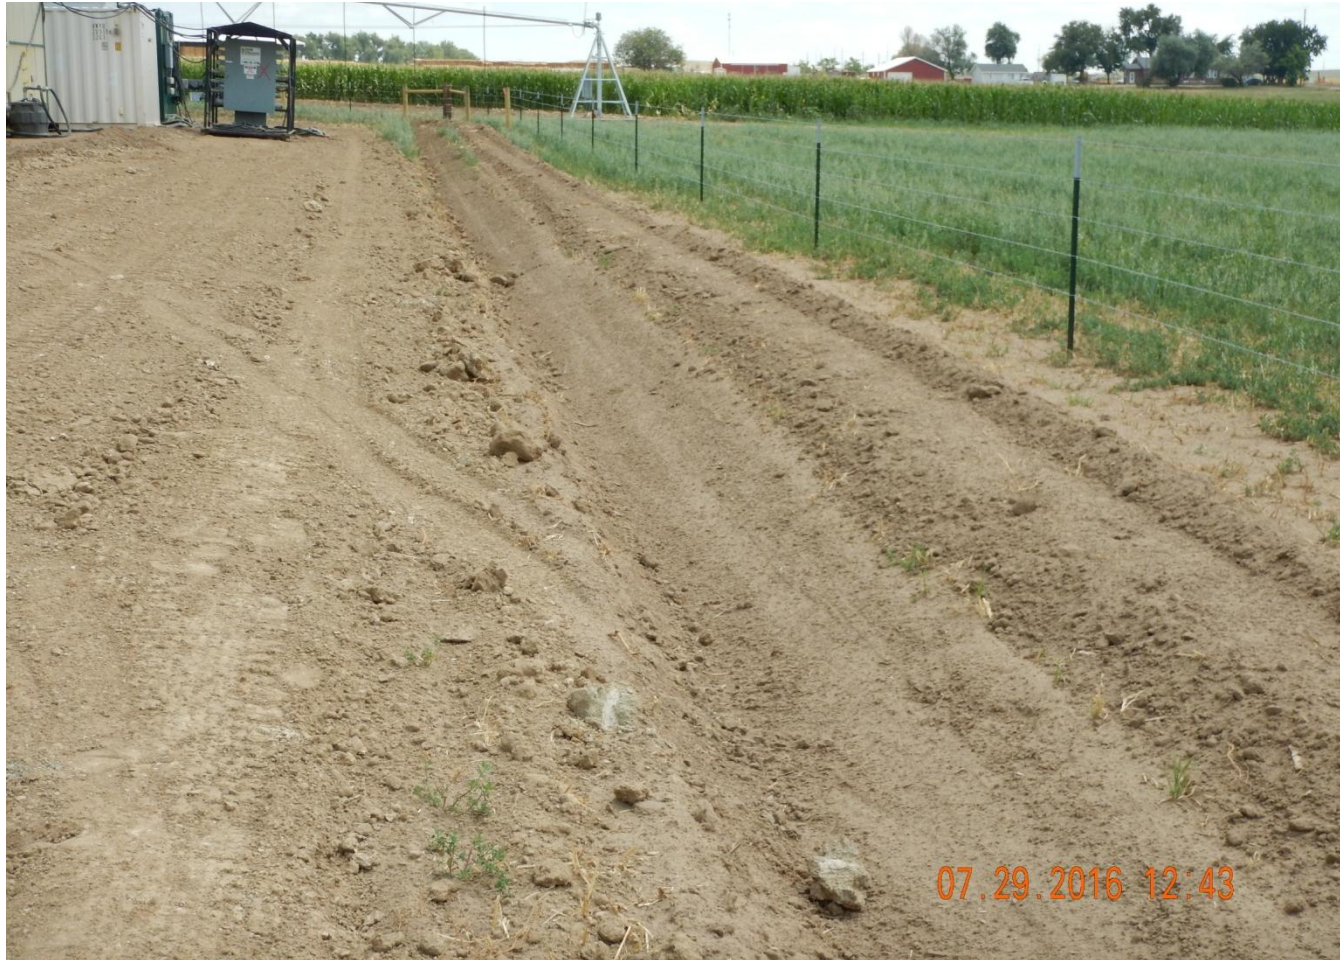
Photo 2. Photo taken from southern location, facing East. BMP installed in center of the photo.

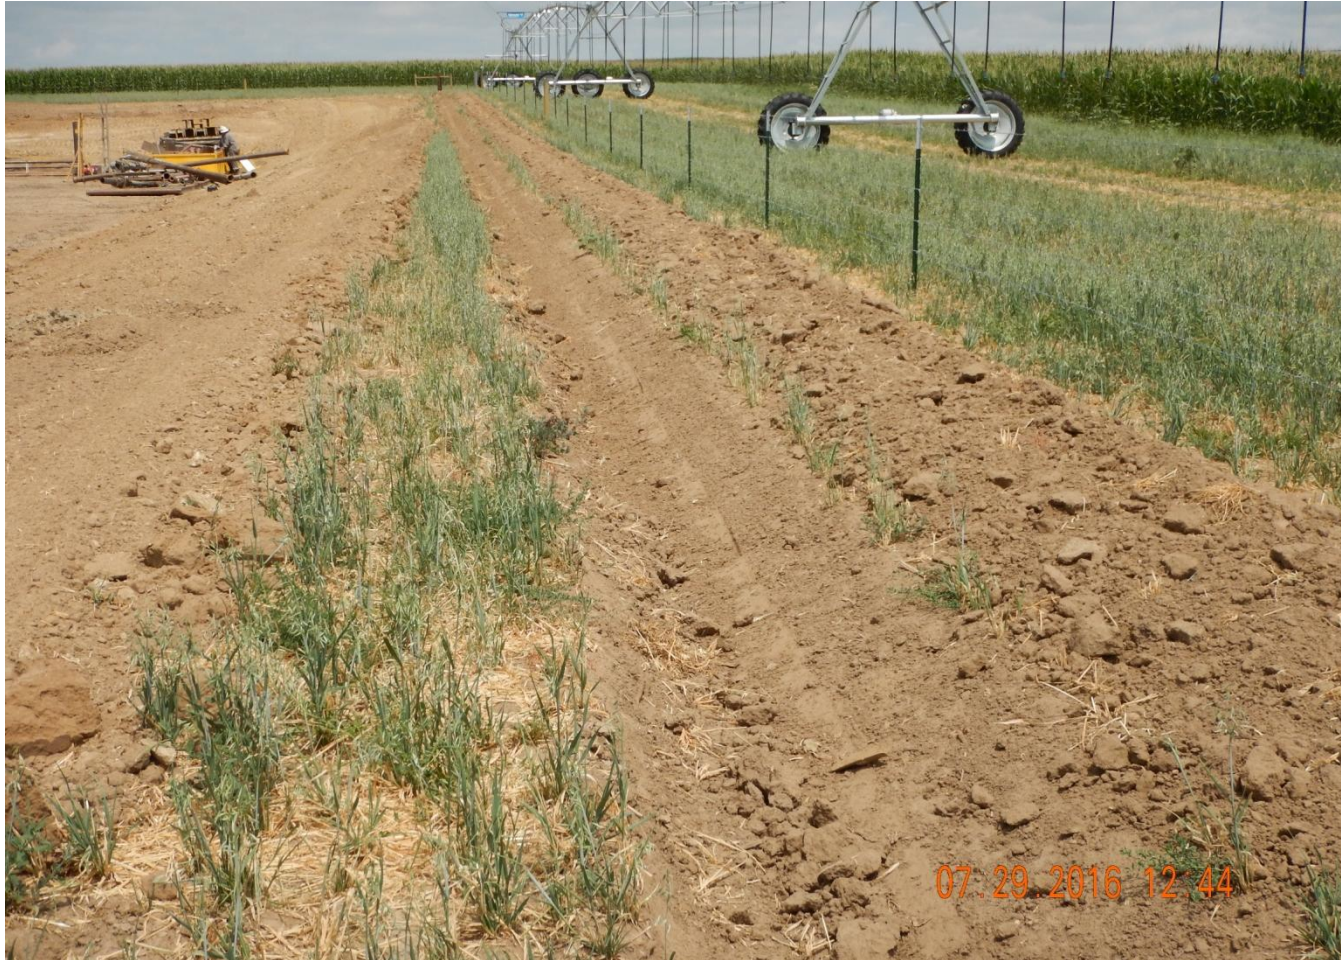
Photo 3. Photo taken from southeast location, facing North. BMP installed in center of the photo.

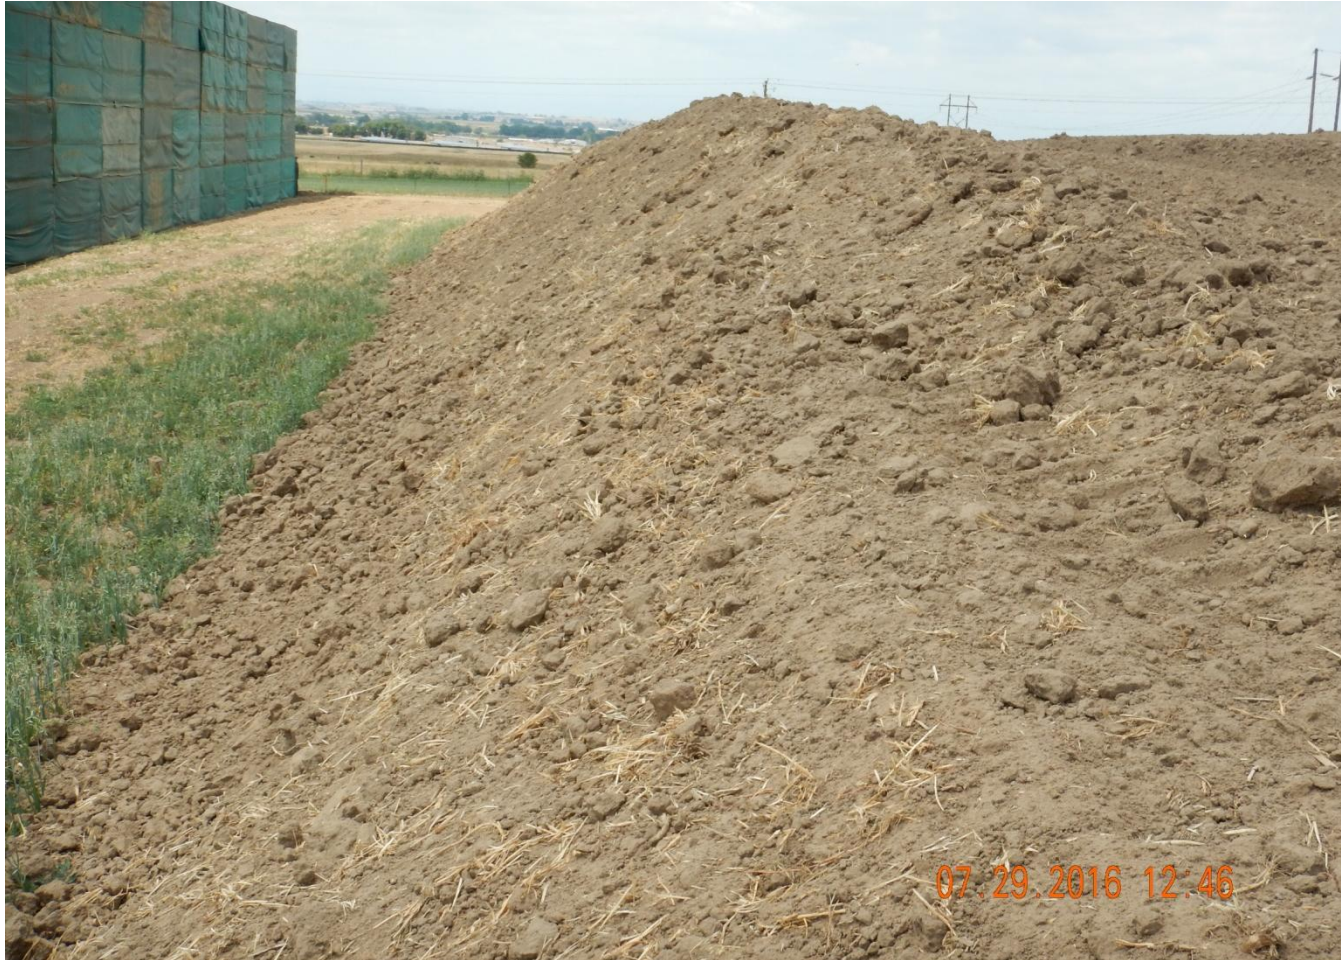
Photo 4. Photo taken from northern location, facing West, towards the south-facing topsoil stockpile. Topsoil stockpile, north-facing and south-facing, sides are steep and could pose erosion issues in the future. In the future, spread out the topsoil stockpile to eliminate the chance of erosion.

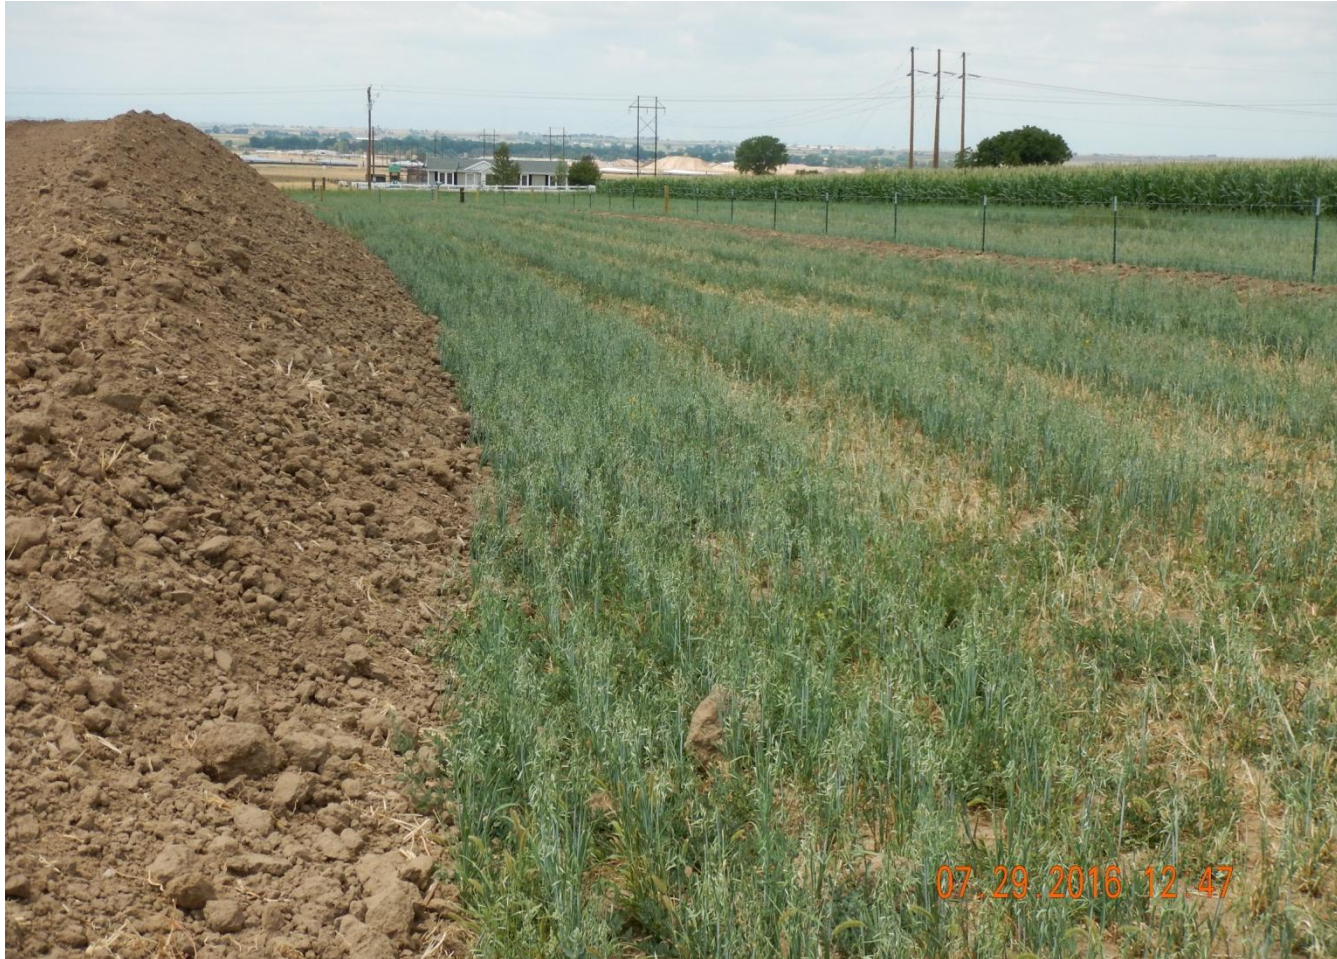
Photo 5. Photo taken from northern location, facing West, towards the north-facing topsoil stockpile. Topsoil stockpile, north-facing and south-facing, sides are steep and could pose erosion issues in the future. In the future, spread out the topsoil stockpile to eliminate the chance of erosion. There appears to be sufficient space to spread this topsoil pile out to reduce the steep side slopes.

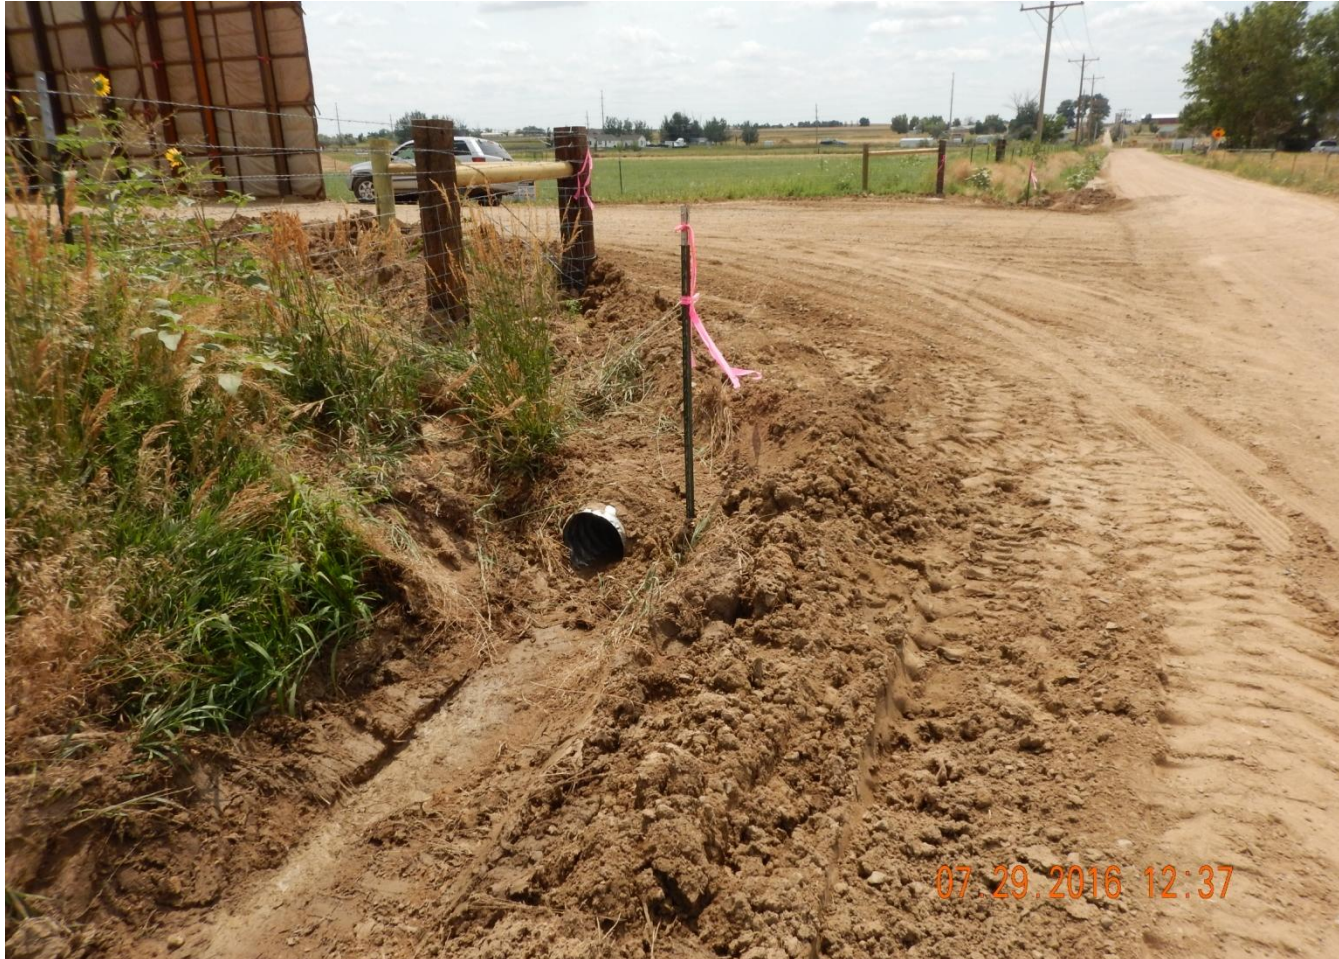
Photo 6. Photo taken from location entrance, facing South. Culvert installed but need to address stormwater and sediment run-on and run-off. Refer to photos 7-8.

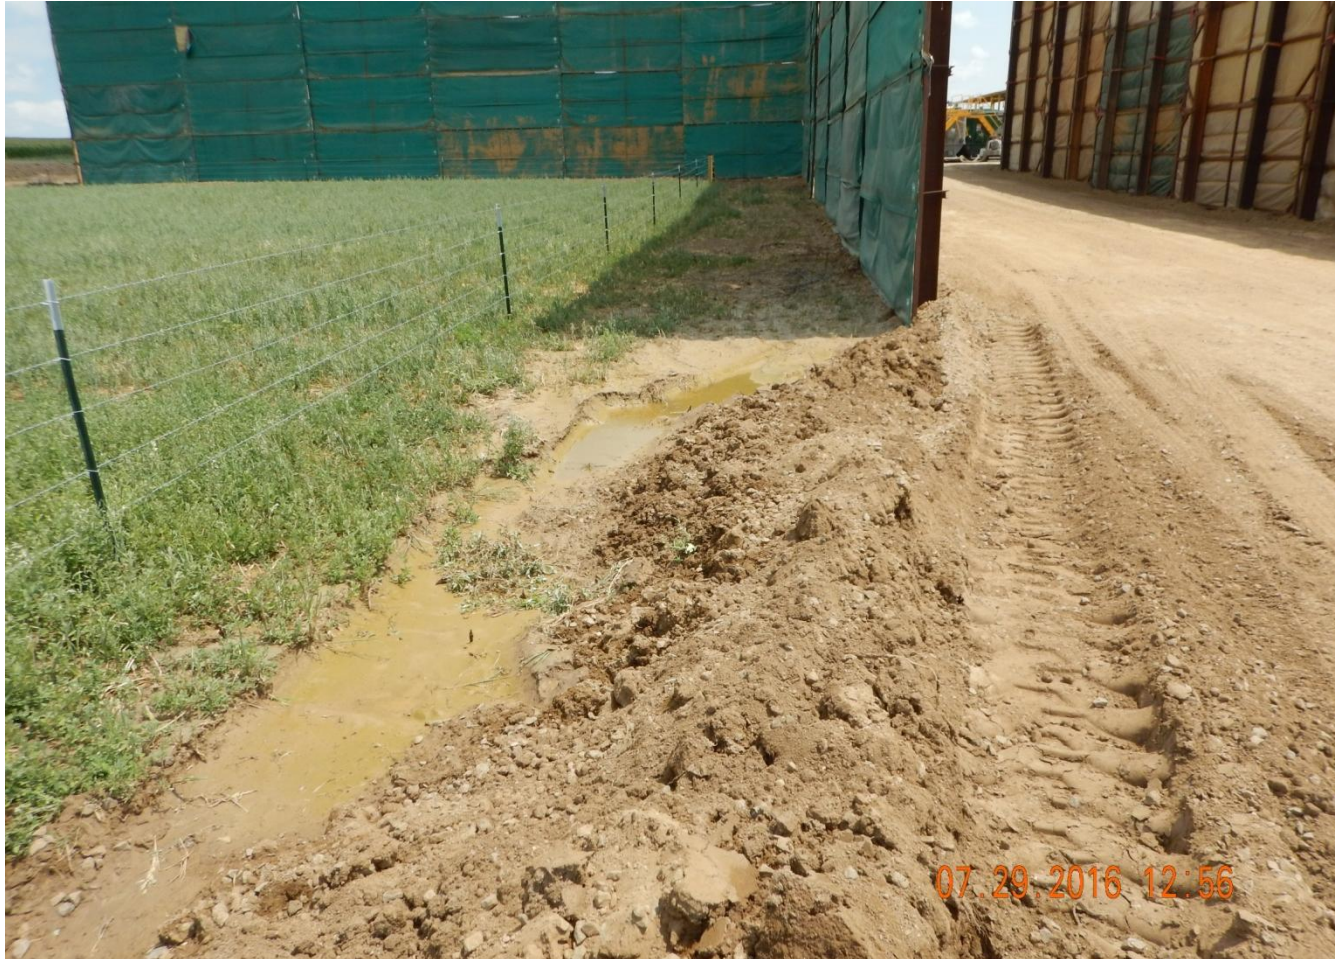
Photo 7. Photo taken from entrance of location, facing East. Flood irrigated water is running onto location from adjacent lands. Need to control run-on so that sediment is controlled and not leaving location.

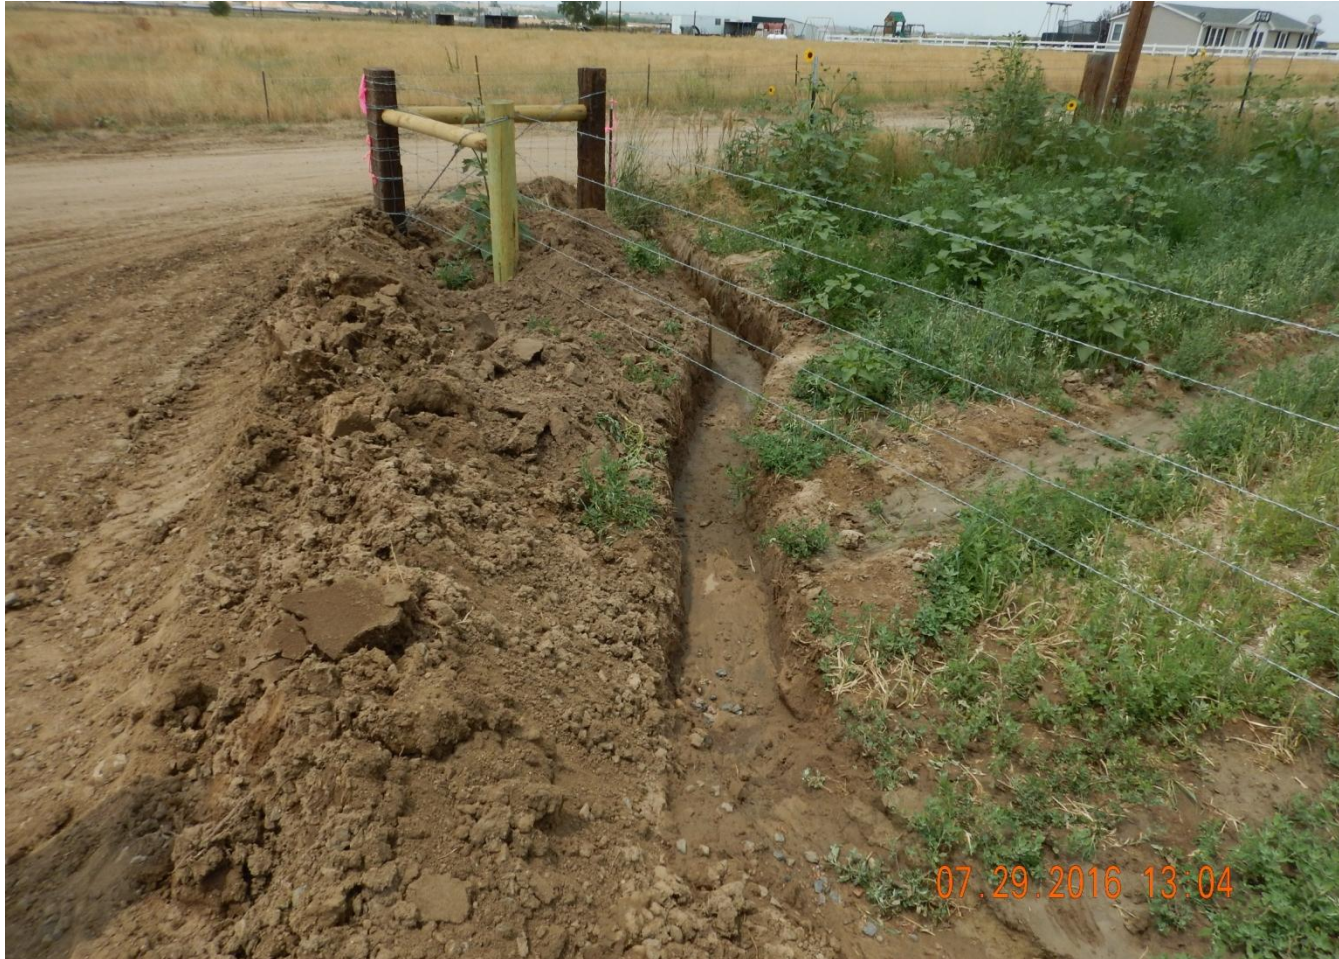
Photo 8. Photo taken from entrance of location, facing West. Temporary ditch was cut but need to install permanent BMPs to control sediment from leaving location.
