# Final Reclamation Inspection

08/05/2016

Operator: Markus Production inc.

Location ID: 406198

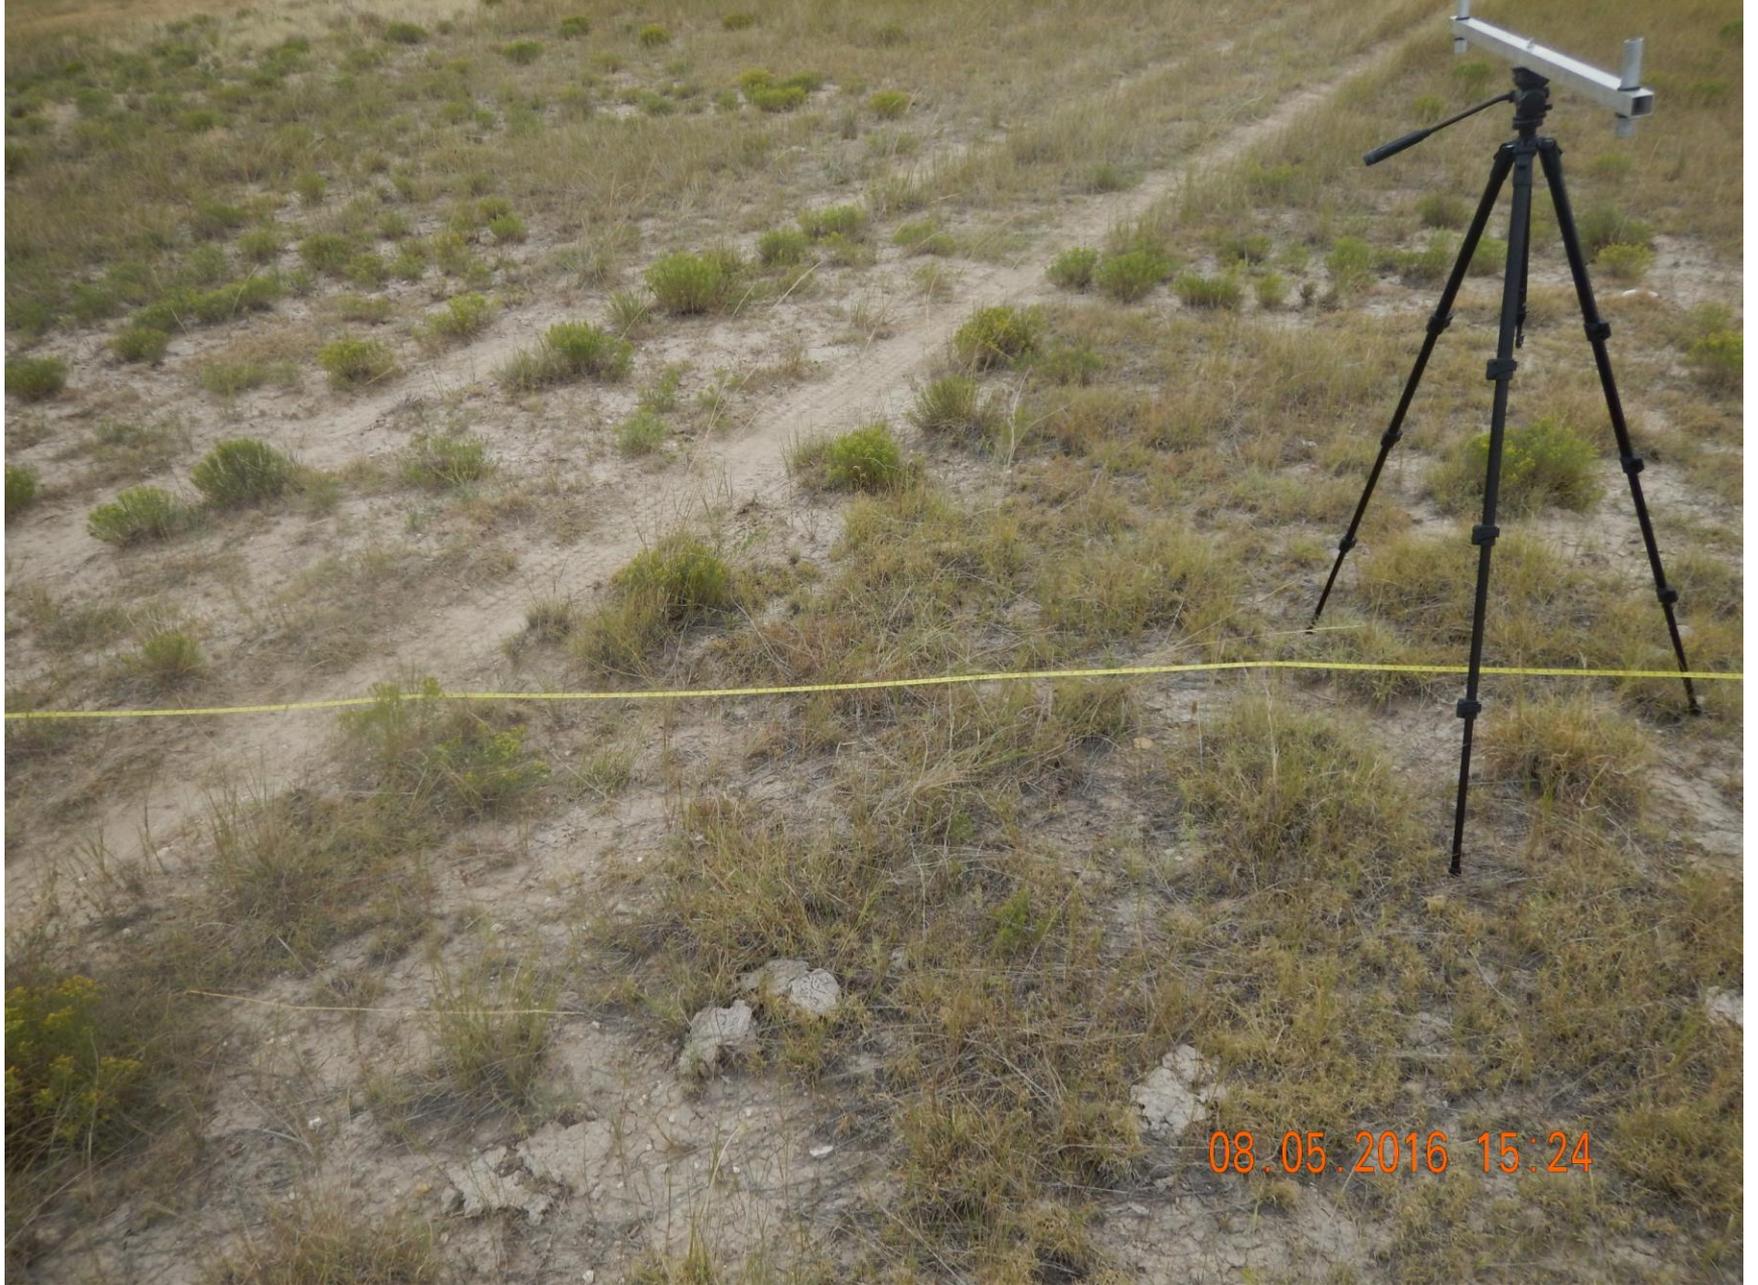
**Figure 3:** Photo of vegetation at the 50th point of the disturbance transect, facing west.

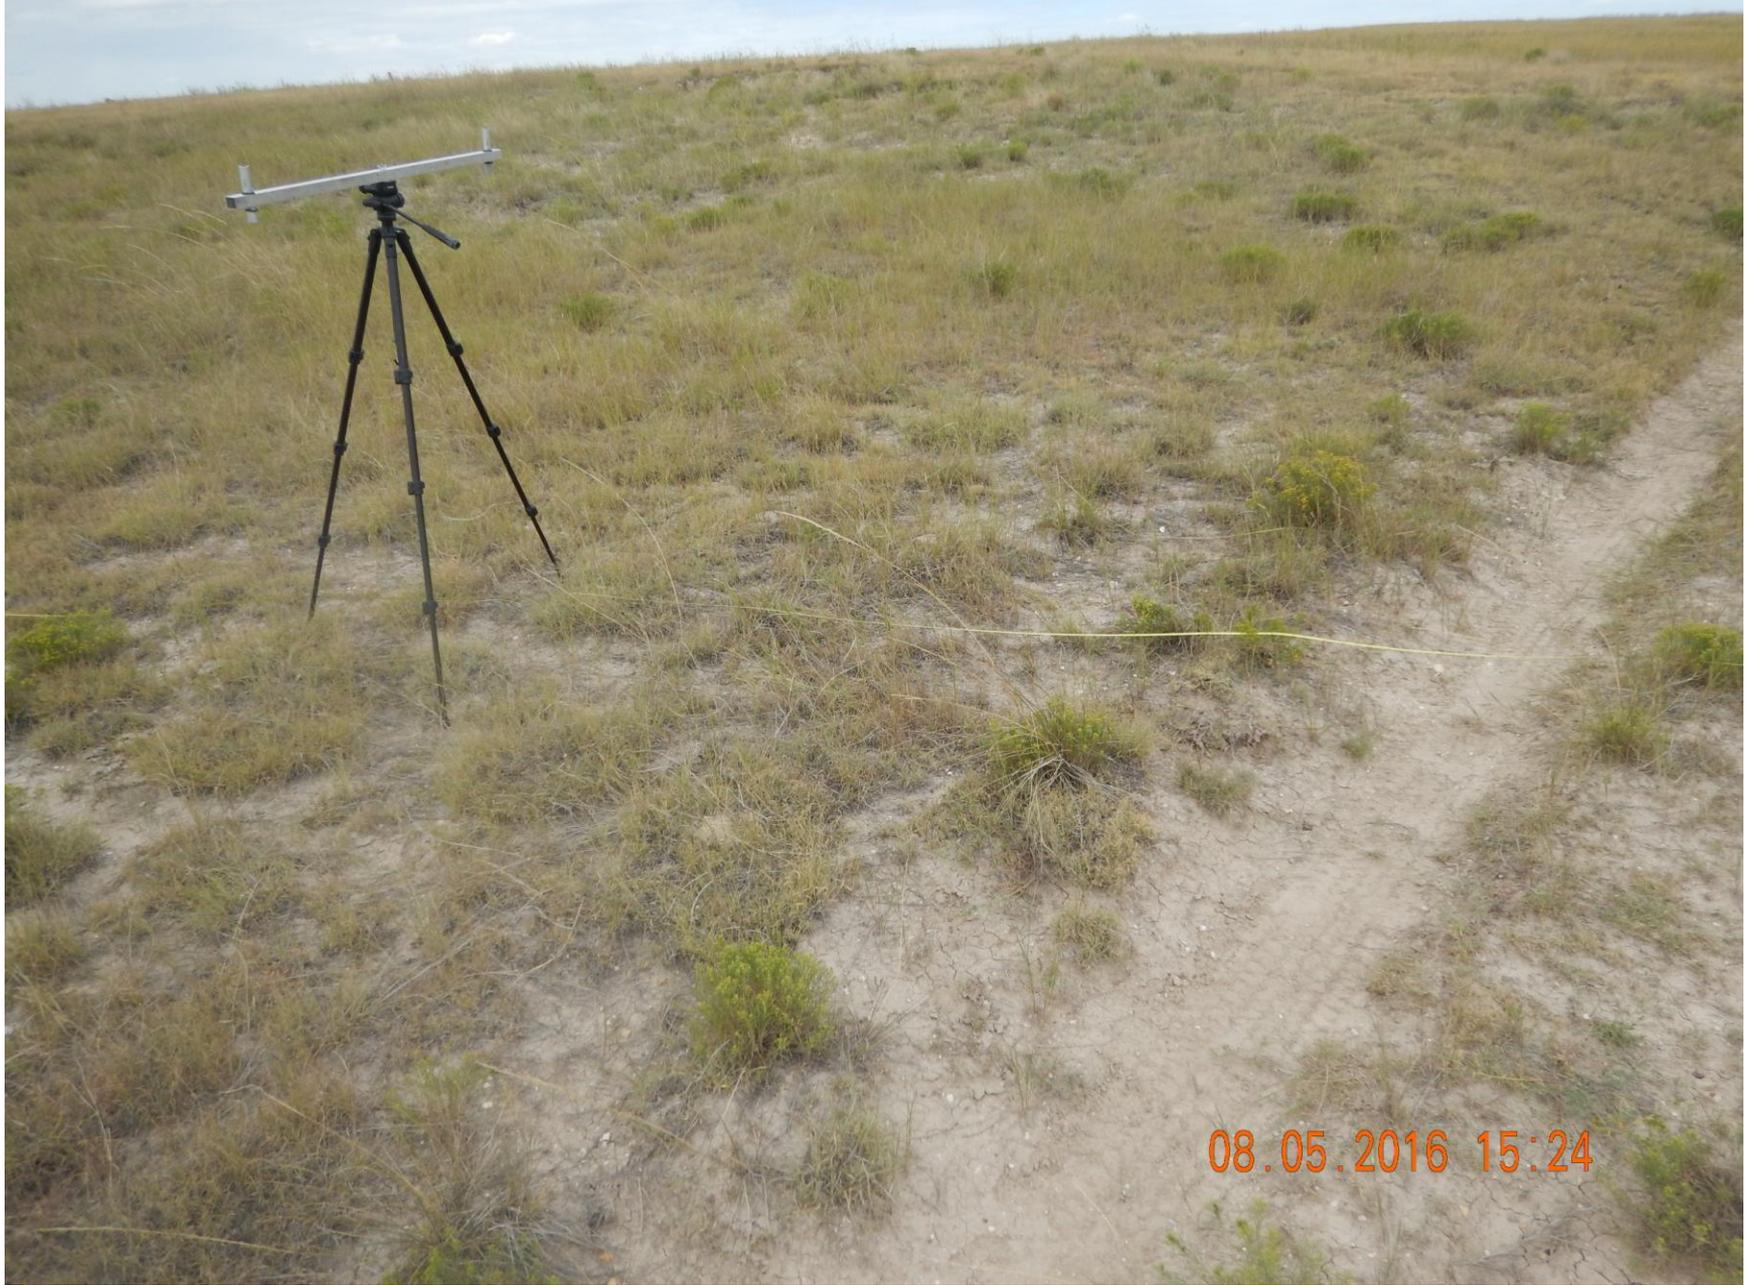
**Figure 4:** Photo of vegetation at the 50th point of the disturbance transect, facing east.

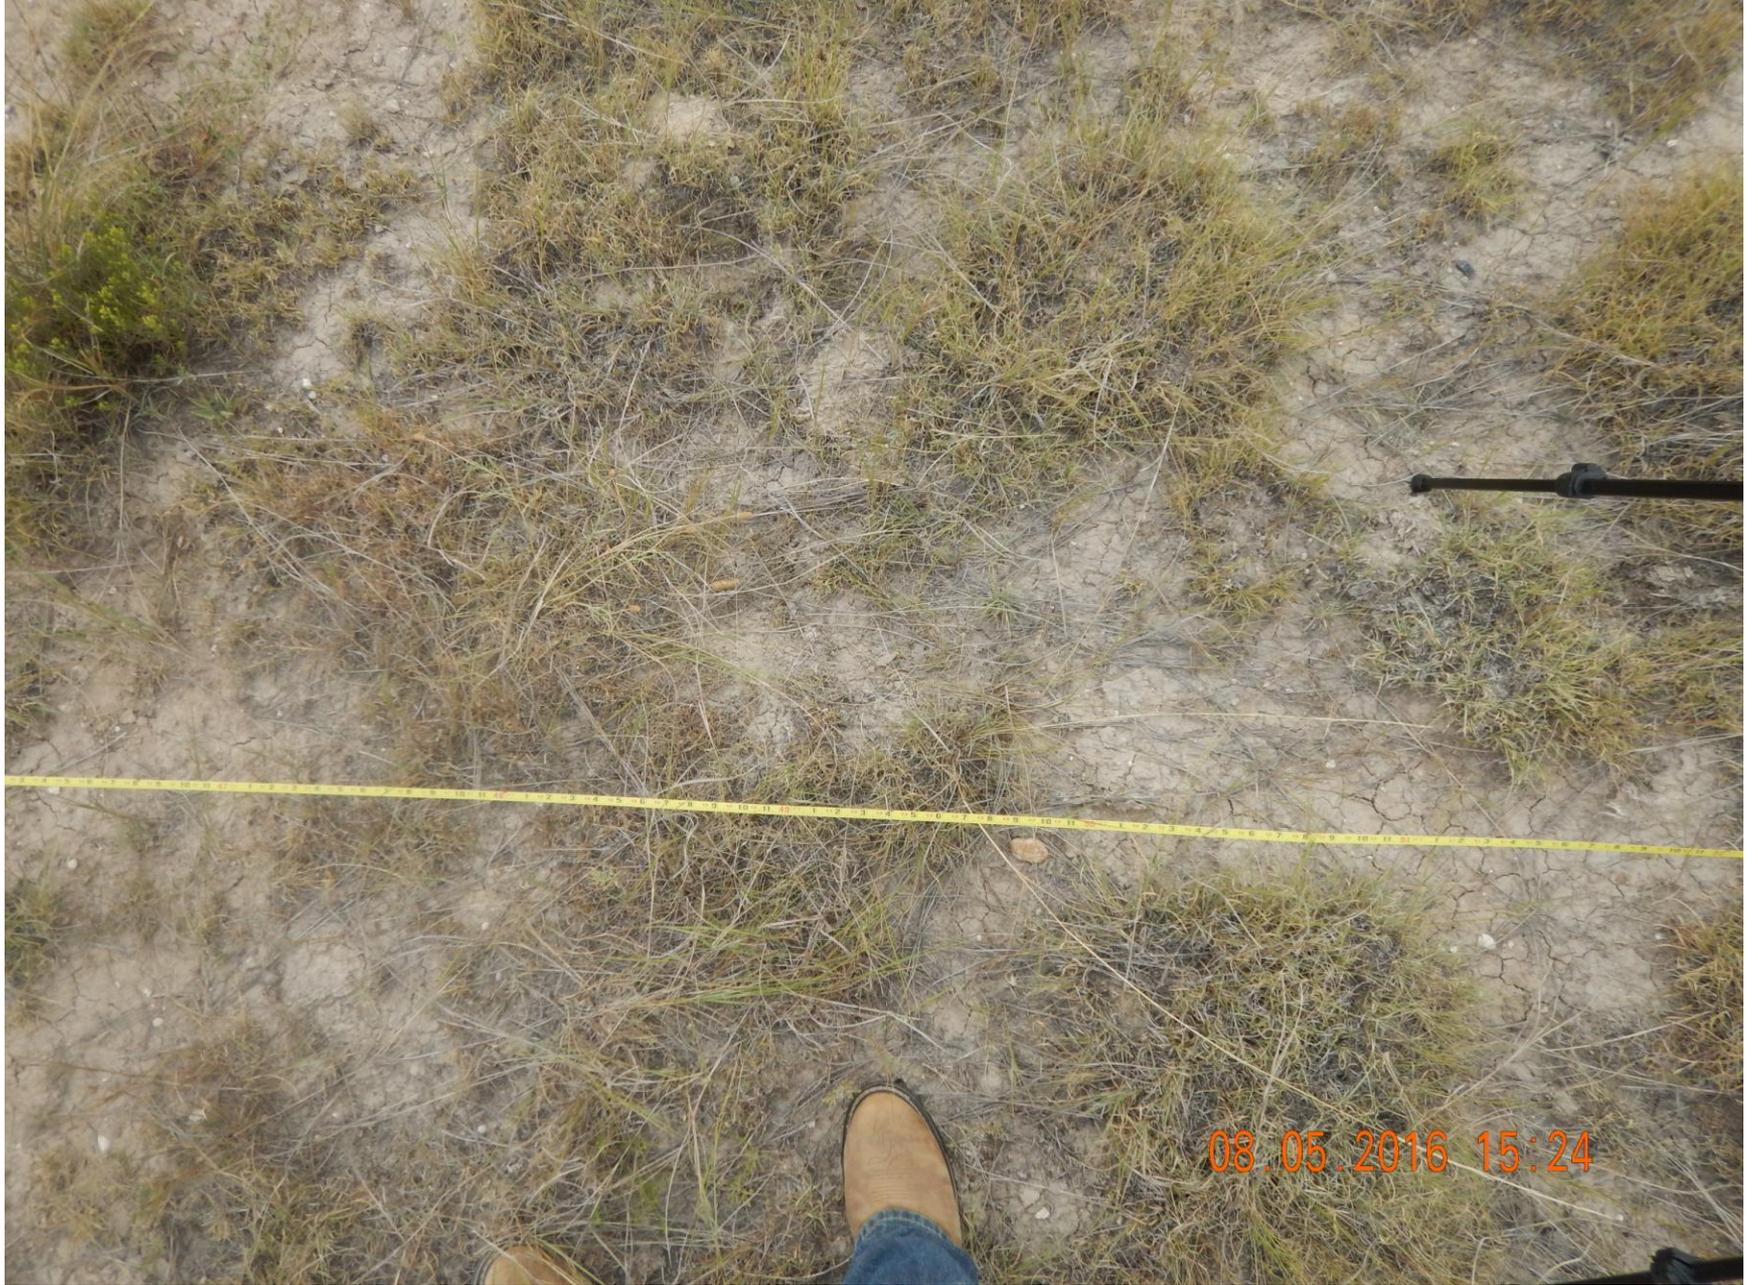
**Figure 5:** Photo of vegetation at the 50th point of the disturbance transect.

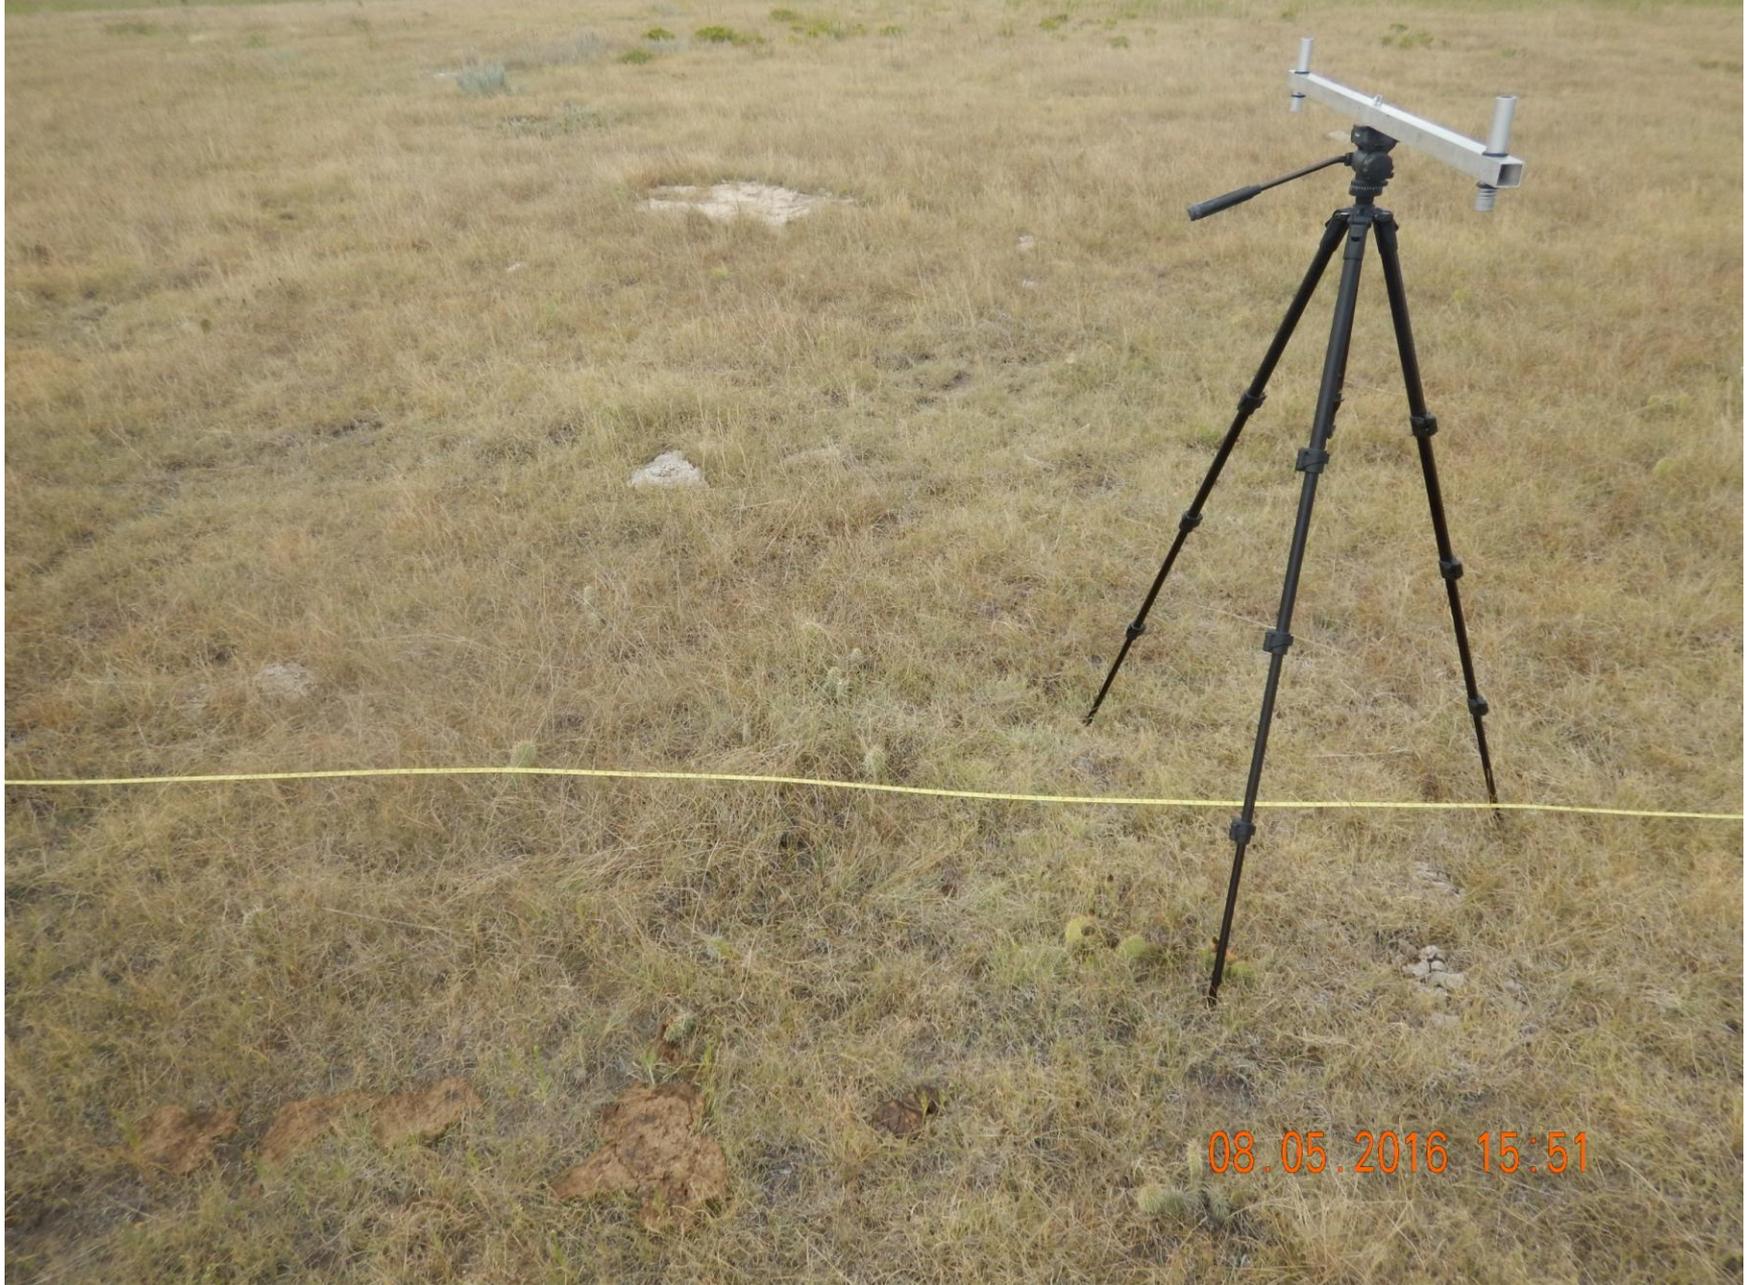
**Figure 8:** Photo of vegetation at the 50th point of the reference transect, facing north.

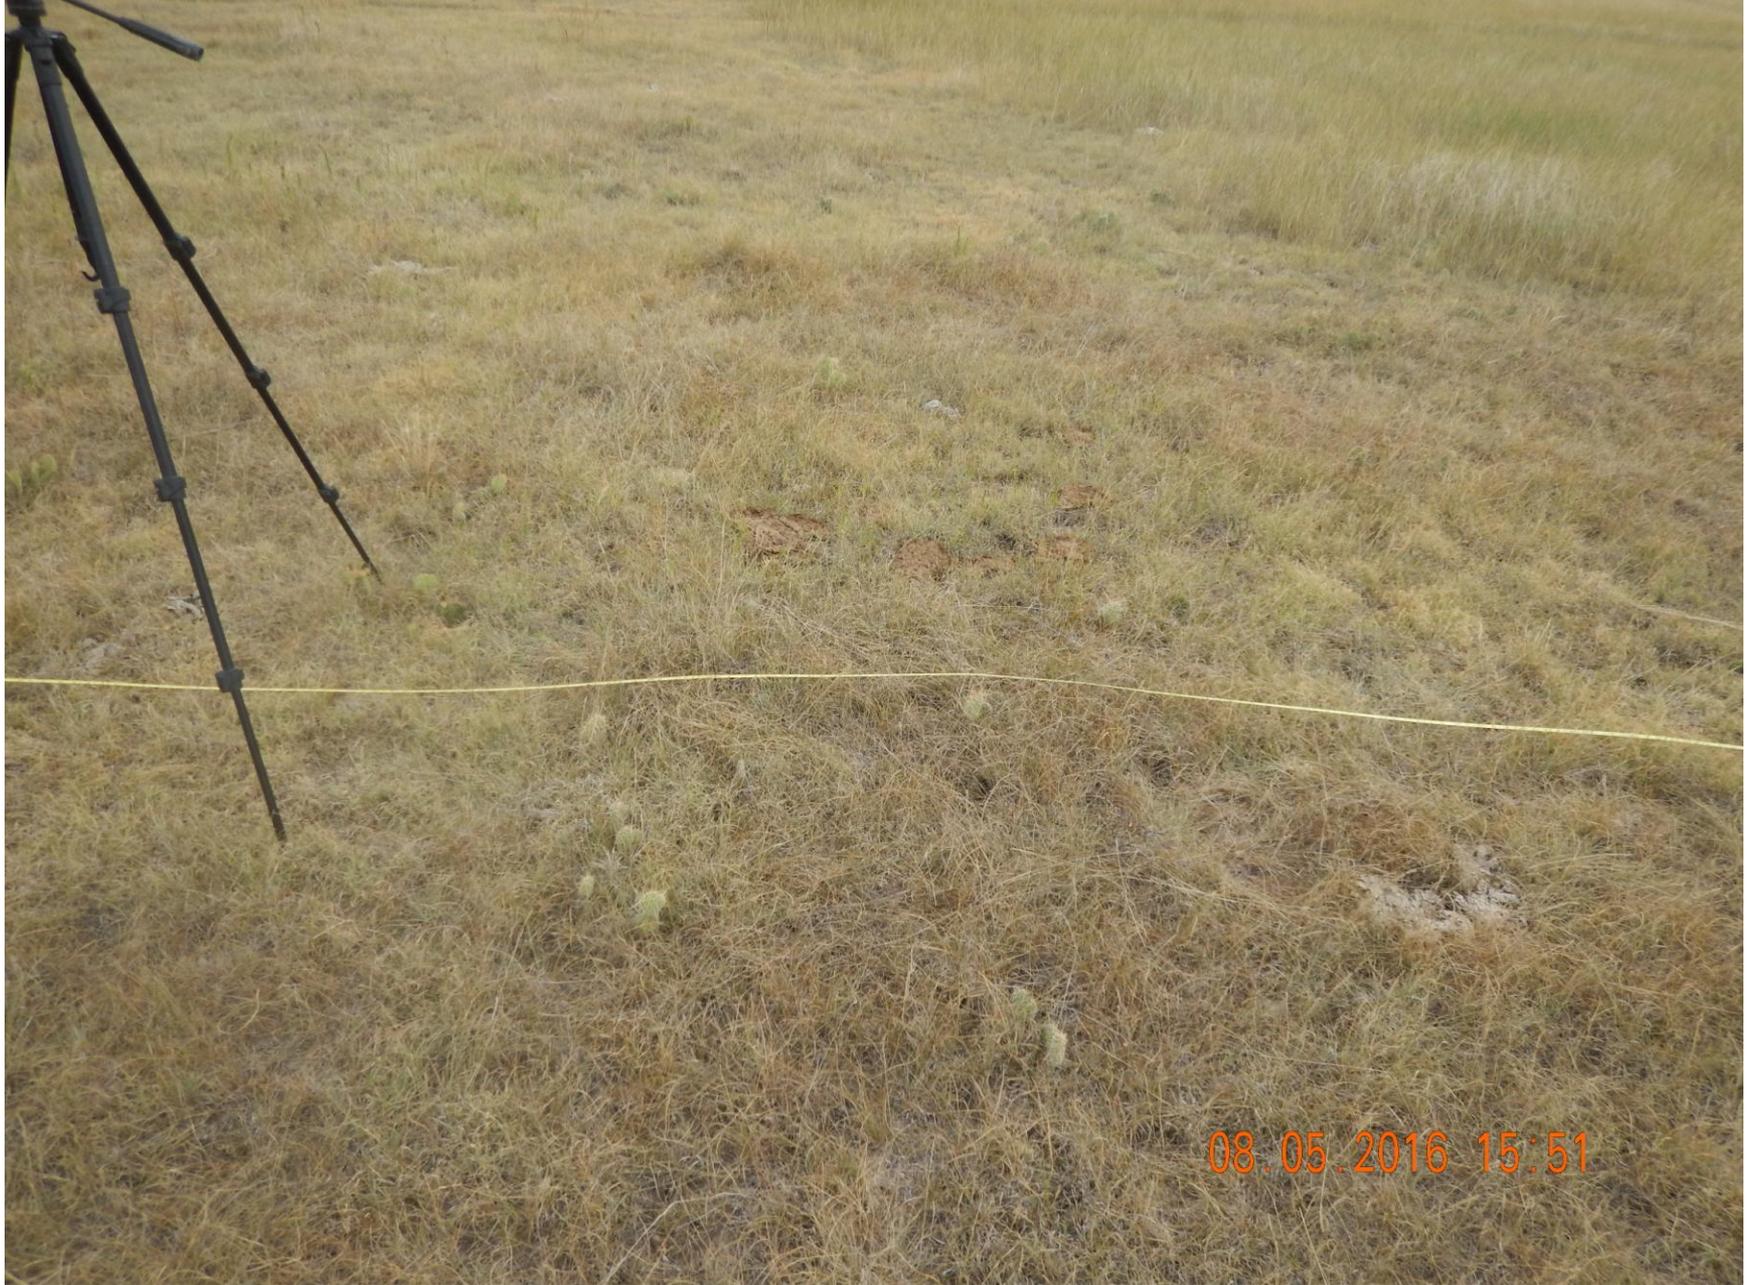
**Figure 9:** Photo of vegetation at the 50th point of the reference transect, facing south.

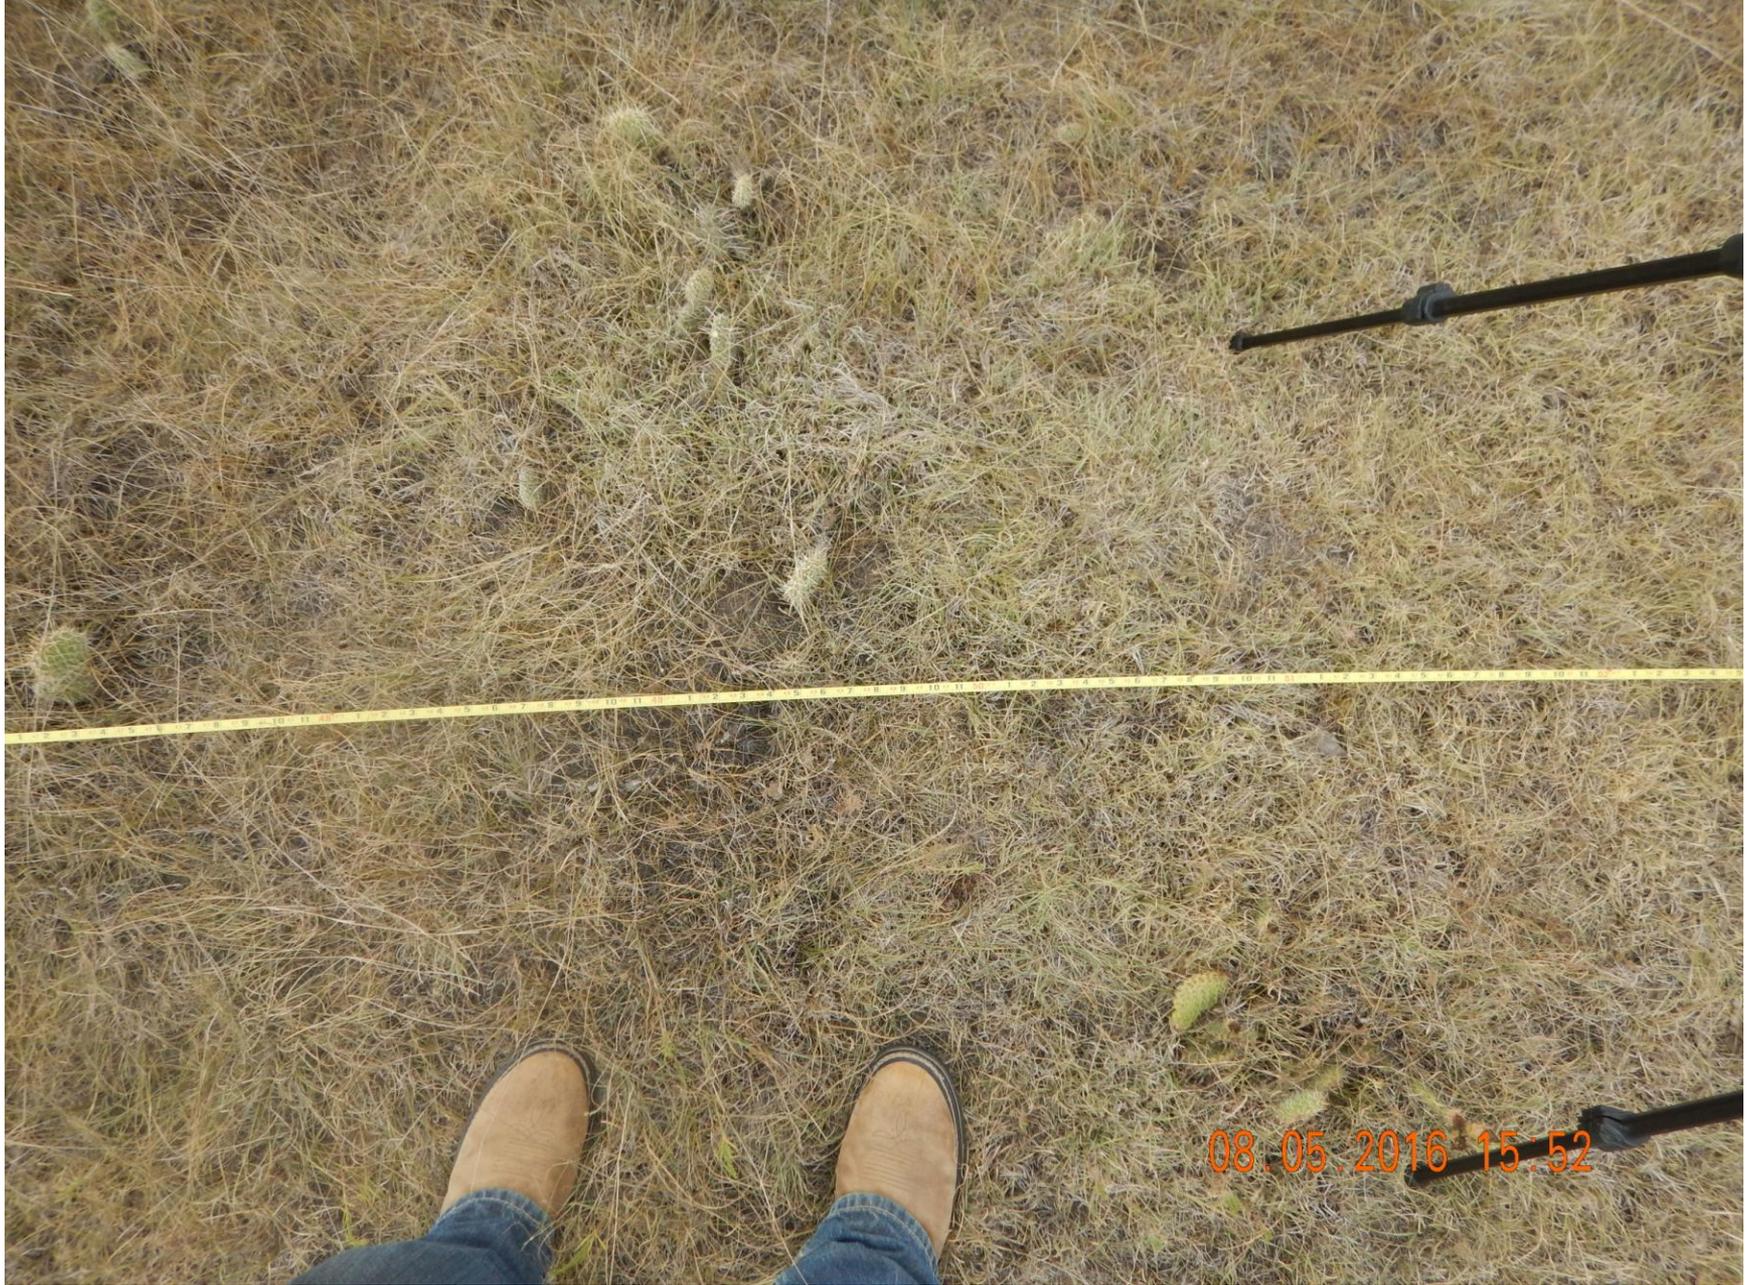
**Figure 10:** Photo of vegetation at the 50th point of the reference transect.

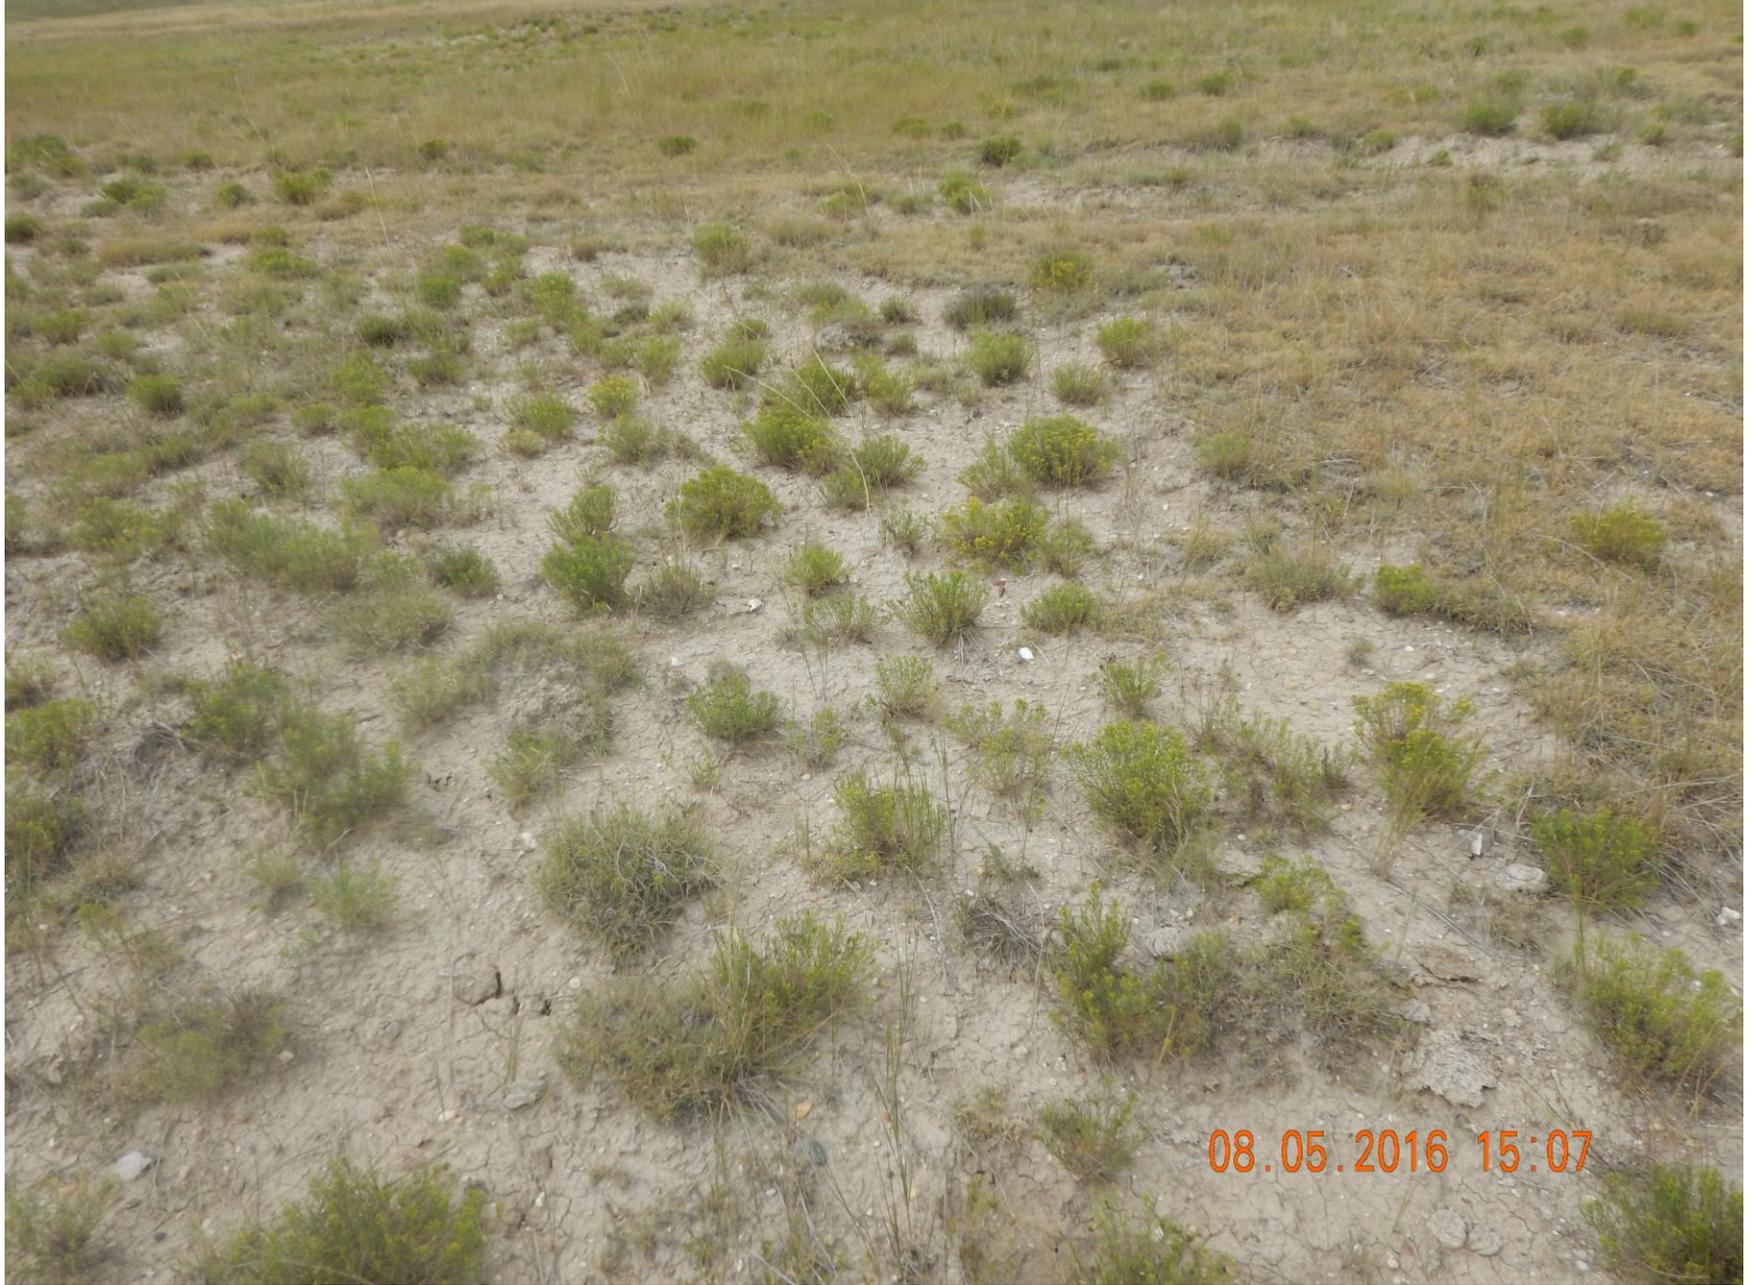
**Figure 12:** Photo taken from the southeast corner of the location, facing north. Photo shows vegetation over the reclamation area. Note vegetation has not achieved uniform cover.

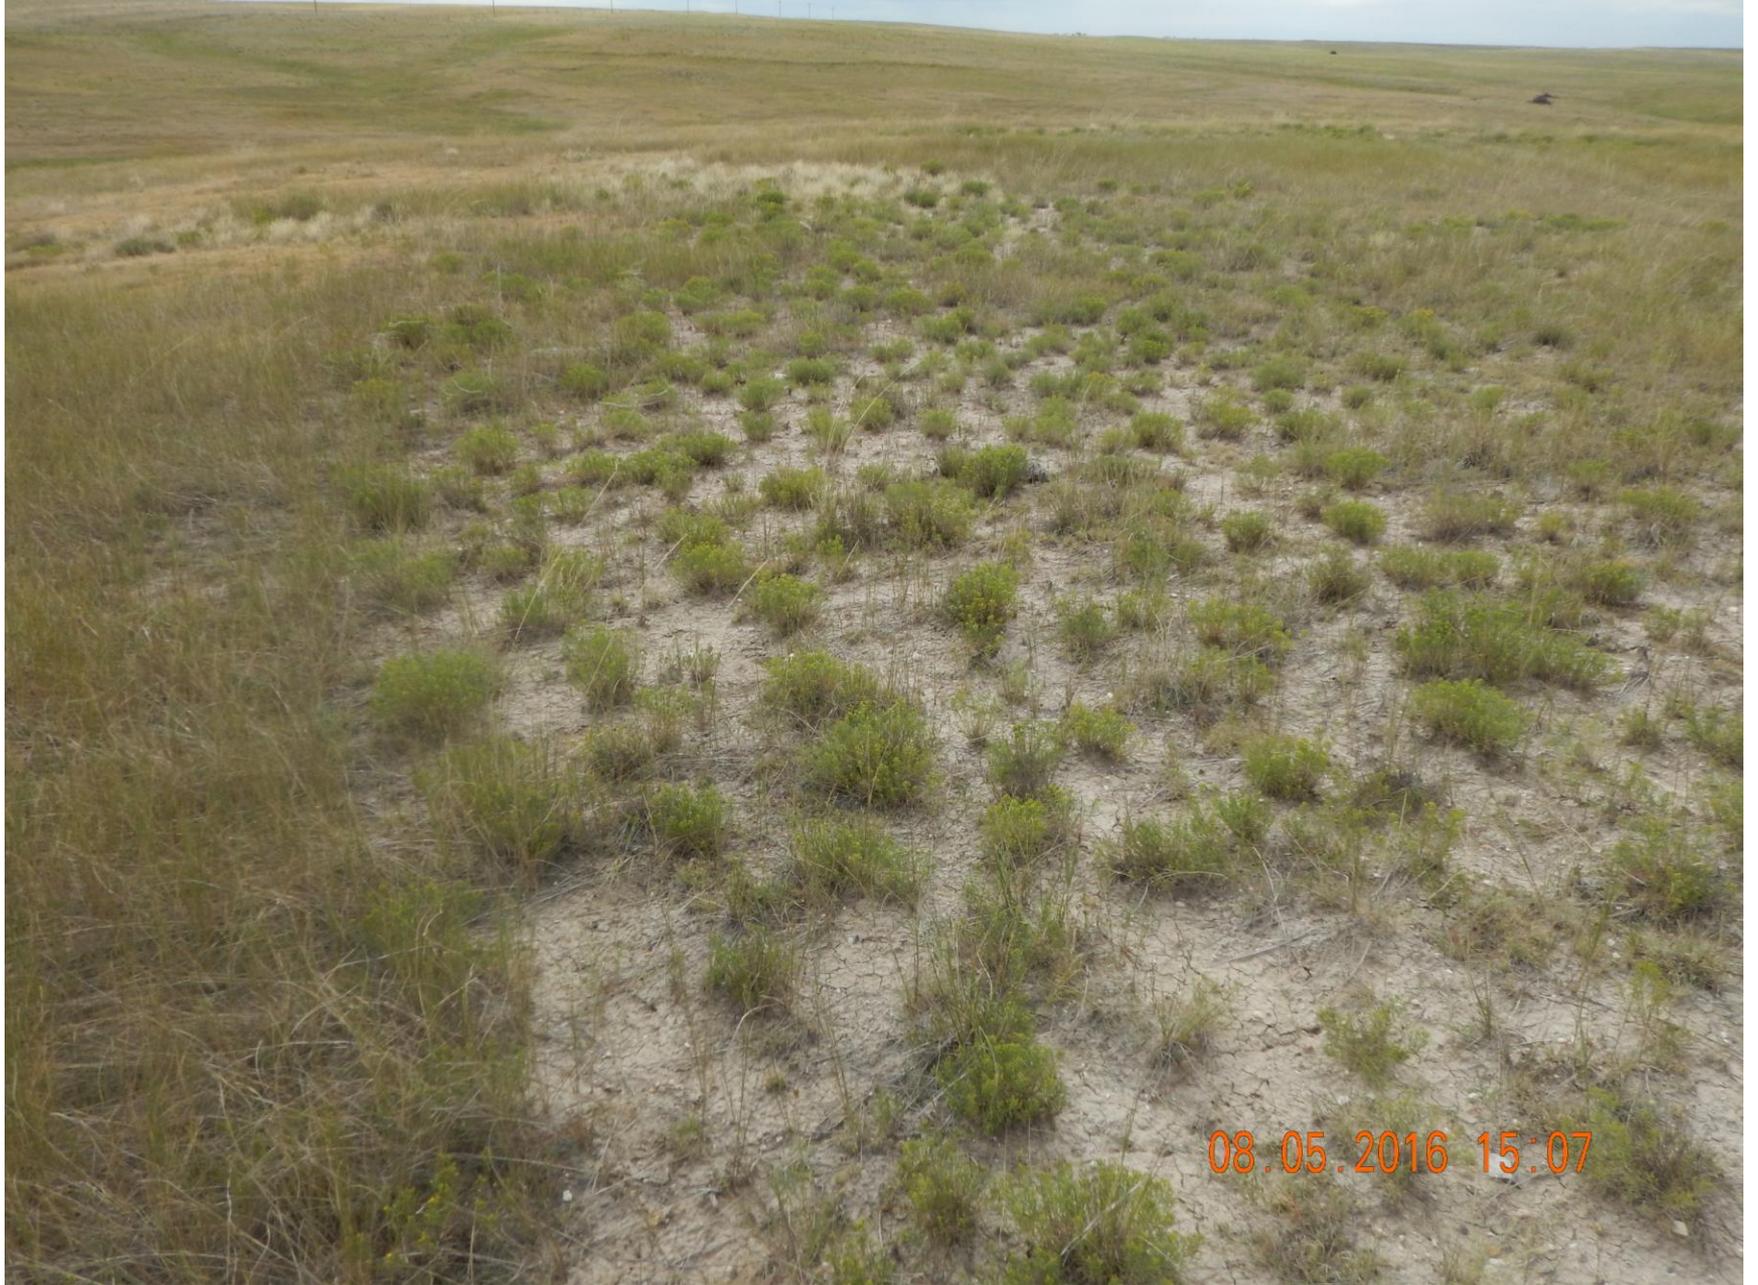
**Figure 13:** Photo taken from the southeast corner of the location, facing west. Photo shows vegetation over the reclamation area. Note vegetation has not achieved uniform cover.

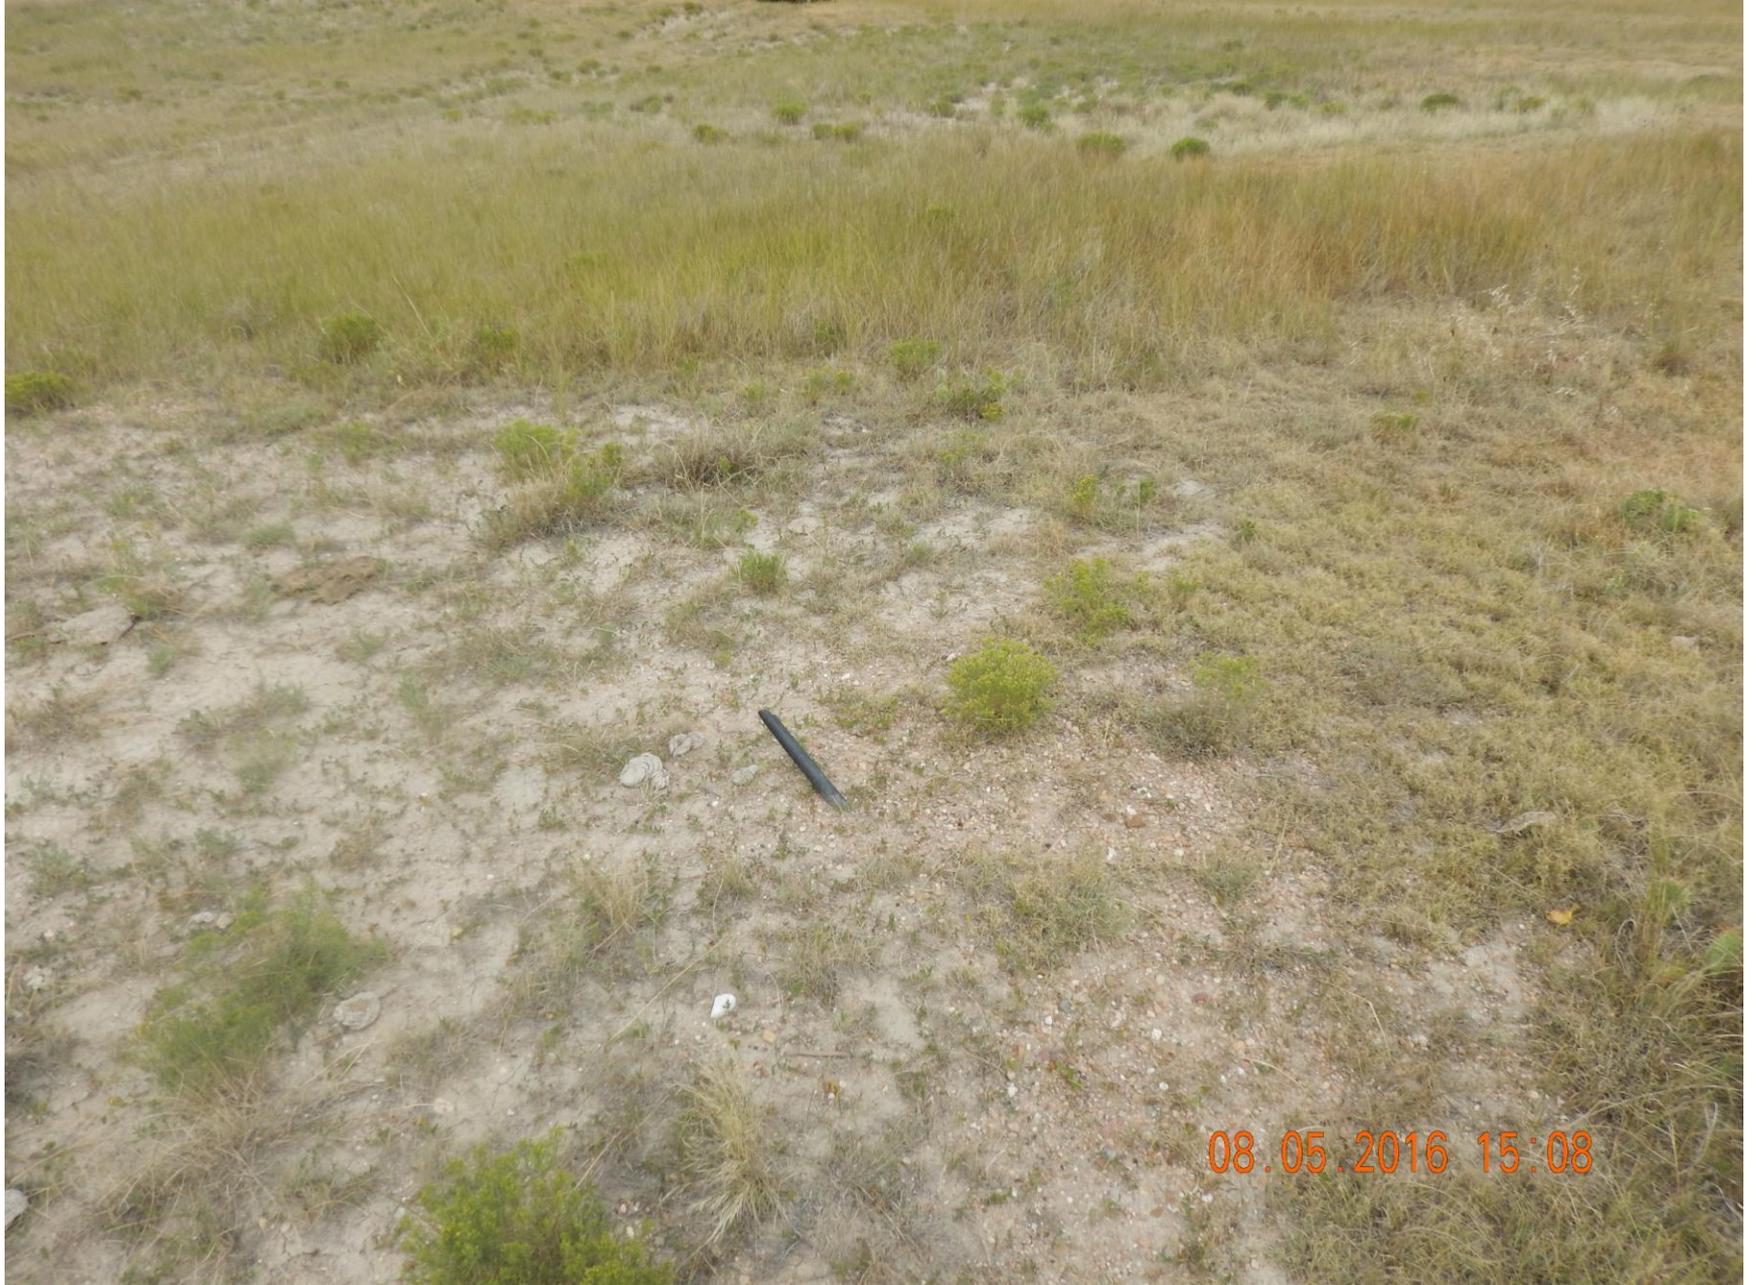
**Figure 14:** Photo taken from the southwest corner of the location, facing east. Photo shows vegetation over the reclamation area. Note vegetation has not achieved uniform cover.

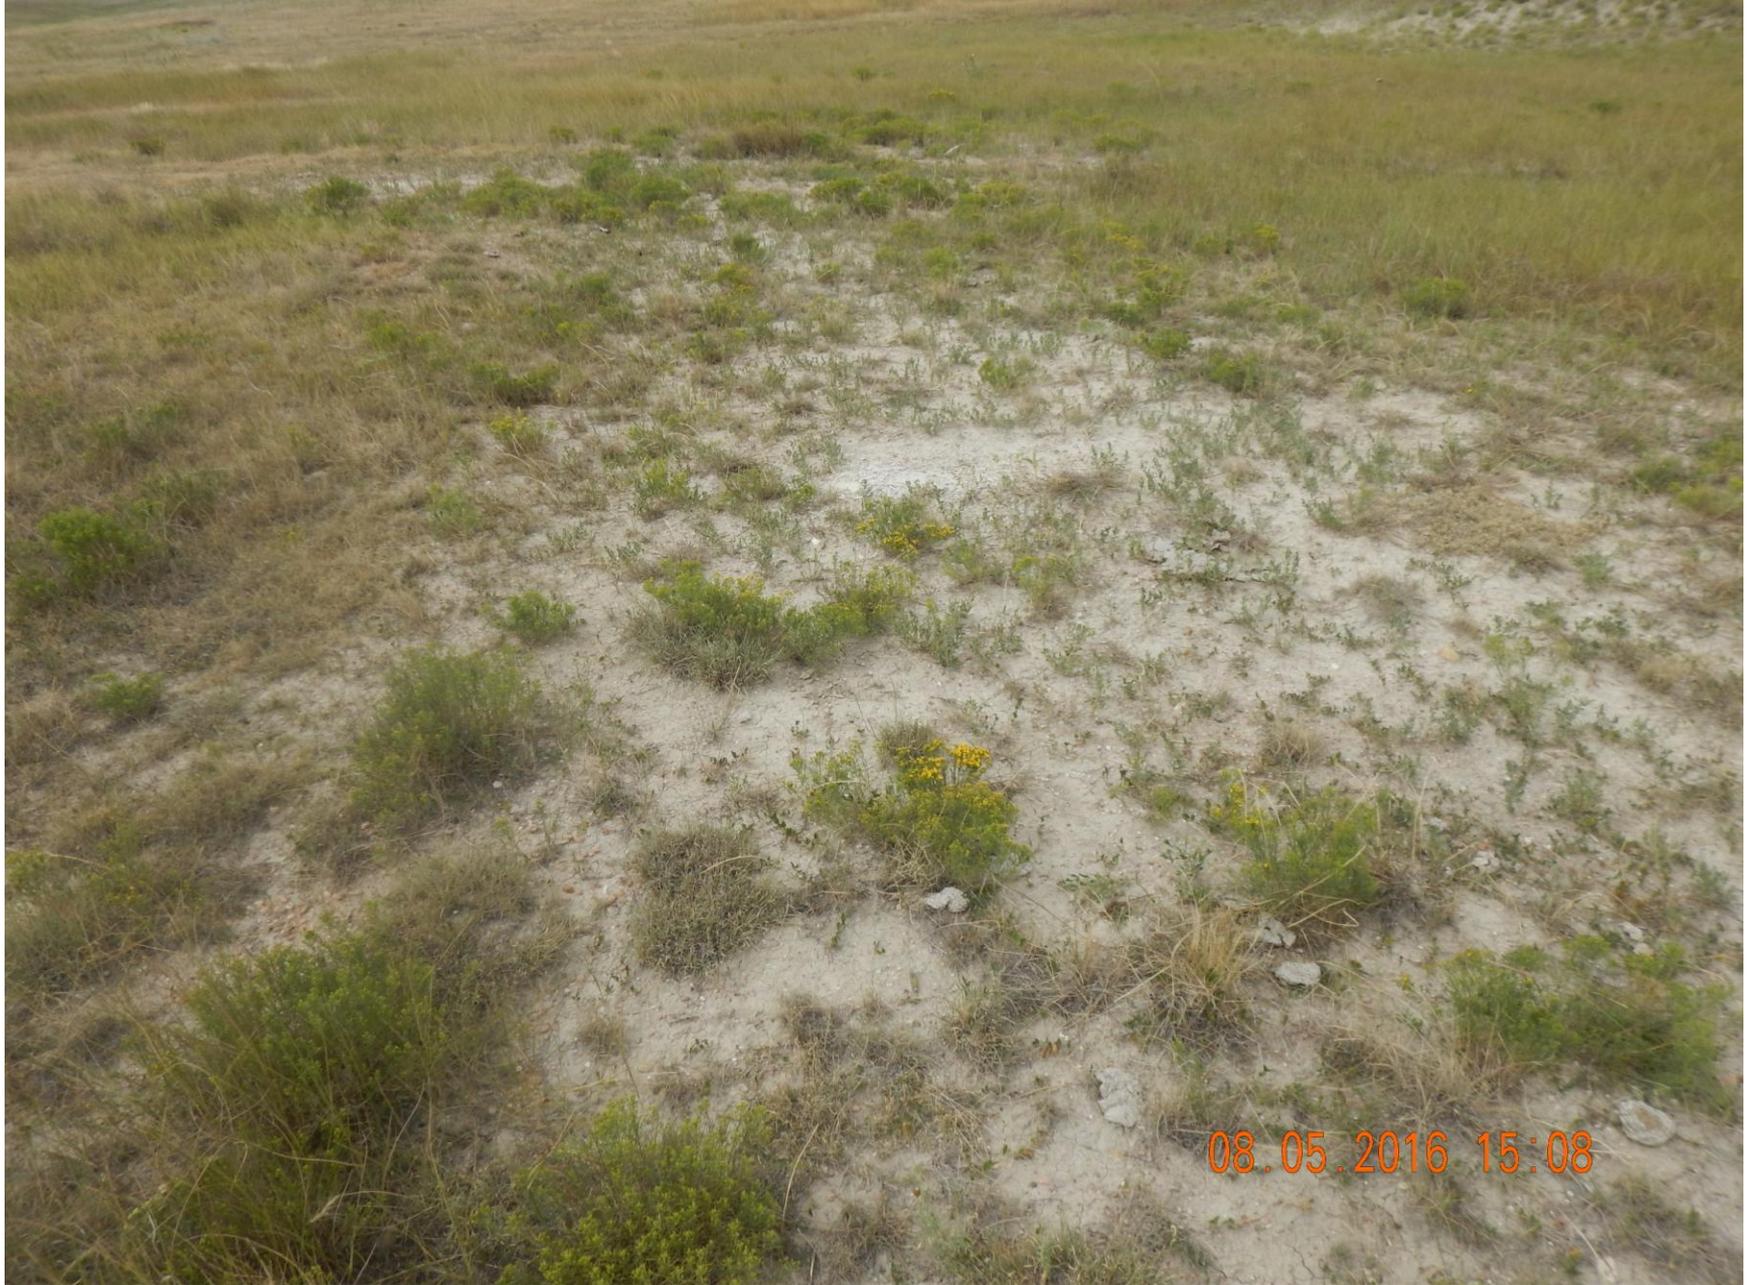
**Figure 15:** Photo taken from the southwest corner of the location, facing north. Photo shows vegetation over the reclamation area. Note vegetation has not achieved uniform cover.
