# Final Reclamation Inspection

08/05/2016

Operator: Markus Production inc.

Location ID: 406198

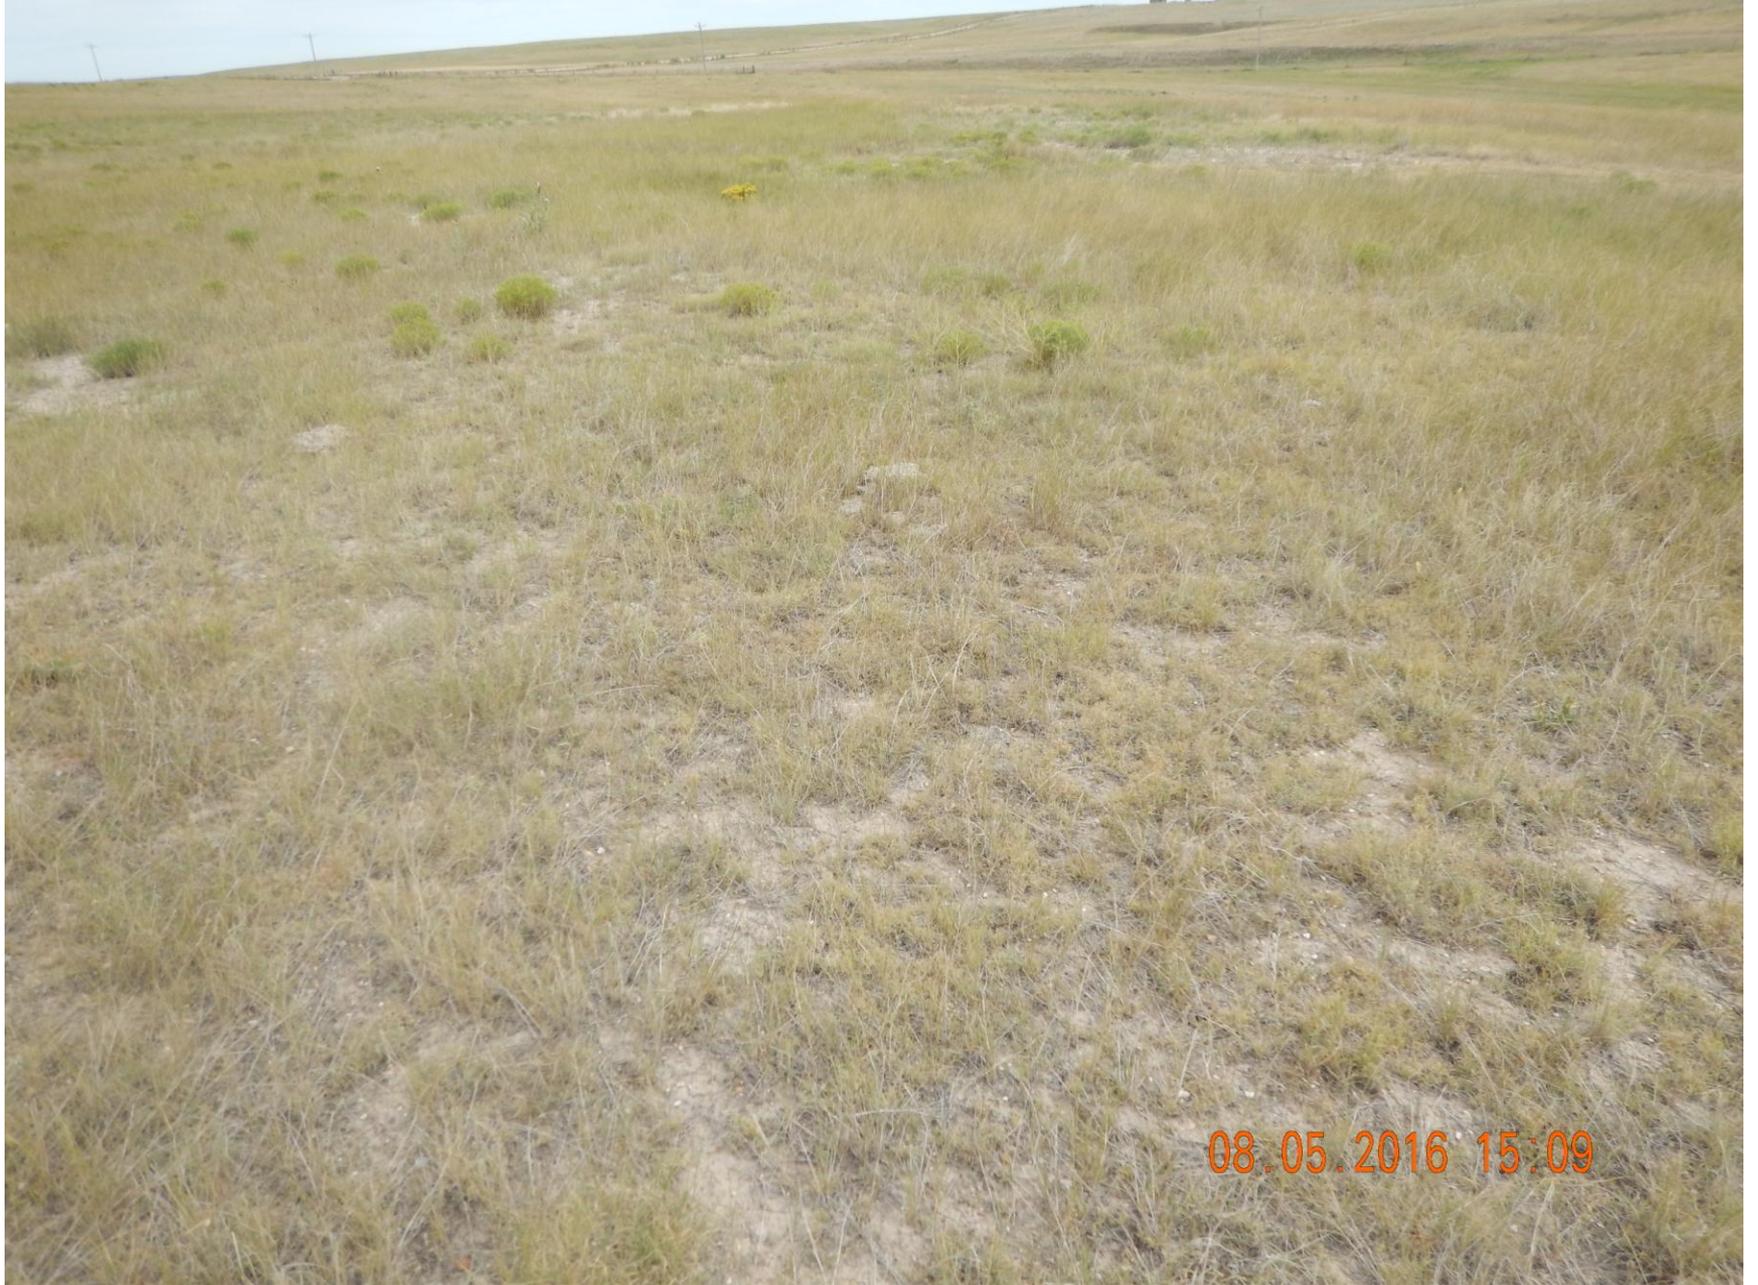
**Figure 16:** Photo taken from the northwest corner of the location, facing south. Photo shows vegetation over the reclamation area.

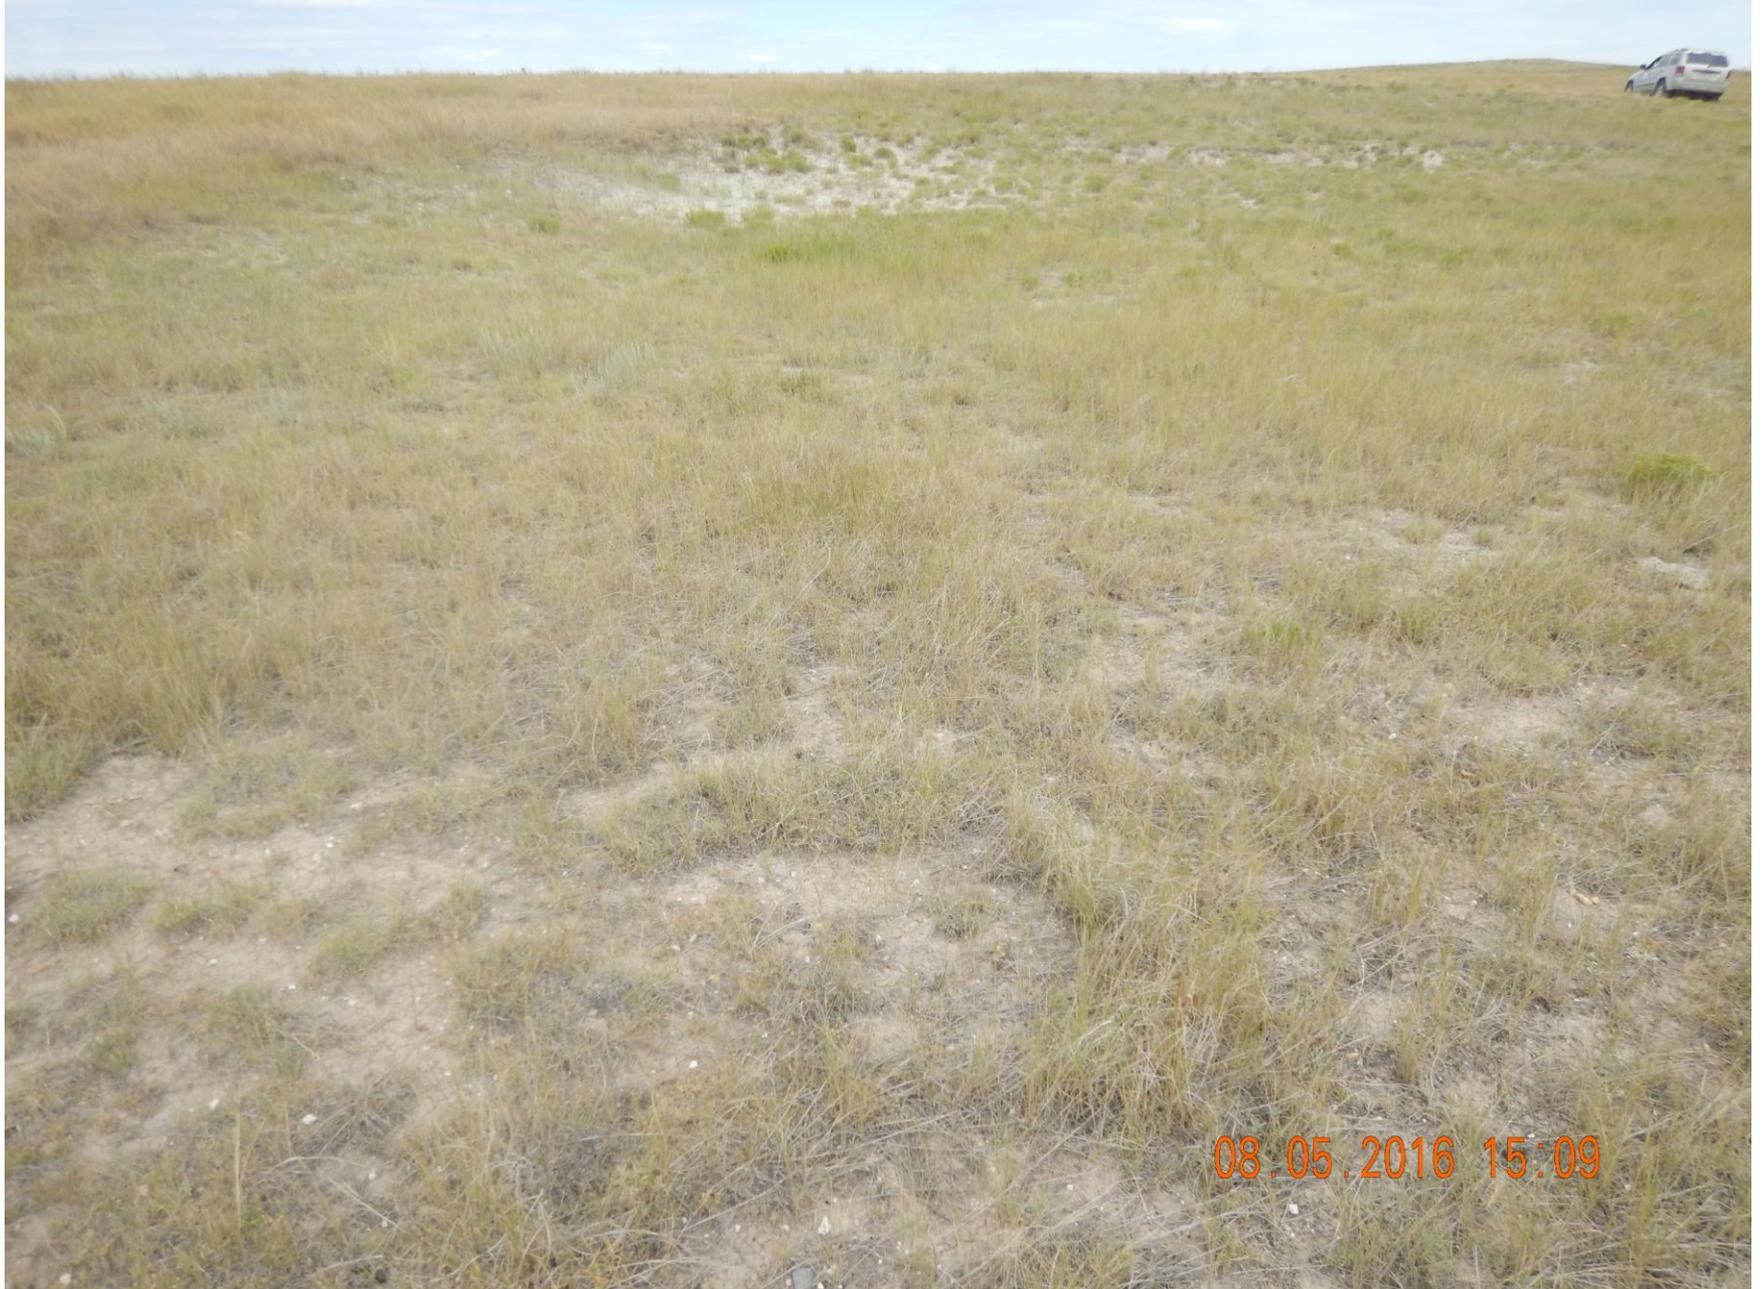
**Figure 17:** Photo taken from the northwest corner of the location, facing east. Photo shows vegetation over the reclamation area. Note vegetation area in the northeast corner experiencing erosion.

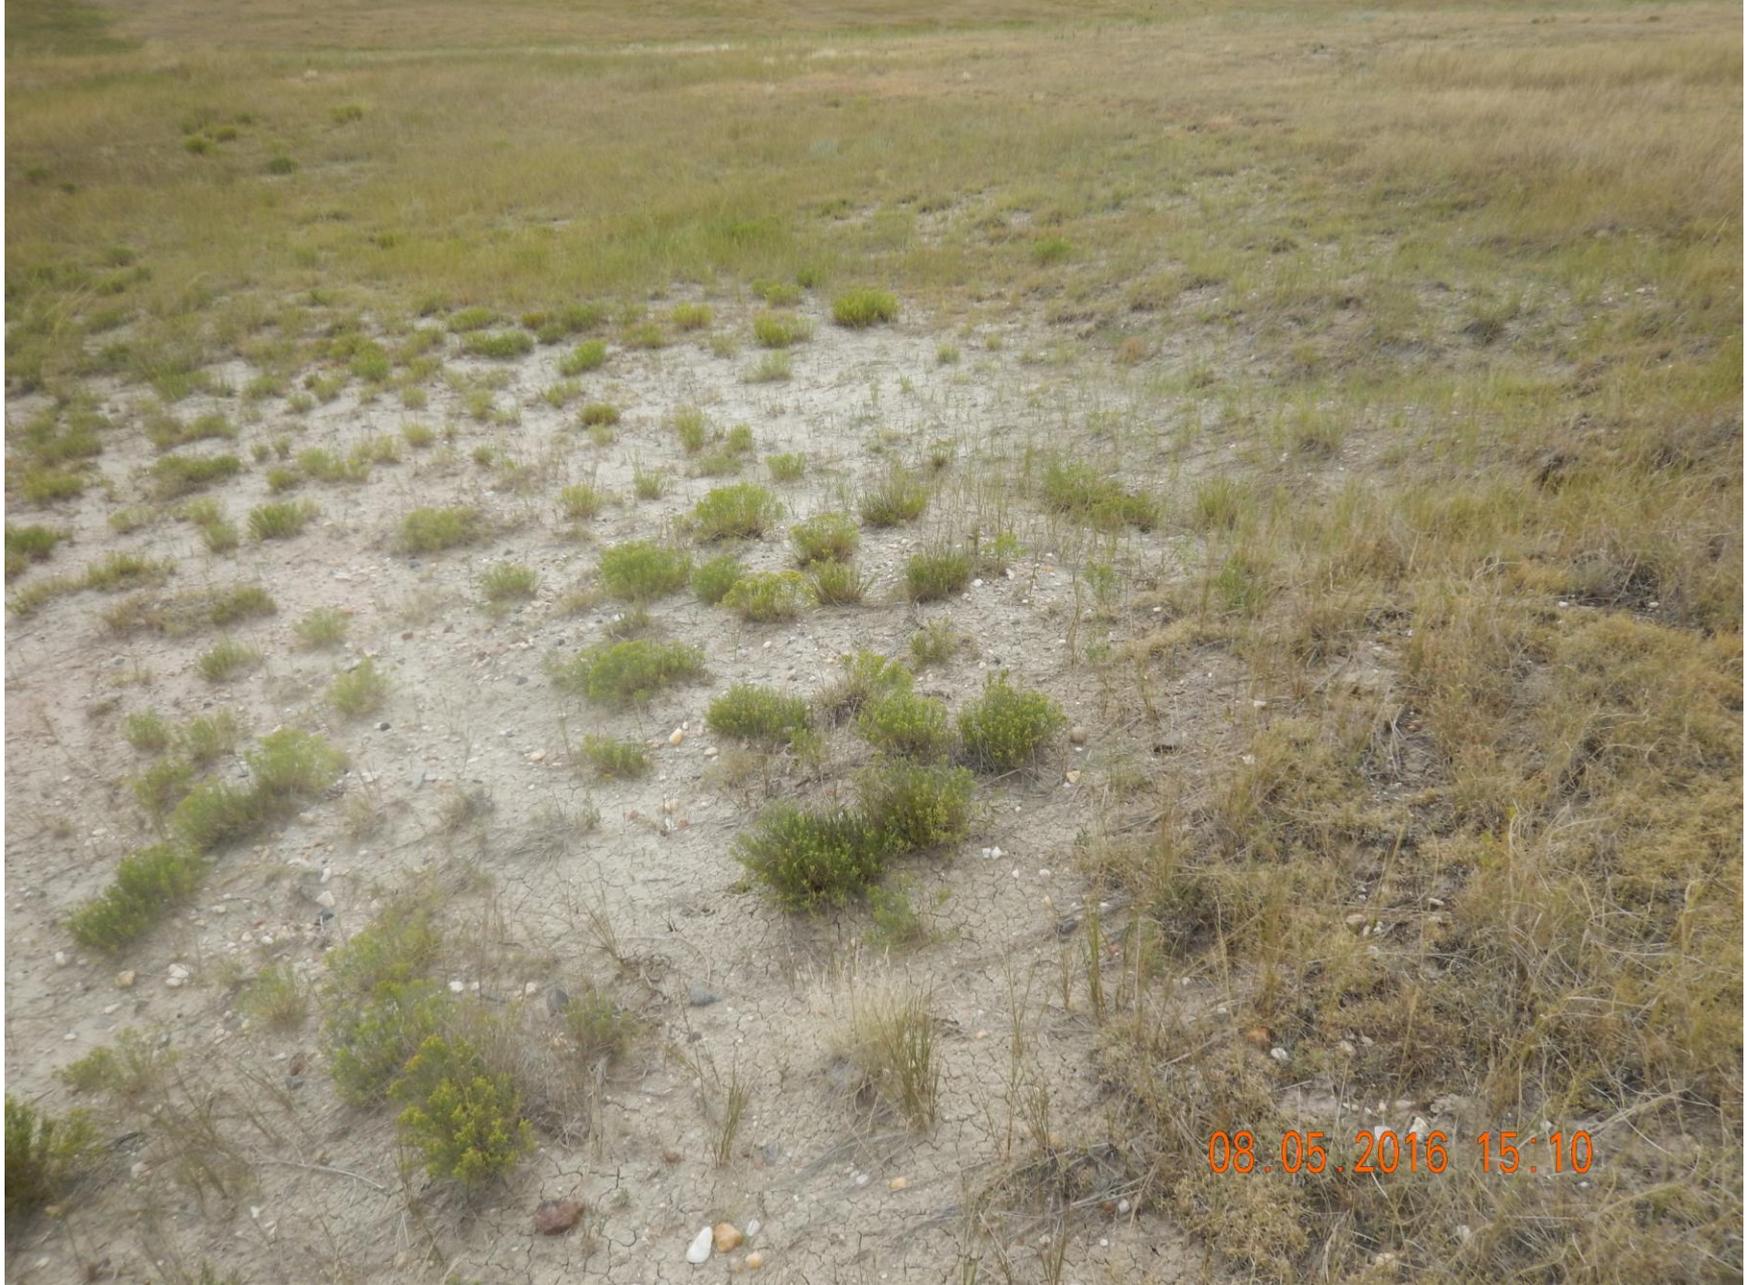
**Figure 18:** Photo taken from the northeast corner of the location, facing east. Photo shows vegetation over the reclamation area. Note area experiencing erosion.

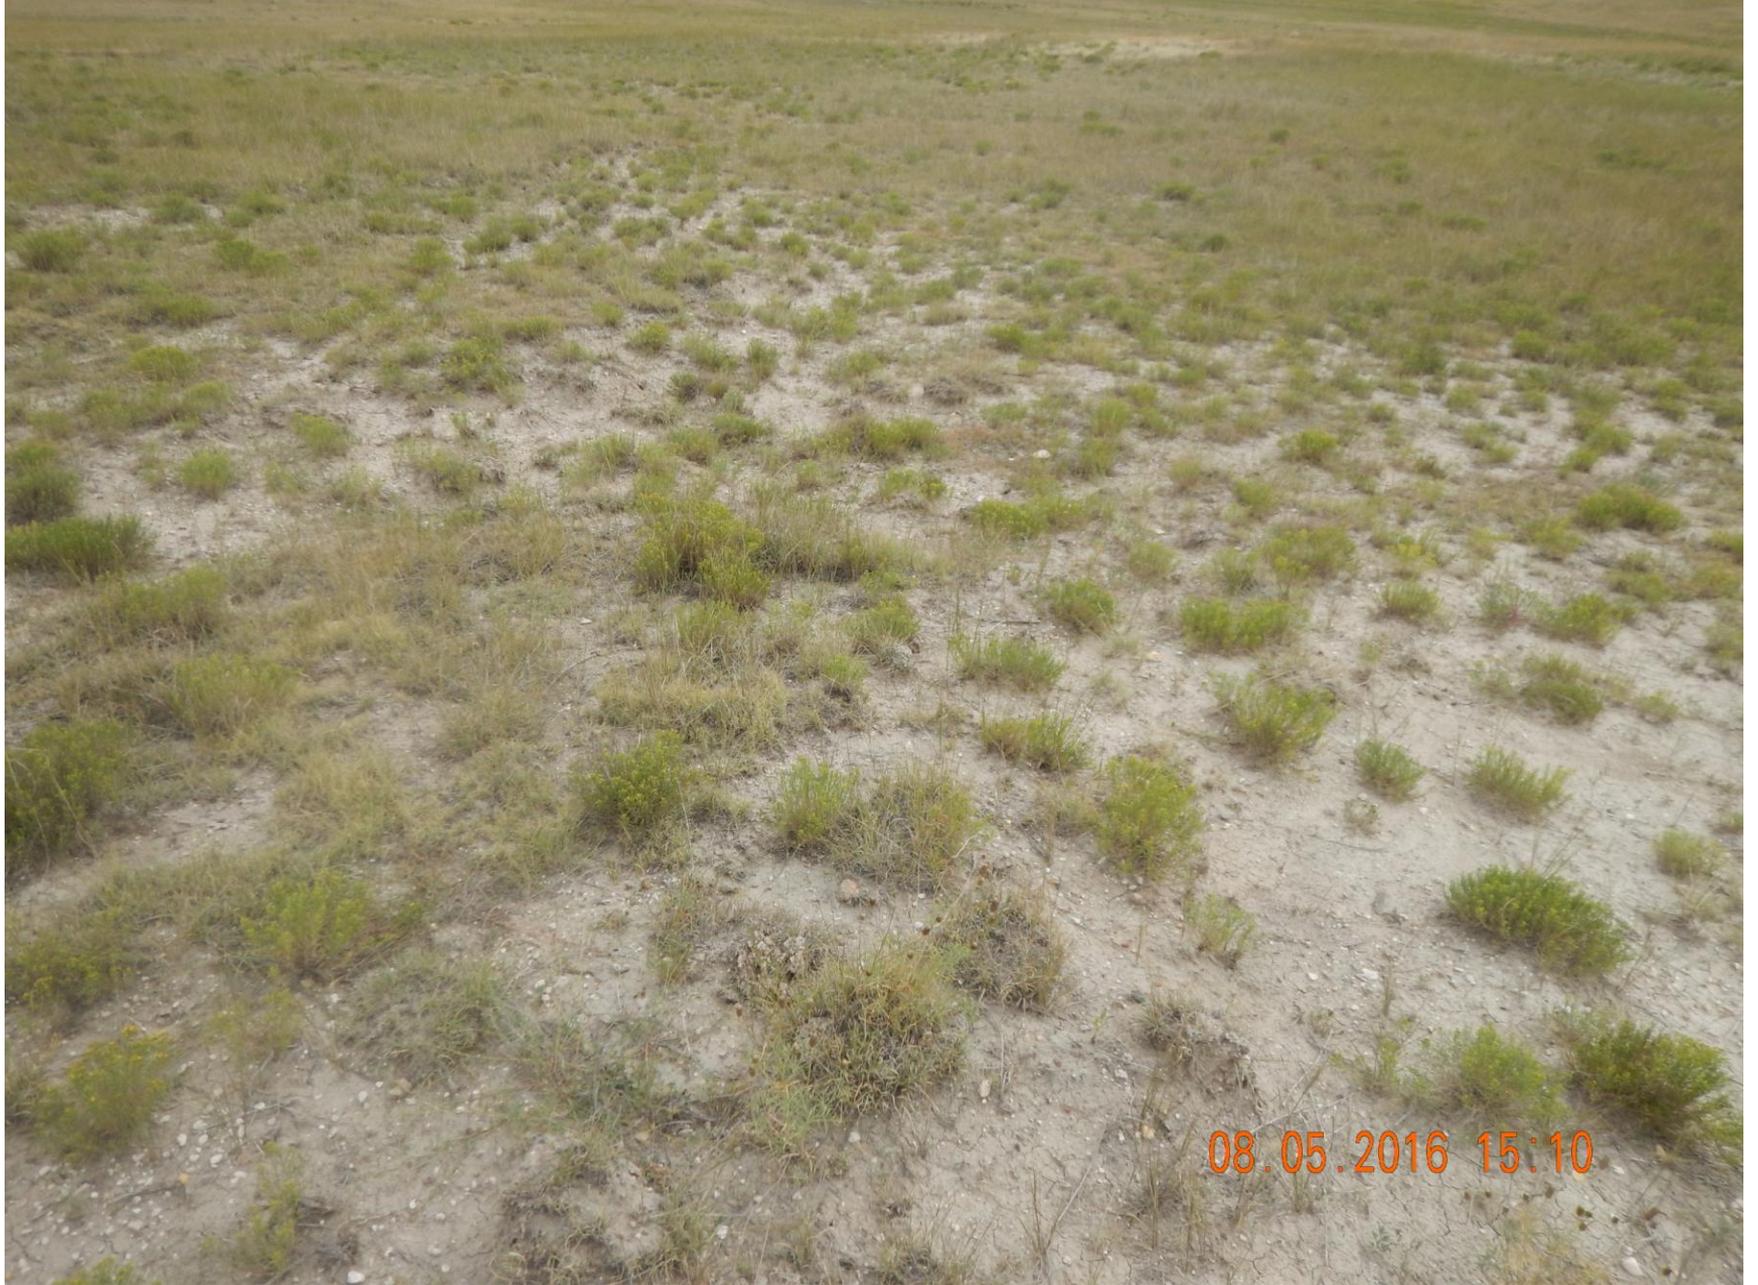
**Figure 19:** Photo taken from the northeast corner of the location, facing south. Photo shows vegetation over the reclamation area. Note area experiencing erosion.
