August 11, 2016

Inspection Photos: Mustang PR API# 045-06567 : Complaint

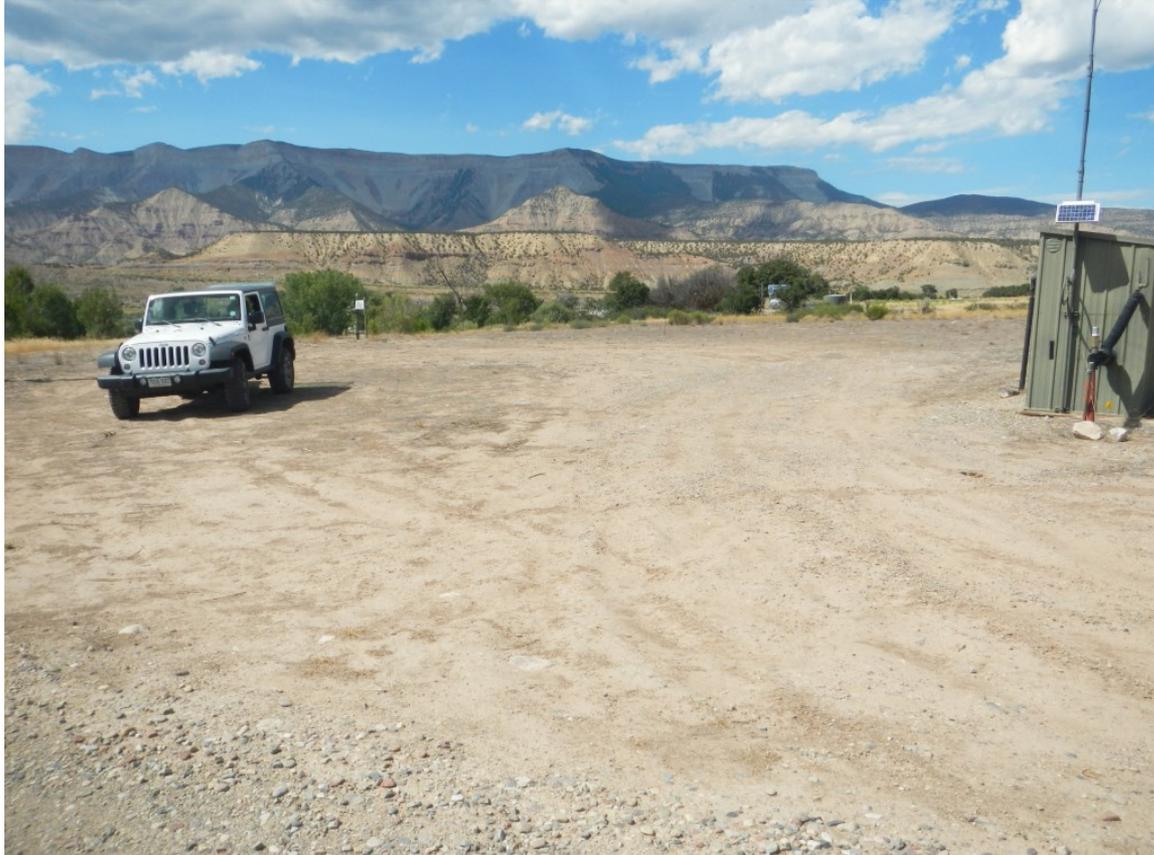
Photo#1: View to North of Location from Entry.

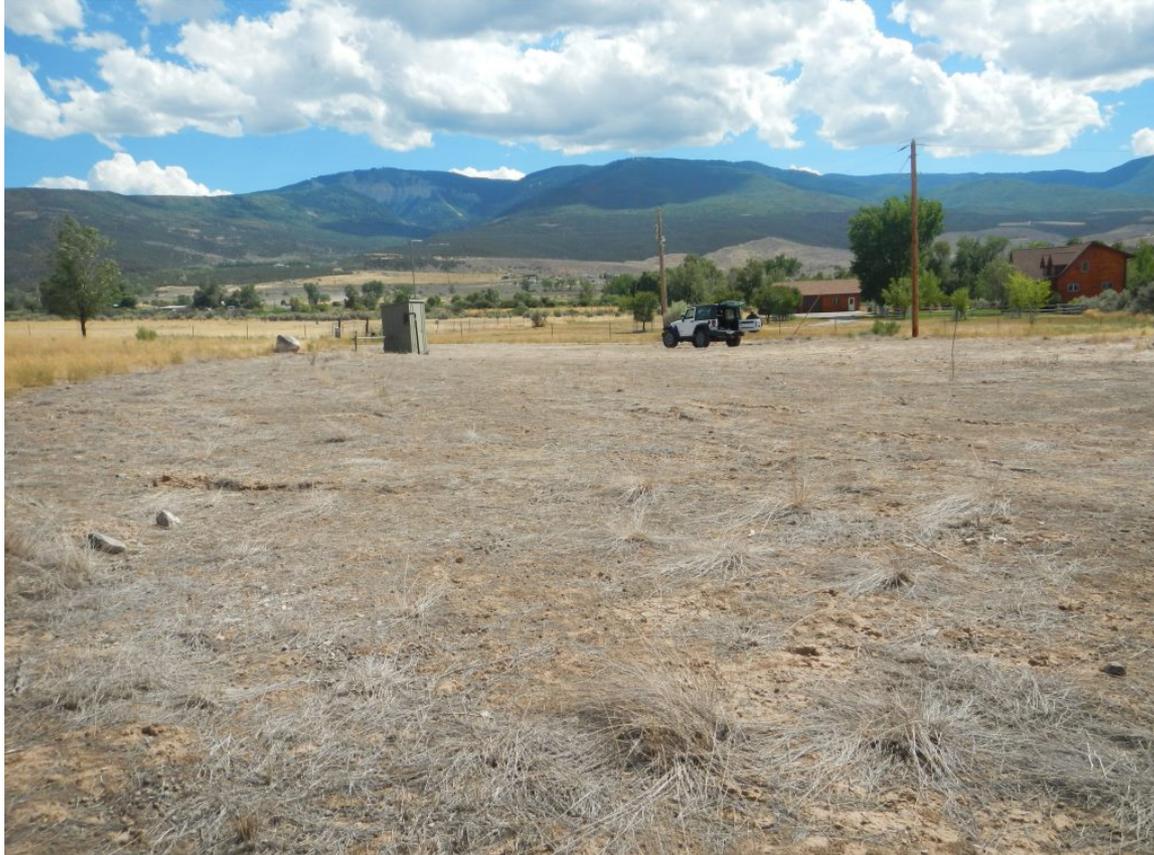
Photo#2: View over Location to South.

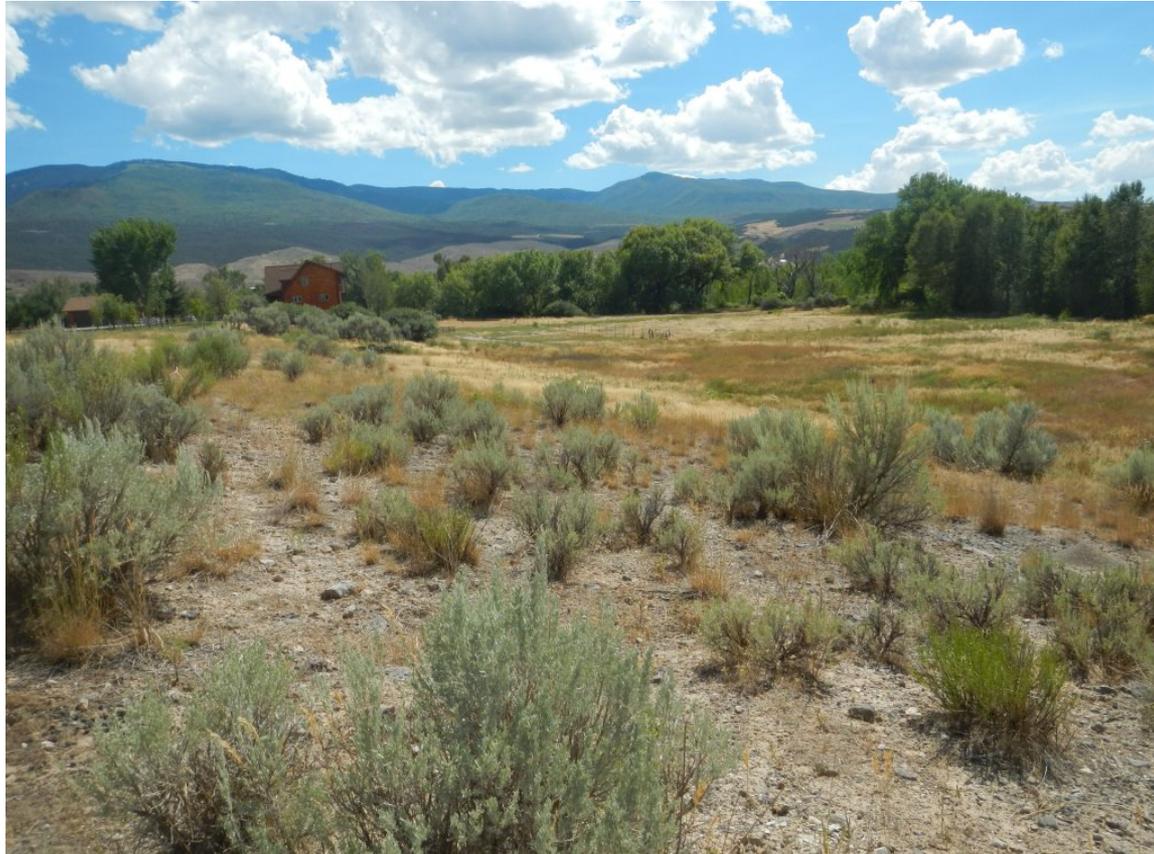
Photo#3: Field of Concern adjacent and SW of Location.

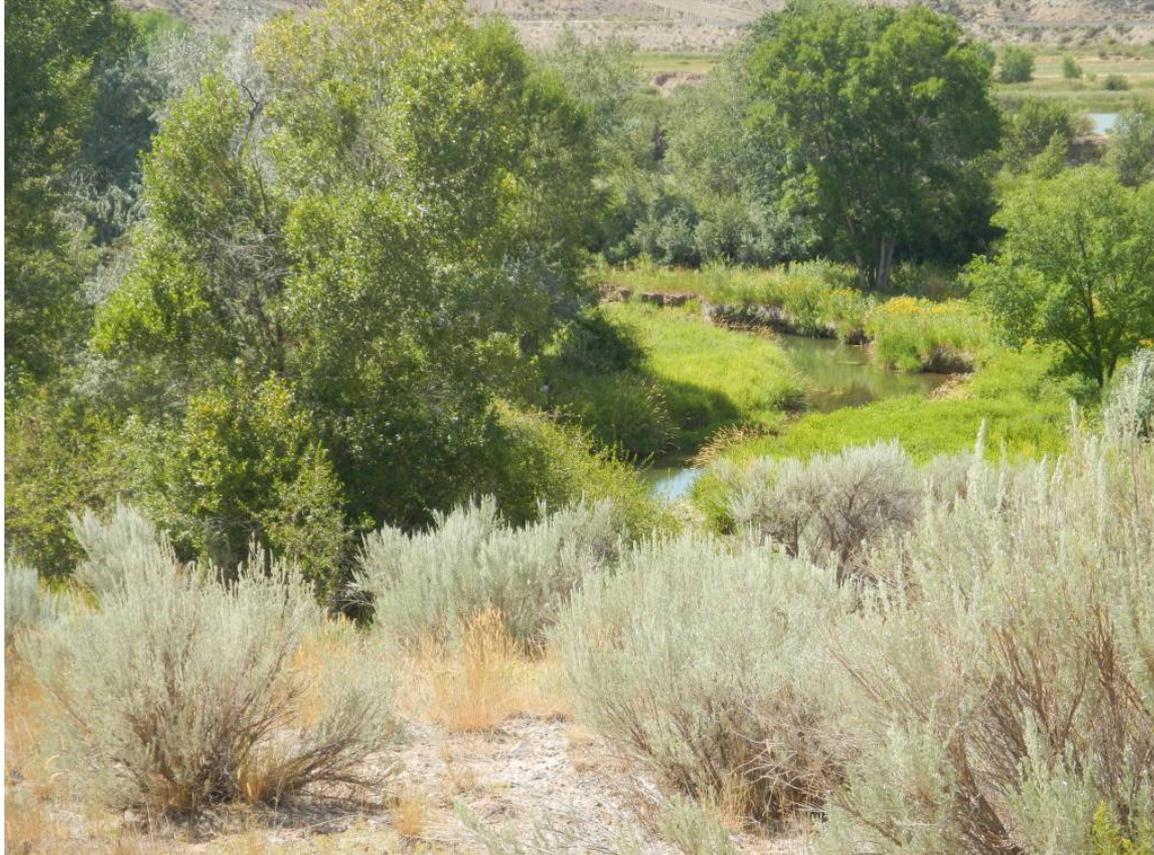
Photo#4: Water body of concern to NW of Location.

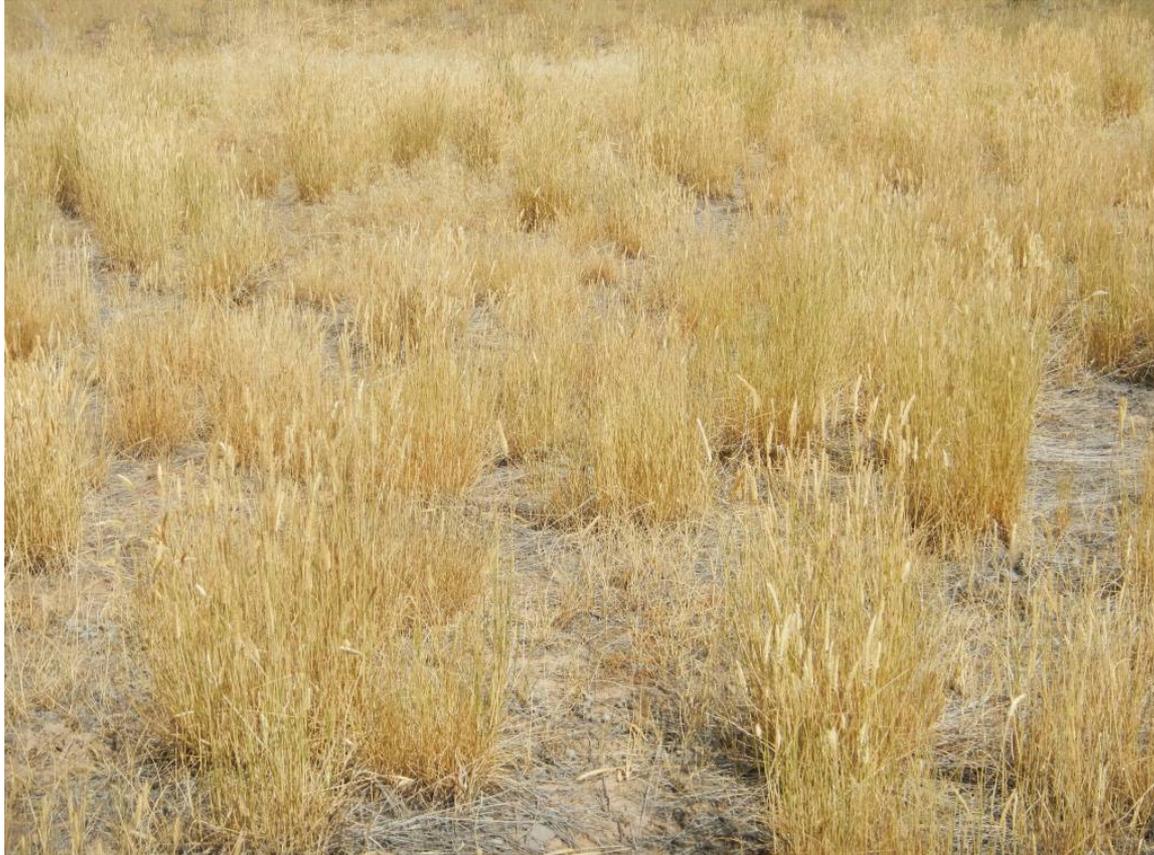
Photo#5: Interim Vegetation consists mainly of Crested Wheat Grass..

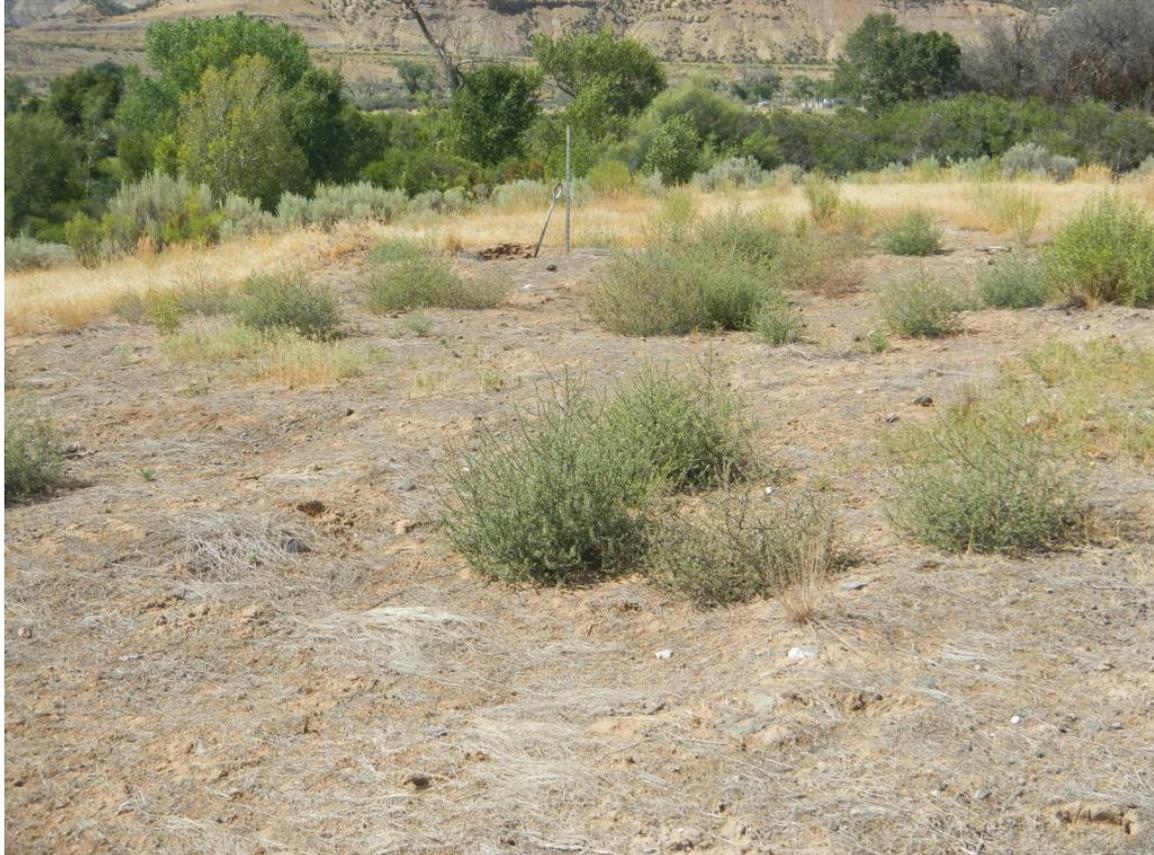
Photo#6: View of Guy Anchor at NW corner of Location, showing some Russian thistle (Noxious Weed) has emerged and matured in this area.
