## Location ID 438023- Follow up inspection

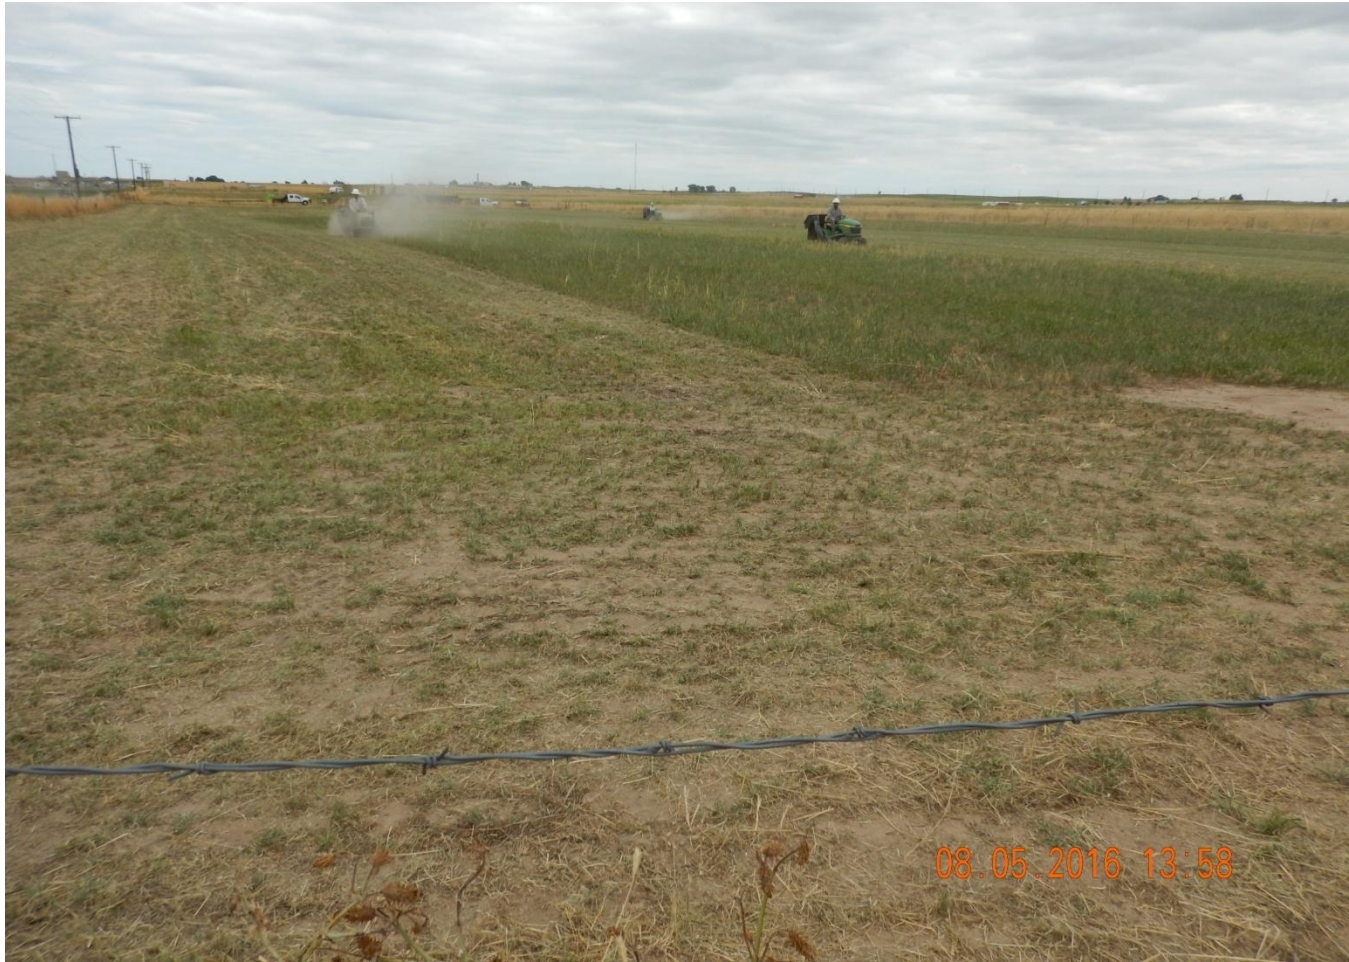
**Photo 1.** Photo taken from the western flowline area, facing East. Flowline area was mowed and bagged to remove longspine sandbur.
