# Construction and Stormwater Inspection

08/17/2016

Operator: Grand Mesa Operating

Location ID: 445661

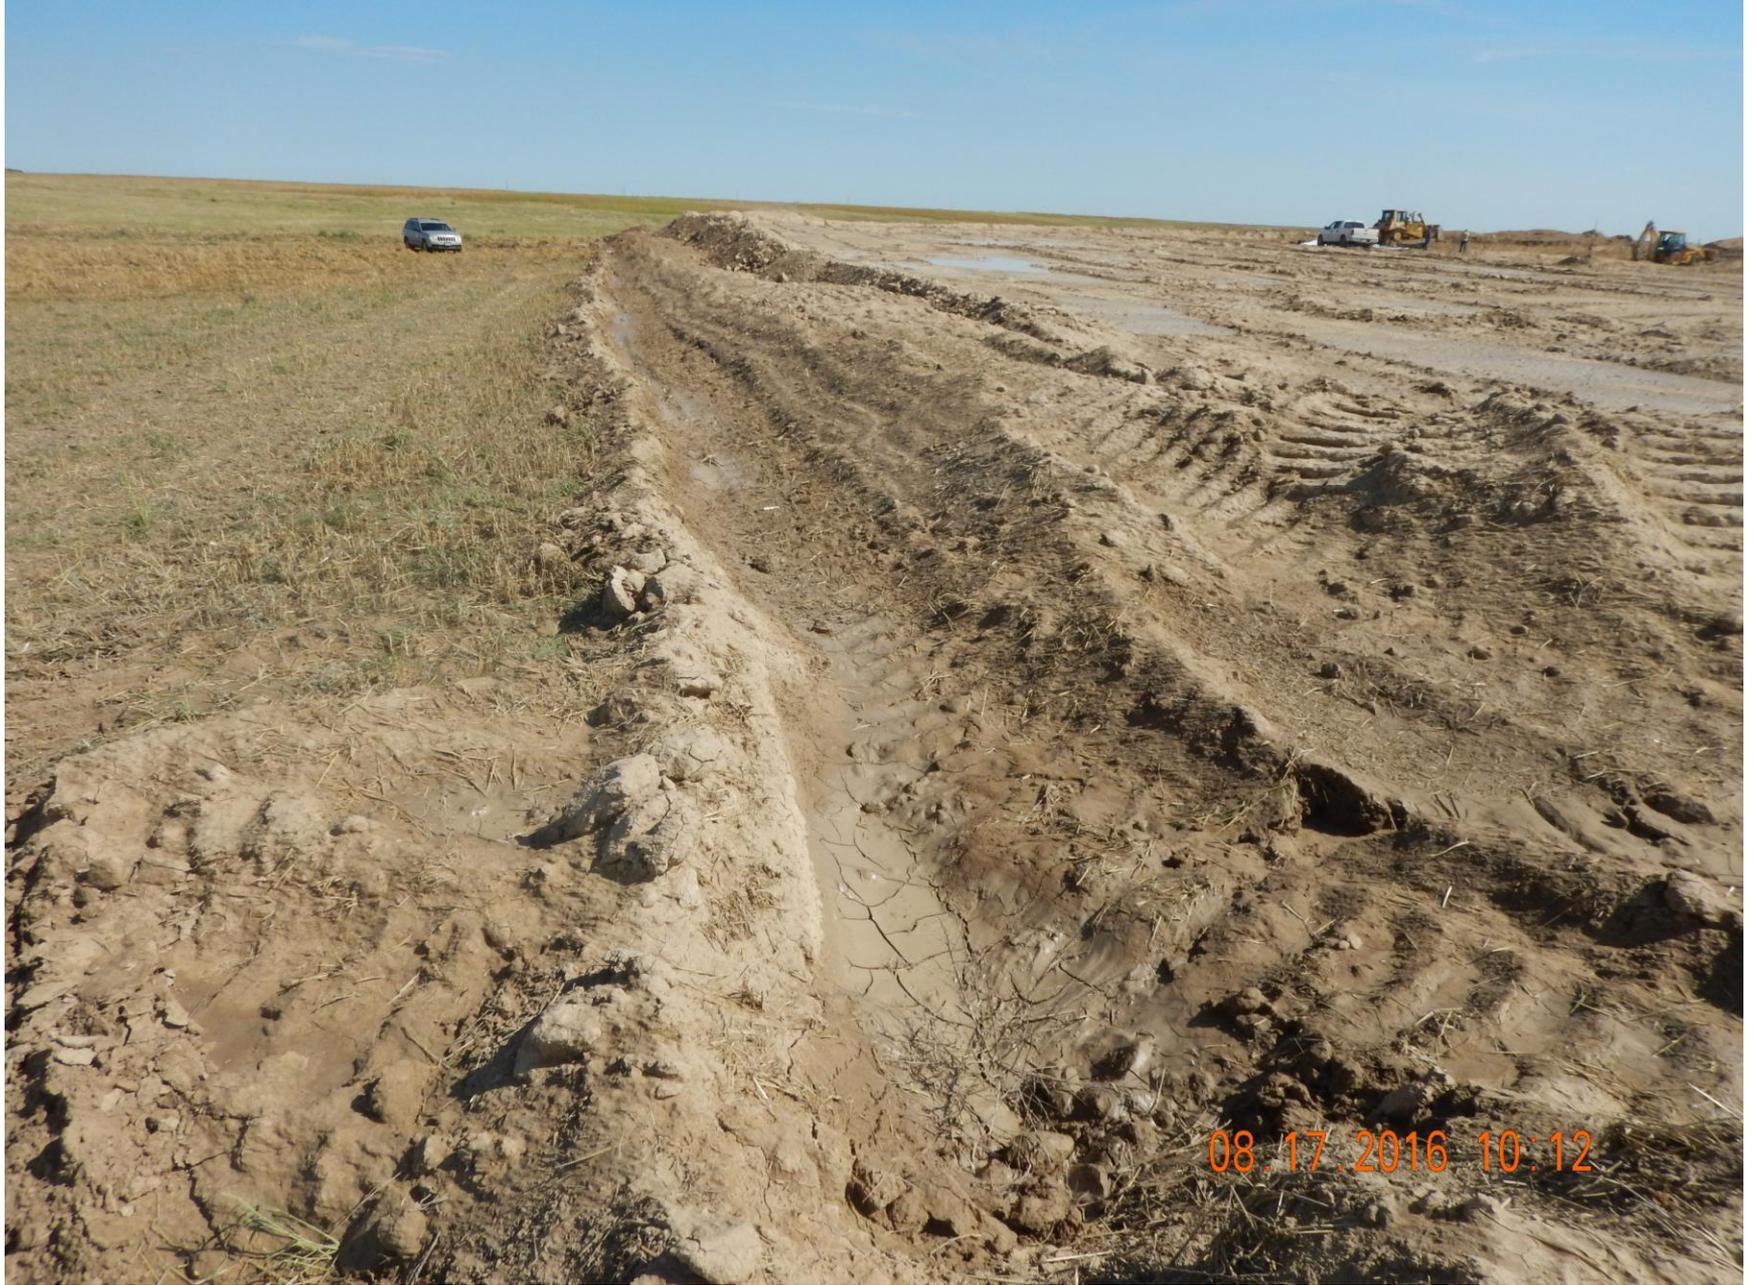
**Figure 1:** Photo taken from the southwest corner of the location, facing north. Photo shows stormwater and sediment control ditch.

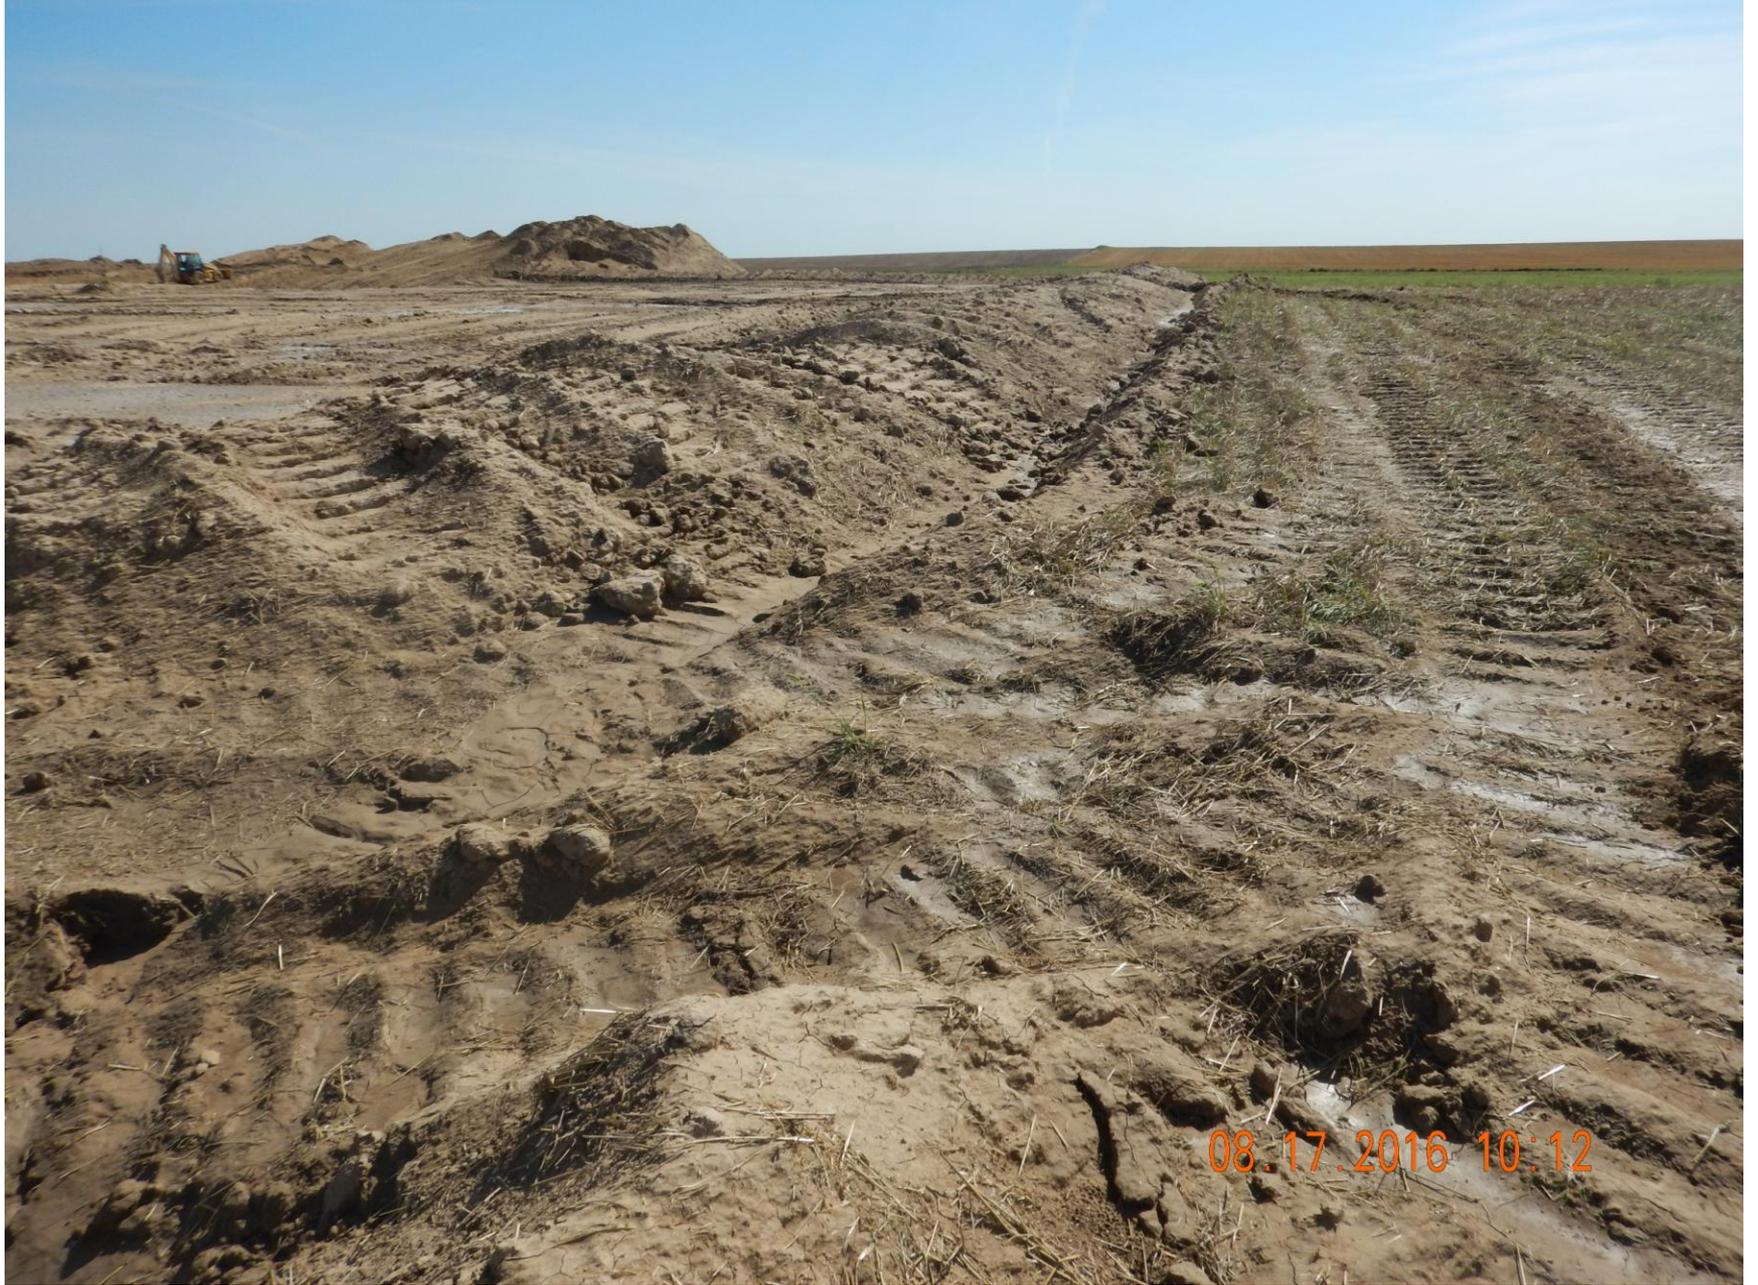
**Figure 2:** Photo taken from the southwest corner of the location, facing east. Photo shows stormwater and sediment control ditch.

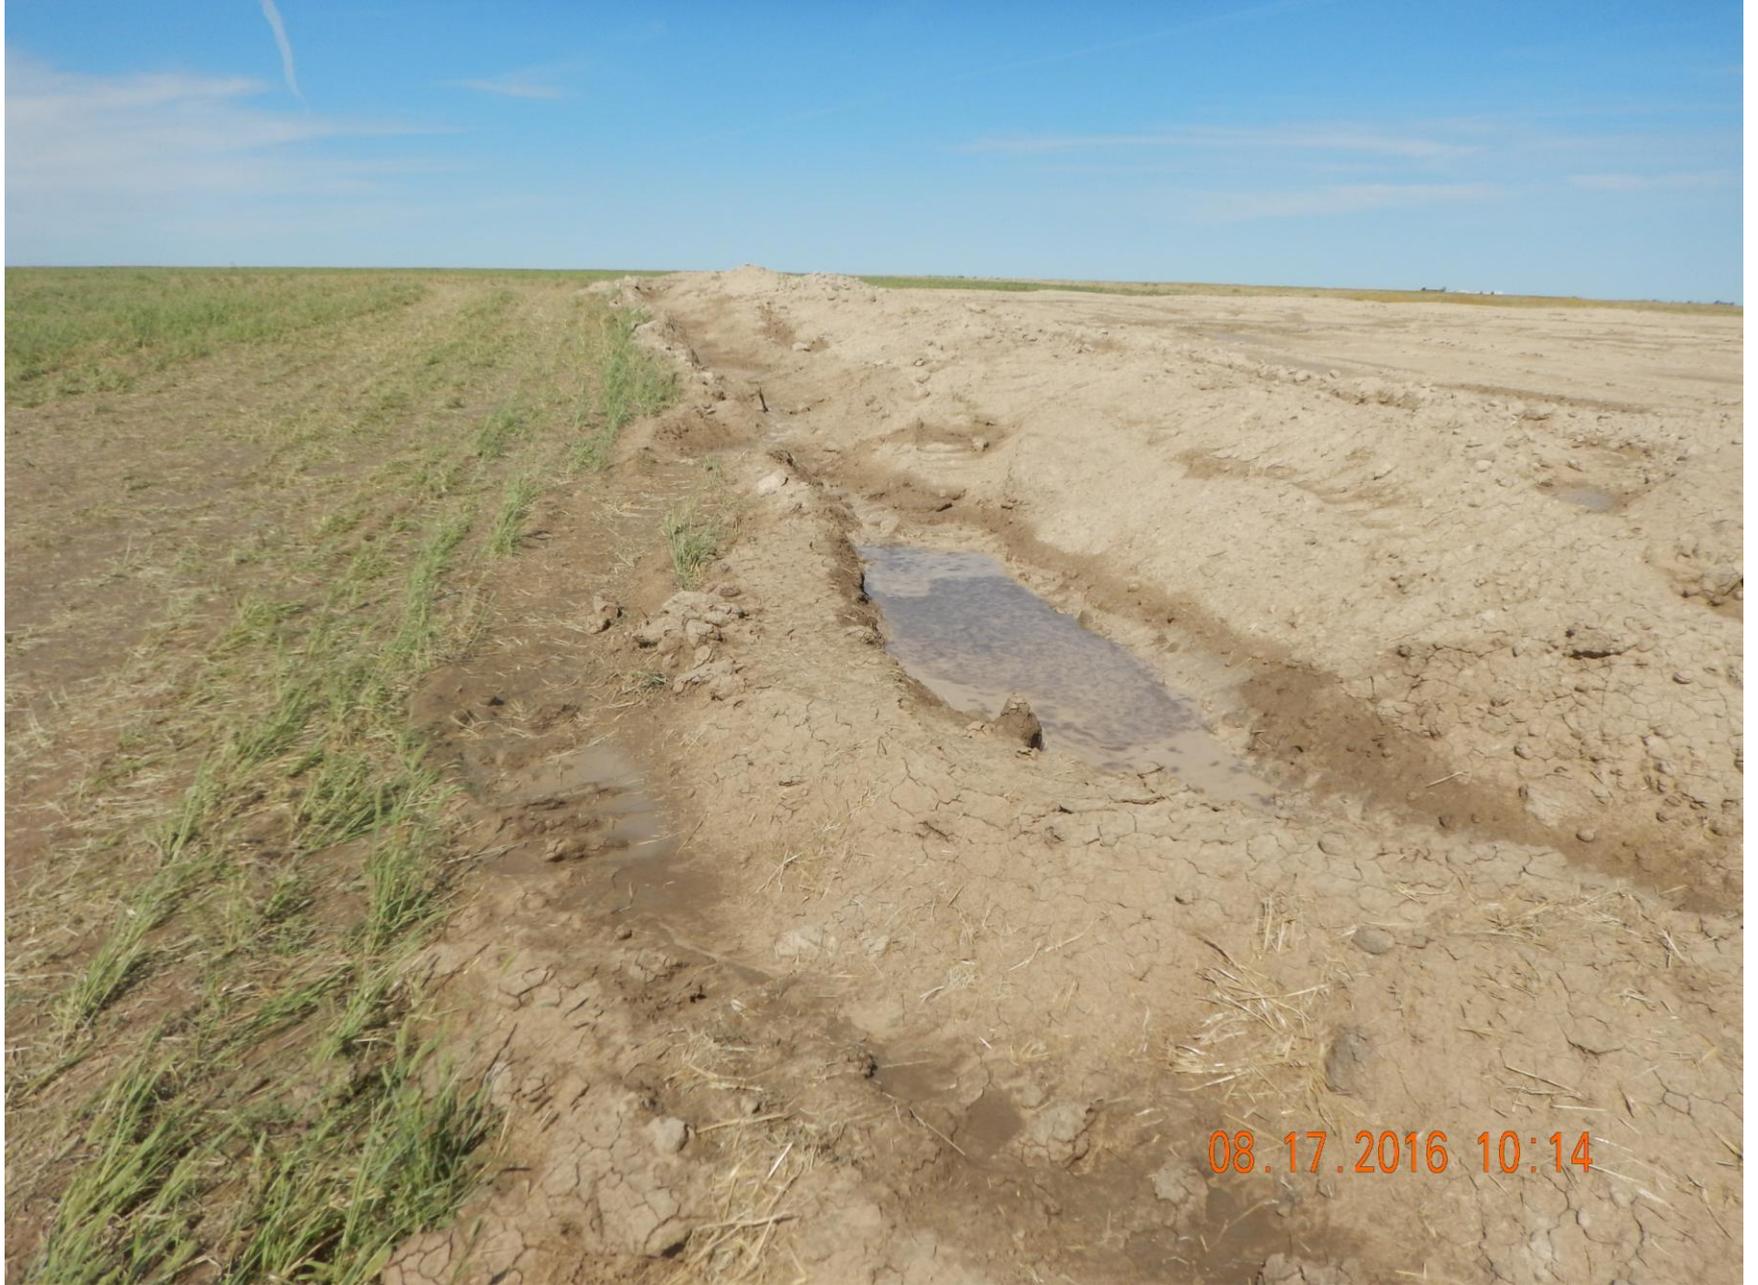
**Figure 3:** Photo taken from the southeast corner of the location, facing east. Photo shows stormwater and sediment control ditch.

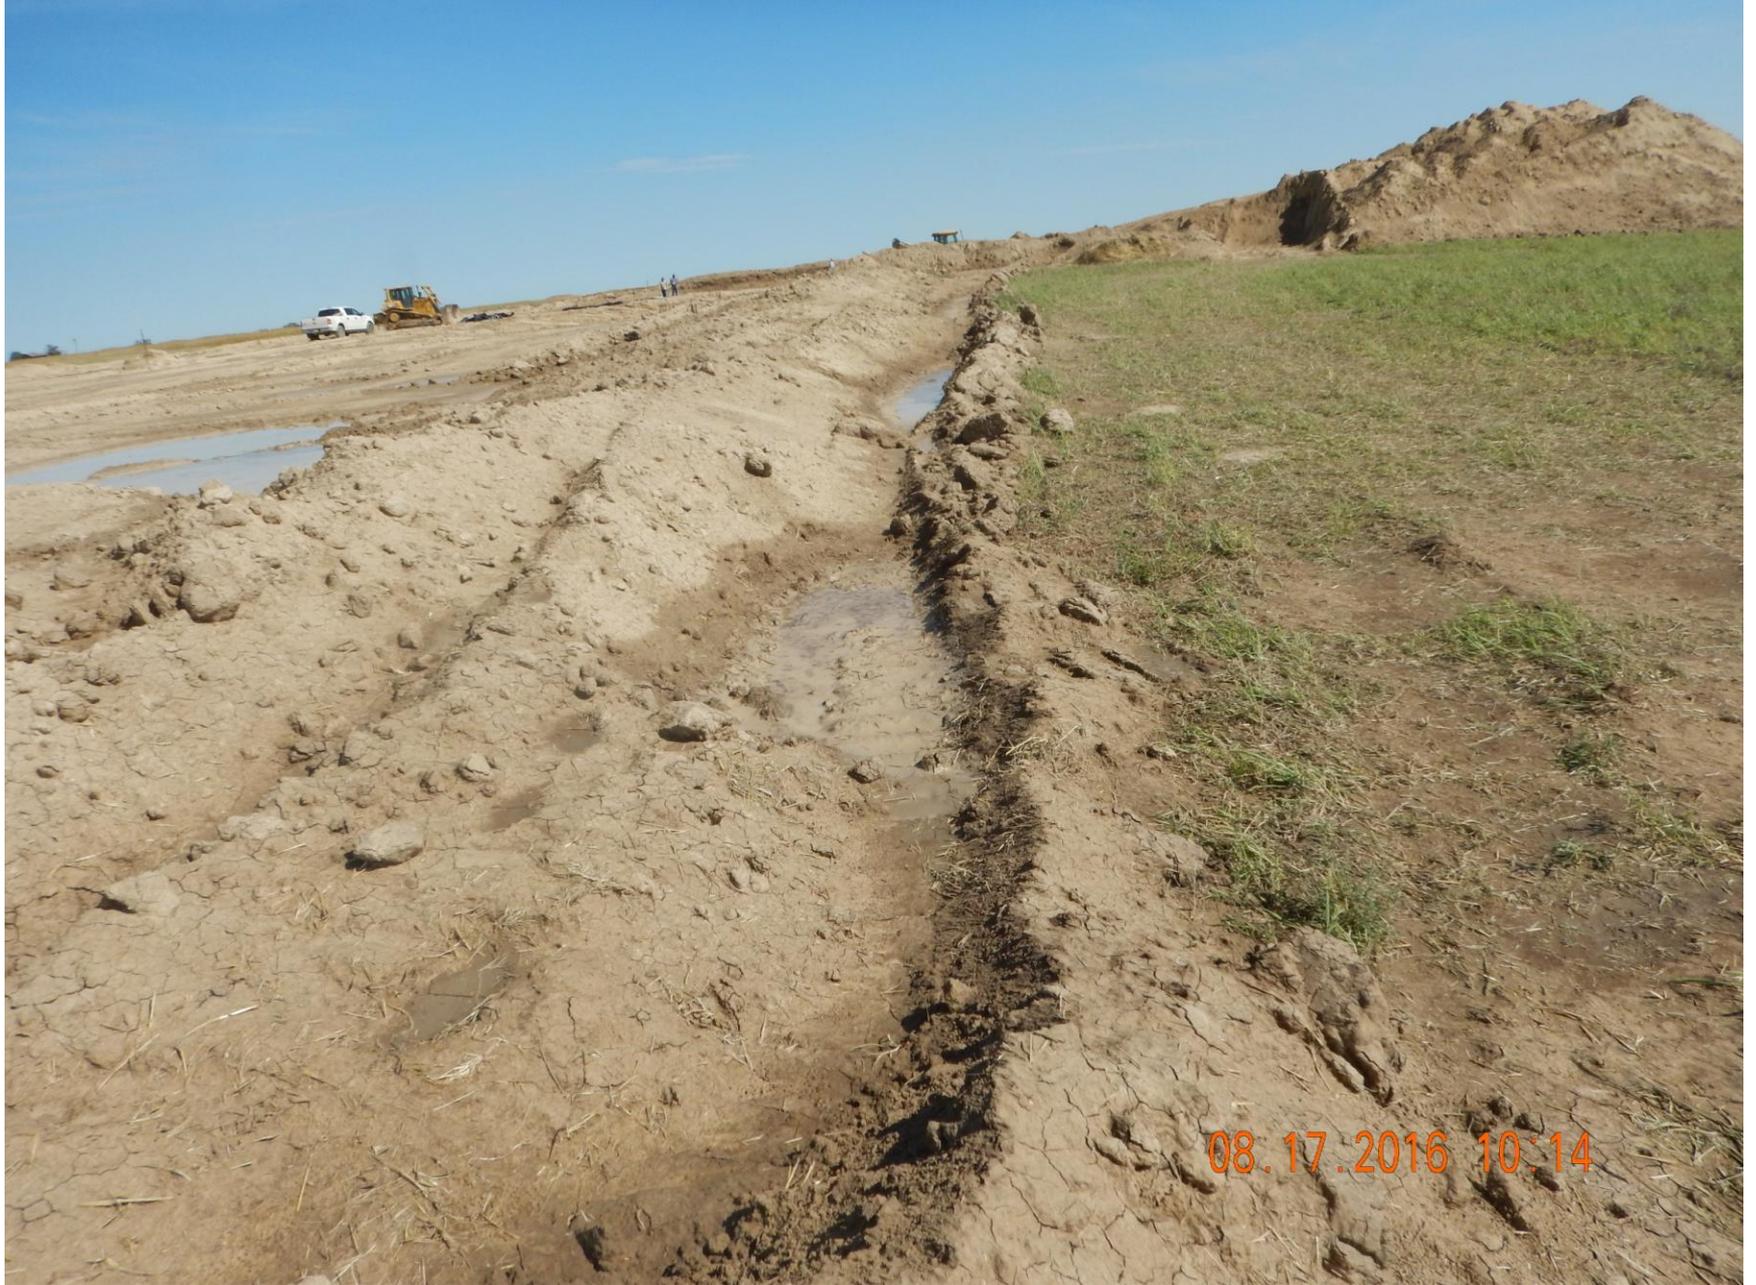
**Figure 4:** Photo taken from the southeast corner of the location, facing north. Photo shows stormwater and sediment control ditch. Some sections of the ditch appear to be filling with sediment, advise cleaning in these areas.

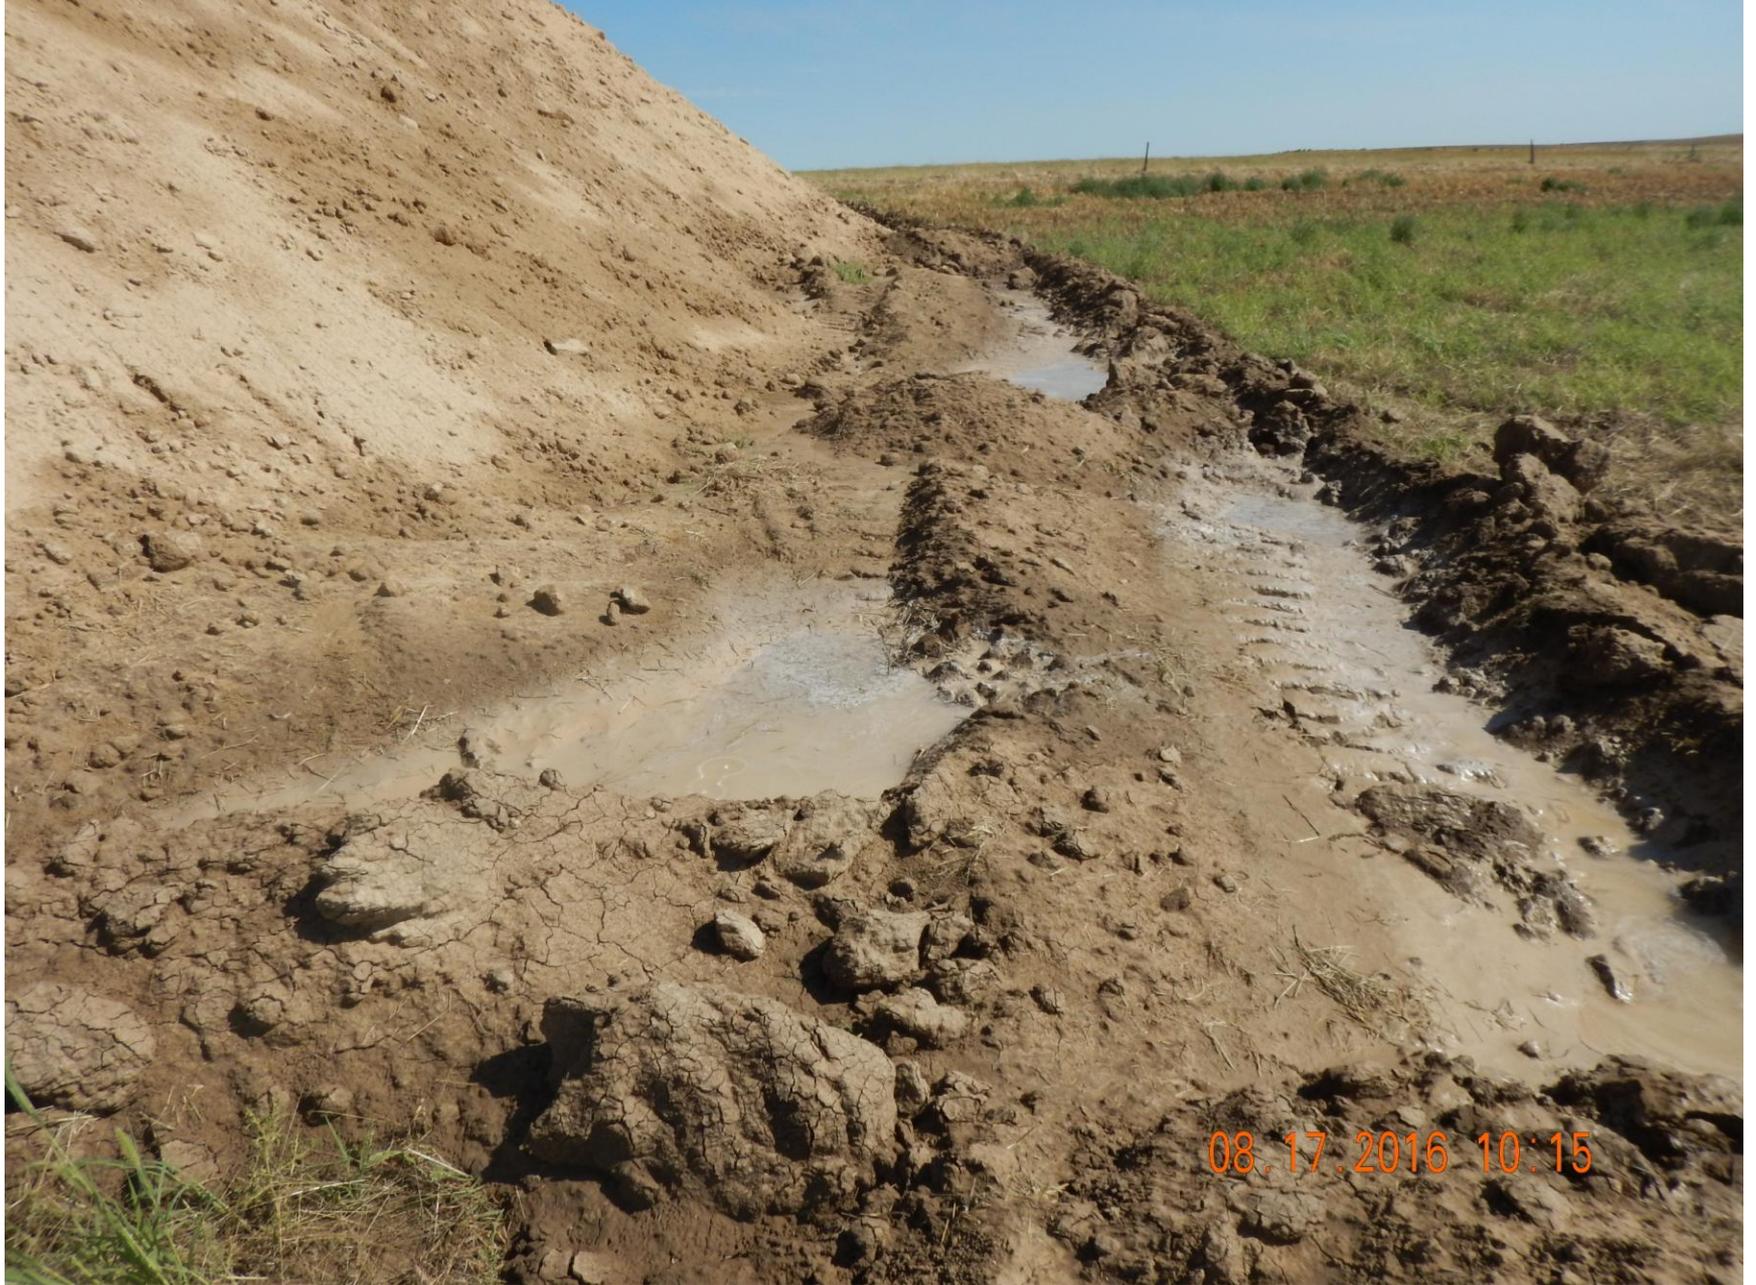
**Figure 5:** Photo taken from the east end of the location, facing north. Photo shows stormwater and sediment control ditch. Some sections of the ditch appear to be filling with sediment, advise cleaning in these areas.

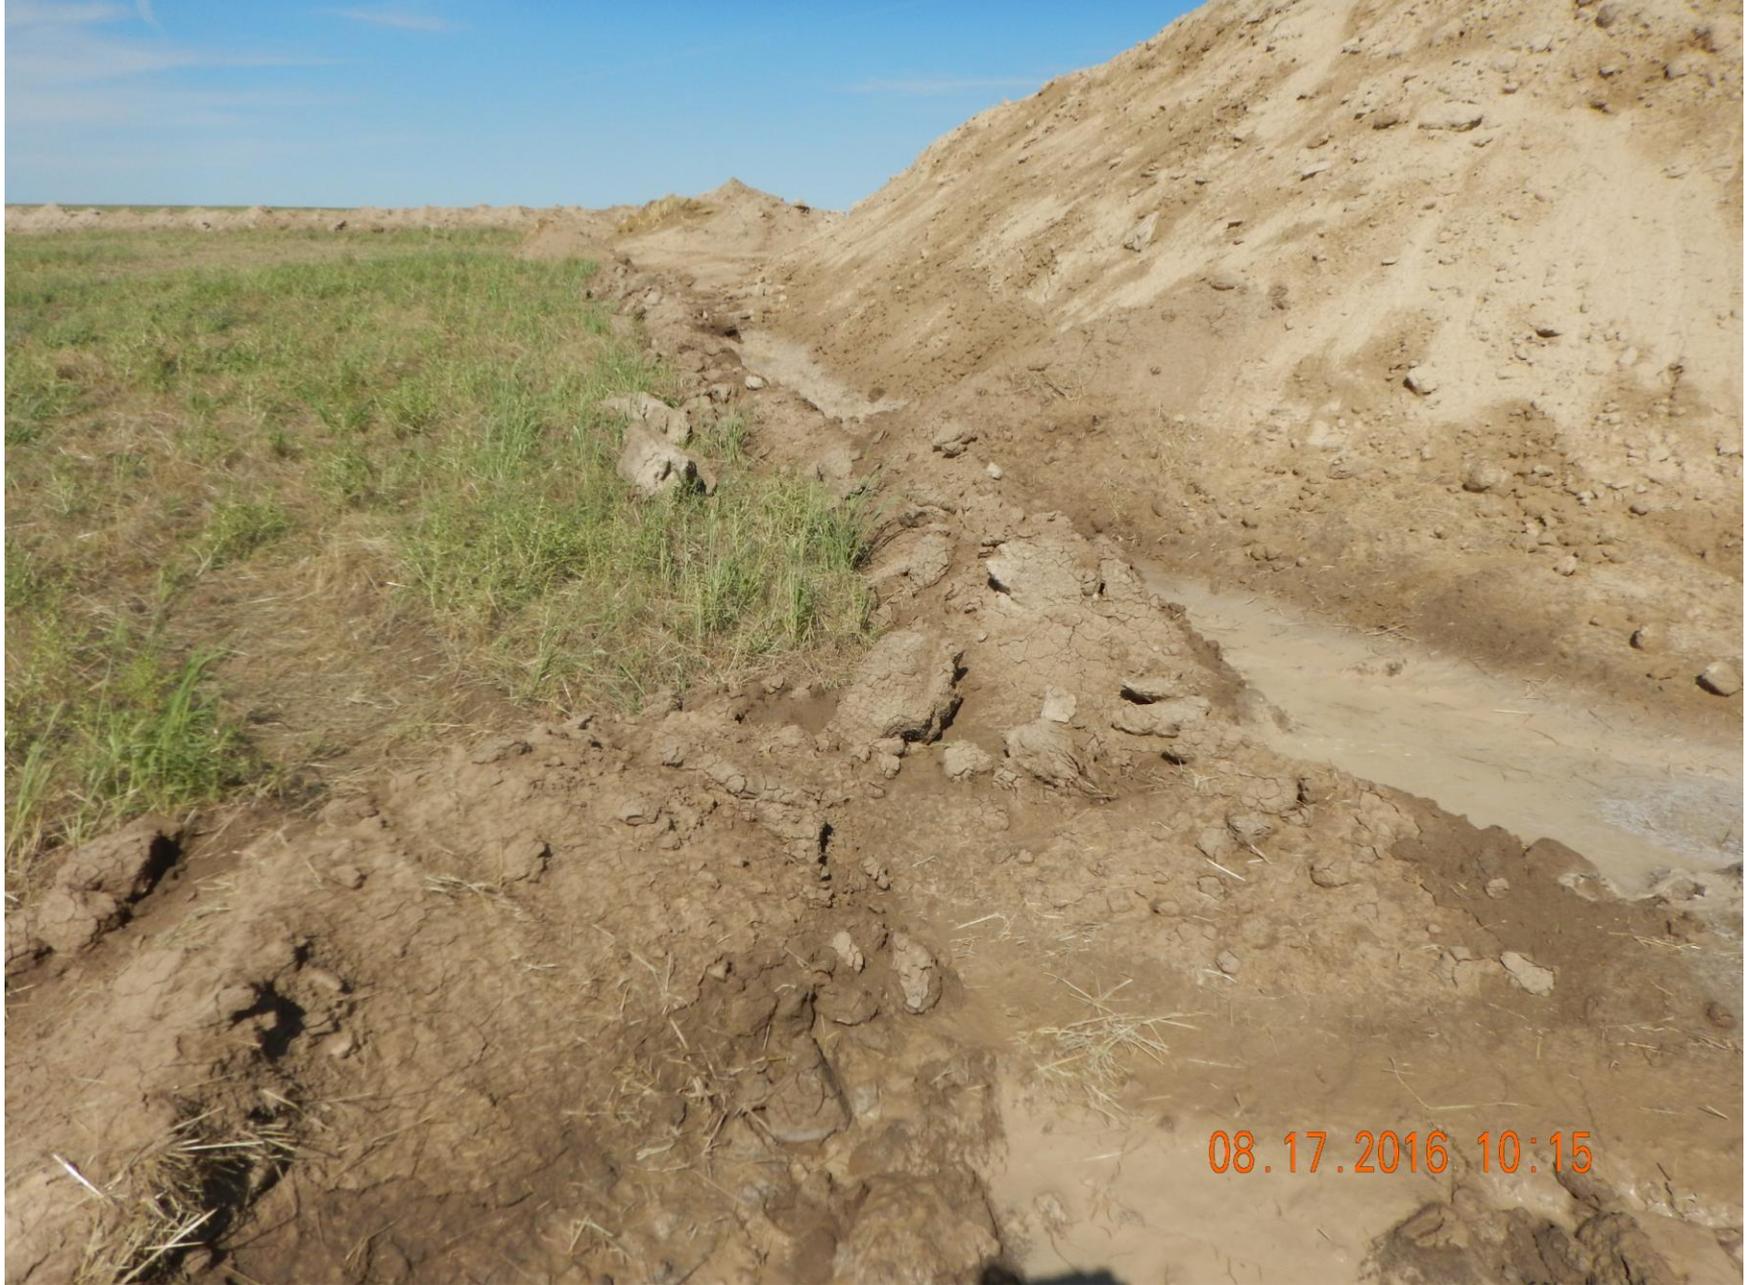
**Figure 6:** Photo taken from the east end of the location, facing west. Photo shows stormwater and sediment control ditch. Some sections of the ditch appear to be filling with sediment, advise cleaning in these areas.

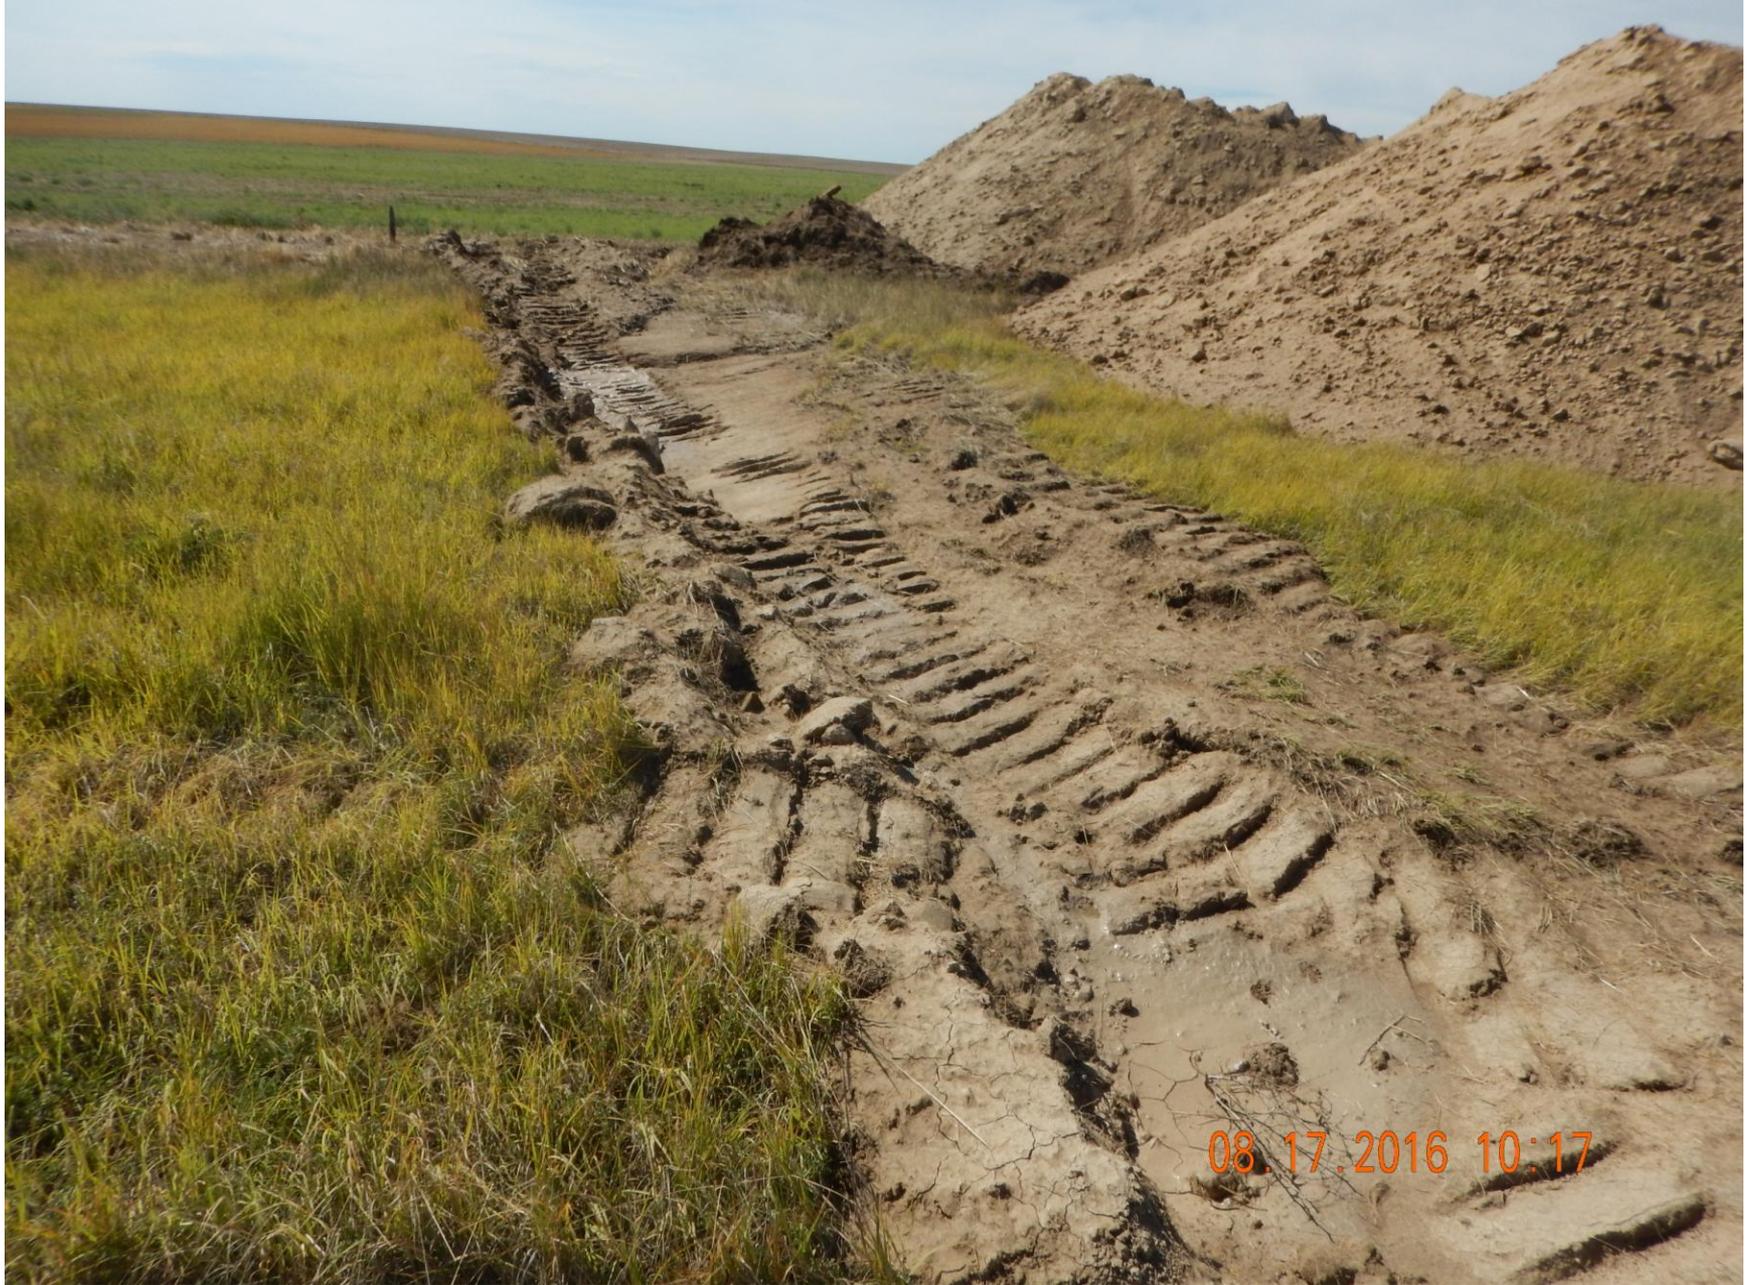
**Figure 7:** Photo taken from the northeast end of the location, facing south. Photo shows stormwater and sediment control ditch.

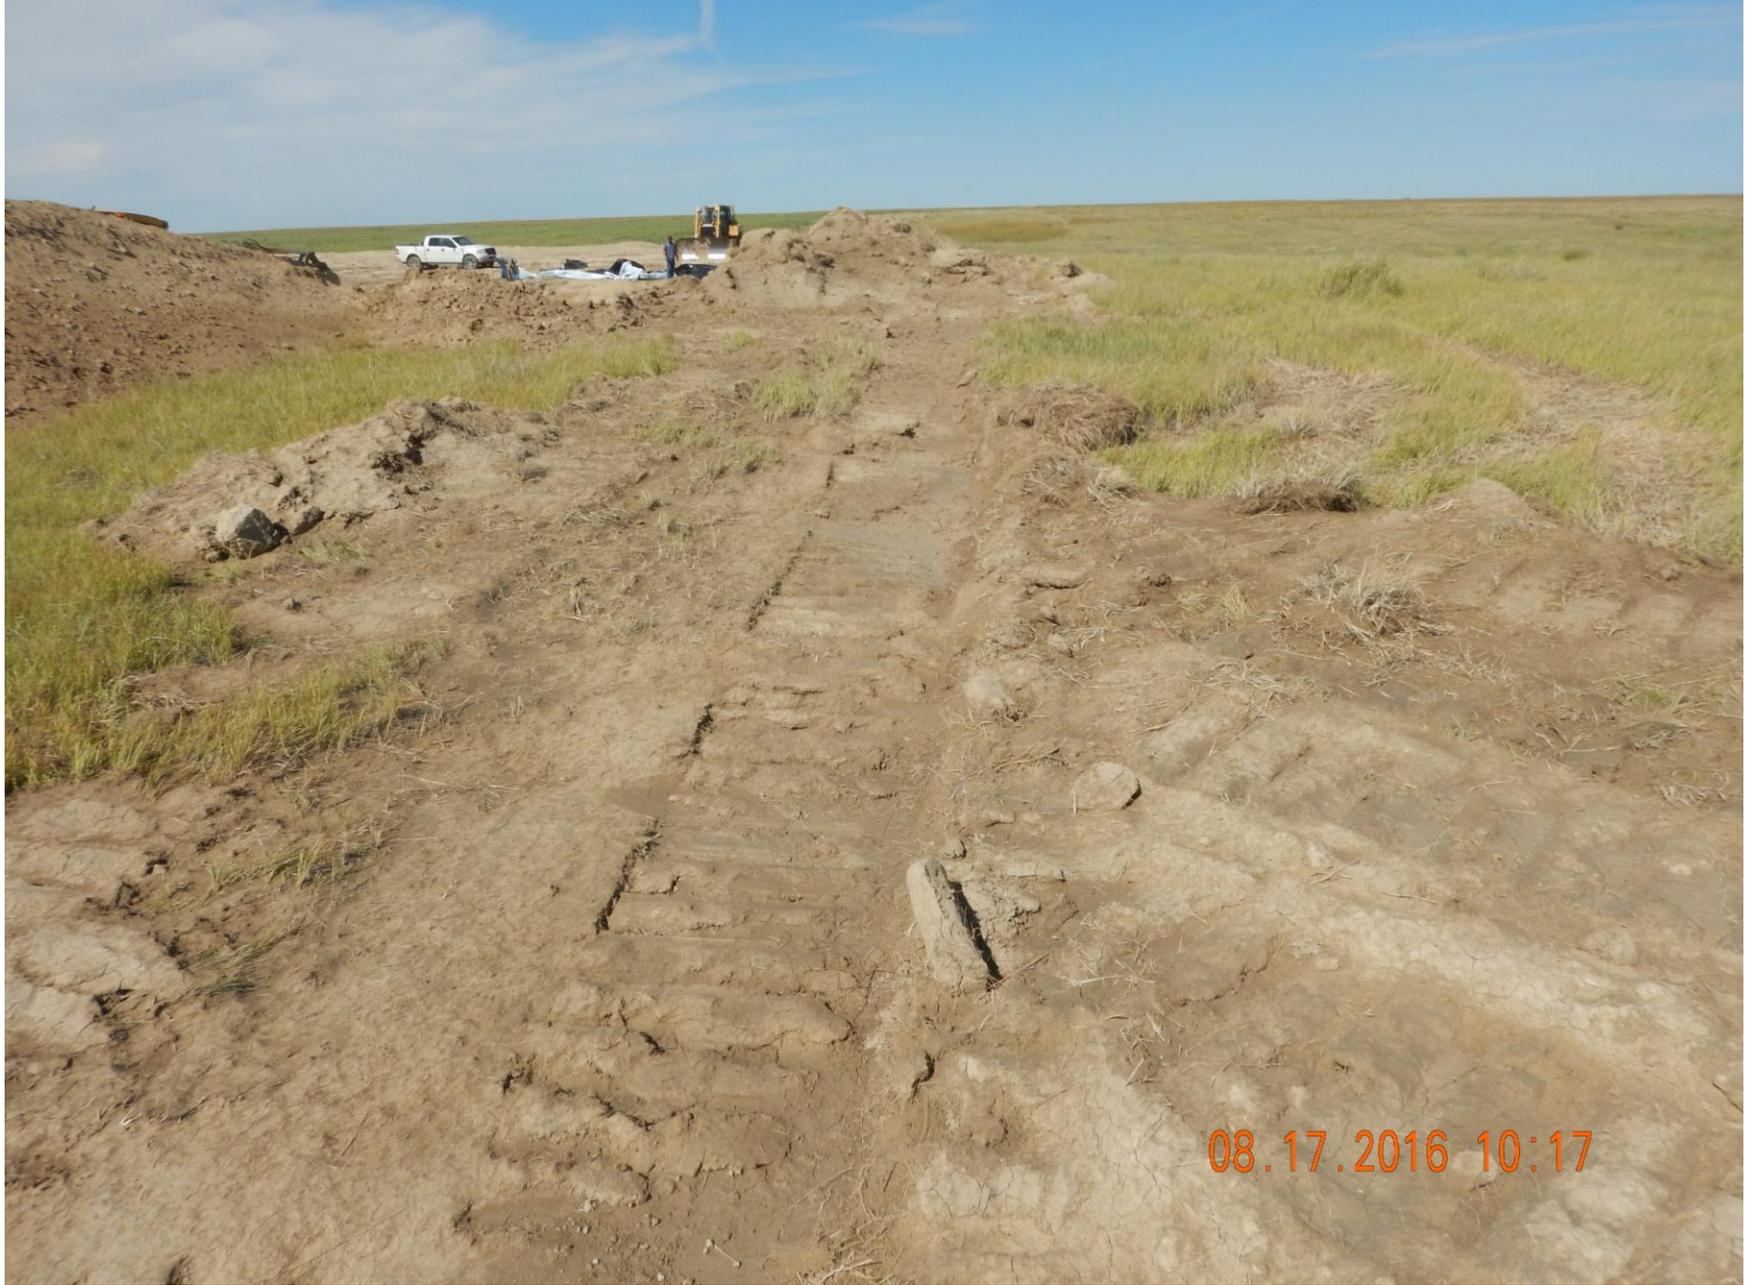
**Figure 8:** Photo taken from the northeast end of the location, facing west. Photo shows stormwater and sediment control ditch.

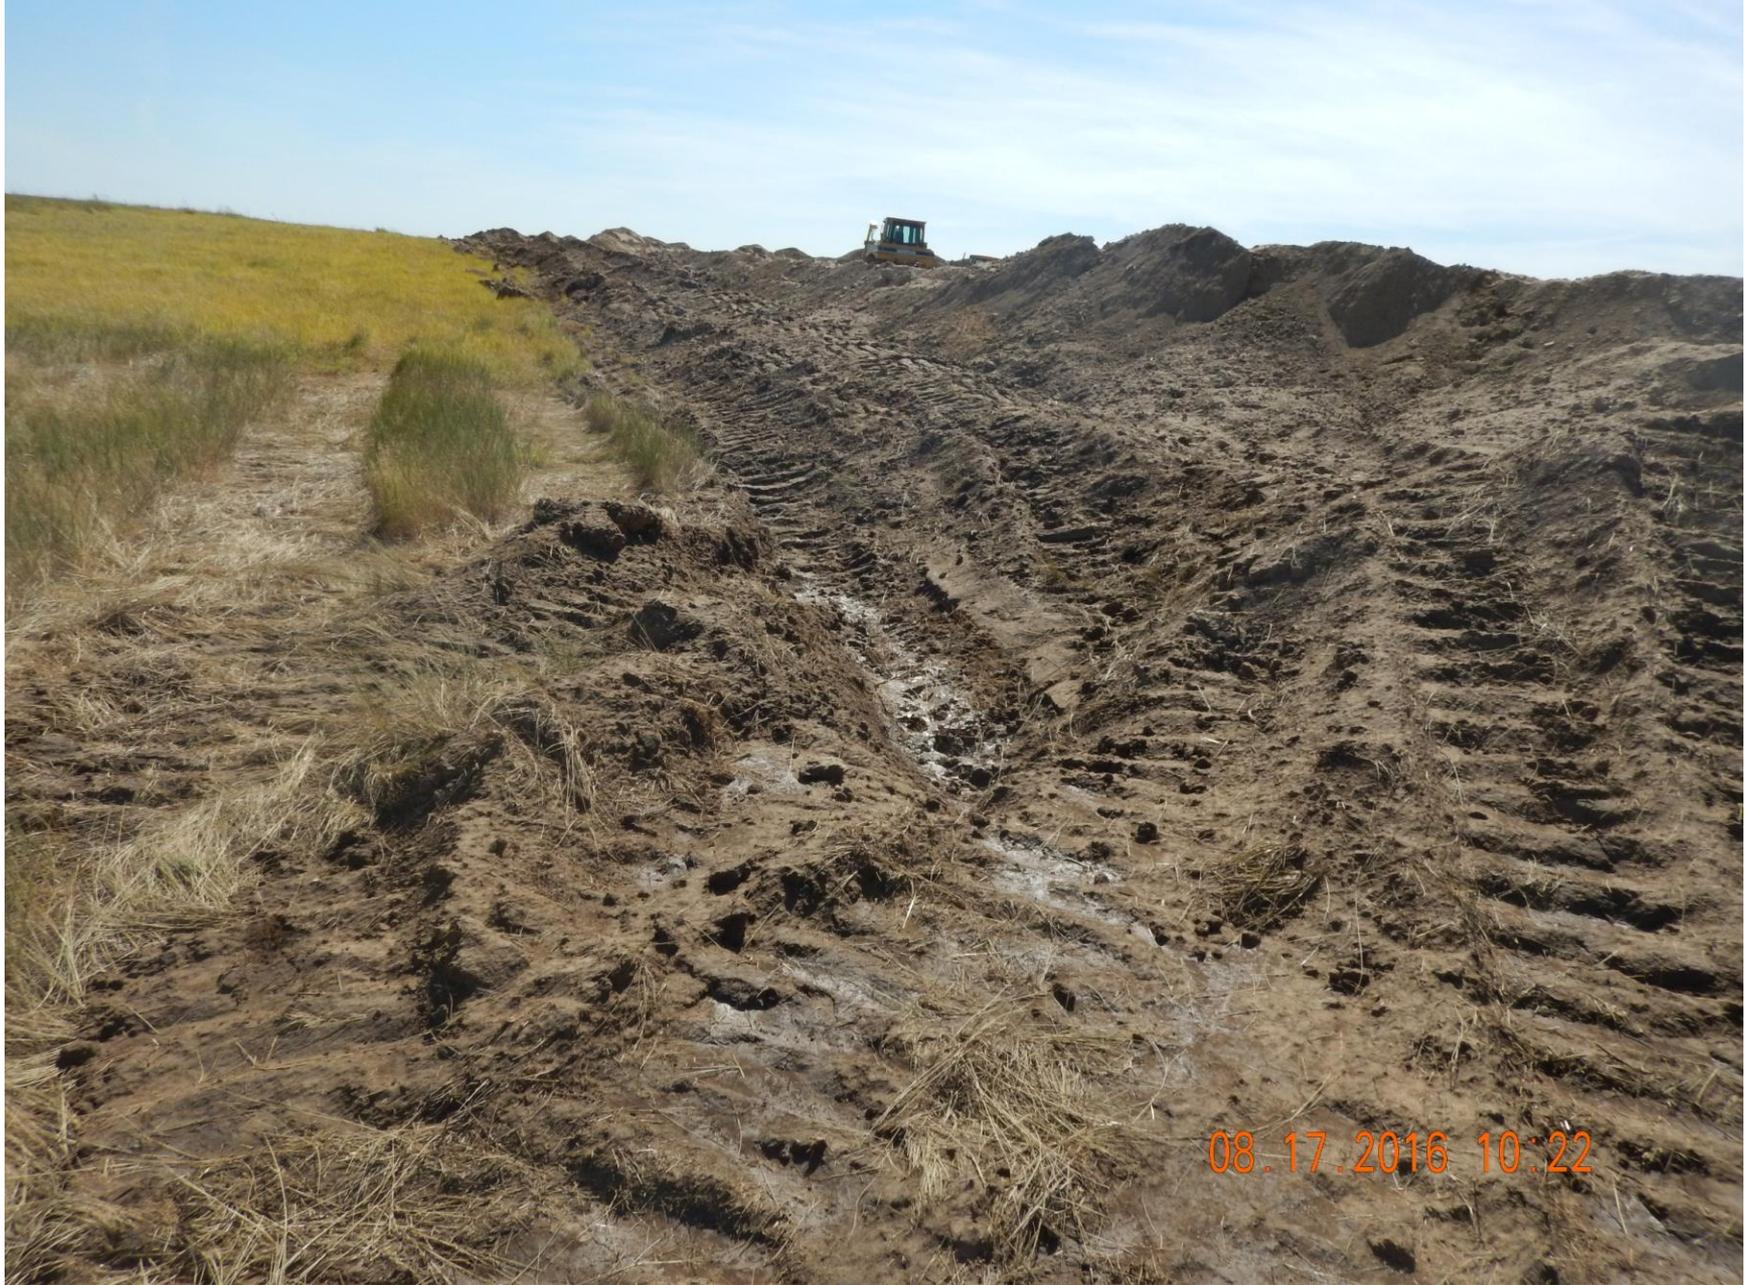
**Figure 9:** Photo taken from the northwest end of the location, facing south. Photo shows stormwater and sediment control ditch. Ditch ends before corner of location. This area is at higher risk of seeing stormwater and sediment transport off site and degradation. Advise incorporating other BMPs or connecting ditch.

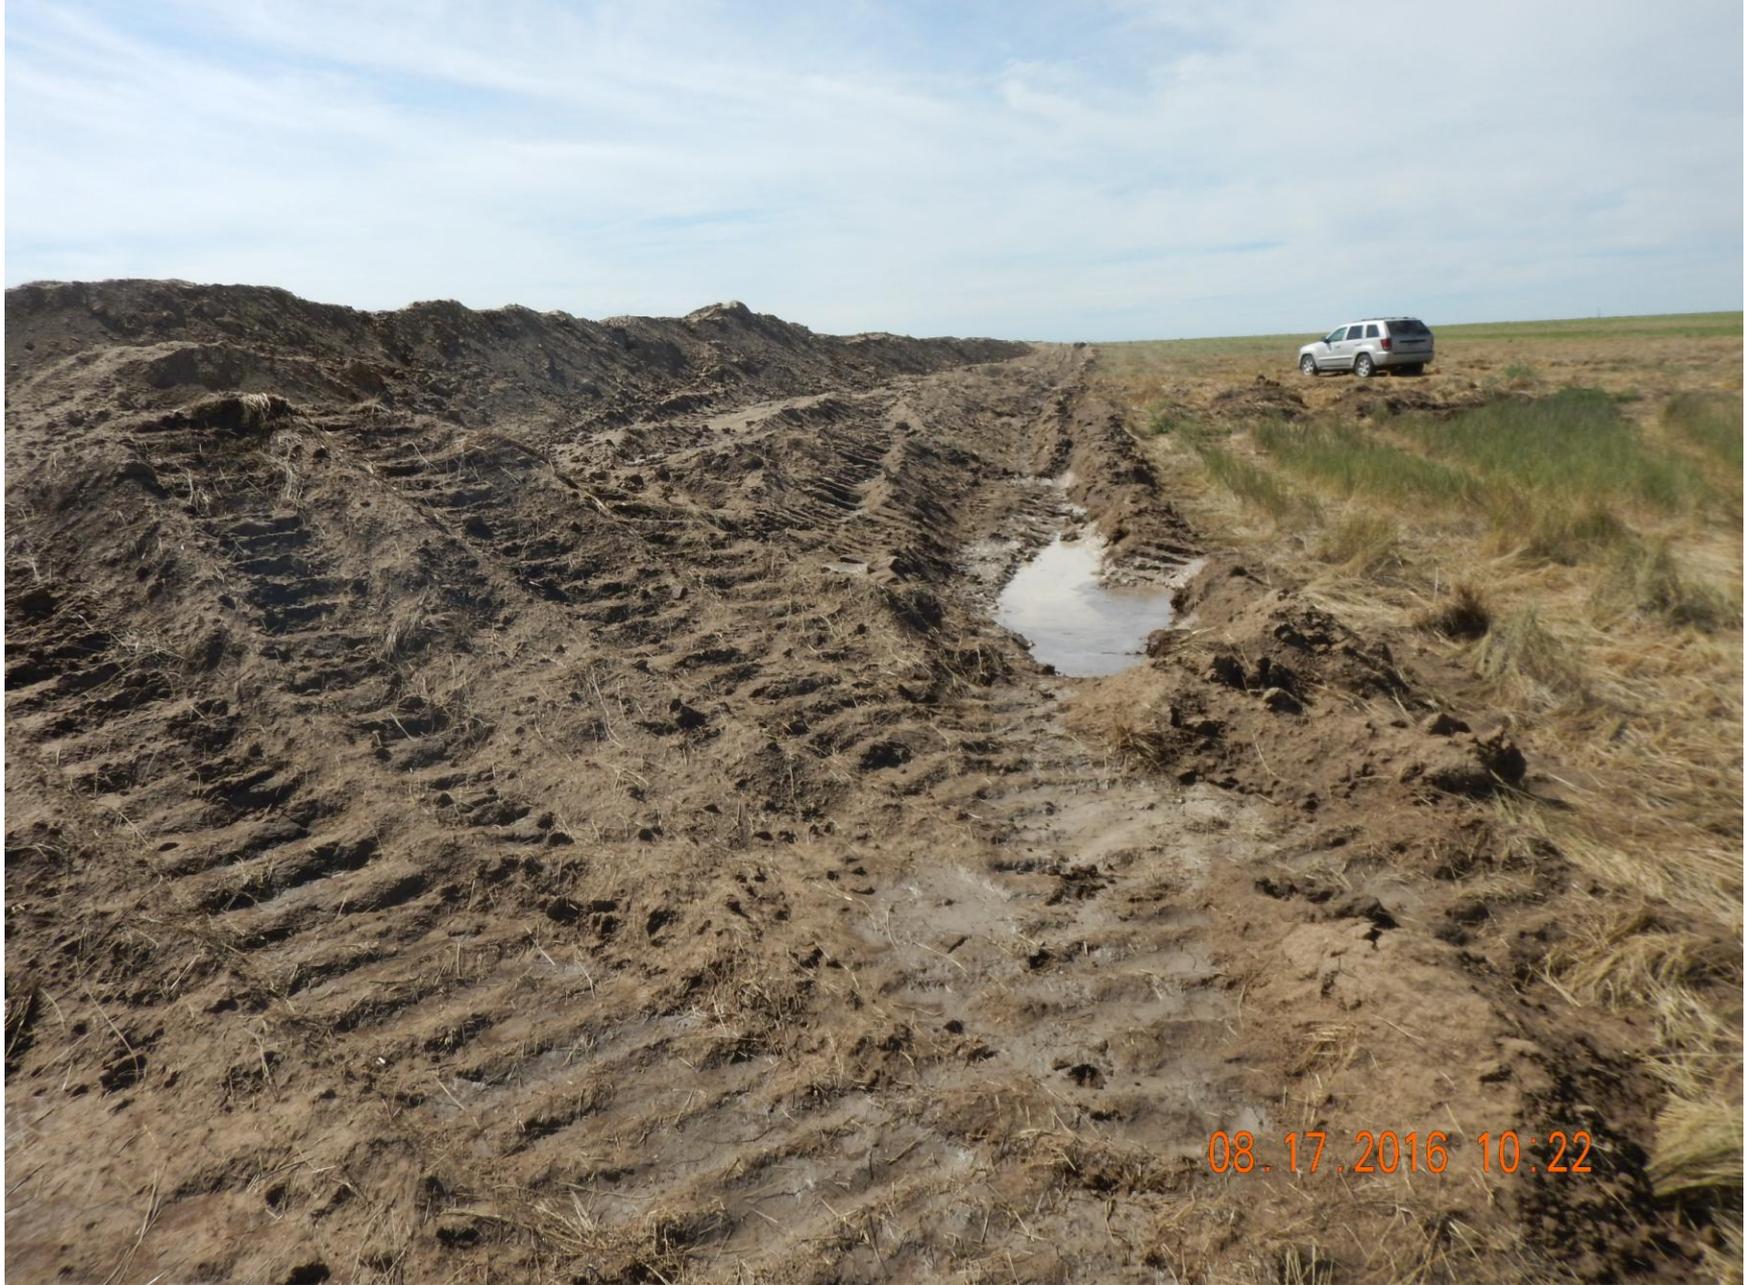
**Figure 10:** Photo taken from the northwest end of the location, facing south. Photo shows stormwater and sediment control ditch. Ditch ends before corner of location. This area is at higher risk of seeing stormwater and sediment transport off site and degradation. Advise incorporating other BMPs or connecting ditch.
