# Construction and Stormwater Inspection

08/17/2016

Operator: Grand Mesa Operating

Location ID: 445661

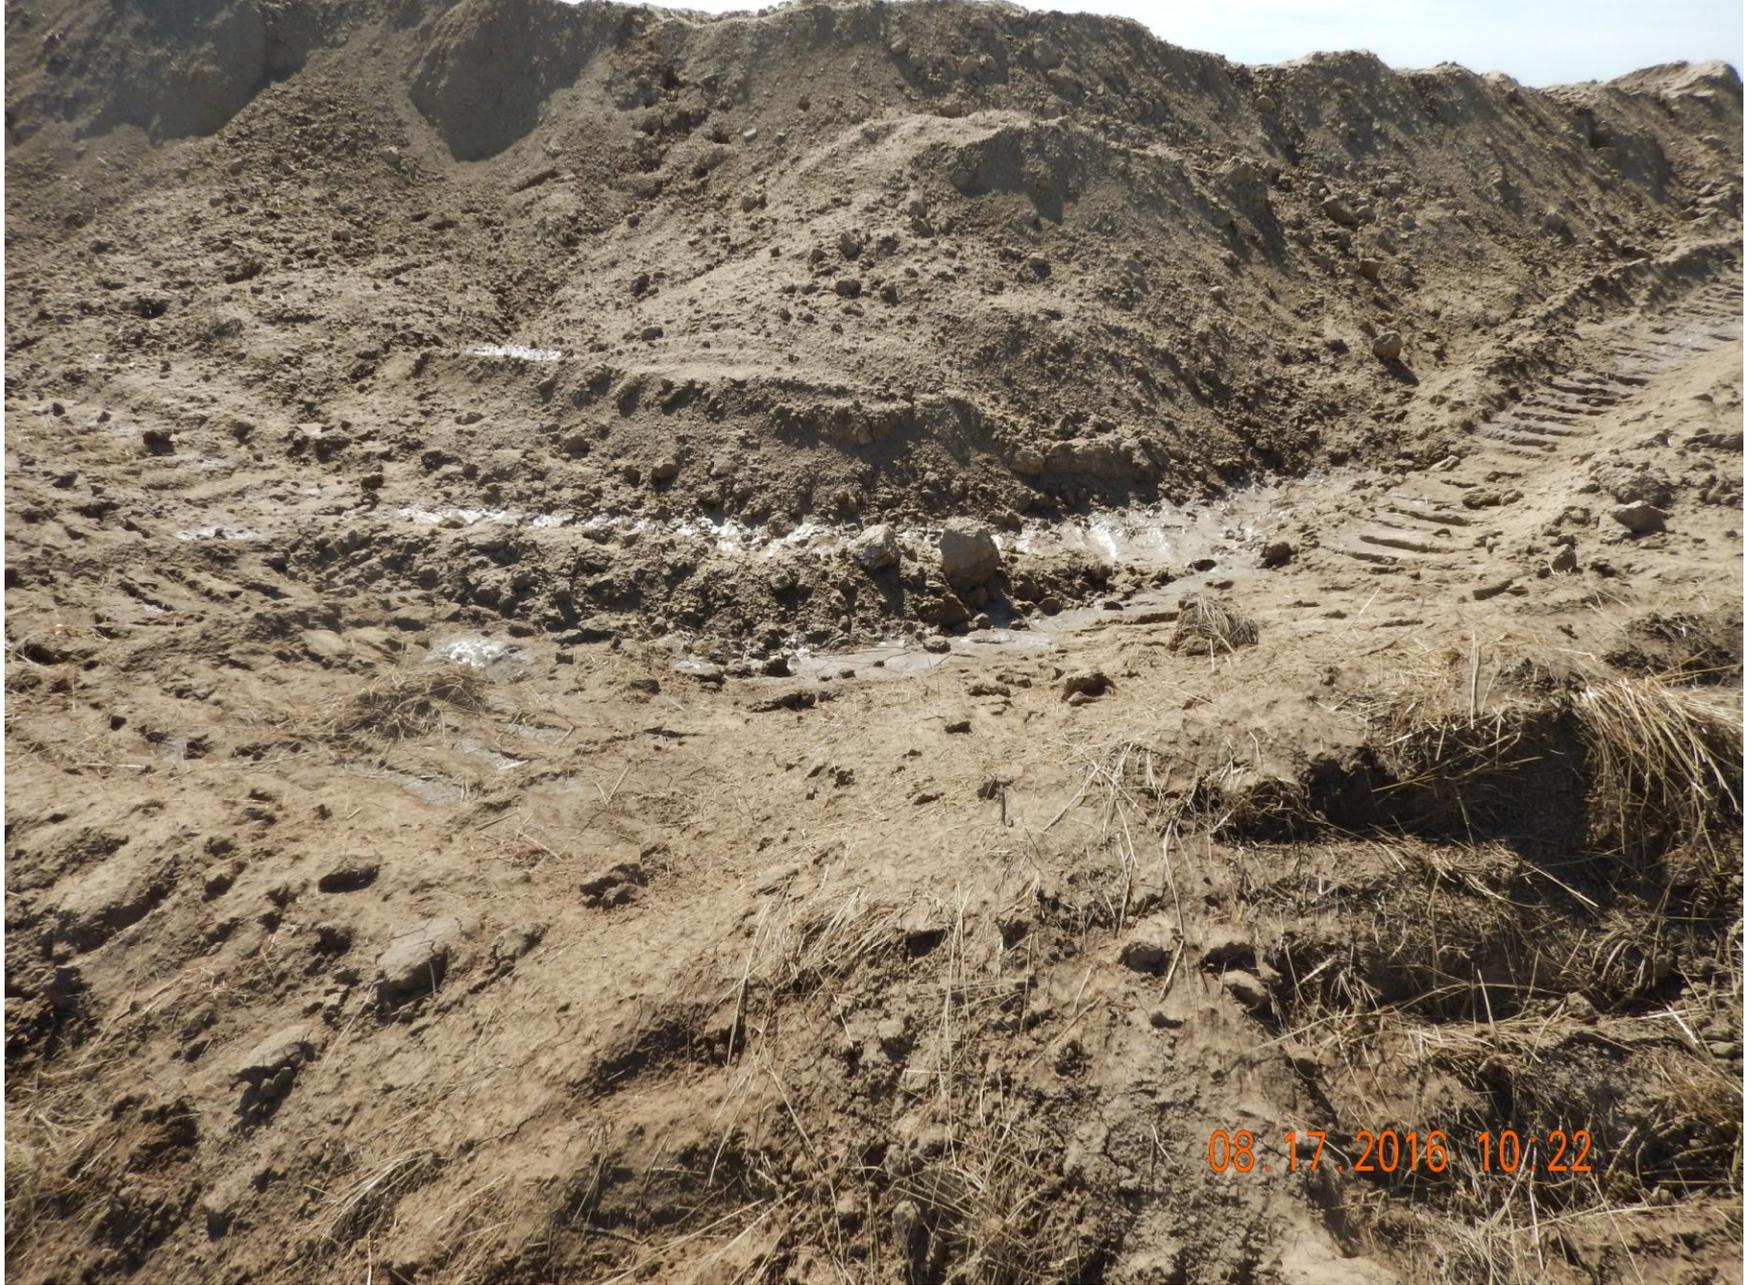
**Figure 11:** Photo taken from the northwest corner. Photo shows an elevated ditch/berm constructed in corner.
