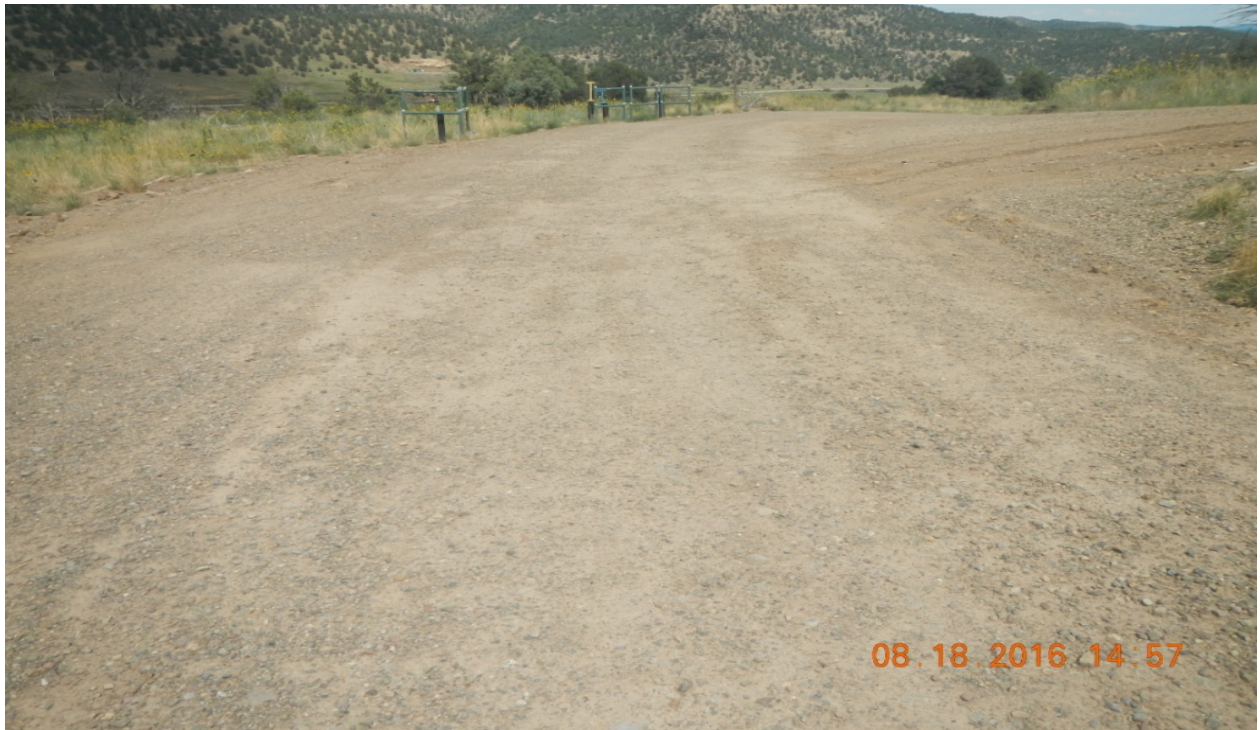
**photo 1:** Facing northeast along the access road where erosion issues were repaired.

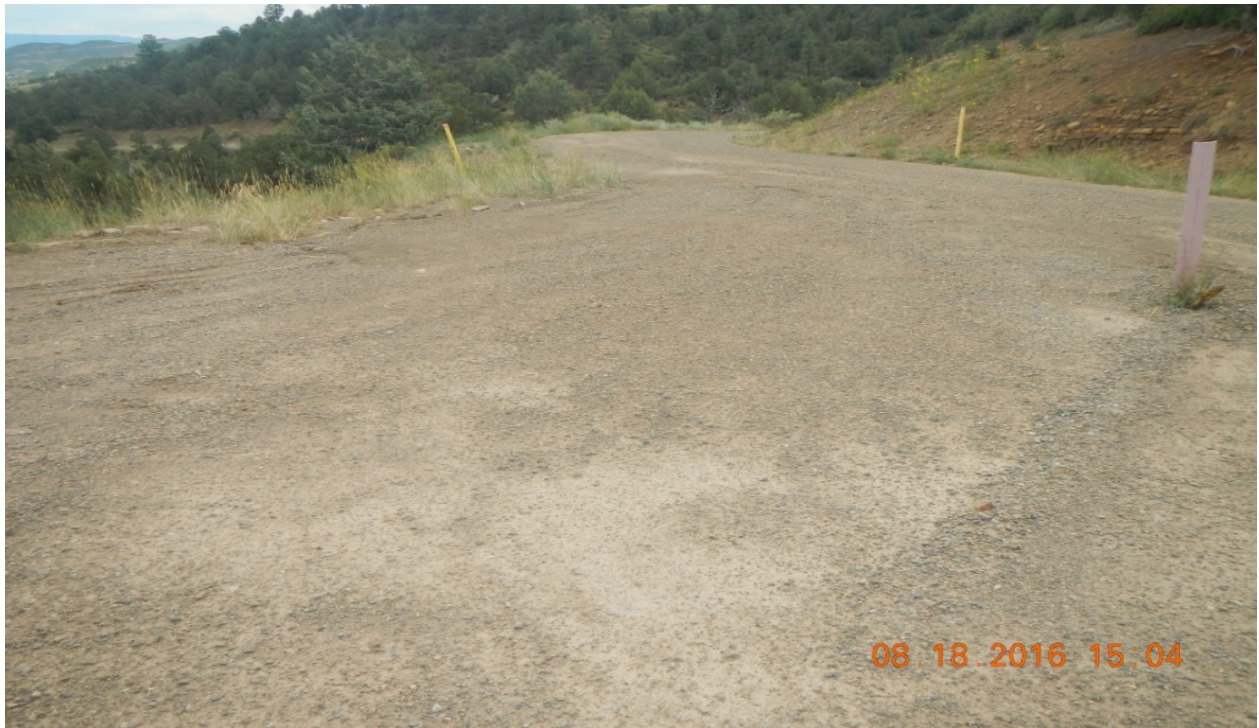
**photo 3:** Facing southeast at the location where erosion issues were repaired.

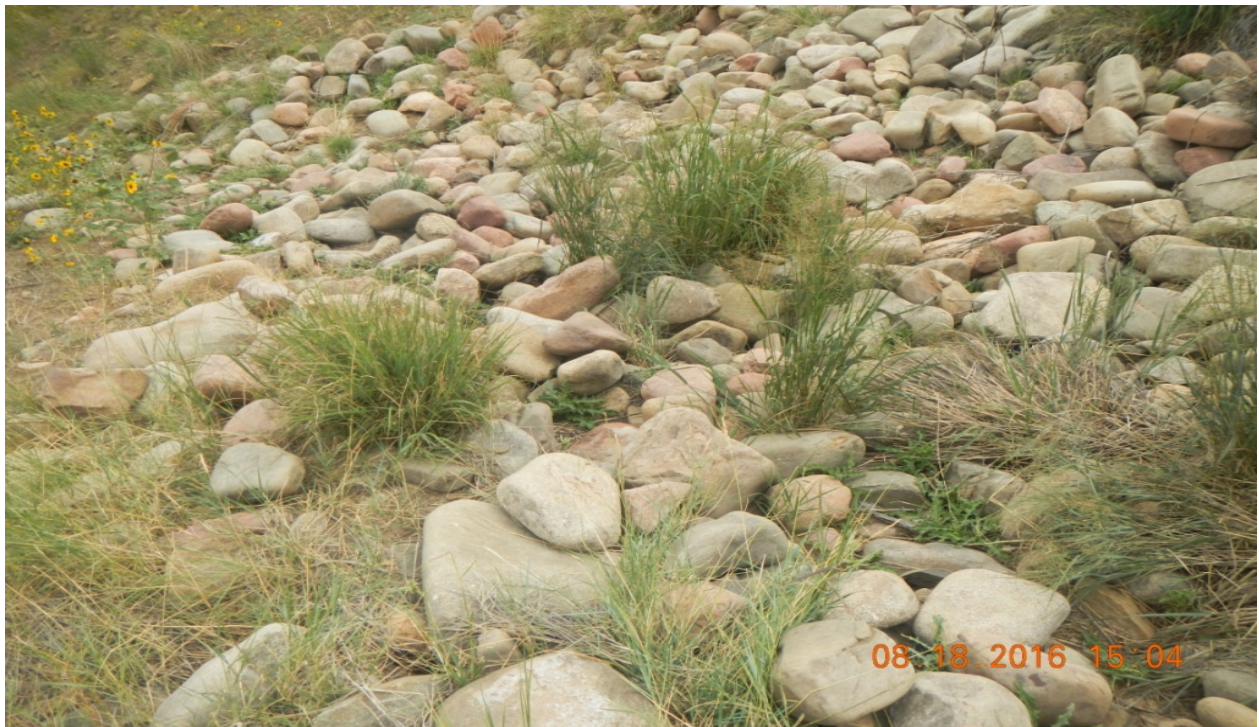
**photo 4:** The Canada thistle noticed in the previous inspection has been removed.

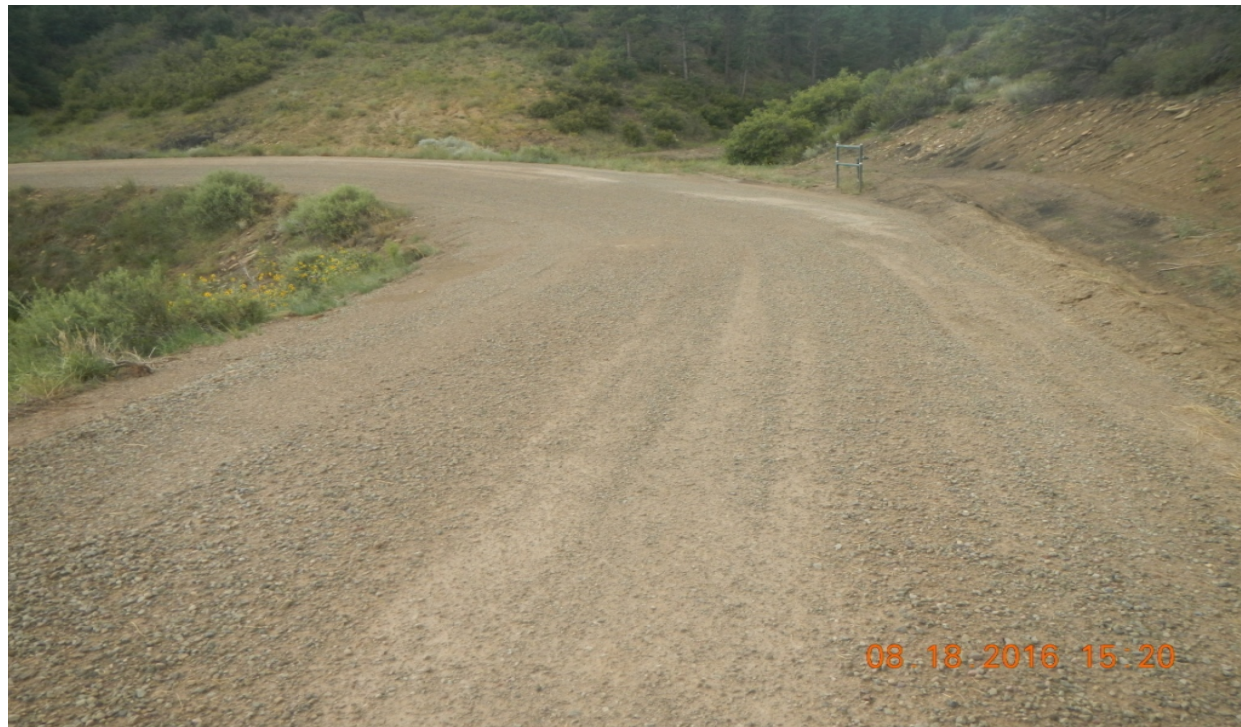
**photo 6:** Facing south along the access road where erosion issues were repaired.
