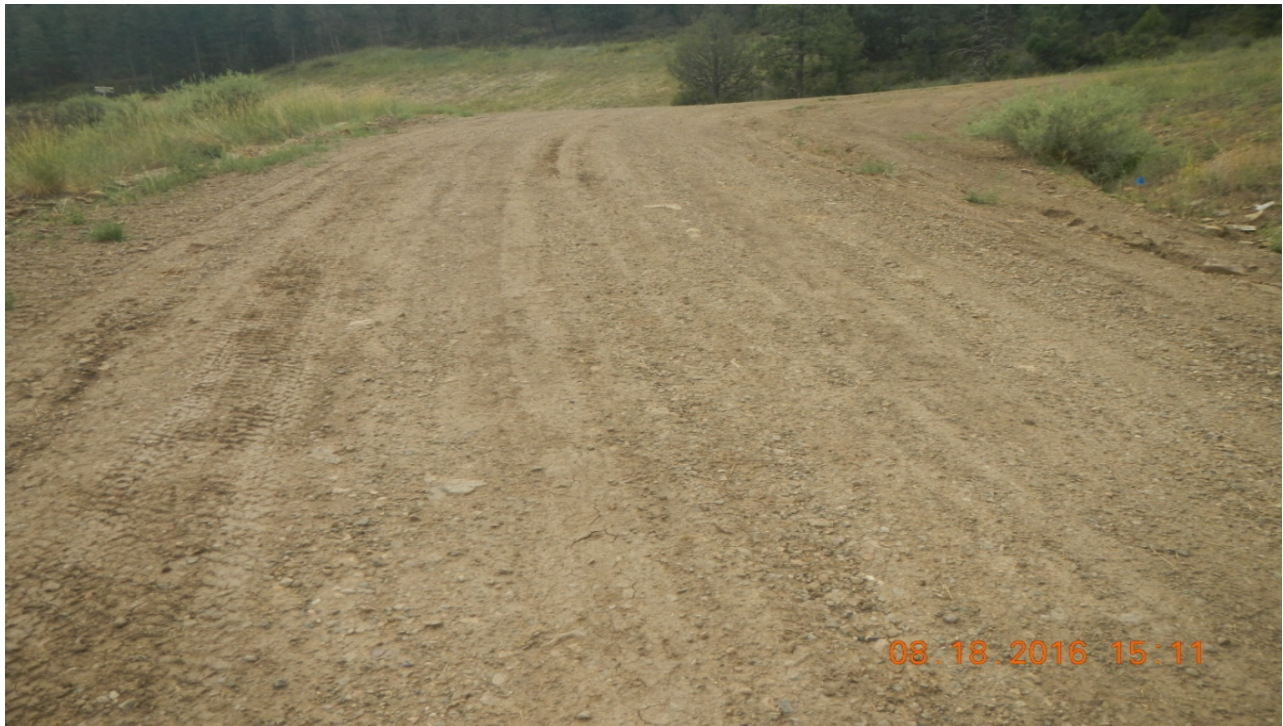
photo 1: Access road near the location, erosion issues has been repaired.

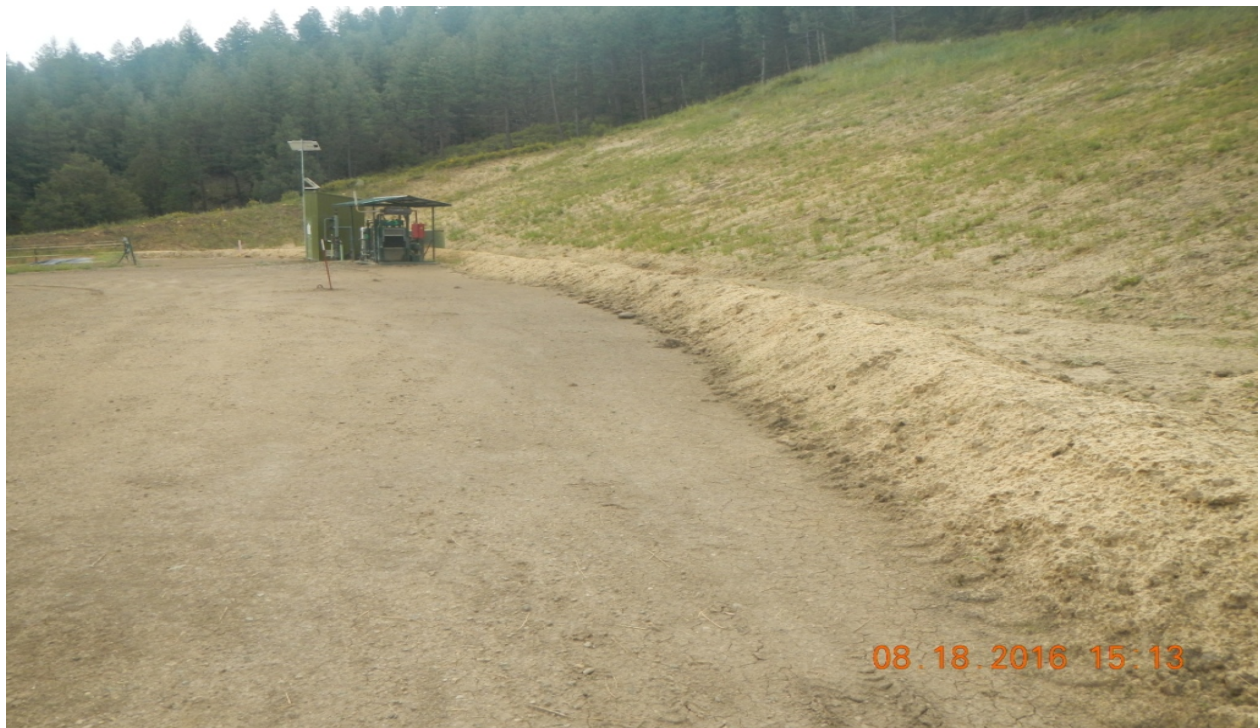
photo 4: The south slope has been hydro mulched/seeded and a berm has been installed.
