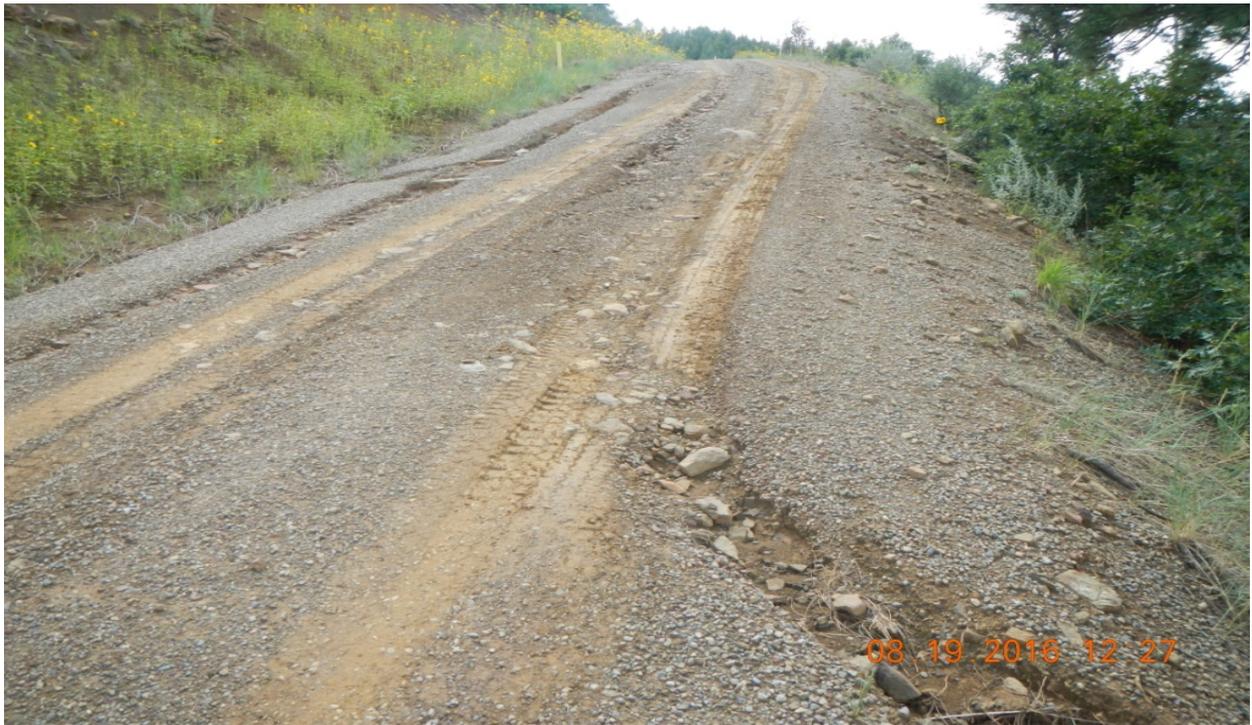
photo 1: Facing south along the main access road to the location. There are signs of erosion occurring along the road.

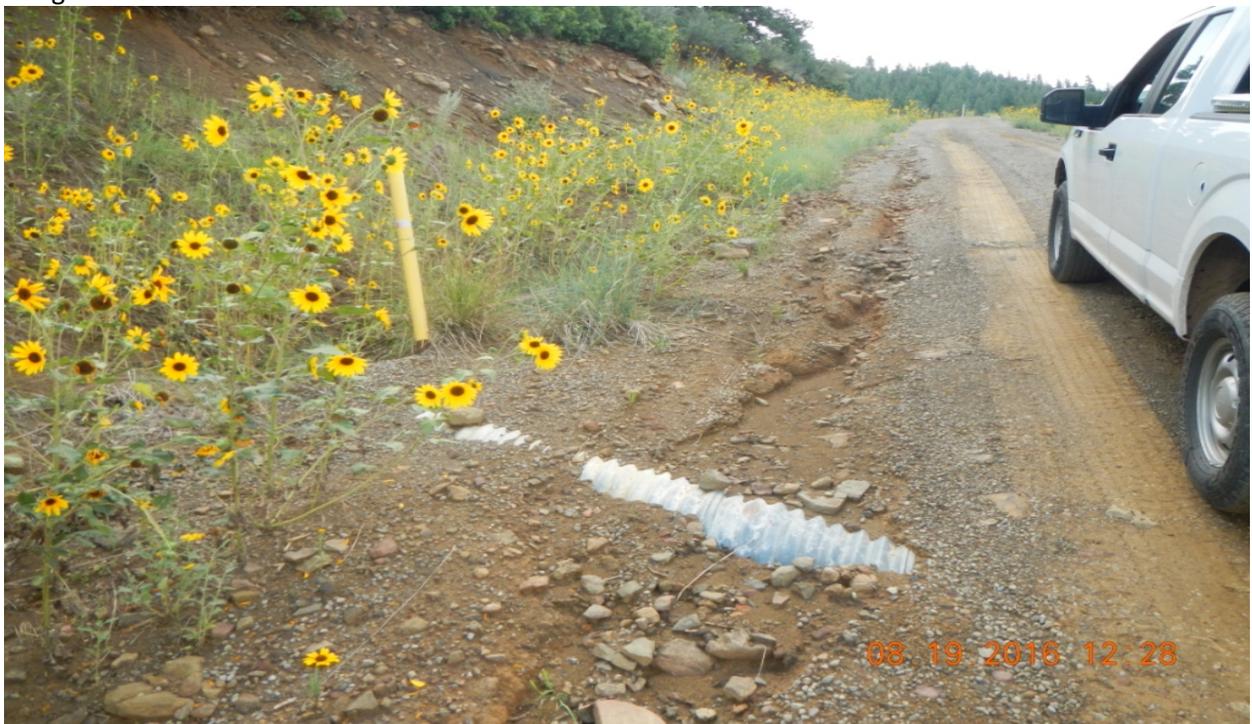
photo 2: Stormwater is not being diverted to the culvert and is running down the road causing erosion.

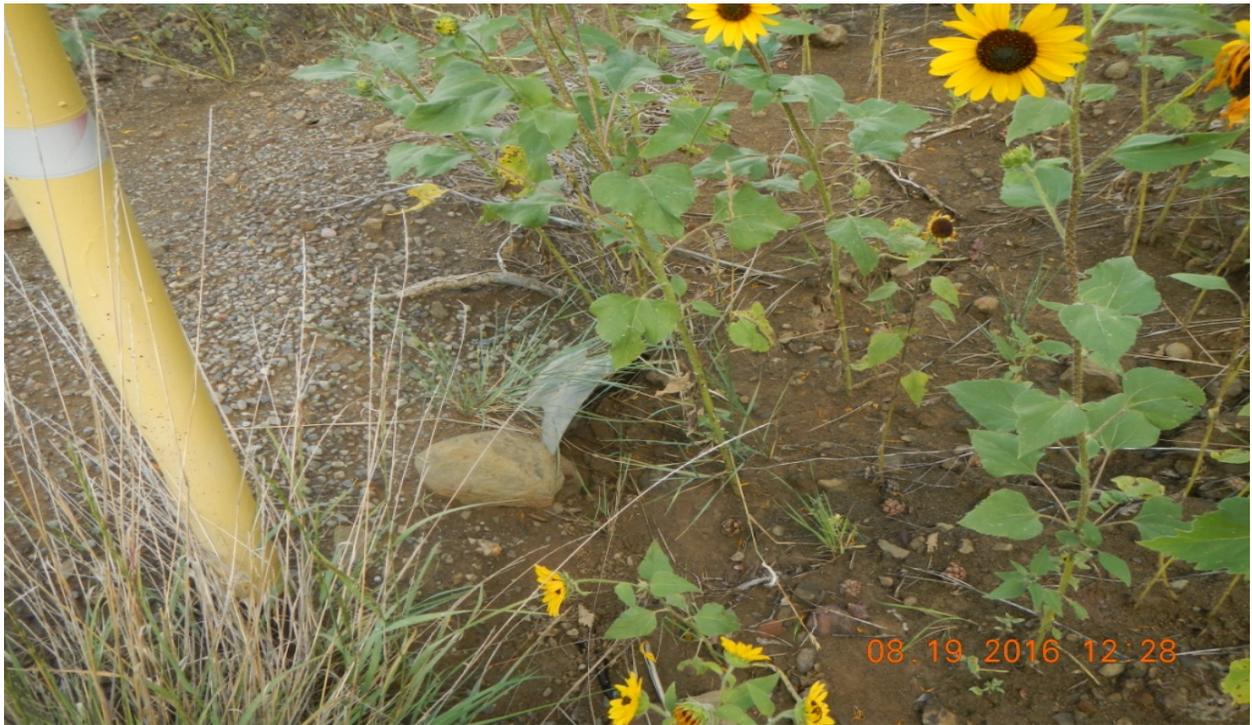
photo 3: The culvert along the road is filled in with sediment. Approximate Lat/Long:37.1637,-104.9130.

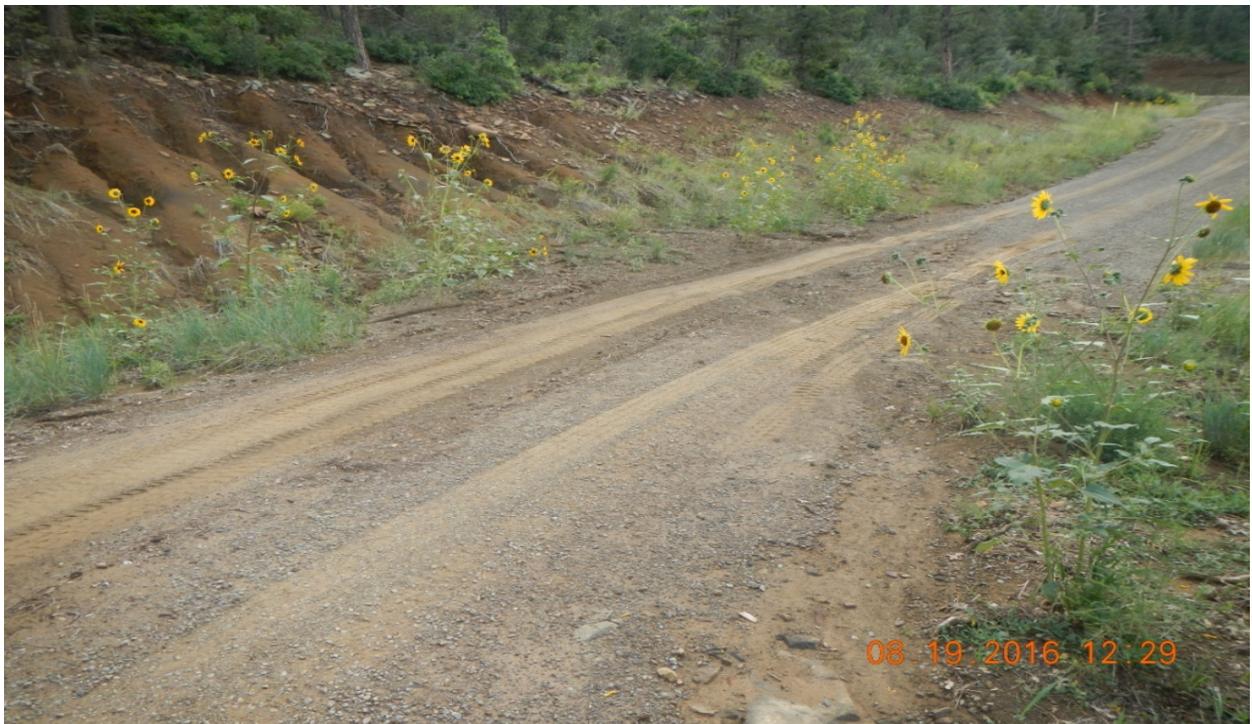
photo 4: Stormwater is flowing across the access road at this point causing erosion across and along the fill slope of the access road. There are erosion channels along the cut slope which is not stabilized.

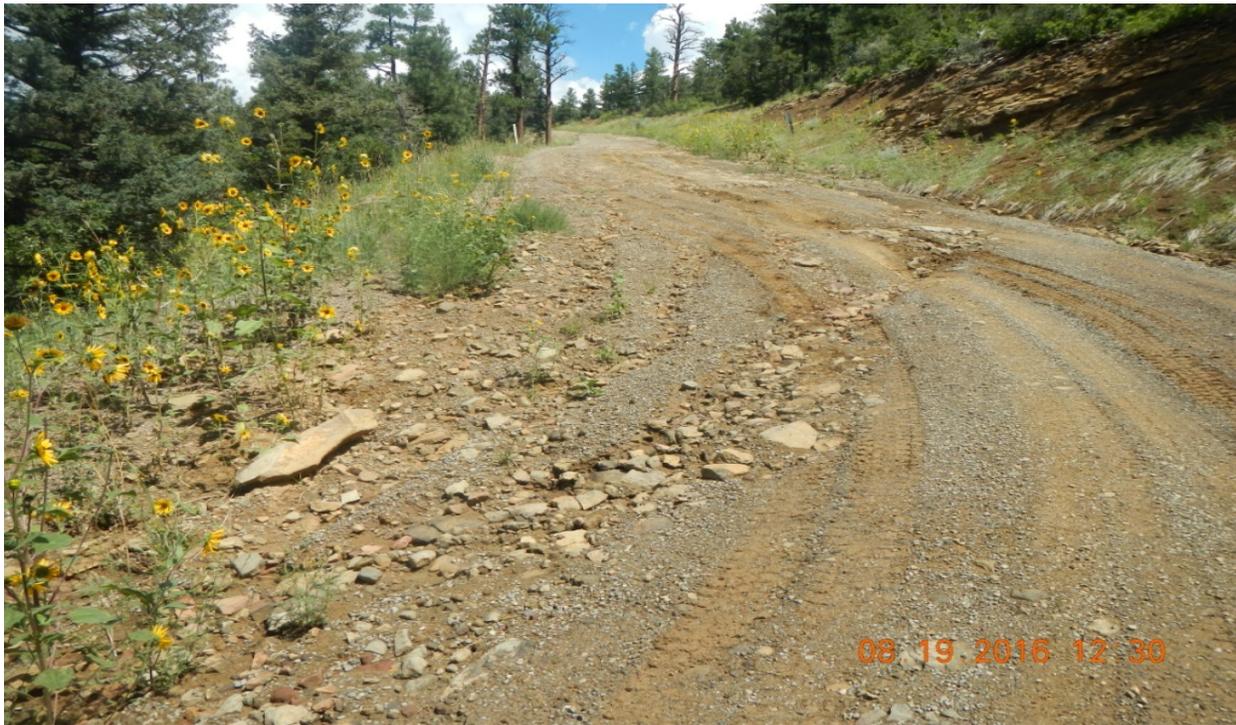
photo 5: The main road switches back to the northeast at this point. There are signs of erosion occurring on the road.

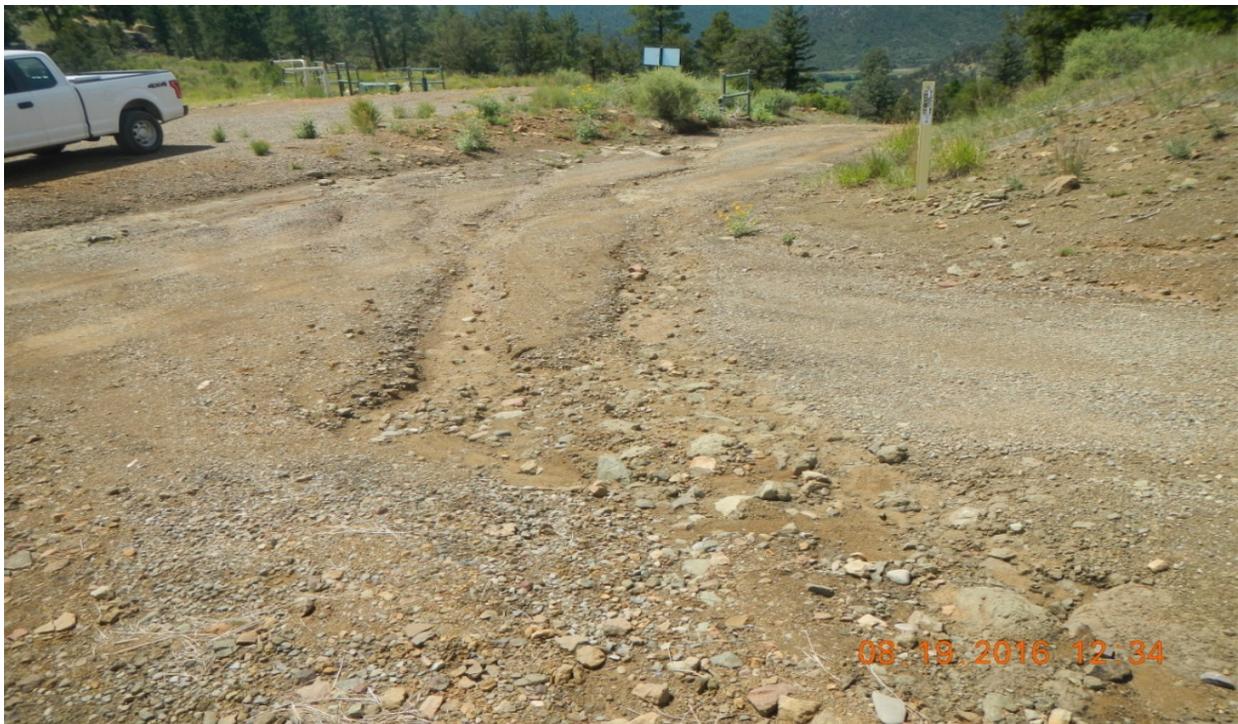
photo 8: Facing back toward the southwest along the main access road. There are signs of stormwater flow causing erosion down the road.
