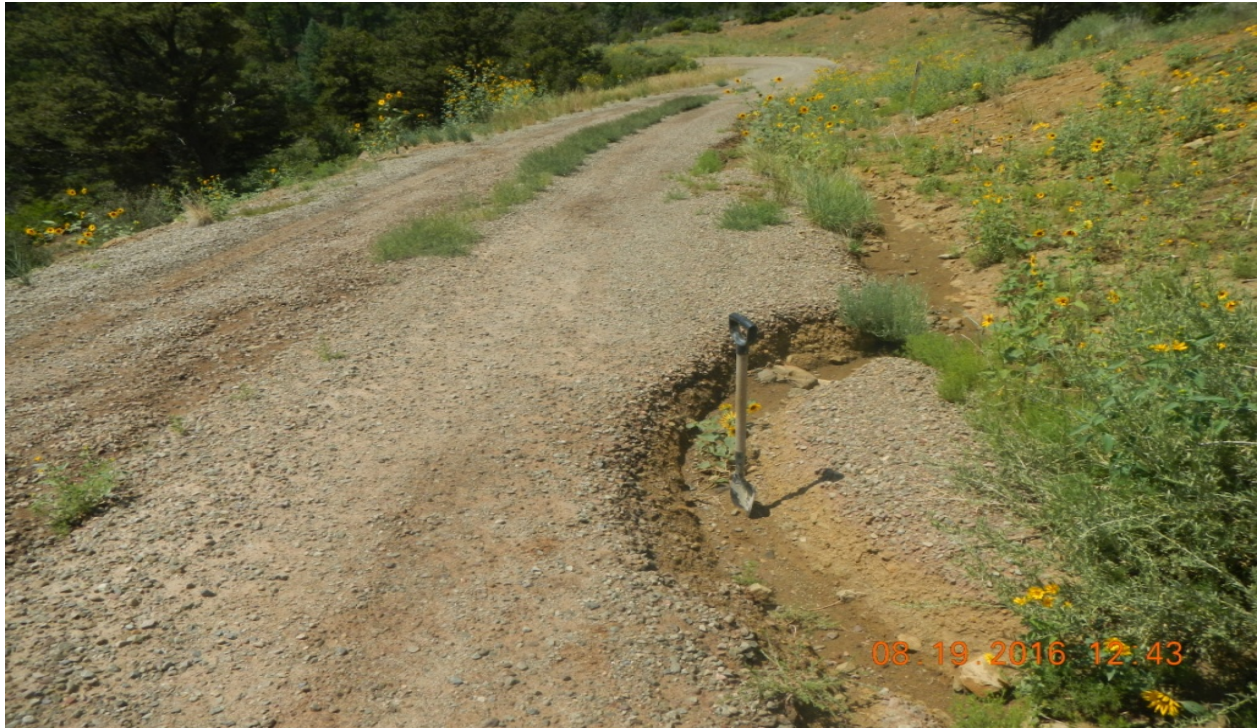
photo 1: Facing southwest along the main access road. There are signs of erosion occurring along the road.

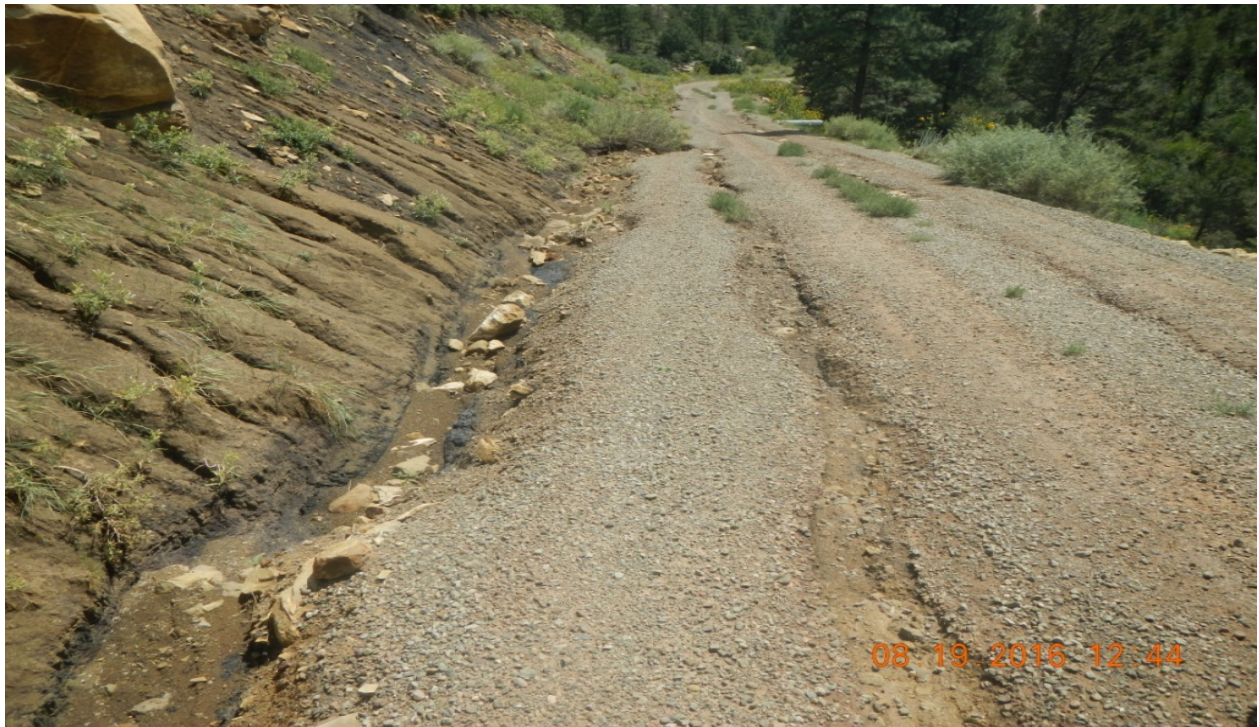
photo 2: Facing southwest along the main access road. Stormwater is being down the road causing erosion on the road. The cut slope is not stabilized and there are signs of erosion occurring.

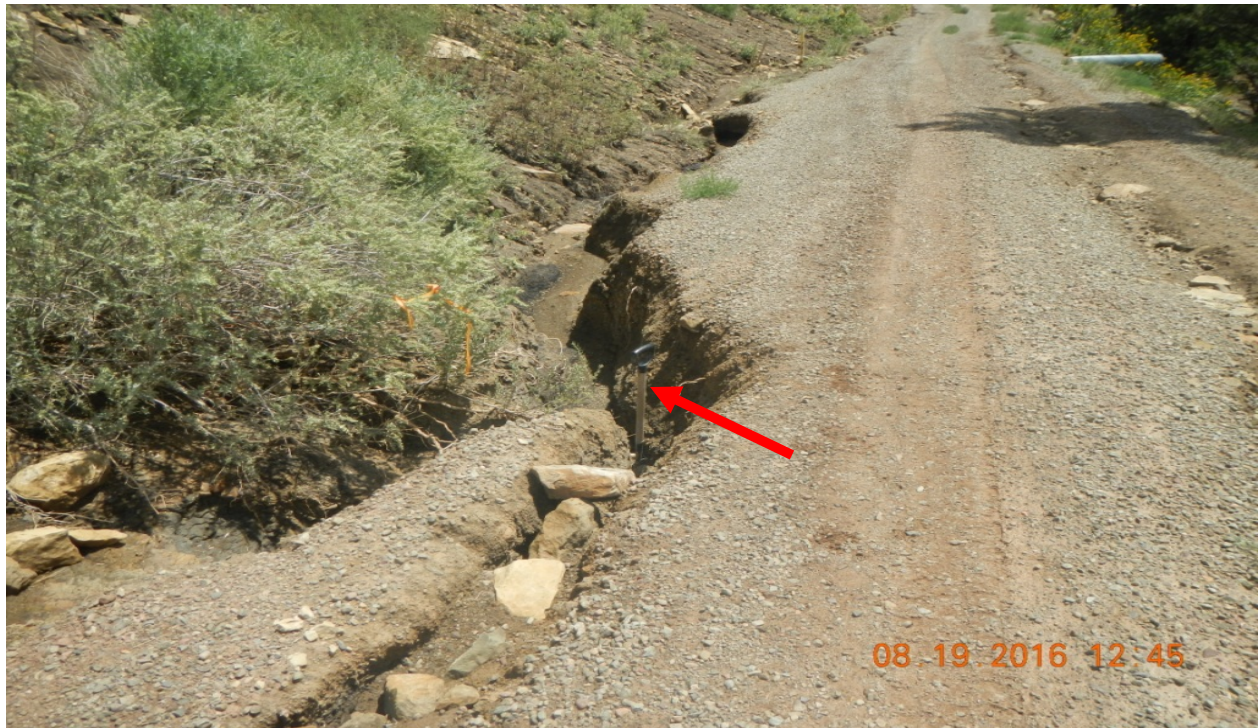
photo 3: Erosion occurring along the road has created a 3 ½ foot hole as indicated by the shovel which red arrow points to.

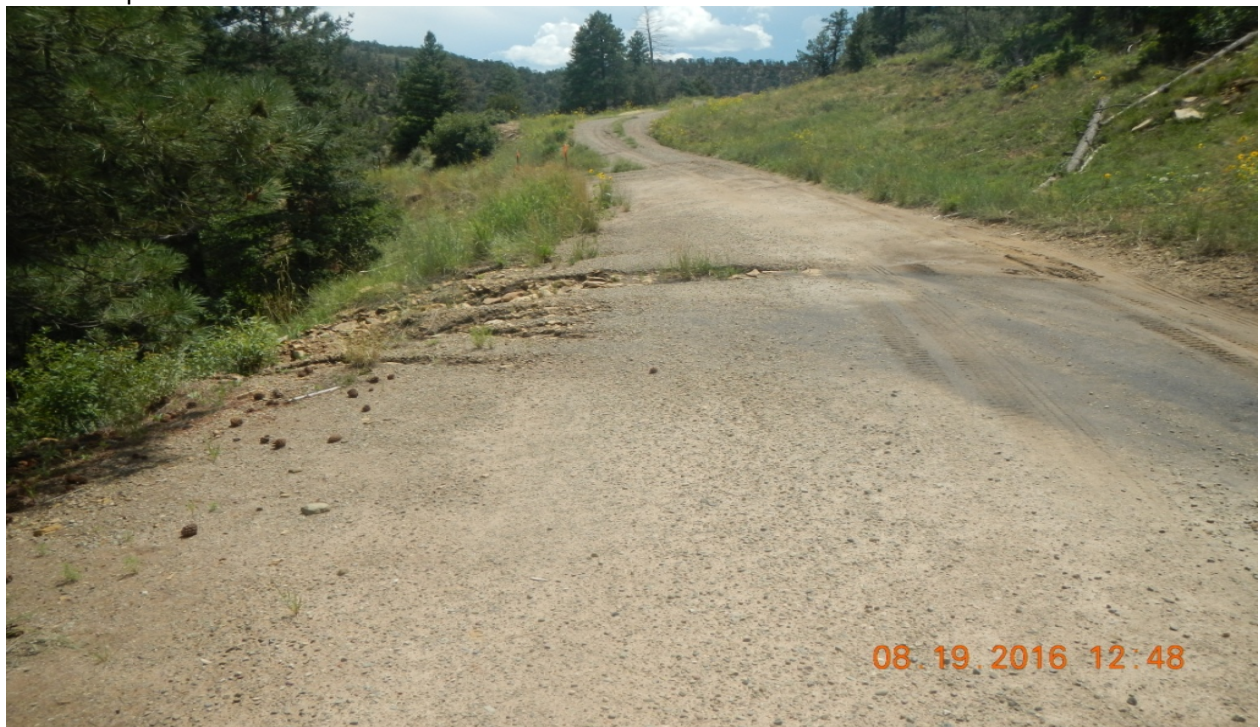
photo 4: Stormwater is flowing across the access road at this point causing erosion across and along the fill slope of the access road.

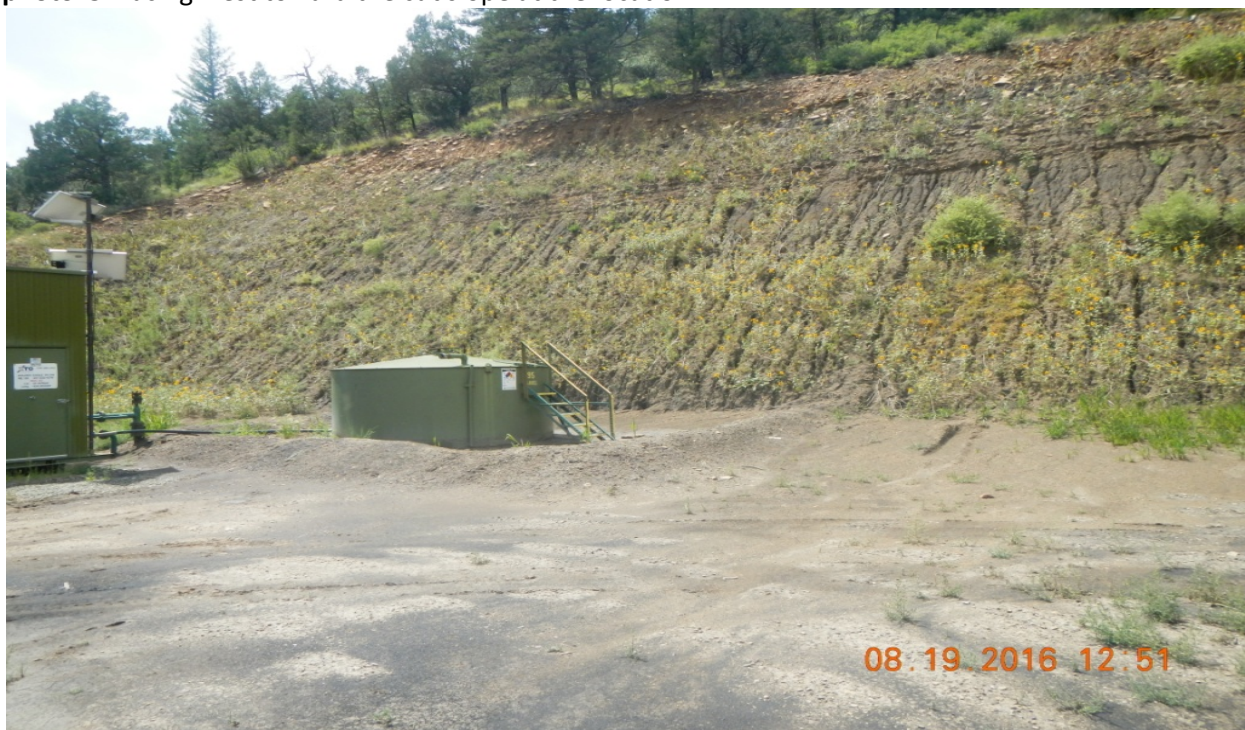
photo 6: Stormwater run-on is causing erosion along the cut slope.

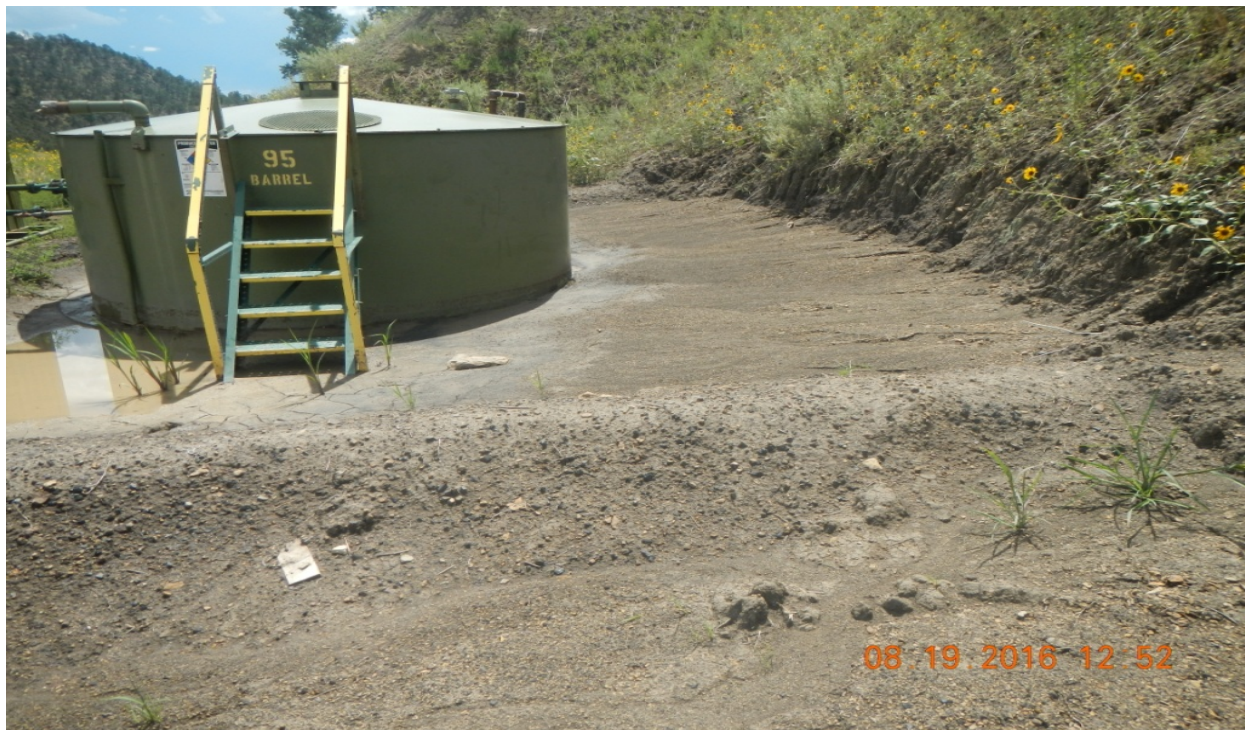
photo 7: Sediment is being deposited off the cut slope into the berm area of this tank.

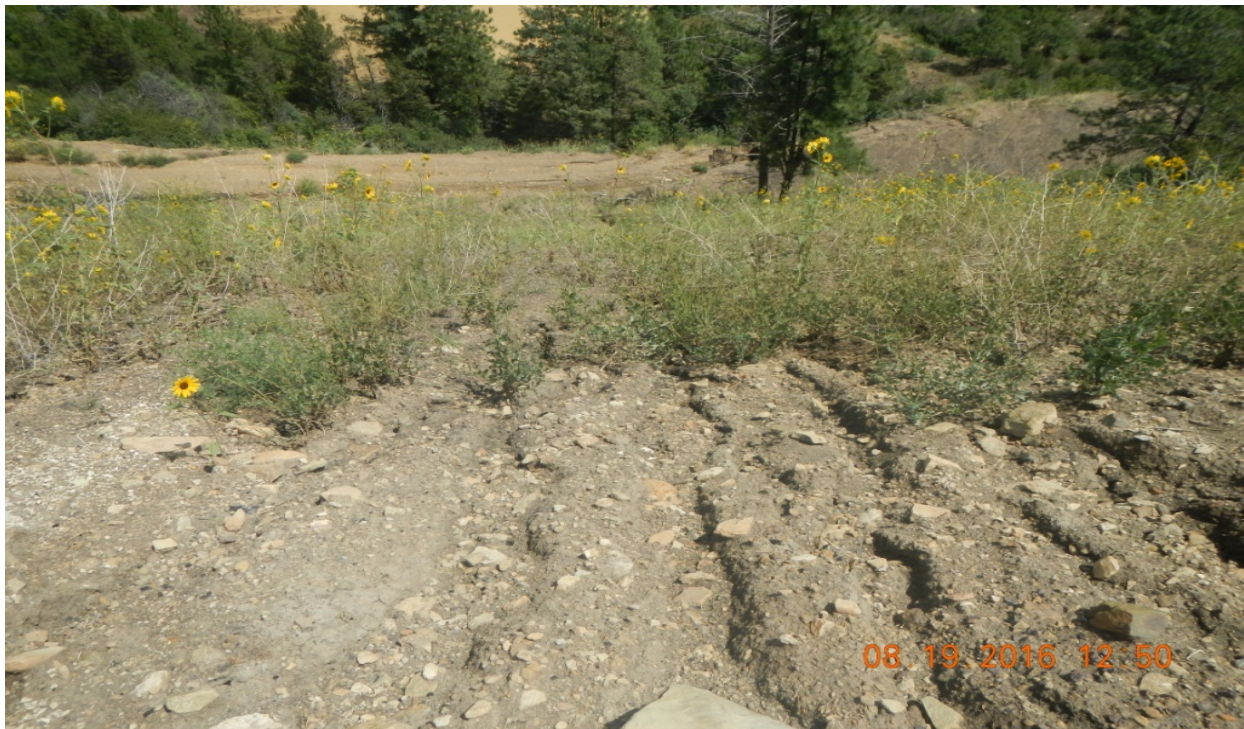
photo 10: Facing east off the fill slope. There is erosion occurring down off the slope.
